**Government of Odisha (GOO)
Chief Engineer, World Bank Projects, Odisha
Odisha State Roads Project**

**Consultancy Services for
Road Sector Institutional Development
Loan # 7577-IN**

**ROAD INFRASTRUCTURE
SAFETY MANAGEMENT REVIEW**

VOLUME I - REPORT

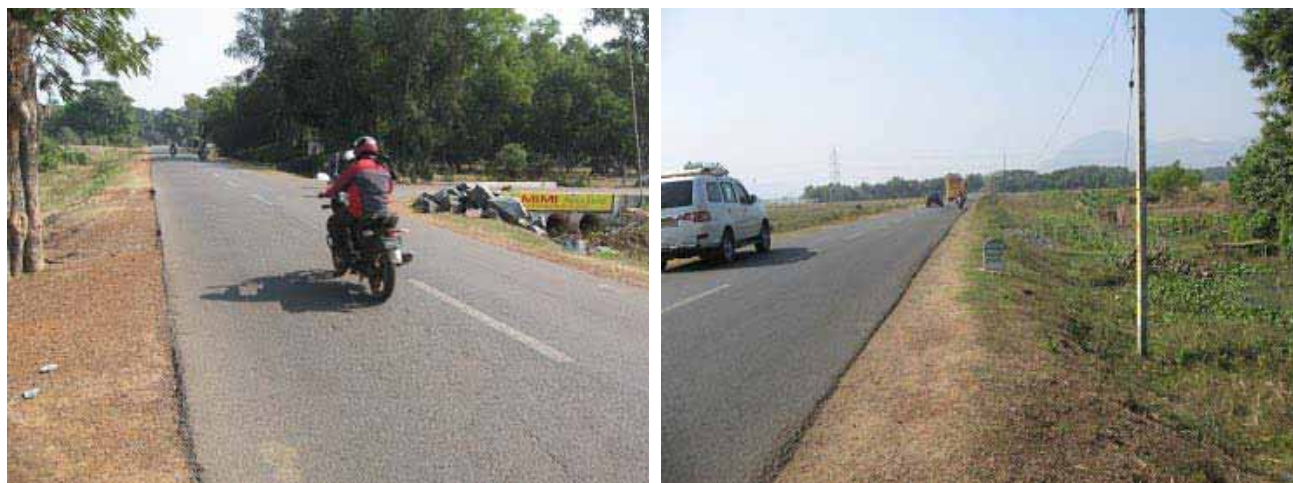
Ch: 1+900

It was informed by the OWD that this intersection location is accident – prone. This stretch of the road is straight and vehicles tend to go at a high speed. The general type of accidents occurring here are angled collision culminating from the speeding side road colliding with vehicle on the main road.

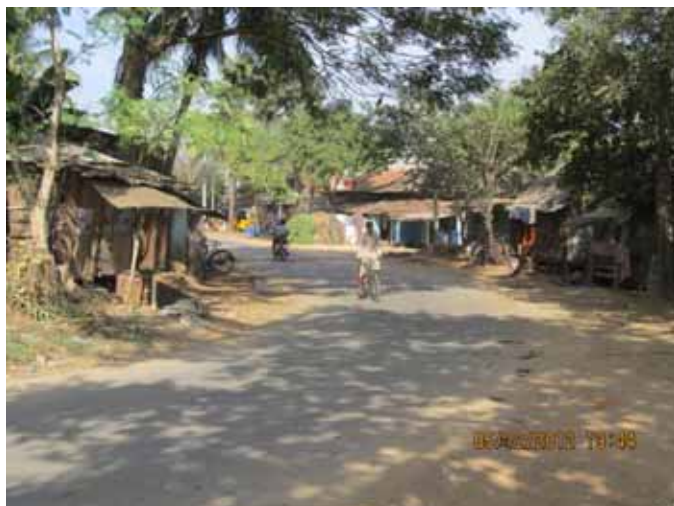
Sharp Curves on Project Road at Km 36+800 and Km 24+900 respectively

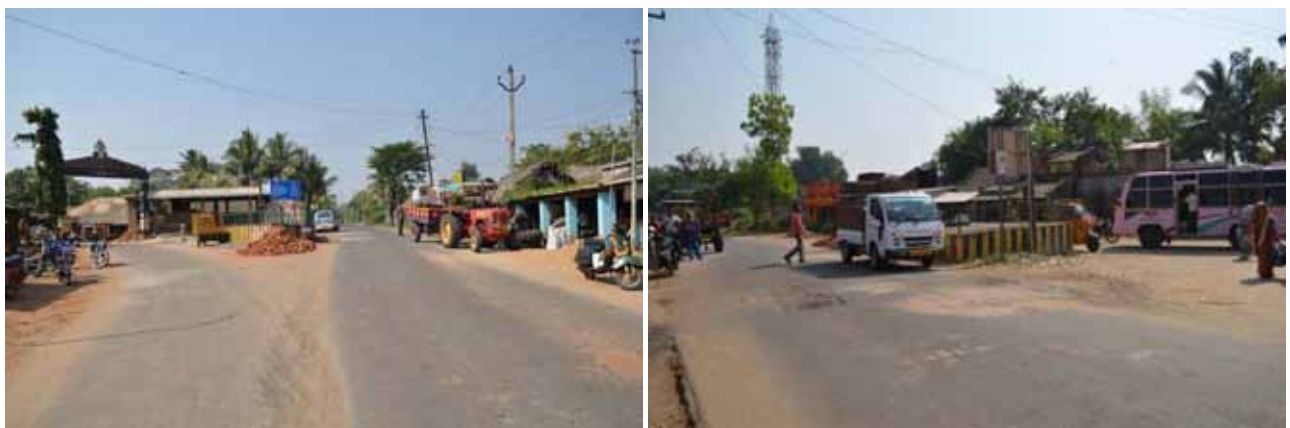
Km 51+000

- Junction of ODR (towards Sambalpur) with SH-65;
- Poor layout of the junction;
- On street boarding of buses, which obstructs visibility;
- Built up structures are present very near to junction;
- Junction control is not established; and
- No street lighting, traffic signs and road markings provided.

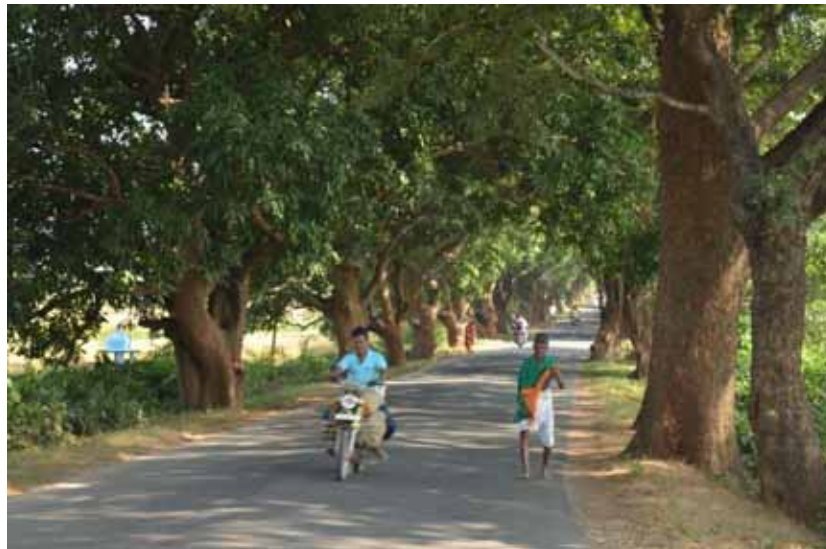
Project road have many locations where trees and street lighting poles are very near to pavement edge.

Several trees near pavement edge

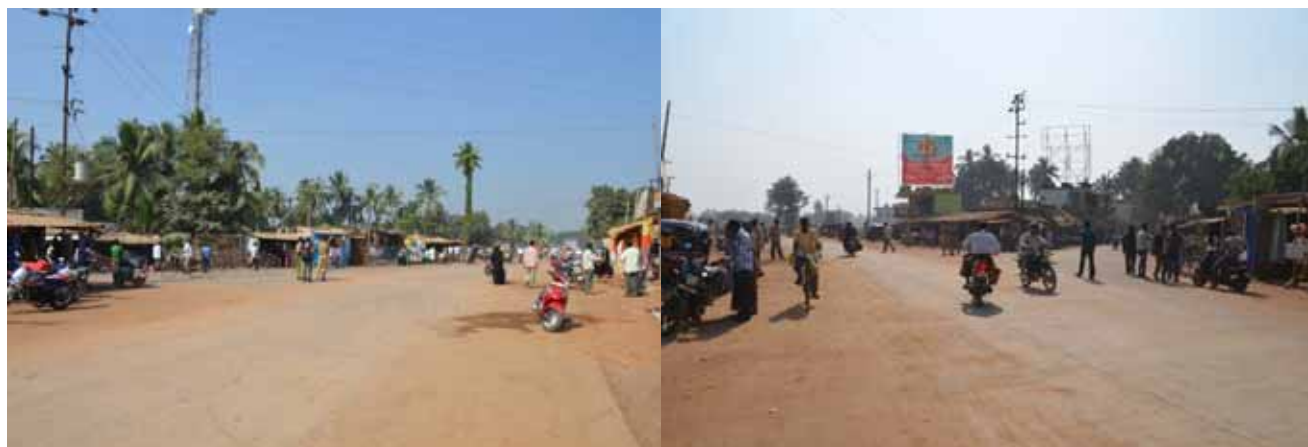
Km 13+700

- Poor layout of the junction with no established traffic control
- Junction area has high commercial activity and the level of encroachment is high
- Significant presence of pedestrians and cyclists, but no separate provisions has been provided
- Street lighting is not provided

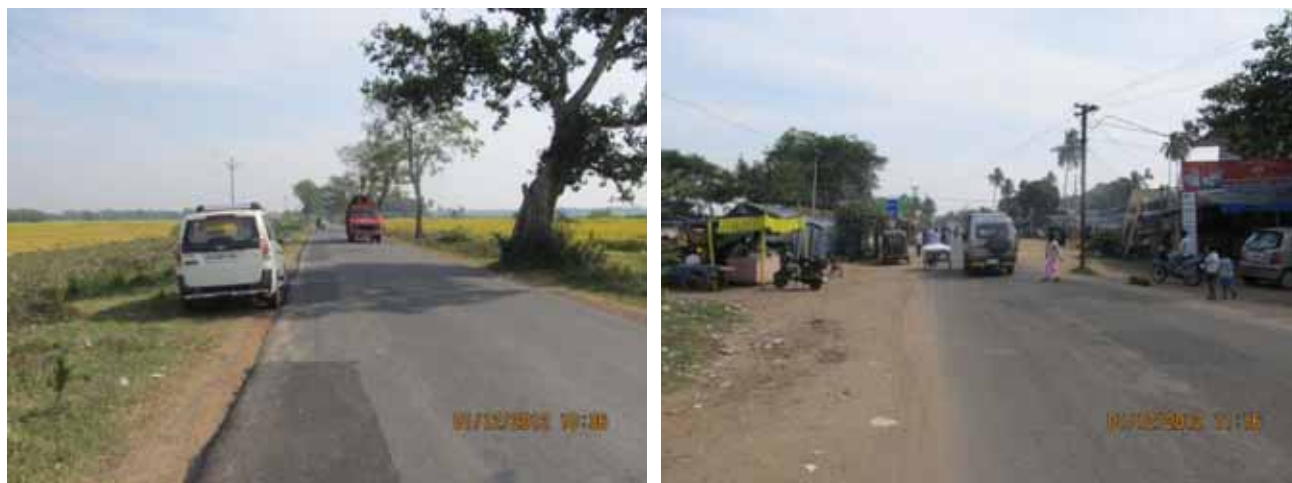
Project road have many locations where trees and street poles are very near to pavement edge.

Tree and street pole near pavement edge

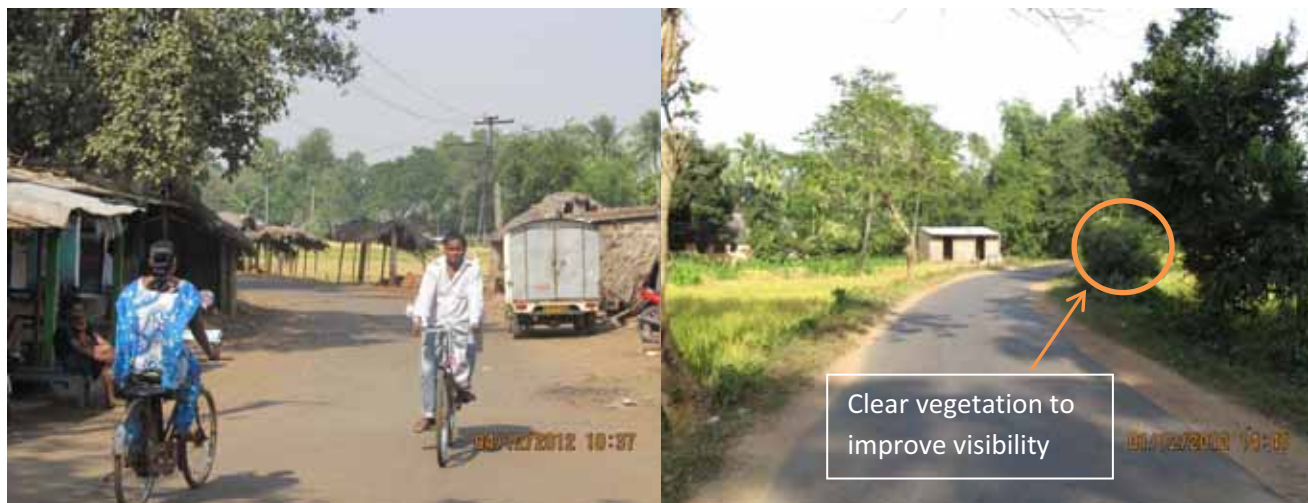
Sharp Curves on Project Road at Km 26+600 and Km 3+550

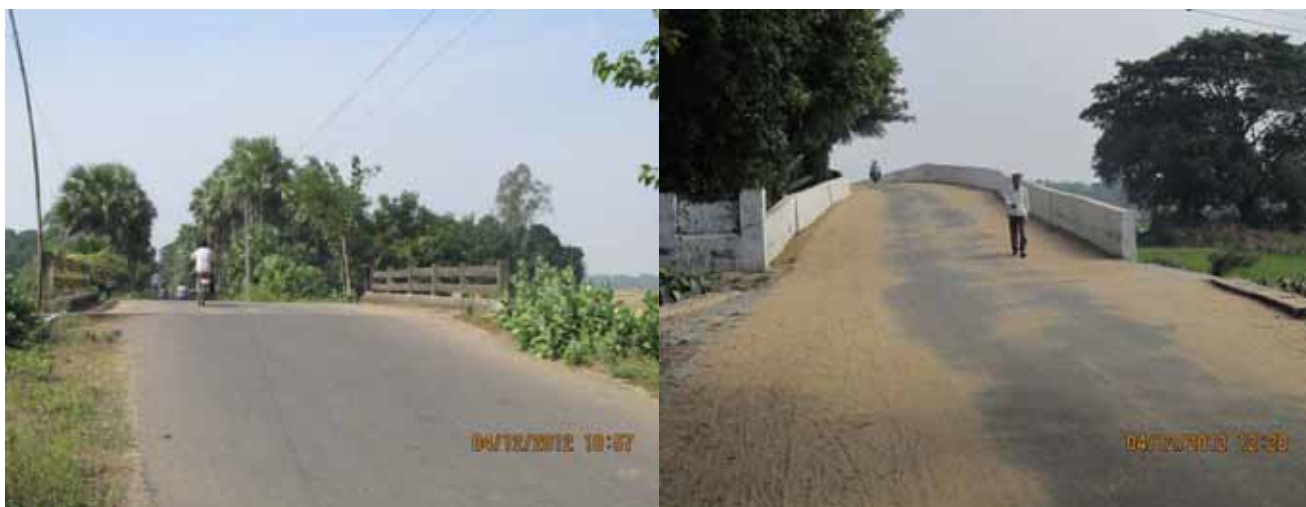
Absence of OHM at Km 24+200 and Km 16+800

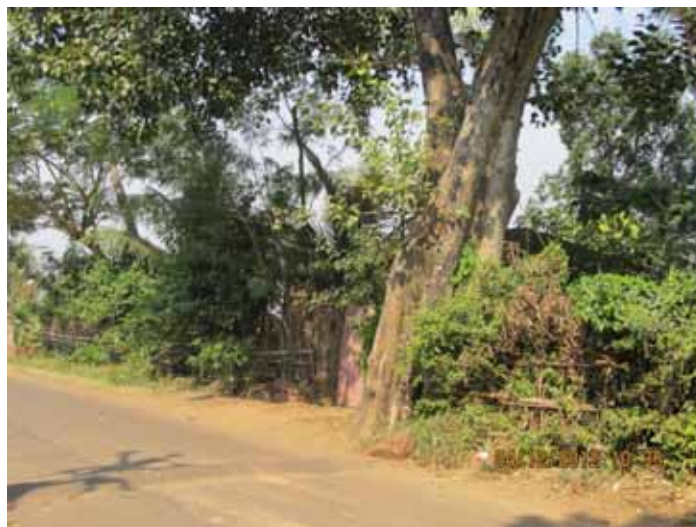
Tree near pavement edge

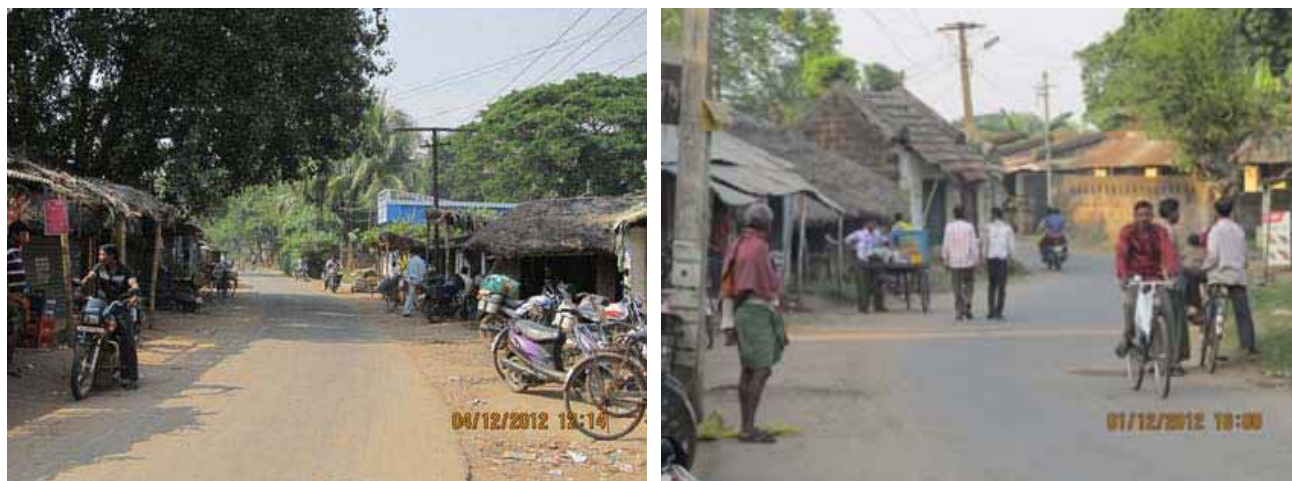
- Traffic is observed not to be very high, but still poses a hazard to cyclists and pedestrians inside village zones
- Heavy encroachments observed on all roadside villages
- Visibility is hampered due to structures present along the road and stopped vehicles, buses on the road

Commercial Sections at Km 16+900 (Kalayanpur Village) and Km 16+400

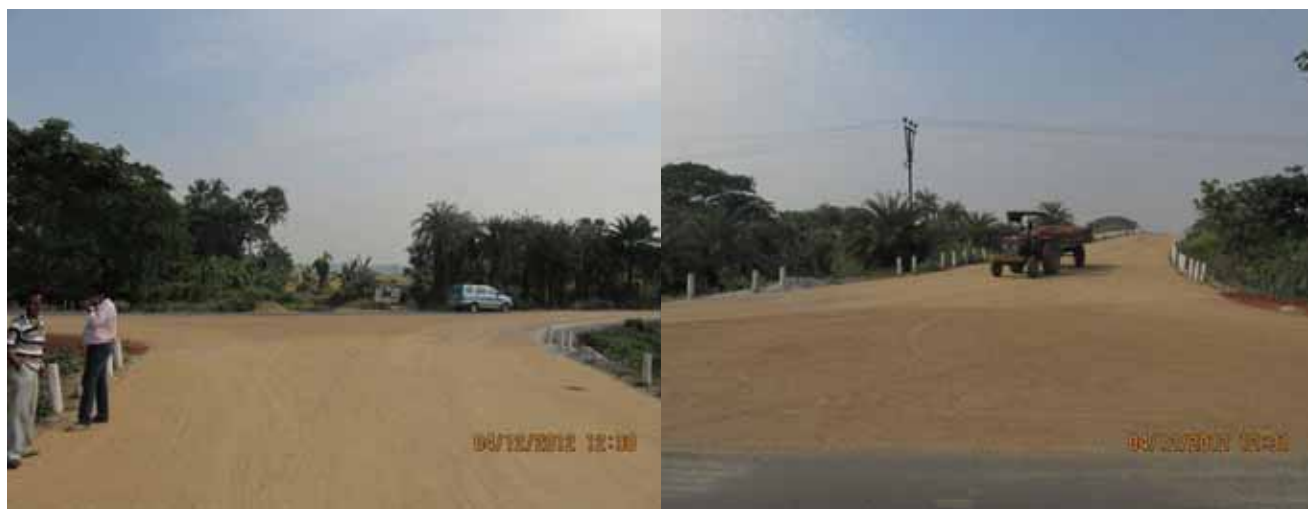
- Two ODRs meet at this point to form a 3-arm junction
- The minor road is wider than the single lane major road
- The minor road leads to a major bridge in less than 50m length from the mouth of the junction
- Layout of the junction is hazardous, and no traffic control/ priority has been established
- Dangerous Overtaking is observed
- No signs and markings provided leaving this junction significantly hazardous during dark conditions

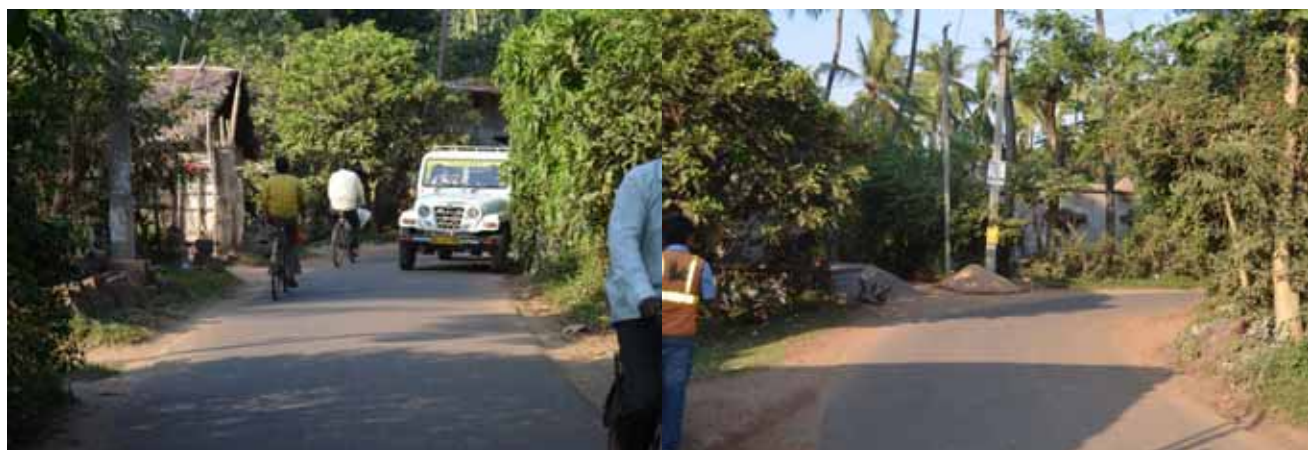
Sharp Curves on Project Road at 1+300 and 1+450

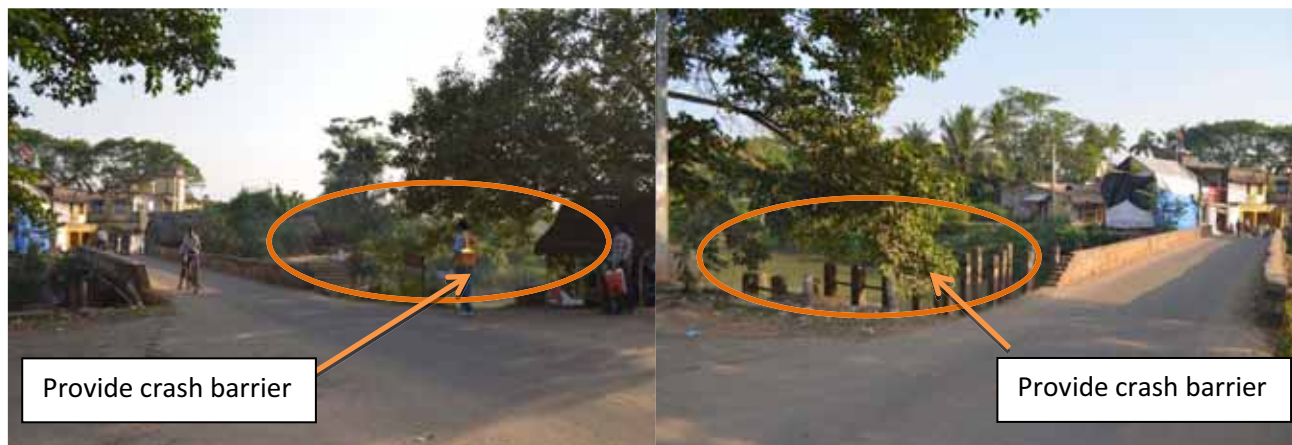
Junction at Km 4+950

At this location, cross roads are noted on approaches to the bridge on either side. The corners of the junctions are unprotected and the traffic is exposed to the gaps in high embankment. At night conditions, this situation becomes significantly hazardous. In the event of the vehicle losing control, fatalities or major injuries may occur due to the exposure to the waterbed.

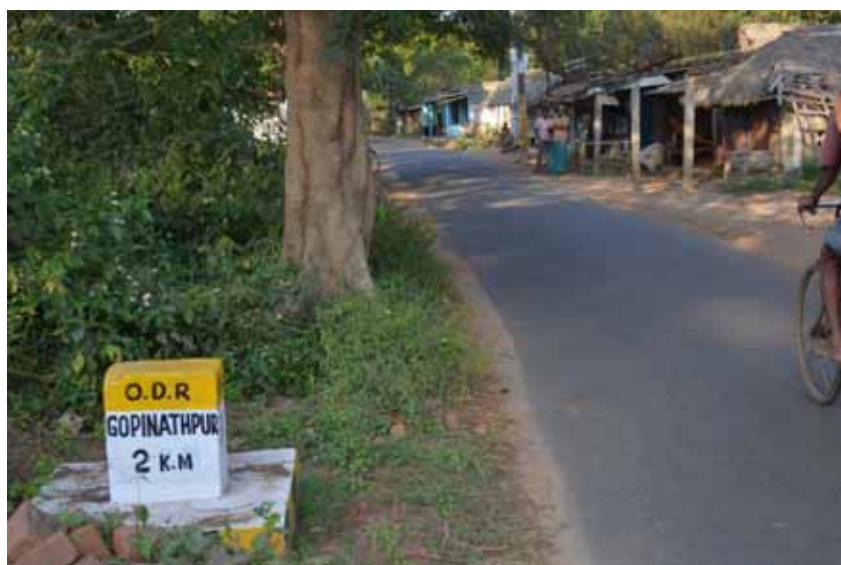
Project road have many locations where trees and street poles are very near to pavement edge.

Tree near pavement edge

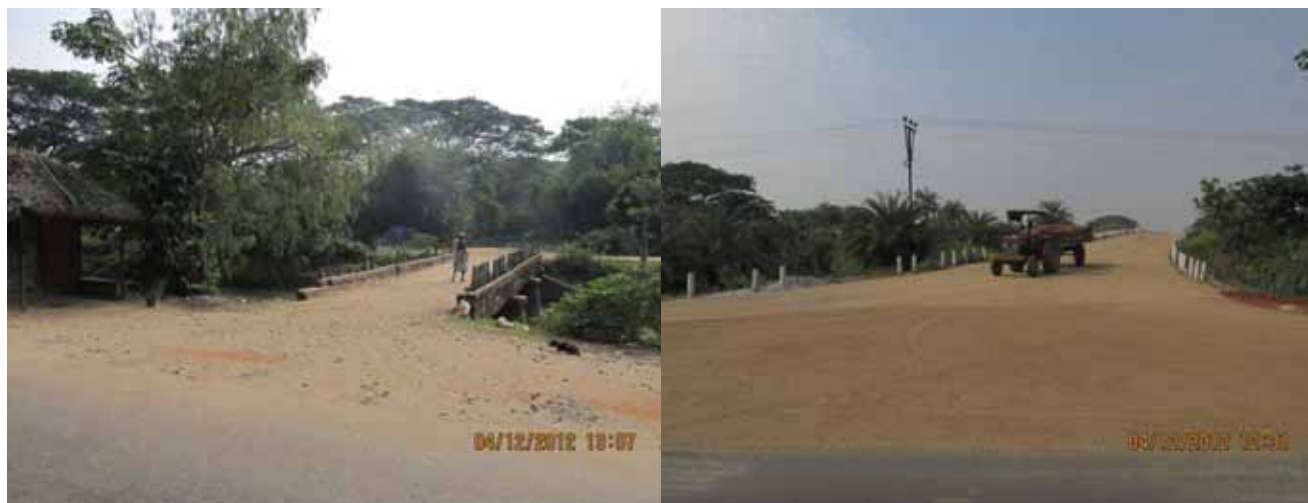
Side Roads at 5+500 and 0+700

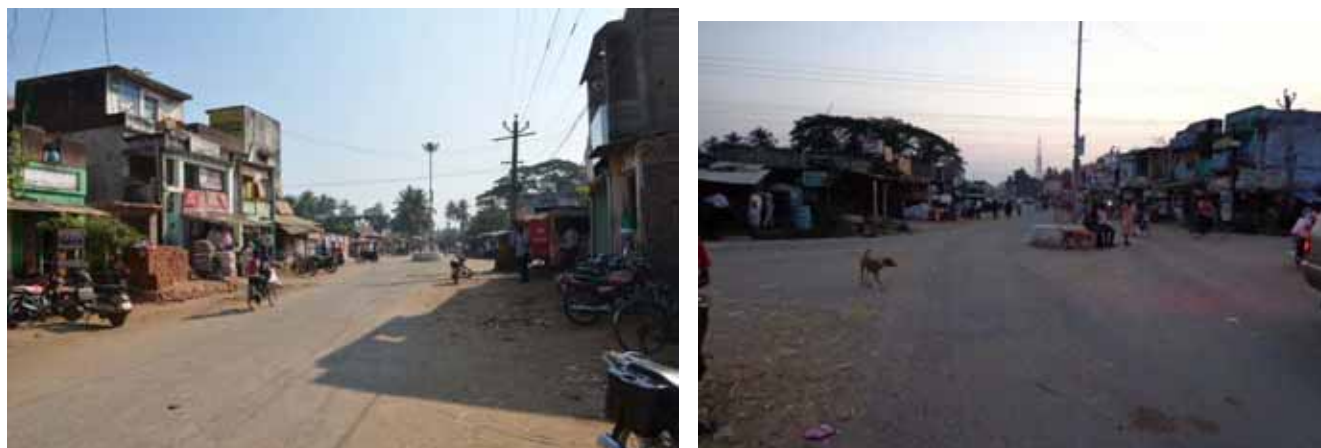
Km 51+200, Sheragada Junction

This intersection is located on Sheragada of SH-29. The Sheragada Junction is joining SH-29 from left and a village road is joining from right side at this location. The intersection layout is non-standard and has no control over the traffic movement, and the priority is also confusing. This encourages lawless traffic movement and may be hazardous for the traffic. This Junction is completely built up.

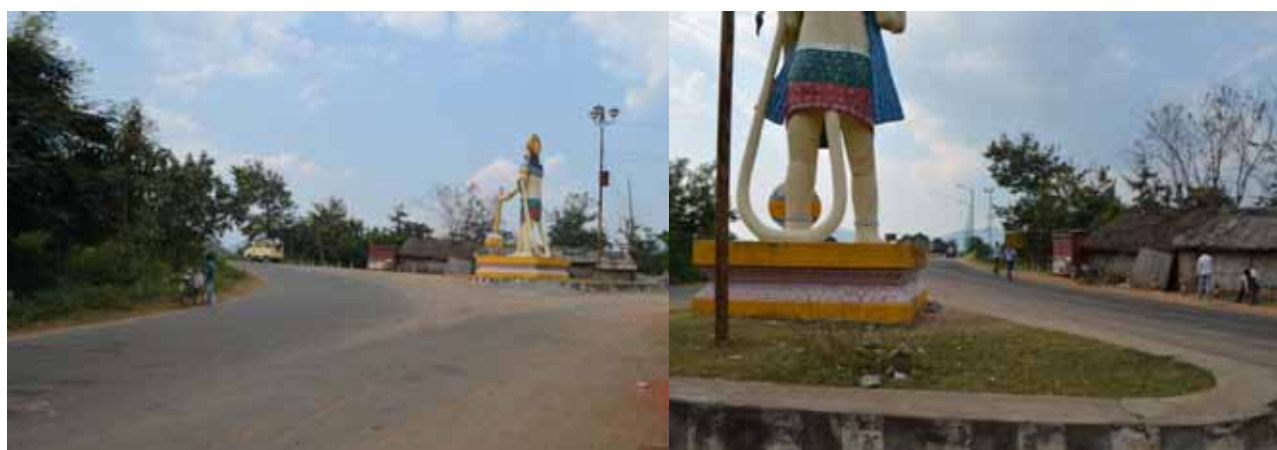
Km 96+000

This intersection is located on Sorada of SH-36. The Sorada Junction is joining with NH-59 at this location.

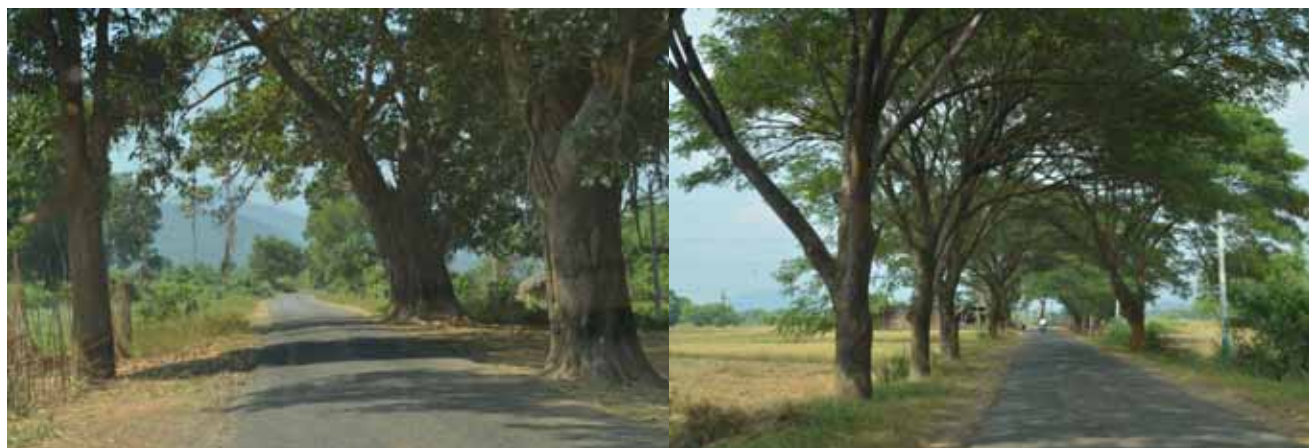
Road side objects present along this stretch of road are few trees. Trees are on the edges of the carriageway, which has no any protection.

Trees are on the edges of the carriageway

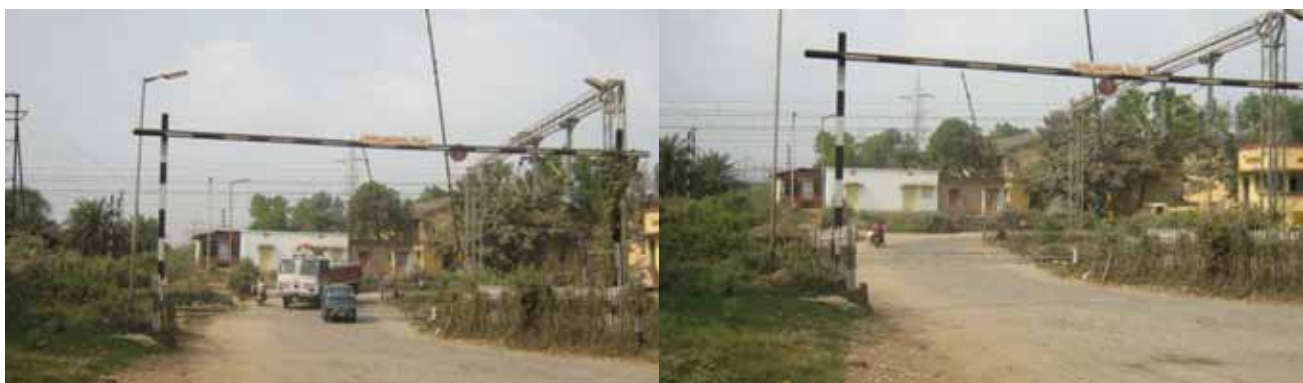
In this section, accident prone area as per directed by OWD representative are at chainage Km 24+000 (level crossing near Jagannathpur) due to bad road condition and also level crossing on curve.

Accident prone area (Level Crossing)

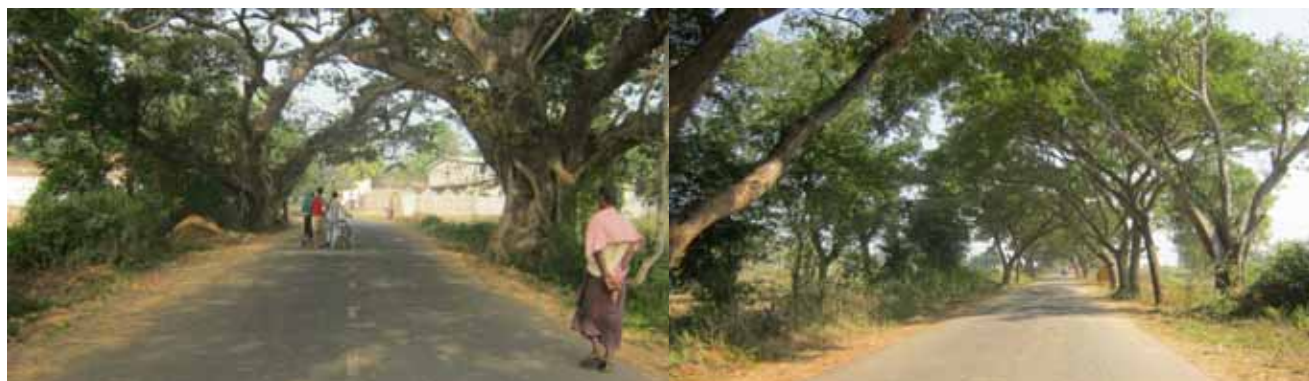
Road side objects present along this stretch of road are few trees.

Trees are on the edges of the carriageway

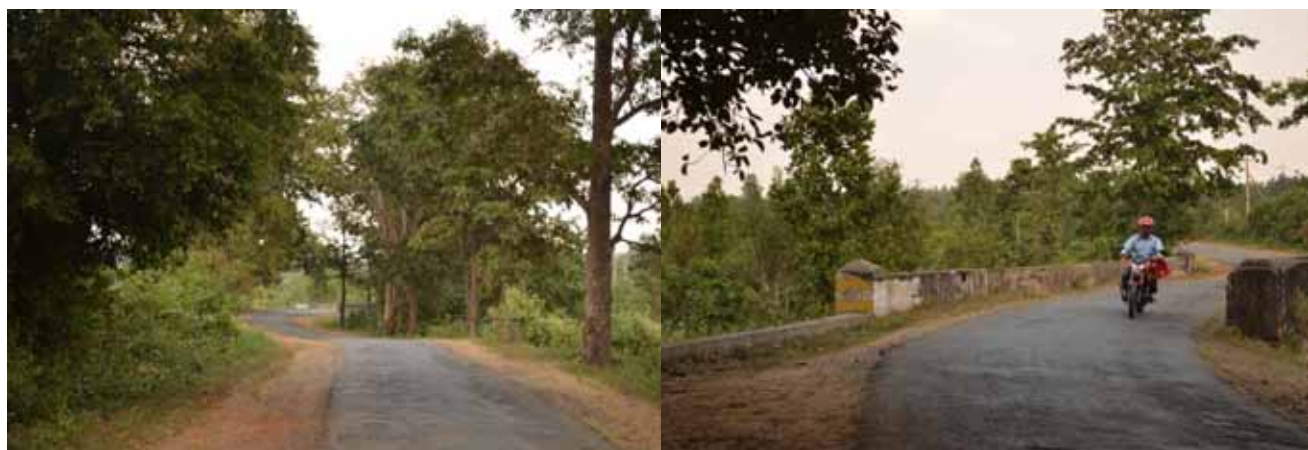
These are observed at chainage Km 14+300;

Reverse Curve

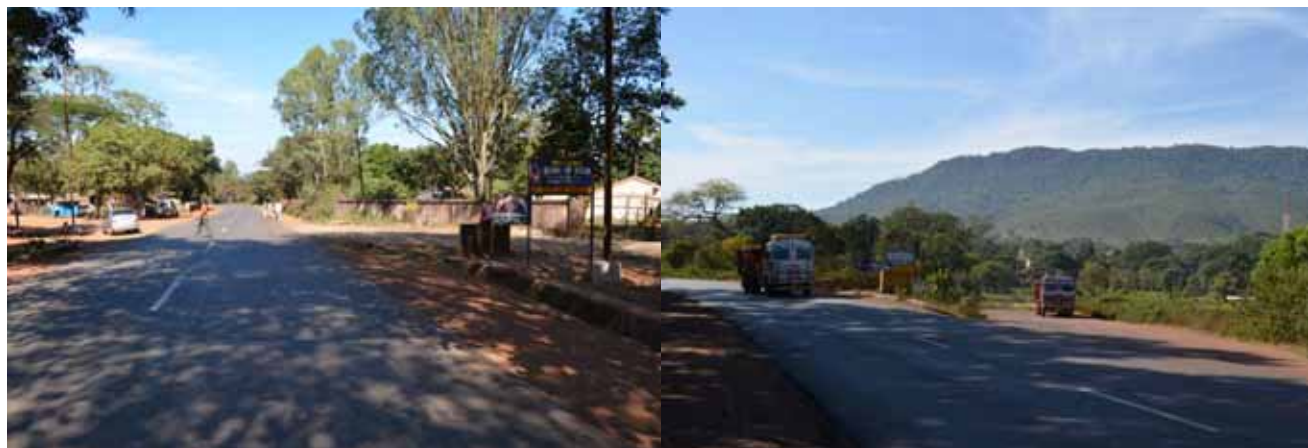
Skwed Minor Junctions at Km 451+600 and Km 467+400

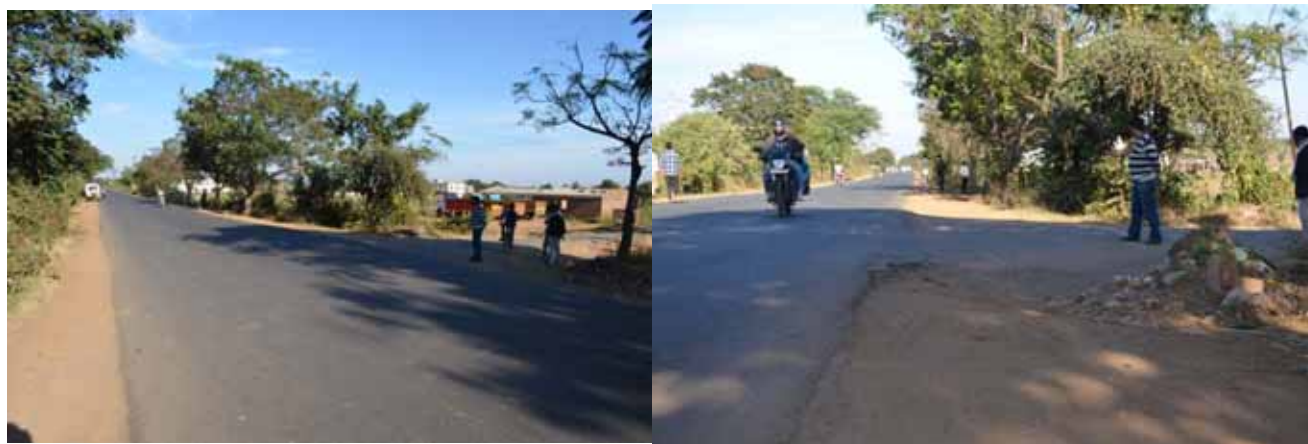
Minor Junctions at Km 481+200

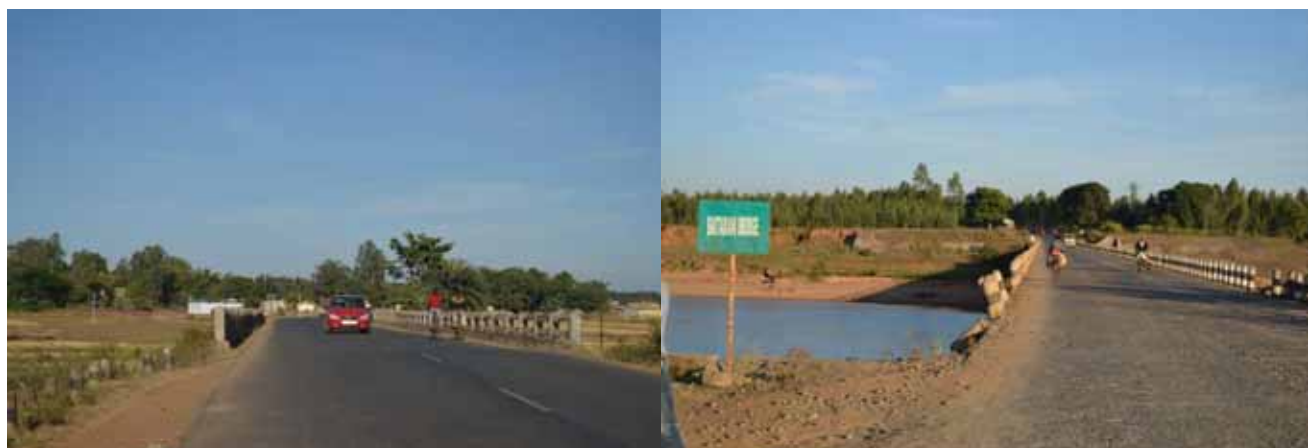
Absence of OHM on the structure at Km 484+900 and absence of approach protection at Km 509+800

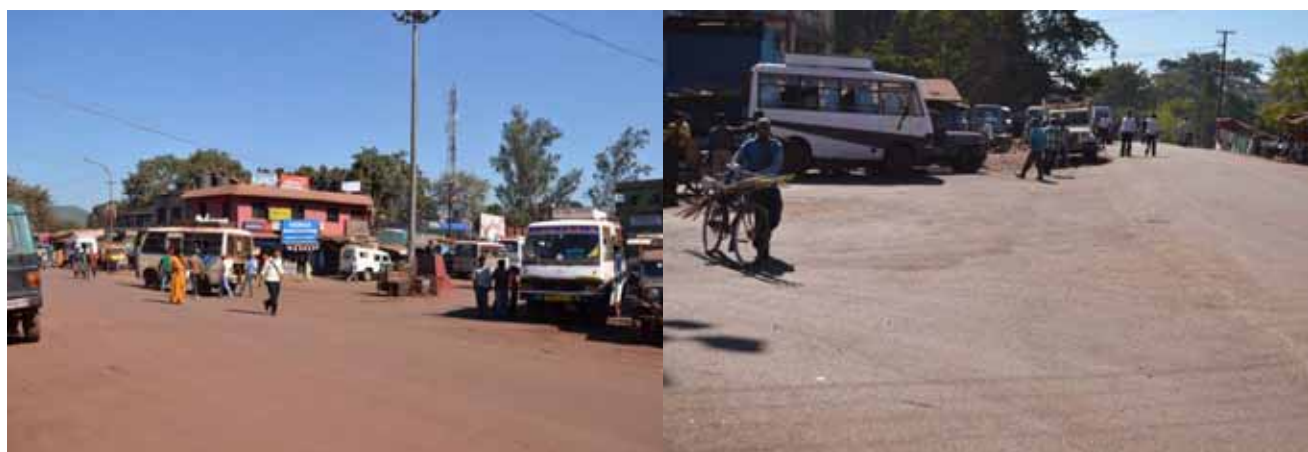
- This junction is intersection of urban road and expressway.
- Heavy two wheelers, pedestrians, cyclists are present on the junction.
- No traffic islands are present for safe and effective maneuver of traffic. A non-standard central island is present obstructing the sight of the approaching traffic.
- Street light is present on the junction.

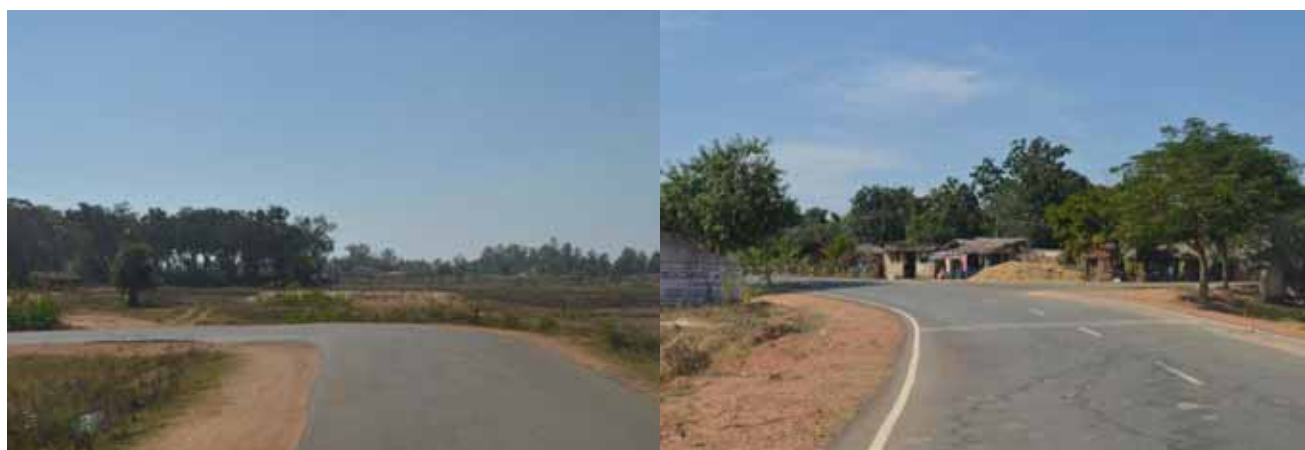
Sharp Curves on Project Road at Km 80+000 and Km 75+200

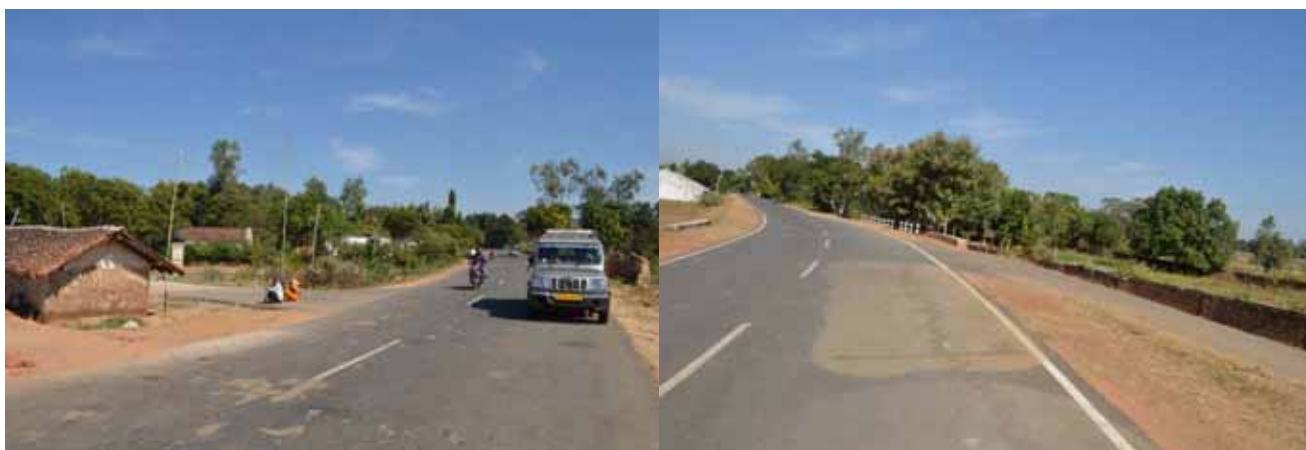
Skewed Side Road at Km 73+600 and Km 88+100

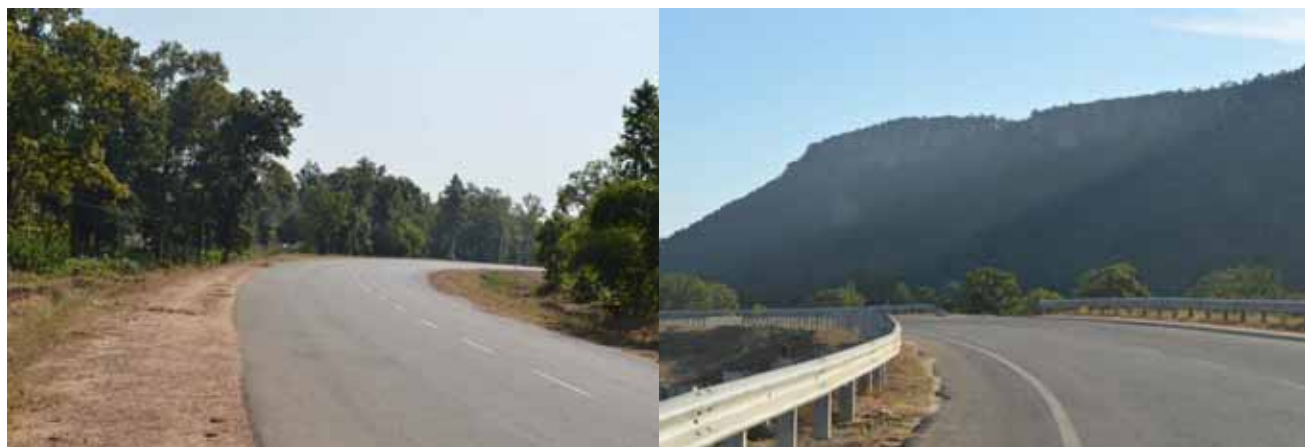
Curves on Project Road

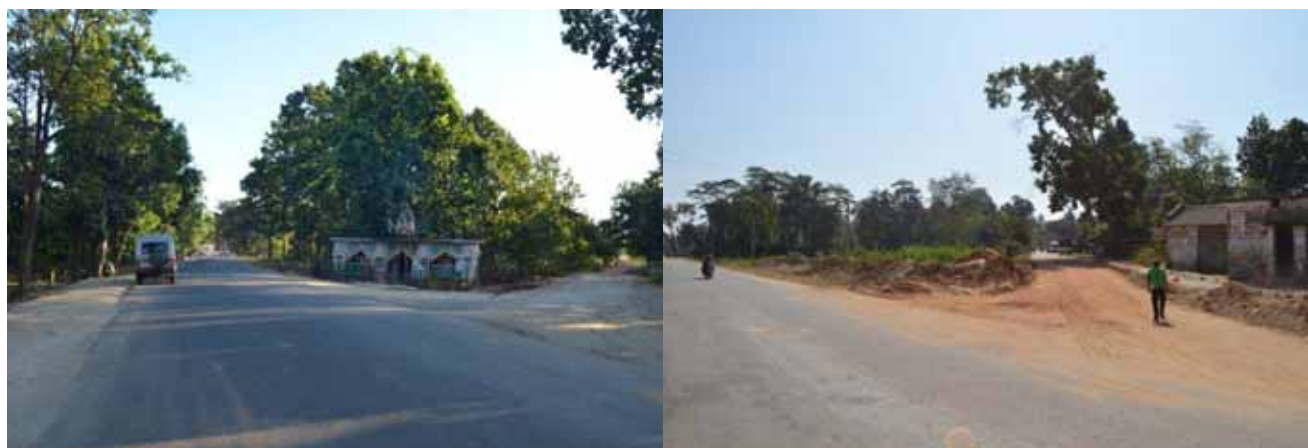
Skewed Side Road at Km (Section I) and Km 10+500 (Section II)

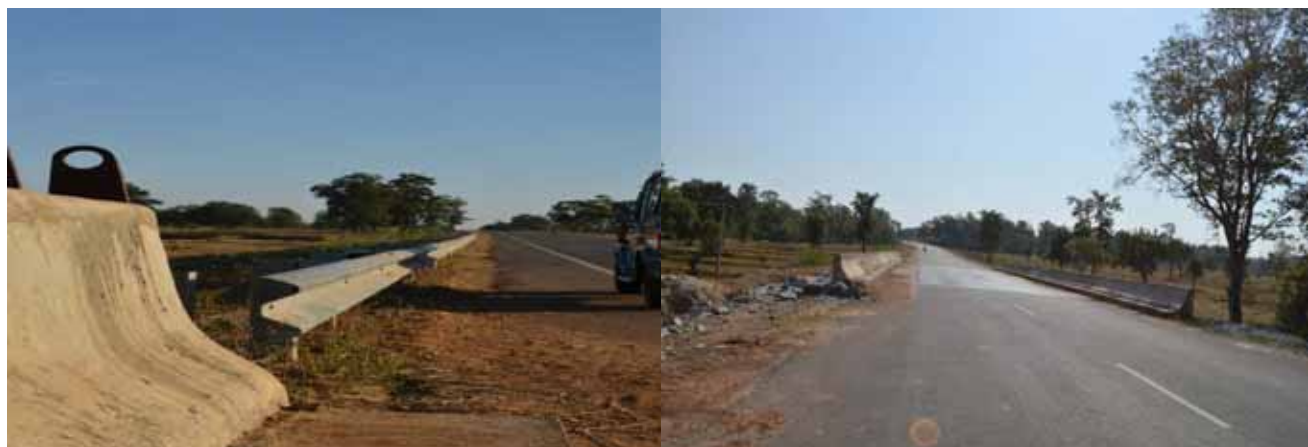
Gap in Crash Barrier and New Jersey Barrier and Absence of OHM on structure

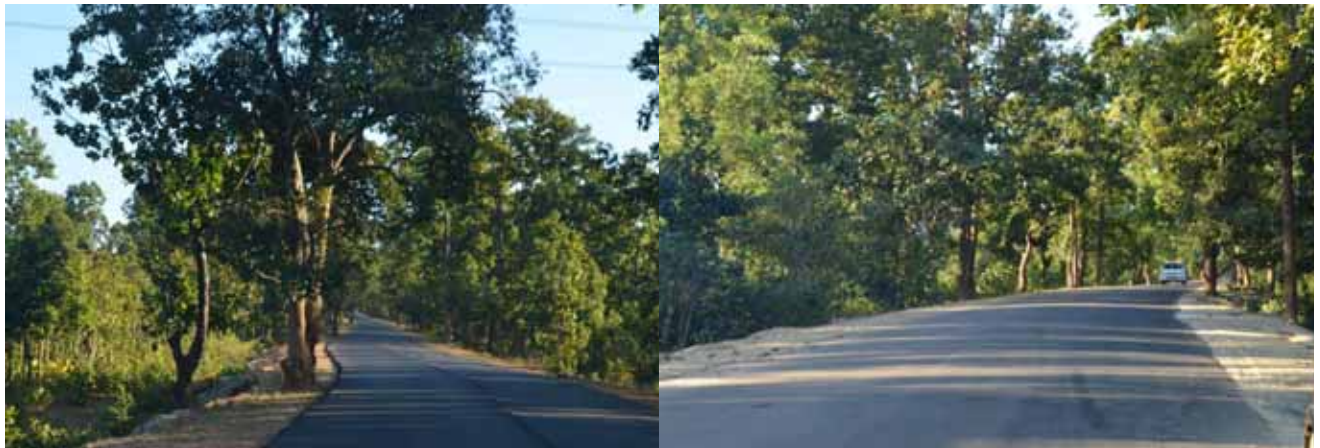
At several locations on the project road, many trees and/or street light poles are found, which obstruct the view and also potential hazard during night if not visible, vehicle may collide with it and severity may be very high.

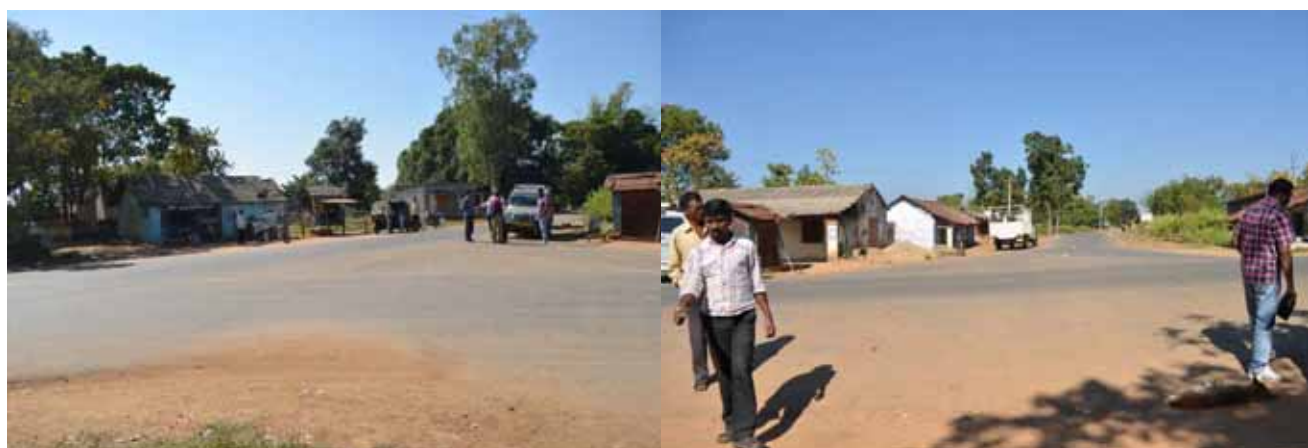
- Medium commercial activities are present
- Significant pedestrians, cyclists and motor cyclists are present.
- Street light is absent
- No Traffic island is present

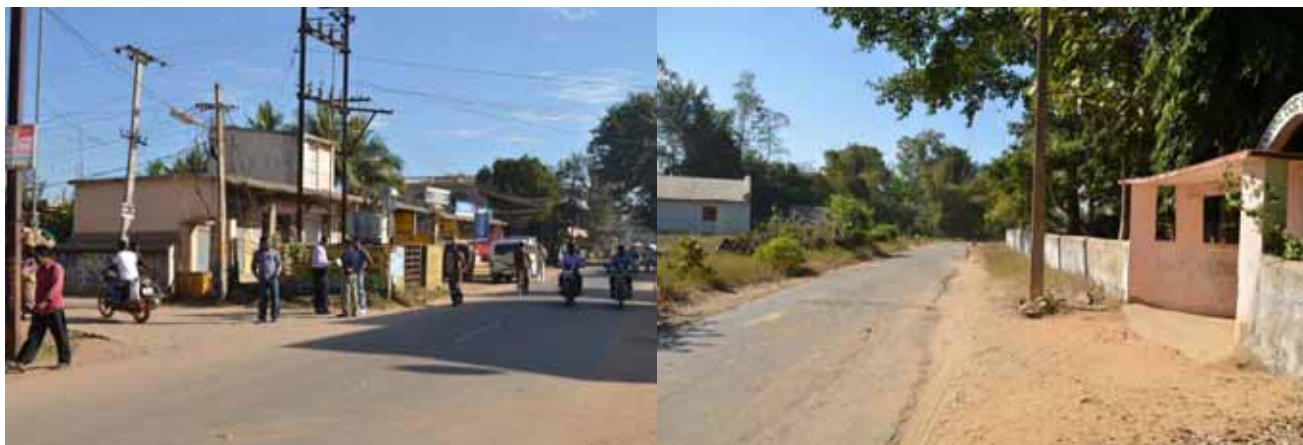
Built up area at Km 0+500 and School at Km 11+250

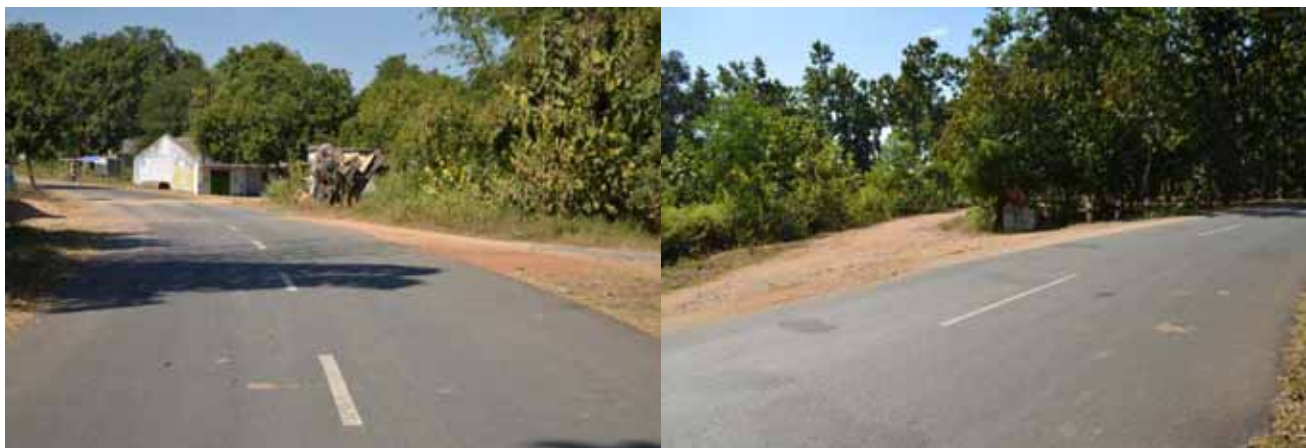
Skewed Side Road at Km 42+900 and Km 45+800

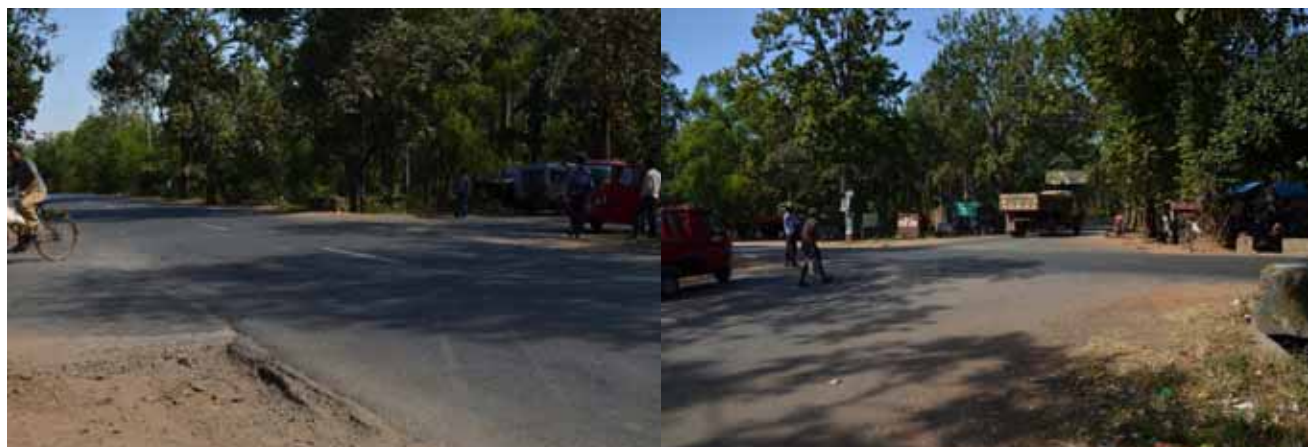
- This junction is intersection of ODR and NH149
- High Accident prone zone
- No warning for NH ahead
- Significant two wheelers, pedestrians, cyclists are present on the junction.
- No traffic islands are present for safe and effective maneuver of traffic.
- Street light is not present on the junction.

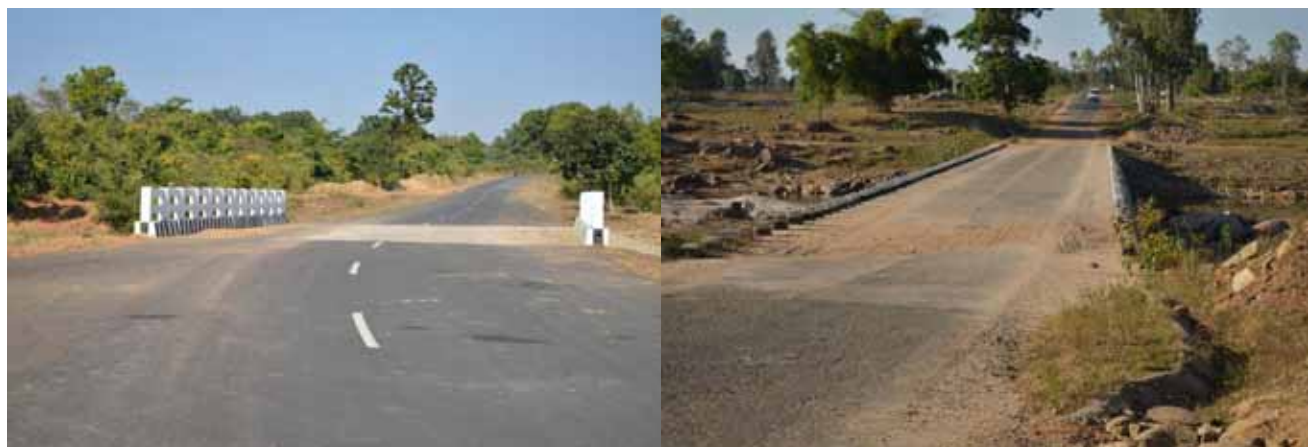
- Curves approaches to major/minor bridges
- High embankment
- No approach protection
- Dangerous overtaking is observed
- No traffic signs are present on the road.

Absence of OHM on structure at Km 44+500 and submersible structure at Km 58+900

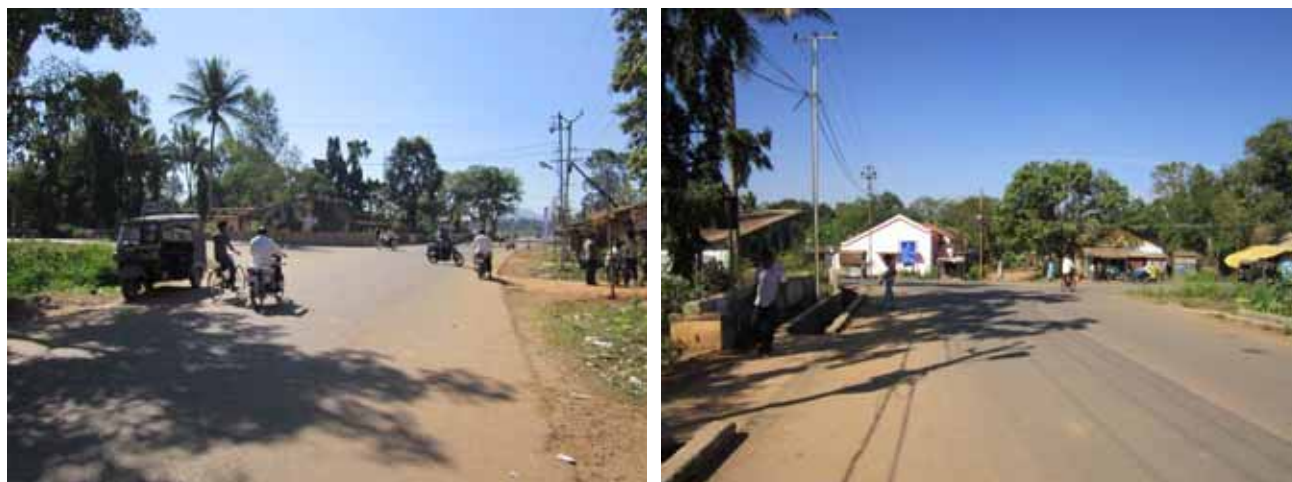
Ch: 3+700

In the existing situation, there is one major junction along this road at Ch: 3+700.
