**Government of Odisha (GOO)
Chief Engineer, World Bank Projects, Odisha
Odisha State Roads Project**

**Consultancy Services for
Road Sector Institutional Development
Loan # 7577-IN**

**ROAD INFRASTRUCTURE
SAFETY MANAGEMENT REVIEW**

VOLUME I - REPORT

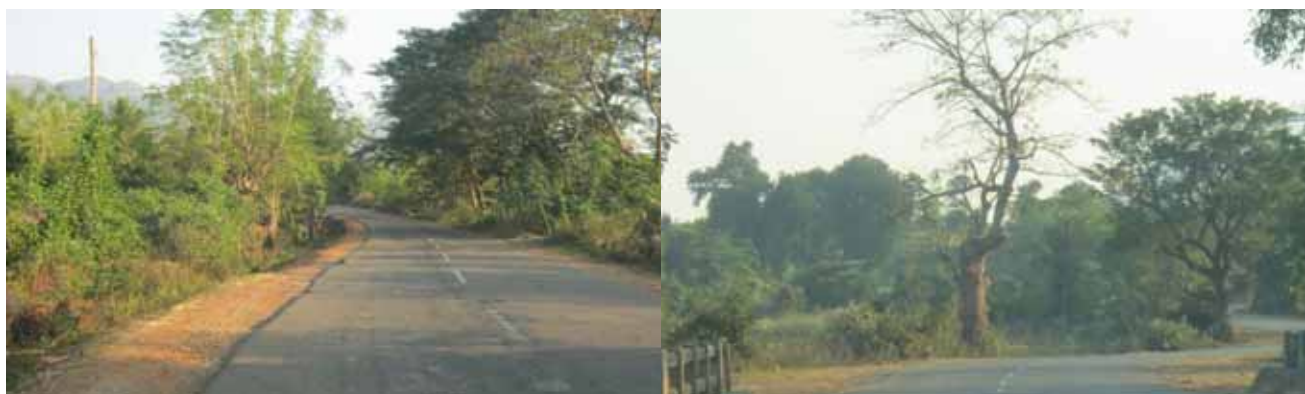
Road side hazards/objects present along this stretch of road are predominantly trees at Km 17+050, Km 17+800 and Km 24+500.

Road side hazards-Trees

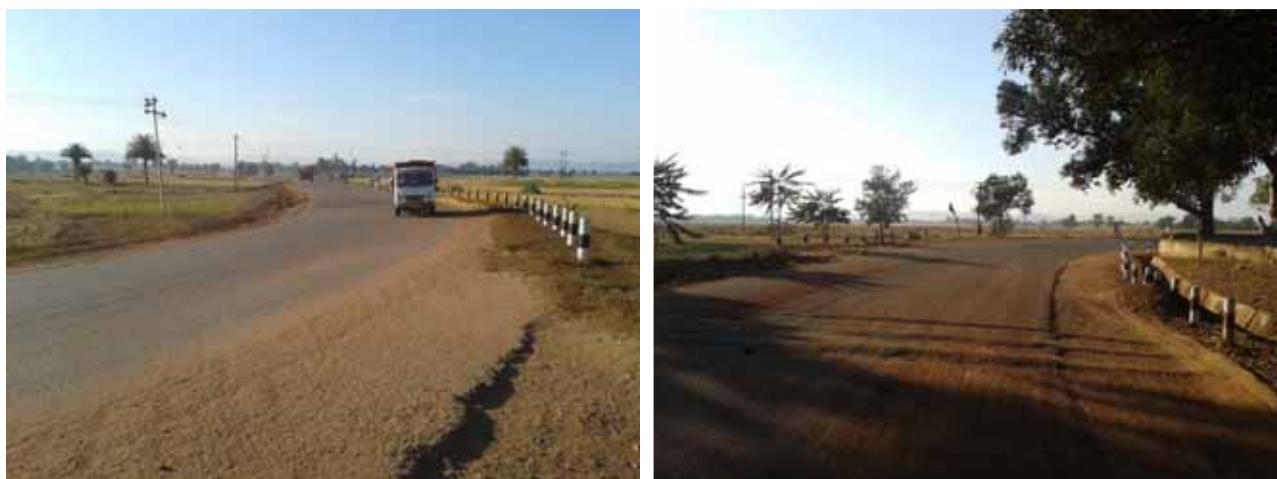
Lack of delineation in the stretch of road from Km 45+000 to 43+000

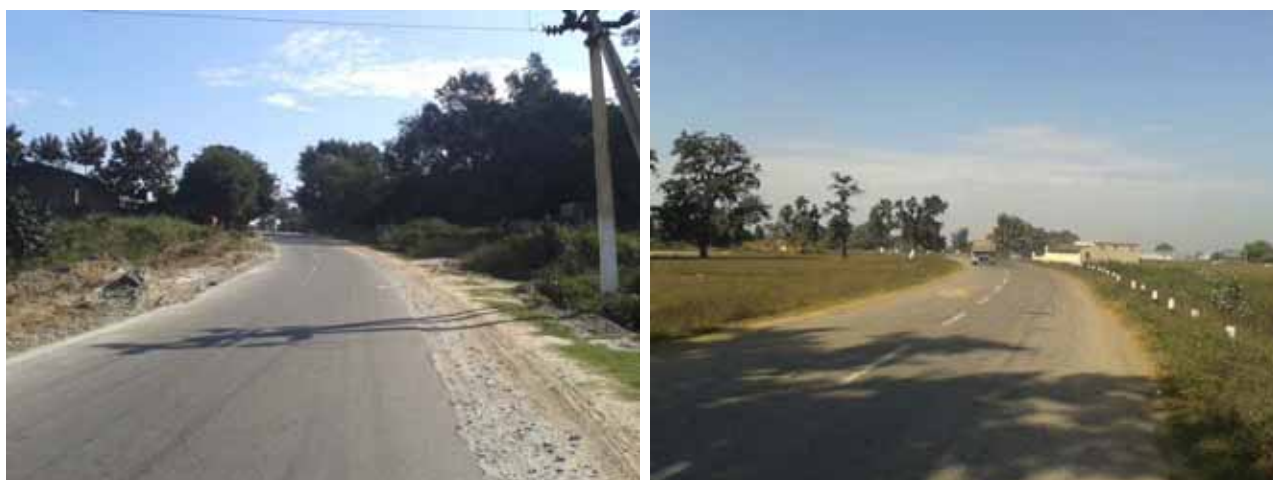
Lack of delineation in the stretch of (i) Km 0+000 to 1+000, and (ii) Km 6+000 to 7+000

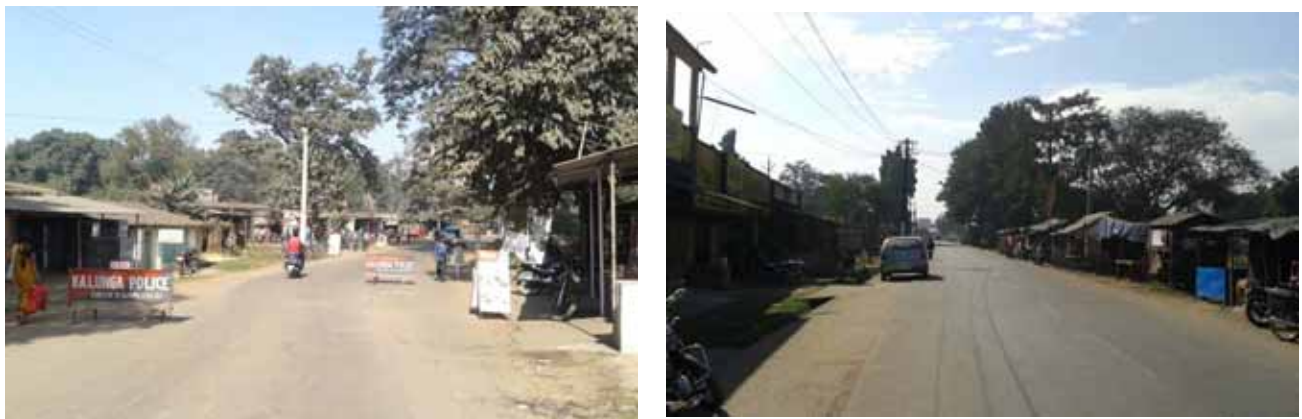
Built-up area of Kalunga town

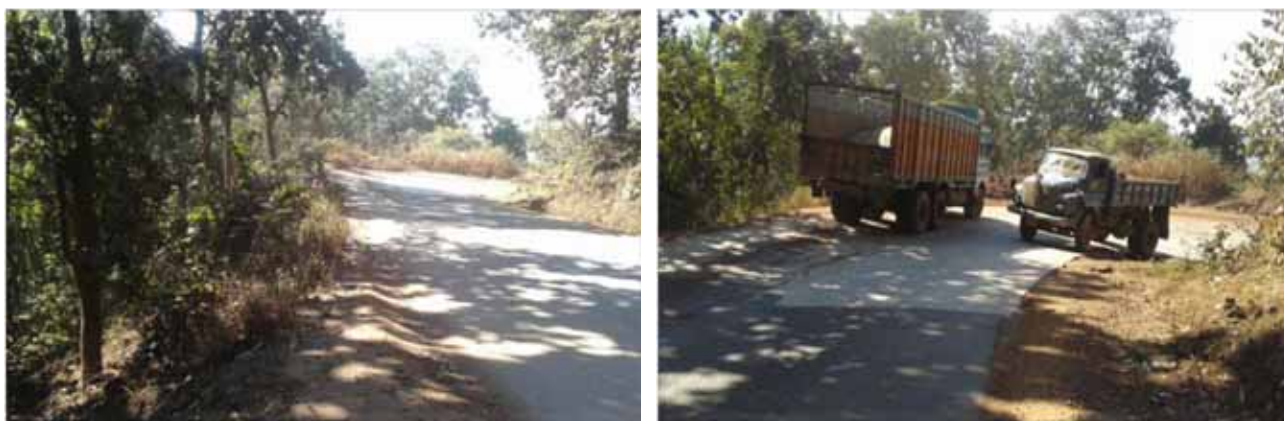
- There is a hairpin bend at Km 19+250 with deep valley on the outer edge without any edge protection or delineation.
- There are no warning signs or traffic calming measures on the approaches.
- The road width is not sufficient for turning of heavy vehicles and the profile is inadequate.
- The risk of run-off accidents of high speed descending vehicles and head-on collisions is very high in such situation.
- There is high probability of fatal or major injuries for all motor vehicle user groups; in particular truck and car traffic.
- As informed by the OWD staff this place is having a history of several accidents.

Km 19+250, dangerous hairpin bend

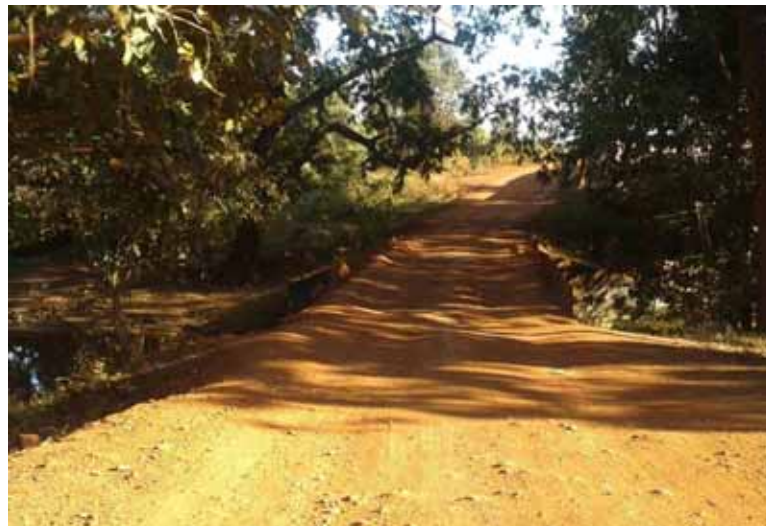
At Km 4+100 the parapets of bridge are not delineated.

Parapets of culvert not delineate, Km 4+100

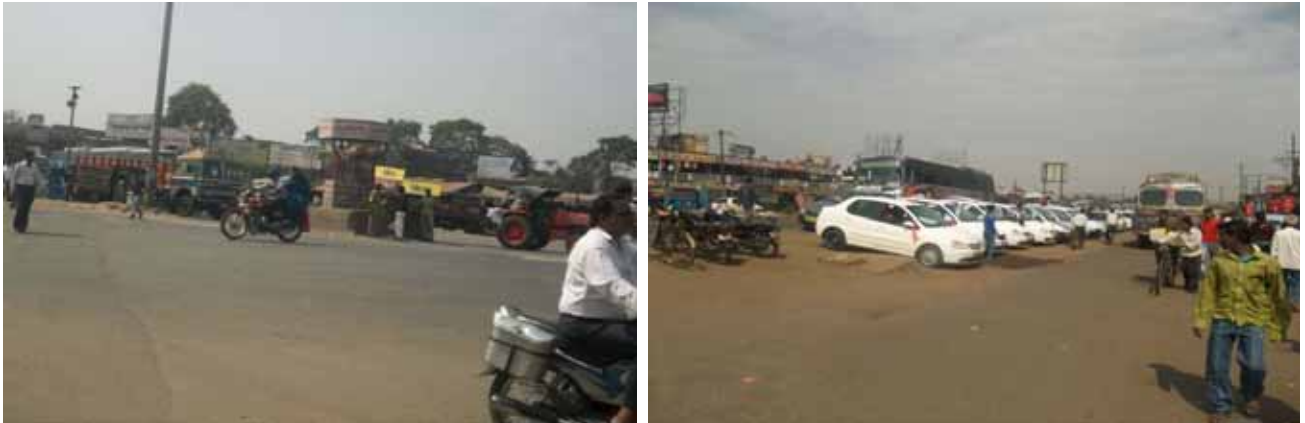
- Junction is built-up with shops and resulting in on-street parking problems
- Heavy two wheelers, pedestrians, cyclists are present at the junction
- Heavy vehicle volume is significant
- Layout of the junction is poor
- Street lighting is provided, but no traffic signs or road markings exist to warn, delineate and establish junction control
- No provision for VRUs

Poor junction layout and on street parking at roundabout at Km 219+000

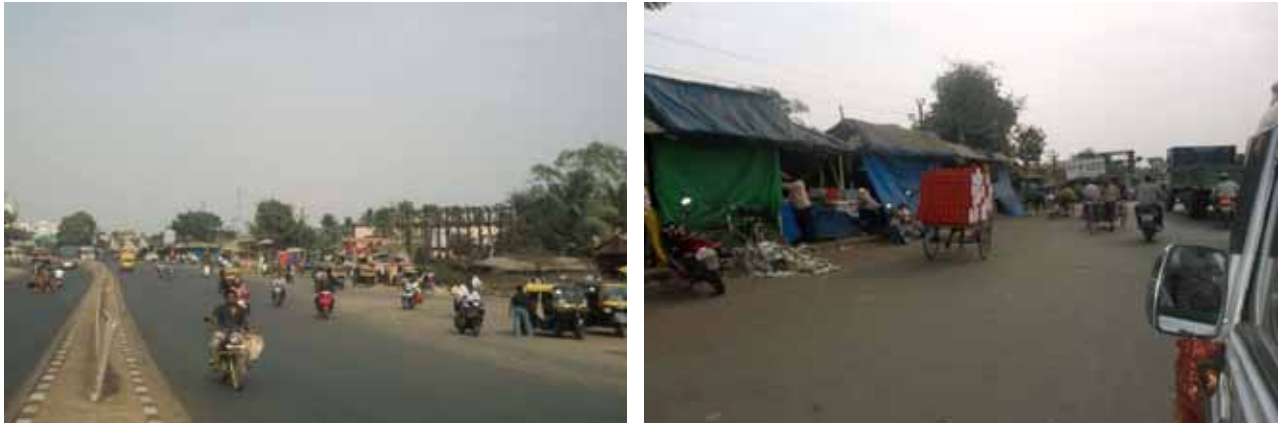
Roadside villages are particularly hazardous points on a rural road network. Project road has many such roadside villages. It is important to inform the road user in advance of the impending roadside village and if necessary, traffic calming measures needs to be provided for improved speed management through such villages/ built up areas.

Built up area and high encroachments at Km 265+400

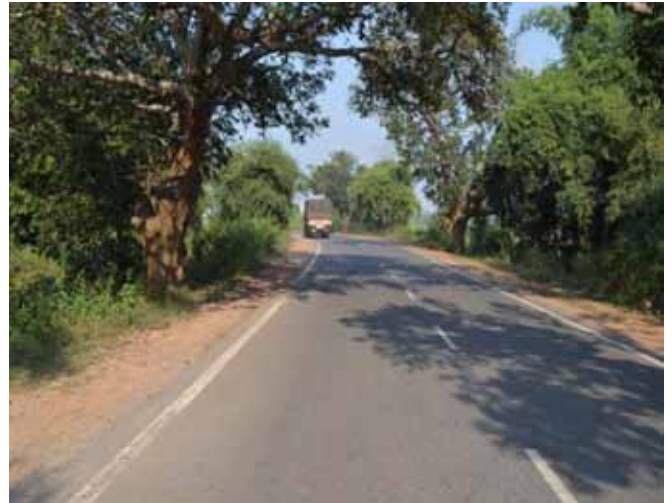
Tree and street light pole near pavement edge
