**Government of Odisha (GOO)
Chief Engineer, World Bank Projects, Odisha
Odisha State Roads Project**

**Consultancy Services for
Road Sector Institutional Development
Loan # 7577-IN**

**ROAD INFRASTRUCTURE
SAFETY MANAGEMENT REVIEW**

VOLUME I - REPORT

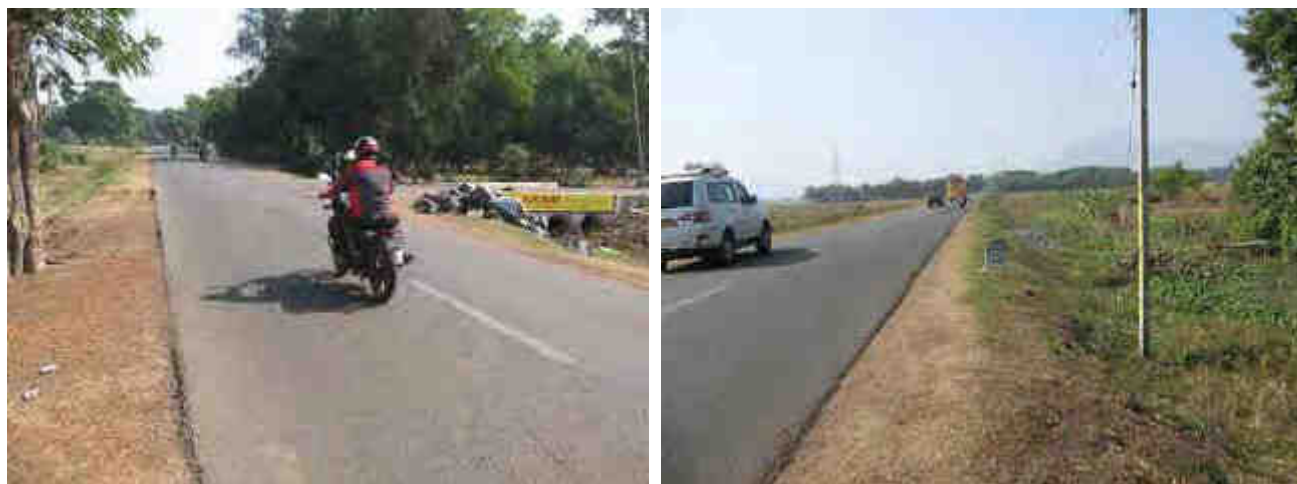
Ch: 1+900

It was informed by the OWD that this intersection location is accident – prone. This stretch of the road is straight and vehicles tend to go at a high speed. The general type of accidents occurring here are angled collision culminating from the speeding side road colliding with vehicle on the main road.

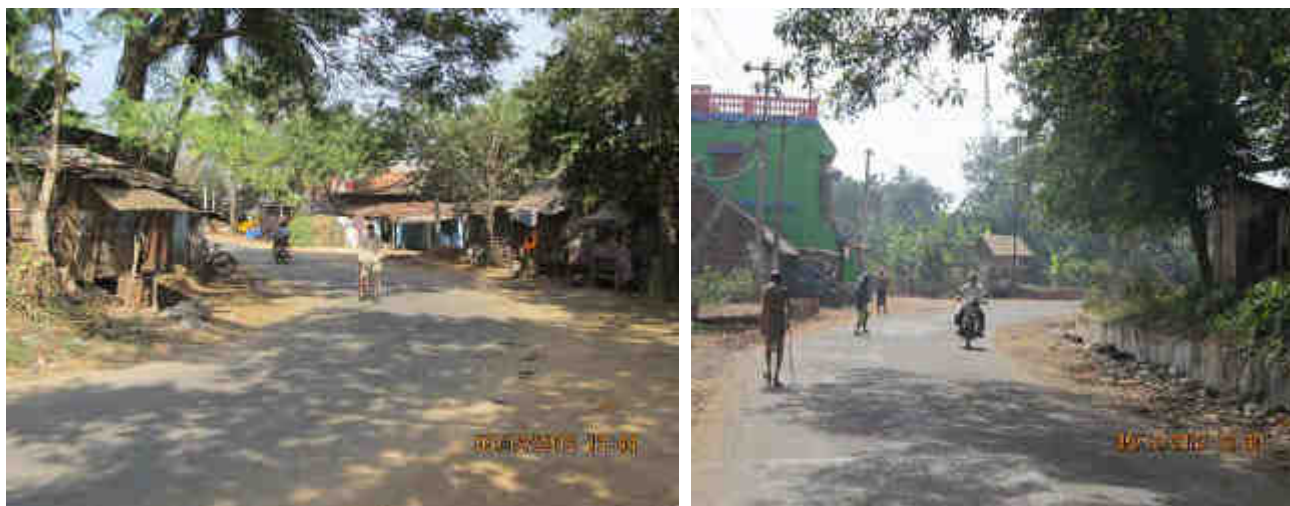
Sharp Curves on Project Road at Km 36+800 and Km 24+900 respectively

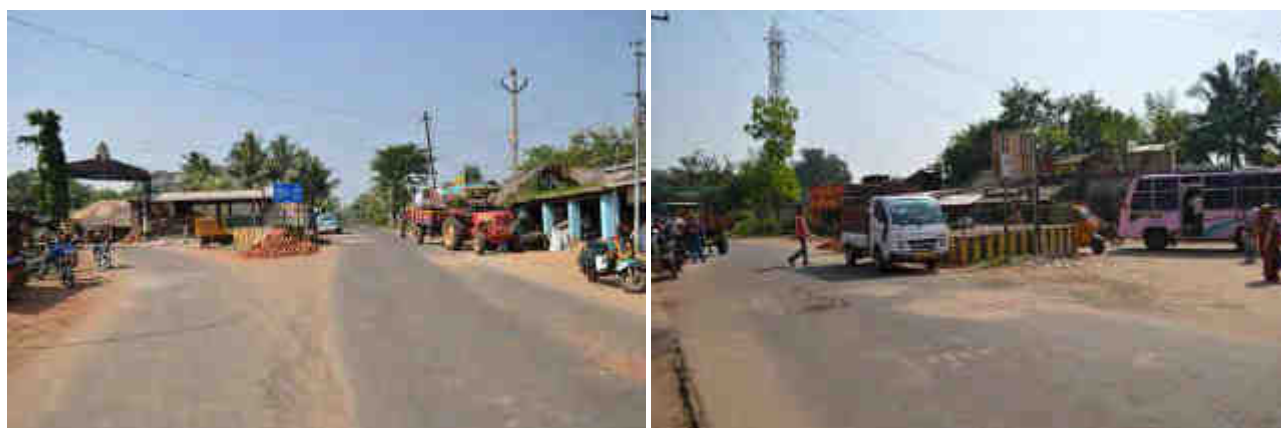
Km 51+000

- Junction of ODR (towards Sambalpur) with SH-65;
- Poor layout of the junction;
- On street boarding of buses, which obstructs visibility;
- Built up structures are present very near to junction;
- Junction control is not established; and
- No street lighting, traffic signs and road markings provided.

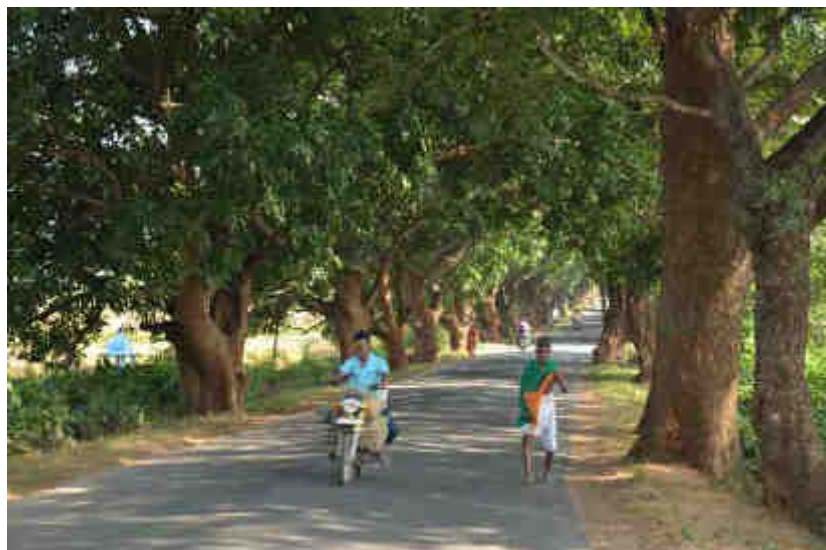
Project road have many locations where trees and street lighting poles are very near to pavement edge.

Several trees near pavement edge

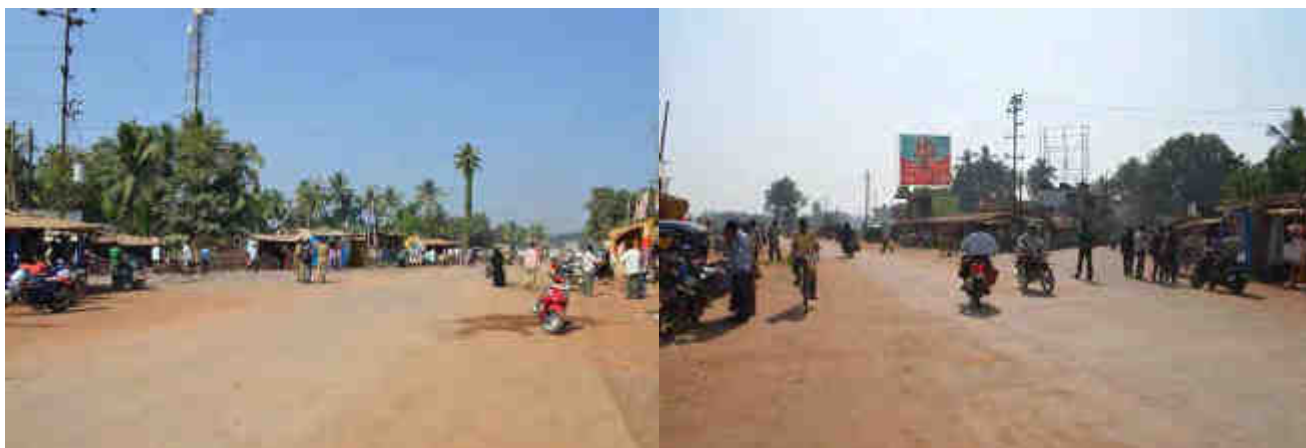
Km 13+700

- Poor layout of the junction with no established traffic control
- Junction area has high commercial activity and the level of encroachment is high
- Significant presence of pedestrians and cyclists, but no separate provisions has been provided
- Street lighting is not provided

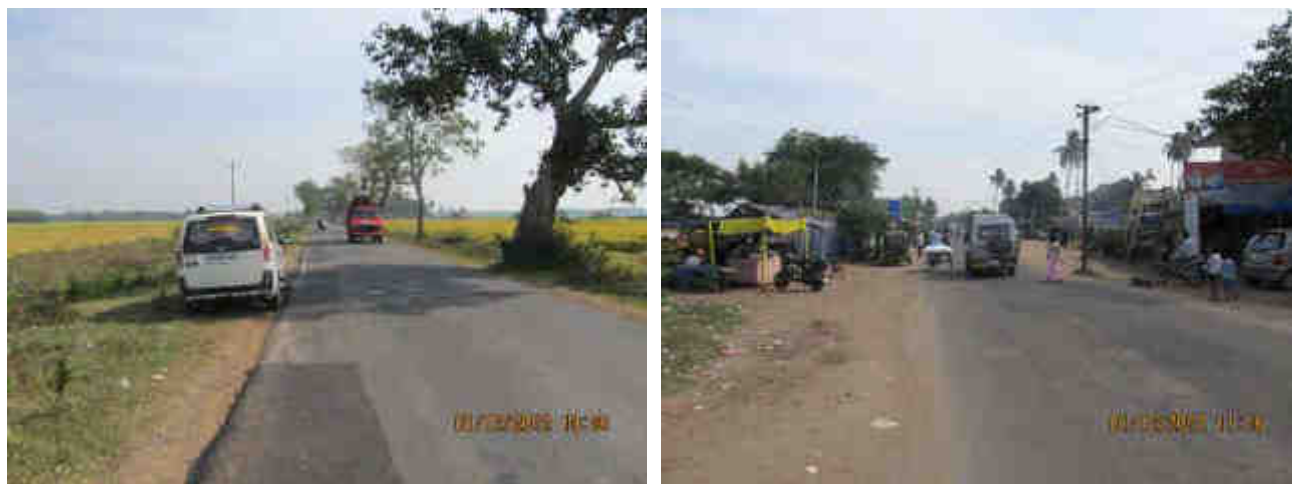
Project road have many locations where trees and street poles are very near to pavement edge.

Tree and street pole near pavement edge

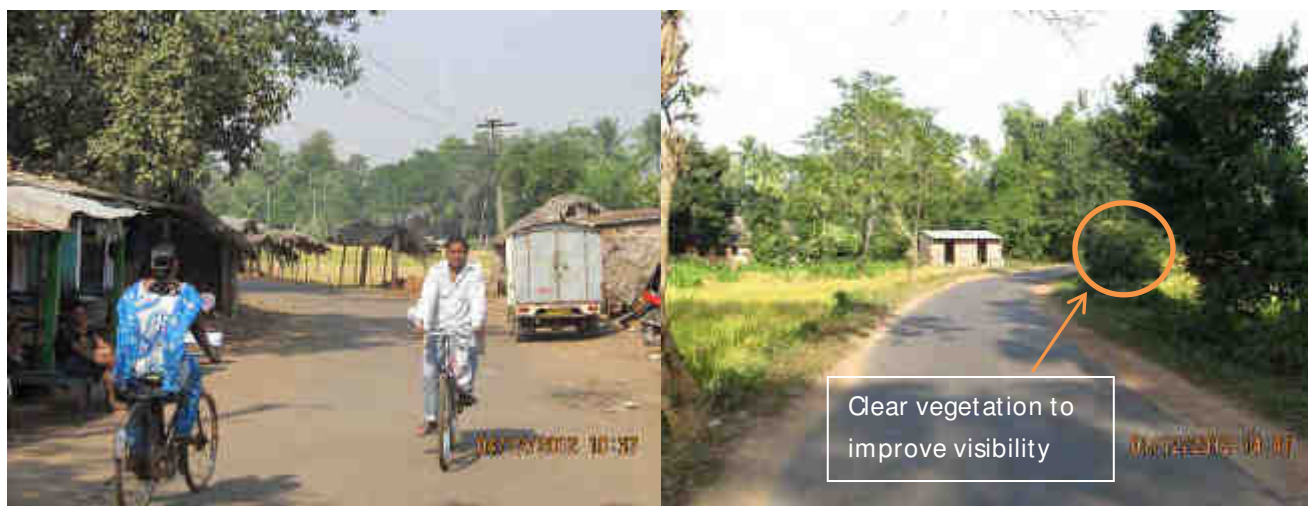
Sharp Curves on Project Road at Km 26+600 and Km 3+550

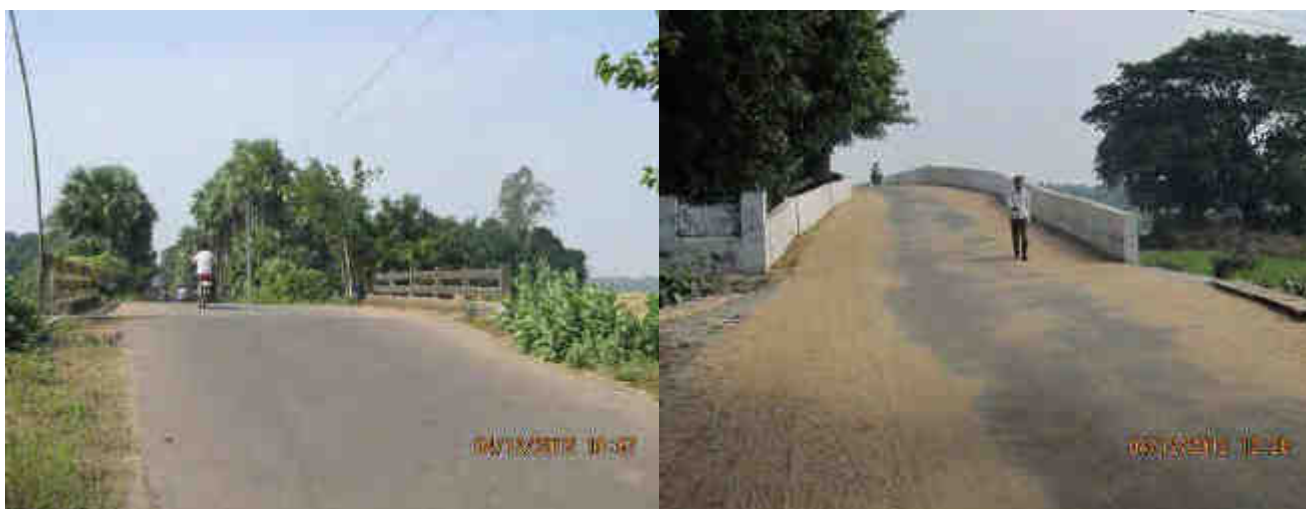
Absence of OHM at Km 24+200 and Km 16+800

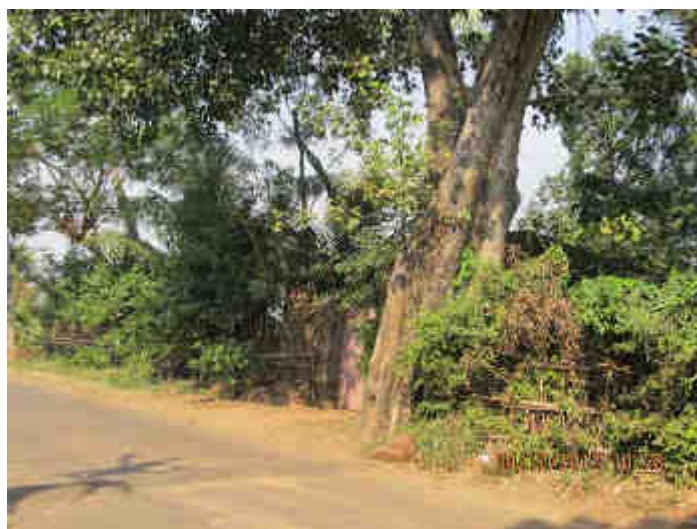
Tree near pavement edge

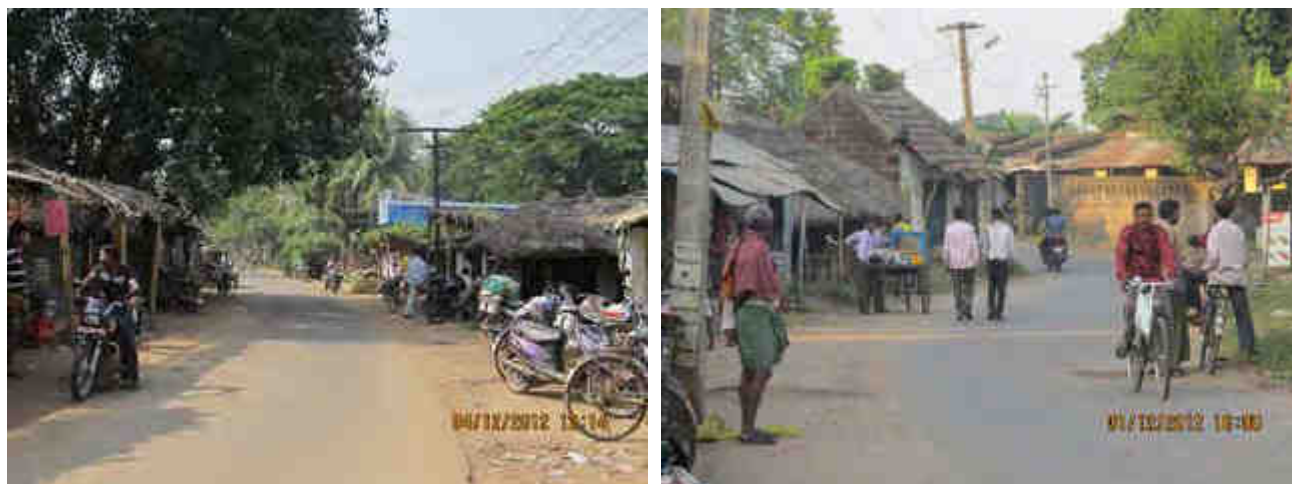
- Traffic is observed not to be very high, but still poses a hazard to cyclists and pedestrians inside village zones
- Heavy encroachments observed on all roadside villages
- Visibility is hampered due to structures present along the road and stopped vehicles, buses on the road

Commercial Sections at Km 16+900 (Kalayanpur Village) and Km 16+400

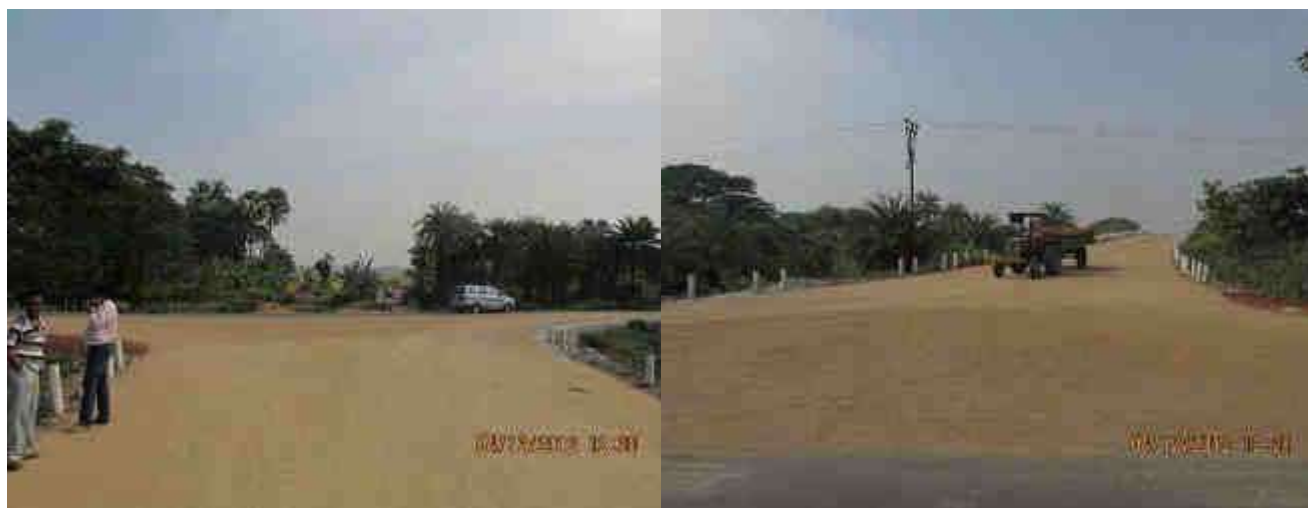
- Two ODRs meet at this point to form a 3-arm junction
- The minor road is wider than the single lane major road
- The minor road leads to a major bridge in less than 50m length from the mouth of the junction
- Layout of the junction is hazardous, and no traffic control/ priority has been established
- Dangerous Overtaking is observed
- No signs and markings provided leaving this junction significantly hazardous during dark conditions

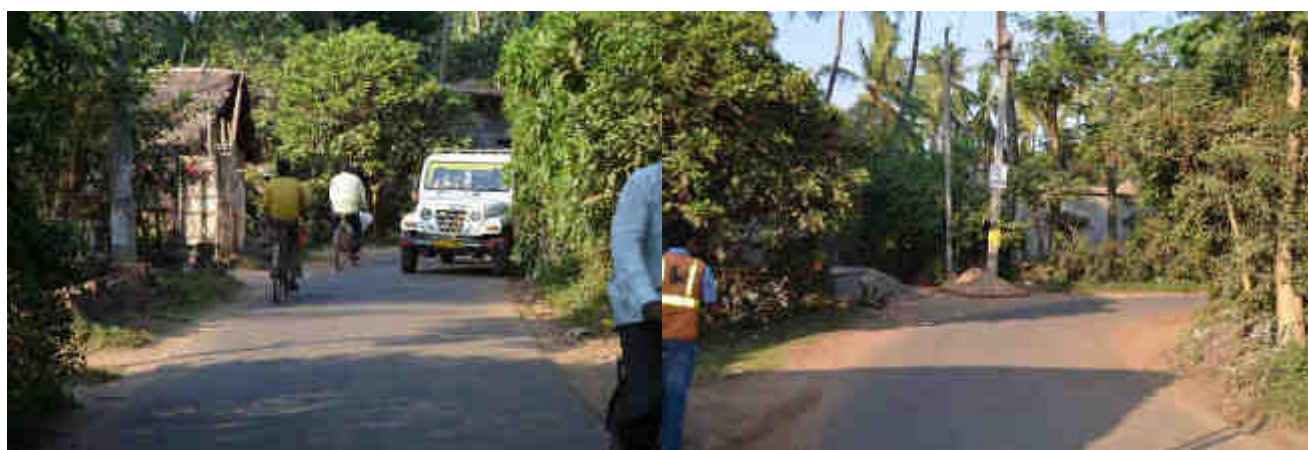
Sharp Curves on Project Road at 1+300 and 1+450

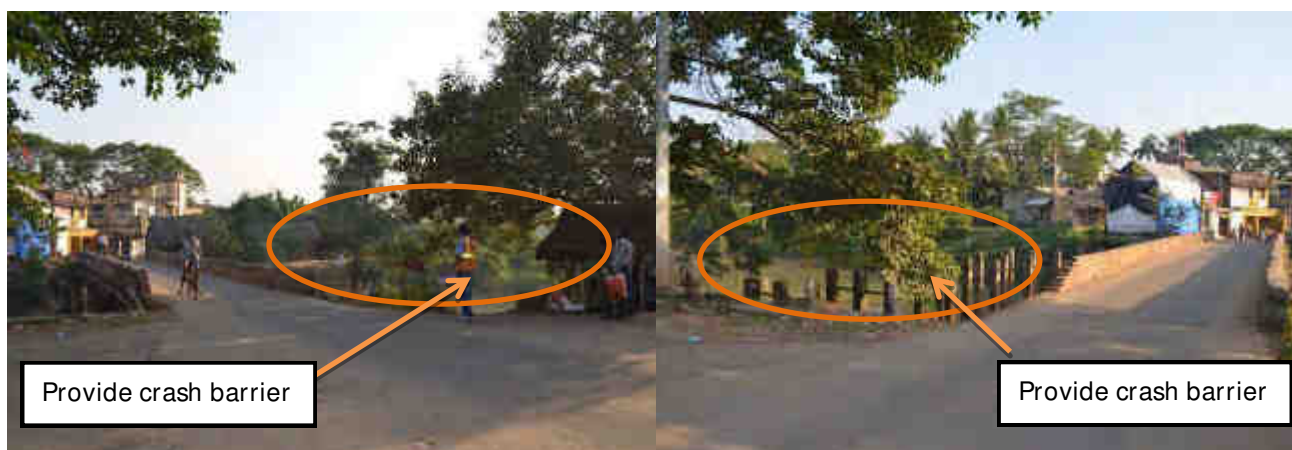
Junction at Km 4+950

At this location, cross roads are noted on approaches to the bridge on either side. The corners of the junctions are unprotected and the traffic is exposed to the gaps in high embankment. At night conditions, this situation becomes significantly hazardous. In the event of the vehicle losing control, fatalities or major injuries may occur due to the exposure to the waterbed.

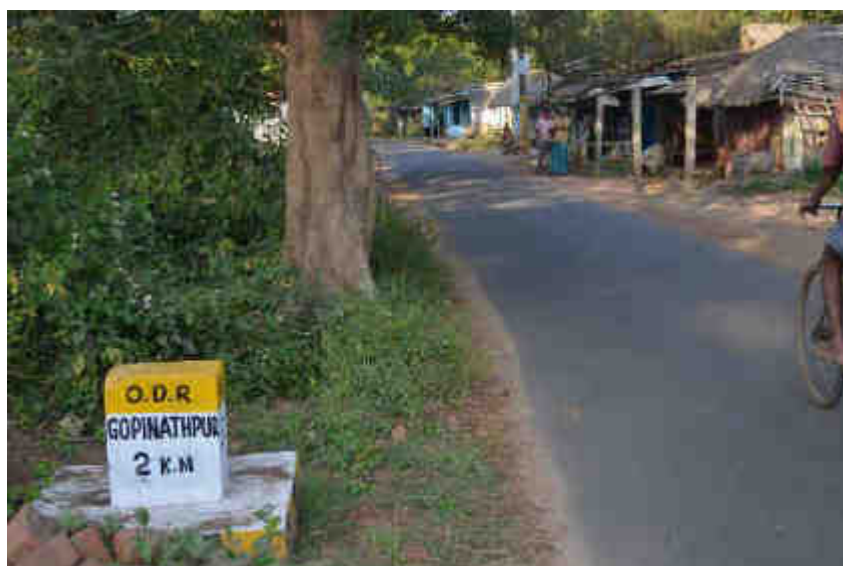
Project road have many locations where trees and street poles are very near to pavement edge.

Tree near pavement edge

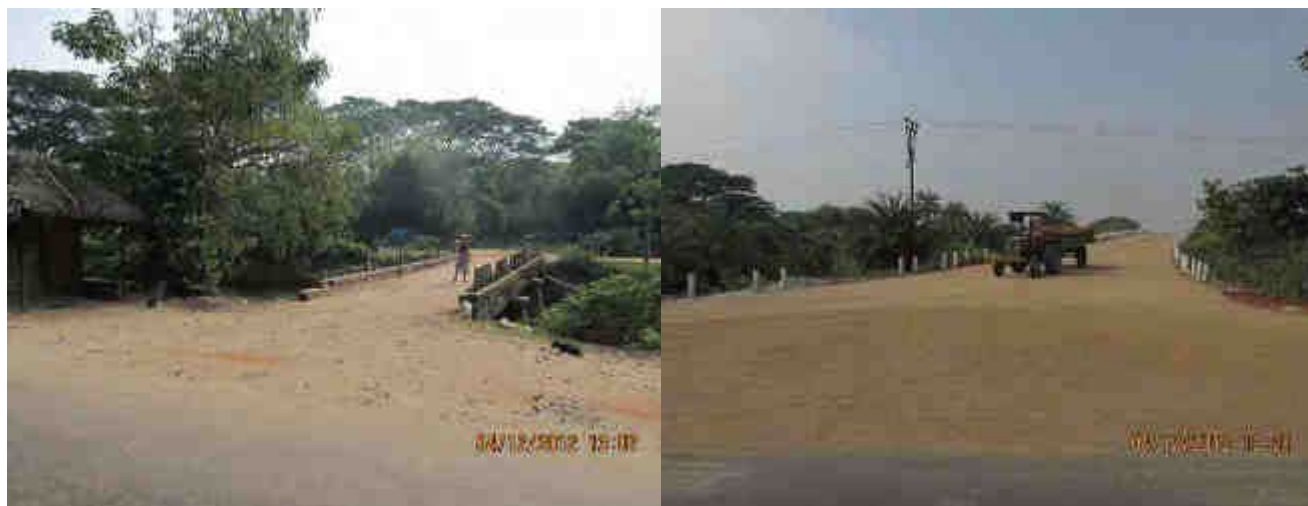
Side Roads at 5+500 and 0+700

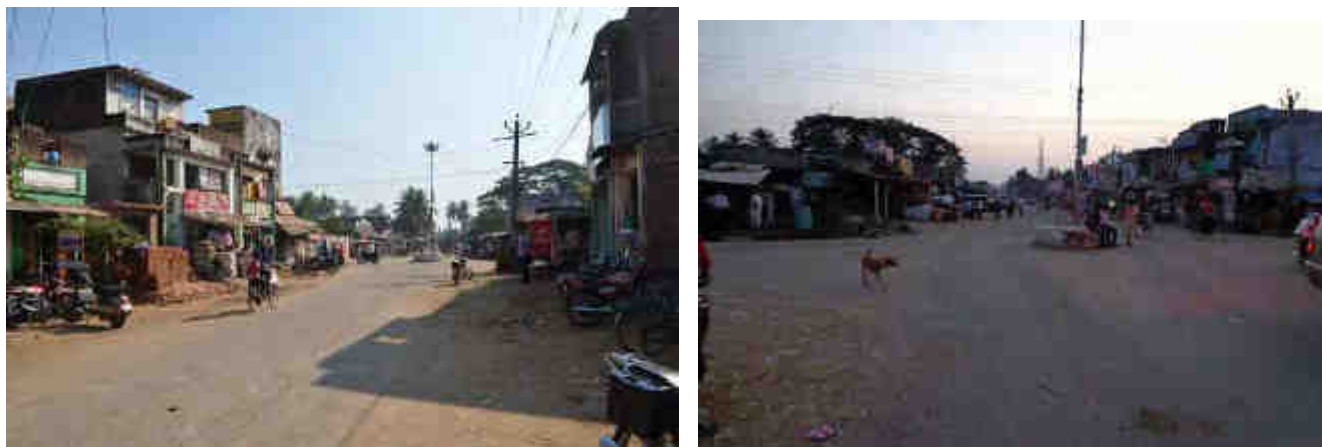
Km 51+200, Sheragada Junction

This intersection is located on Sheragada of SH-29. The Sheragada Junction is joining SH-29 from left and a village road is joining from right side at this location. The intersection layout is non-standard and has no control over the traffic movement, and the priority is also confusing. This encourages lawless traffic movement and may be hazardous for the traffic. This Junction is completely built up.

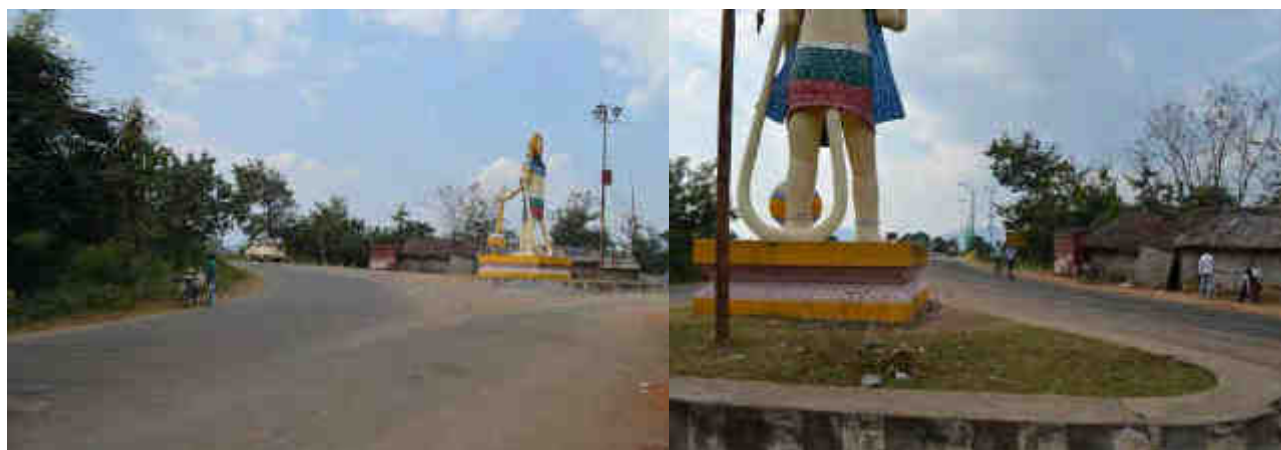
Km 96+000

This intersection is located on Sorada of SH-36. The Sorada Junction is joining with NH-59 at this location.

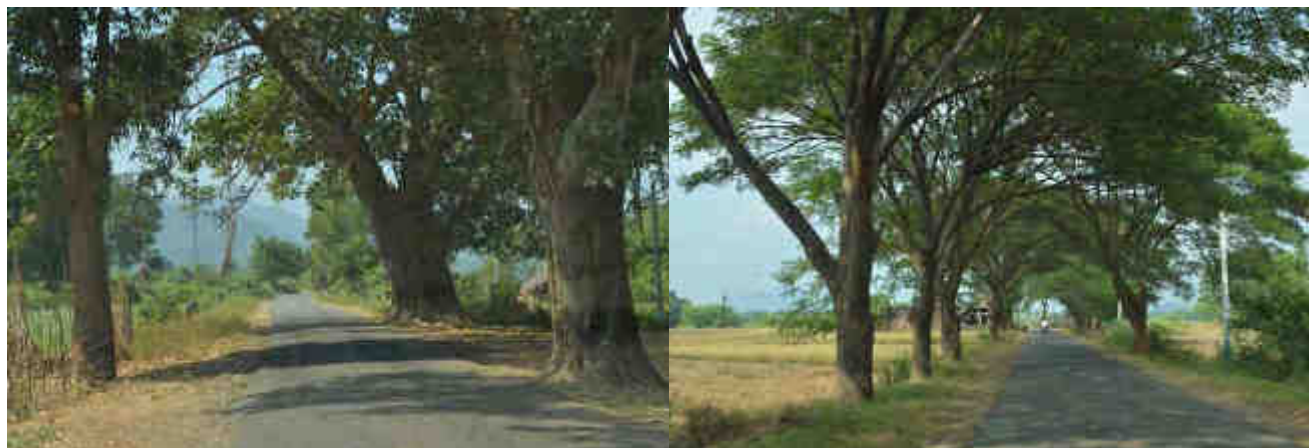
Road side objects present along this stretch of road are few trees. Trees are on the edges of the carriageway, which has no any protection.

Trees are on the edges of the carriageway

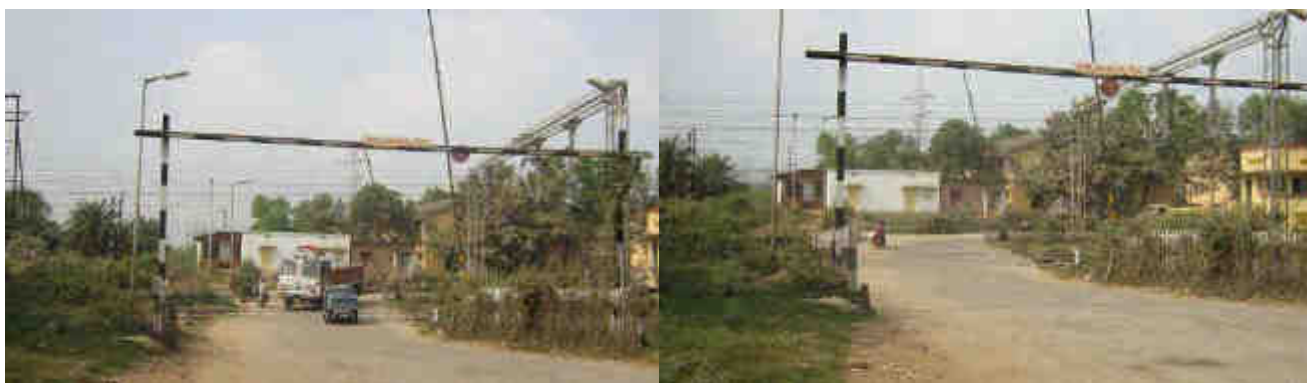
In this section, accident prone area as per directed by OWD representative are at chainage Km 24+000 (level crossing near Jagannathpur) due to bad road condition and also level crossing on curve.

Accident prone area (Level Crossing)

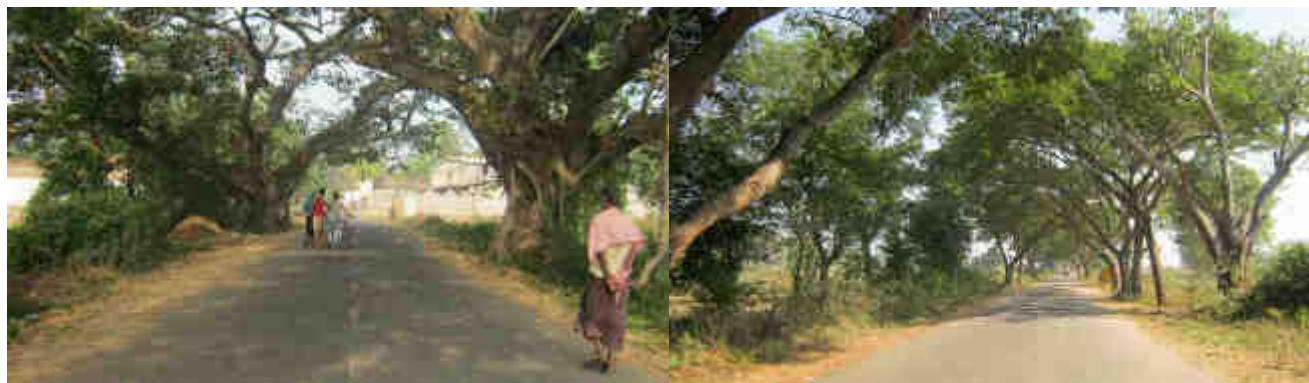
Road side objects present along this stretch of road are few trees.

Trees are on the edges of the carriageway

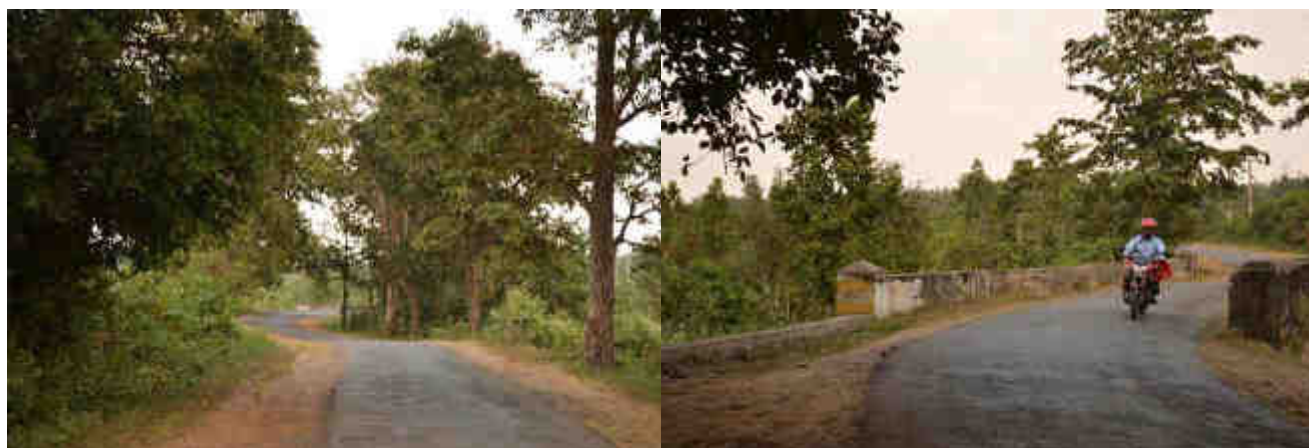
These are observed at chainage Km 14+300;

Reverse Curve

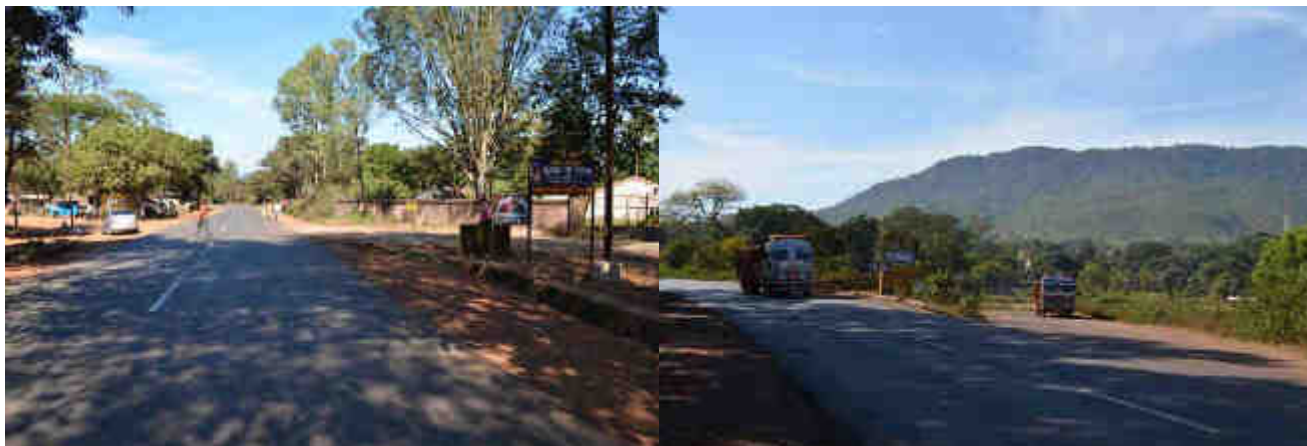
Skwed Minor Junctions at Km 451+600 and Km 467+400

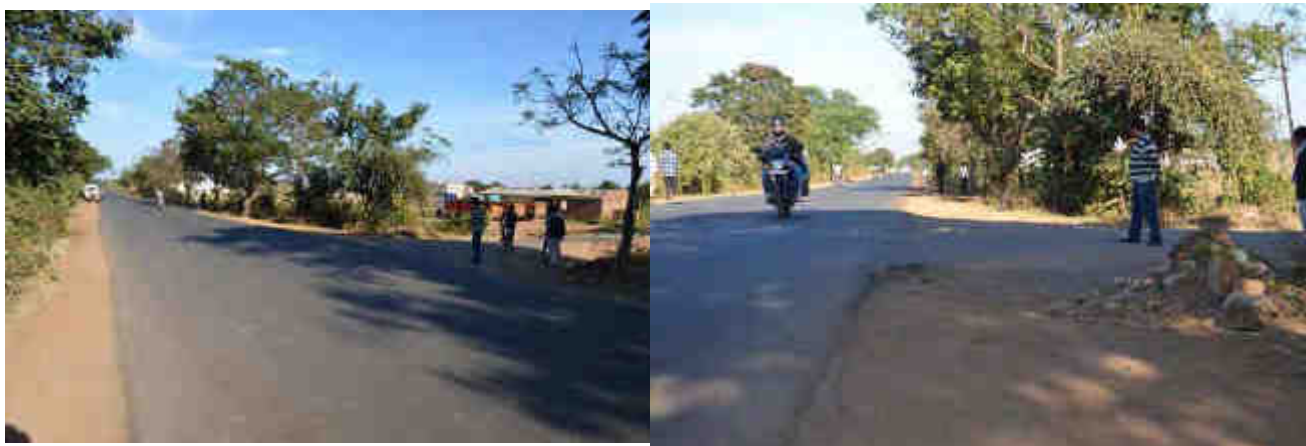
Minor Junctions at Km 481+200

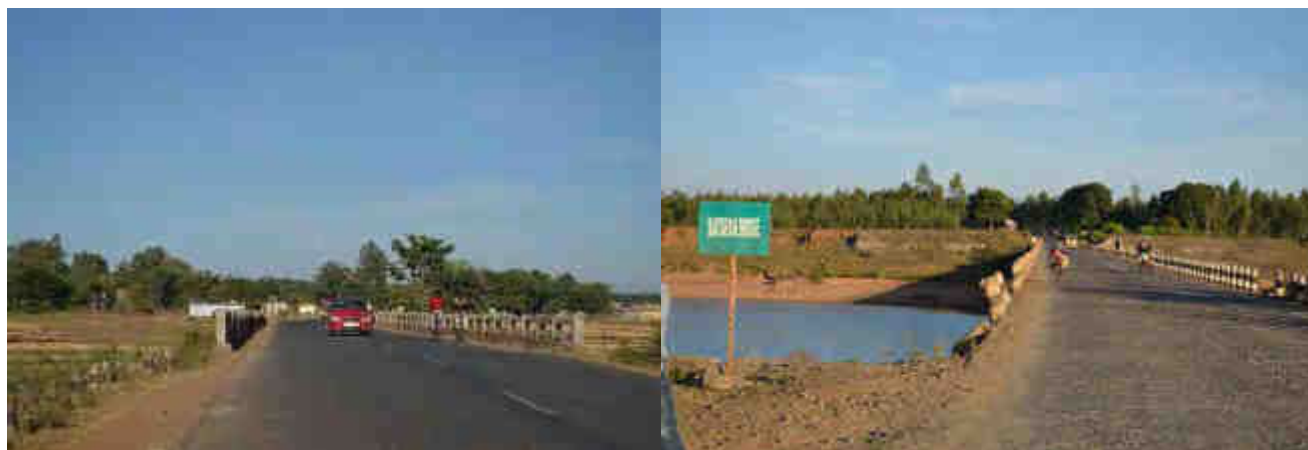
Absence of OHM on the structure at Km 484+900 and absence of approach protection at Km 509+800

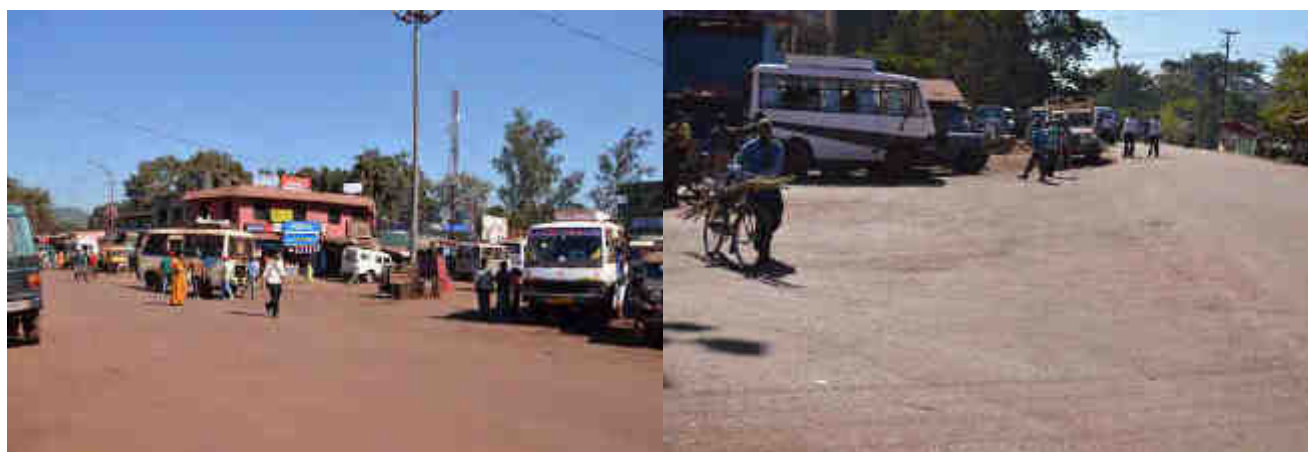
- This junction is intersection of urban road and expressway.
- Heavy two wheelers, pedestrians, cyclists are present on the junction.
- No traffic islands are present for safe and effective maneuver of traffic. A non-standard central island is present obstructing the sight of the approaching traffic.
- Street light is present on the junction.

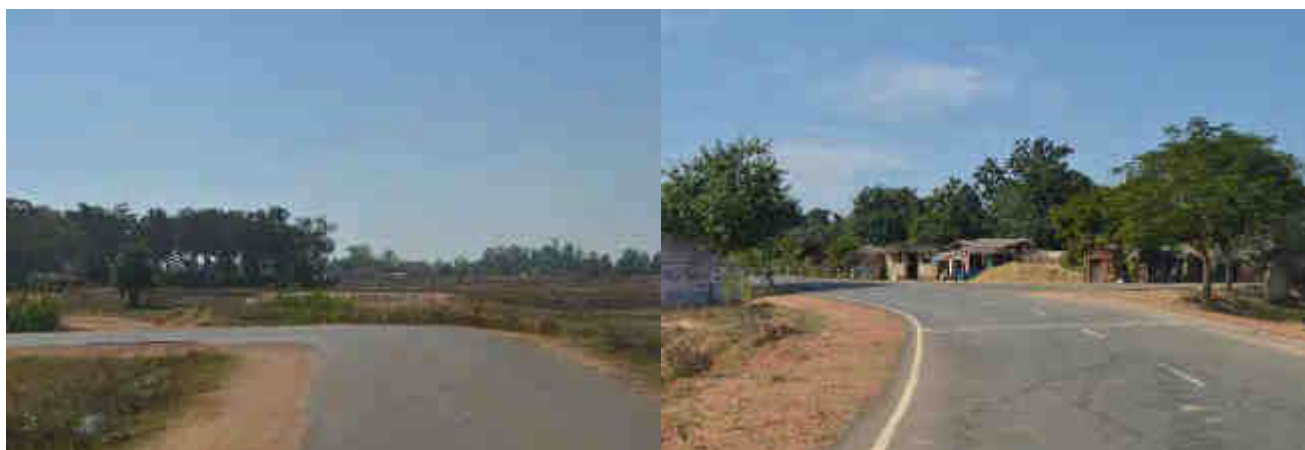
Sharp Curves on Project Road at Km 80+000 and Km 75+200

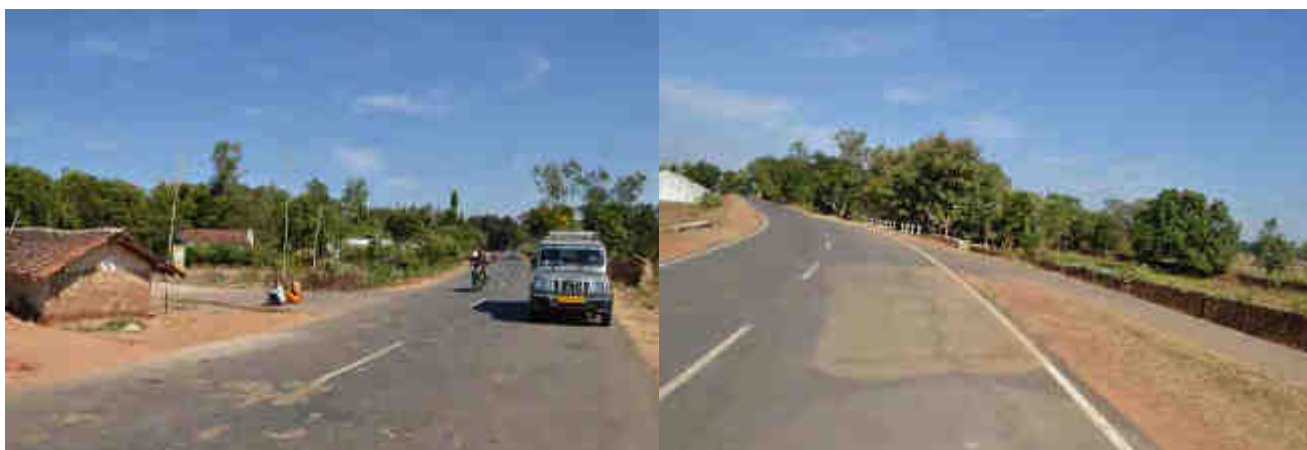
Skewed Side Road at Km 73+600 and Km 88+100

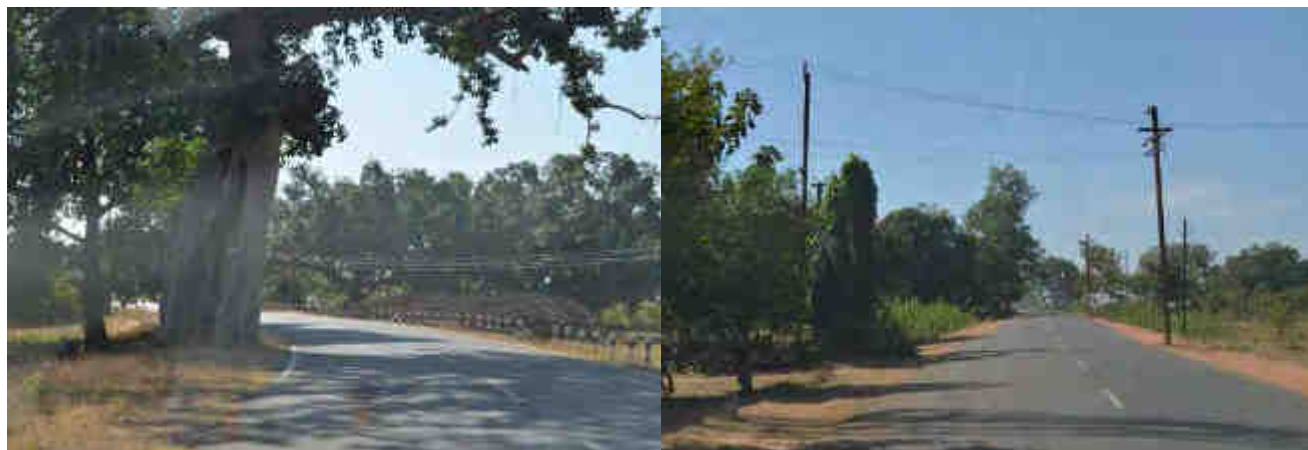
At several locations on the project road, many trees and/or street light poles are found,

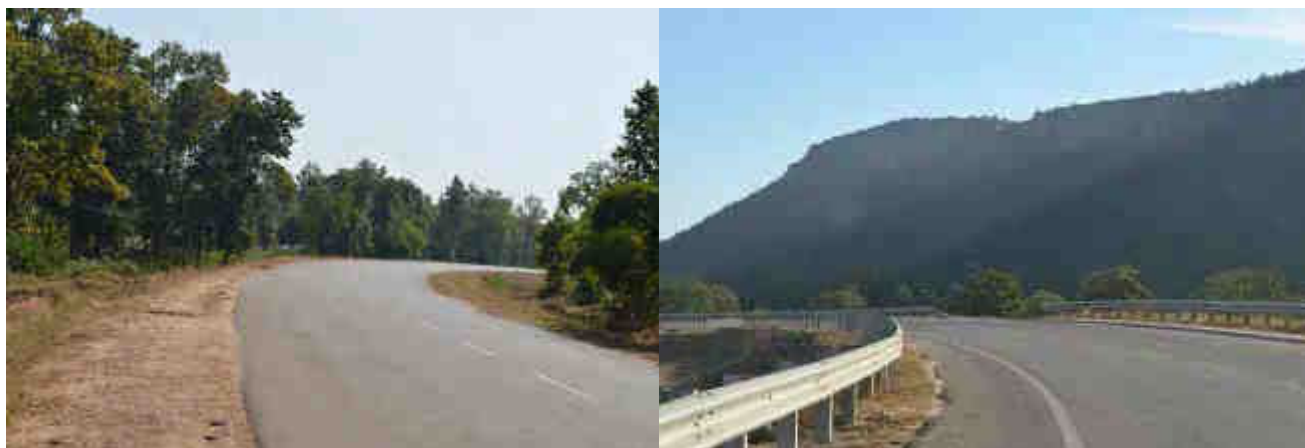
Curves on Project Road

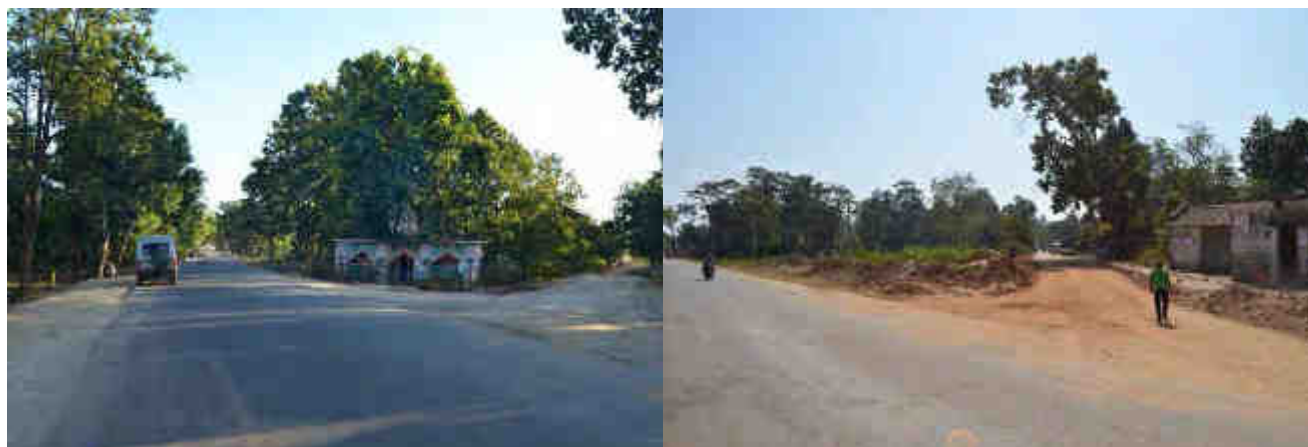
Skewed Side Road at Km (Section I) and Km 10+500 (Section II)

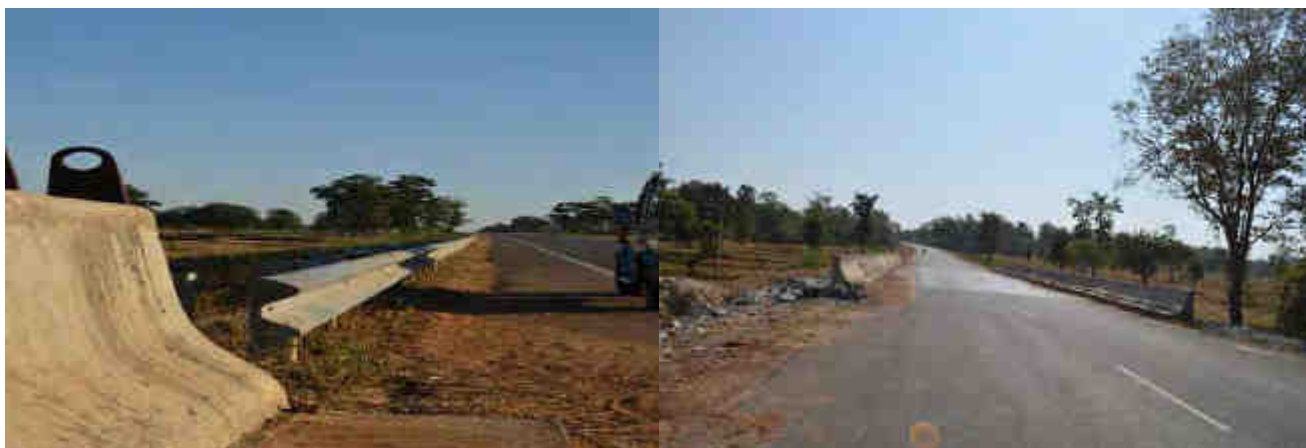
Gap in Crash Barrier and New Jersey Barrier and Absence of OHM on structure

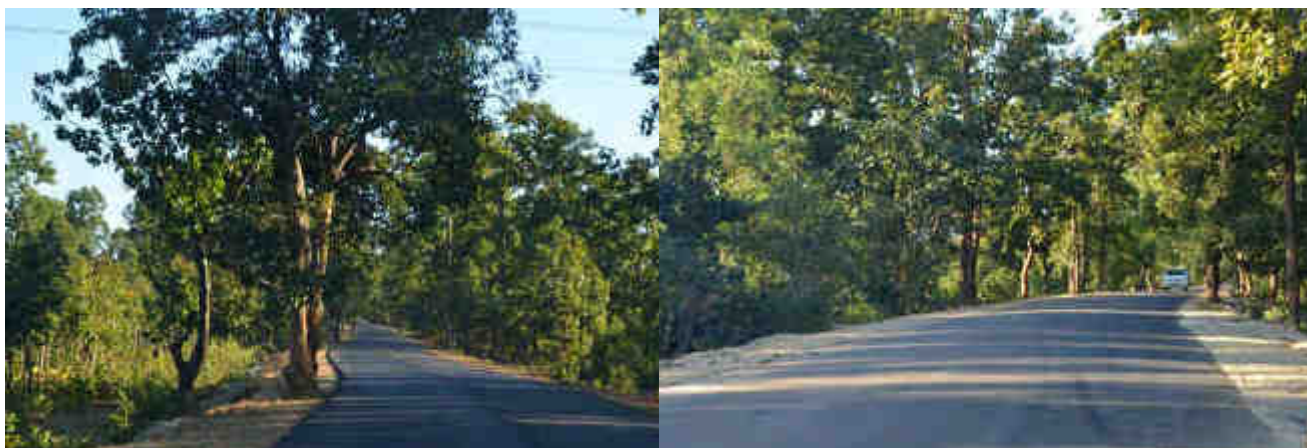
At several locations on the project road, many trees and/or street light poles are found, which obstruct the view and also potential hazard during night if not visible, vehicle may collide with it and severity may be very high.

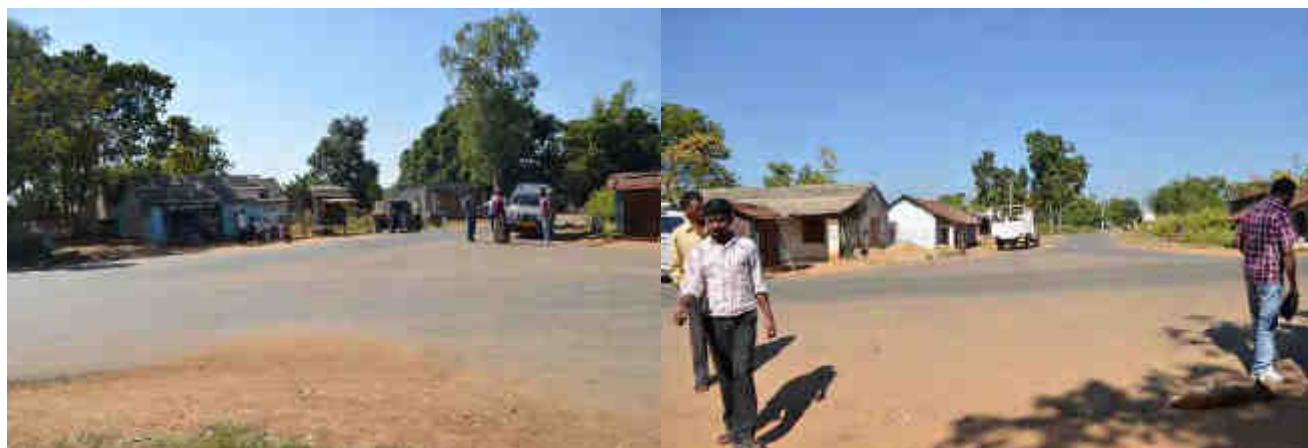
- Medium commercial activities are present
- Significant pedestrians, cyclists and motor cyclists are present.
- Street light is absent
- No Traffic island is present

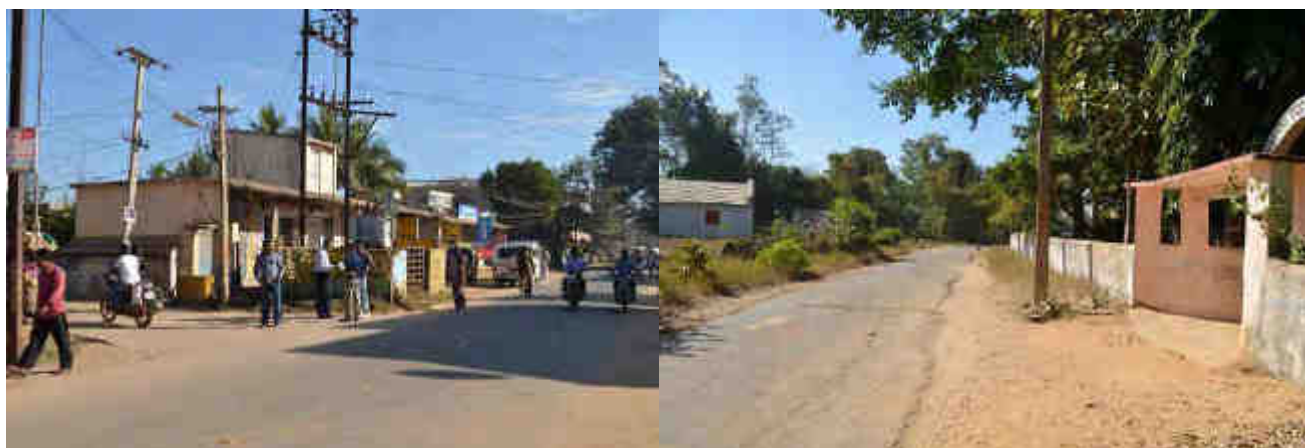
Built up area at Km 0+500 and School at Km 11+250

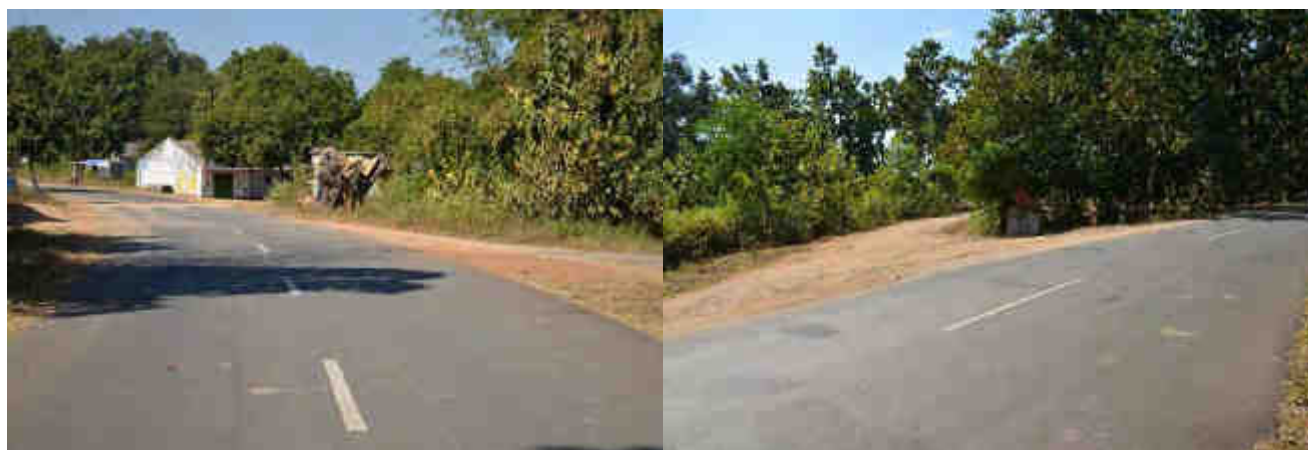
Skewed Side Road at Km 42+900 and Km 45+800

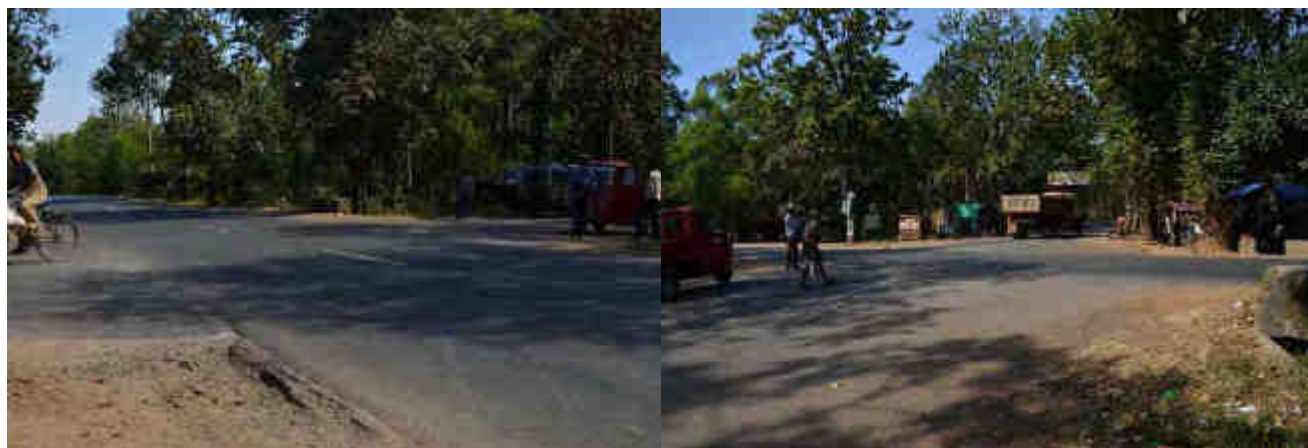
- This junction is intersection of ODR and NH149
- High Accident prone zone
- No warning for NH ahead
- Significant two wheelers, pedestrians, cyclists are present on the junction.
- No traffic islands are present for safe and effective maneuver of traffic.
- Street light is not present on the junction.

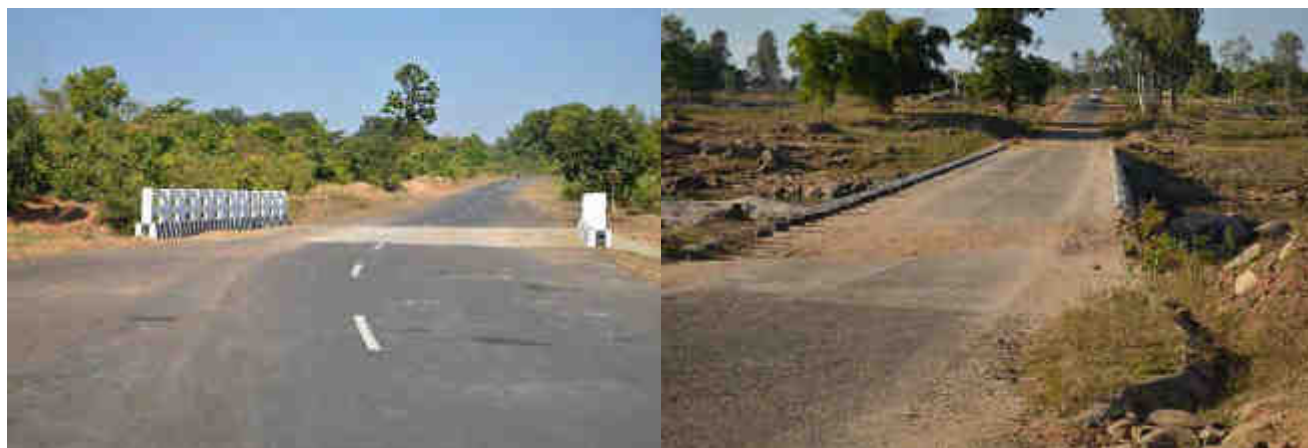
- Curves approaches to major/ minor bridges
- High embankment
- No approach protection
- Dangerous overtaking is observed
- No traffic signs are present on the road.

Absence of OHM on structure at Km 44+500 and submersible structure at Km 58+900
