**Government of Odisha (GOO)
Chief Engineer, World Bank Projects, Odisha
Odisha State Roads Project**

**Consultancy Services for
Road Sector Institutional Development
Loan # 7577-IN**

**ROAD INFRASTRUCTURE
SAFETY MANAGEMENT REVIEW**

VOLUME I - REPORT

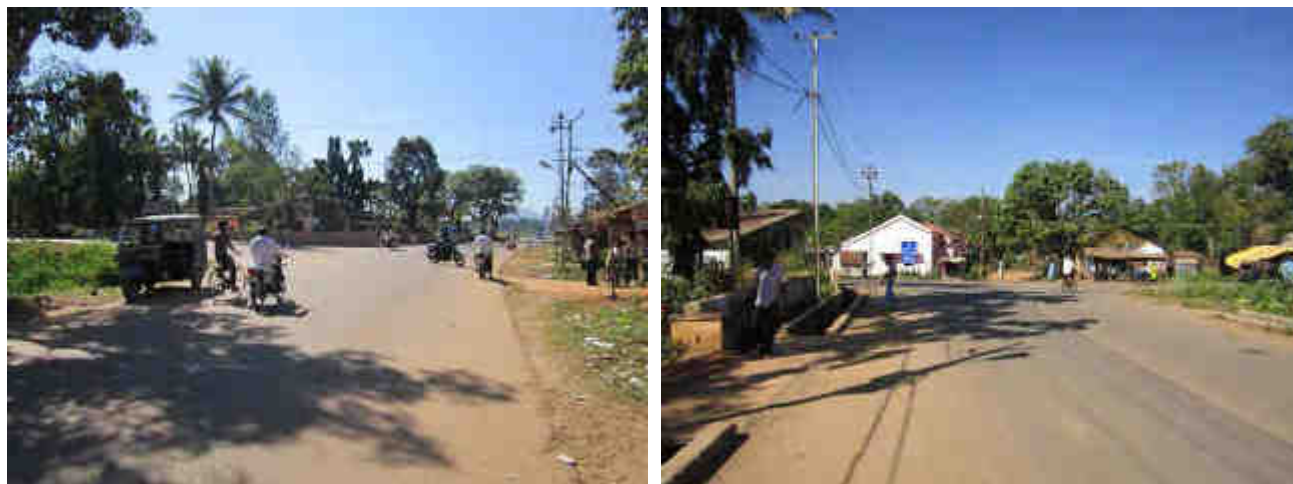
Ch: 3+700

In the existing situation, there is one major junction along this road at Ch: 3+700.

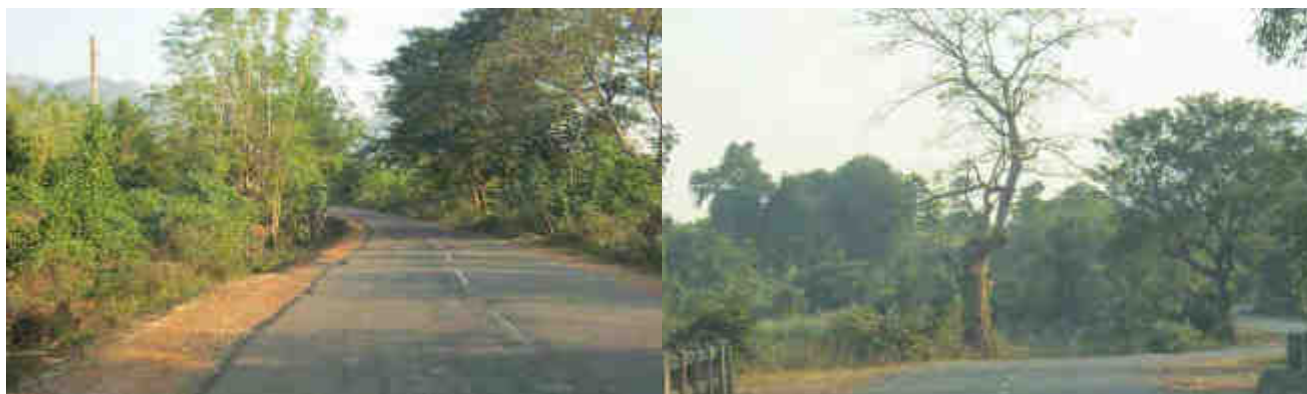
Road side hazards/objects present along this stretch of road are predominantly trees at Km 17+050, Km 17+800 and Km 24+500.

Road side hazards-Trees

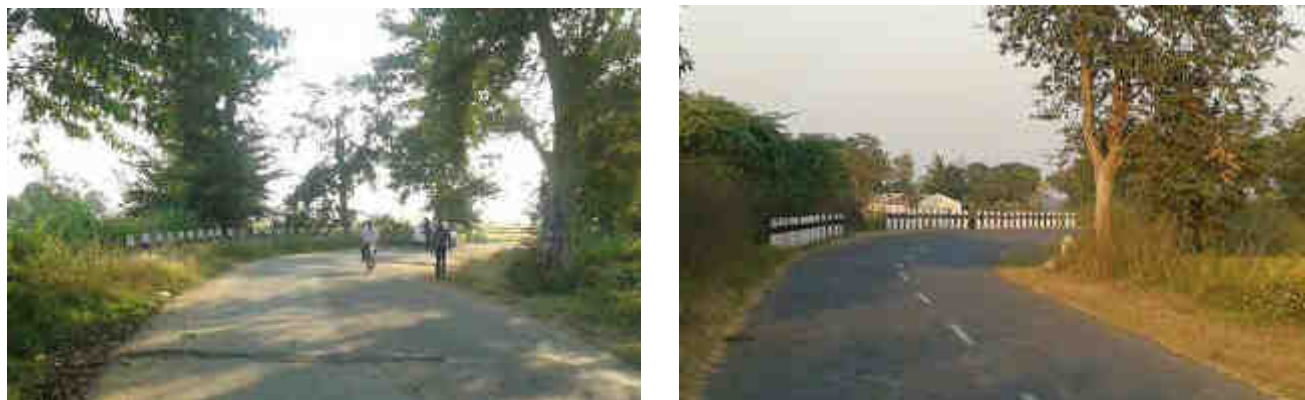
Image 1.1: Sharp curve with restricted visibility at Km 0+400 and Km 3+800

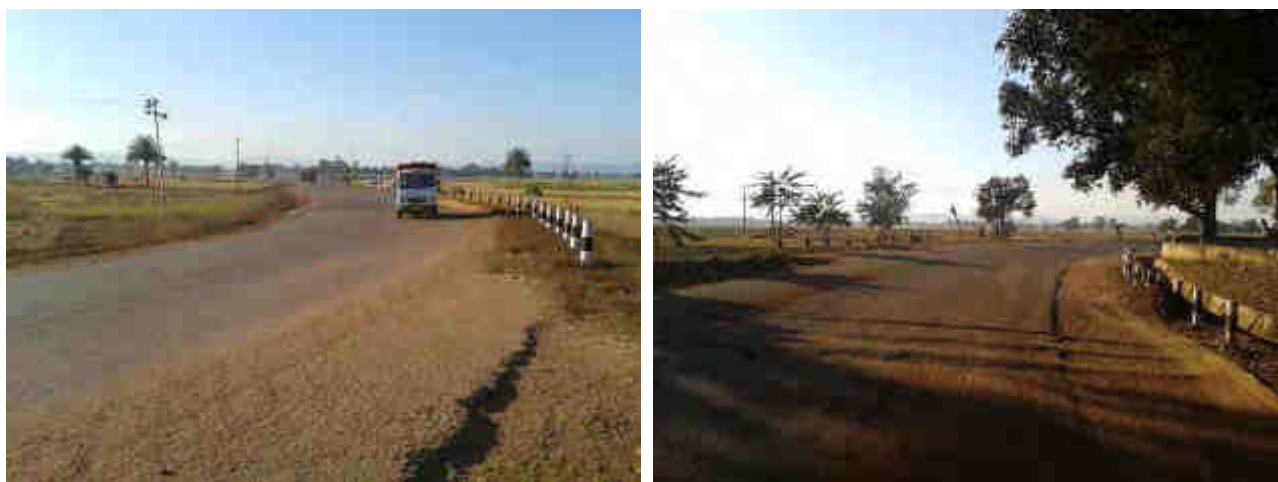
Lack of delineation in the stretch of road from Km 45+000 to 43+000

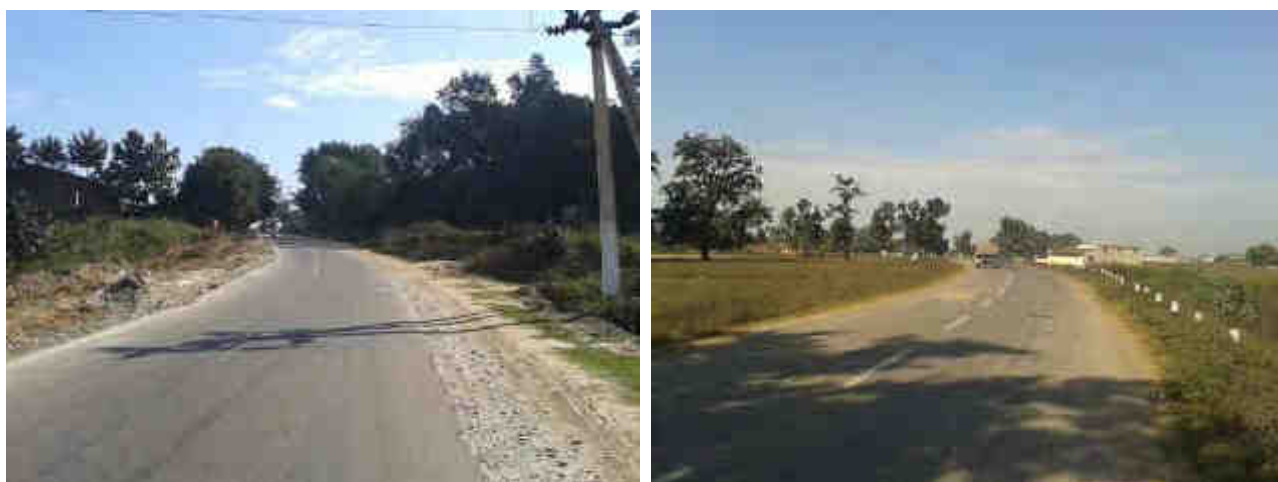
Lack of delineation in the stretch of (i) Km 0+000 to 1+000, and (ii) Km 6+000 to 7+000

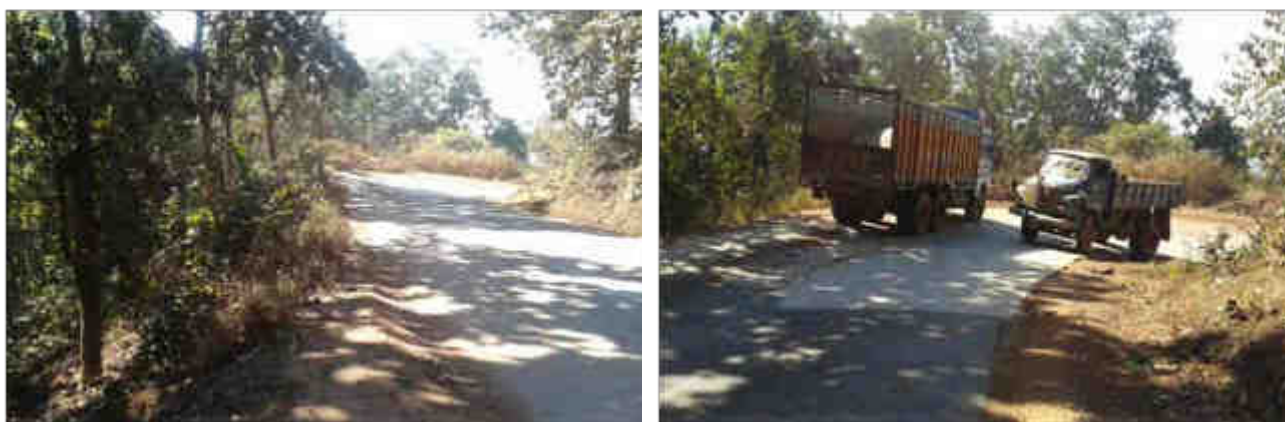
Km 19+250, dangerous hairpin bend

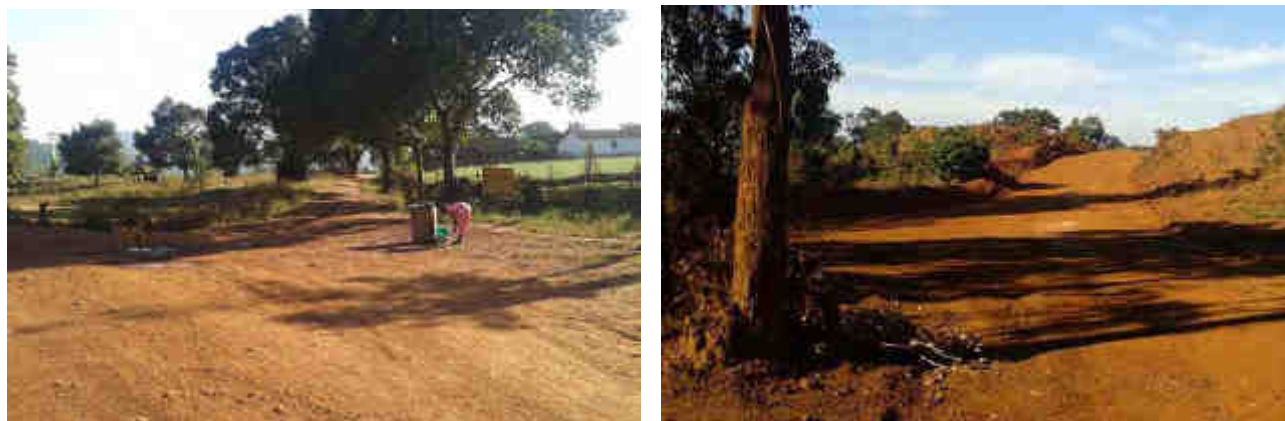
Side road joining with Patmunda/ Khajurdihi Road at Km 2+150 and Km 3+400

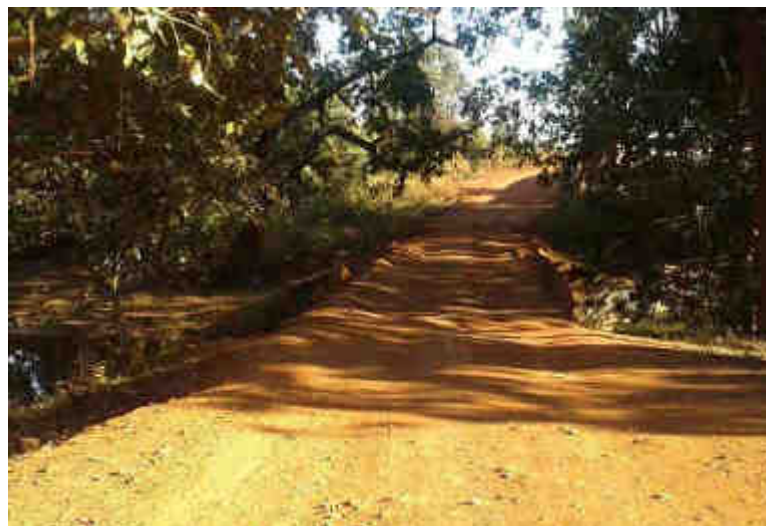
At Km 4+100 the parapets of bridge are not delineated.

Parapets of culvert not delineate, Km 4+100

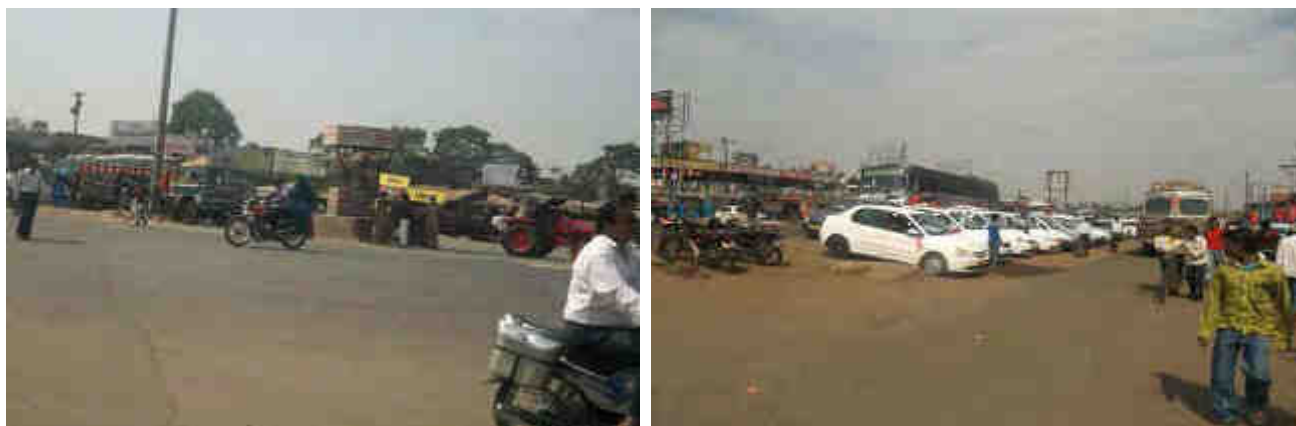
Poor junction layout and on street parking at roundabout at Km 219+000

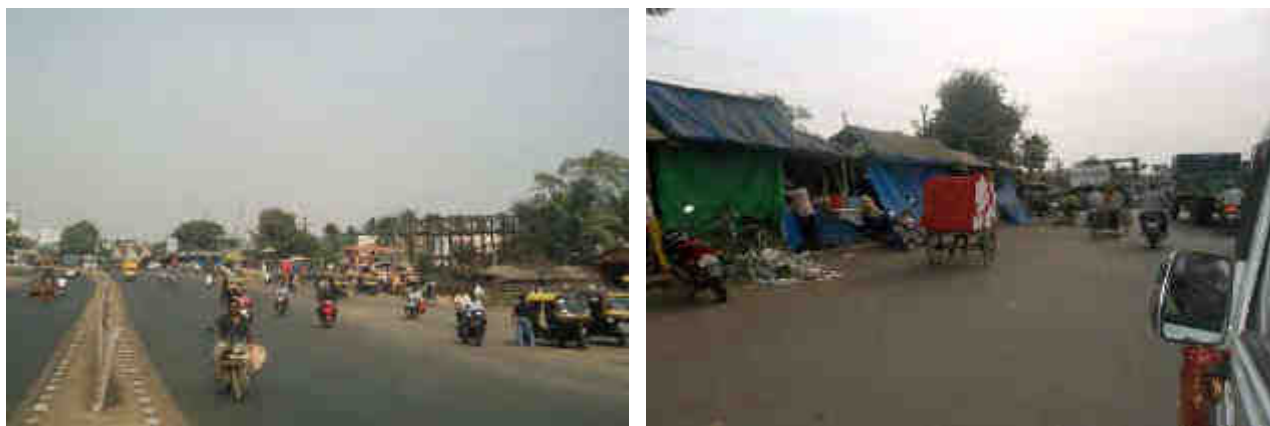
Built up area and high encroachments at Km 265+400
