**Government of Odisha (GOO)
Chief Engineer, World Bank Projects, Odisha
Odisha State Roads Project**

**Consultancy Services for
Road Sector Institutional Development
Loan # 7577-IN**

**ROAD INFRASTRUCTURE
SAFETY MANAGEMENT REVIEW
VOLUME II - APPENDICES**

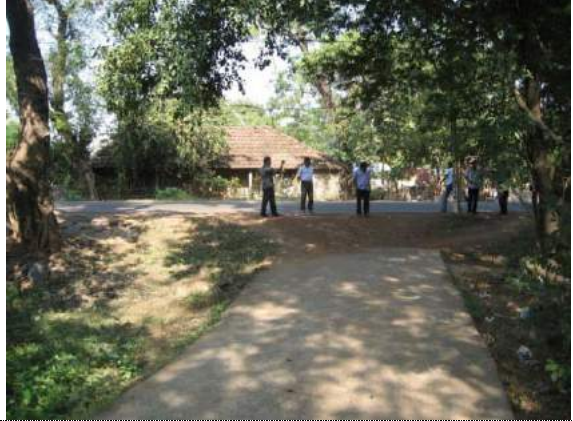
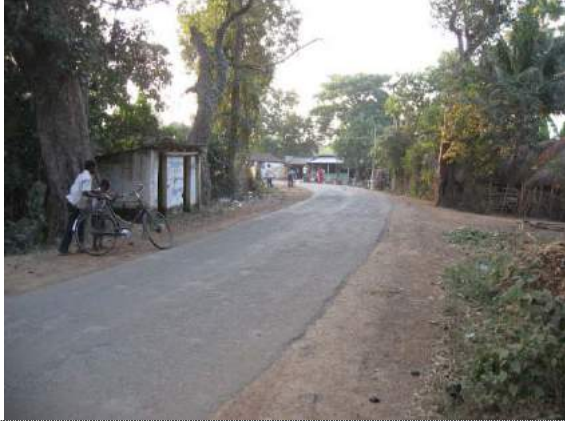
Ch: 6+700, Unsafe junction of the side road	Ch: 23+050, Sharp curve after a bridge, with a side road on the outside of the curve, approaching a village

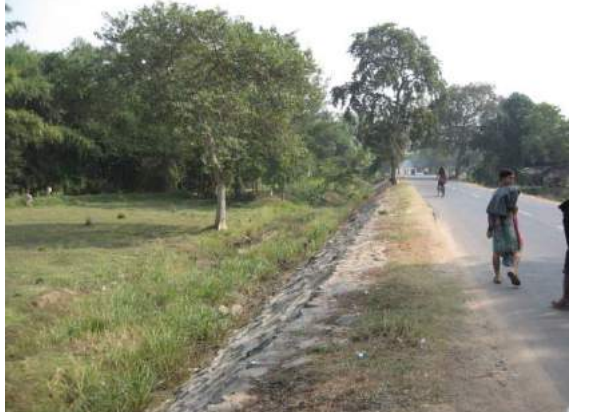
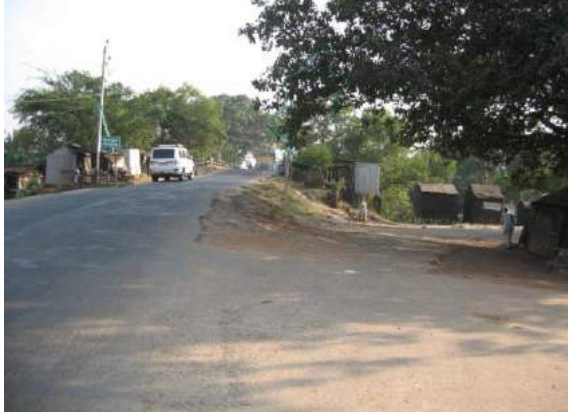
<p>Photo A</p>	<p>Photo B</p>

<p>Ch: 10+100, The road on high embankment doesn't have any run-off protection.</p>	<p>Ch: 26+550, the road on high embankment with side road joining with minimum sight distance. Another side road also joining here.</p>

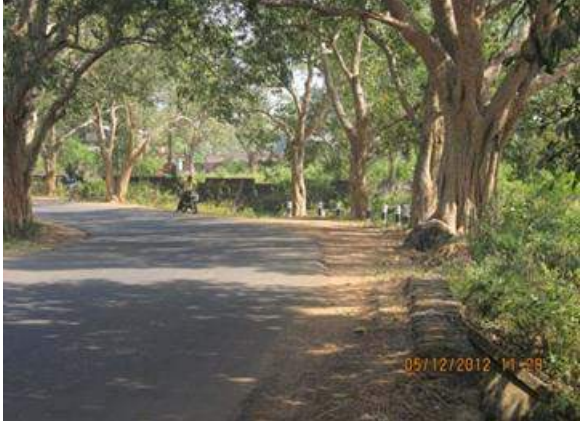
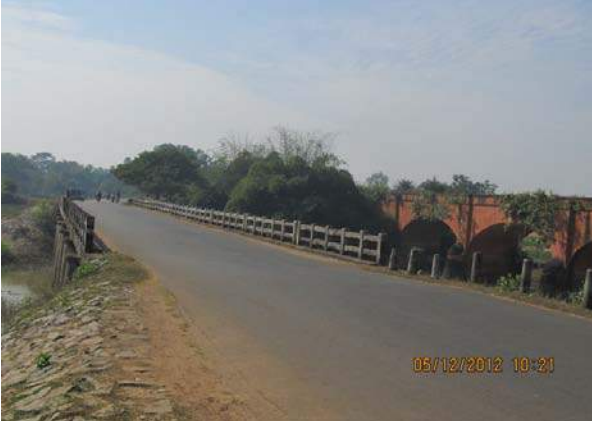
<p style="text-align: center;">Sharp Curve and Broken Parapet wall</p>	<p style="text-align: center;">Unprotected and unwarned approach to Major bridge at high embankment</p>

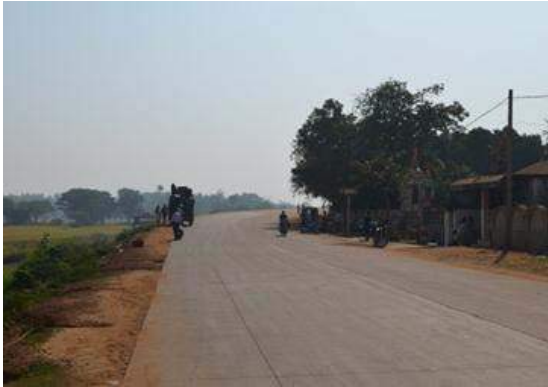
<p style="text-align: center;">Sharp curve with gradient; approaching to major bridge</p>	<p style="text-align: center;">Busy intersection with high encroachments and on street parking</p>

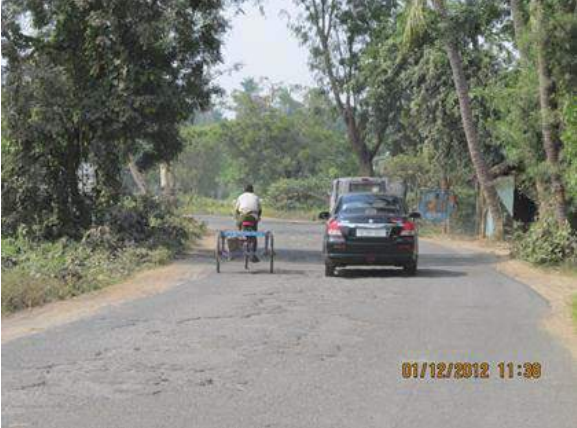
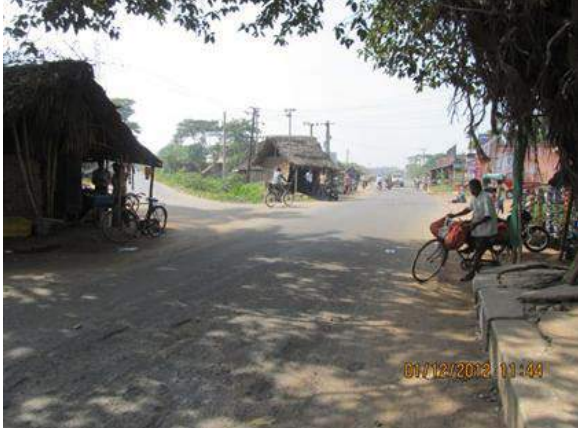
<p style="text-align: center;">Sharp curve and dangerous overtaking</p>	<p style="text-align: center;">Skewed side road with poor visibility</p>

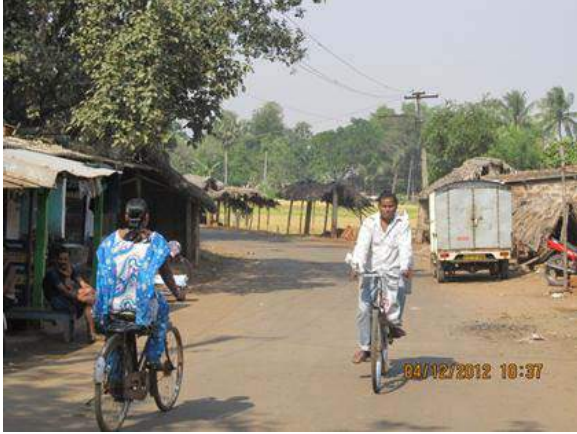
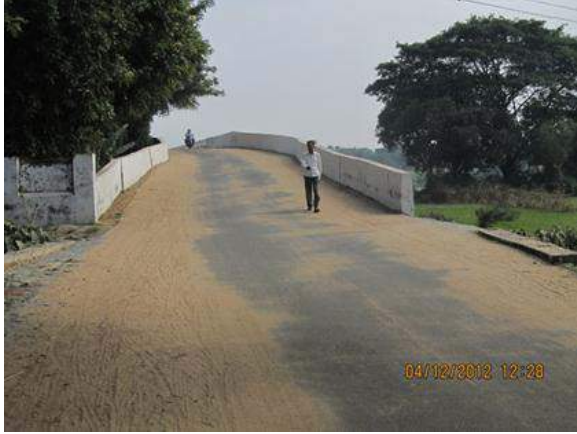
<p style="text-align: center;">Sharp Curve and high encroachment</p>	<p style="text-align: center;">Absence of OHM at approach of bridge</p>

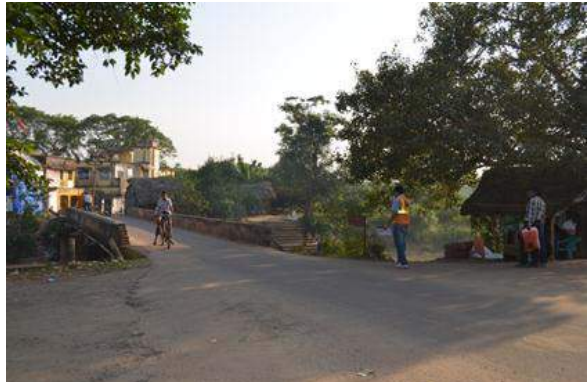
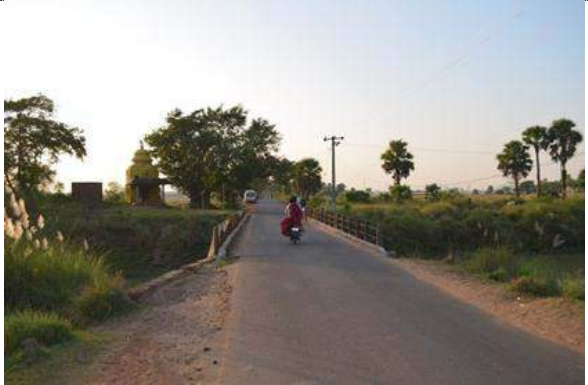
<p style="text-align: center;">Broken and unwarned parapet walls at major intersection</p>	<p style="text-align: center;">Unprotected and unwarned approach to bridge</p>

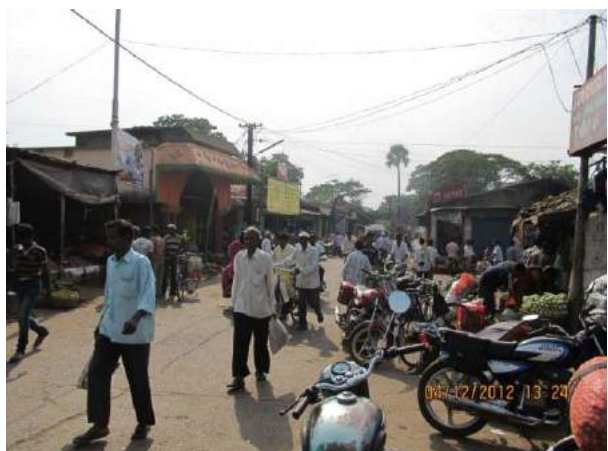
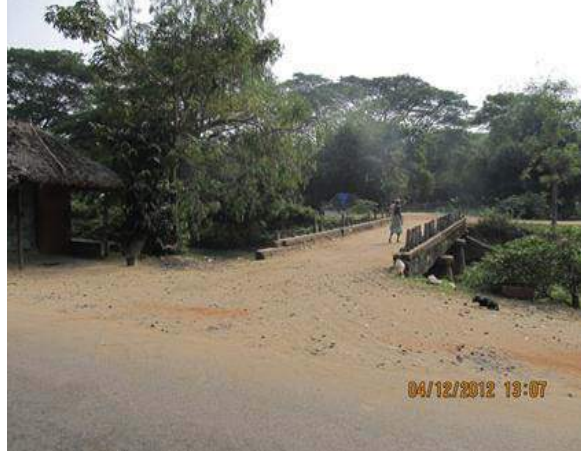
<p>High pedestrian and cyclists volume at Commercial Area of Balichandrapur</p>	<p>Side road approaching to minor bridge at high embankment</p>

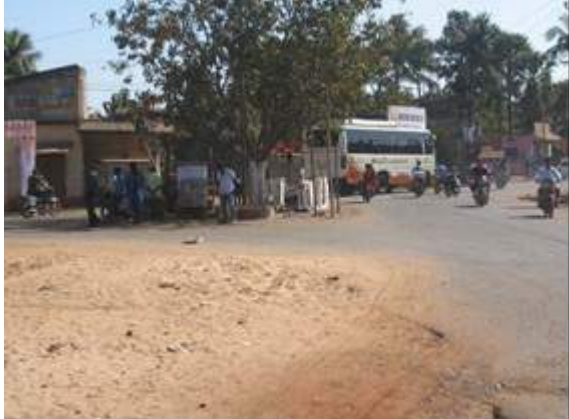
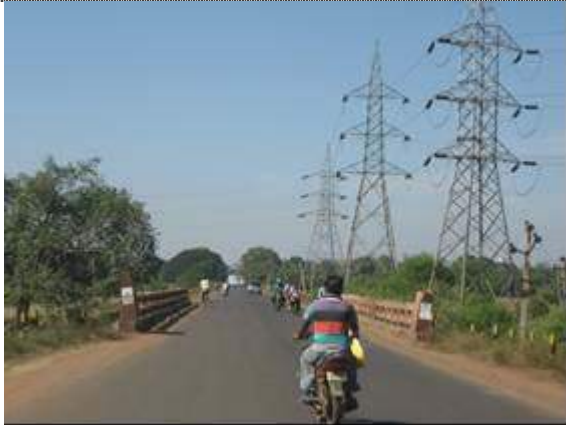
Ch: 0+000, Unsafe behaviour of parking vehicles in the middle of junction.	Ch: 7+000, the absence of delineation of the approach of the bridge parapet.

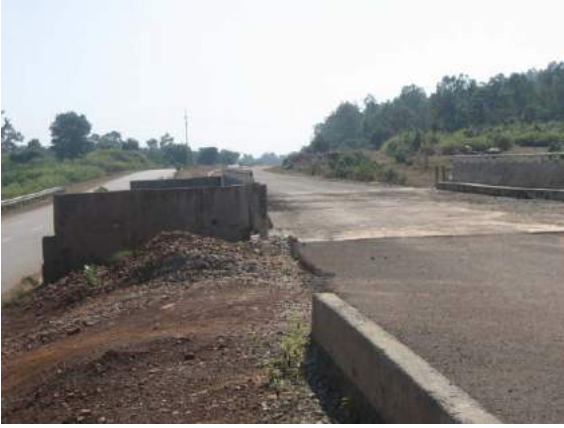
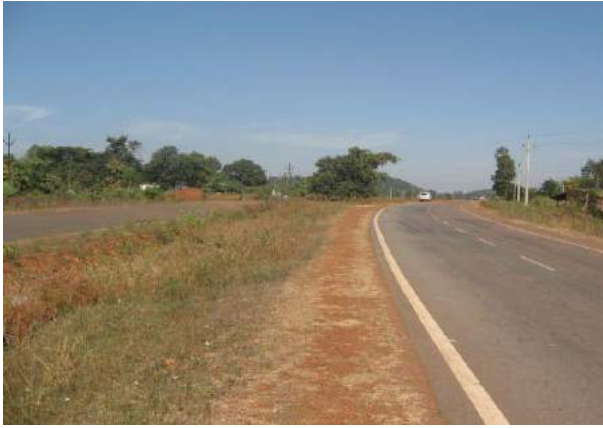
<p>Photo A</p>	<p>Photo B</p>

<p>Ch: 7+500, the presence of non-breakaway parapet of the culverts close to the road with proper delineation.</p>	<p>Ch: 15+800, absence of run-off protection on curves.</p>

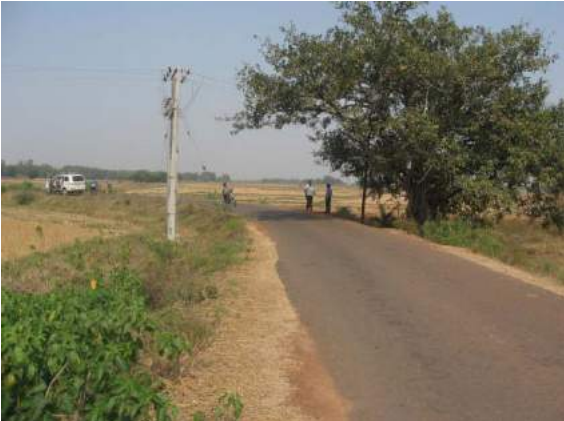
<p>Photo A</p>	<p>Photo B</p>

<p>Ch: 6+300, The obstructed sight triangle of the side road joining the main road.</p>	<p>Ch: 19+000, The presence of road side friction could lead to accidents.</p>

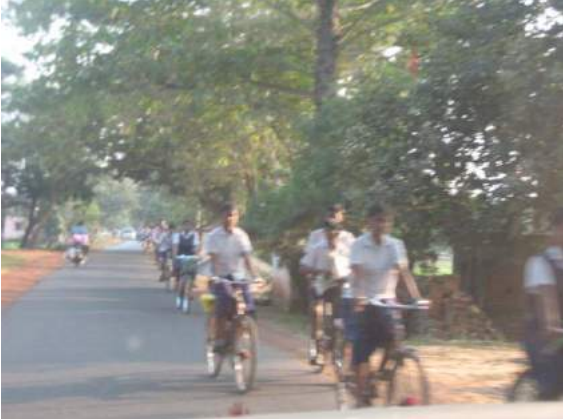
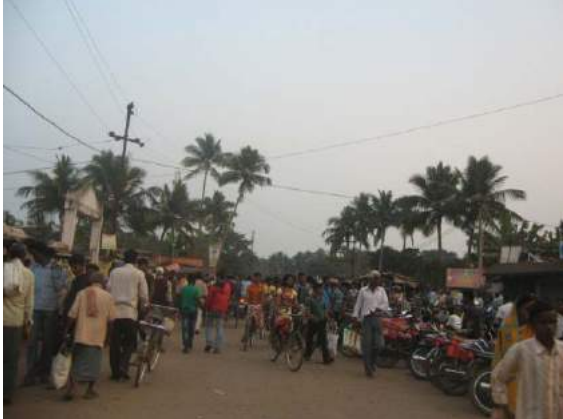
<p style="text-align: center;">Photo A</p>	<p style="text-align: center;">Photo B</p>

<p>Ch: 10+100, the absence of cycle paths for the school children.</p>	<p>Ch: 22+100, On-street parking, jaywalking pedestrians decreasing operational efficiency of road and an unsafe situation.</p>

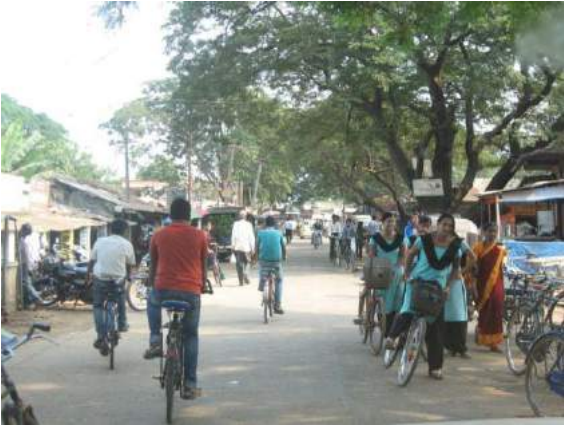
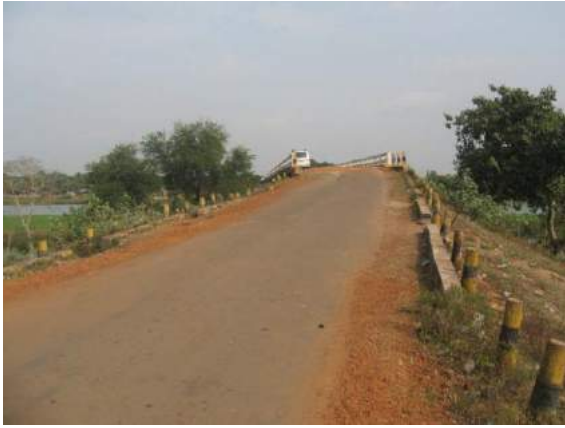
<p>Photo A</p>	<p>Photo B</p>

<p>Ch: 37+500, The absence of segregated right-of-way for school children</p>	<p>Ch: 47+600, The absence of delineation / protection on high embankment.</p>

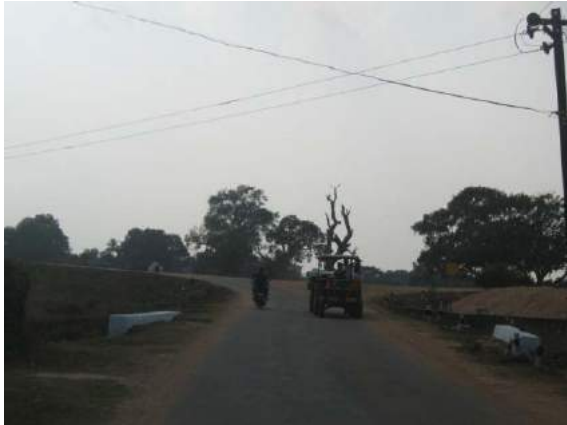
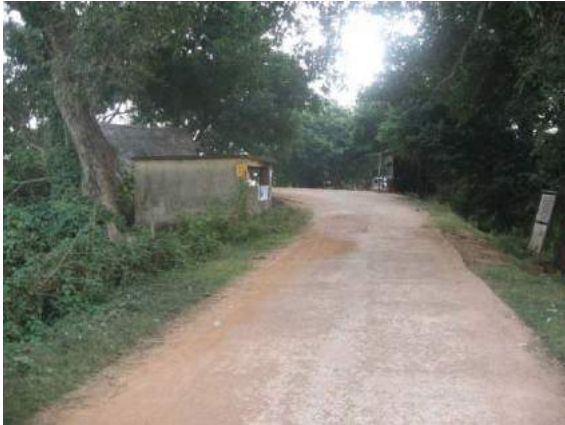
<p style="text-align: center;">Photo A</p>	<p style="text-align: center;">Photo B</p>

<p>Ch: 3+000, the absence of crash-protection of the road on high embankment.</p>	<p>Ch: 7+200, the unsafe gradient at which the side road joins the main road</p>

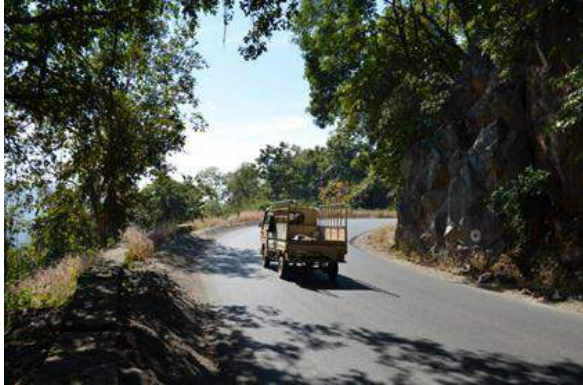
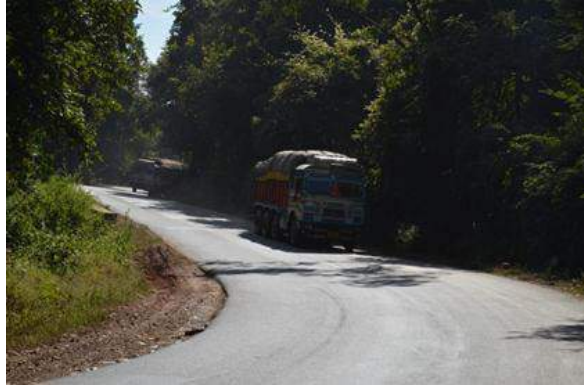
<p style="text-align: center;">Unprotected sharp curve and Valley on outside Curve</p>	<p style="text-align: center;">Trucks negotiating Reverse Curve</p>

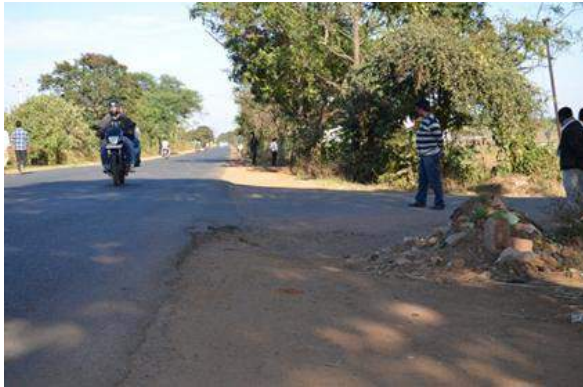
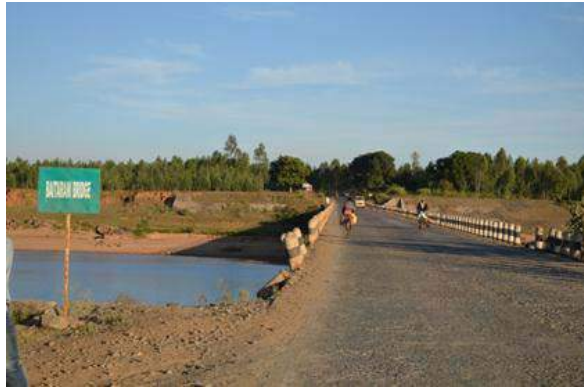
<p>Side road with level difference and poor visibility</p>	<p>Unprotected approach of Major bridge</p>

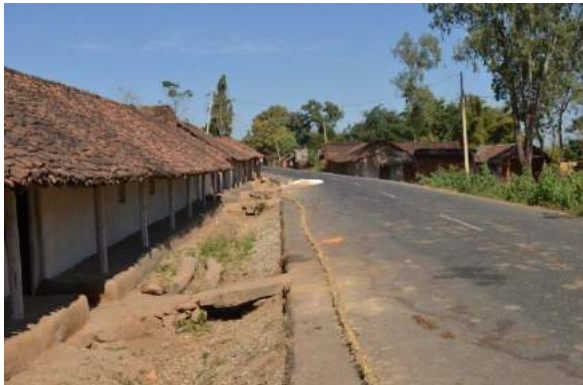
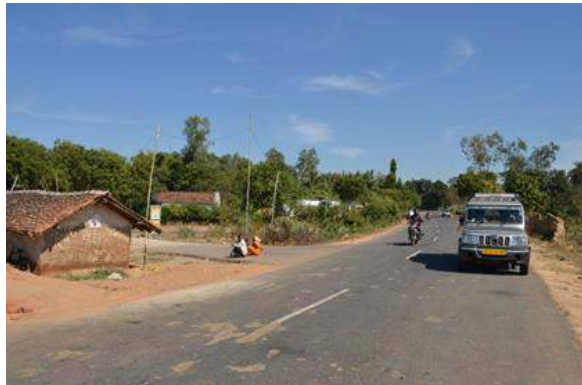
<p style="text-align: center;">Houses very near to the pavement edge</p>	<p style="text-align: center;">Side road with poor visibility</p>

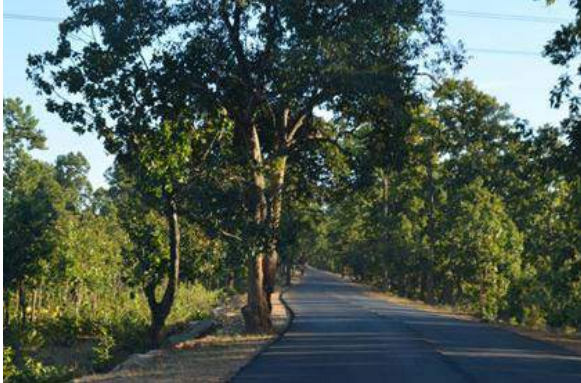
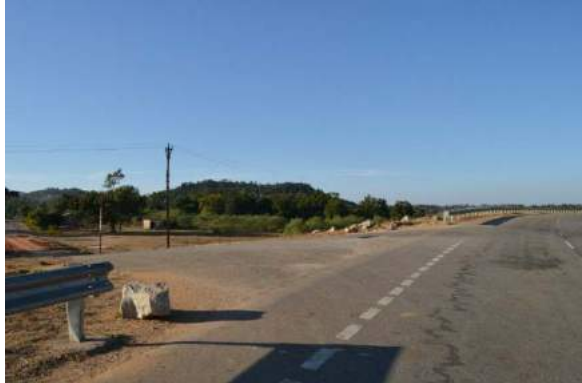
<p style="text-align: center;">Road side trees hampering the visibility</p>	<p style="text-align: center;">Unsafe side road with higher level difference</p>

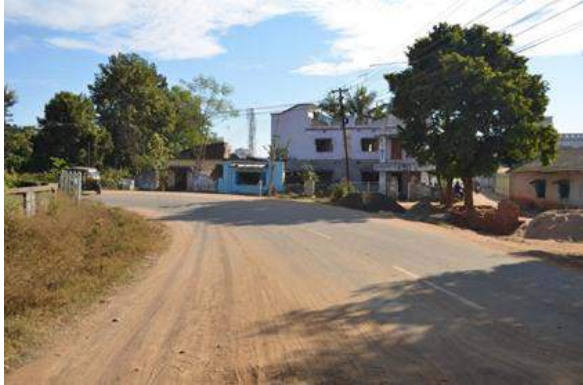
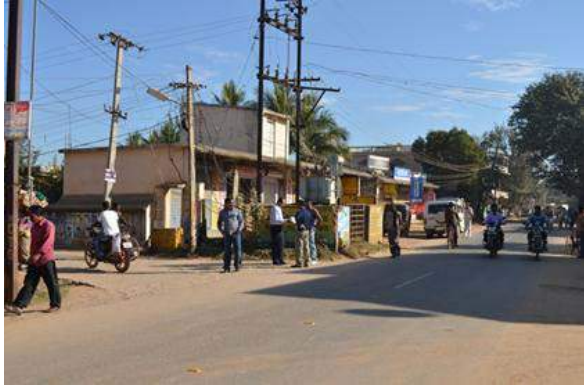
<p>Sharp curve with poor visibility</p>	<p>Side road with poor visibility and high encroachments</p>

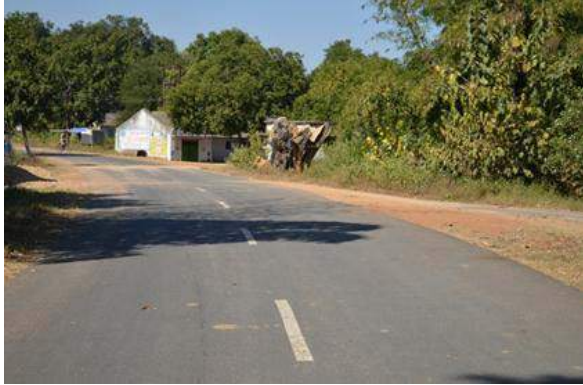
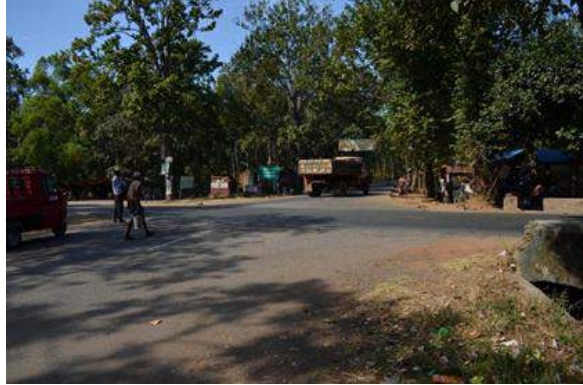
<p>Sharp Curve and skewed side road with poor visibility due to overgrown vegetation</p>	<p>Major Junction with poor junction layout</p>

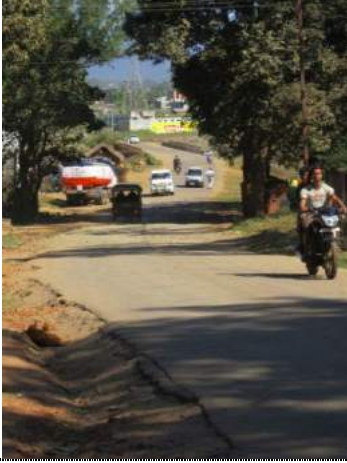
<p>Ch: 4+900, The presence of a reverse curve on a varying elevation and no run-off protection on the curves.</p>	<p>Ch: 10+000, The presence of a horizontal curve after a vertical curves, without proper delineation decreases the sight distance and could lead to an accident.</p>

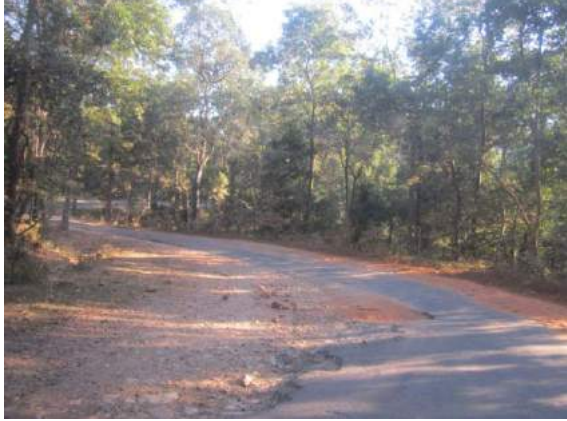
<p>Ch: 37+300, the absence of delineation on the curves in hilly terrain.</p>	<p>Ch:40+500, the presence of a horizontal curve after a vertical curve leads to limited sight distances.</p>

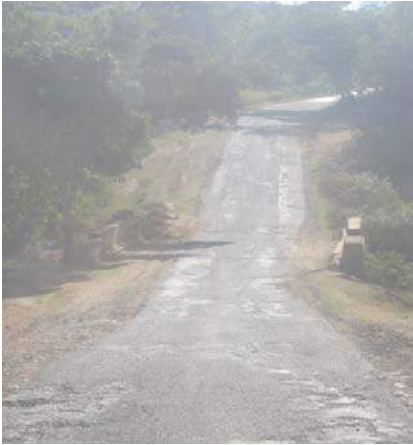
<p>Ch: 30+000, The absence of delineation on vertical sag curves</p>	<p>Ch: 43+000, The absence of delineation / protection on the approaches to the bridge / culvert.</p>

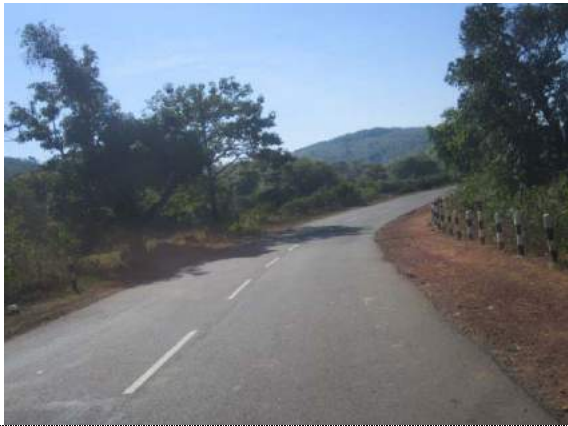
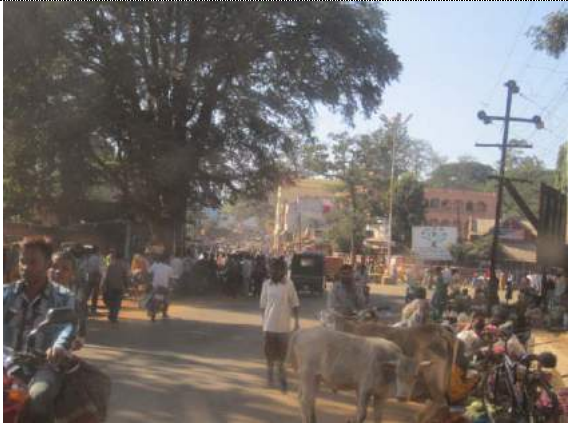
<p>Photo A</p>	<p>Photo B</p>

<p>Ch: 392+700, the absence of delineation of the sharp curves.</p>	<p>CH: 401+100, the absence of vulnerable road user facilities leads to conflicts during village markets on the roads.</p>

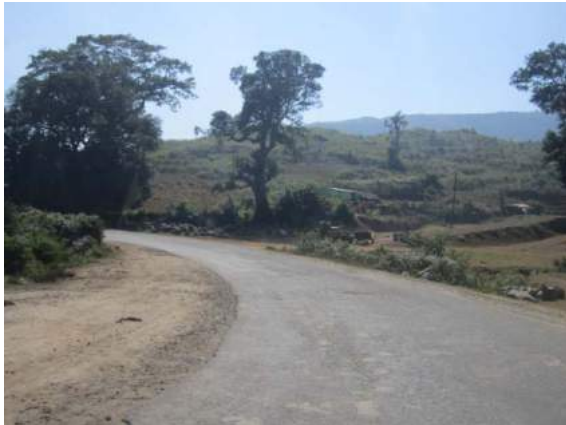
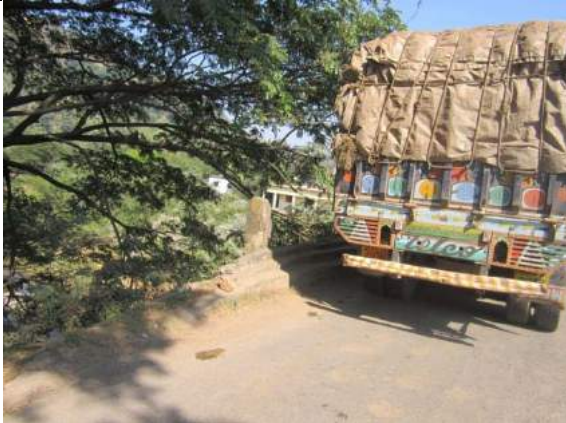
<p style="text-align: center;">Photo A</p>	<p style="text-align: center;">Photo B</p>

<p>Ch: 457+000, The absence of delineation on blind / sharp curves with valley on one side with no crash protection.</p>	<p>Ch: 466+500, The absence of protection / delineation of the approaches to the bridge / culvert.</p>

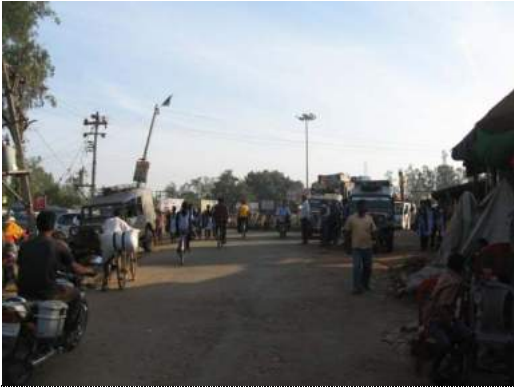
<p>Ch: 0+000, The unsegregated pedestrians, cyclist occupying the road along with vehicles parked on road.</p>	<p>Ch: 29+500, The non-delineated / unprotected parapet walls of the bridges / culverts.</p>

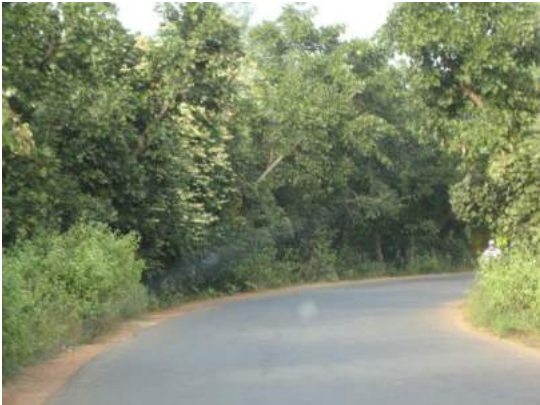
<p>Ch: 49+700, the absence of delineation on sharp curves</p>	<p>Ch: 86+500, the absence of run-off protection and delineation at the approaches of the culvert.</p>

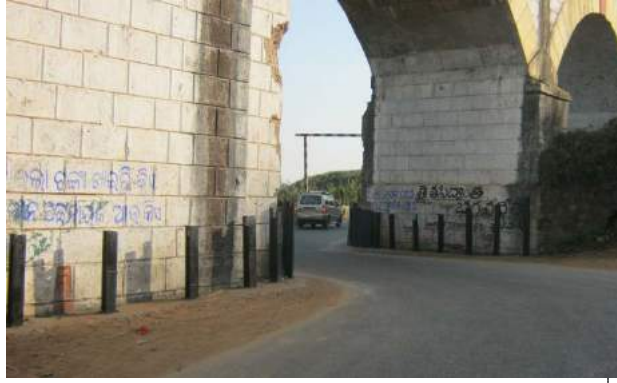
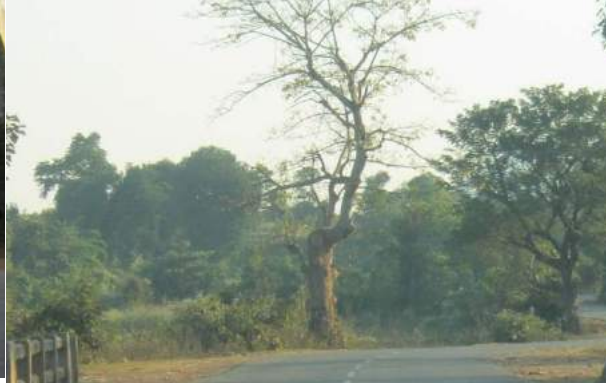
<p>1. Road No: MDR 48B</p>	<p>2. Road Section: Raygada to Kerada</p>
<p>3. OWD Officer accompanied: Mr Bhabugrahi Mohanty,AE</p>	
<p>4. Date of Assessment:</p>	<p>5. Assessor: Ashif Hussain, ICT</p>
<p>6. Length: 25 Km</p>	<p>7. Road Geometry: single lane with 0.5m shoulder, mix of Plain and hilly terrain</p>
<p>8. Road surface: Bituminous</p>	<p>9. Land use along road: Mixed, Commercial, Residential and Agriculture</p>
<p>10. List major safety deficiencies of this road</p> <ul style="list-style-type: none"> (i) Centre line & Edge line is missing in many sections of the road. Traffic signage is missing or improper. (ii) Absence of warning or cautionary sign near curves and also there is no any protection on bridges/culverts. (iii) Absence of provisions for VRUs in built-up and commercial areas 	
<p style="text-align: center;">Photo A</p>	<p style="text-align: center;">Photo B</p>

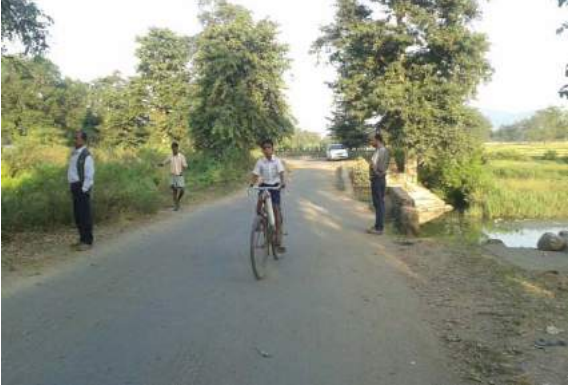
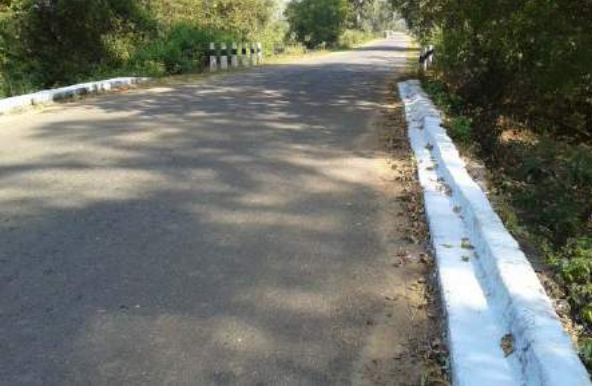
<p>Culvert at Km 0+400, sharp curve at the approach, no delineation, and no parapets</p>	<p>No parapets on Culvert/Bridge highly unsafe for VRUs as well as other traffic, Km 20+000</p>

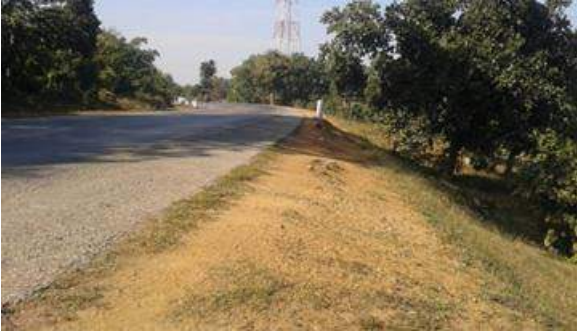
<p>Sharp curve with high embankment without any protection on outer edge, Km 93+600</p>	<p>Lack of edge protection and delineation on approaches of ROB at Km 49+900</p>

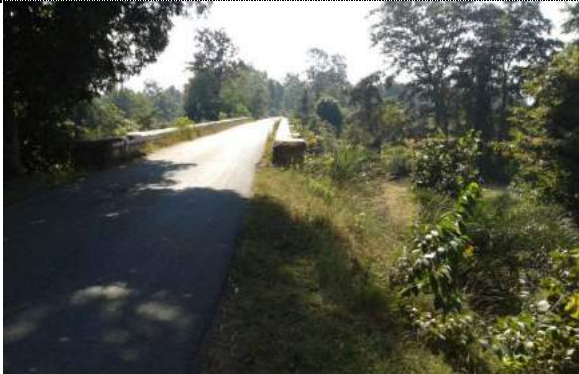
<p>Unprotected approach to bridge with high embankment at Km 164+700</p>	<p>Sharp curve on high embankment without edge protection near railway crossing at Bamra (Km 198+700)</p>

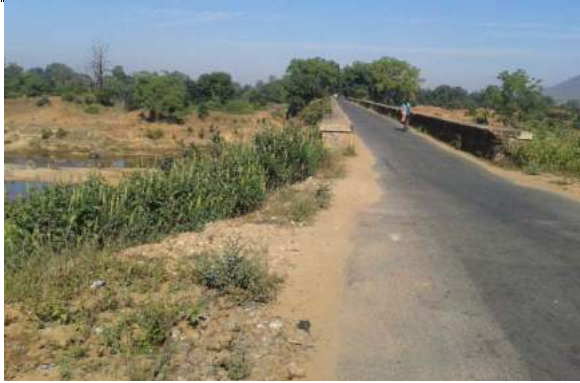
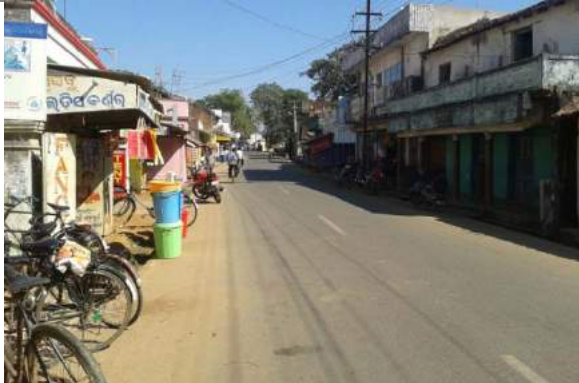
Unprotected high embankments of bridge approach and bridge parapets close to road edge not delineated at Km 313+300	On-street parking and commercial activities on road in Kuchinda, Km 14+000 to 16+000

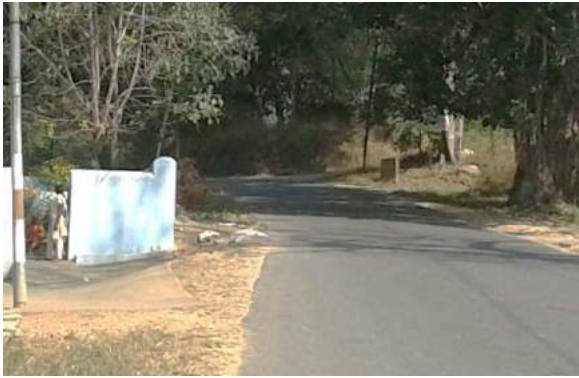
<p>Image 1.1: Sharp curve with gradient, side road, and restricted visibility in BUA at Km 16+200</p>	<p>Sharp curve on high embankment without edge protection near approaching culvert (under construction), Km 31+800</p>

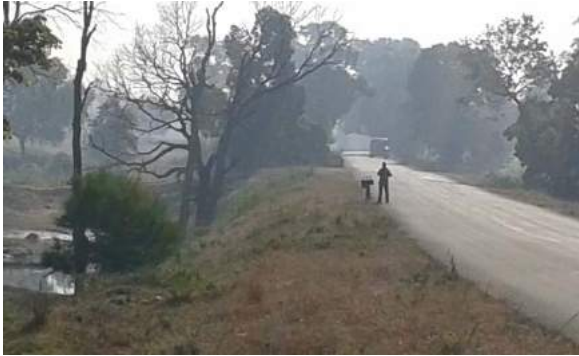
<p style="text-align: center;">Unprotected approach to bridge with high embankment, Km 6+500</p>	<p style="text-align: center;">Unprotected approach to culvert under construction – lack of warning signs and barricades, Km 9+200</p>

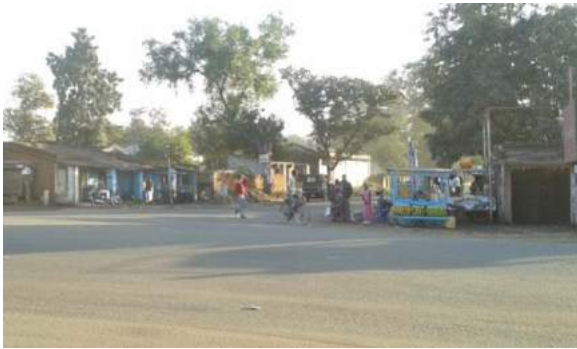
<p>Km 0+000, intersection of MDR-26 with SH-10 with poor layout and no control over traffic movement</p>	<p>Parapets of Culvert/Bridge close to the road edge and not delineated, Km 3+300 and Km 9+300</p>

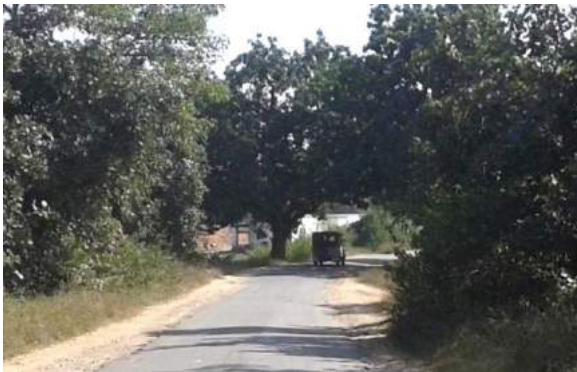
<p>Sharp curve with restricted visibility and lack of delineation at Km 2+400</p>	<p>Lack of footpaths and pedestrian crossing, and trees/buildings very near the road edge in BUA at Km 7+300</p>

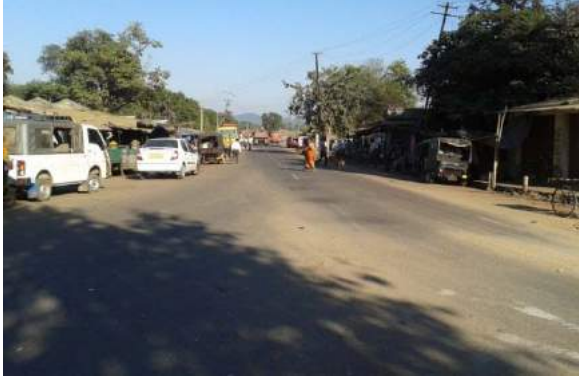
<p>Poor junction layout, lack of road markings, and encroachment on approaches of intersection with NH-520, Km 48+500</p>	<p>Parapets of Culvert/Bridge very near the road edge with lack of delineated, Km 30+200</p>

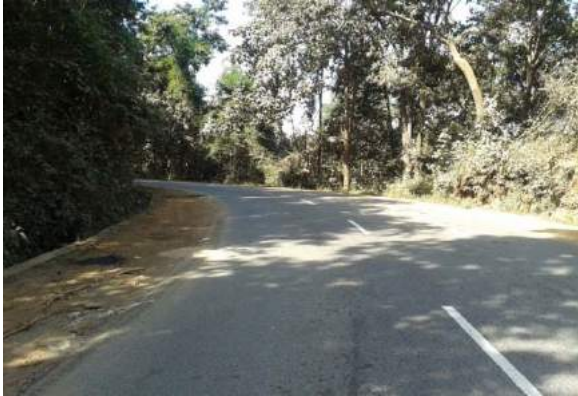
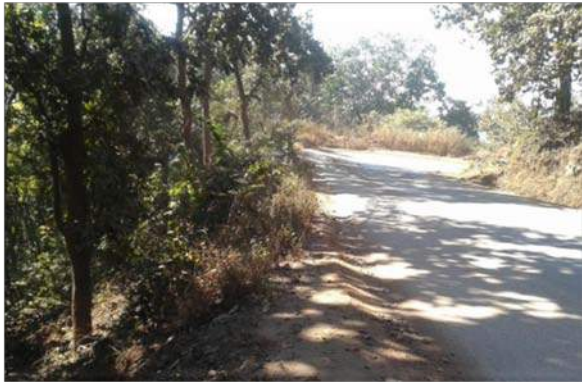
<p style="text-align: center;">Sharp curve in ghat section with restricted visibility at Km 30+200</p>	<p style="text-align: center;">Dangerous hairpin bend in ghat section with lack of delineation and outer edge protection at Km 19+250</p>

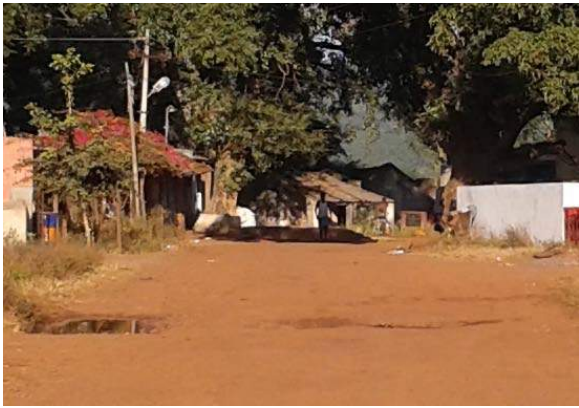
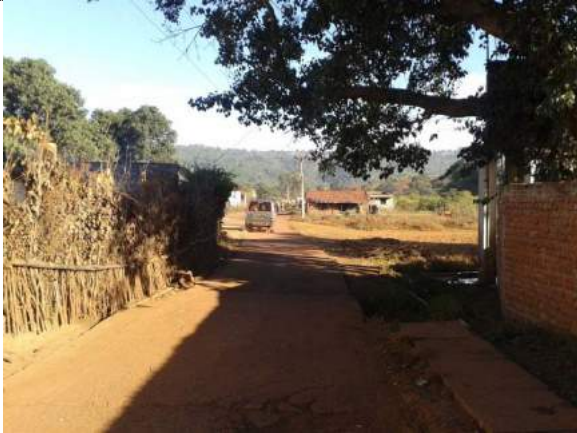
<p>Lack of delineation and signs at sharp curve, Km 7+900 (in BUA) on Koida-Patmunda Road</p>	<p>Lack of footpath or wide shoulders in BUA at Km 7+700 on Koida-Patmunda Road</p>

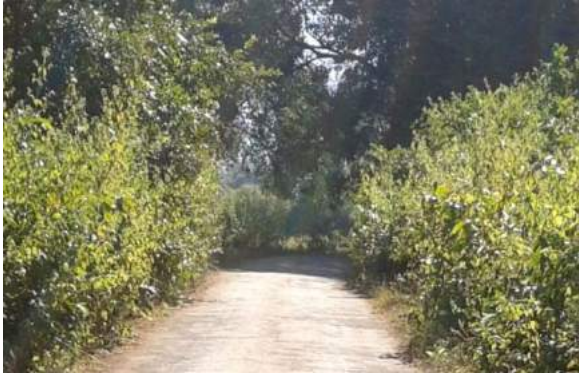
<p style="text-align: center;">Sharp curve with restricted visibility at Km 14+900</p>	<p style="text-align: center;">Road side hazards (poles and building) close to road edge and lack of facilities for pedestrians in BUA</p>

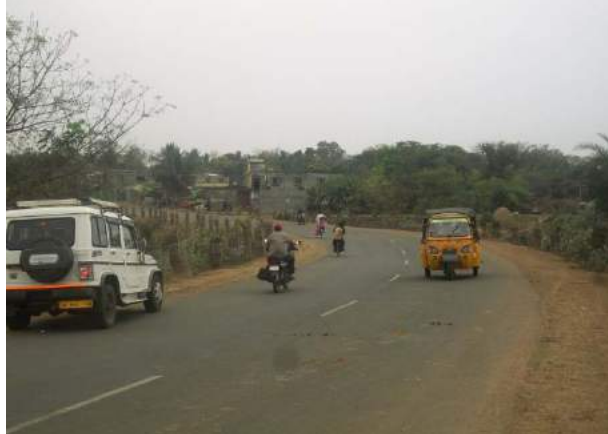
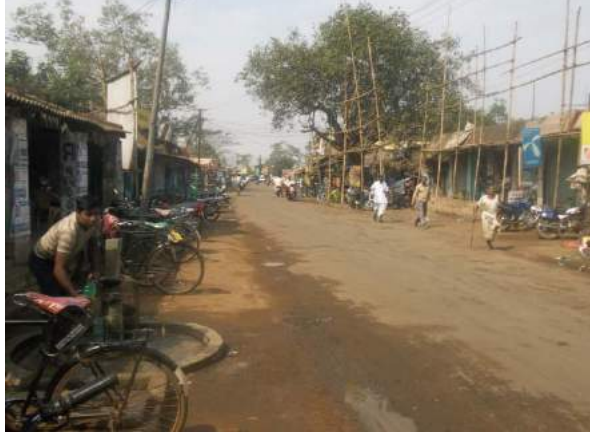
<p>Negotiation of Sharp curve</p>	<p>High encroachments and on street parking due to commercial activities</p>

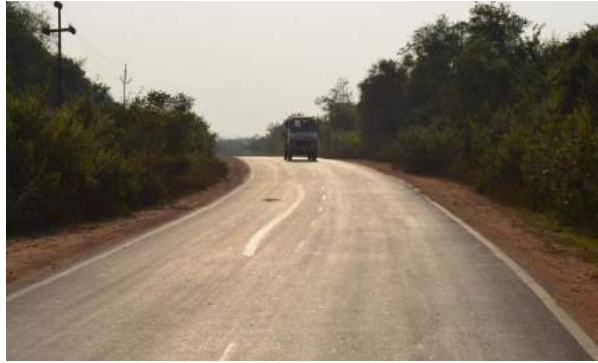
<p style="text-align: center;">Sharp curve with vertical gradient</p>	<p style="text-align: center;">Poorly designed 3-leg junction</p>

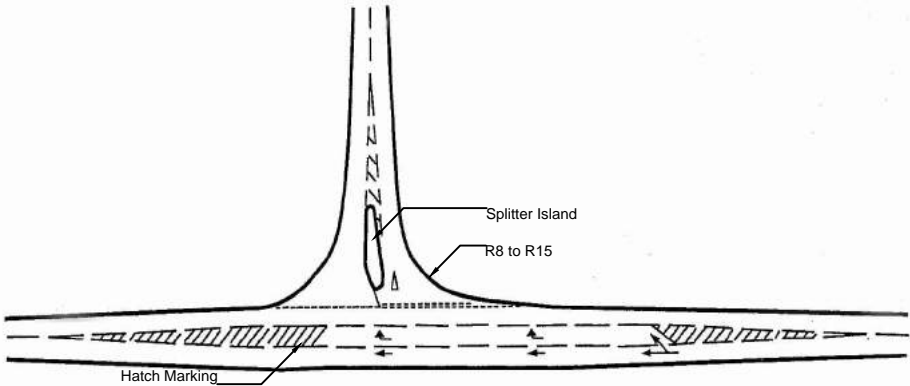
PLATE 10: Typical Layouts of Three Arm Junctions

Ghost Island Junction

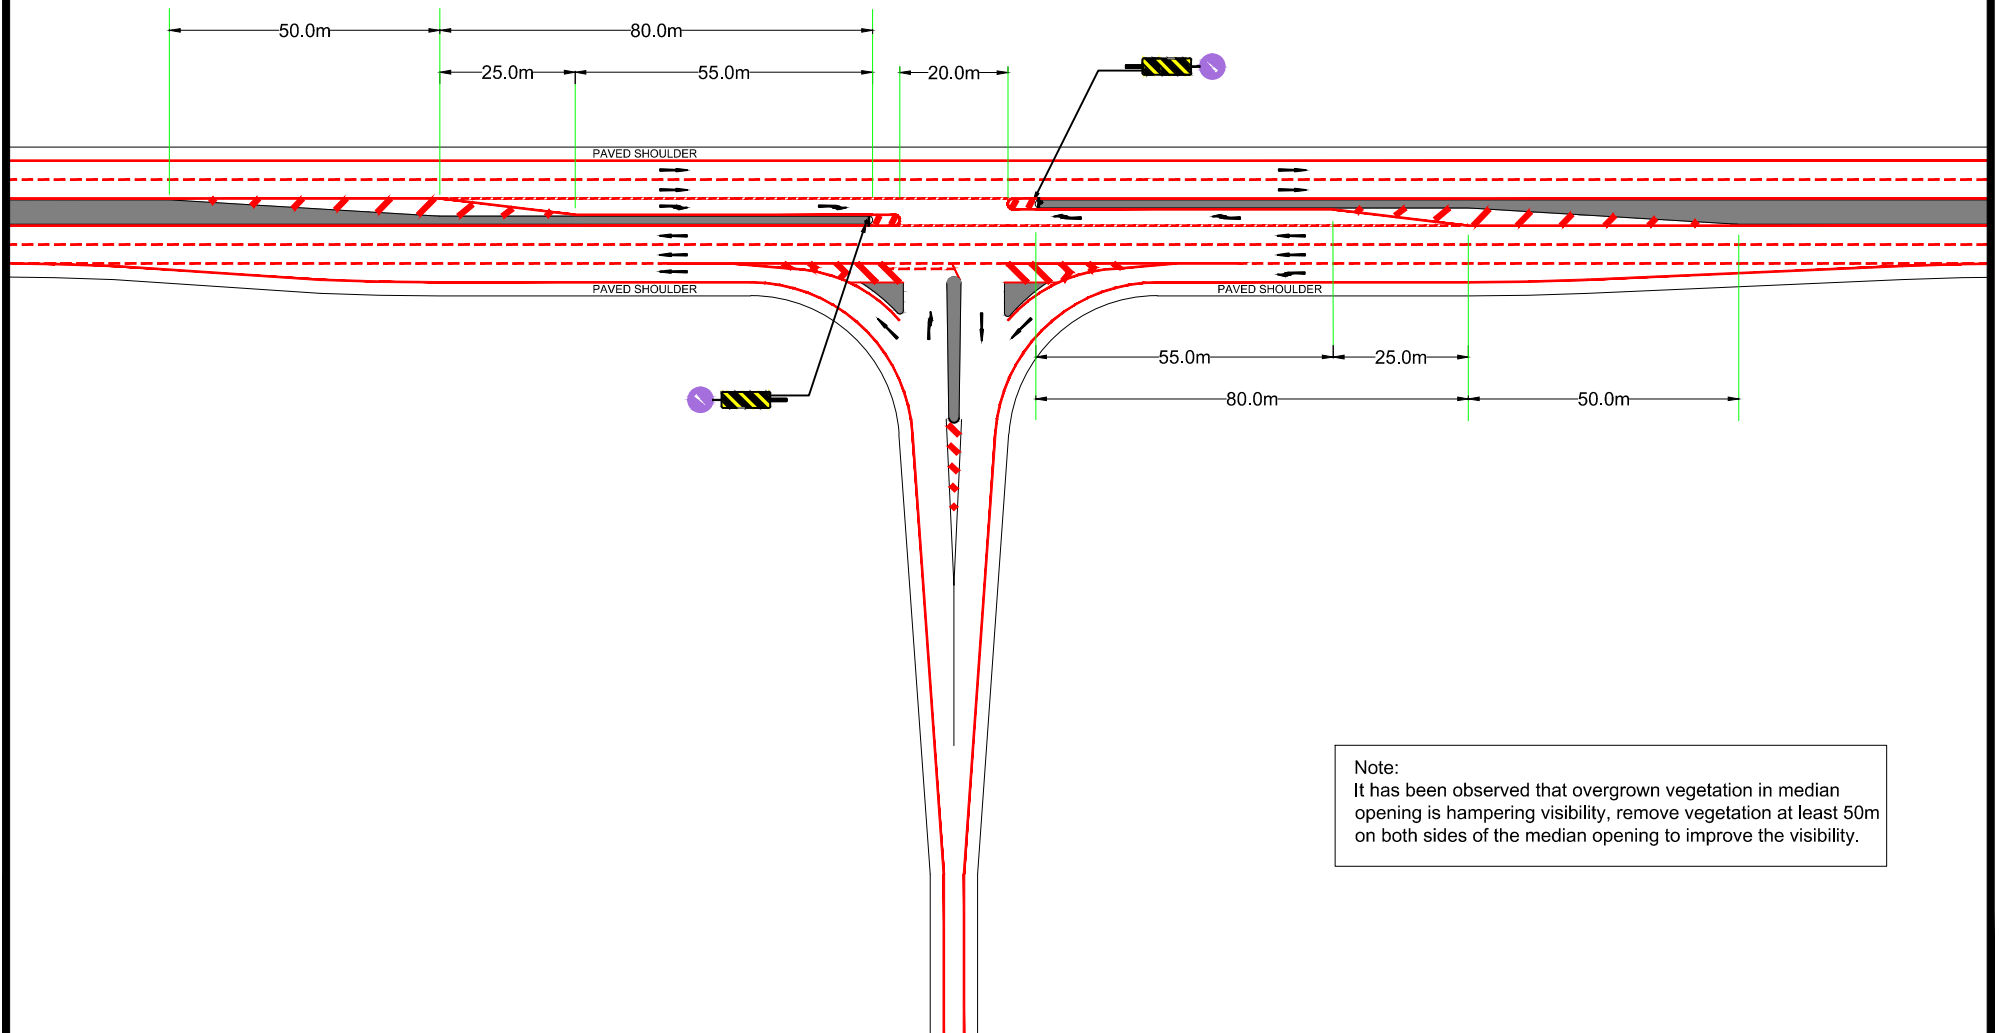
Note:
It has been observed that overgrown vegetation in median opening is hampering visibility, remove vegetation at least 50m on both sides of the median opening to improve the visibility.

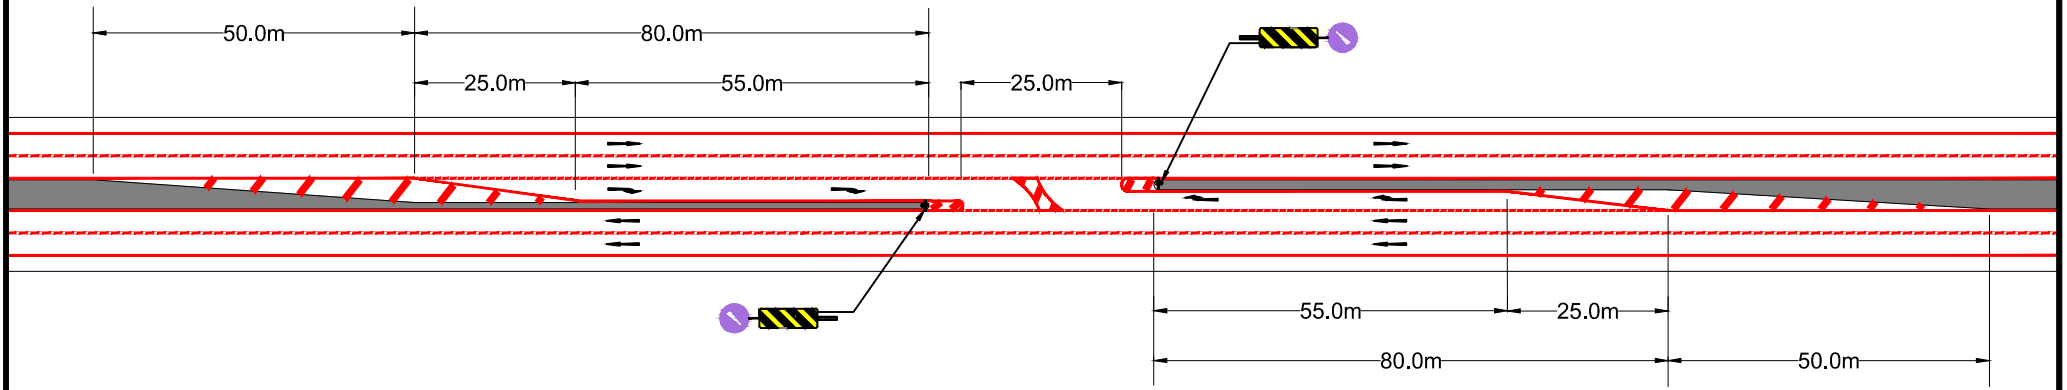
Note:
It has been observed that overgrown vegetation in median opening, is hampering visibility, remove vegetation at least 50m on both sides of the median opening to improve the visibility.

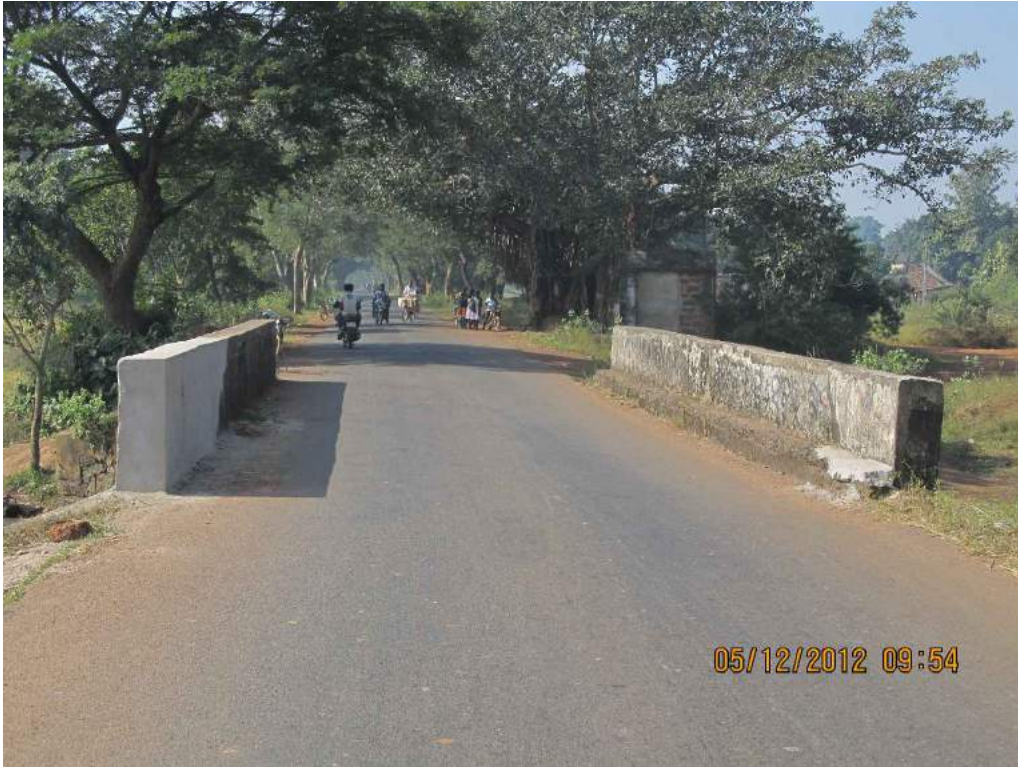
PLATE 24: Application of Object Hazard Marker

EXISTING SCENARIO
