**Government of Odisha (GOO)
Chief Engineer, World Bank Projects, Odisha
Odisha State Roads Project**

**Consultancy Services for
Road Sector Institutional Development
Loan # 7577-IN**

**ROAD INFRASTRUCTURE
SAFETY MANAGEMENT REVIEW**

VOLUME I - REPORT

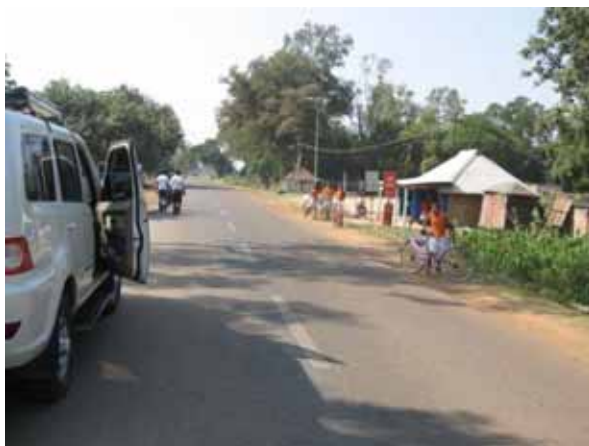
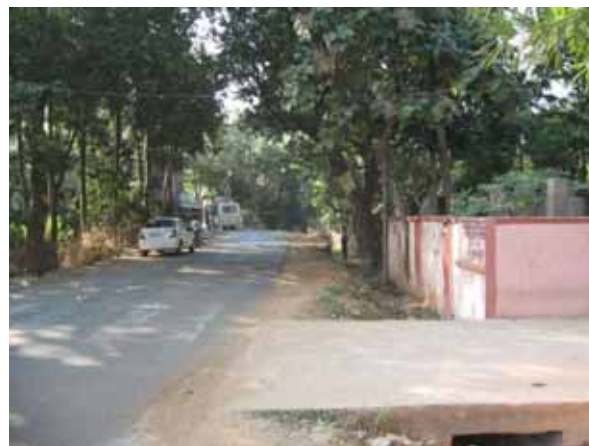
Reasons for concern: Centerline and edge line road markings are absent in the some sections of the road section.

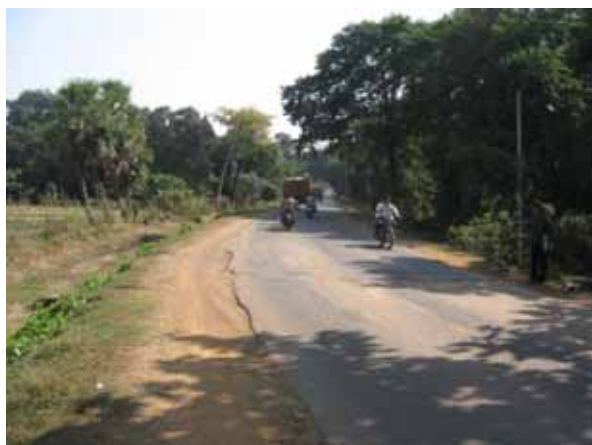
Ch: 1+500

Horizontal curves of radius less than 200 m were observed at Km. 1+500; 6+700; 7+400; 8+400; 8+750; 8+850; 9+150; 20+170; 21+500; 22+300; 23+050; 23+300; 25+160; 26+150

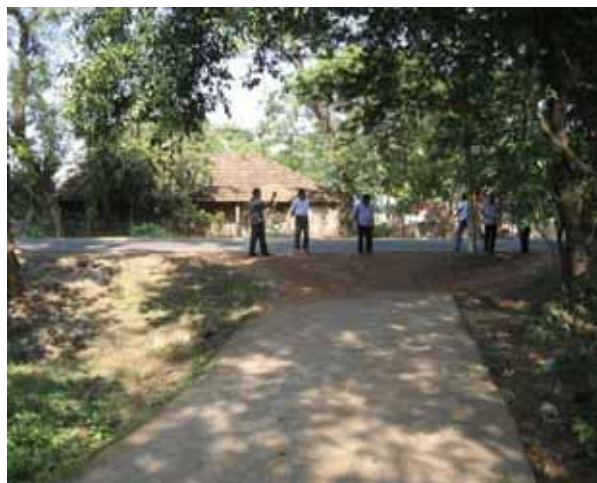
Ch: 6+700

Location of Side roads at skew with the major road

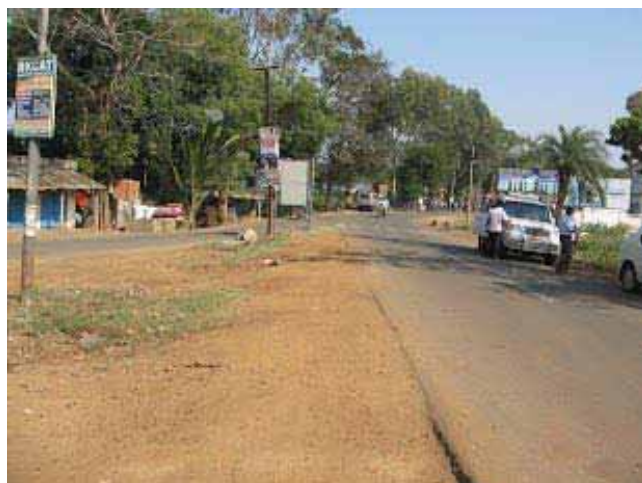
Two major junctions at Ch: 7+400 and Ch: 8+700 were located along this road. In both the cases, the junctions are located at the end of a sharp curve with limited visibility.

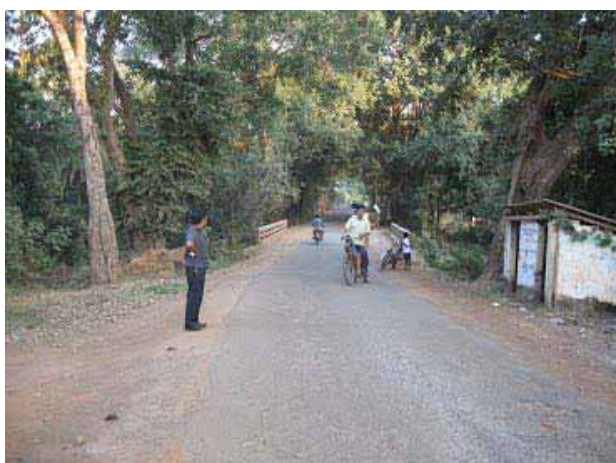
Ch: 23+050

The unprotected bridge approaches of three minor bridges present along the road at the chainages shown below:

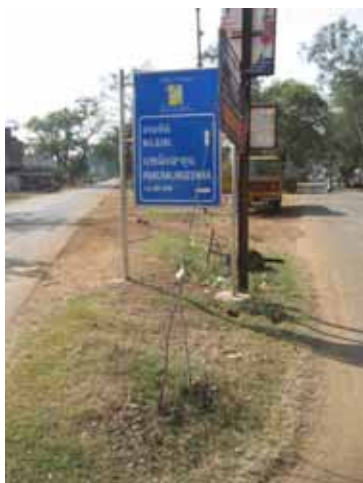
Ch: 7+400

Along the road, there are road side objects like electricity poles, signs, trees were present at significant number of locations.

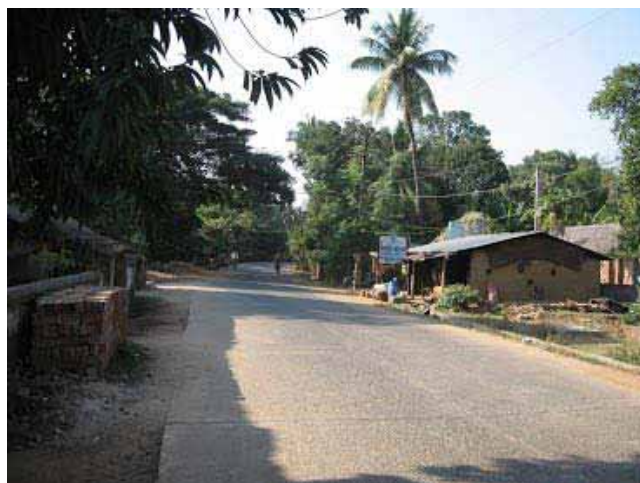
Ch: 9+500

There are many small hamlets along the road. The presence of houses/schools along the road generates vehicular traffic / pedestrians / cyclists on the road in the stretches. The roadside villages, which are particularly exposed to hazards were observed on the following chainages:

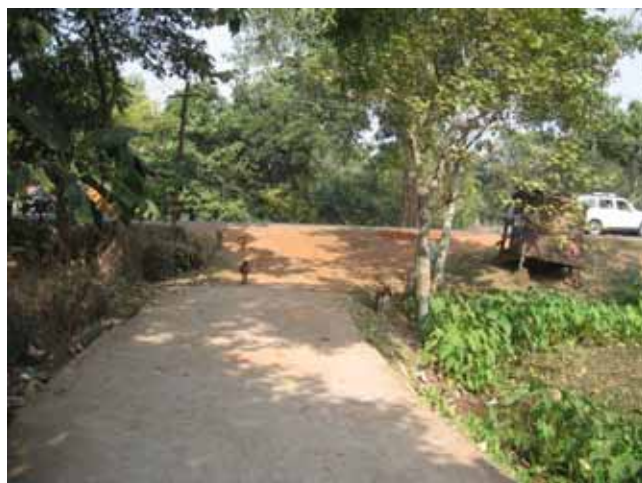
Ch: 4+300

Location of Side roads at skew with the major road

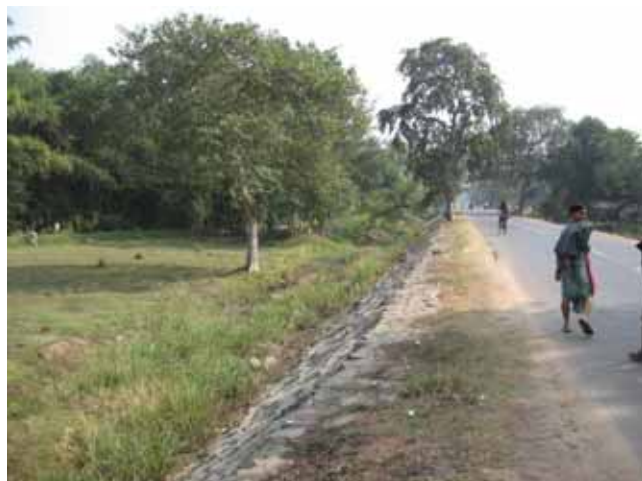
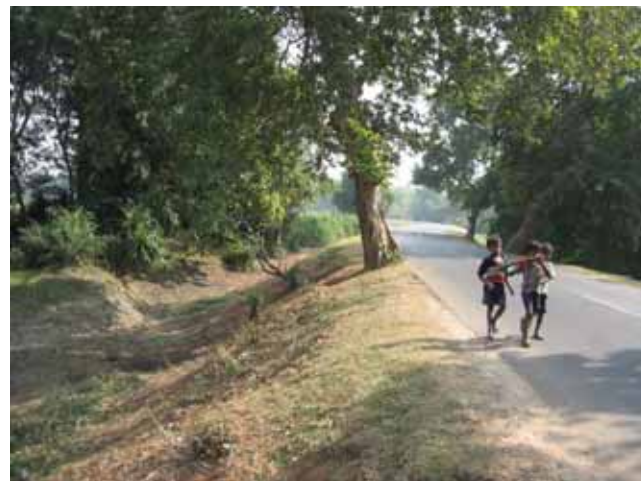
Along the road, road side objects like electricity poles, signs, trees are present at significant number of locations.

Reasons for concern: Roadside objects constitute a significant hazard, if the driver loses control and will result in major injuries/ fatalities

- Remove Trees/ street lighting poles from the road shoulders
- Remove encroachments from the right of way
- Provide crash barriers on locations where trees acts as a significant hazard and where the space is available to install crash barrier

- Delineate the hazards by installing OHMs or painting of the trees in black and white strips
- Remove encroachments on at least 2m from the road edge

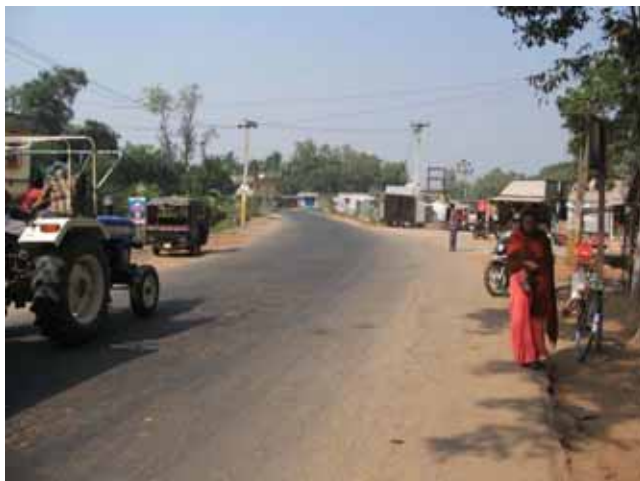
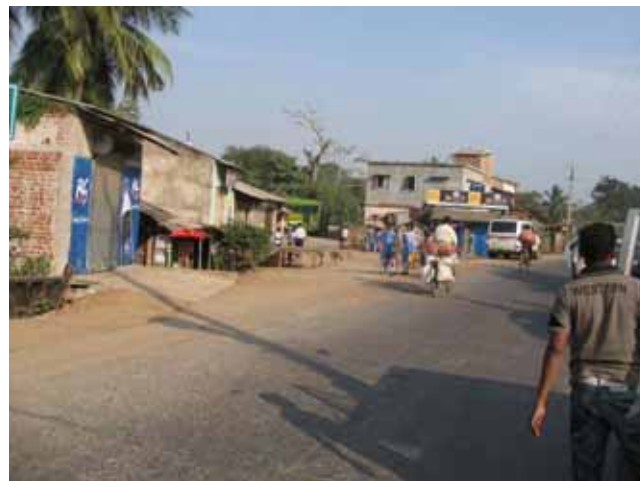
There are many small hamlets along the road. The presence of houses / schools along the road generates vehicular traffic / pedestrians / cyclists on the road in the stretches. The chainages of roadside villages observed to be hazardous for vulnerable road users and motorized traffic alike is given below.

- Significant pedestrians including school children are noted, but no separate pedestrian facilities are provided along the road inside the BUA or to cross the road
- Significant number of access roads within the BUA, the visibility of which has been hampered due to shops/ establishments on all corners of the junction
- No traffic calming measures are provided to slow down vehicles approaching at high speeds to the built up area
- No speed limit signs provided
- Street lighting not provided on some of the roadside villages

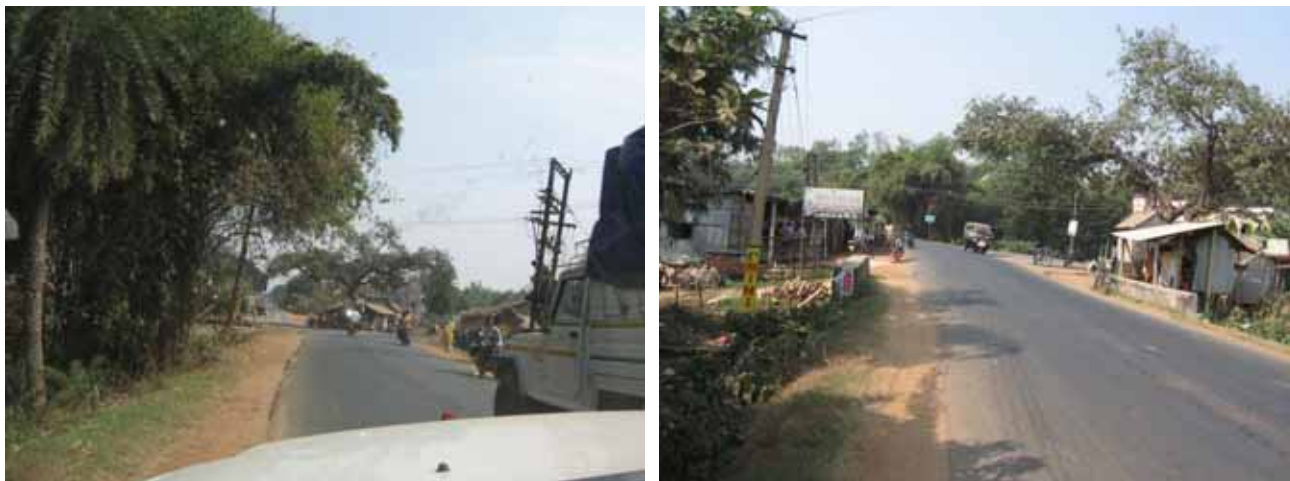
Ch: 3+600

It was informed by OWD, that this junction near Nachimpur village Chainage:3+600 is a black spot. This is a three arm uncontrolled junction on a curve after a long straight section.

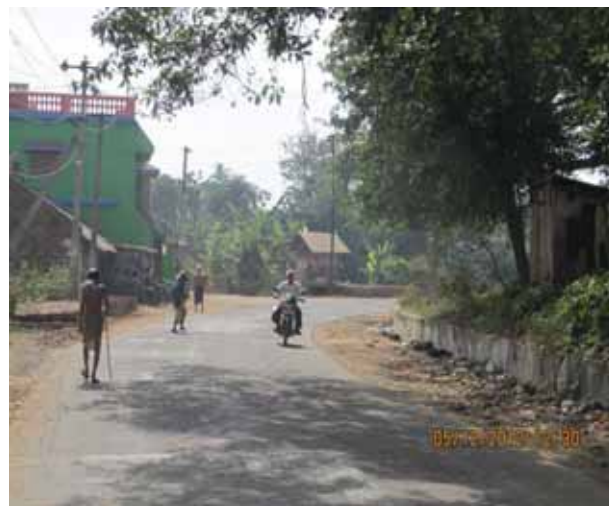
Project road have many curves, some of them observed to be sharp which requires slowing down the vehicles to more than 20 km/ hour than the approach speed for safe maneuvering of the vehicle. Such curves need warning signs, chevron marking and edge lines.

Sharp Curves on Project Road at Km 36+800 and Km 24+900 respectively

| Recommendations: | <p>Provide curve warning signs, chevron signs, delineators and speed limit sign as appropriate.</p> <p>Refer to Appendix III - Engineering Countermeasures, for guidelines on situations where to install the above</p> |
| Recommendations: | <ul style="list-style-type: none"> • Improve the line of sight by removing trees from the shoulder and cut down vegetation which hampers visibility along the curves |
| Recommendations: | <p>Provide crash barriers with delineators on the outer edge on such curves.</p> |

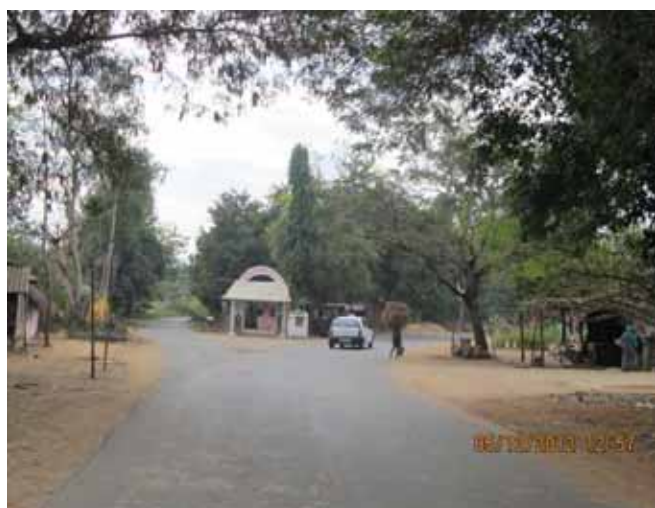
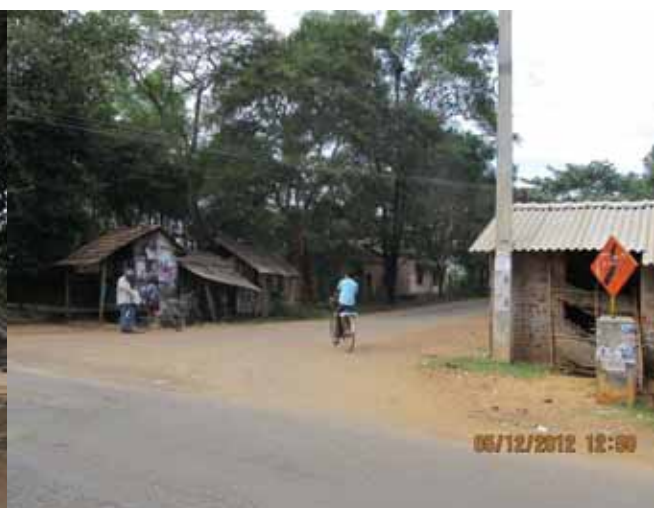
Skewed Side road at Km 28+850

Perpendicular Side Road at Km 27+500

| Reasons for concern: | Inadequate Visibility <p>This is a major hazard observed on most of the 3-armed uncontrolled junctions. The major reasons for poor visibility at such junctions on SH-15 are due to buildings/ encroachments on the corners.</p> |
| Reasons for concern: | Poor delineation <p>No traffic signs or road markings are observed on any of such junctions, the presence of which would have informed and warned the road user of the layout ahead. Poor delineation may result in sudden braking behavior by road users who are required to stop, or wish to make turns. In the worst case, it can also result in rear-end collisions at high speeds.</p> |
| Reasons for concern: | High approach speeds <p>High approach speeds were observed by traffic turning from side roads into the main carriageway and no traffic calming measures/ warning is provided on the side road. Coupled with inadequate visibility, in the worst case, this may result in right angle collision with vehicles coming from the major road leading to serious injury or fatal accidents.</p> |
| Reasons for concern: | Poor Geometry <p>It has been observed that on few junctions, the level difference between the side road and major road and the vertical profile of the side road joins the edge of main carriageway in an unsafe manner. This requires special skills from the drivers of vehicles coming from the side road to stop/ slow down before they enter into the main carriageway at the junction and most of the drivers in such circumstances tend to drive into the major road without stopping/ slowing down. This may lead to collisions resulting in major injury/ fatalities.</p> |

| Recommendations: | Remove encroachments at least from the visibility triangle required for such junctions. |
| Recommendations: | <ul style="list-style-type: none">• Provide warning signs to provide drivers of advance notice of the upcoming junction• Provide Give Way/ Stop signs as applicable, on side roads• Provide Give Way/ Stop road marking at side roads <p>Refer to Appendix III for typical 3-arm junctions layouts with appropriate road markings and traffic signs.</p> |
| Recommendations: | <ul style="list-style-type: none">• Provide road humps on the side road at junctions having history of accidents• Provide raised markings on the entry to the side road• Provide adequate warning signs on major road and side road <p>Refer to Appendix III for standard details of road humps.</p> |
| Recommendations: | Correct the vertical alignment of side road so that vehicles approaching from side roads has adequate length on the side road to slow down/ stop before entering into the main carriageway. <p>Refer to Appendix III for safe geometrical arrangements of junction with side road.</p> |

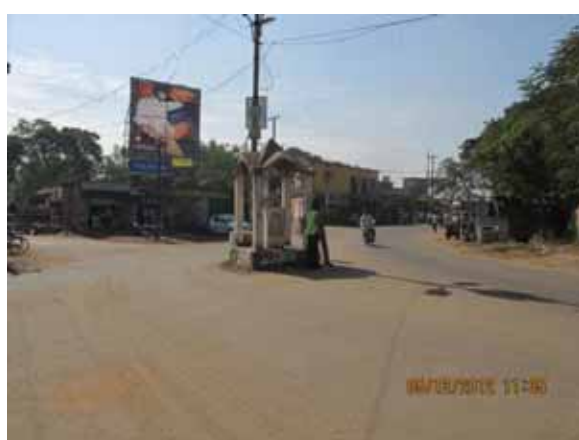
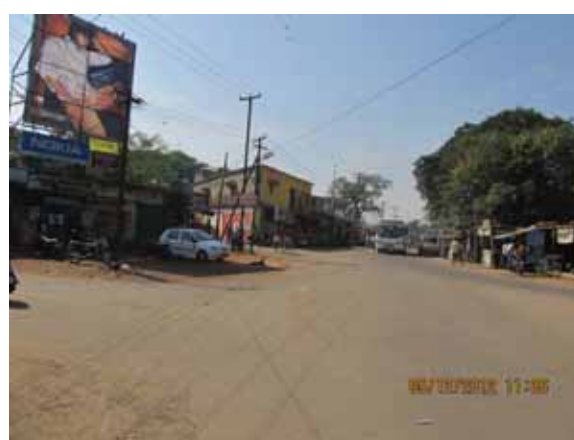
Km 11+700

- Junction point of two ODRs and one VR with SH65;
- Junction is built-up with shops and consequently on-street parking pose a problem;
- Heavy two wheelers, pedestrians, cyclists are present on the junction;
- Layout of the junction is poor with no established traffic control and a non-standard central island is present obstructing the sight of the approaching traffic; and
- Street lighting is provided, but no traffic signs or road markings to warn, delineate and establish junction control.

The junction layout is non-standard and has no control over the traffic movement. It is confusing who has priority in such a situation. This encourages lawless traffic movement and is hazardous. The existing central island is non-standard and hampers visibility at the junction.

Reasons for concern: **Provision for VRUs**
Significant presence of pedestrians and cyclists noted, but no provisions have been provided. Pedestrians were observed using the road for commuting and this expose them to the fast moving traffic which can lead to crashes resulting in serious injuries.

Reasons for concern: **On-street Parking**
There are no parking spaces provided for commercial vehicles and vehicles are parked encroaching the road and shoulder space. This hampers visibility at the junction and force pedestrians to move into the center of the road resulting in hazardous situation.

Recommendations: Provide wide shoulders/ footpaths for pedestrians to commute in the junctions without interfering with the motorized traffic

Recommendations: Provide designated parking spaces for commercial vehicles

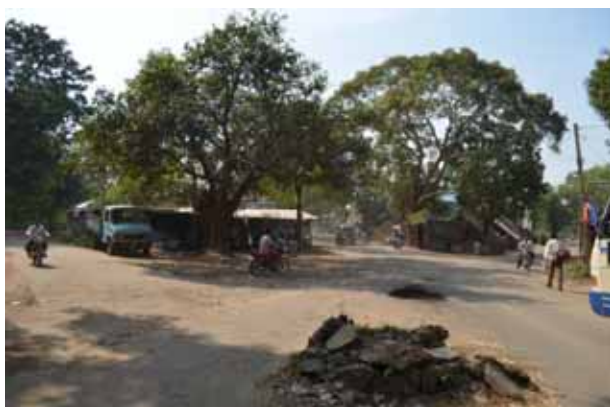
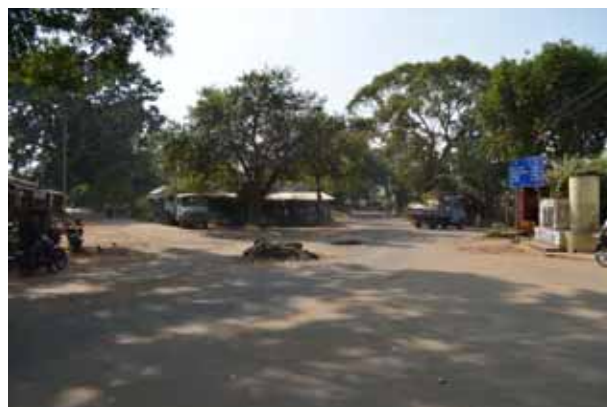
Km 75+700

- Poor junction layout;
- Priority is not established;
- Shops noted around the corners and approaches of the junction;
- No designated bus stop provided, leading to buses stopping in hazardous manner;
- No road markings or traffic signs (direction, warning and informatory) are provided; and
- Street lighting and provision for VRUs are not provided.

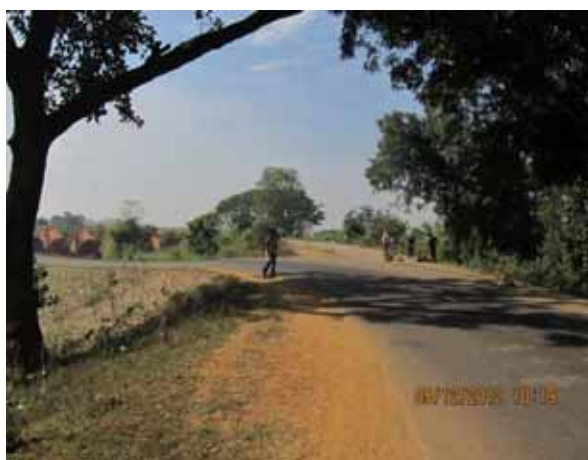
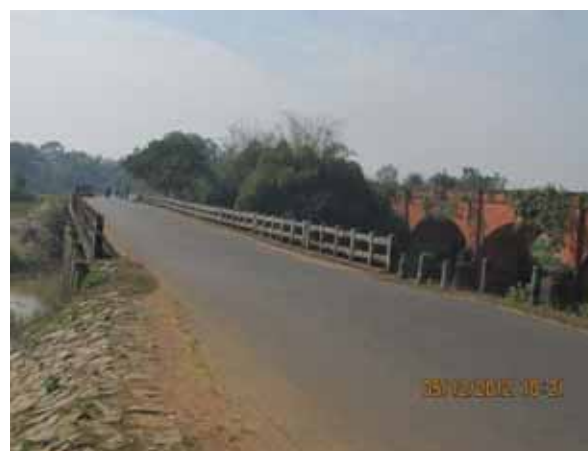
- Sharp Curve on approaches;
- No protection on outside curve;
- Very high embankment; and
- No road markings and traffic signs to delineate and inform the road user of the impending hazards

Approach to Bridge at high embankment at Km 5+700

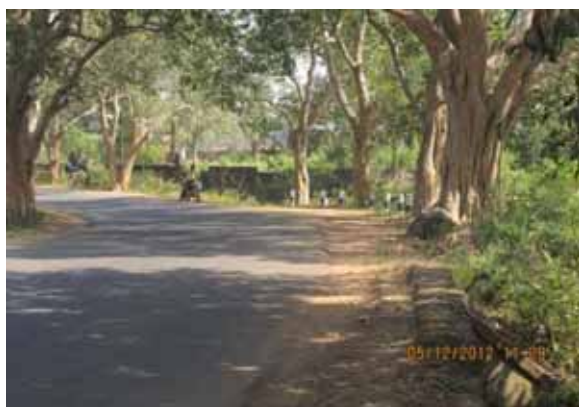
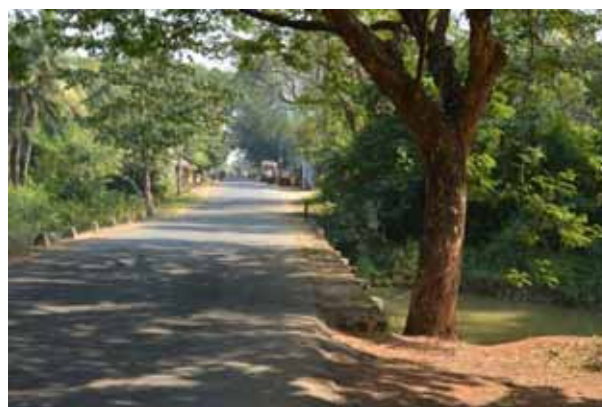
At the following chainages, parapet wall is broken or no parapet wall at all, water bodies along these structures are hazardous and can increase the severity of accident.

Broken Parapet wall at Km 13+600

Absence of Parapet wall at Km 41+150

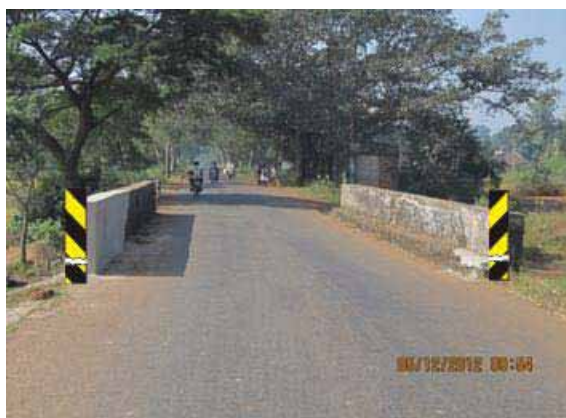
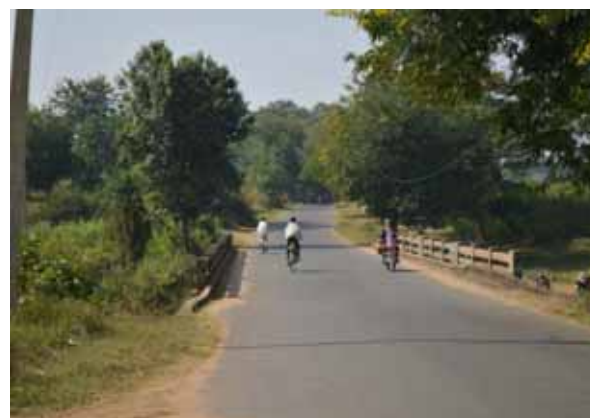
Bridges/ Parapets having parapets on the road edge were observed on the following locations where delineation is not present.

Culvert at Km 2+600

Minor Bridge at Km 48+700

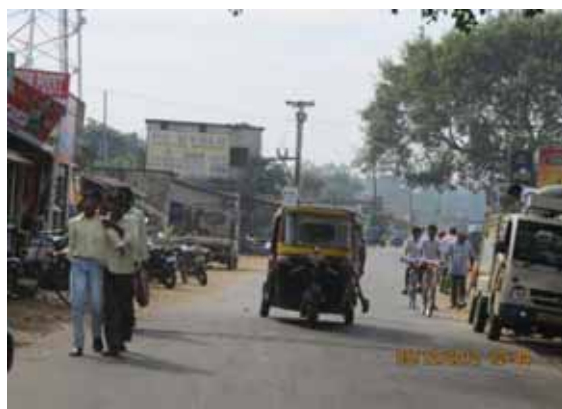
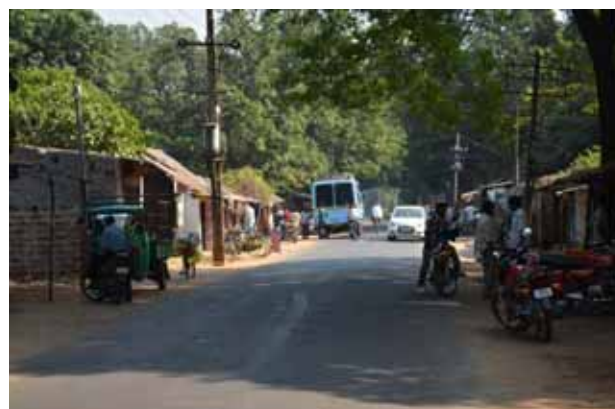
Roadside villages are particularly hazardous points on a rural road network. SH 65 has many such roadside villages, where the vulnerable road users, including school children are particularly at risk from high speed traffic. It is important to inform the road user in advance of the impending roadside village and if necessary, traffic calming measures needs to be provided for improved speed management through such villages/ built up areas.

Tigria Village at Km 26+100

Badamba Town at Km. 45+600

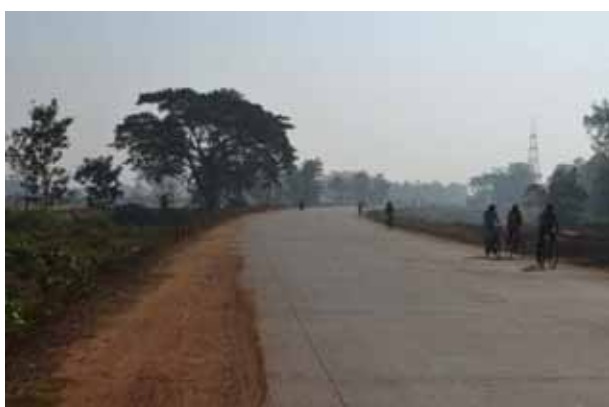
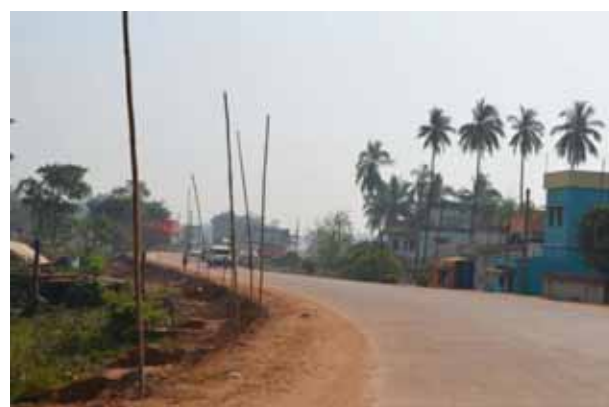
During the course of assessment, the consultant has carried out average speed and spot speed survey. The average speed and maximum speed were noted for one trial run on the road during 10:00 hrs to 11:00 hrs, from chainage 12+000 to 2+000. An average speed of 60 km/ hour and a maximum speed of 80 km/ hour is noted during this survey. A spot speed survey was conducted at location 4+400, and the 85th percentile speed at this location was found to be 56km/ hour.

Curve at Km 4+400

Curve at Km 8+600

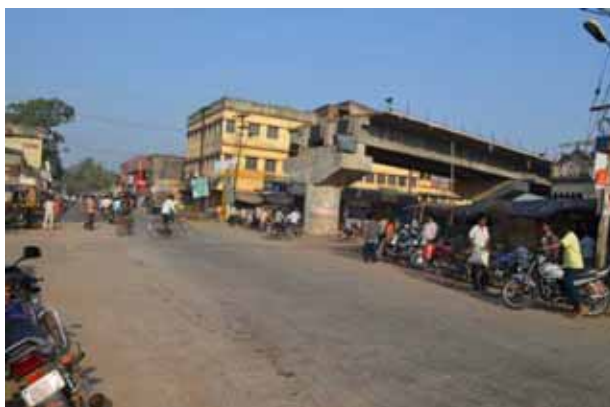
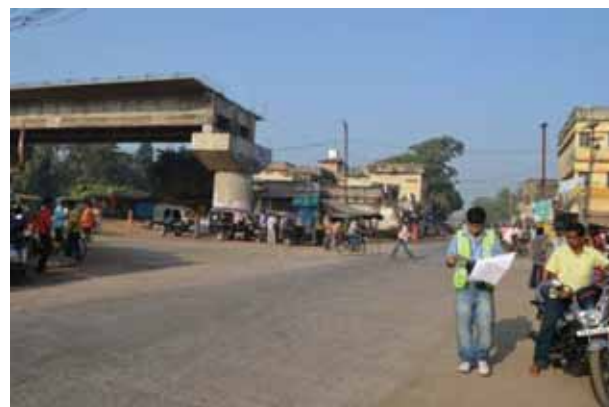
Km 11+700

- The layout of the junction is poor, and no junction control has been established;
- Junction is heavily built-up with commercial establishments
- High presence of pedestrians and cyclists, but no separate provisions has been made which forces pedestrians and cyclists to mix with the motor traffic on the road to travel within the junction area; and
- Street light is provided.

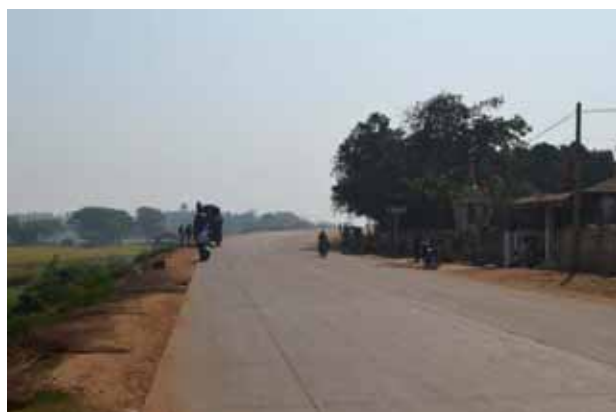
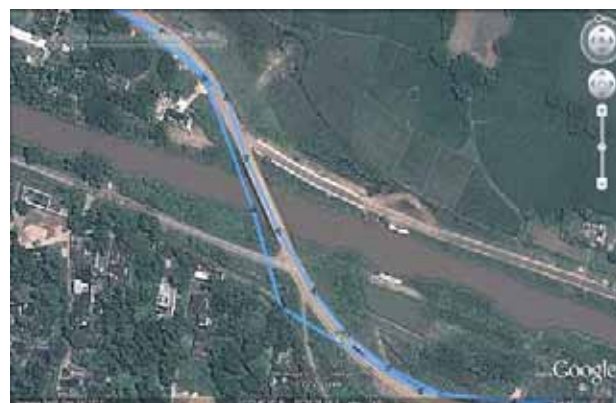
- At chainage 8+600, a curve leads to a bridge on both approaches in high embankment, but it has been observed that no safety measures has been provided.

Approach to Major Bridge at high embankment

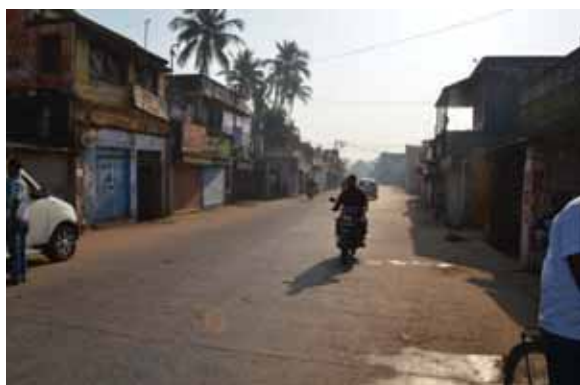
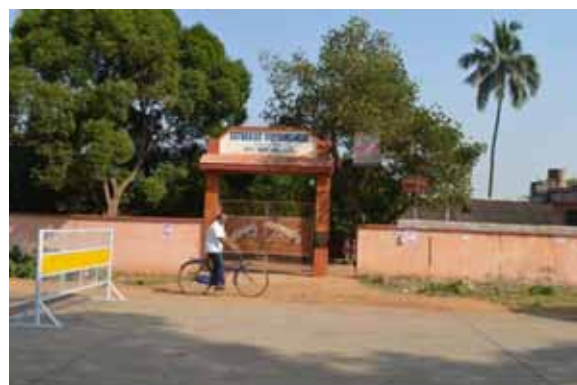
- Most of the villages have schools along the roads, but no separate provisions (wide shoulders of footpaths and safe crossing points) are provided for school children to cross or walk along the road in a safe manner
- On street Parking was observed, which hampers visibility
- Roadside is heavily encroached, leaving little or no space for pedestrians to walk along the road in a safe manner. In addition, encroachments encourage parking on the road, which further hampers visibility and create hazardous situations.

Commercial Area at Km 2+000

School at Km 8+400 in Biribati Village

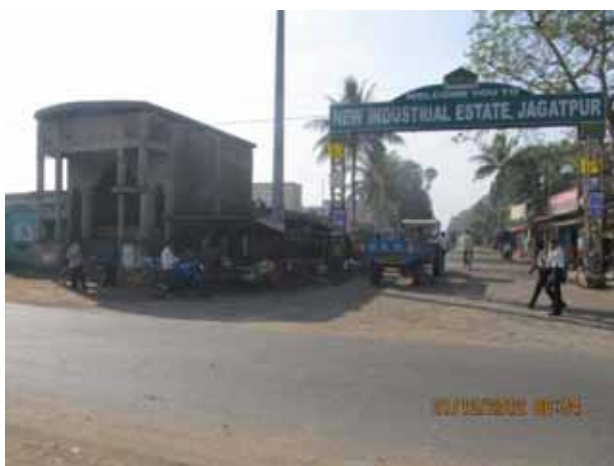
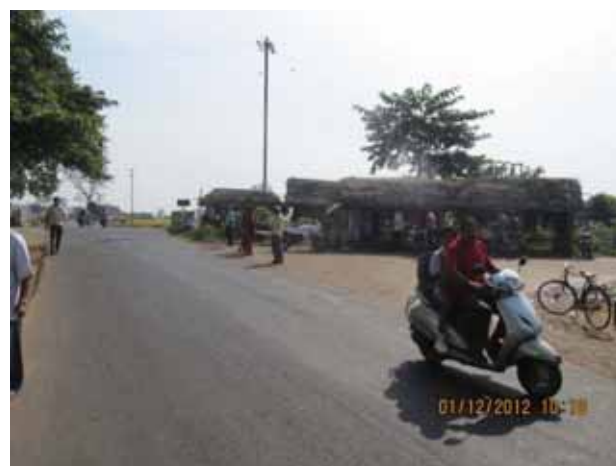
Perpendicular Side Roads at Km 1+900 and Km 10+900

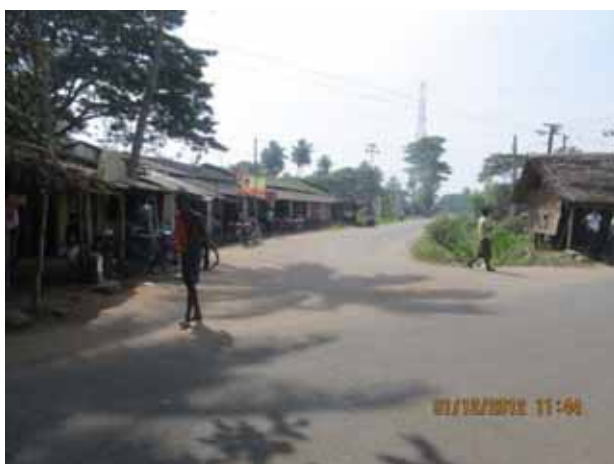
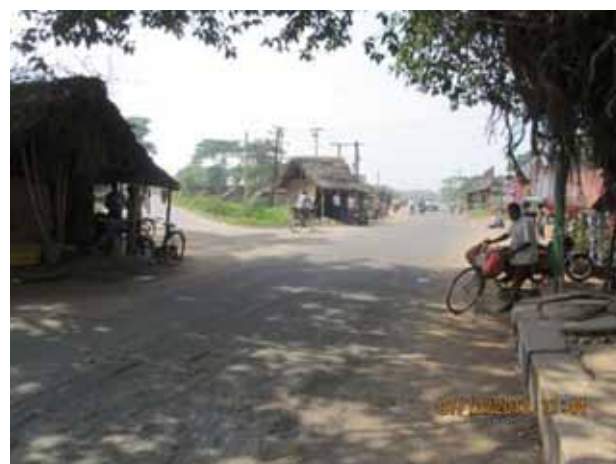
Skewed Side Road at Km 24+100

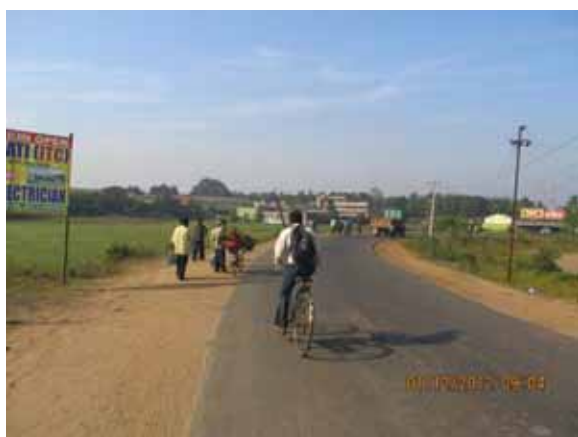
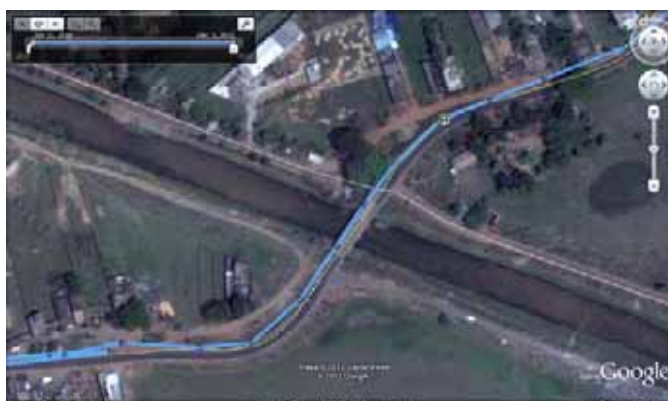
4.3.3.5 Approach to Bridges (Chainage 2+300)

Reasons for concern: Unprotected high embankment

Recommendations: Provide crash barriers on either approaches of the structures with delineators

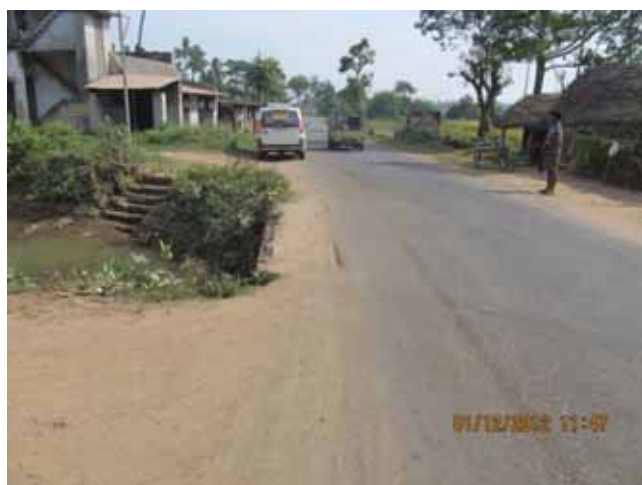
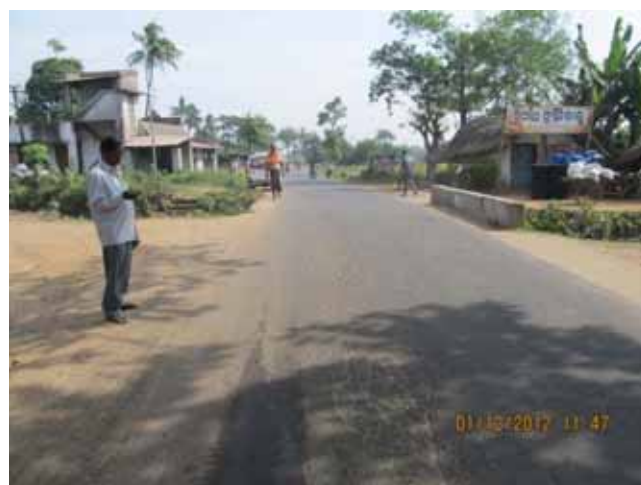
At the following chainages parapet wall was either broken or found missing. In the event of a vehicle loses control, the resultant injury will be fatal or major, due to the presence of water body.

absence of parapet wall at Km 24+800

| Reasons for concern: | Broken or missing parapets The absence of parapet on bridge/culvert increases the risk of vehicles falling in to the drain. In the context of high speed traffic movement observed on SH-10, the absences of parapets at such locations are hazardous for traffic, especially for VRUs. |

| Recommendations: | Provide continuous parapets on all culverts and bridges. |

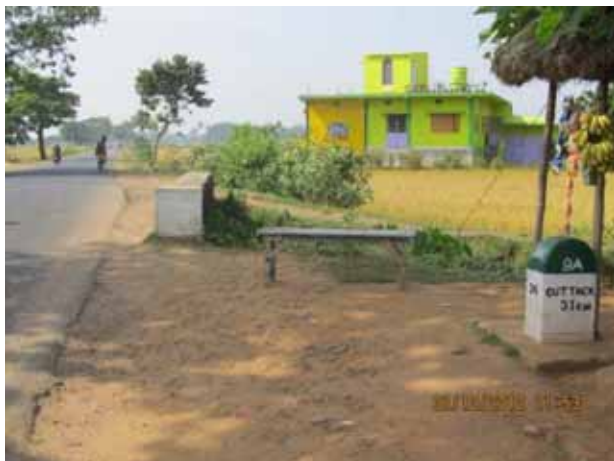
Km 26+000

There is no hazard marker present on structures and major/minor bridges. Such locations are

| Reasons for concern: | Delineation of the parapet walls The bridge/ culvert parapets on the edge of the road adjacent to high speed traffic movement will be hazardous, particularly at dark conditions, and needs to be delineated for a driver to judge the position of such road side hazard. |

| Recommendations: | Install Object Hazard Marker (OHM) on both sides and for both approaches (i.e. Four numbers of each OHM for each structure). |

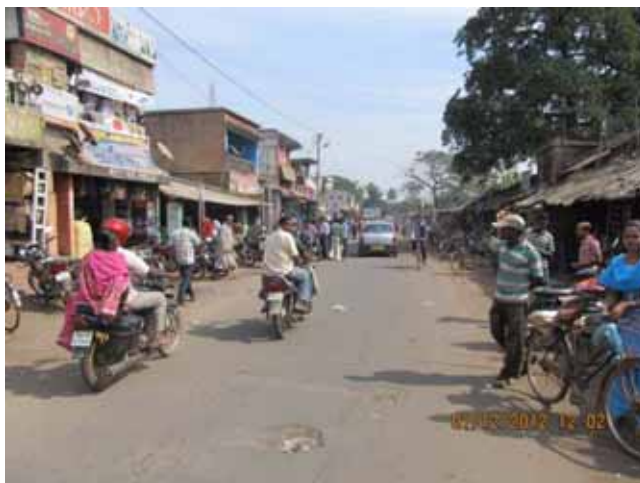
Nishint Kunj Commercial Area at Km 27+400

Reasons for concern: High level of encroachment on certain village zone hinders visibility, forces pedestrians and cyclists to mix with the motor traffic leading to hazardous situations.

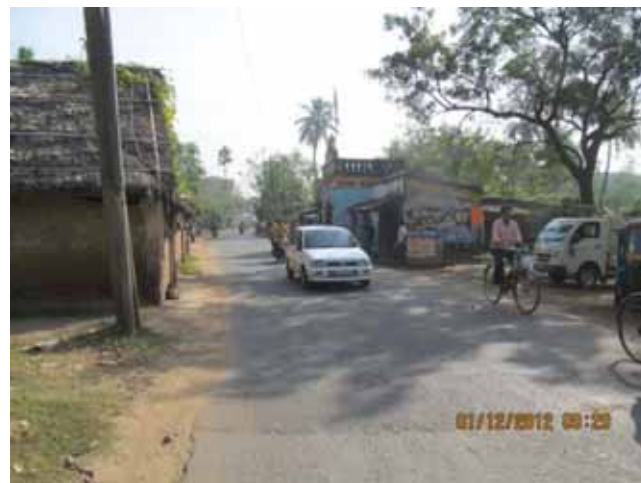
Built up area at Km 7+000

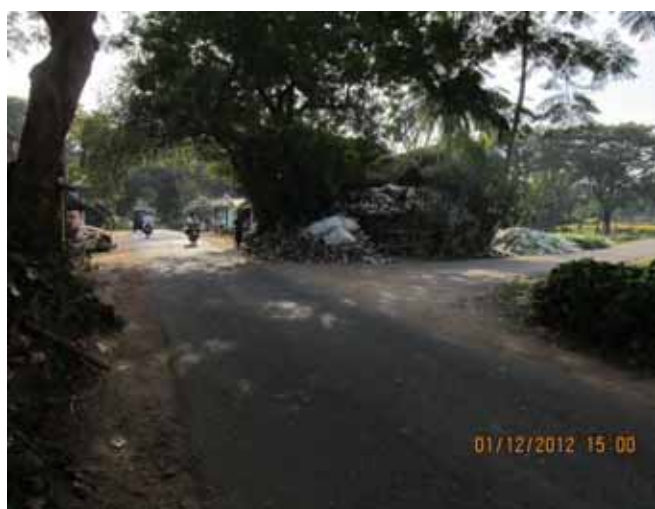
Perpendicular Side Road at Km 5+500

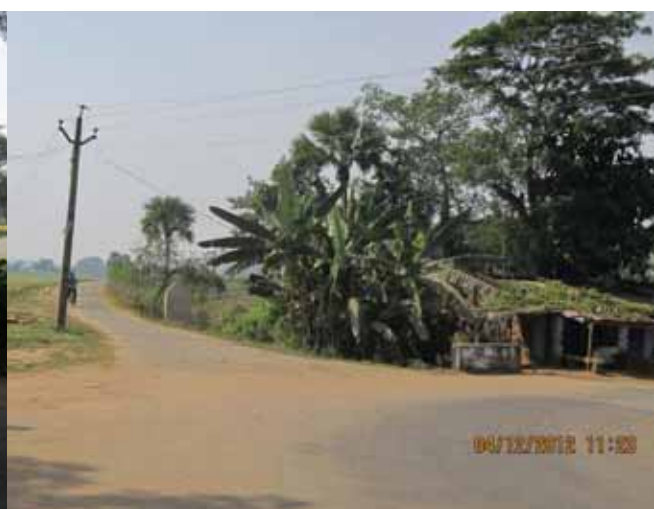
Side roads skewed to Major Road at Km 22+650

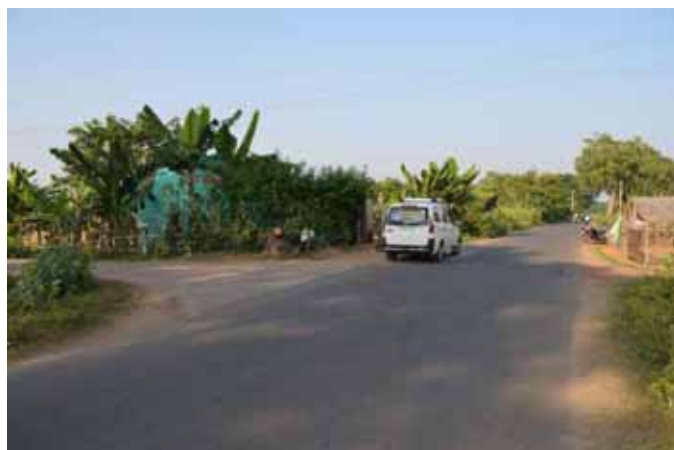
Perpendicular Side Road at 0+500

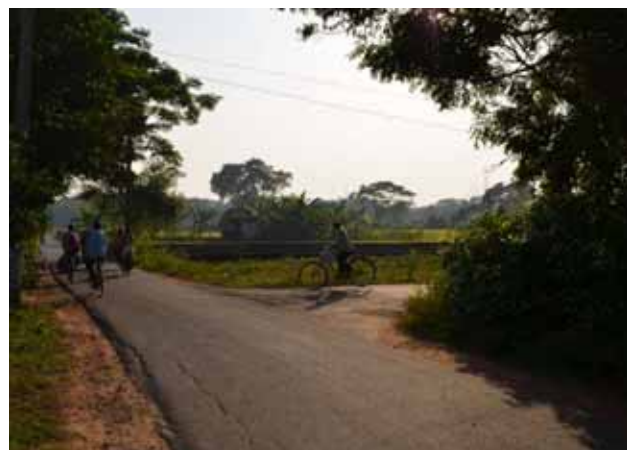
Perpendicular Side Road at 3+300

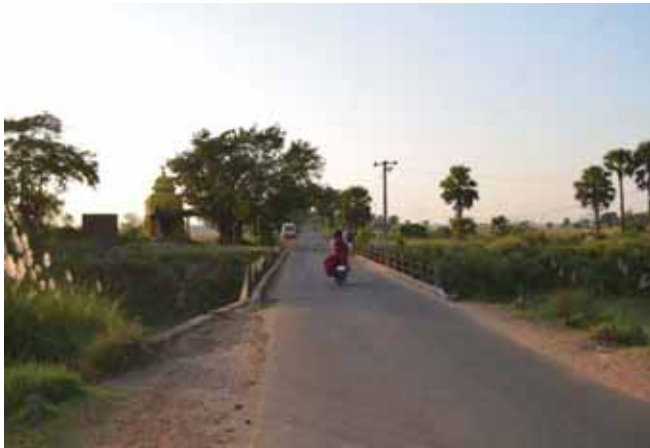
Missing bridge approach protection at Km 9+600

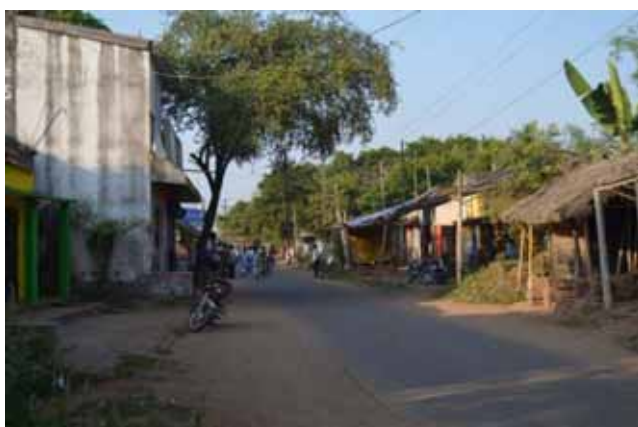
- In villages/town wherever schools are present, ‘School Ahead’ and ‘Slow’ warning signs are not provided on either approaches.
- On street Parking and on street bus stops are observed
- Significant pedestrians/school children, cyclists, motorcycles are present
- Very high encroachments are present
- Visibility is hampered due to structures present along the road and stopped vehicles, buses on the road

Built up area at Km 4+200

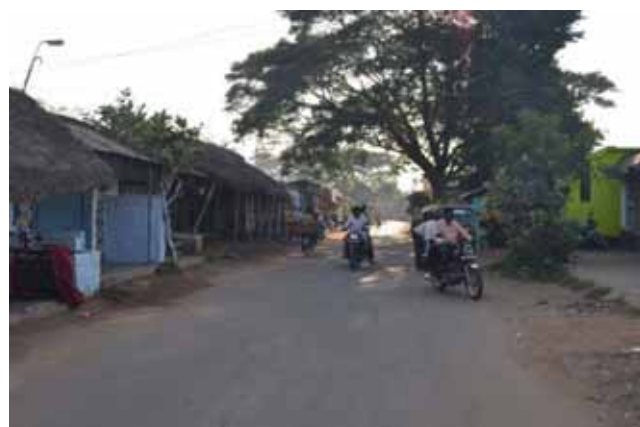
Built up area at Km 0+100 in Paga

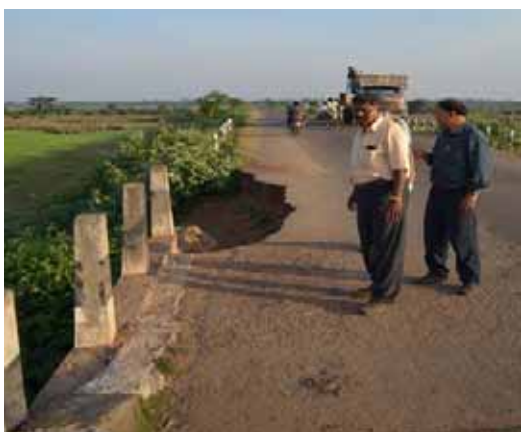
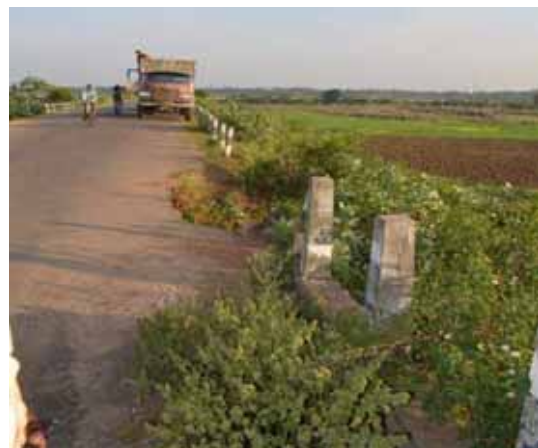
Damaged Road Edge and Approach Slab at chainage 6+100

- Two major bridges are connected by intermediate lane at high embankment
- Pavement is broken on both side
- Broken pavement is not visible from a distance ahead
- High speeds observed on the approaches to this bridge
- Broken section is used by pedestrians and cattle to get down on sides of the road

| Reasons for concern: | Broken pavement is not visible from distance, road is straight thus high speed is observed which is very dangerous for fast moving traffic , in particular for two wheelers. Small vehicles may fall into ditch and bigger vehicles may undergo overturning. |

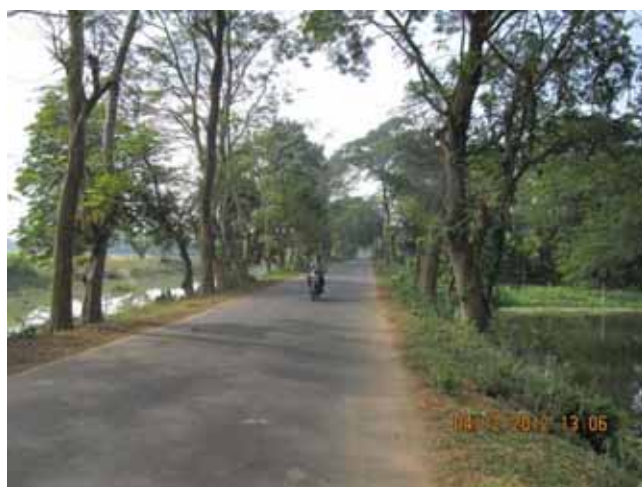
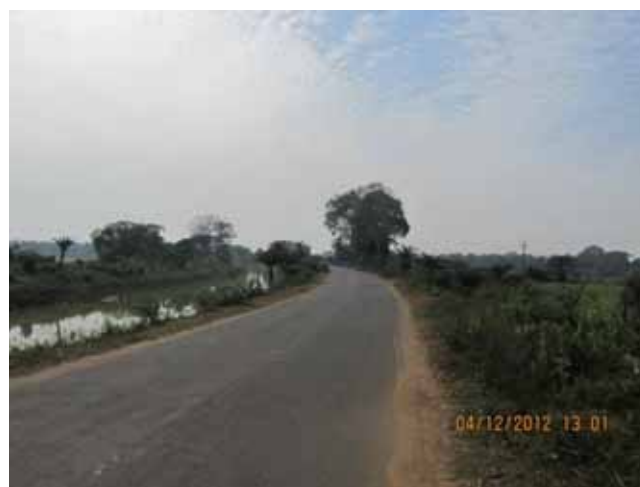
- Project road is along the irrigation canal
- Embankment is high throughout the road
- At some locations project road have water bodies on both side of project road

Road with high embankment and water bodies on either side at Km 6+200 and 3+400;

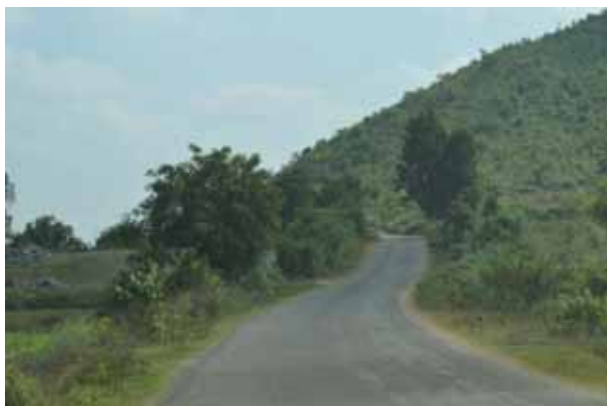
These are observed at chainages Km 272+770 and Km 316+300;

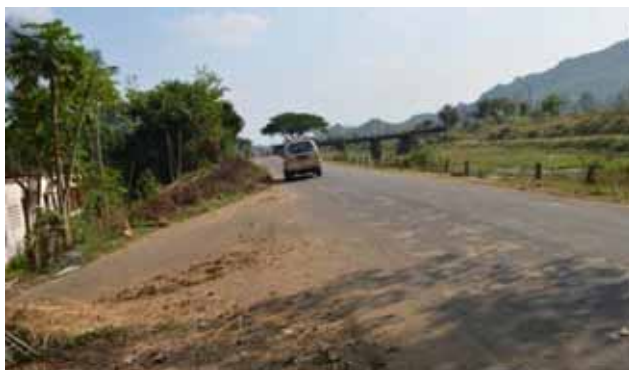
Km 292+440

Location of Side roads at skew with the major road

This is a major hazard observed on most of the 3-armed uncontrolled junctions. The major reasons for poor visibility at junctions on this road are due to 1) Encroachments at Junctions 2) Overgrown vegetation or presence of trees and 3) poor layout of the side roads.

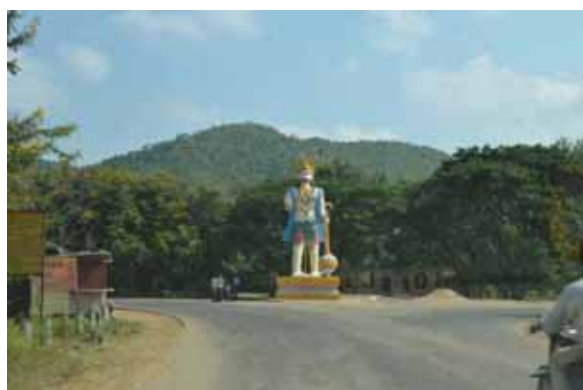
Km 270+700

- In this section of road all the major junctions are 3-arm uncontrolled junction.
- Medium to high encroachments
- Commercial activities nearer to the road edge.
- Street lights is missing

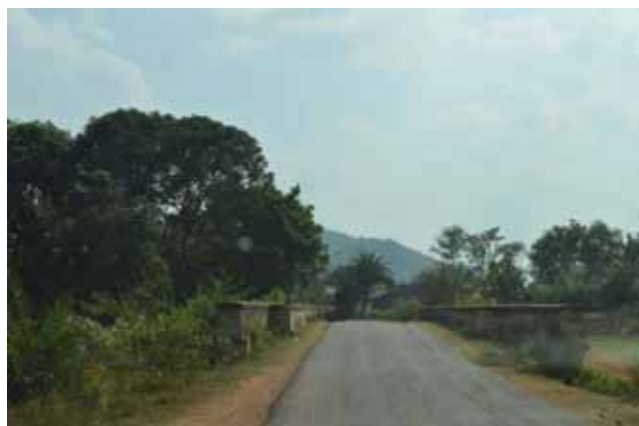
Km 282+680

The bridge/ culvert parapets on the edge of the road adjacent to high speed traffic movement will be hazardous, particularly at dark conditions, and needs to be illuminated for a driver to judge the position of such road side hazard.

Recommendations: Install Object Hazard Marker (OHM) on both sides and for both approaches (i.e. Four numbers of each OHM for each structure).

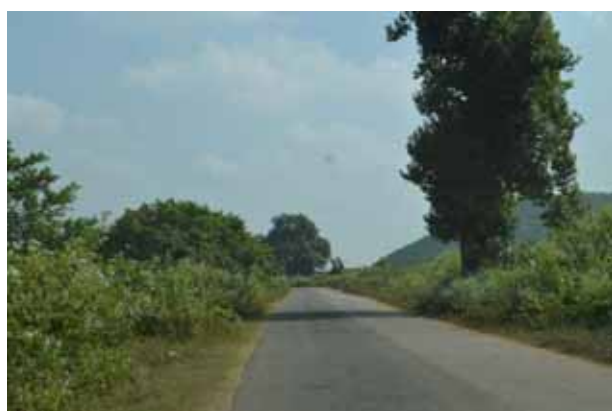
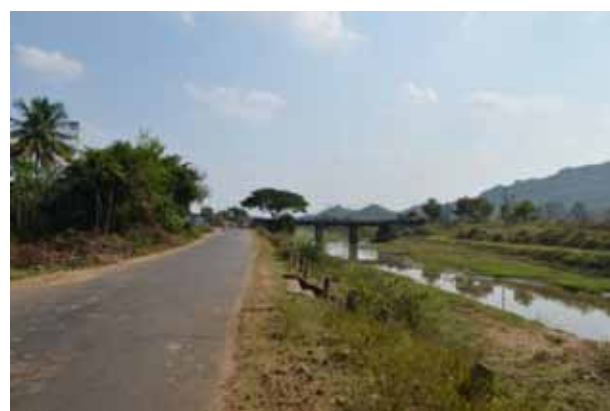
Trees/Embankment are on the edges of the carriageway

Reasons for concern: The road side objects like trees, street light or other poles, buildings, and unprotected deep drains which are near the edge of road needs to be. At night time it becomes very difficult for drivers to judge the position of such road side hazard. If the road side objects are not protected and/or illuminated there are chances of driver losing control and hitting these objects which may result into fatal accident.

Recommendations: Either remove such objects or provide crash barrier where such objects are <2m from the edge of road.
