**Government of Odisha (GOO)
Chief Engineer, World Bank Projects, Odisha
Odisha State Roads Project**

**Consultancy Services for
Road Sector Institutional Development
Loan # 7577-IN**

**ROAD INFRASTRUCTURE
SAFETY MANAGEMENT REVIEW**

VOLUME I - REPORT

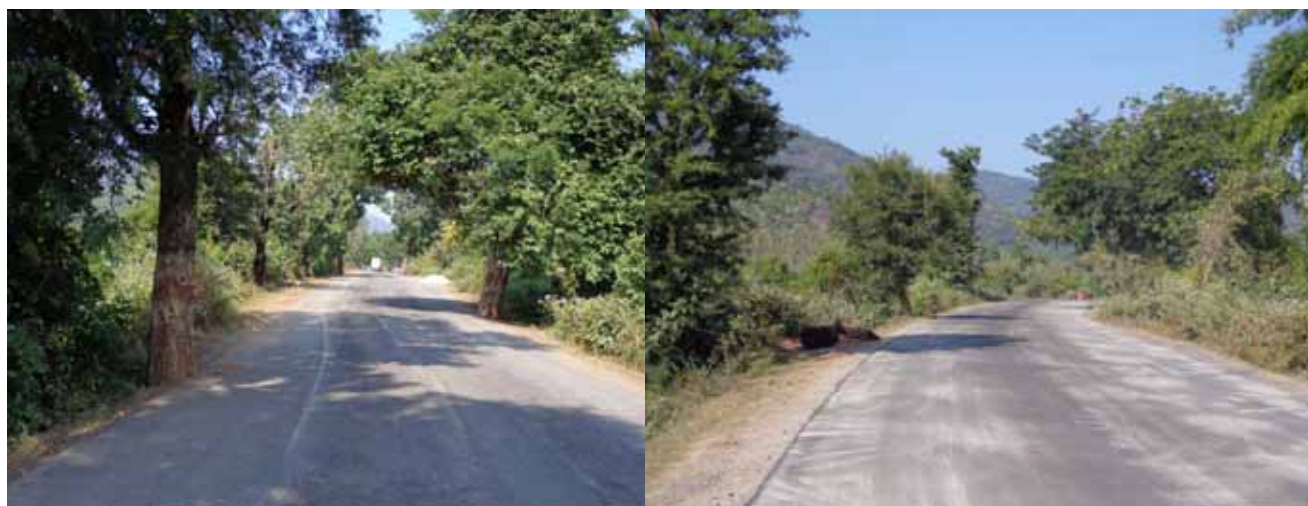
Road side objects present along this stretch of road are few trees and high embankment.

Reasons for concern: The road side objects like trees, street light or other poles, buildings, and unprotected deep drains which are near the edge of road needs to be. At night time it becomes very difficult for drivers to judge the position of such road side hazard. If the road side objects are not protected and/or illuminated there are chances of driver losing control and hitting these objects which may result into fatal accident.

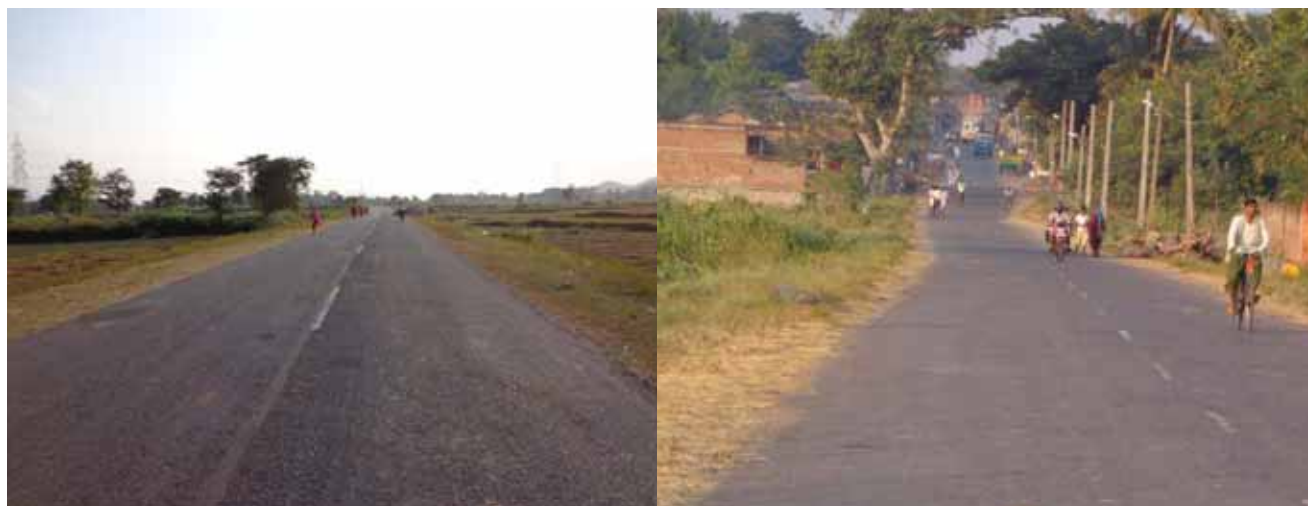
Reasons for concern: Centerline and edgeline road markings are not provided in many sections of the road.

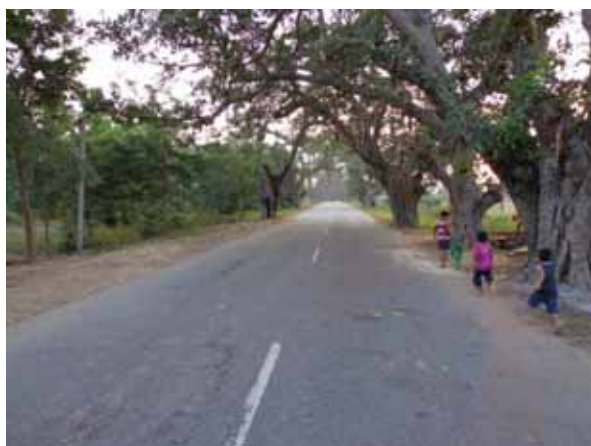
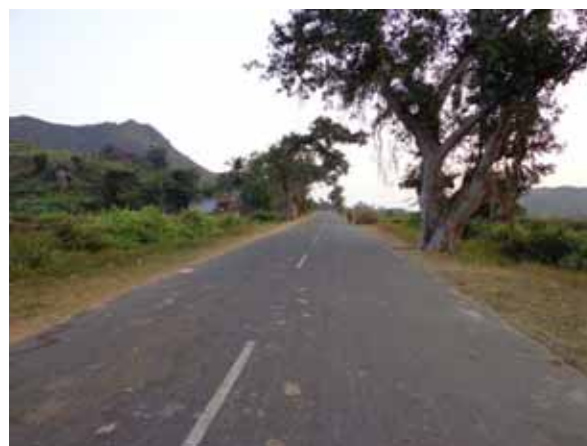
Road side objects present along this stretch of road are few trees. Trees are on the edges of the carriageway, which has no any protection.

Trees are on the edges of the carriageway

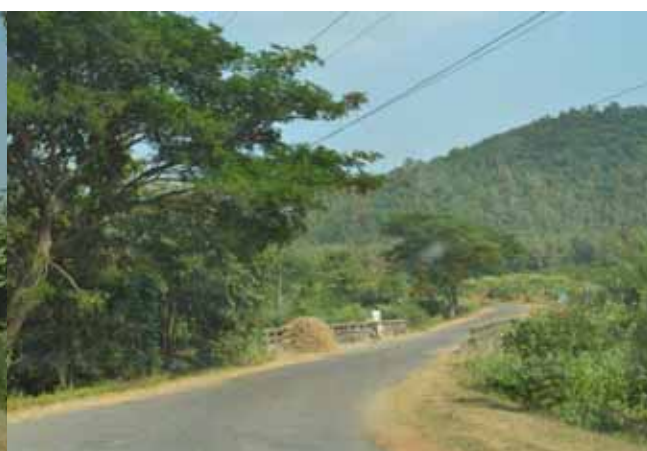
Km 93+100

Reasons for concern: The bridge/ culvert parapets on the edge of the road adjacent to high speed traffic movement will be hazardous, particularly at dark conditions, and needs to be illuminated for a driver to judge the position of such road side hazard.

Recommendations: Install Object Hazard Marker (OHM) on both sides and for both approaches (ie. Four numbers of each OHM for each structure).

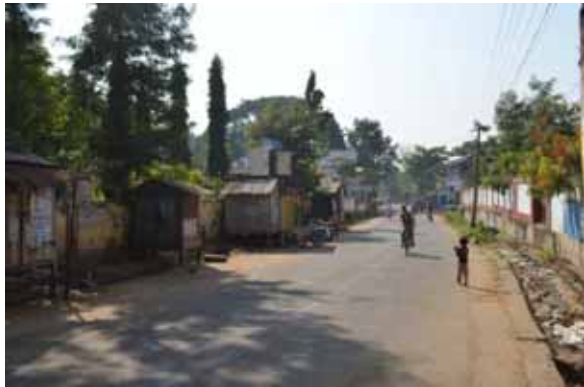
Km 54+200 (Sheragada village)

Road side villages and built-up areas were observed at following locations on SH-36.

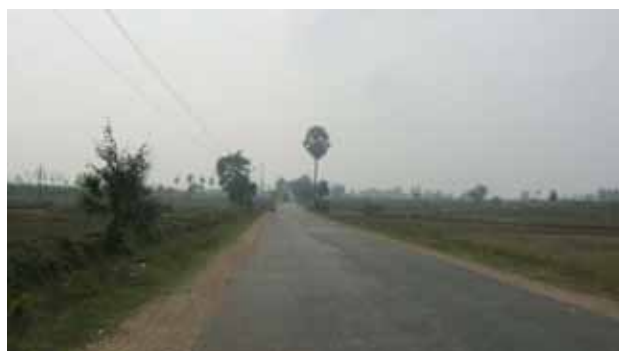
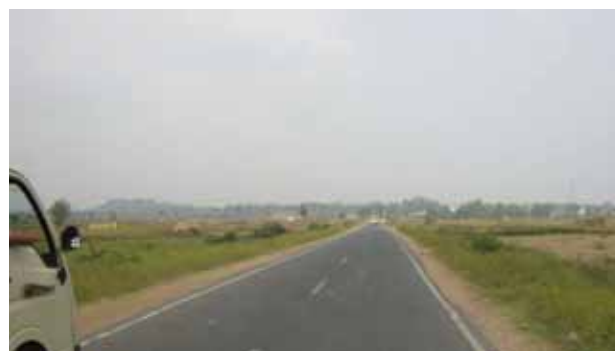
Reasons for concern: Centerline and edgeline road markings are not provided in many sections of the road.

- Recommendations:**
- Provide edge line and centre line with thermoplastic material on whole length of the road (refer to IRC: 35-1997 for details)
 - Provide edge and centre line RRPMs on sharp curves

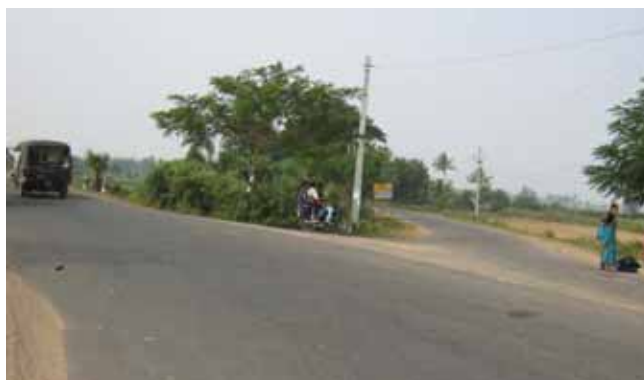
Km 2+400

Location of Side roads at skew with the major road

This is a major hazard observed on most of the 3-armed uncontrolled junctions. The major reasons for poor visibility at junctions on this road are due to 1) Encroachments at Junctions 2) Overgrown vegetation or presence of trees and 3) poor layout of the side roads.

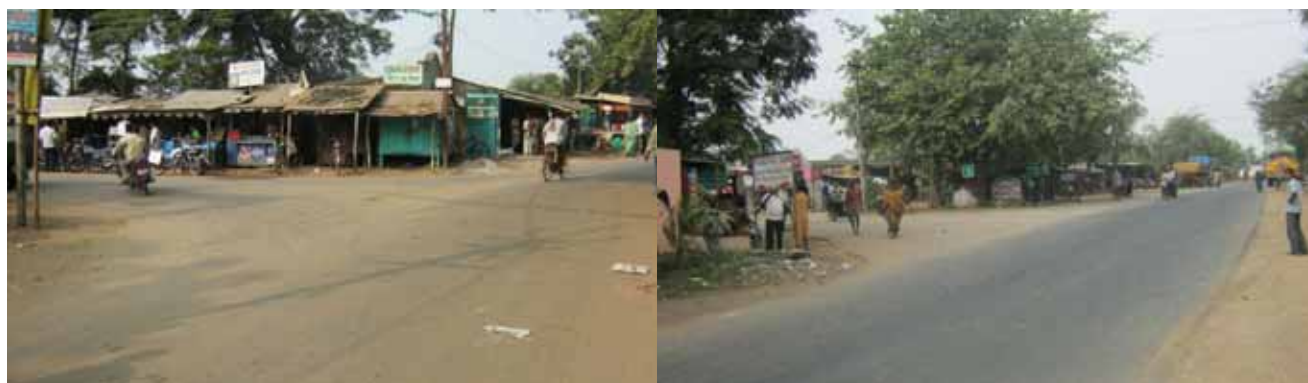
- In this section of road all the major junctions are 3-arm uncontrolled junction.
- Street lights is missing

Km 0+00

Km 14+900

- Recommendations:**
- Re-design the junction layout

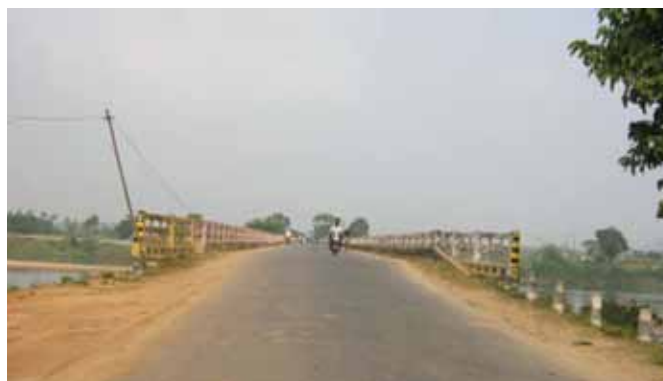
Km 4+700

Reasons for concern: The bridge/ culvert parapets on the edge of the road adjacent to high speed traffic movement will be hazardous, particularly at dark conditions, and needs to be illuminated for a driver to judge the position of such road side hazard.

Recommendations: Install Object Hazard Marker (OHM) on both sides and for both approaches (i.e. Four numbers of each OHM for each structure.

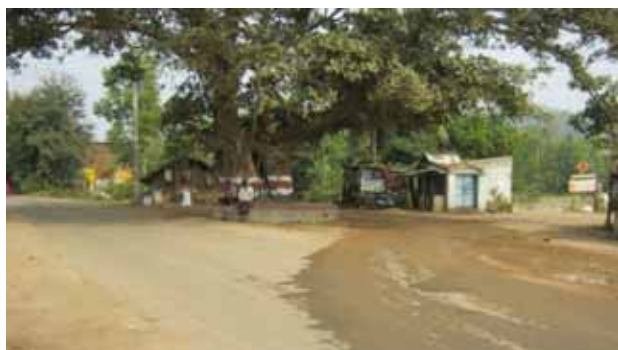
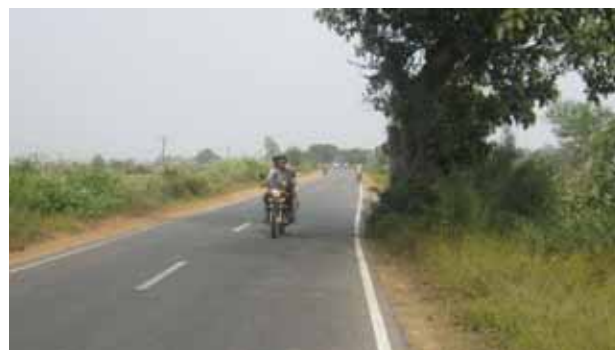
Trees are on the edges of the carriageway

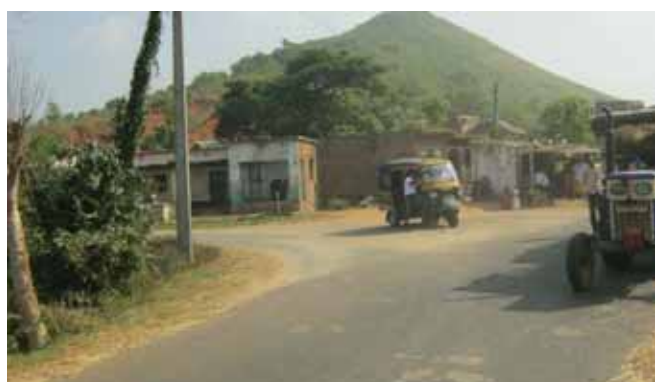
Km 17+200

Location of Side roads at skew with the major road

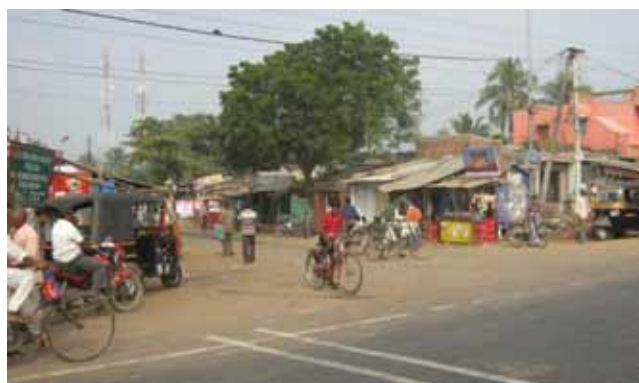
Km 0+000

A. Major 3-arm Junctions

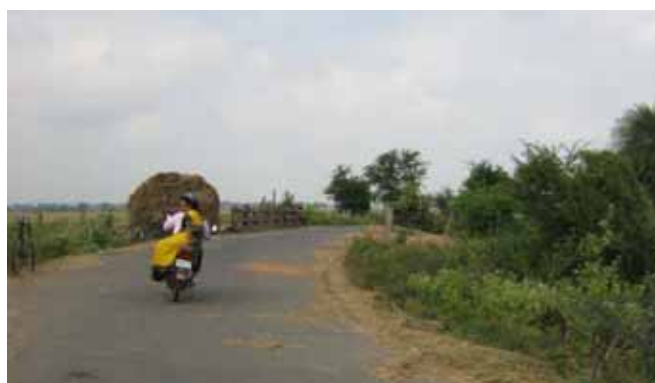
Km 6+100

These are observed at chainages Km 6+100, Km 19+500 and Km 24+200;

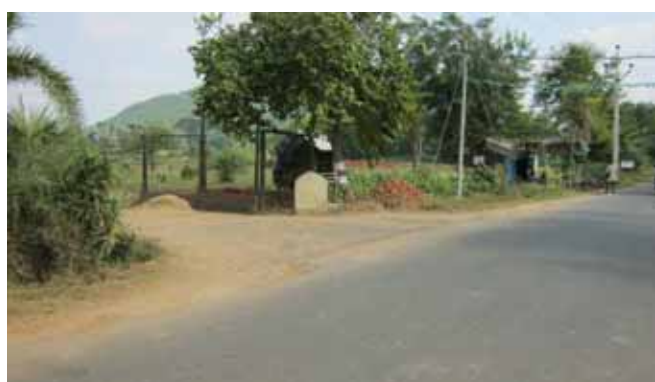
Km 22+880

Location of Side roads at skew with the major road

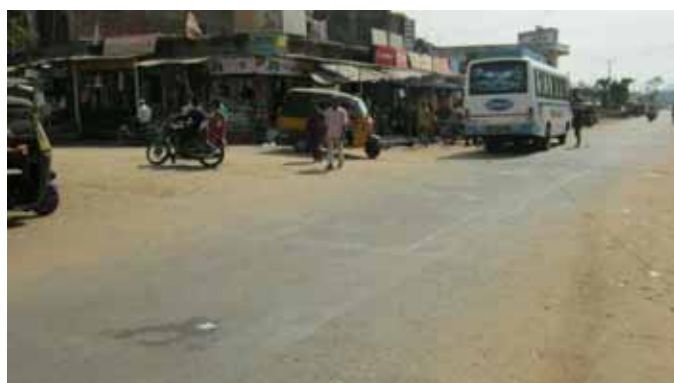
Km 23+880

A. Major 3-arm Junctions

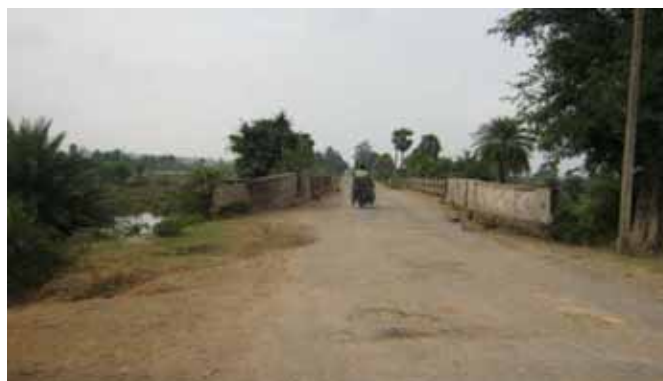
Km 0+500

Bridges/Culverts are observed at chainages:

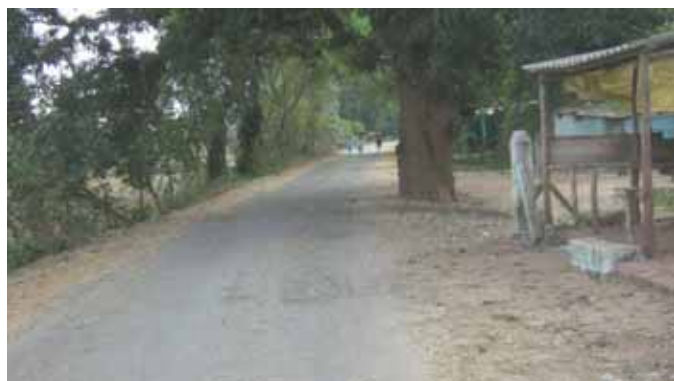
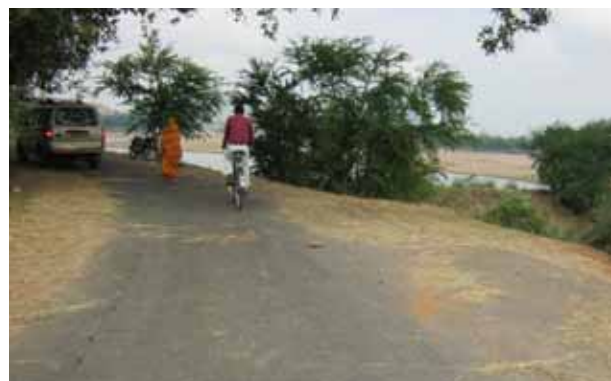
Road side objects present along this stretch of road are few trees, high embankment and Pool.

Road side objects are on the edges of the carriageway

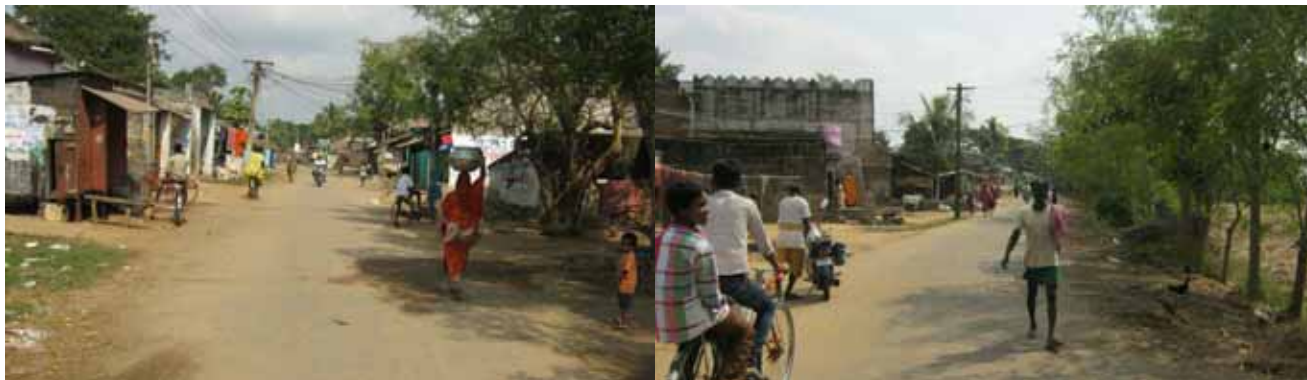
Km 11+420 (Badamadhapur village)

Km 19+100 (Raipur village)

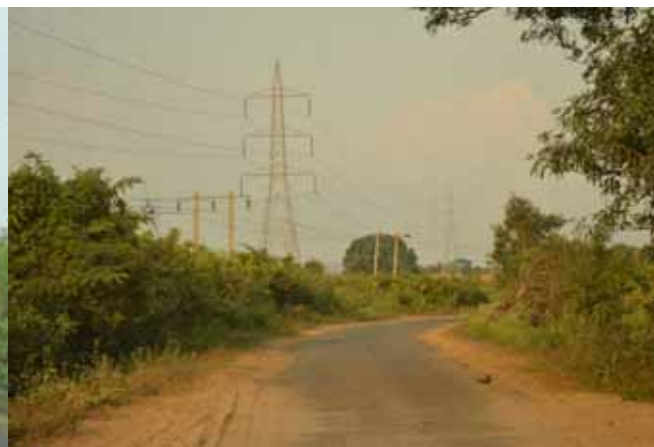
Km 8+200

| Reasons for concern: | Curves on high embankment without safety barriers noted <ul style="list-style-type: none">• Run-off accidents on high embankments will lead to fatalities |

| Recommendations: | Provide curve warning signs, chevron signs, delineators as appropriate <i>Refer to Appendix III for guidelines on treatment of curves.</i> |
| Recommendations: | <ul style="list-style-type: none">• Improve the line of sight by removing trees from the shoulder and cut down vegetation which hampers visibility along the curves |
| Recommendations: | Provide metal beam crash barrier with delineators on sharp curves in high embankment <i>Refer to Appendix III for guidelines on situations where to install the above</i> |

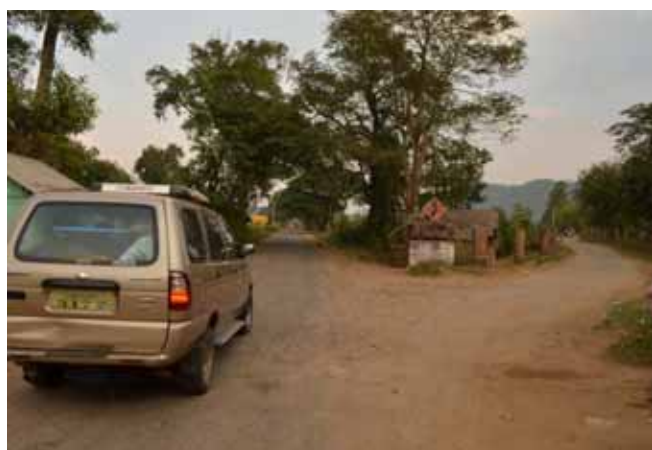
Km 18+000

This is a major hazard observed on most of the 3-armed uncontrolled junctions. The major reasons for poor visibility at junctions on this road are due to 1) Encroachments at Junctions 2) Overgrown vegetation or presence of trees and 3) poor layout of the side roads.

No traffic signs or road markings are observed on any of the junctions, the presence of which would have informed and warned the road user of the layout ahead.

It has been observed that on few junctions, the level difference between the side road and major road and the vertical profile of the side road joins the edge of main carriageway in an unsafe manner.

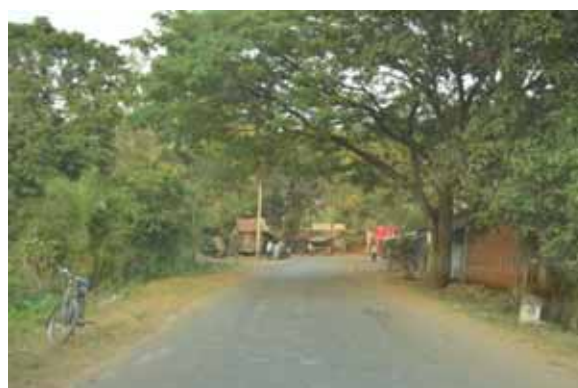
Km 0+000

- In this section of road only one major junctions is 3-arm uncontrolled junction.
- Street lights is missing

Pedestrians and cyclists observed at the junction, but no separate provisions have been made. Pedestrians are particularly vulnerable at such junctions having high approach speed.

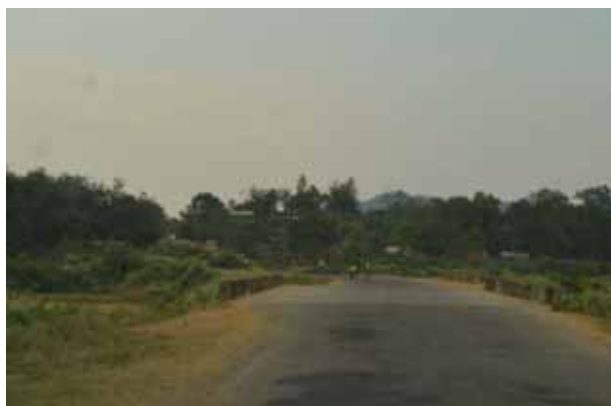
Km 19+720

| Reasons for concern: | The bridge/ culvert parapets on the edge of the road adjacent to high speed traffic movement will be hazardous, particularly at dark conditions, and needs to be illuminated for a driver to judge the position of such road side hazard. |
| Reasons for concern: | Absence of traffic signs and road markings In the absence of adequate warning signs and reflective markings, the road layout and the hazard will not be clear for the road user, particularly during night conditions and in worst conditions, this will lead to serious injury/ fatal accidents |

| Recommendations: | Install Object Hazard Marker (OHM) on both sides and for both approaches (i.e. Four numbers of each OHM for each structure. <i>Refer to Appendix III for guidelines for installation of object hazard markers</i> |
| Recommendations: | Provide crash barriers on either approaches of the structures with delineators <i>Refer to Appendix III for guidelines to treatments on approaches to bridges</i> |
| Recommendation: | <ul style="list-style-type: none"> • Provide curve warning sign in addition to crash barrier with delineators • Provide edge lane markings • Provide hazard markers on either edge of the parapets |

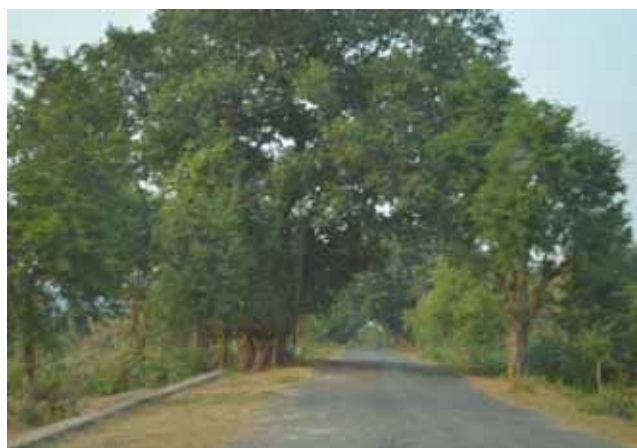
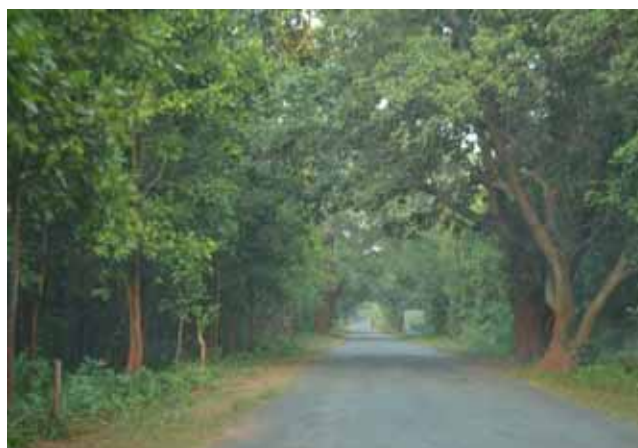
Trees are on the edges of the carriageway

Reasons for concern: The road side objects like trees, street light or other poles, buildings, and unprotected deep drains which are near the edge of road. At night time it becomes very difficult for drivers to judge the position of such road side hazard. If the road side objects are not protected and/or illuminated there are chances of driver losing control and hitting these objects which may result into fatal accident.

Recommendations: Either remove such objects or provide crash barrier where such objects are <2m from the edge of road.

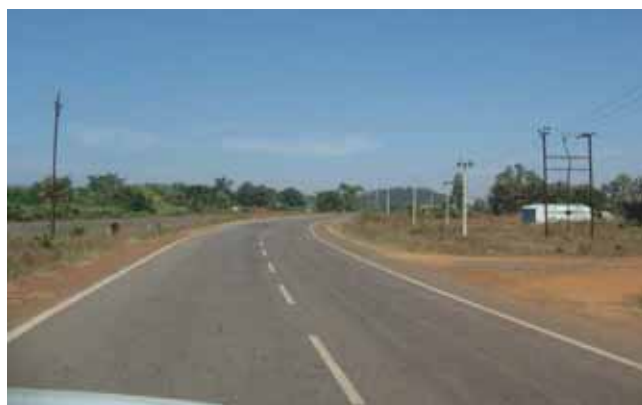
Ch: 8+300

Horizontal curves of radius less than 200 m were observed at Km.6+000, 8+300, 10+600, 11+900, 15+200, 15+500, 17+100 and 18+900.

Reasons for concern: Curves on high embankment without safety barriers noted

| Recommendations: | Provide curve warning signs, chevron signs, delineators and speed limit sign as appropriate <i>Refer to Appendix III for guidelines on treatments of curves.</i> |

Recommendations: Provide metal beam crash barrier with delineators on sharp curves in high embankment

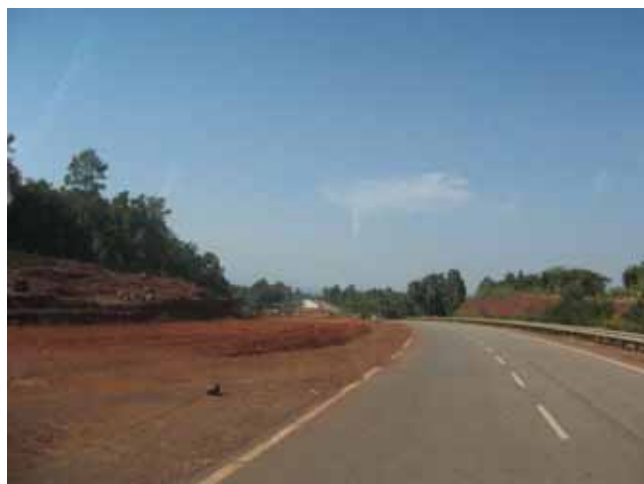
Ch: 15+800

In the existing situation, there are two instances of horizontal bends occurring after a vertical crest along this road at the following chainages:

Reasons for Concern: **Insufficient sight distance**
 The sight distance on a vertical crest is limited in day light and even less in night time. The presence of a horizontal bend after a vertical crest decreases the sight distance available further for the driver to react and could be a potential unsafe location. The vertical deflection of the alignment prevents the road user from being prepared to negotiate the curve and could lead to run off accidents.

Recommendations **Desirable:** Provide advance curve warning signs, no overtaking pavement markings chevrons and delineators.

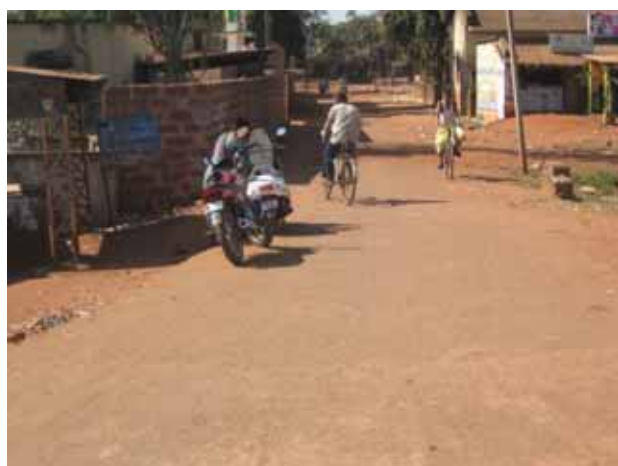
Ch: 22+100

Inadequate Visibility

- No traffic signs or road markings are observed on any of such junctions, the presence of which would have informed and warned the road user of the layout ahead.
- Poor delineation may result in sudden braking behavior by road users who are required to stop, or wish to make turns. In the worst case, it can also result in rear-end collisions at high speeds.

- High approach speeds were observed by traffic turning from side roads into the main carriageway and no traffic calming measures/ warning is provided on the side road.
- Coupled with inadequate visibility, in the worst case, this may result in **right angle collision** with vehicles coming from the major road leading to serious injury or fatal accidents.

It has been observed that on few junctions, the level difference between the side road and major road and the vertical profile of the side road joins the edge of main carriageway in an unsafe manner.

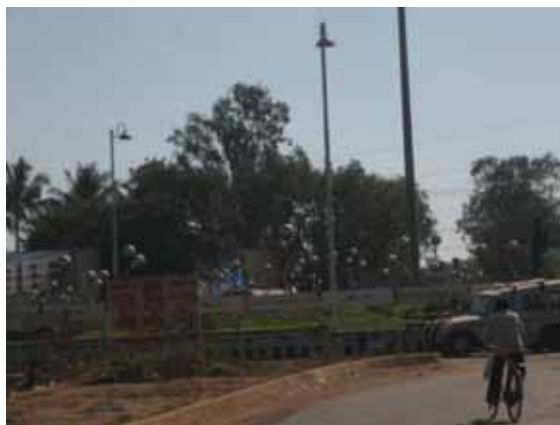
There is one major junction at Duburi, Ch: 15+000 along this road.

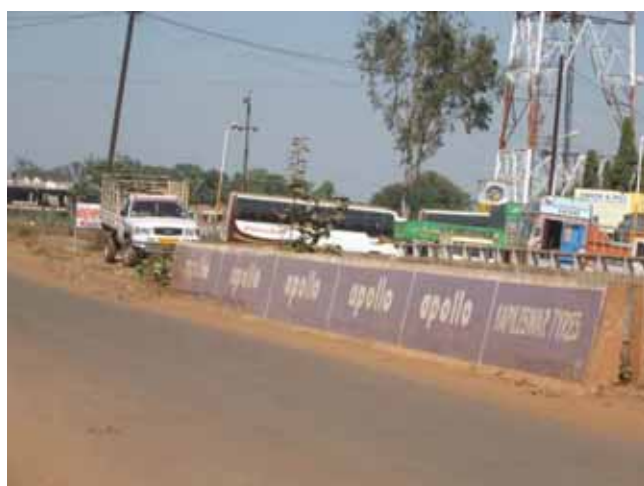
Ch: 2+100

At following locations the parapets of bridge/culvert were found either missing or broken resulting in highly hazardous situation for VRUs and motorized road users.

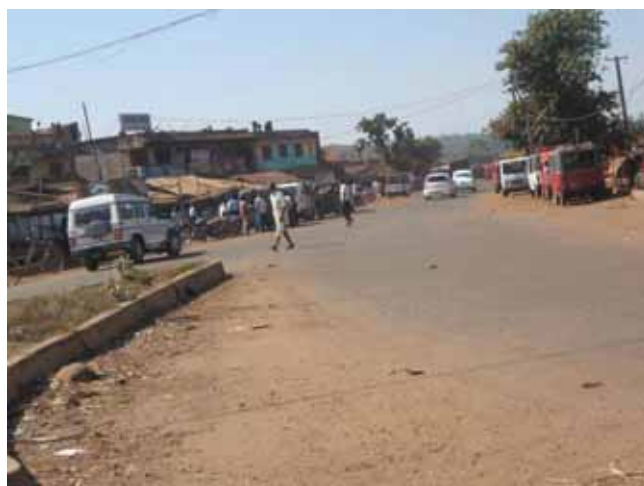
Ch: 0+000

In the existing situation, there are a lot of vulnerable road users present in the built-up area of Duburi town area at the following chainages:

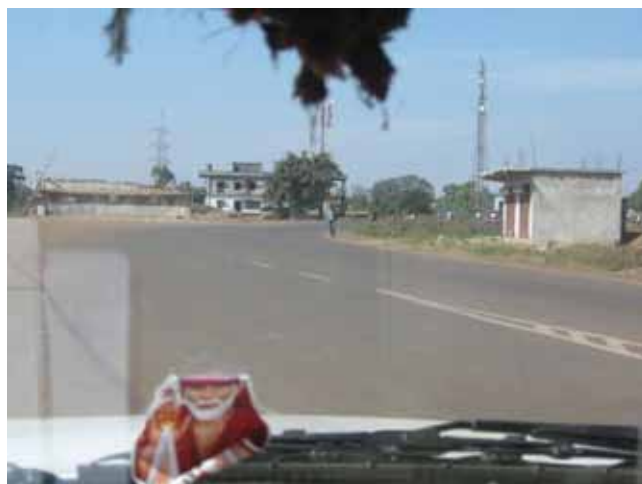
Ch: 7+000

In the existing situation, majority of the curves along this section of the road have good sight distance. Horizontal curves of radius less than 200 m were observed at Km.7+000, 12+150, 13+300 and 13+800.

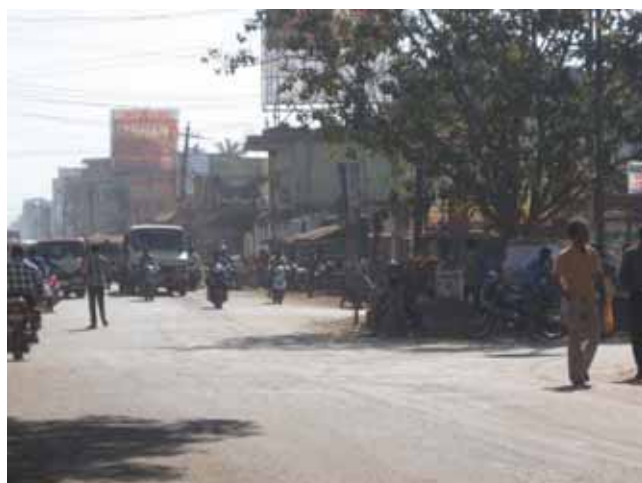
Ch: 0+000

There are two major junctions along this road at following chainages:

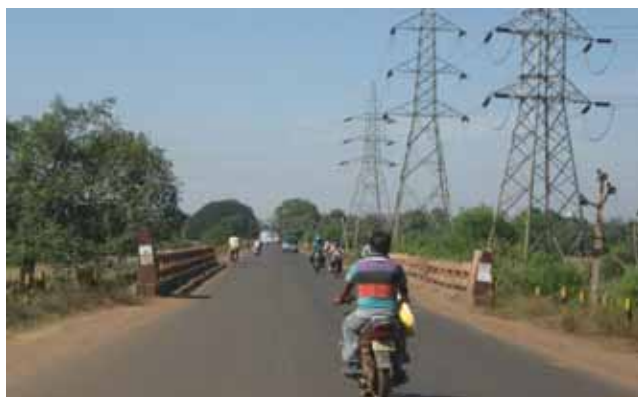
Ch: 2+800

In the existing condition, there is a minor bridge at chainage 2+800.

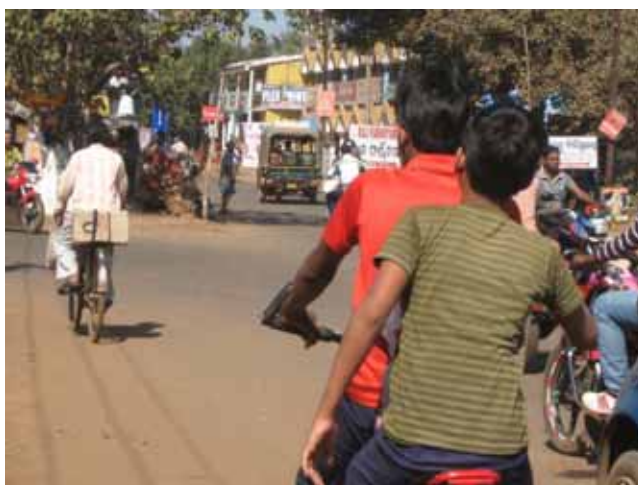
Ch: 0+000

In the existing situation, significant number of vulnerable road users present in the built-up area of Jajpur Road town and near Duburi town area.

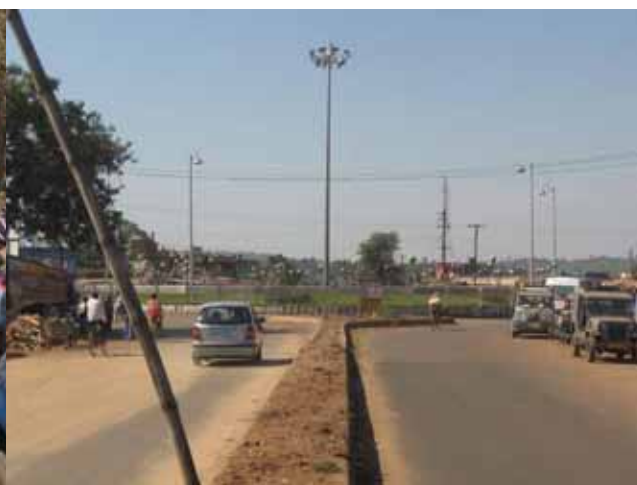
Ch: 15+000

- No traffic calming measures are provided to slow down vehicles approaching at high speeds to the built up area
- Significant pedestrians including school children are noted, but no separate pedestrian facilities are provided along the road inside the BUA or to cross the road
- Significant number of access roads within the BUA, the visibility of which has been hampered due to shops/ establishments on all corners of the junction

- On road bus stops which hampers visibility and encourage dangerous overtaking
- No road markings or warning signs to warn/ inform the road user of the built up nature of the area ahead
- No speed limit signs provided
- On street parking hampers the visibility and resulting in unsafe situations
- On street bus stops observed, which hampers visibility and unsafe overtaking maneuvers.
- The shared usage of road space by the different modes of vehicle puts at risk the safety of vulnerable road users. These are pedestrians, cyclists or two-wheelers. There could be head on / rear end collisions.

- Provide appropriate warning signs various hazards encountered inside the roadside village
- Provide adequate traffic calming measures
- Provision of 2 m wide clear shoulder free of obstructions/ encroachments to segregate the pedestrian traffic.

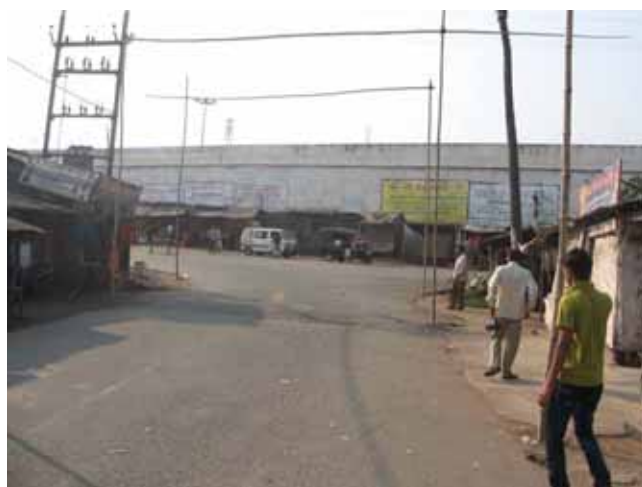
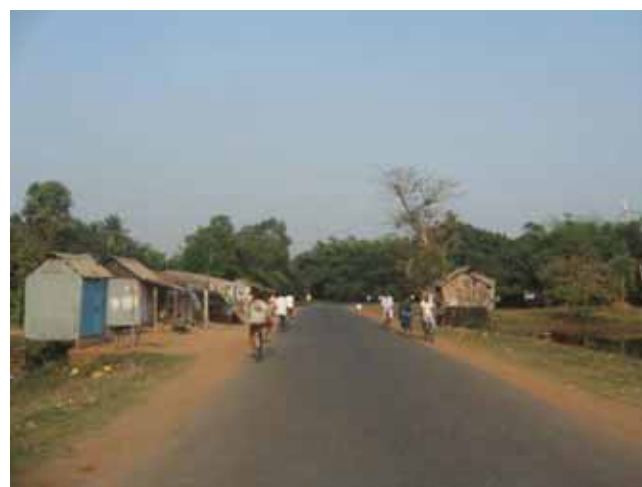
Reasons for concern: Centerline / edge line road markings are absent in the road section, the presence of which could have delineated the road during night conditions and encourages the driver to keep to the designated lanes

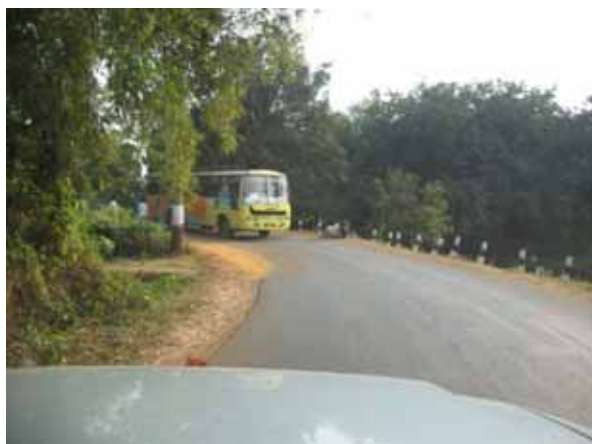
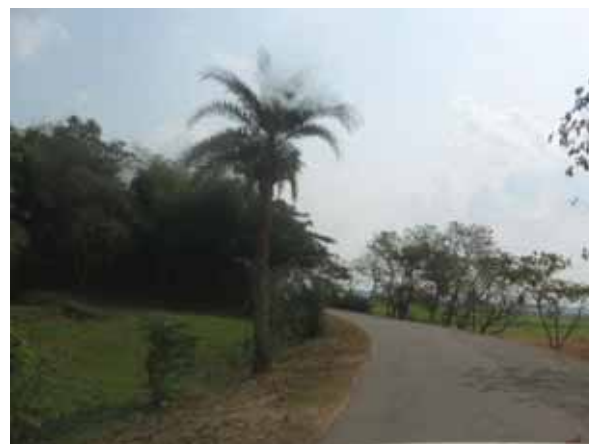
Horizontal curves of radius less than 250 m were observed at chainages 0+300, 0+700, 1+400, 2+500, 3+800, 5+100, 5+200, 5+500, 5+800, 6+400, 9+900, 12+600, 15+600, 25+100,; 29+100 and 31+200.

| Reasons for concern: | Curves on high embankment without safety barriers noted <ul style="list-style-type: none"> • Run-off accidents on high embankments will lead to fatalities |

| Recommendations: | Provide curve warning signs, chevron signs, delineators and speed limit sign as appropriate <i>Refer to Appendix III for guidelines on situations where to install the above</i> |
| Recommendations: | <ul style="list-style-type: none"> • Improve the line of sight by removing trees from the shoulder and cut down vegetation which hampers visibility along the curves |
| Recommendations: | Provide metal beam crash barrier with delineators on sharp curves in high embankment <i>Refer to Appendix III for guidelines on situations where to install the above</i> |

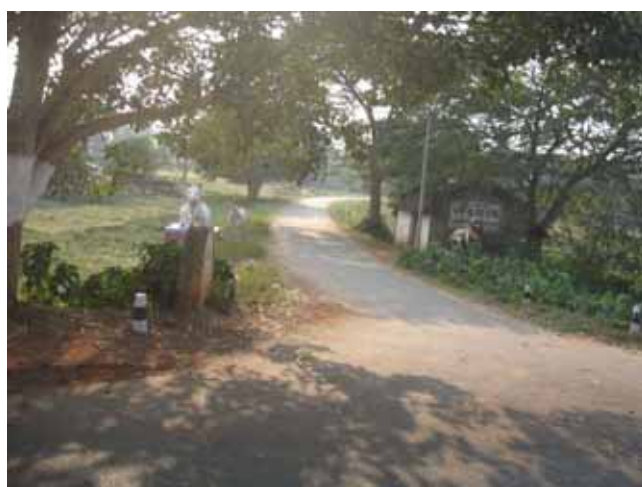
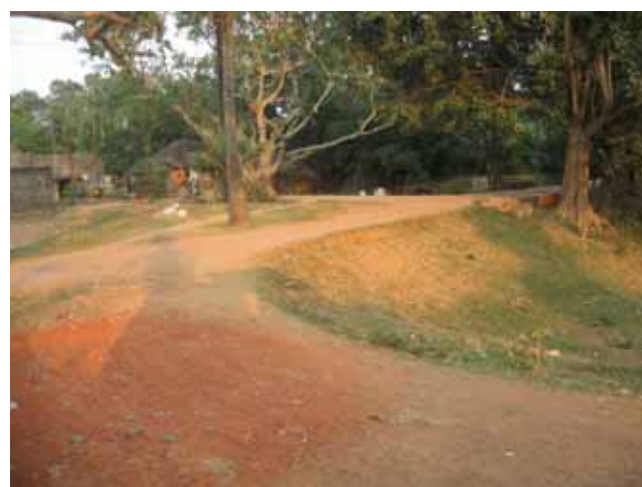
Km. 0+300; 0+600; 1+200; 1+300; 2+100; 3+300; 3+900; 4+100; 4+400; 4+600; 5+400; 5+600; 6+100; 6+500; 6+900; 7+300; 7+500; 7+900; 8+200; 8+600; 9+200; 9+300; 9+350; 9+400; 9+900; 10+860; 11+300; 11+600; 11+950; 12+100; 12+400; 12+500; 12+650; 12+800; 13+100; 13+500; 13+700; 13+950; 14+300; 14+400; 14+700; 15+100; 15+400; 16+400; 16+800; 16+950; 17+200; 17+400; 18+200; 18+500; 18+600; 18+800; 21+100; 22+700; 22+900; 23+100; 23+200; 23+300; 23+450; 23+500; 23+550; 23+750; 24+050; 24+150; 26+100; 26+800; 26+850; 27+850; 28+900; 29+800; 30+400; 30+700; 30+900; 31+500; 32+400; 32+500; 32+900

This is a major hazard observed on most of the 3-armed uncontrolled junctions. The major reasons for poor visibility at junctions on this road are due to

- No traffic signs or road markings are observed on any of such junctions, the presence of which would have informed and warned the road user of the

- High approach speeds were observed by traffic turning from side roads into the main carriageway and no traffic calming measures/ warning is provided on the side road.
- Coupled with inadequate visibility, in the worst case, this may result in **right angle collision** with vehicles coming from the major road leading to serious injury or fatal accidents.

Recommendations: • Provide traffic signs and road markings pertaining to junction control

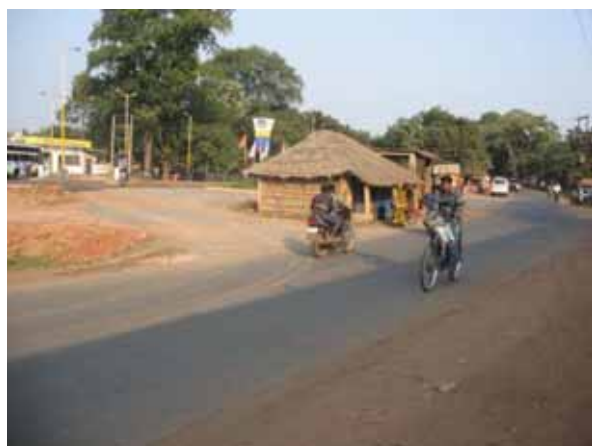
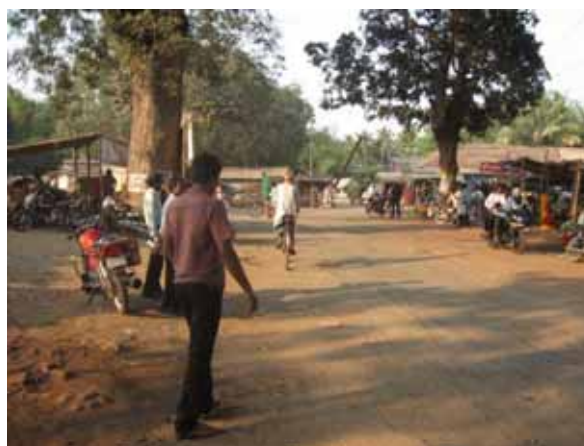
| Reasons for concern: | Poor Junction layout <ul style="list-style-type: none">• The junction layout is non-standard and has no control over the traffic movement. It is confusing who has priority in such a situation. This encourages lawless traffic movement and is hazardous. |

| Reasons for concern: | Provision for VRUs <ul style="list-style-type: none">• Pedestrian space in the intersection area is encroached by commercial establishments.• Pedestrians were observed using the road for commuting, instead of the footpath/ shoulders, and this expose them to the fast moving traffic which can lead to crashes resulting in serious injuries. |

| Reasons for concern: | On-street Parking <ul style="list-style-type: none">• No parking spaces provided for commercial vehicles and vehicles are parked encroaching the road and shoulder space, hampering visibility.• This forces pedestrians to move into the centre of the road resulting in hazardous situation. |

| Recommendations: | <ul style="list-style-type: none">• Re-design the junction after traffic studies and considering the requirements of all road users. |

| Recommendations: | <ul style="list-style-type: none">• Provide edge line markings, centerline markings and other junction road markings pertaining to junction control. |

| Recommendations: | <ul style="list-style-type: none">• Remove encroachments from the shoulder and provide a 2m wide shoulder space free of encroachments |

| Recommendations: | <ul style="list-style-type: none">• Provide designated parking spaces for commercial vehicles |

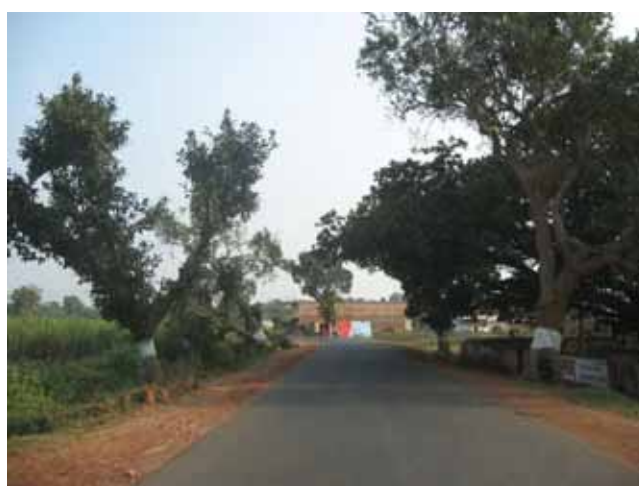
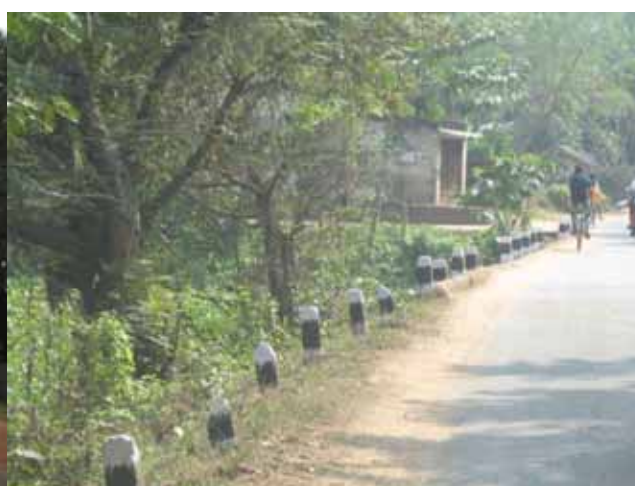
Hazardous road side objects such as, trees (in BUA) were observed on this road very near to the edge of road (within 1 to 2m from the edge of road) at the following chainages:

| Reasons for concern: | Roadside objects constitute a significant hazard, if the driver loses control and will result in major injuries/ fatalities |

| Recommendations: | <p>Desirable:</p> <ul style="list-style-type: none"> • Remove Trees/ street lighting poles from the road shoulders • Remove encroachments from the right of way • Provide crash barriers on locations where trees acts as a significant hazard and where the space is available to install crash barrier <p>Essential:</p> <ul style="list-style-type: none"> • Delineate the hazards by installing OHMs or painting of the trees in black and white strips • Remove encroachments on at least 2m from the road edge |

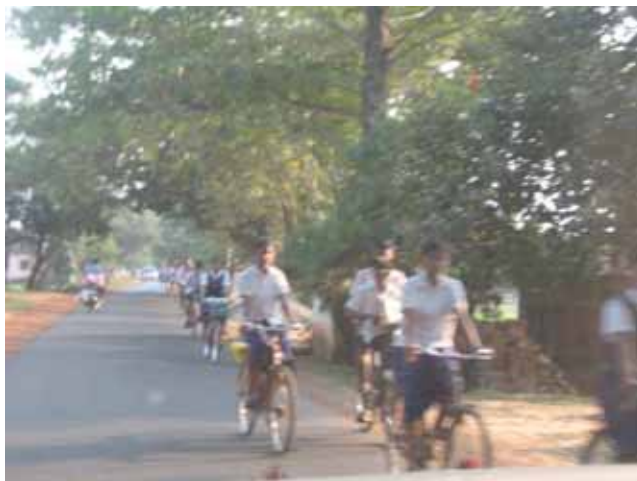
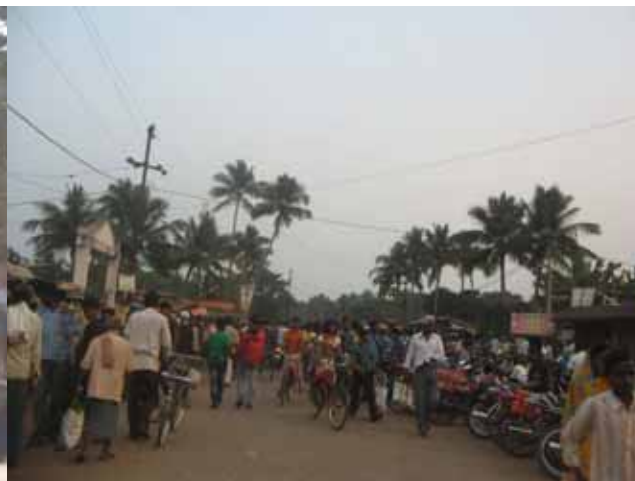
- 6+300
- 6+900
- 10+100
- 20+000
- 22+100
- 23+300
- 24+500
- 26+000

- No traffic calming measures are provided to slow down vehicles approaching at high speeds to the built up area
- Significant pedestrians including school children are noted, but no separate pedestrian facilities are provided along the road inside the BUA or to cross the road
- Significant number of access roads within the BUA, the visibility of which has been hampered due to shops/ establishments on all corners of the junction
- On road bus stops and on-street parking which hampers visibility and encourage dangerous overtaking
- No road markings or warning signs to warn/ inform the road user of the built up nature of the area ahead
- No speed limit signs provided
- The shared usage of road space by the different modes of vehicle puts at risk the safety of vulnerable road users (pedestrians and cyclists).

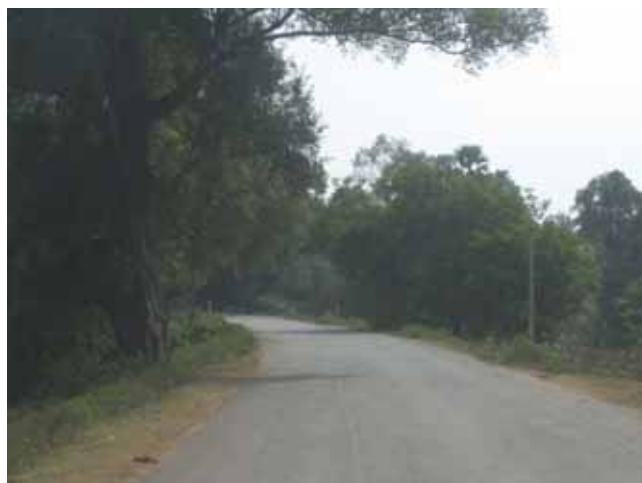
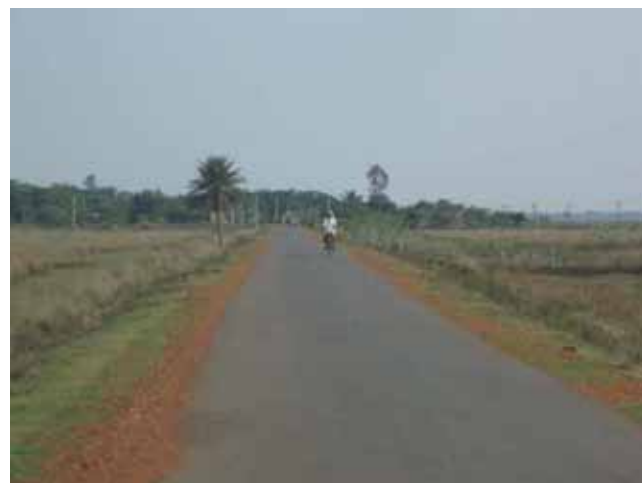
Majority of the stretches of the road is in high embankment with irrigation canals on the sides without any crash protection. Majority of the land use along the road are agricultural and small habitations. Hence the mix of traffic majorly consists of trips generated by these habitations including pedestrian, cyclist, two-wheeler and four wheeler traffic.

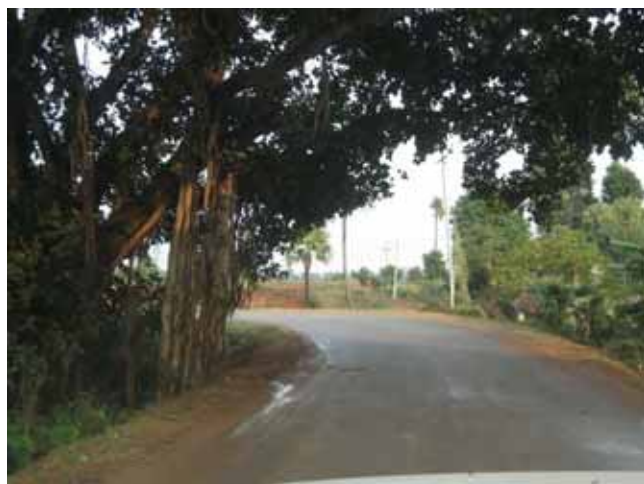
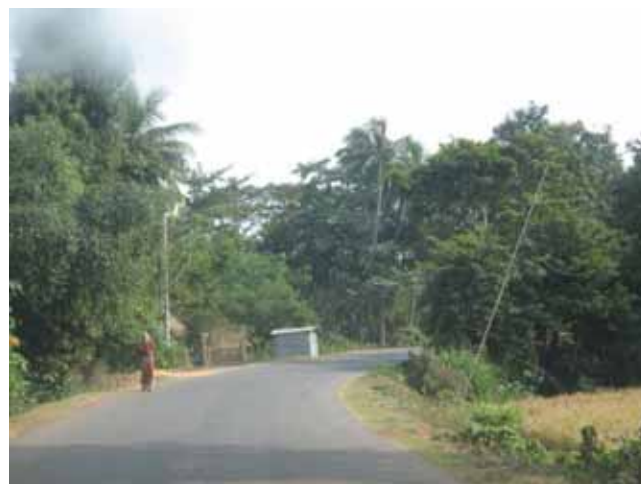
Horizontal curves of radius less than 200 m were observed at Km. 2+100; 3+100; 3+800; 4+700; 5+020; 19+950; 20+400; 22+400; 22+600; 23+700; 23+900; 24+100; 24+700; 32+300; 32+700; 33+000; 33+700; 36+400.

Reasons for concern: Curves on high embankment without safety barriers noted, which may lead to run-off accidents, which can result in fatalities/ major injuries

Recommendations: Provide **curve warning signs, chevron signs, delineators and speed limit sign** as appropriate

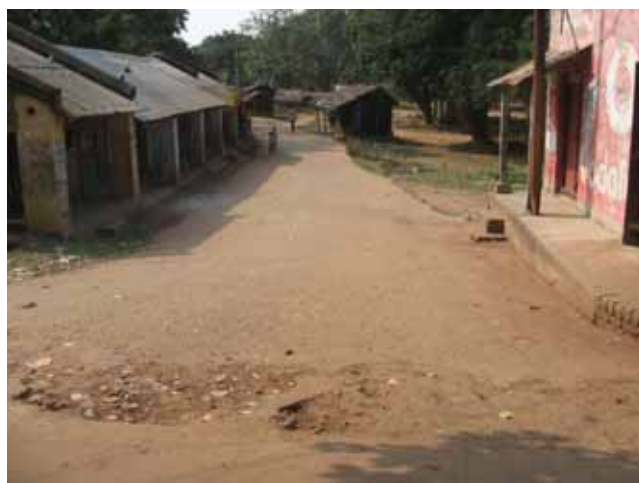
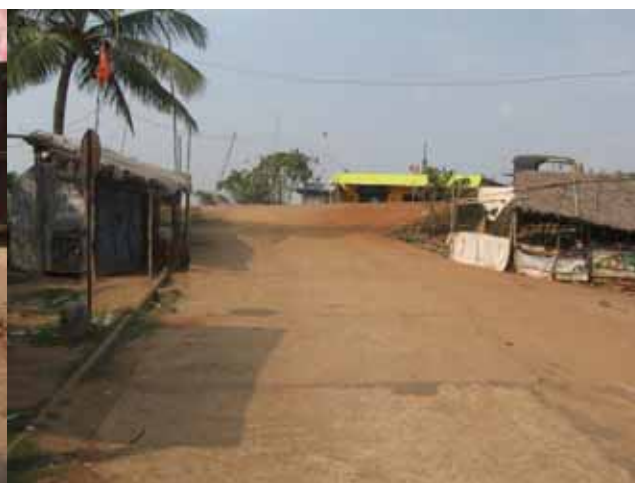
Km. 2+400; 2+500; 2+700; 2+900; 9+100; 19+100; 19+200; 19+400; 20+000, 21+600; 21+850; 22+300; 22+400; 23+600; 23+900; 24+700; 24+800; 26+750; 26+800; 27+700; 27+950; 29+400; 29+500; 30+100; 30+300; 30+700; 33+300; 35+100; 35+600; 36+800; 37+700; 37+800; 38+200; 38+900; 41+900; 42+700; 42+750; 43+400; 45+300; 45+700; 46+500; 47+600
