**Government of Odisha (GOO)
Chief Engineer, World Bank Projects, Odisha
Odisha State Roads Project**

**Consultancy Services for
Road Sector Institutional Development
Loan # 7577-IN**

**ROAD INFRASTRUCTURE
SAFETY MANAGEMENT REVIEW**

VOLUME I - REPORT

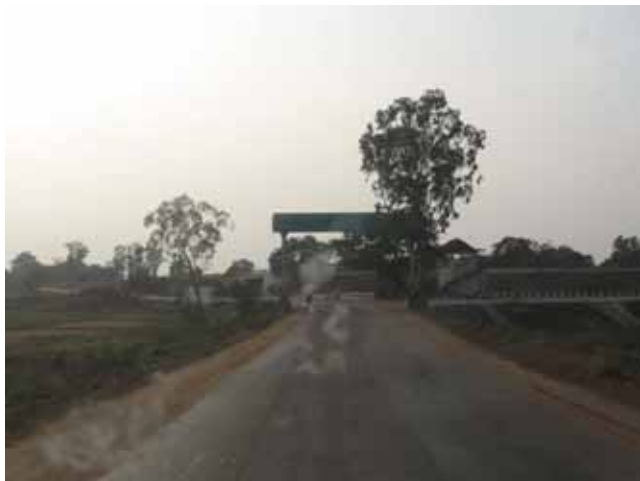
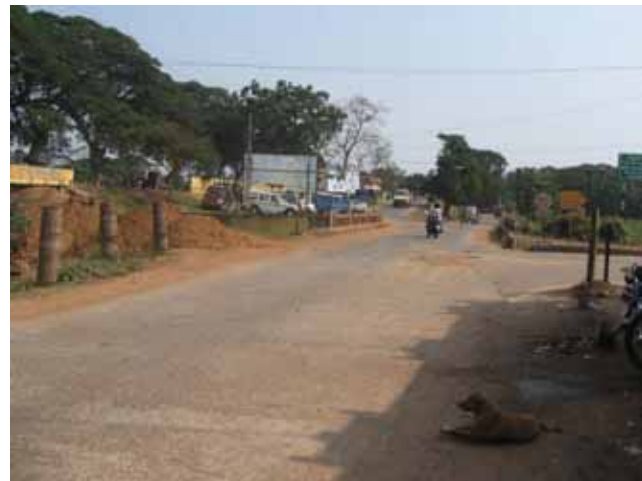
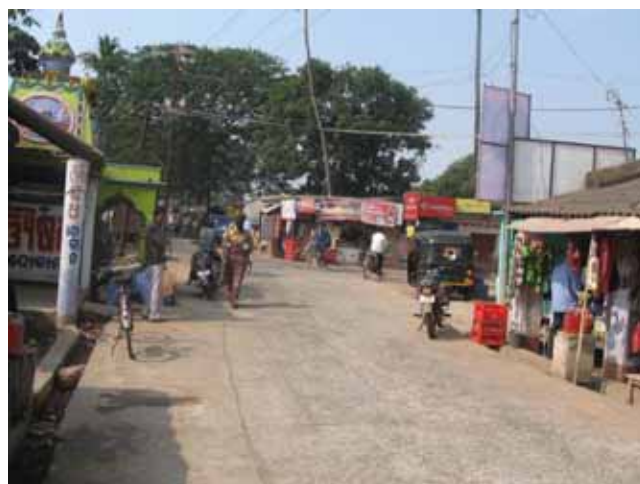
In the existing situation, there are three major junctions along this road at the following chainages:

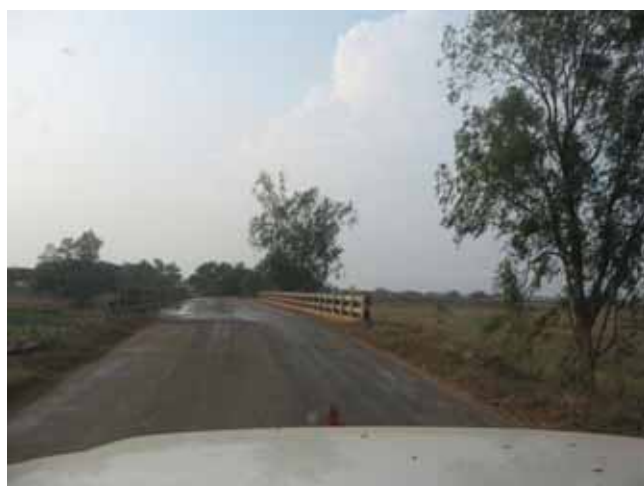
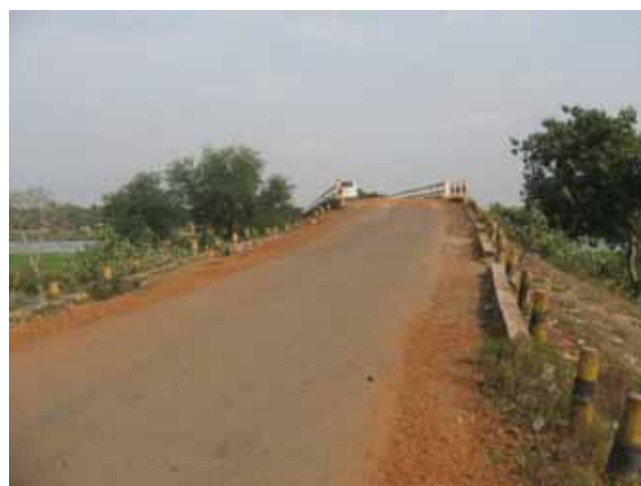
In the existing situation, there are many minor bridges culverts along the road, the approaches of which are not protected. The following are the chainages:

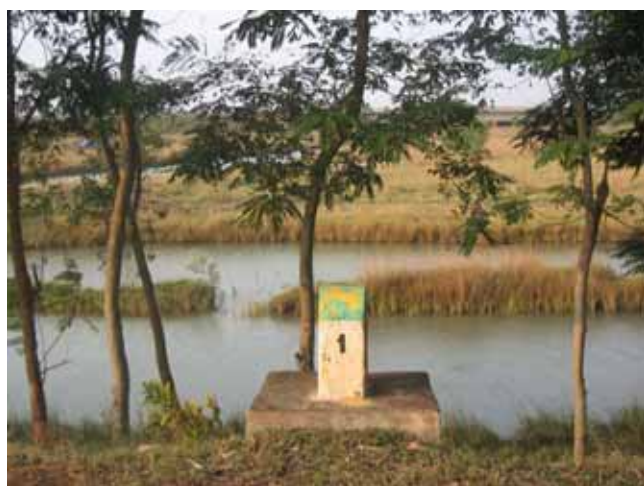
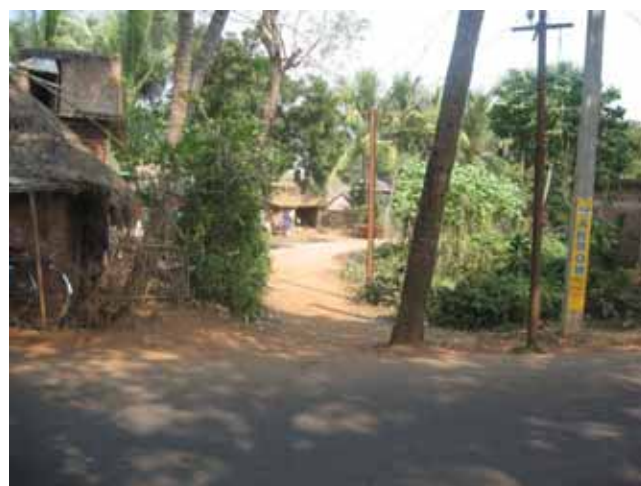
Hazardous road side objects such as trees and Poles (Telephone & Street lighting) were observed nearer to the edge on this road.

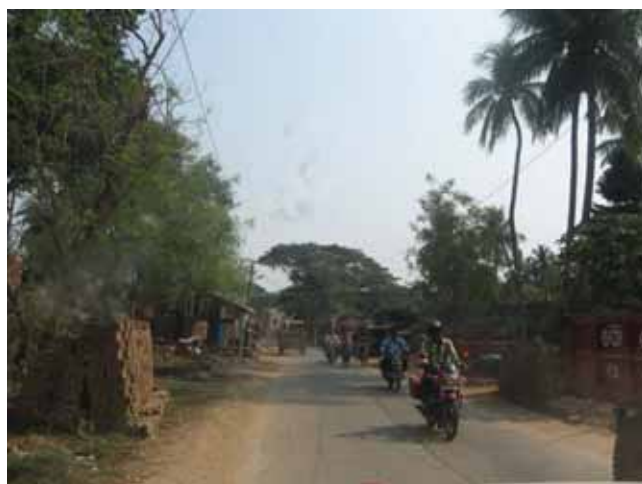
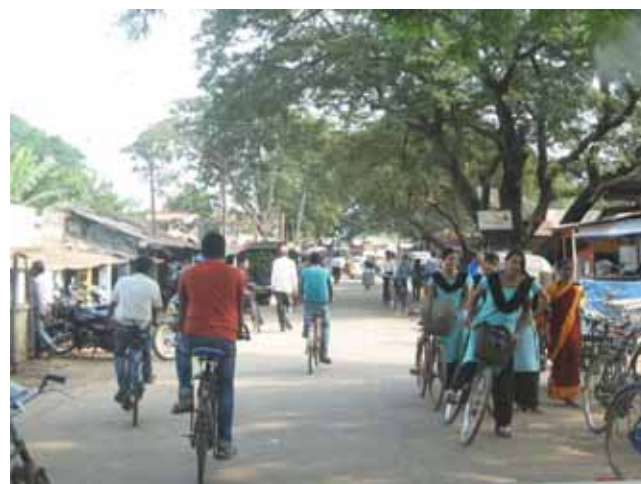
Roadside villages were observed at the following chainages:

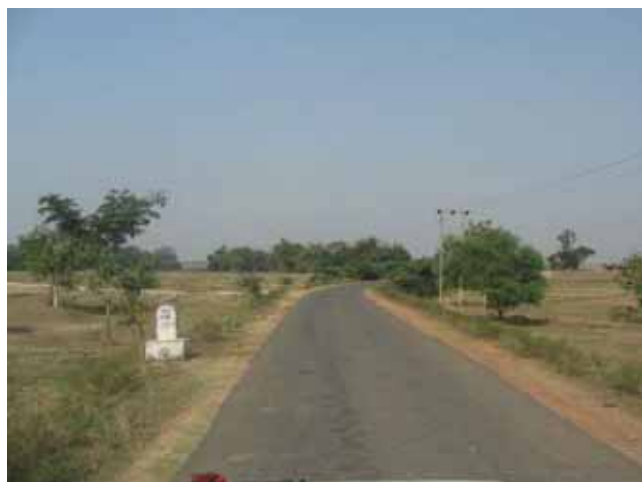
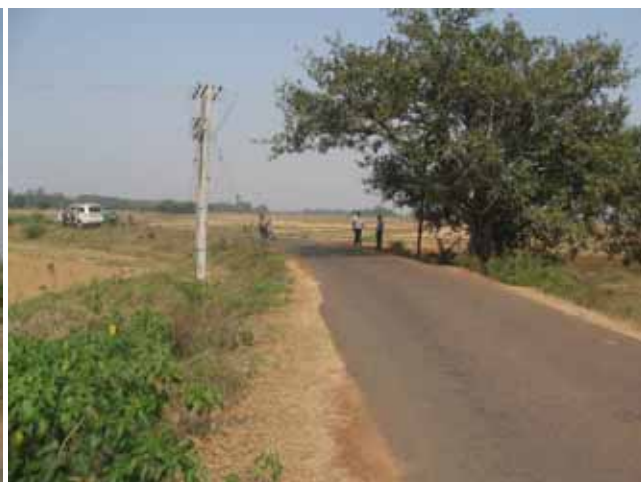
Horizontal curves of radius less than 100 m were observed at Km.2+400; 3+100; 3+400; 4+400; 6+200; 6+500; 7+100; 7+200; 7+400; 8+100; 8+300; 8+500; 13+500; 14+500; 14+700; 15+100; 15+400.

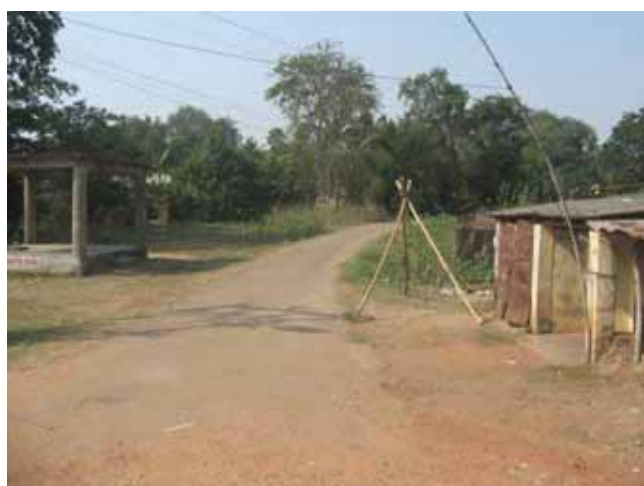
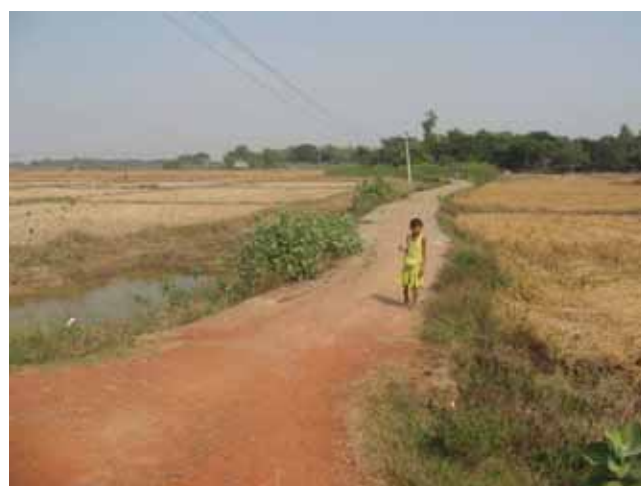
Km. 0+900; 1+700; 5+900; 6+900; 11+200; 11+400; 11+500; 13+500; 13+700; 14+050; 14+600; 15+700; 15+900; 16+100; 16+500; 16+600; 17+900

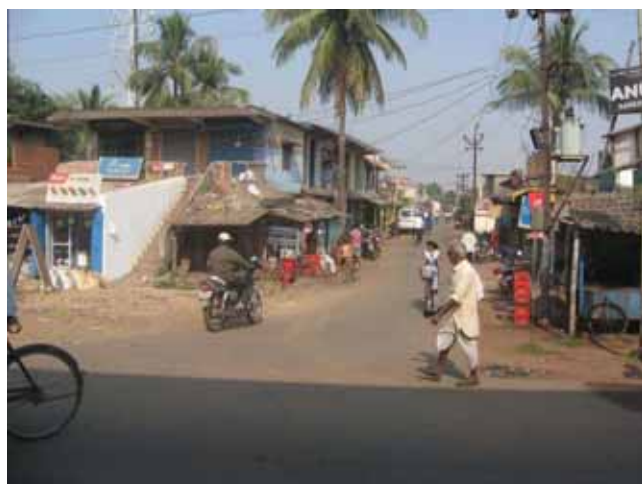
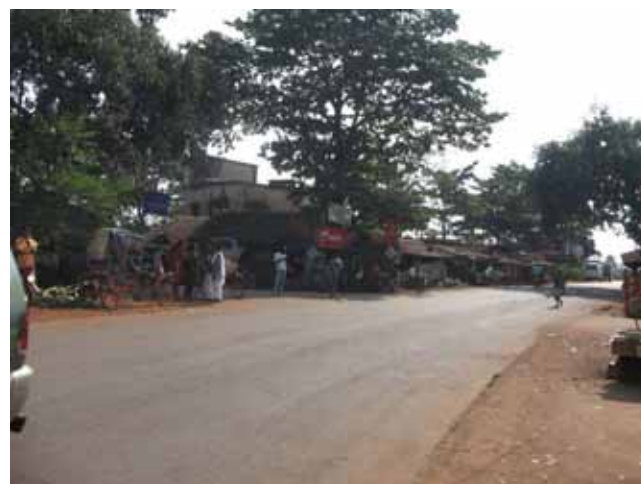
In the existing situation, there are two major junctions along this road at the following chainages:

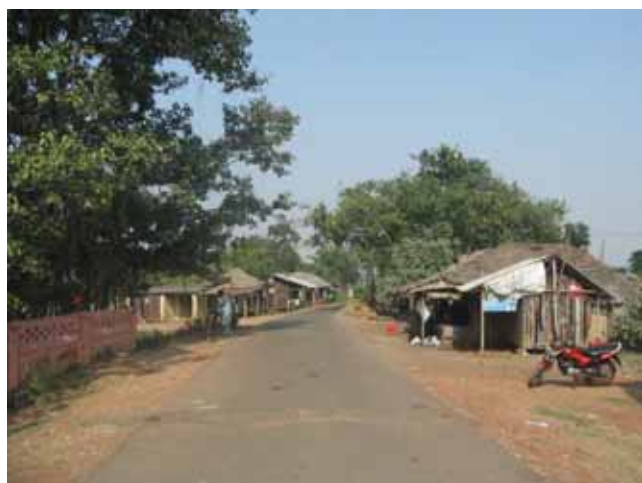
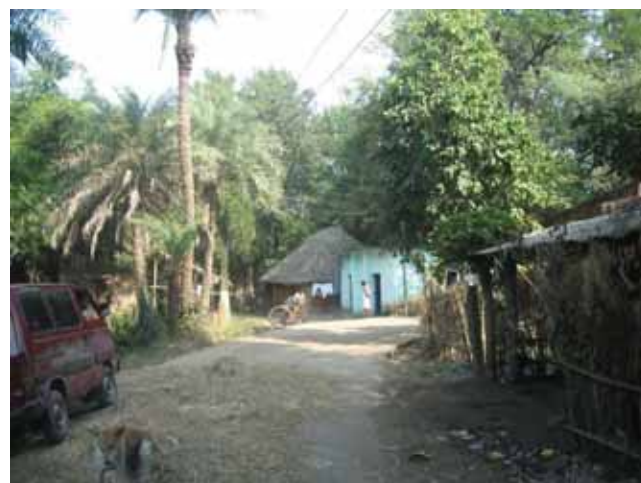
Roadside villages/ BUAs were noted at the following locations:

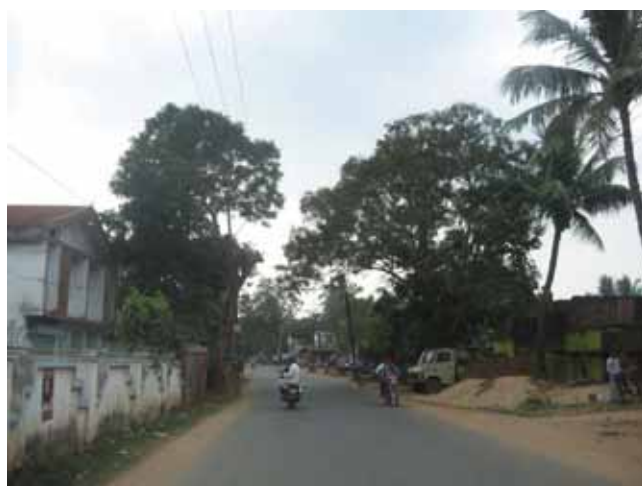
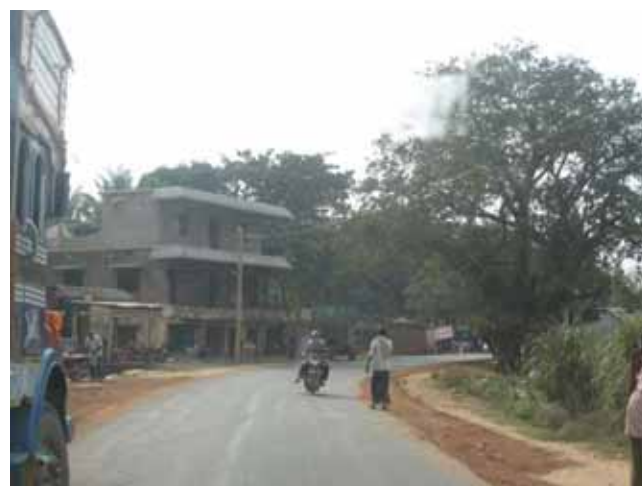
6.5.2.1. Delineation of the road

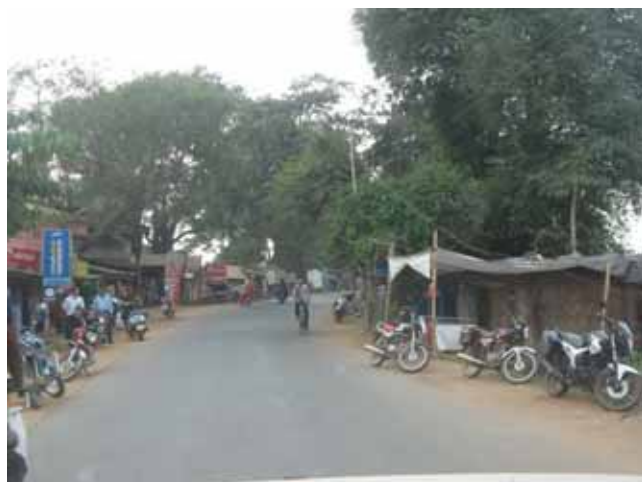
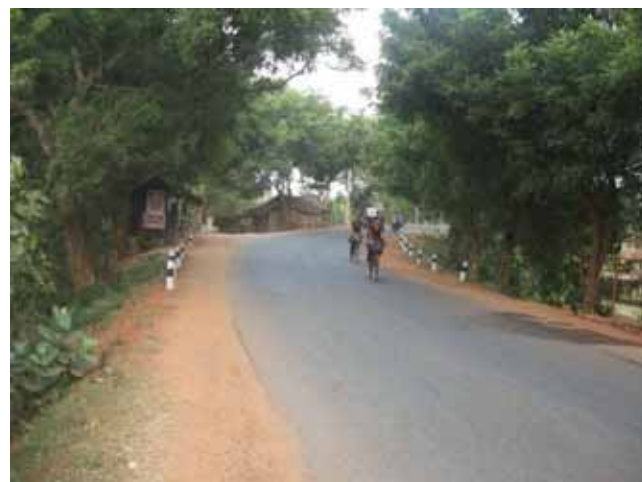
Horizontal curves of radius less than 100 m were observed at Km.4+100; 4+600; 7+200; 7+800; 8+000

Reasons for concern: Curves on high embankment without safety barriers noted

Recommendations: Provide **curve warning signs, chevron signs, delineators and speed limit sign** as appropriate

Recommendations: Provide metal beam crash barrier with delineators on sharp curves in high embankment

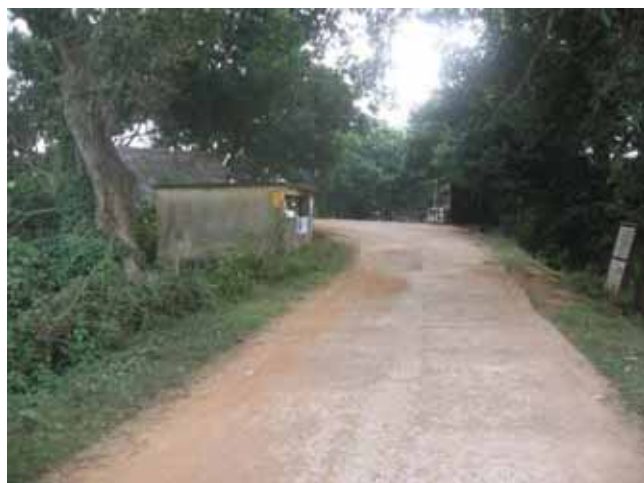
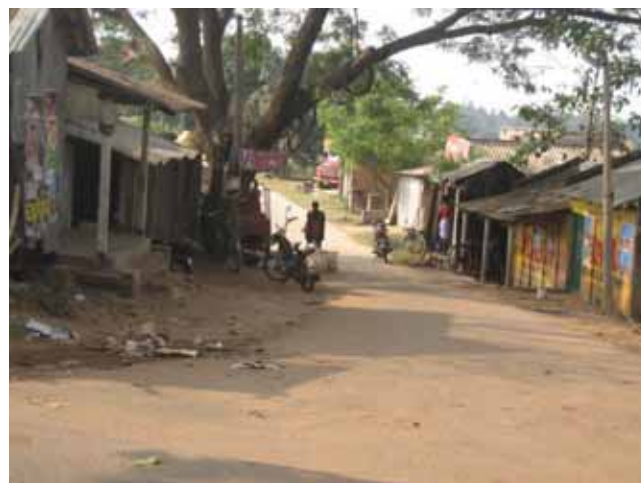
Location of Side roads at skew with the major road

Km. 0+400; 0+900; 1+300; 1+800; 2+900; 6+600; 7+300

This is a major hazard observed on most of the 3-armed uncontrolled junctions. The major reasons for poor visibility at junctions on this road are due to

- No traffic signs or road markings are observed on any of such junctions, the presence of which would have informed and warned the road user of the layout ahead.

It has been observed that on few junctions, the level difference between the side road and major road and the vertical profile of the side road joins the edge of main carriageway in an unsafe manner.

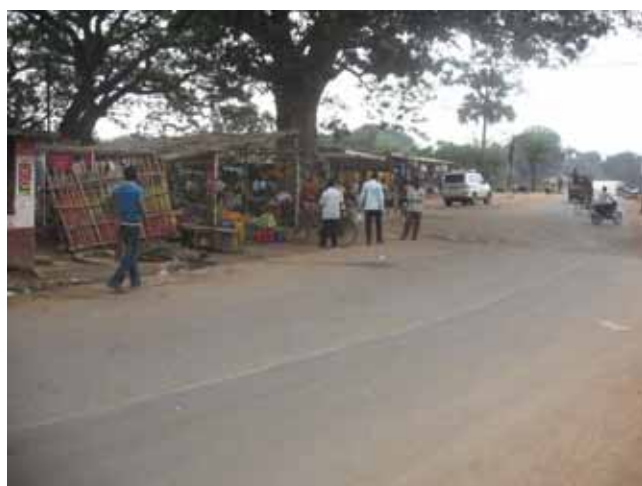
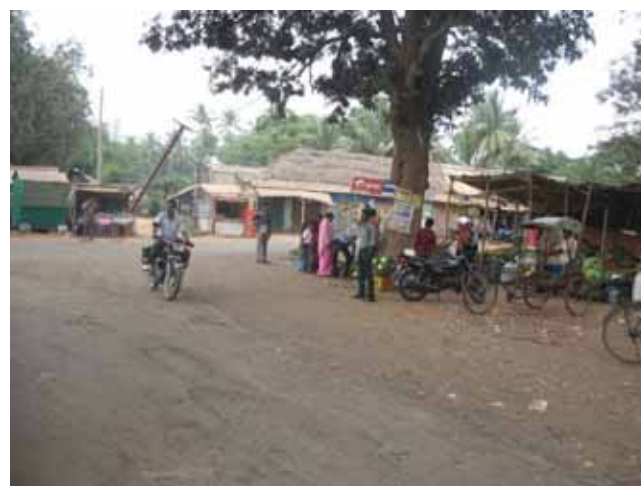
Ch: 8+000

There is a major junction along this road at Baruan, Ch: 8+000.

- The junction layout is non-standard and has no control over the traffic movement. It is confusing who has priority in such a situation. This encourages lawless traffic movement and is hazardous.

- No direction signs to guide the traffic through the junction layout which may lead to hazardous driving and may lead to rear-end collision.

- Shoulders in the junction area are encroached by shops and other such establishments.
- Pedestrians were observed using the road for commuting, instead of the footpath, and this expose them to the fast moving traffic which can lead to crashes resulting in serious injuries.

- Remove encroachments from the shoulders
- Provide a well maintained 2m wide shoulder space for pedestrians in rural areas

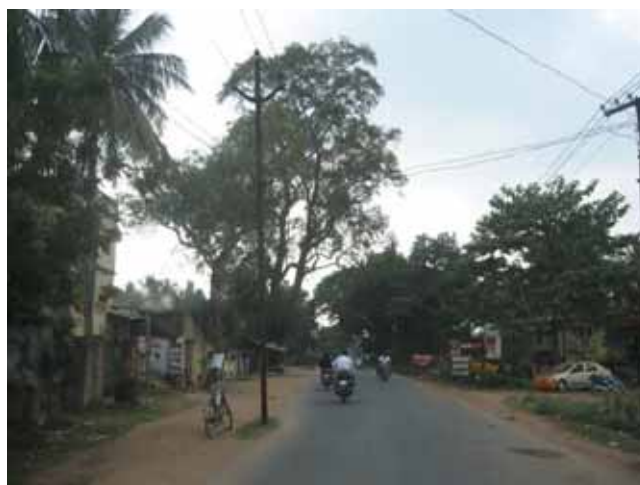
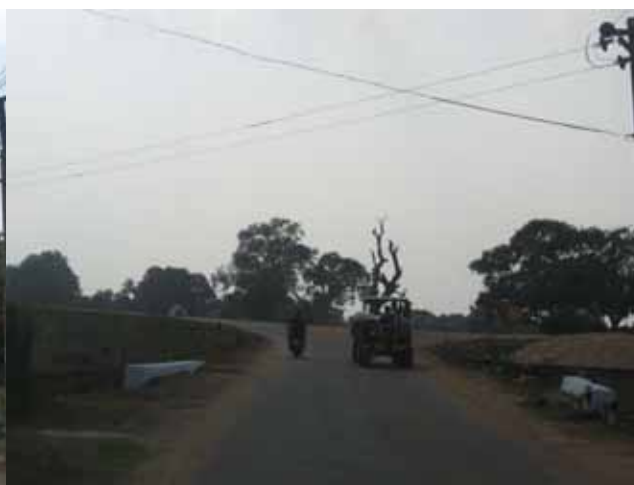
6.5.2.5. Roadside Hazards - Trees, Poles, and Buildings

Roadside objects constitute a significant hazard, if the driver loses control and will result in major injuries/ fatalities

- Remove Trees/ street lighting poles from the road shoulders
- Remove encroachments from the right of way
- Provide crash barriers on locations where trees acts as a significant hazard and where the space is available to install crash barrier

- Delineate the hazards by installing OHMs or painting of the trees in black and white strips
- Remove encroachments on at least 2m from the road edge

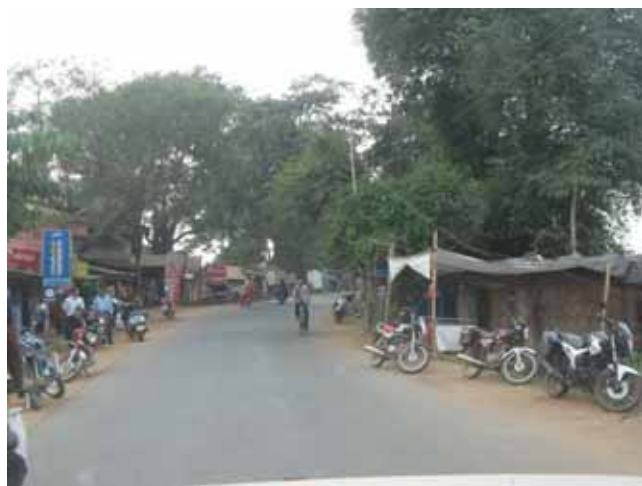
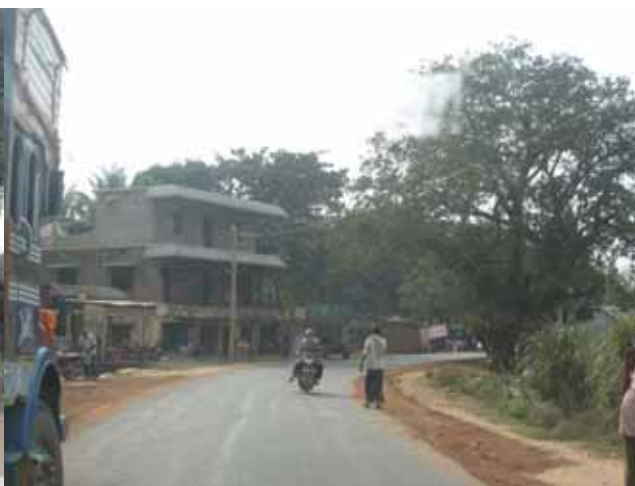
6.5.2.6. Roadside Villages/ Built-up Areas (BUA)

- No traffic calming measures are provided to slow down vehicles approaching at high speeds to the built up area
- Significant number of pedestrians were noted, but no separate facilities are provided
- Access roads within the BUA, the visibility of which has been hampered due to shops/ establishments on all corners of the junction
- No road markings or warning signs to warn/ inform the road user of the built up nature of the area ahead
- No speed limit signs provided
- The shared usage of road space by the different modes of vehicle puts at risk the safety of vulnerable road users.

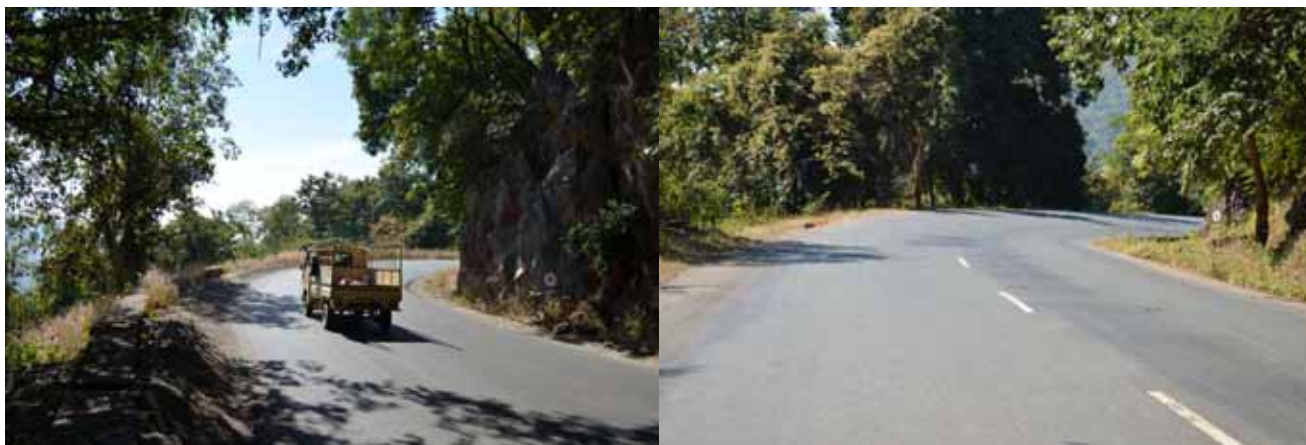
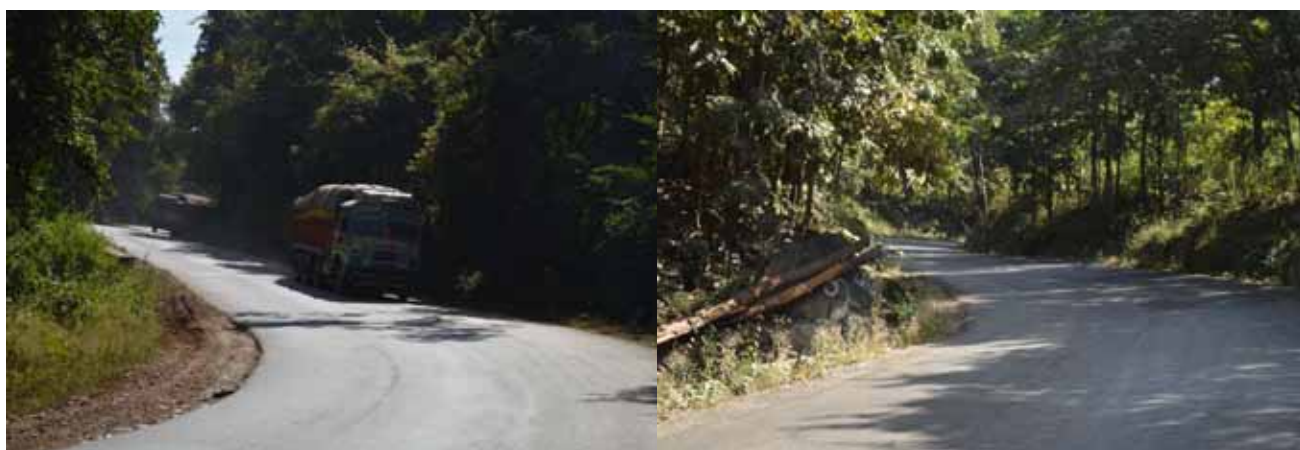
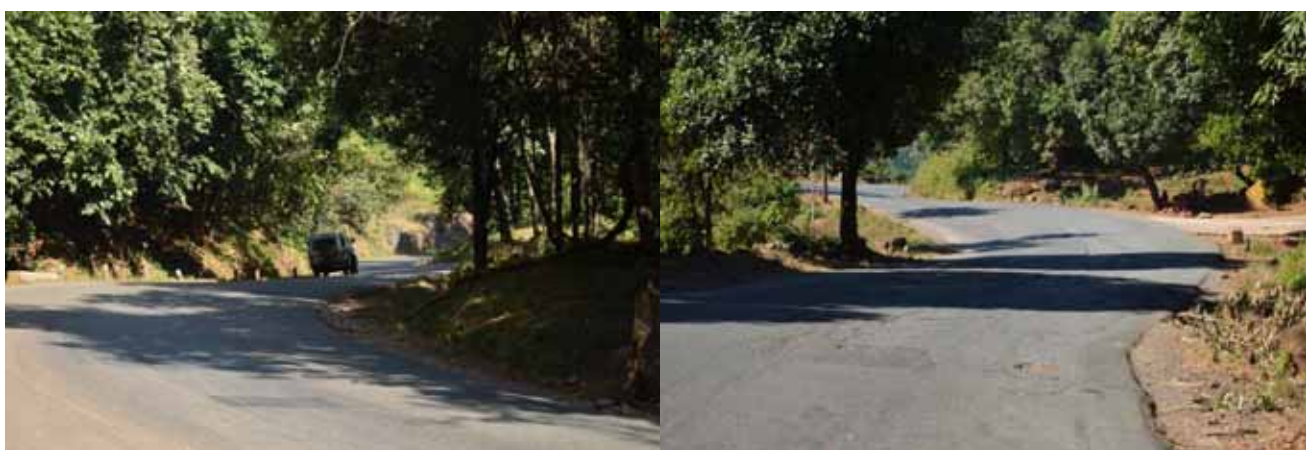
Reasons for concern (1): No warning signs/ delineation to inform the road user to make him/her slow down to negotiate the curve in a safe speed, which may lead to

| Reasons for concern (3): | On outer edge of some of these curves, Concrete Guard Posts (CGP) are provided to protect the errant vehicles. As per international standards and practices, any concrete structure which is near the edge of road and larger by 10cm X 10cm in cross section is hazardous to the traffic. |

| Recommendations: | Provide curve warning signs, chevron signs, delineators and speed limit sign as appropriate <i>Refer to Appendix III for guidelines on treatment on curves.</i> |
| Recommendations: | <ul style="list-style-type: none">• Improve the line of sight by removing trees from the shoulder and cut down vegetation which hampers visibility along the curves |
| Recommendations: | For delineation, at all these sharp curves provide chevron signs. |
| Recommendations: | Provide crash barriers on the outer edge on such curves. |
| Recommendations: | <ul style="list-style-type: none">• Provide Crash Barrier on the outer side of curves• Warning sign before the curve and traffic calming on down gradient• Proper chevron signs• 'No overtaking' sign board |

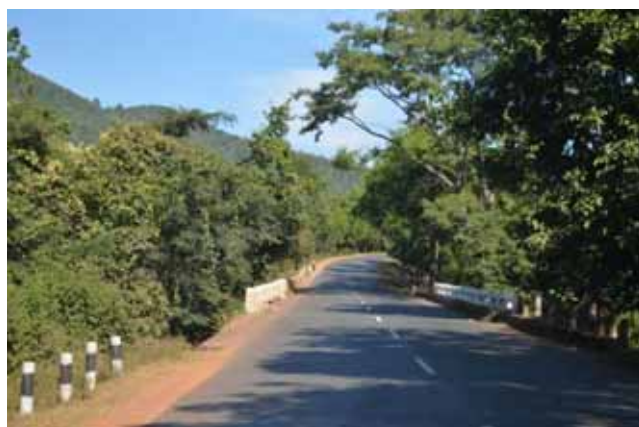
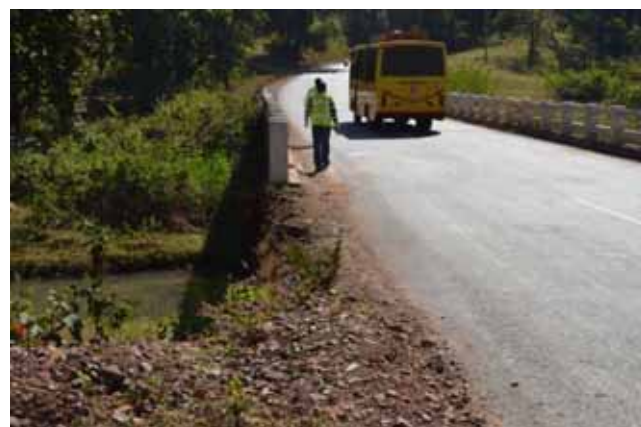
Approach to bridge is found to be highly hazardous in the following locations;

Absence of OHM and absence of approach protection at Km 461+800 and Km 470+250

Recommendations: Provide crash barriers on either approaches of the structures with delineators

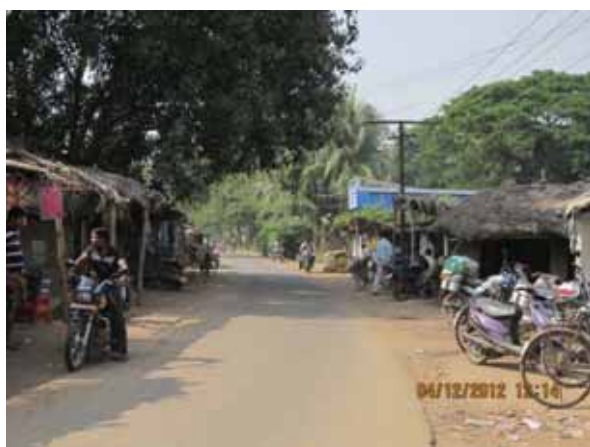
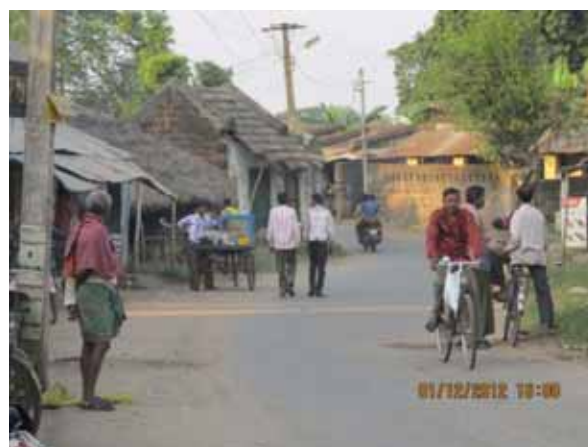
Road side villages and built up areas are found on following locations.

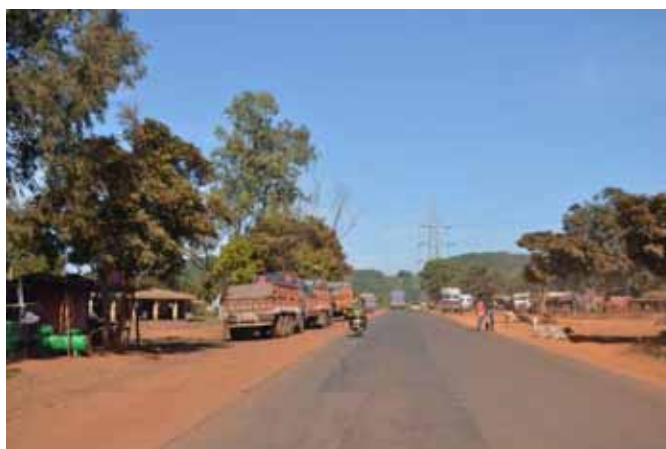
At chainage 473+000 truck resting area is present which is used by trucks before entering into Ghat section and after coming from Ghat section in the opposite direction.

Reasons for concern: Absence of proper entry/exit is created for trucks in resting areas which can lead to collision between vehicles moving on NH and vehicles leaving/entering the resting area.

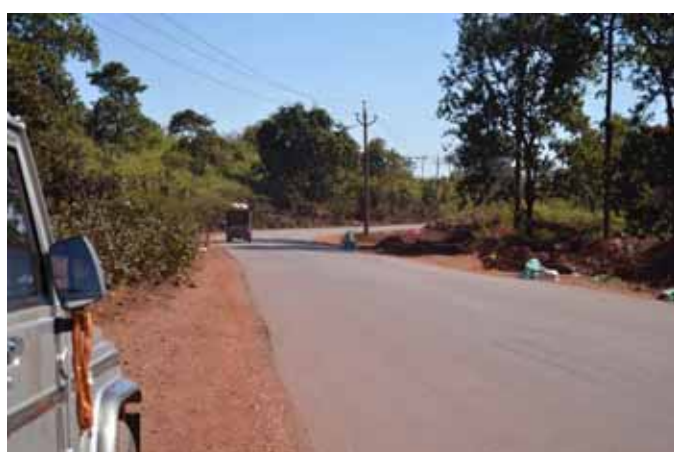
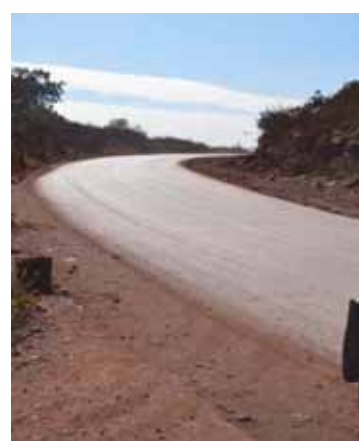
- Reasons for concern:** No warning signs/ delineation to inform the road user to make him/her slow down to negotiate the curve in a safe speed
- Potential run-off accidents

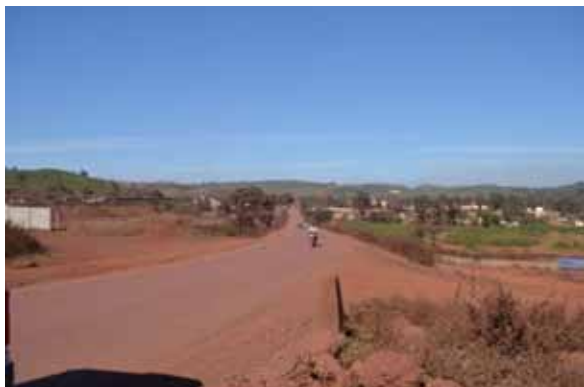
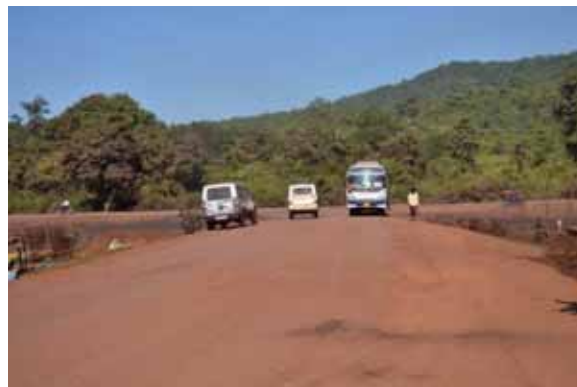
Location of Side roads at skew with the major road

| 1+550 | 2+100 | 17+300 |

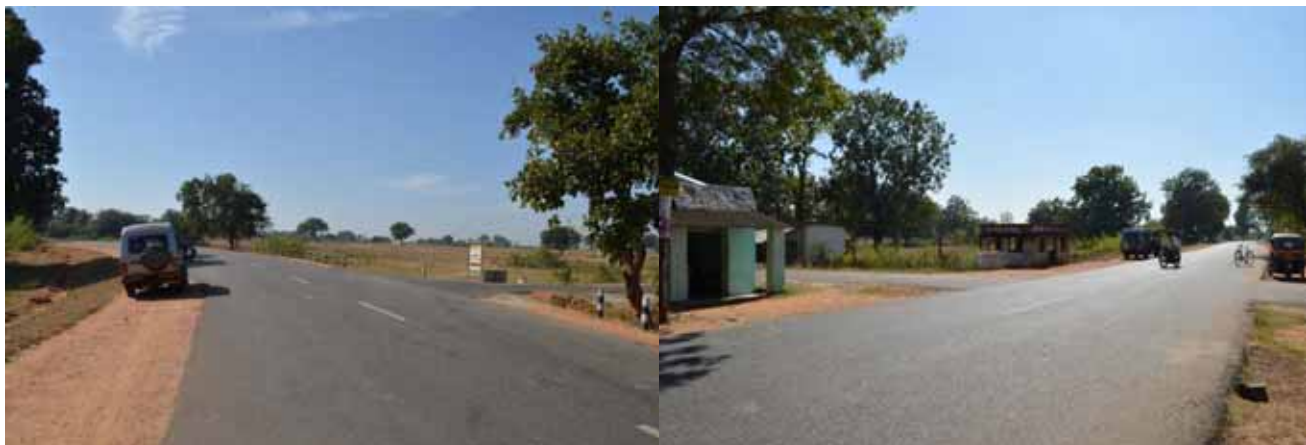
Minor Junctions at Km 66+950 and at Km 76+800

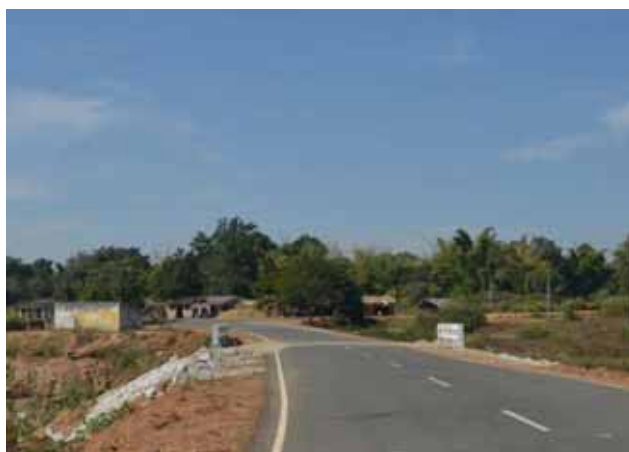
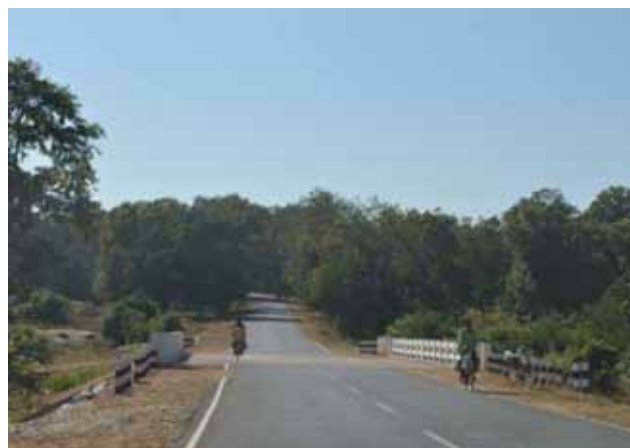
Absence of OHM on structure at Km 76+000 and Km 94+600

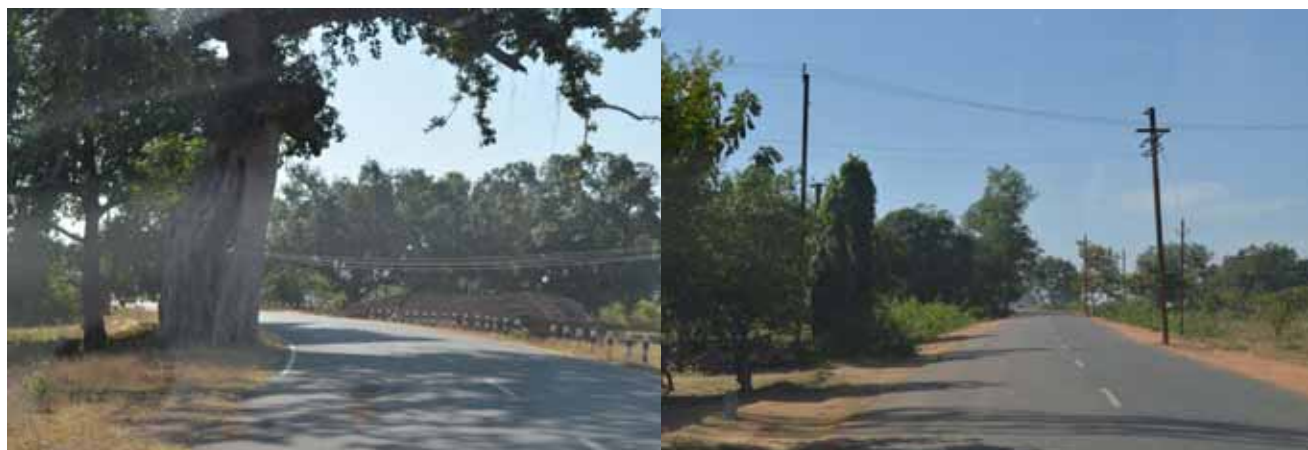
At several locations on the project road, many trees and/or street light poles are found,

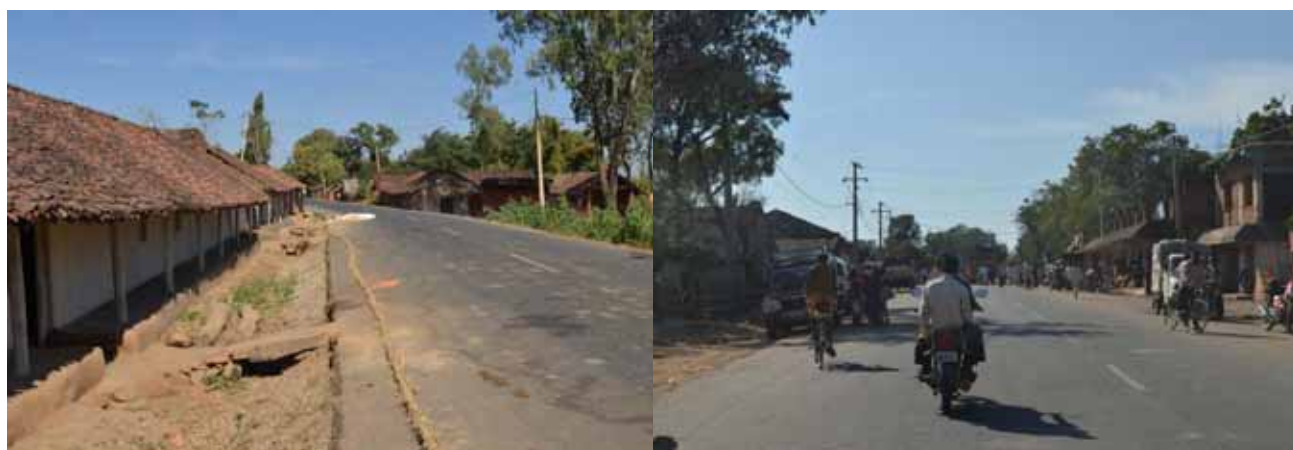
Village Barbil at 72+500 and Town Dhenkikote (99+000)

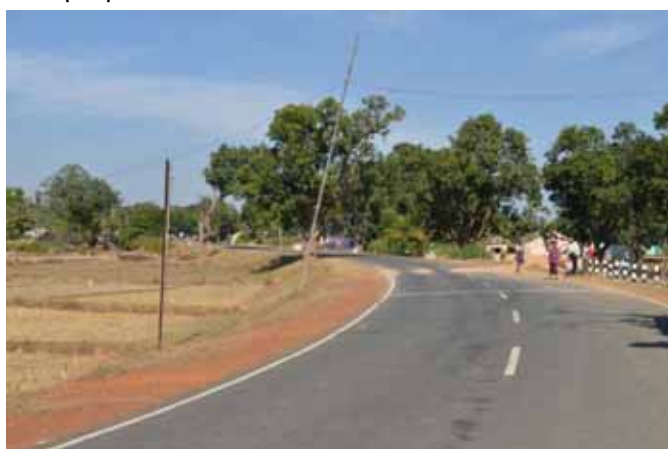
- Location 87+200 have some past accident record history.
- A curve is present with good visibility
- Super elevation is not proper

| Reasons for concern: | Profile Correction On curve proper super elevation is not provided thus vehicles negotiating curve have chance to run off |

| Recommendations: | Correct the profile of the curve by providing the designed super elevation. |

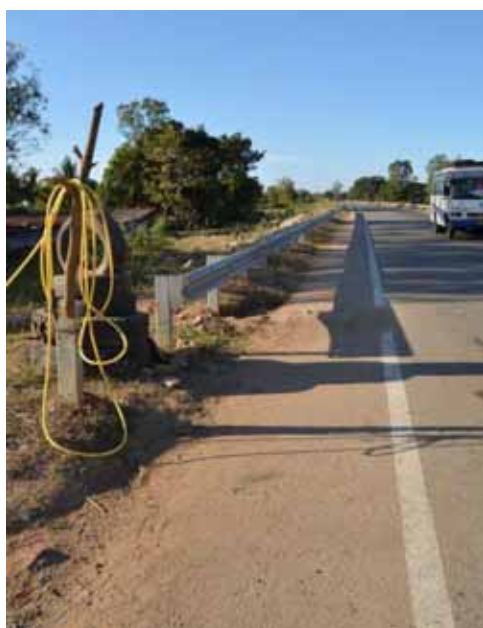
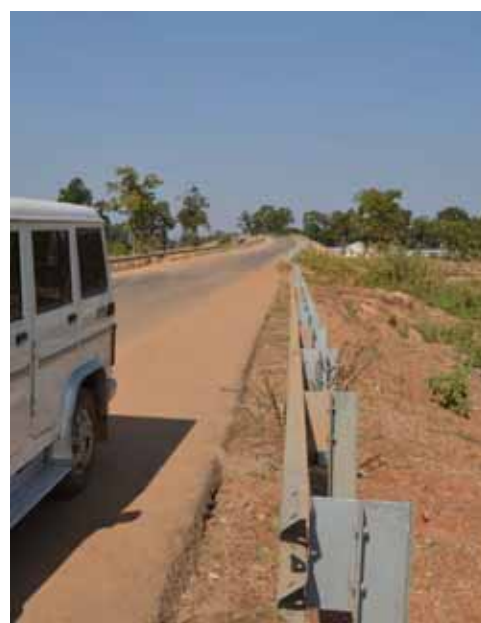
Crash Barrier very near to pavement edge

| Recommendations: | Provide crash barrier after earthen shoulder. |

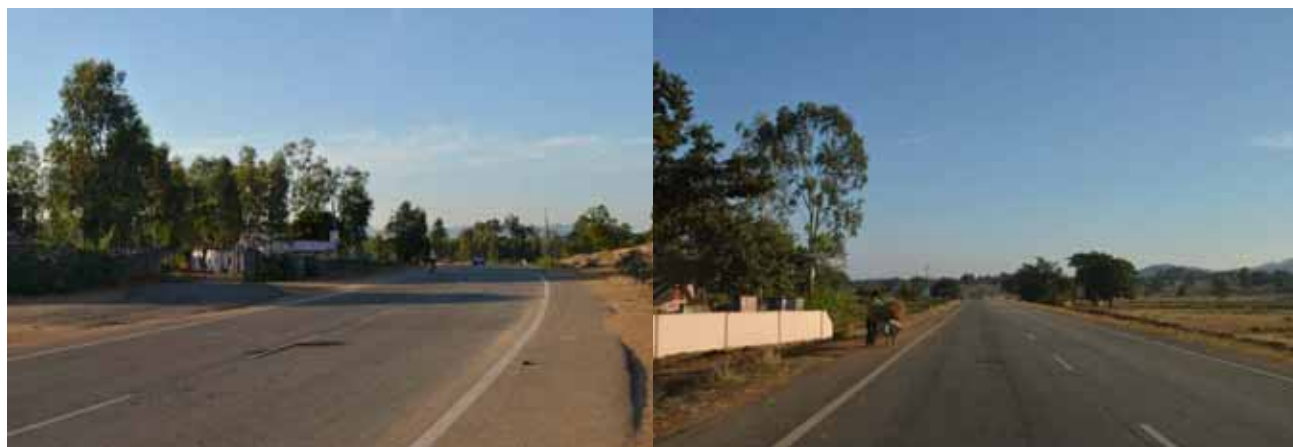
13+750 (Babdrapur)

- In villages/town wherever schools are present, warning sign “School Ahead” and “Slow” are not provided on either approaches.
- Significant pedestrians/school children, cyclists, motorcycles are present

- No traffic calming measures are provided to slow down vehicles approaching at high speeds to the built up area
- Significant pedestrians including school children are noted, but no separate pedestrian facilities are provided along the road inside the BUA or to cross the road
- On road bus stops which hampers visibility and encourage dangerous overtaking
- No road markings or warning signs to warn/ inform the road user of the built up nature of the area ahead
- No speed limit signs provided
- On street parking hampers the visibility and resulting in unsafe situations

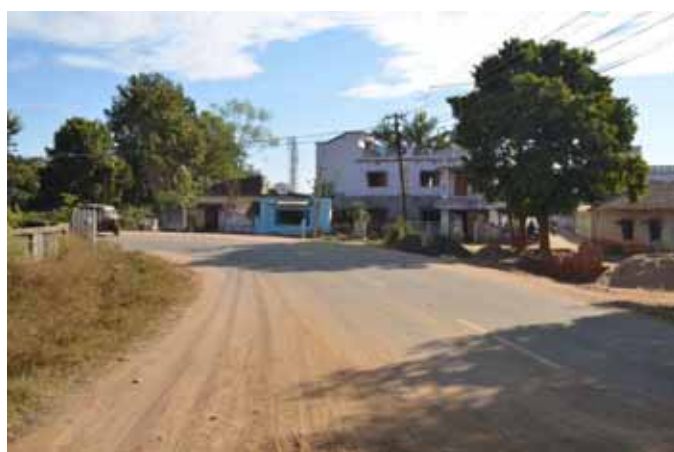
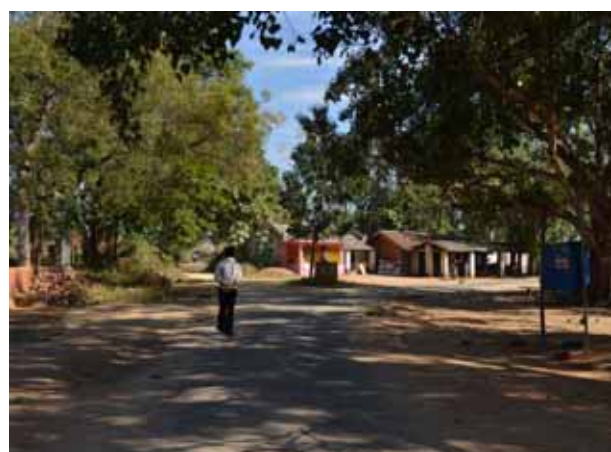
Sharp Curves on Project Road at Km 2+650 and Km 12+100

Recommendations: Provide **curve warning signs, chevron signs and delineators** as appropriate

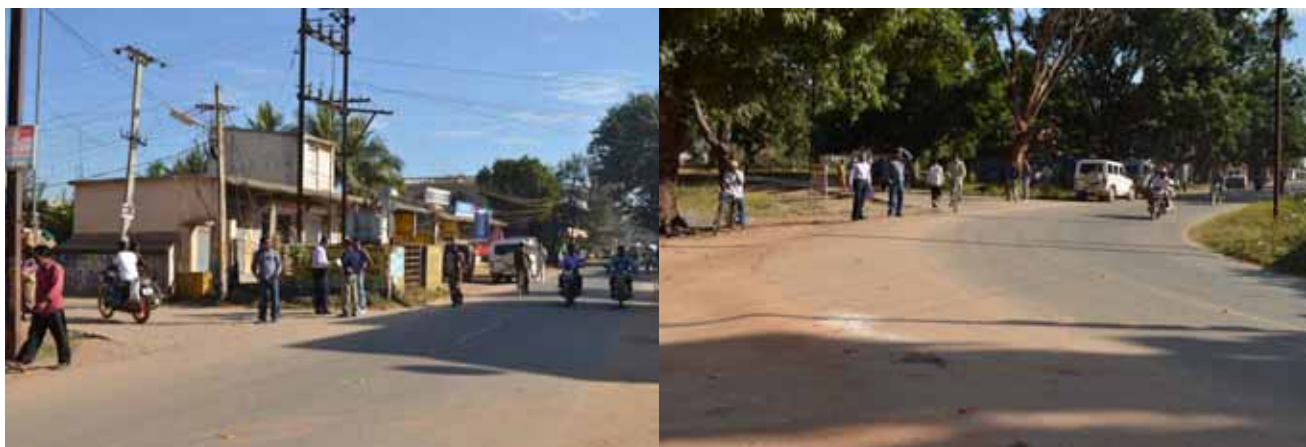
Minor Junctions at Km 0+700 and at 1+670

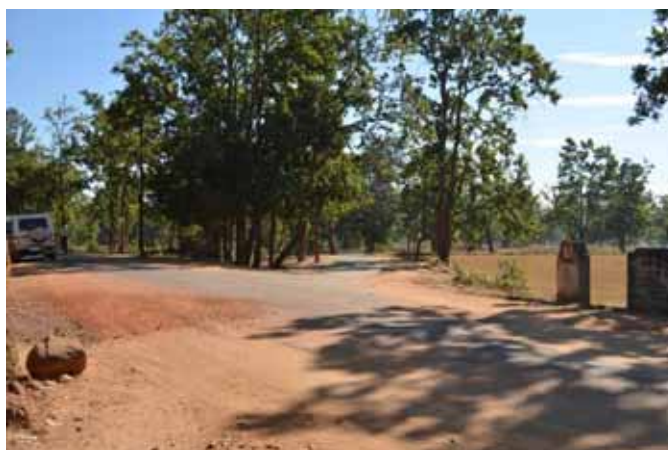
Skewed Side Road

| Reasons for concern: | Poor Geometry It has been observed that on few junctions, the level difference between the side road and major road and the vertical profile of the side road joins the edge of main carriageway in an unsafe manner. |

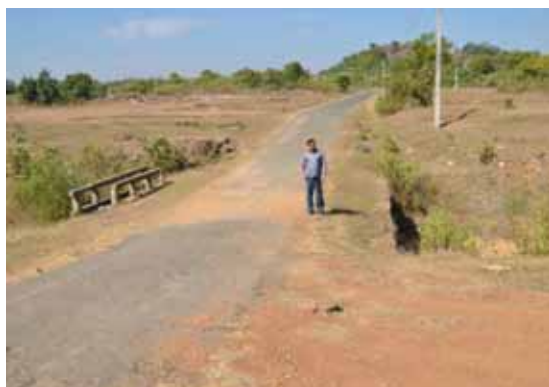
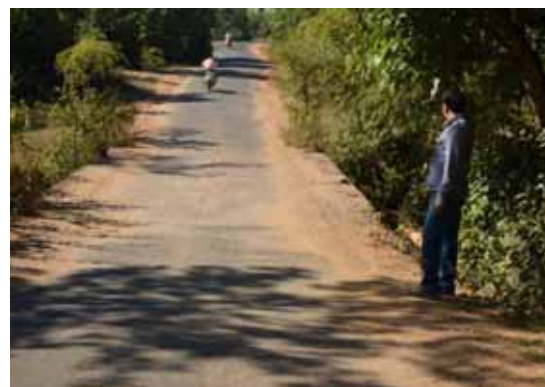
Absence of protection and OHM on structure at Km 7+400 and Km 10+300

Recommendations: Provide continuous parapets on all culverts and bridges.

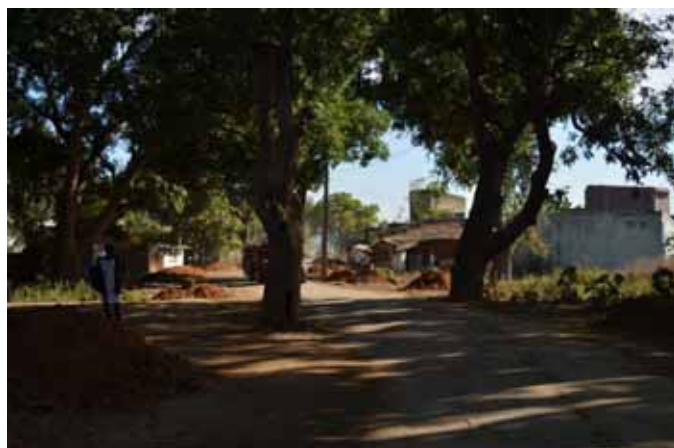
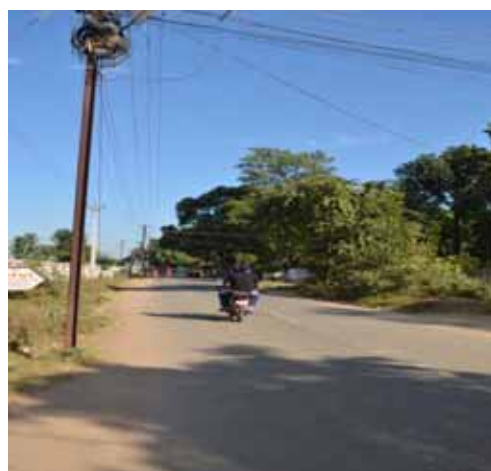
Several trees and street pole near pavement edge

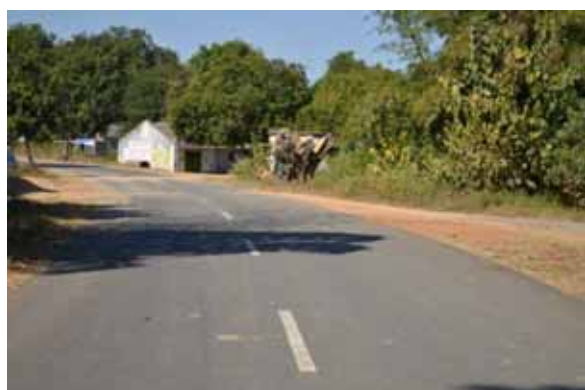
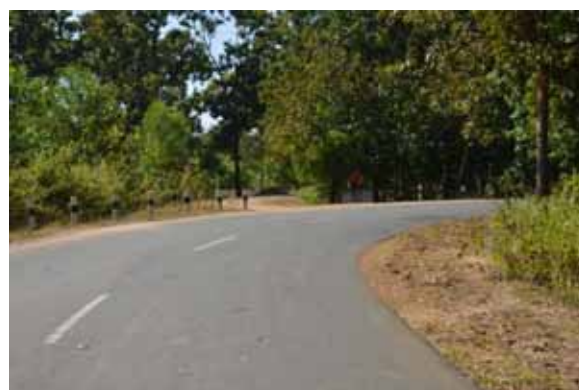
Sharp Curves on Project Road at Km 41+400 and Km 45+800

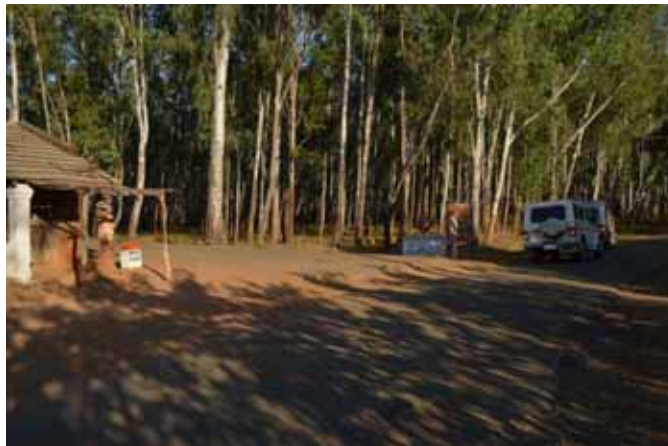
Minor Junctions at Km 63+400

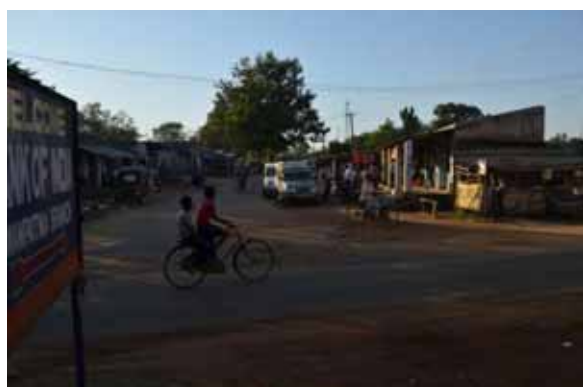
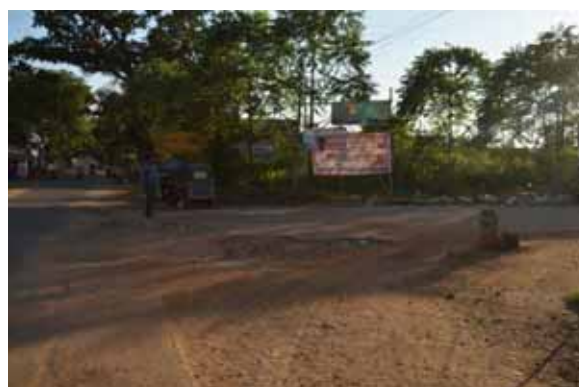
- This junction is intersection of ODR and SH
- Significant two wheelers, pedestrians, cyclists are present on the junction.
- No traffic islands are present for safe and effective maneuver of traffic.
- Street light is not present on the junction.

| Reasons for concern: | <p>Poor Junction layout</p> <p>The junction layout is non-standard and has no control over the traffic movement. It is confusing who has priority in such a situation. This encourages lawless traffic movement and is hazardous. The existing central island is non-standard and hampers visibility at the junction.</p> |
