**Government of Odisha (GOO)
Chief Engineer, World Bank Projects, Odisha
Odisha State Roads Project**

**Consultancy Services for
Road Sector Institutional Development
Loan # 7577-IN**

**ROAD INFRASTRUCTURE
SAFETY MANAGEMENT REVIEW**

VOLUME I - REPORT

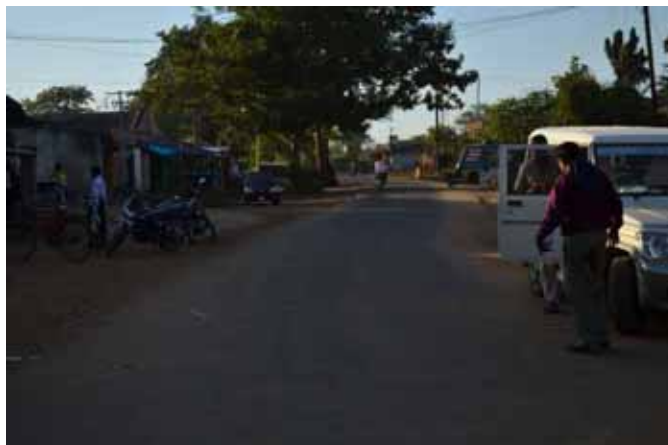
- In villages/town wherever schools are present, warning sign “School Ahead” and “Slow” are not provided on either approaches.
- Significant pedestrians/school children, cyclists, motorcycles are present.

Built up area at Km 67+000

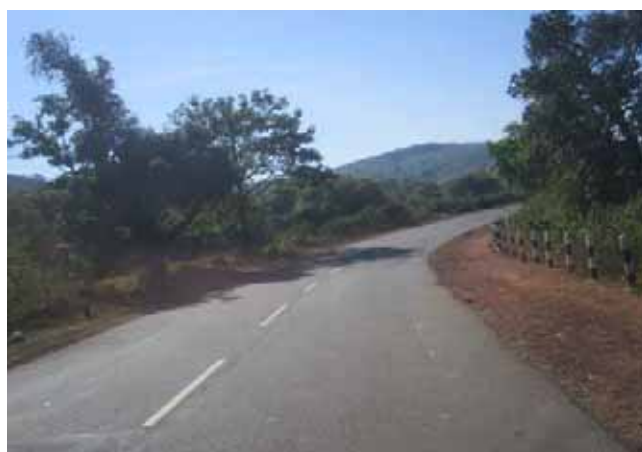
Ch: 392+700

Horizontal curves of radius less than 100m were observed at Km.380+400; 382+100; 382+350; 382+750; 382+900; 383+080; 388+320; 388+700; 389+250; 391+400; 392+700; 393+850; 397+100; 397+500; 398+900; 399+200; 399+700; 403+600.

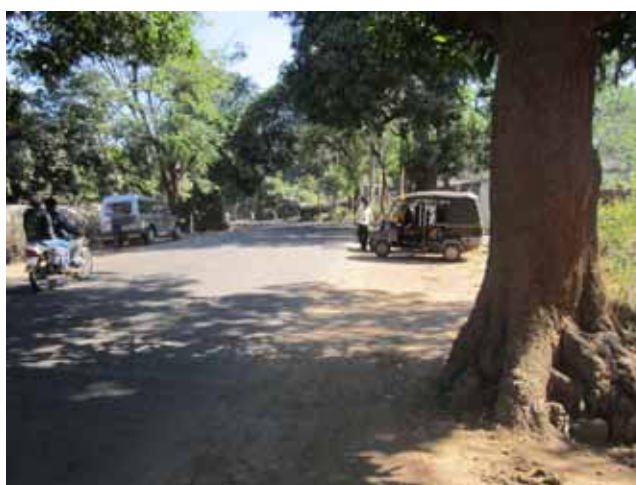
Ch: 383+500

At Chainage 383+500 horizontal bend after a vertical crest is found.

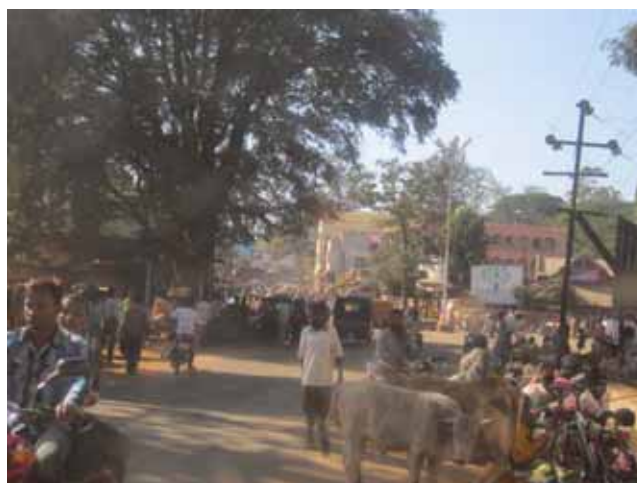
Ch: 401+100

A major junction at chainage 401+100 is found.

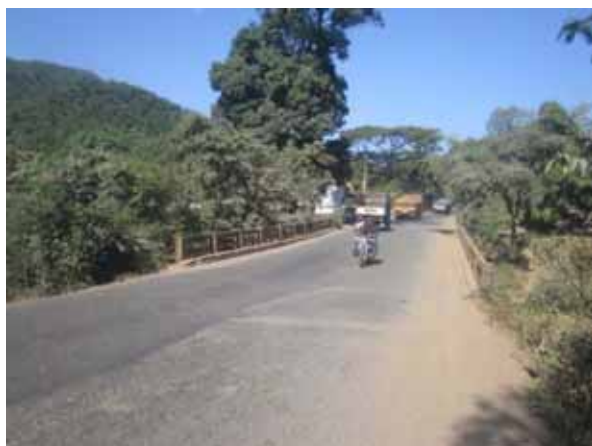
Ch: 383+500

- 383+500
- 389+600

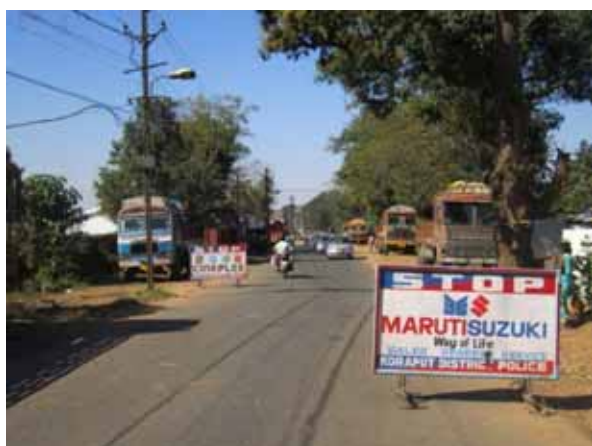
Ch: 381+500

- No traffic calming measures are provided to slow down vehicles approaching at high speeds to the built up area
- Significant pedestrians including school children are noted, but no separate pedestrian facilities are provided along the road inside the BUA or to cross the road
- Significant number of access roads within the BUA, the visibility of which has been hampered due to shops/ establishments on all corners of the

- On road bus stops which hampers visibility and encourage dangerous overtaking
- No road markings or warning signs to warn/ inform the road user of the built up nature of the area ahead
- No speed limit signs provided
- On street parking hampers the visibility and resulting in unsafe situations

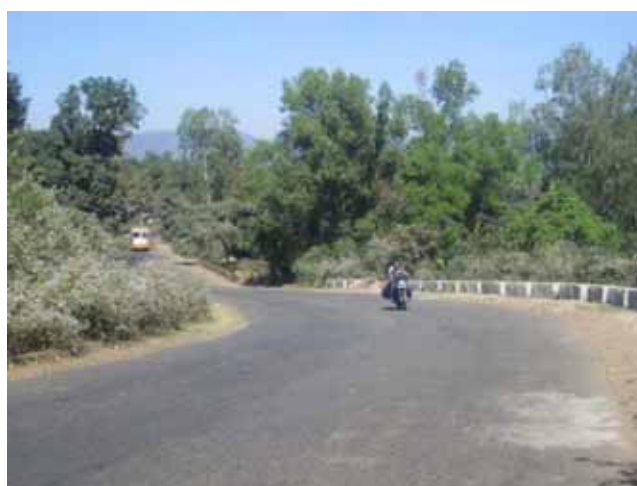
Ch: 384+500

At chainage 384+500 vertical Sag curve is found.

negotiate for an errant vehicle and lead to unsafe condition.

Recommendations The provision of retro – reflective guard posts along the entire sag curve with provisions of advanced warning signs and pavement markings to delineate the center and edge line of the road.

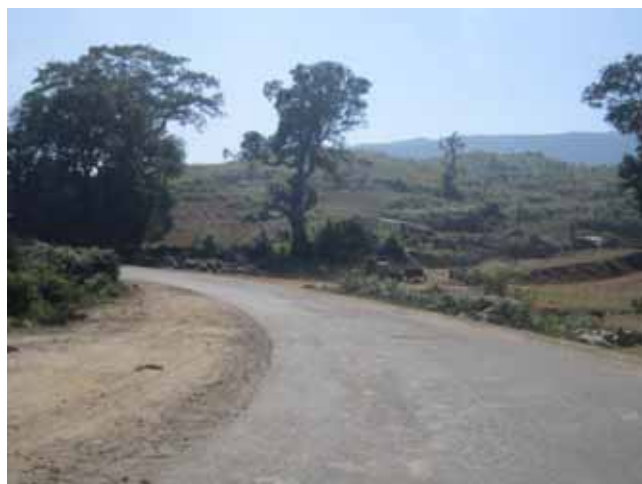
Ch:457+000

Horizontal curves of radius less than 100m were observed at significant number of location along the project road.

| Reasons for concern: | Curves on high embankment without safety barriers noted <ul style="list-style-type: none"> • Run-off accidents on high embankments will lead to fatalities |

| Recommendations: | Provide curve warning signs, chevron signs, delineators and speed limit sign as appropriate <i>Refer to Appendix III for guidelines on treatment of curves.</i> |
| Recommendations: | <ul style="list-style-type: none"> • Improve the line of sight by removing trees from the shoulder and cut down vegetation which hampers visibility along the curves |
| Recommendations: | Provide metal beam crash barrier with delineators on sharp curves in high embankment <i>Refer to Appendix III for guidelines on situations where to install the above</i> |

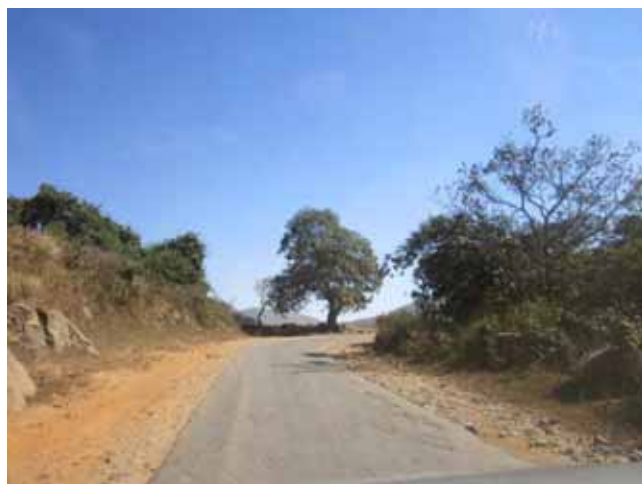
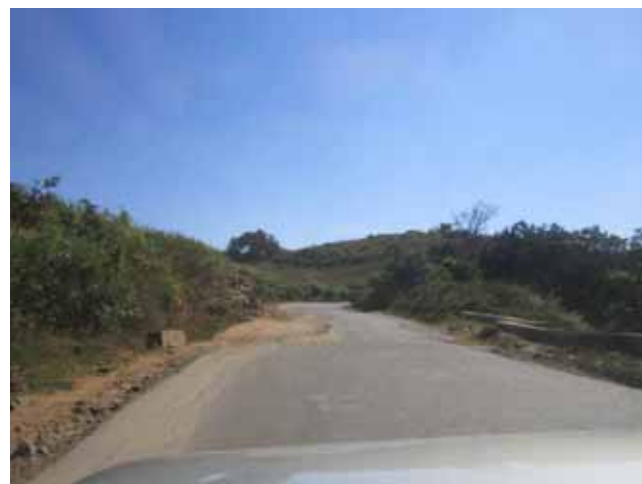
Ch: 453+000 - 454+000

In the existing situation, there are many instances of horizontal bends after a vertical crest at 453+000 – 454+000 (4).

The sight distance on a vertical crest is limited in day light and even less in night time. The presence of a horizontal bend after a vertical crest decreases the sight distance available further for the driver to react and could be a potential unsafe location. The vertical deflection of the alignment prevents the road user from being prepared to maneuver required to negotiate the curve and could lead to run off accidents.

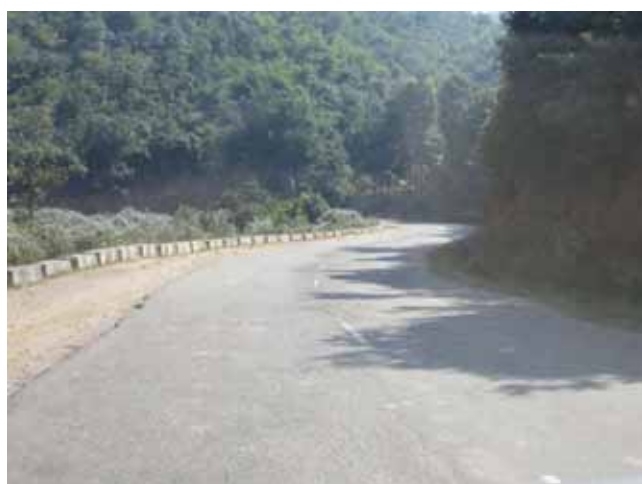
In the existing situation, there are two reverse curves along the road at Chainages, Ch: 433+500 & 452+000.

| Recommendations | The provision of guard posts along the points of maximum curvature of the two curves. |

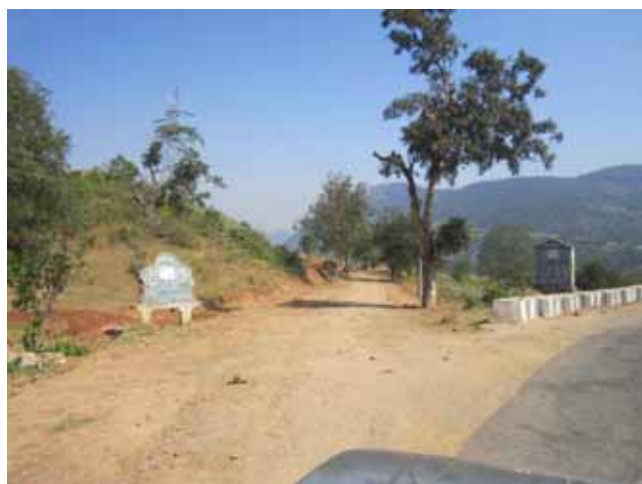
Ch: 462+000

| Reasons for concern: | Inadequate Visibility This is a major hazard observed on most of the 3-armed uncontrolled junctions. The major reasons for poor visibility at junctions on this road are due to |

- No traffic signs or road markings are observed on any of such junctions, the presence of which would have informed and warned the road user of the layout ahead.

- High approach speeds were observed by traffic turning from side roads into the main carriageway and no traffic calming measures/warning is provided on the side road.

It has been observed that on few junctions, the level difference between the side road and major road and the vertical profile of the side road joins the edge of main carriageway in an unsafe manner.

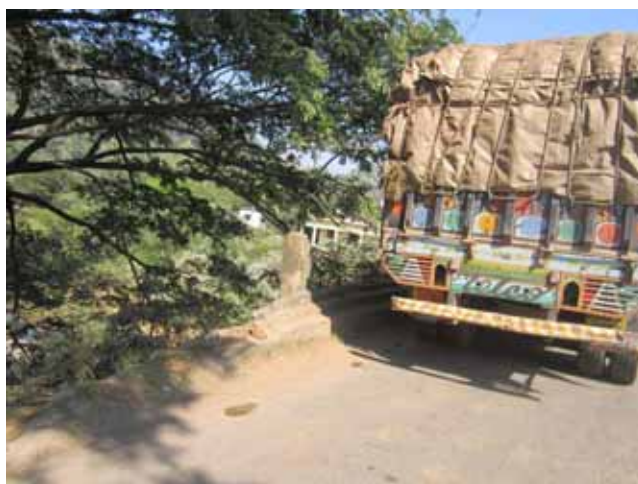
Ch:466+500

In the existing situation, there is only one approach to bridge / culvert at Ch: 466+500, which is unsafe.

| Recommendations: | Provide crash barriers on either approaches of the structures with delineators <i>Refer to Appendix III for guidelines to treatments on approaches to bridges</i> |

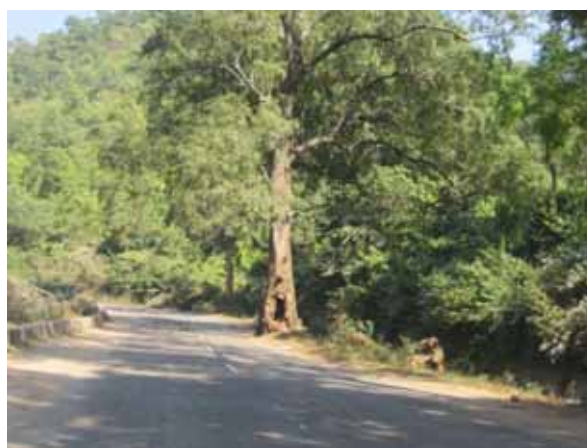
Road side objects like electricity poles, pool, trees are found at significant number of location on the project road.

| Reasons for concern: | Roadside objects constitute a significant hazard, if the driver loses control and will result in major injuries/ fatalities |

| Recommendations: | Desirable: <ul style="list-style-type: none">• Remove Trees/ street lighting poles from the road shoulders• Provide crash barriers on locations where trees acts as a significant hazard and where the space is available to install crash barrier |

- Delineate the hazards by installing OHMs or painting of the trees in black and white strips
- Remove encroachments on at least 2m from the road edge

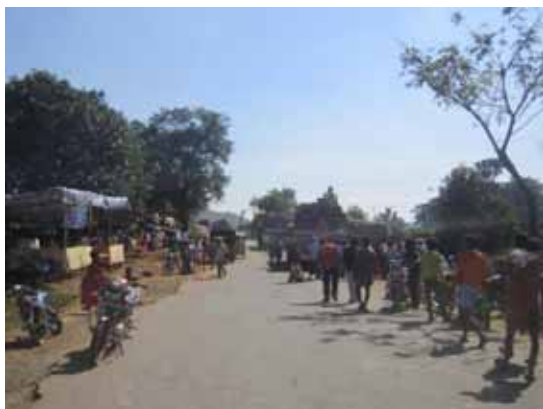
Ch: 455+400

- No traffic calming measures are provided to slow down vehicles approaching at high speeds to the built up area
- Significant pedestrians including school children are noted, but no separate pedestrian facilities are provided along the road inside the BUA or to cross the road
- No road markings or warning signs to warn/ inform the road user of the built up nature of the area ahead
- No speed limit signs provided
- On street parking hampers the visibility and resulting in unsafe situations
- On street bus stops observed, which hampers visibility and unsafe overtaking maneuvers.

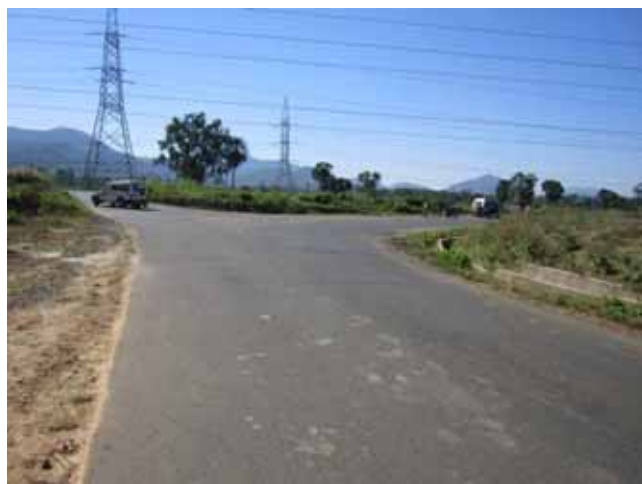
Ch: 2+160

Horizontal curves of radius less than 250m were observed at Km. 2+160; 3+700; 5+700; 6+600; 7+700; 8+400; 8+900; 9+600; 11+000; 11+390; 12+200

| Reasons for concern: | Curves on high embankment without safety barriers noted <ul style="list-style-type: none"> • Run-off accidents on high embankments will lead to fatalities |

| Recommendations: | Provide curve warning signs, chevron signs, delineators and speed limit sign as appropriate <i>Refer to Appendix III for guidelines on treatment of curves.</i> |
| Recommendations: | <ul style="list-style-type: none"> • Improve the line of sight by removing trees from the shoulder and cut down vegetation which hampers visibility along the curves |
| Recommendations: | Provide metal beam crash barrier with delineators on sharp curves in high embankment <i>Refer to Appendix III for guidelines on situations where to install the above</i> |

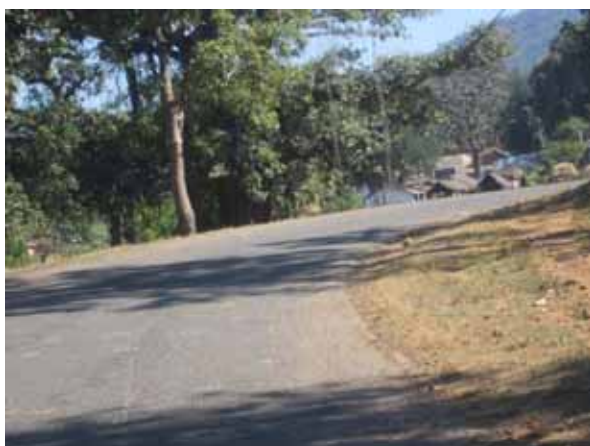
Ch: 10+000

The sight distance on a vertical crest is limited in day light and even less in night time. The presence of a horizontal bend after a vertical crest decreases the sight distance available further for the driver to react and could be a potential unsafe location. The vertical deflection of the alignment prevents the road user from being prepared to maneuver required to negotiate the curve and could lead to run off accidents.

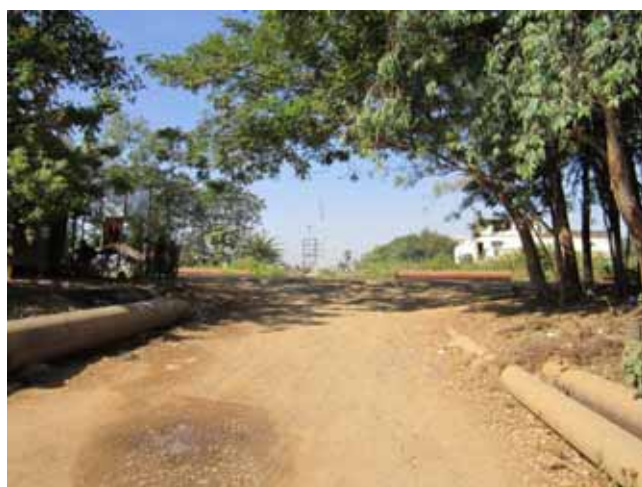
Ch: 1+300

Inadequate Visibility

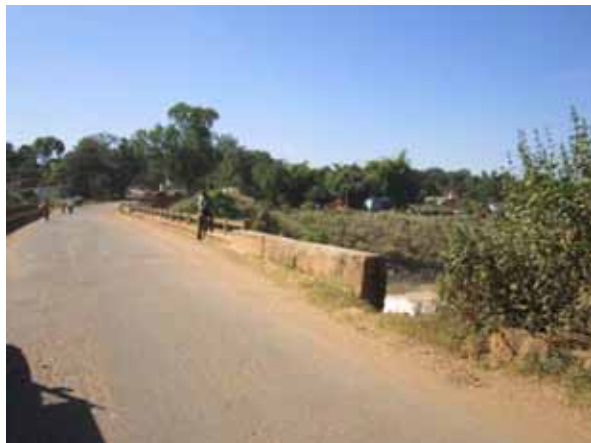
Ch: 4+700

The unprotected bridge approaches of two minor bridges present along the road at the chainages shown below:

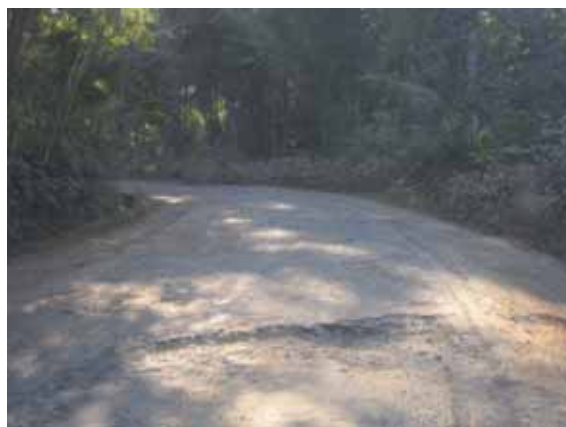
Ch: 41+700

Horizontal curves of radius less than 150m were observed at significant number of location along the road.

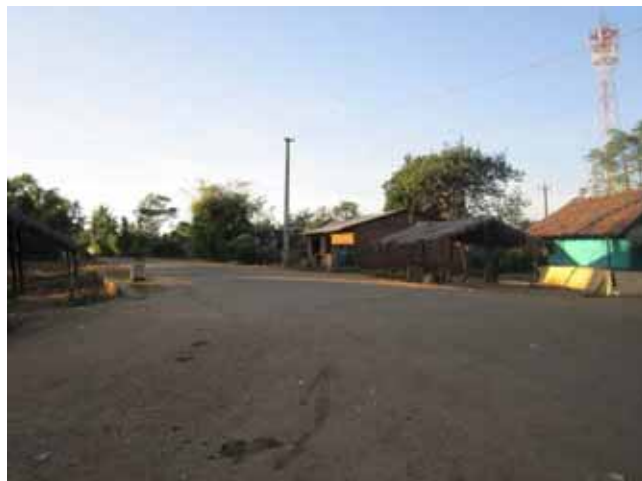
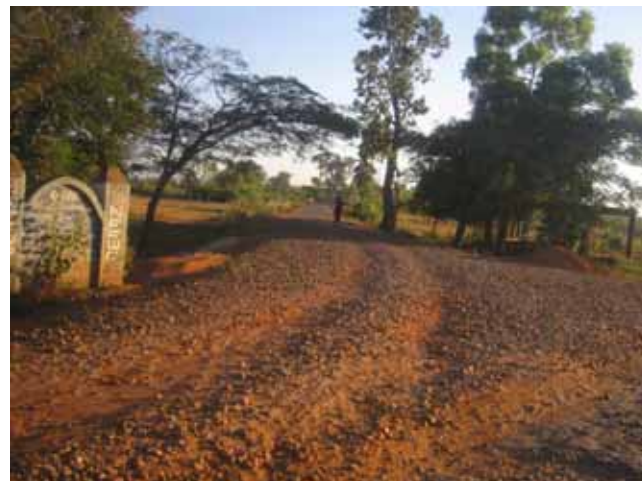
Location of Side roads at skew with the major road

Inadequate Visibility

This is a major hazard observed on most of the 3-armed uncontrolled junctions. The major reasons for poor visibility at junctions on this road are due to

- No traffic signs or road markings are observed on any of such junctions, the presence of which would have informed and warned the road user of the layout ahead.

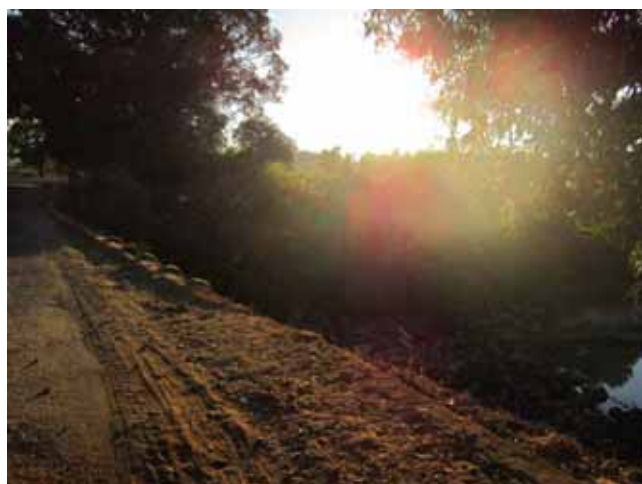
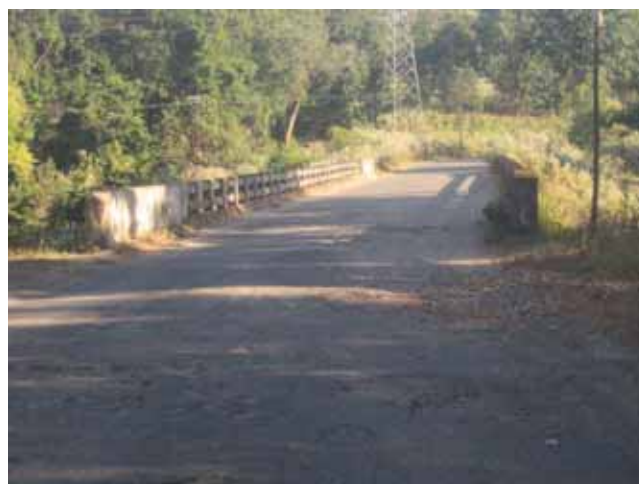
The unprotected bridge approaches of two minor bridges present along the road at the chainages shown below:

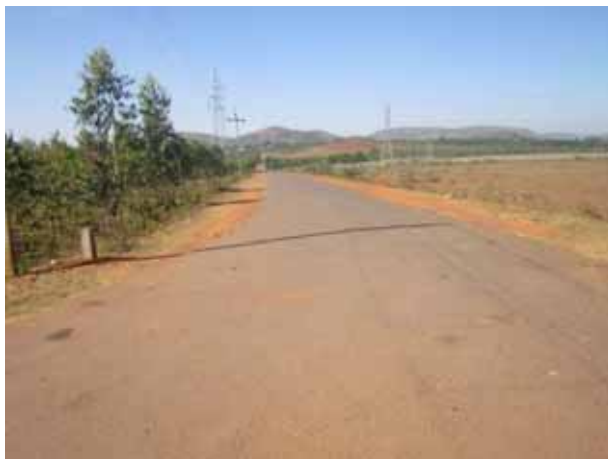
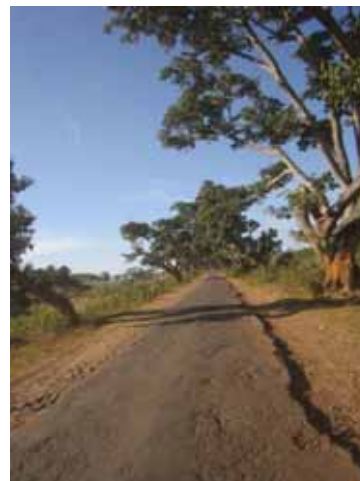
8.5.2.1. Delineation of the road

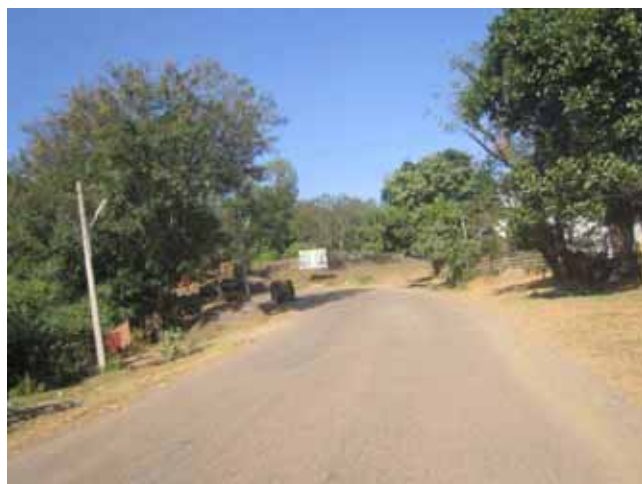
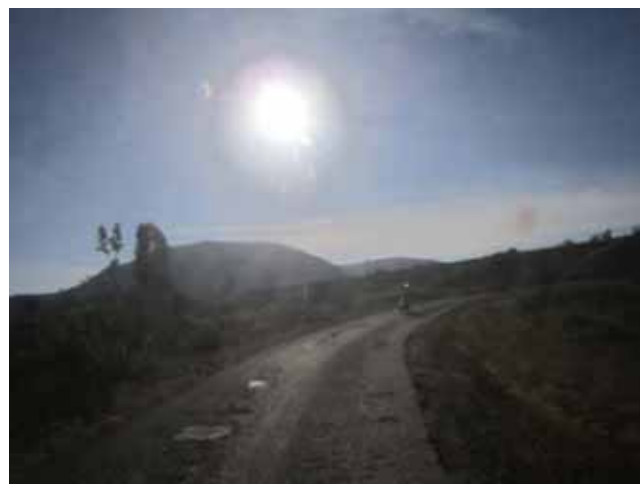
8.5.2.2. Alignment – Sharp Horizontal Curves

Horizontal curves of radius less than 100m were observed at Km. 0+650; 1+500; 1+850; 2+800; 3+400; 3+600; 4+100; 4+300; 5+580; 6+600; 7+140; 7+880; 8+100; 8+260; 9+020; 9+500; 10+250; 11+920; 12+200; 16+250; 16+800; 20+600; 21+700; 22+900; 23+300; 23+500; 23+950; 24+600; 24+900; 25+100; 25+500; 25+800; 27+500; 28+300; 28+650; 28+750; 30+100; 30+850+ 31+250; 31+450; 32+300; 36+850; 37+150; 38+800; 42+400; 44+300; 44+550; 44+900;

Reasons for concern: Curves on high embankment without safety barriers noted

Recommendations: Provide **curve warning signs, chevron signs and delineators** as appropriate
Refer to Appendix III for guidelines on treatment at curves.

Recommendations: Provide metal beam crash barrier with delineators on sharp curves in high embankment

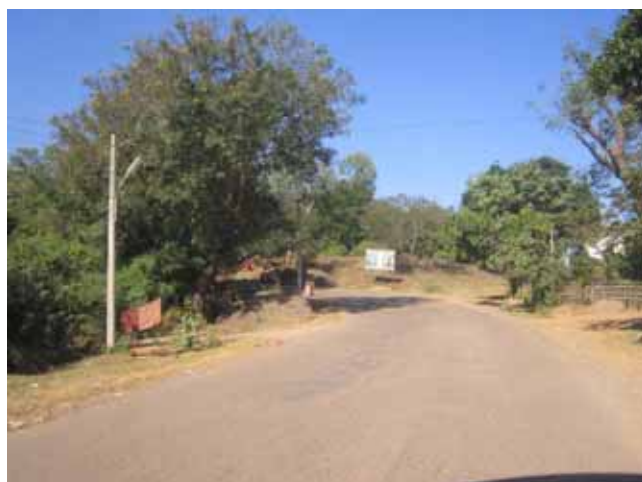
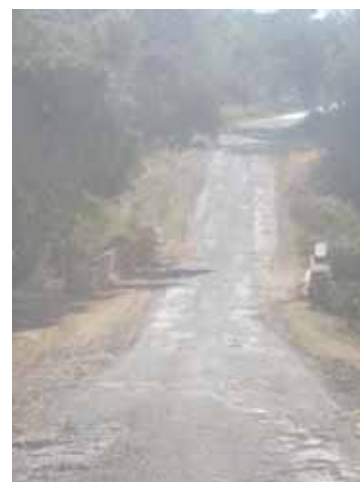
The following are the chainages of the instances of the horizontal bend after a vertical crest:

The sight distance on a vertical crest is limited in day light and even less in night time. The presence of a horizontal bend after a vertical crest decreases the sight distance available further for the driver to react and could be a potential unsafe location. The vertical deflection of the alignment prevents the road user from being prepared to maneuver required to negotiate the curve and could lead to run off accidents.

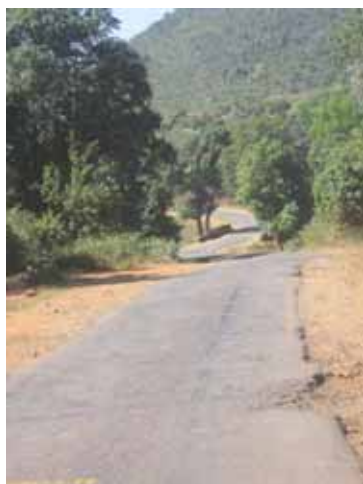
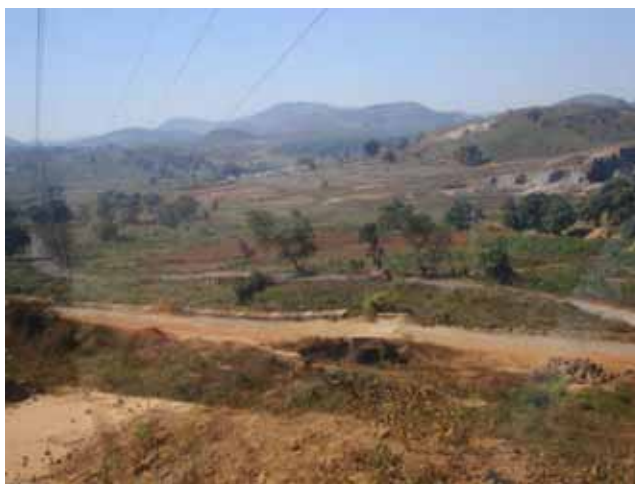
Reverse curve is found at following locations:

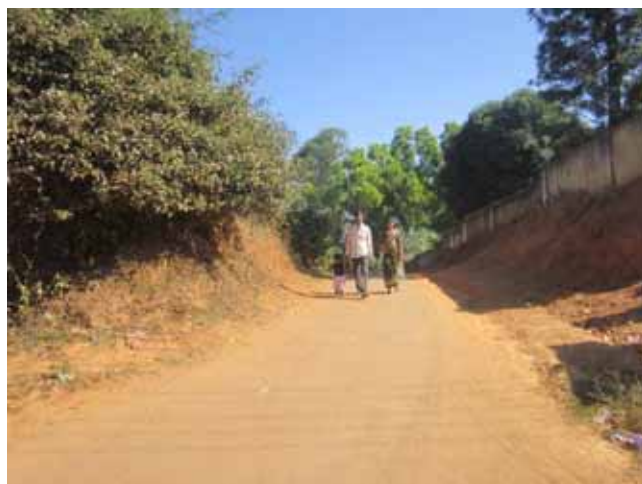
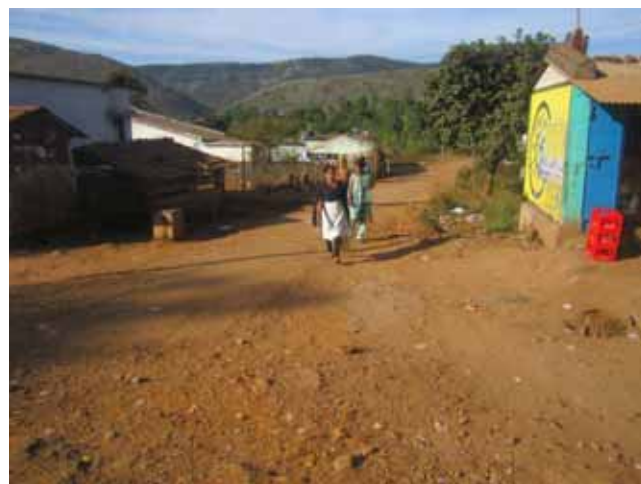
Location of Side roads at skew with the major road

Inadequate Visibility

This is a major hazard observed on most of the 3-armed uncontrolled junctions. The major reasons for poor visibility at junctions on this road are due to

- No traffic signs or road markings are observed on any of such junctions, the presence of which would have informed and warned the road user of the layout ahead.

It has been observed that on few junctions, the level difference between the side road and major road and the vertical profile of the side road joins the edge of main carriageway in an unsafe manner.

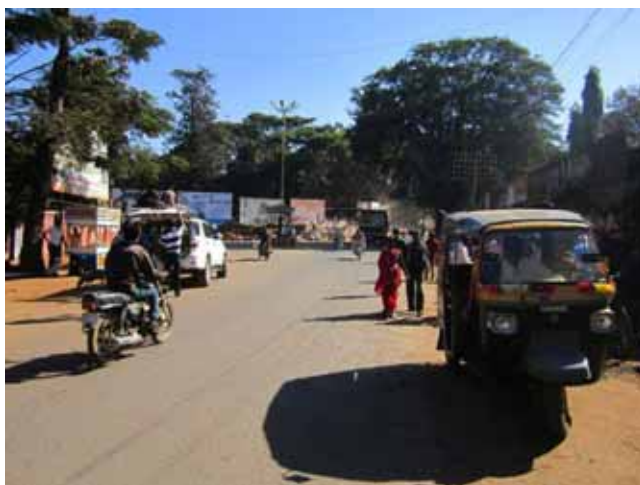
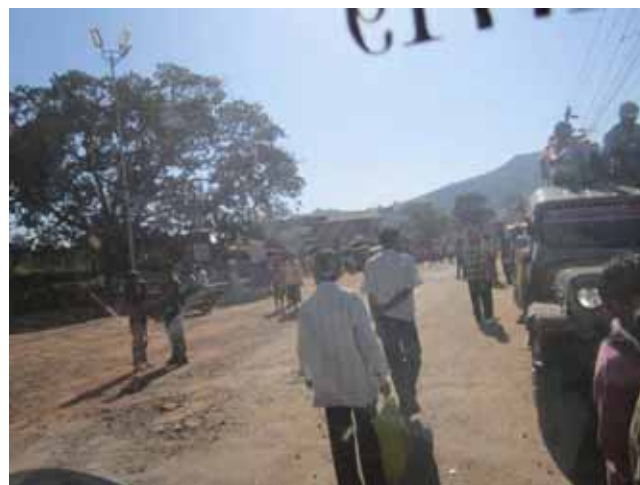
In the existing situation, there are two major junctions along this road at the following Chainages,

- The junction layout is non-standard and has no control over the traffic movement. It is confusing who has priority in such a situation. This encourages lawless traffic movement and is hazardous. The existing central island is non-standard and hampers visibility at the junction.

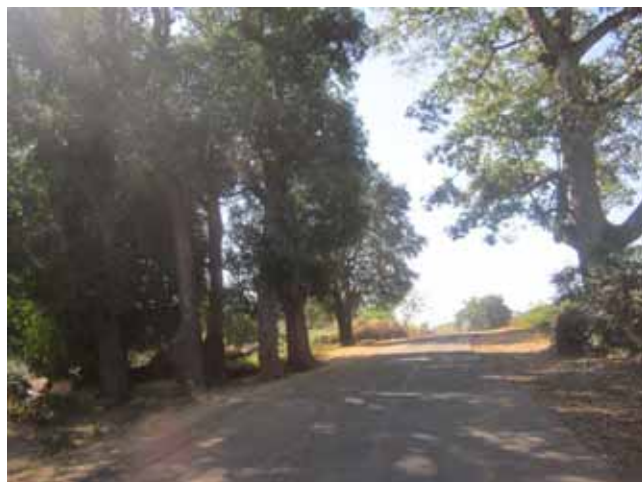
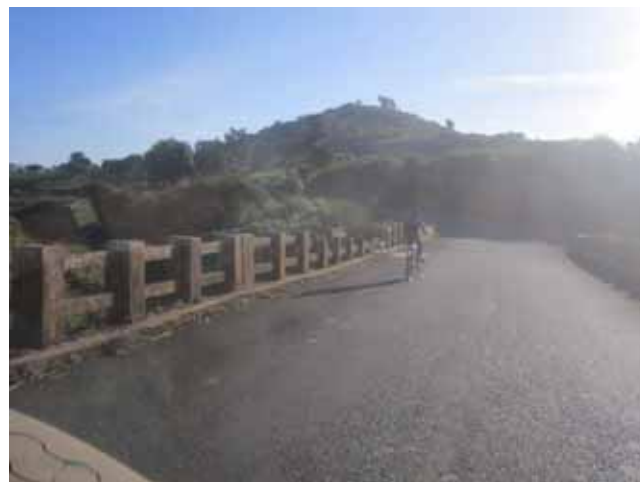
8.5.2.8. Roadside Hazards - Trees, Poles, and Buildings

Along the road there are many road size hazards like trees and street light poles were present.

| Reasons for concern: | Roadside objects constitute a significant hazard, if the driver loses control and will result in major injuries/ fatalities |

- Remove Trees/ street lighting poles from the road shoulders
- Provide crash barriers on locations where trees acts as a significant hazard and where the space is available to install crash barrier

- Delineate the hazards by installing OHMs or painting of the trees in black and white strips
- Remove encroachments on at least 2m from the road edge

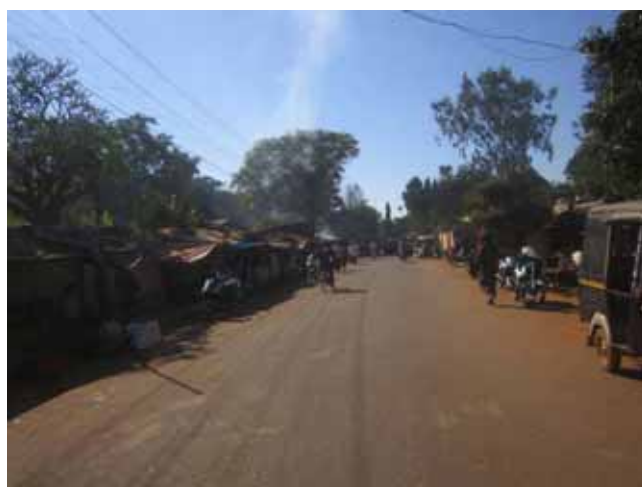
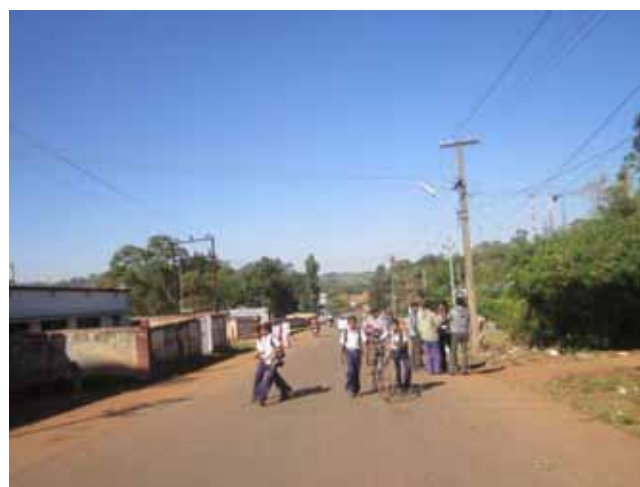
- No traffic calming measures are provided to slow down vehicles approaching at high speeds to the built up area
- Significant pedestrians including school children are noted, but no separate pedestrian facilities are provided along the road inside the BUA or to cross the road
- No road markings or warning signs to warn/ inform the road user of the built up nature of the area ahead
- No speed limit signs provided

- Provide Gateway signs at before start and after the end of BUA. Provide a Gateway effect on approaches to road side villages.
- Provide well maintained wide shoulders (min. 2m wide), free of encroachments and overgrown vegetation in roadside villages in rural areas
- Provide ‘School Ahead’ and ‘SLOW’ signs on appropriate locations near schools
- Provide appropriate warning signs various hazards encountered inside the roadside village
- Provide adequate traffic calming measures

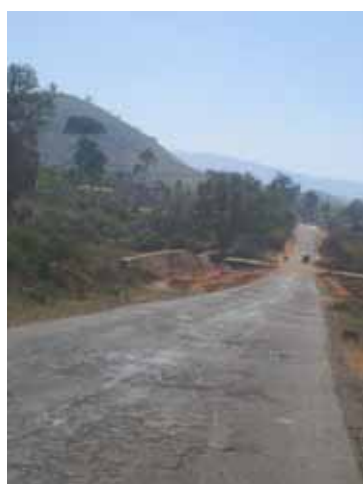
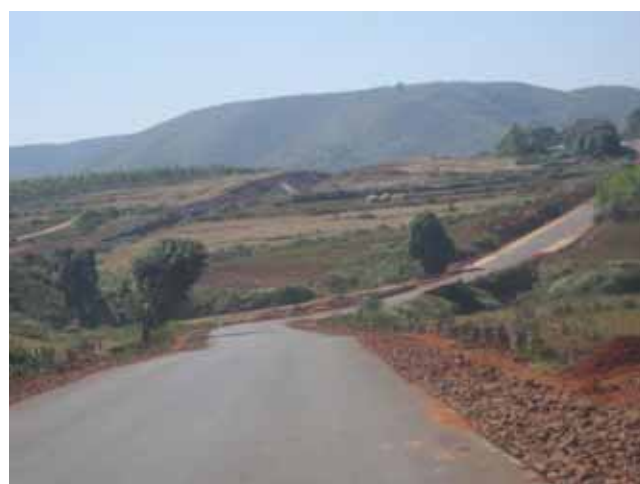
8.5.2.10. Vertical Sag Curves / Depressed Causeways

| Reasons for Concern: | Simultaneous change in horizontal and vertical alignment The abrupt change of horizontal and vertical alignment may be difficult to negotiate for an errant vehicle and lead to unsafe condition. |

| Recommendations | The provision of retro – reflective guard posts along the entire sag curve with provisions of advanced warning signs and pavement markings to delineate the center and edge line of the road. |

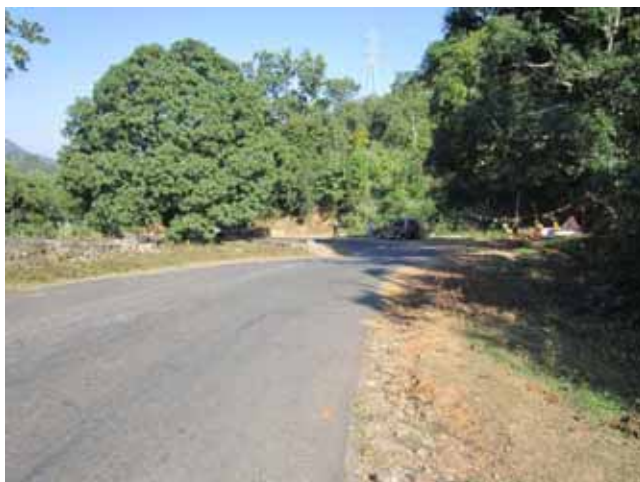
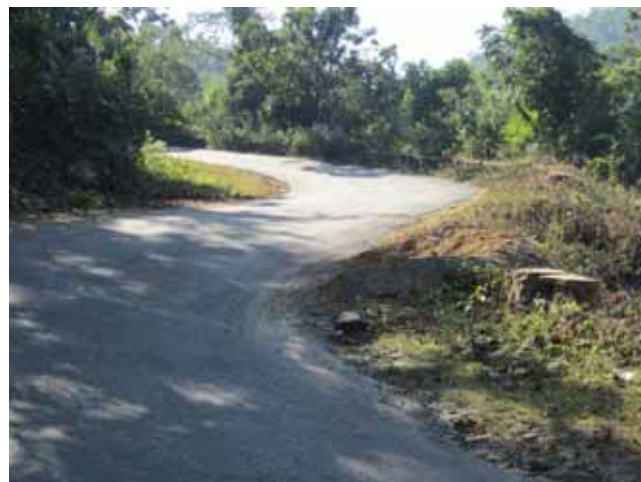
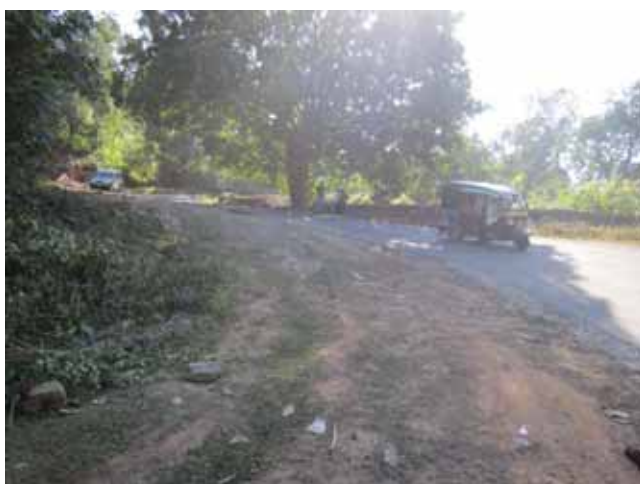
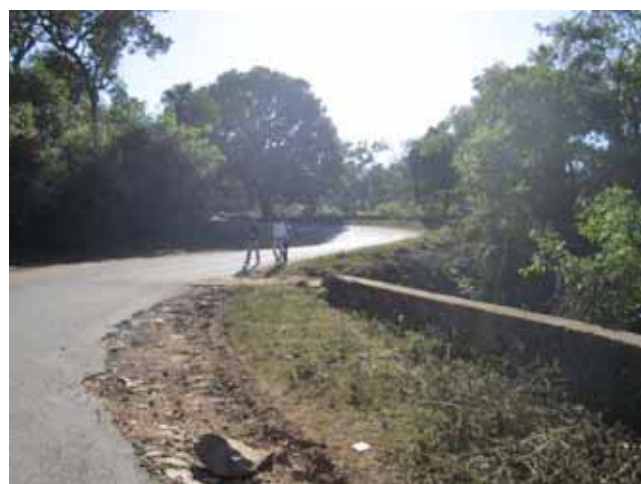
Ch: 64+300 – 64+500

It was pointed out by OWD that the stretch of 1 km road from Ch: 64+000 – Ch: 65+0000 is the location of many accidents. After the reconnaissance, it was found that there are thirteen (13) curves in this stretch of

1 km with varying gradient and sharp curves. It was also found that there is end protection on the valley side of the road and some accident impact traces were found on the hill side of the road.

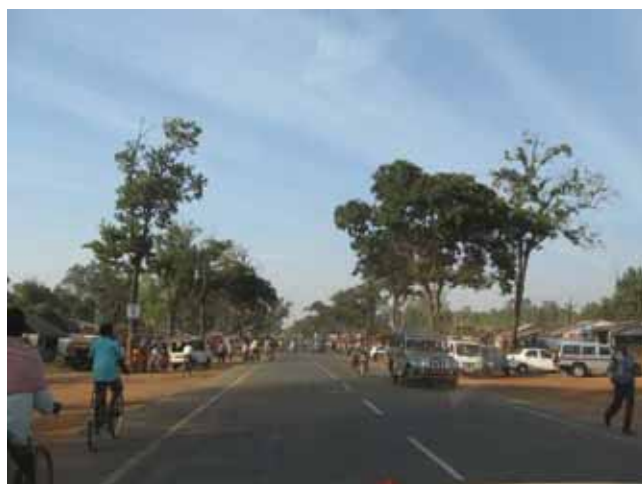
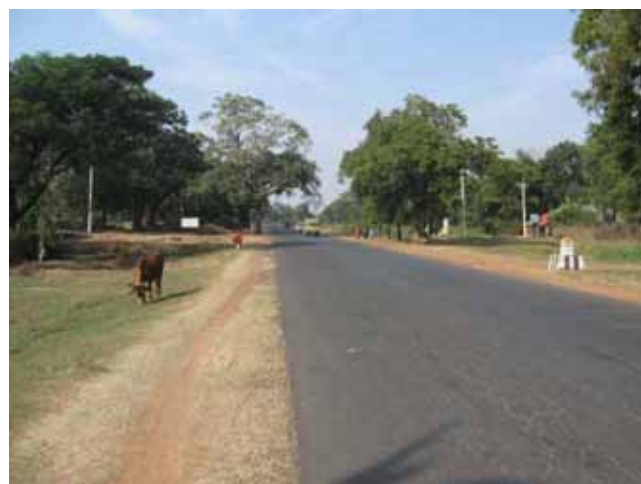
9.3.1.1. Delineation of the road

Reasons for concern: Centerline / edge line road markings are absent in some of the sections of the project road, the presence of which should have delineated the road, particularly during night conditions

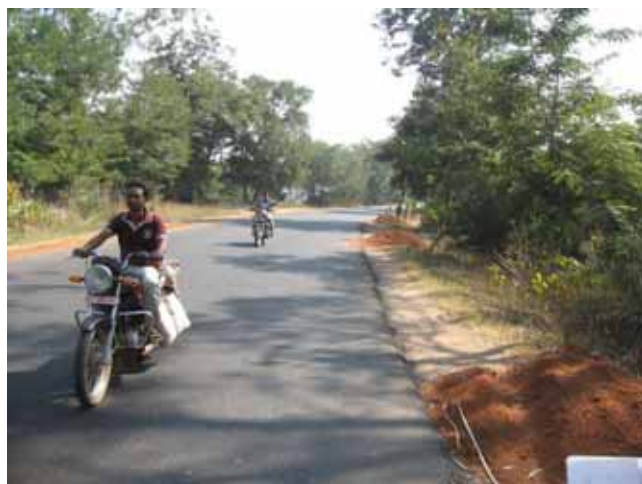
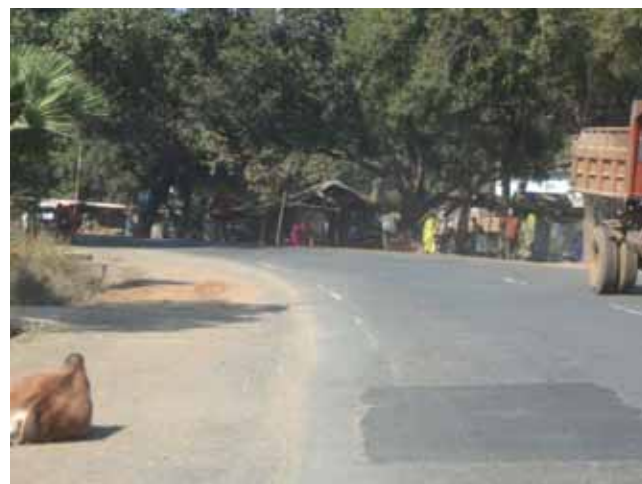
9.3.1.2. Alignment - Sharp horizontal Curves

Horizontal curves of radius less than 200 m were observed at Chainages: 0+950; 1+750; 2+300; 3+750; 6+210; 7+570; 9+500; 10+150; 11+100; 22+700; 51+550; 71+700; 73+500

Reasons for concern: Curves on high embankment without safety barriers noted

Recommendations: Provide **curve warning signs, chevron signs, delineators and speed limit sign** as appropriate

Recommendations: Provide metal beam crash barrier with delineators on sharp curves in high embankment

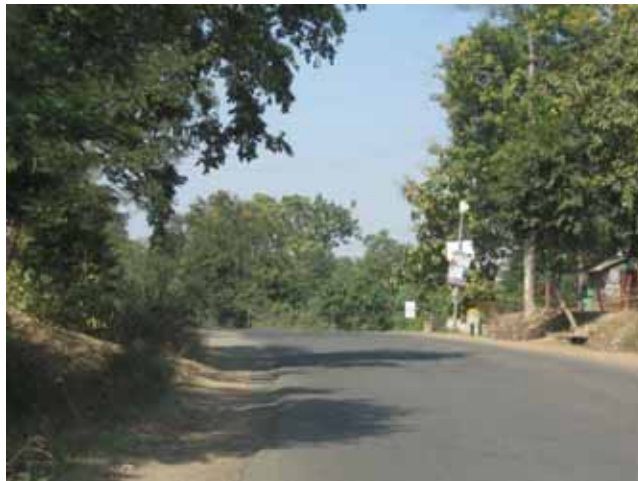
Ch: 29+000

9.3.1.3. **Alignment - Horizontal bend after a vertical crest**

In the existing situation, there is one instance of horizontal bends occurring after a vertical crest at Chainage, Ch: 29+000.

The sight distance on a vertical crest is limited in day light and even less in night time. The presence of a horizontal bend after a vertical crest decreases the sight distance available further for the driver to react and could be a potential unsafe location.

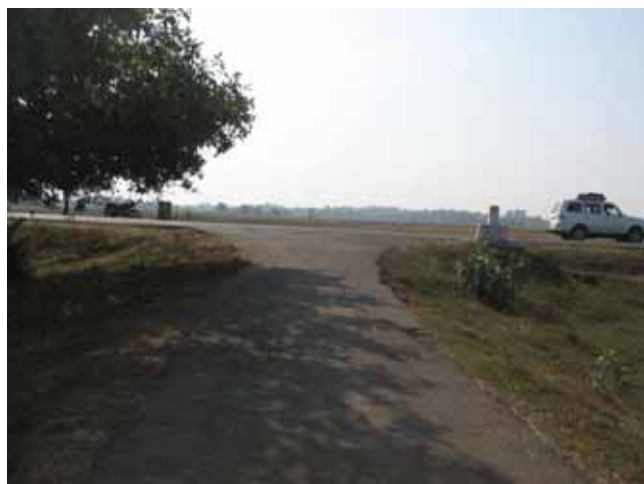
Ch: 73+000

This is a major hazard observed on most of the 3-armed uncontrolled junctions. The major reasons for poor visibility at junctions on this road are due to

- No traffic signs or road markings are observed on any of such junctions, the presence of which would have informed and warned the road user of the layout ahead.
- Poor delineation may result in sudden braking behavior by road users who are required to stop, or wish to make turns. In the worst case, it can also result in rear-end collisions at high speeds.

- High approach speeds were observed by traffic turning from side roads into the main carriageway and no traffic calming measures/ warning is provided on the side road.
- Coupled with inadequate visibility, in the worst case, this may result in **right angle collision** with vehicles coming from the major road leading to serious

- Recommendations:**
- Provide road humps on the side road at junctions having history of accidents
 - Provide raised markings on the entry to the side road
 - Provide adequate warning signs on major road and side road

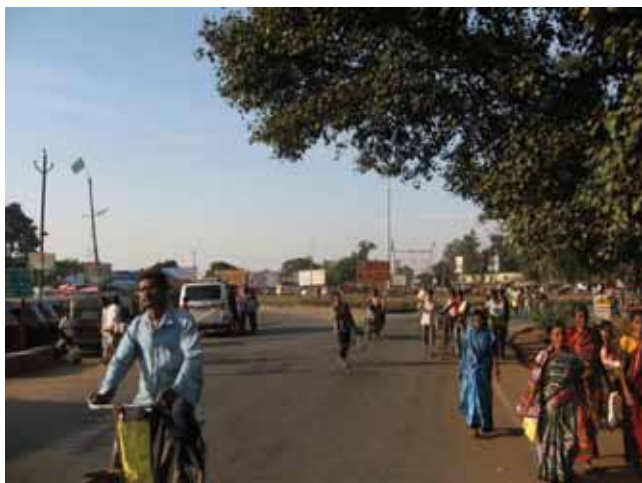
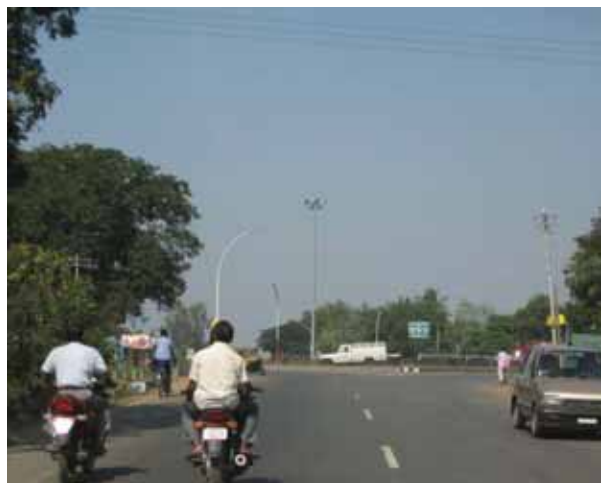
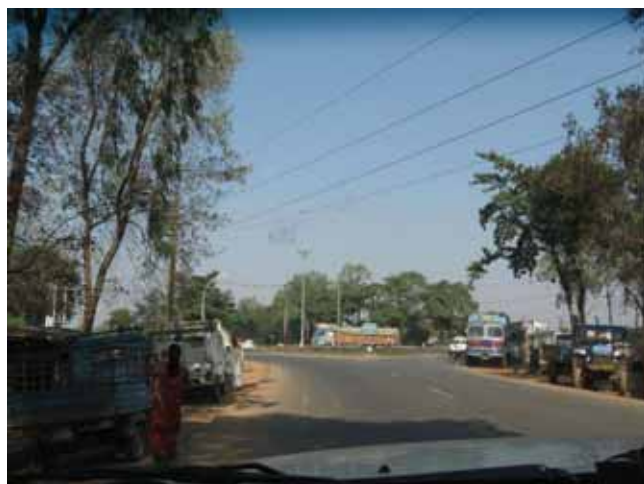
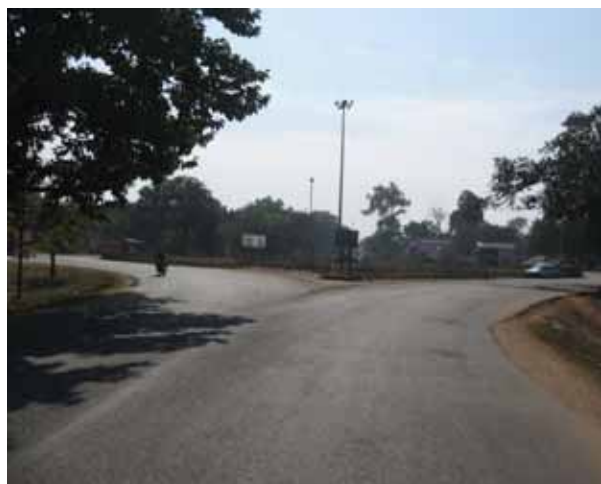
- The junction layout is non-standard and has no control over the traffic movement. It is confusing who has priority in such a situation. This encourages lawless traffic movement and is hazardous. The existing central island is non-standard and hampers visibility at the junction.

- No direction signs to guide the traffic through the junction layout which may lead to hazardous driving and may lead to rear-end collision.

- Recommendations:**
- Remove encroachments from the footpaths.
 - Provide well maintained 2m wide shoulders at junction zone free of encroachments.
 - Provide pedestrian crossings at appropriate locations for safe crossing by pedestrians and bicycles.

- Recommendations:**
- Provide designated parking spaces for commercial vehicles

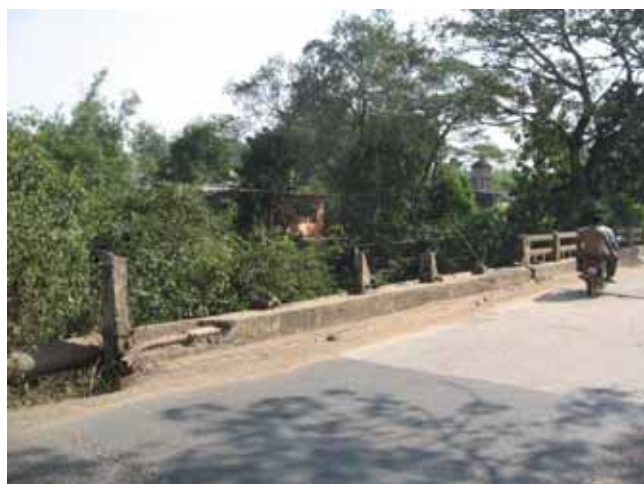
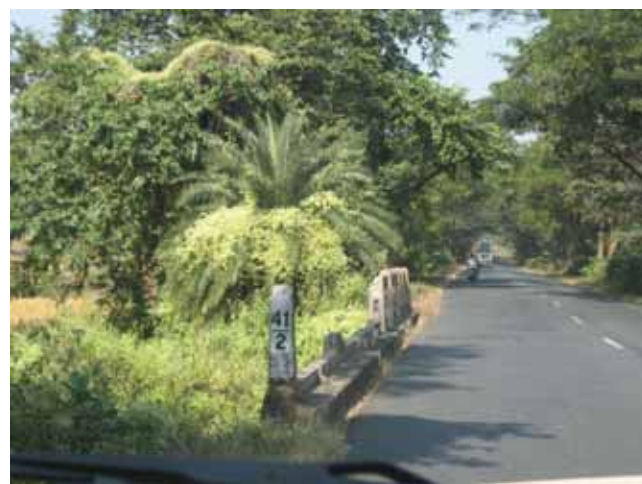
- The bridge parapets adjacent to high speed traffic movement are hazardous especially at night if not delineated as the driver cannot judge the position of such road side hazards.

The absence of parapet on bridge/culvert increases the risk of vehicles falling on to the canal. In the context of high speed traffic movement observed on SH-10, the absence of parapets at such locations is hazardous for traffic, especially for VRUs.

- Provide edge line markings and Object Hazard Marker (OHM) on both sides and for both approaches (i.e. Four numbers of OHM for each

Recommendations: Provide continuous parapets on all culverts and bridges.

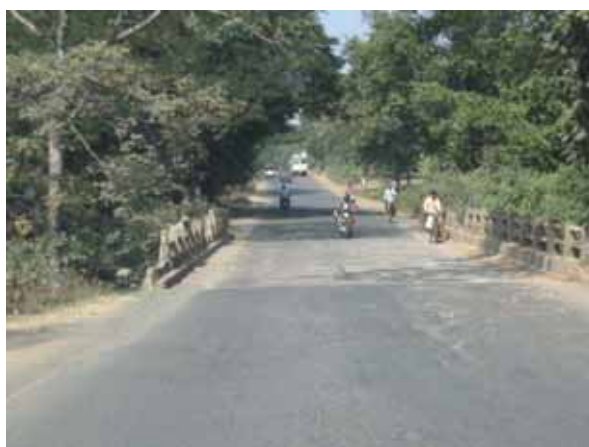
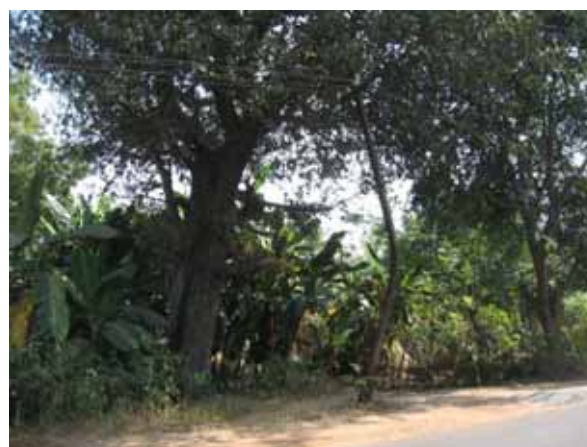
Roadside objects constitute a significant hazard, if the driver loses control and will result in major injuries/ fatalities

- Remove Trees/ street lighting poles from the road shoulders
- Remove encroachments from the right of way
- Provide crash barriers on locations where trees acts as a significant hazard and where the space is available to install crash barrier

- Delineate the hazards by installing OHMs or painting of the trees in black and white strips
- Remove encroachments on at least 2m from the road edge
