**Government of Odisha (GOO)
Chief Engineer, World Bank Projects, Odisha
Odisha State Roads Project**

**Consultancy Services for
Road Sector Institutional Development
Loan # 7577-IN**

**ROAD INFRASTRUCTURE
SAFETY MANAGEMENT REVIEW**

VOLUME I - REPORT

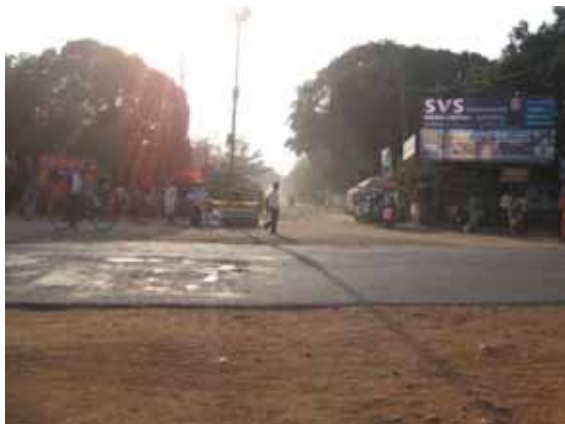
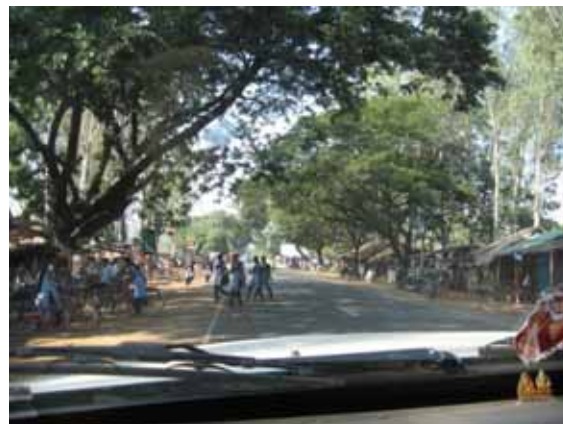
- No traffic calming measures are provided to slow down vehicles approaching at high speeds to the built up area
- Significant pedestrians including school children are noted, but no separate pedestrian facilities are provided along the road inside the BUA or to cross the road
- Significant number of access roads within the BUA, the visibility of which has been hampered due to shops/ establishments on all corners of the junction
- On road bus stops which hampers visibility and encourage dangerous overtaking
- No road markings or warning signs to warn/ inform the road user of the built up nature of the area ahead
- No speed limit signs provided
- On street parking hampers the visibility and resulting in unsafe situations

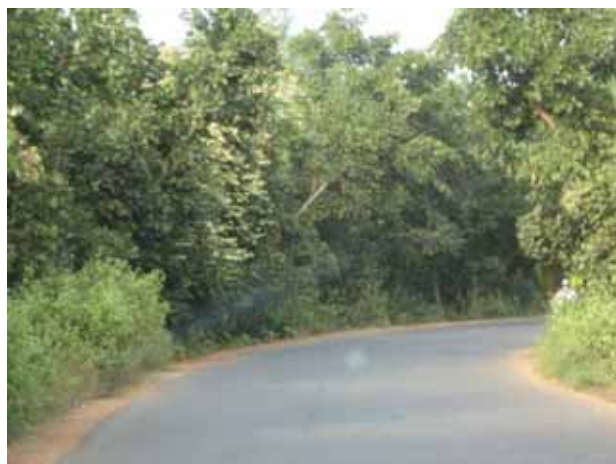
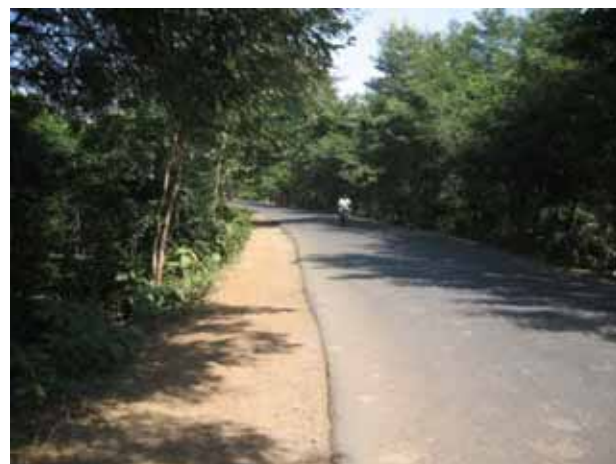
Horizontal curves of radius less than 200 m were observed at Km. 48+800; 49+700; 64+400; 67+300; 70+200; 70+700; 73+600; 91+000

Reasons for concern: Curves on high embankment without safety barriers noted

Recommendations: Provide **curve warning signs, chevron signs, delineators and speed limit sign** as appropriate
Refer to Appendix III for guidelines on treatment of curves.

Recommendations: Provide metal beam crash barrier with delineators on sharp curves in high embankment
Refer to Appendix III for guidelines on situations where to install the above

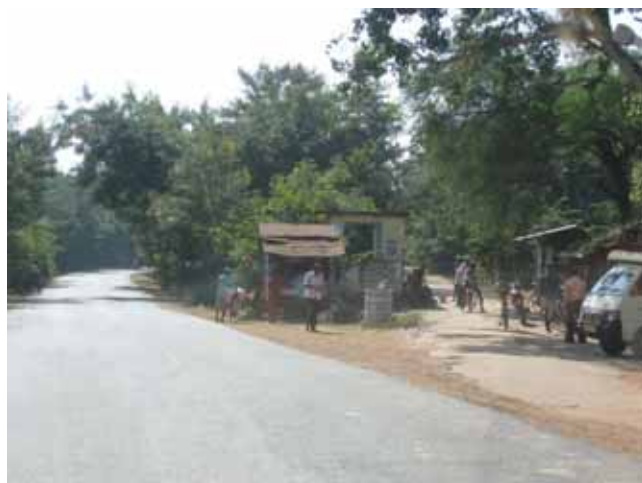
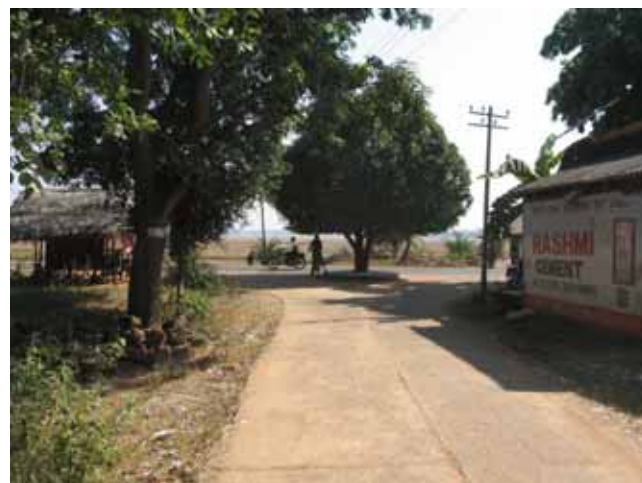
This is a major hazard observed on most of the 3-armed uncontrolled junctions. The major reasons for poor visibility at junctions on this road are due to

- No traffic signs or road markings are observed on any of such junctions, the presence of which would have informed and warned the road user of the layout ahead.

- High approach speeds were observed by traffic turning from side roads into the main carriageway and no traffic calming measures/ warning is provided on the side road.

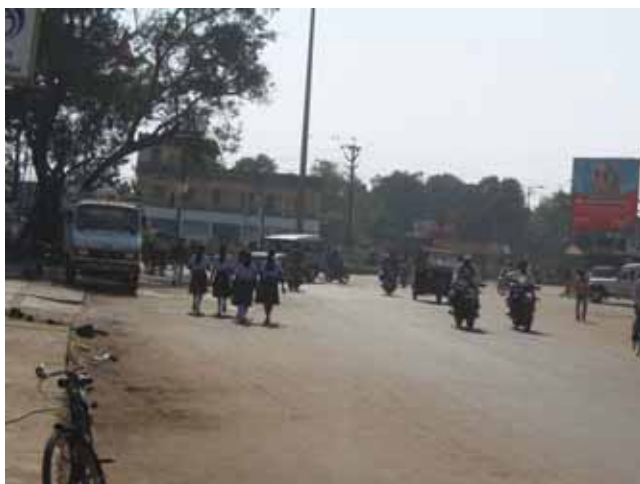
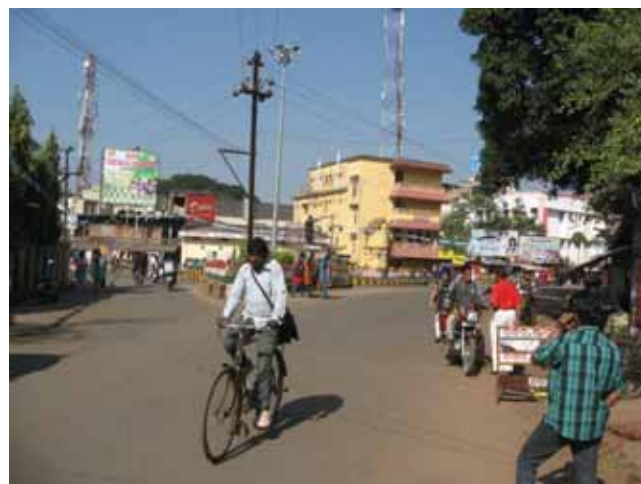
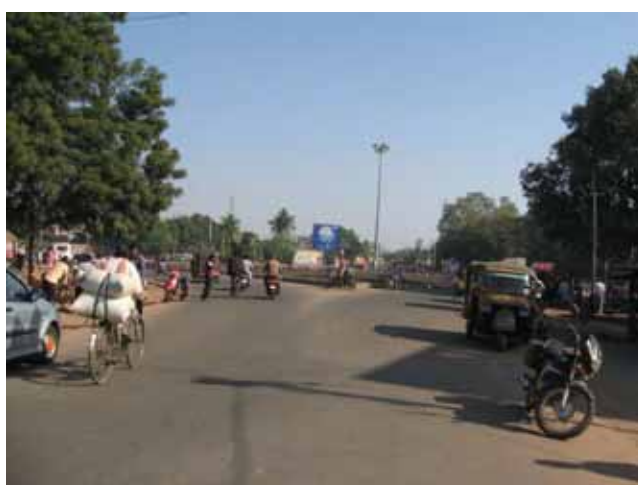
| Reasons for concern: | Poor Junction layout <ul style="list-style-type: none">• The junction layout is non-standard and has no control over the traffic movement. It is confusing who has priority in such a situation. This encourages lawless traffic movement and is hazardous. The existing central island is non-standard and hampers visibility at the junction. |
| Reasons for concern: | Direction Signs <ul style="list-style-type: none">• No direction signs to guide the traffic through the junction layout which may lead to hazardous driving and may lead to rear-end collision. |

| Recommendations: | <ul style="list-style-type: none">• Re-design the junction after traffic studies and considering the requirements of all road users. <p><i>Refer to the Appendix III for guideline to standard layout of 3-arm junctions.</i></p> |
| Recommendations: | <ul style="list-style-type: none">• Provide direction signs on approaches to the junction to guide the traffic through the junction layout. <p><i>Refer to Appendix III for guidelines on road markings & traffic signs at 3-arm junctions.</i></p> |
| Recommendations: | <ul style="list-style-type: none">• Provide edge line markings, centerline markings and other junction road markings pertaining to junction control. <p><i>Refer to Appendix III for guidelines on road markings & traffic signs at 3-arm junction</i></p> |
| Recommendations: | <ul style="list-style-type: none">• Remove encroachments from the shoulders.• Provide well maintained 2m wide shoulders at junction zone free of encroachments. <p><i>Refer to Appendix III for guidelines for safe treatments in roadside villages</i></p> |
| Recommendations: | <ul style="list-style-type: none">• Provide designated parking spaces for commercial vehicles |

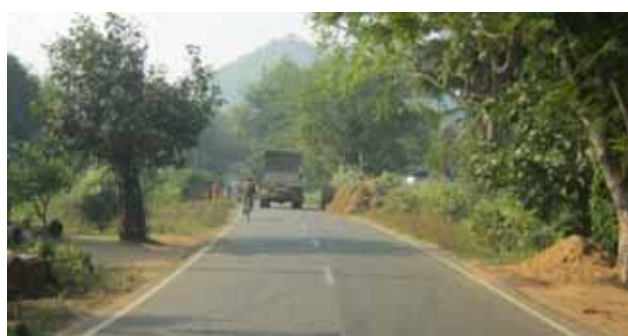
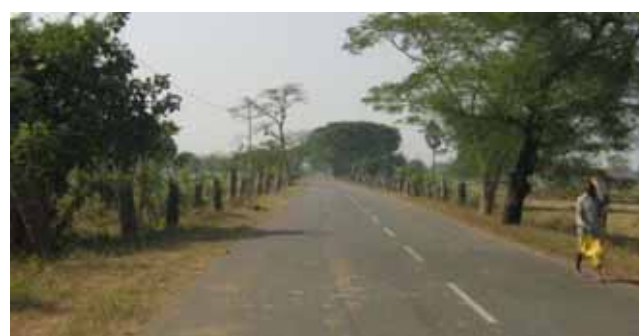
Reasons for concern: Centerline and edgeline road markings are not provided in almost 50 percent of the road section.

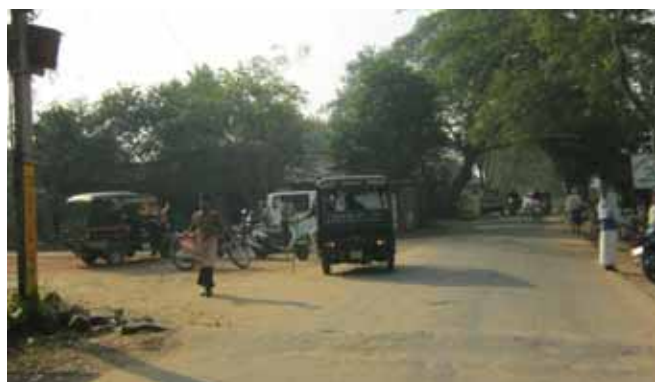
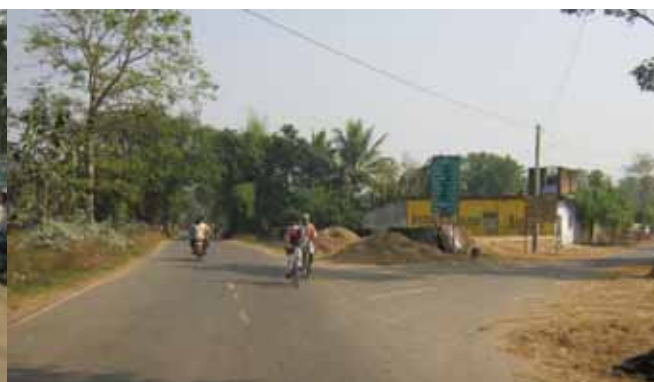
Side Roads perpendicular and skew with the Main Road

This is a major hazard observed on most of the 3-armed uncontrolled junctions. The major reasons for poor visibility at junctions on this road are due to 1) Encroachments at Junctions 2) Overgrown vegetation or presence of trees and 3) poor layout of the side roads.

- No traffic signs or road markings are observed on any of the junctions, the presence of which would have informed and warned the road user of the layout ahead.
- Poor delineation may result in late braking behaviour by road users who are required to stop, or wish to make turns. In the worst case, it can also result in collisions at high speeds.

- High approach speeds were observed by motorcyclists turning from side roads into the main carriageway and no traffic calming measures/ warning is provided on the side road.
- Coupled with inadequate visibility, in the worst case, this may result in right angle collision with vehicles coming from the major road leading to serious injury or fatal accidents.

- It has been observed that on few junctions, the level difference between the side road and major road and the vertical profile of the side road joins the edge of main carriageway in an unsafe manner.
- This requires special skills from the drivers of vehicles coming from the side road to stop/ slow down before they enter into the main carriageway at the junction and most of the drivers in such circumstances tend to drive into the major road without stopping/ slowing down. This may lead to collisions resulting in major injury/ fatalities.

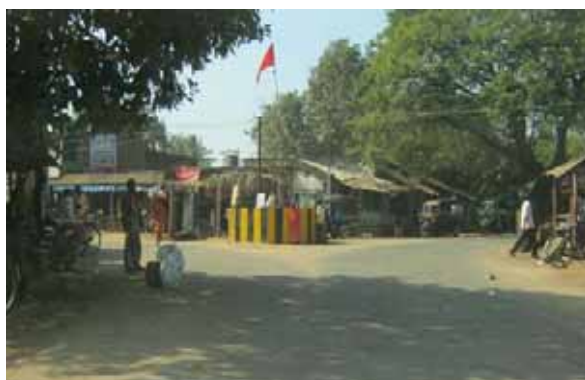
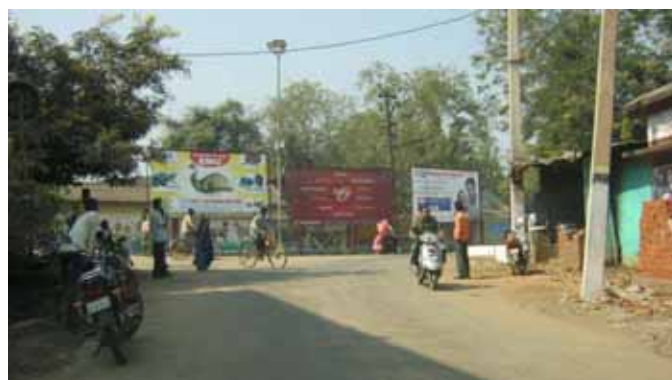
Major Junctions

Reasons for concern: **Provision of VRUs**
Pedestrians and cyclists observed at the junction, but no separate provisions have been made. Pedestrians are particularly vulnerable at such junctions having high approach speed.

Recommendations: Provide designated bus stop at a safer location so that required visibility is available for road users approaching from all arms of the junction

Recommendations: Provide footpaths to segregate pedestrians from high speed traffic at the junction approaches;

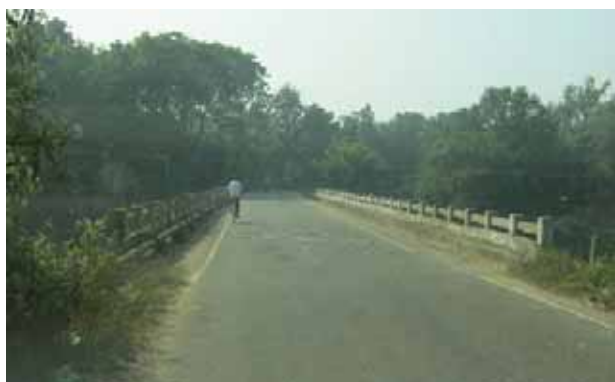
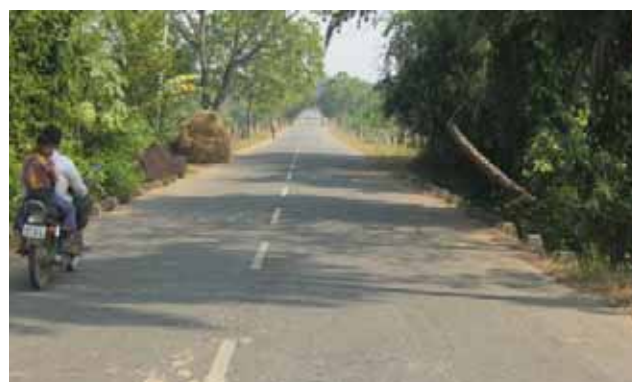
Bridge/Culverts

Reasons for concern: The bridge/ culvert parapets on the edge of the road adjacent to high speed traffic movement will be hazardous, particularly at dark conditions, and needs to be illuminated for a driver to judge the position of such road side hazard.

Reasons for concern: **Absence of traffic signs and road markings**
 In the absence of adequate warning signs and reflective markings, the road layout and the hazard will not be clear for the road user, particularly during night conditions and in worst conditions, this will lead to serious injury/ fatal accidents

Reasons for concern: **High approach speed**
 In the absence if any warning of the layout ahead, vehicles will tend to drive faster and approach the hazard in high speed. This may cause head-on or run-off collision.

Recommendations: Install Object Hazard Marker (OHM) on both sides and for both approaches (i.e. Four numbers of each OHM for each structure.

Recommendations: Provide crash barriers on either approaches of the structures with delineators

- Provide curve warning sign in addition to crash barrier with delineators
- Provide edge lane markings
- Provide hazard markers on either edge of the parapets

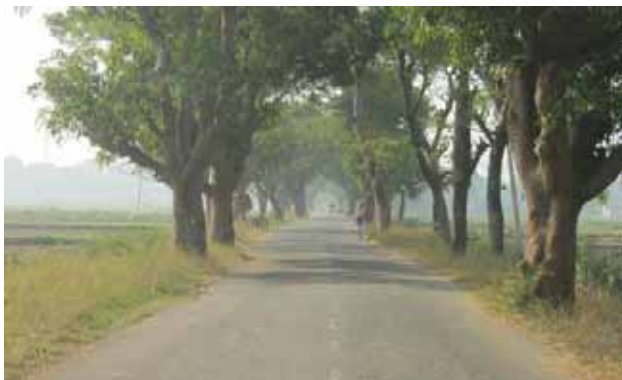
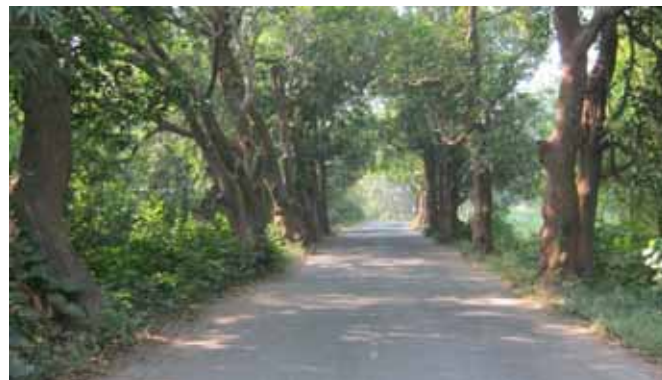
Road side objects present along this stretch of road are mainly trees. Lots of trees are on the edges of the carriageway from Km 2+000 to Km 40+000, which has no any protection. Some of them protected by providing studs near the trees but it is not sufficient.

Reasons for concern: The road side objects like trees, street light or other poles, buildings, and unprotected deep drains which are near the edge of road needs to be. At night time it becomes very difficult for drivers to judge the position of such road side hazard. If the road side objects are not protected and/or illuminated there are chances of driver losing control and hitting these objects which may result into fatal accident.

Recommendations: Either remove such objects or provide crash barrier where such objects are <2m from the edge of road.

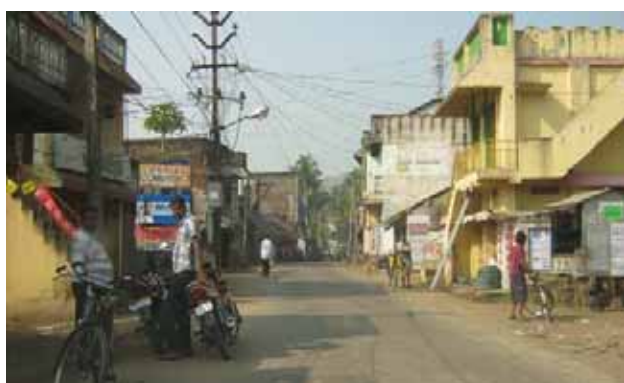
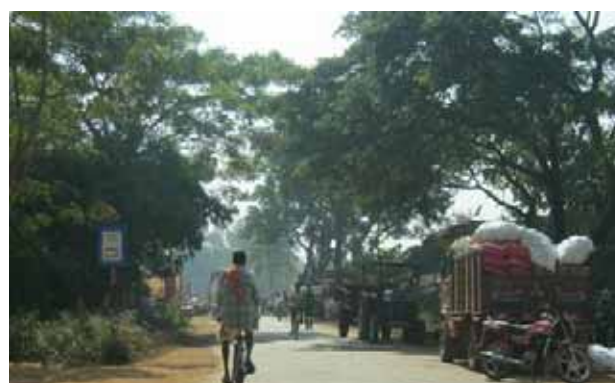
Built up area/Road side villages

Recommendations: Provide gateway signs with speed restriction on start and end of BUA, additionally provide rumble strips, speed humps, or speed tables as traffic calming measures. Provide pedestrian crossings (either marked or speed tables), footpaths, and streetlights.

Recommendations: Provided bus-bays with proper signage and road markings.

Recommendations: Regulate roadside commercial activities and remove encroachment, if any.

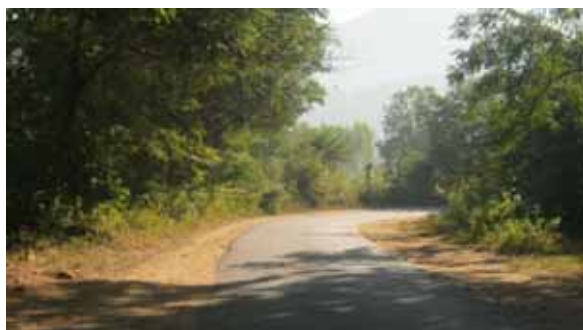
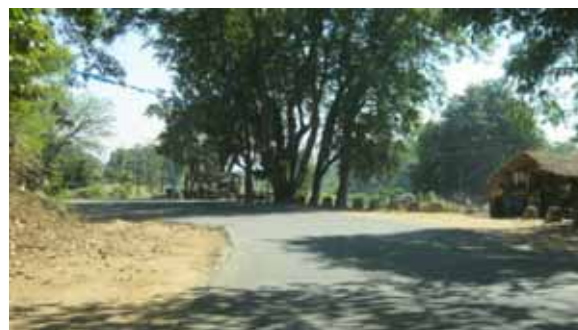
Sharp Curves on Project Road

| Reasons for concern: | Curves on high embankment without safety barriers noted <ul style="list-style-type: none"> • Run-off accidents on high embankments will lead to fatalities |
| Reasons for concern: | On two lane roads, the constricted width will cause the rear of trucks/ big vehicles |

concern: to protrude on to the opposite lane and can be hazardous

| Recommendations: | Provide curve warning signs, chevron signs, delineators and speed limit sign as appropriate <i>Refer to Appendix III for guidelines on situations where to install the above</i> |
| Recommendations: | <ul style="list-style-type: none"> • Improve the line of sight by removing trees from the shoulder and cut down vegetation which hampers visibility along the curves |
| Recommendations: | Provide metal beam crash barrier with delineators on sharp curves in high embankment <i>Refer to Appendix III for guidelines on situations where to install the above</i> |

Recommendations: Provide extra widening on sharp curves, with ‘no overtaking’ markings (refer to IRC 35 for details)

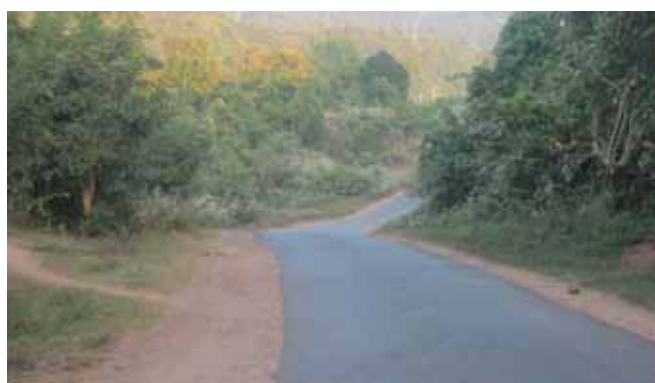
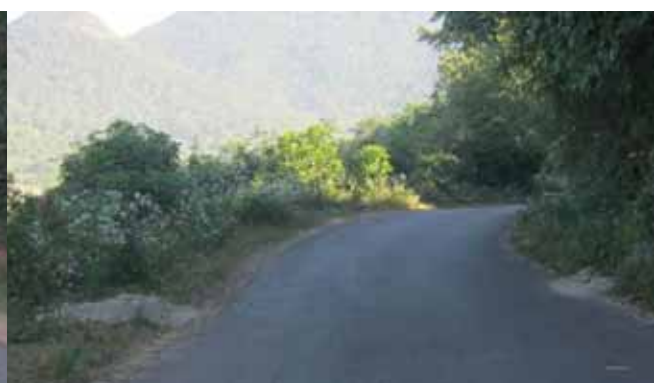
The ‘horizontal bend after a vertical crest’ situations were observed at chainages Km 98+150, Km 126+700 and Km 129+000. This situation is particularly hazardous, particularly, if this geometry follows after a long straight section. The drivers tend to expect a straight section after the vertical crest and may not be able to negotiate the horizontal bend after the vertical crest, if appropriate safety measures are not provided. The reverse curves were observed on the chainages Km 85+500, Km 128+280, Km 141+500, Km 143+200 and Km 154+400.

Horizontal bend after a vertical crest

Recommendations: Provide **curve warning signs, chevron signs, SLOW Signs** as appropriate
Refer to Appendix III for guidelines on situations where to install the above

Recommendations: Provide appropriate traffic calming measures

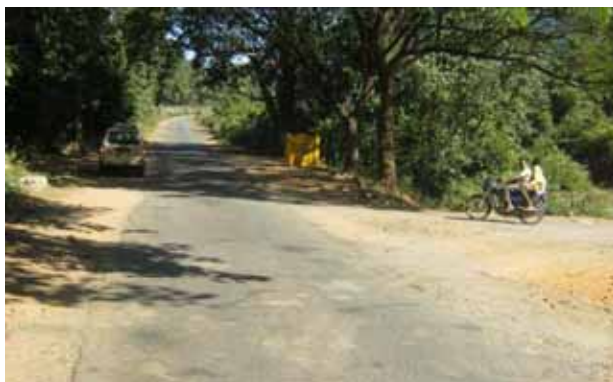
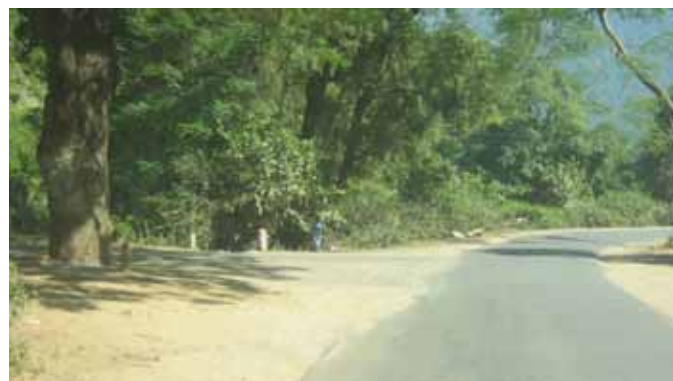
Side roads Perpendicular and skewed to Main Road

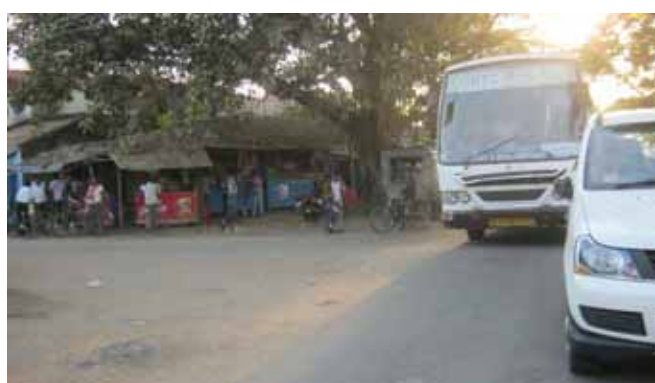
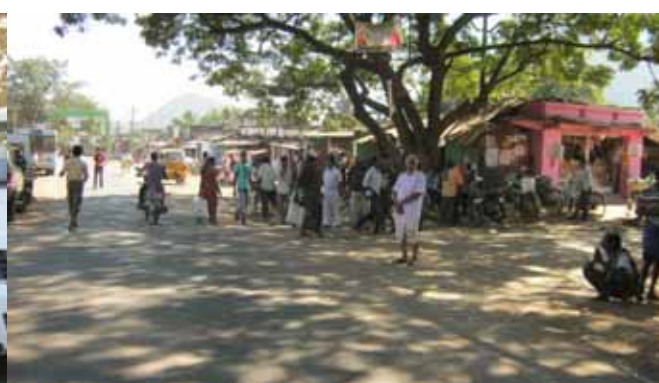
Major 3-arm Junctions

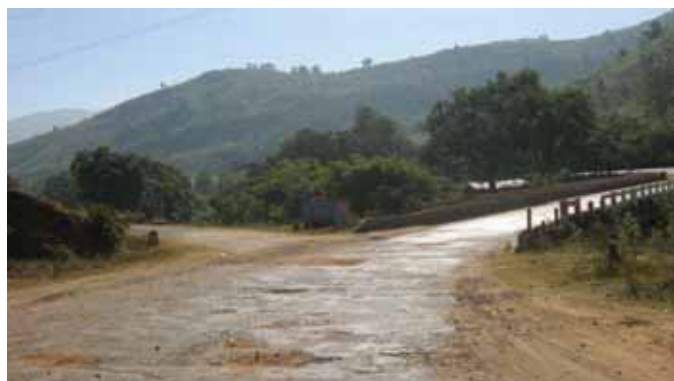
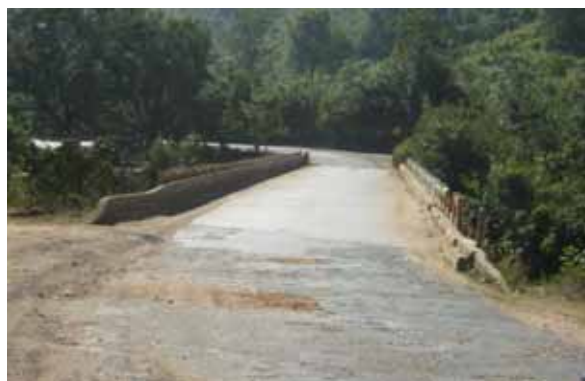
At chainage Km 80+200, sharp curve approaching a bridge on high embankment.

Bridge/Culverts

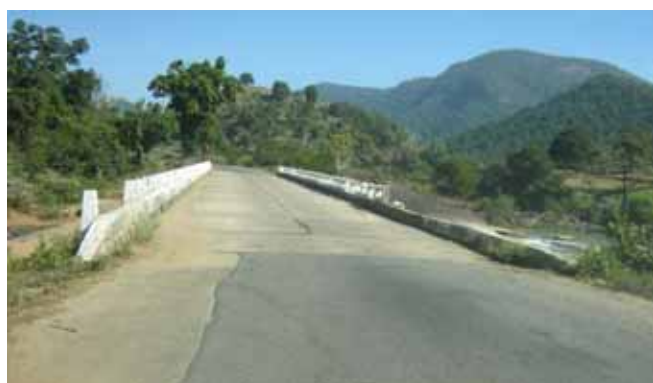
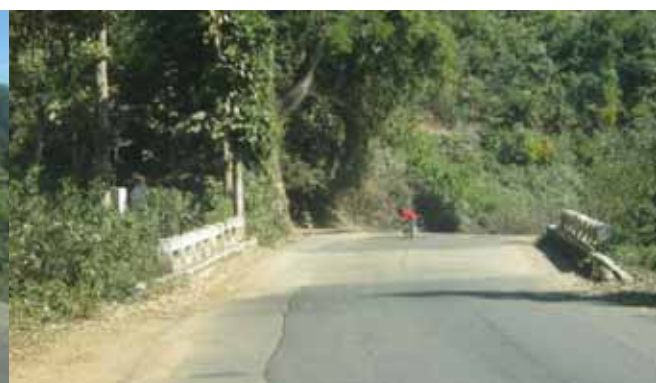
Road side hazards-Parapet of narrow culverts/bridges

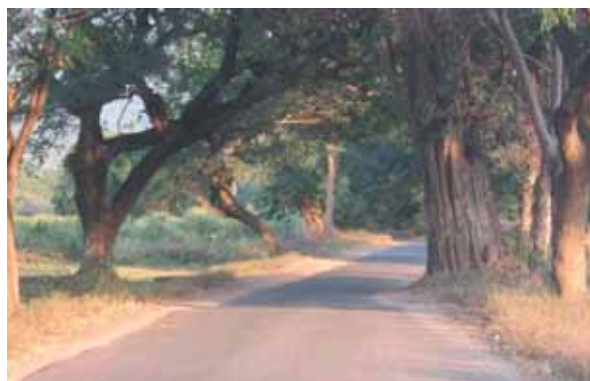
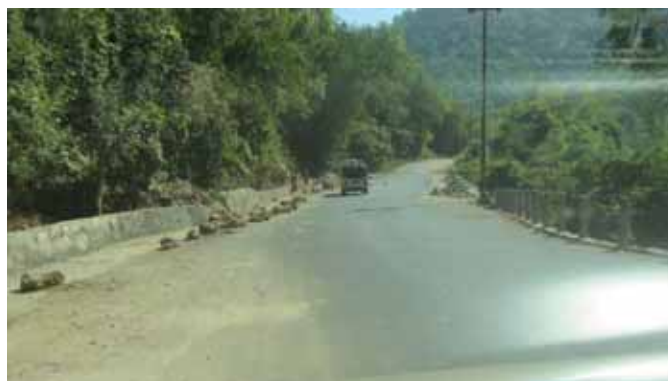
It has been noted that huge trees near to road edge pose a significant hazard in this road section, which is one of the major hazard identified in this road section.

Road side hazards-Trees and high embankment

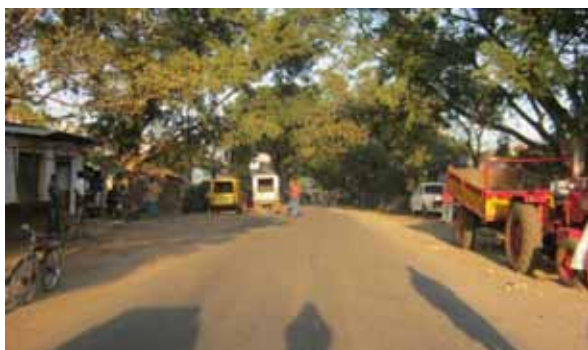
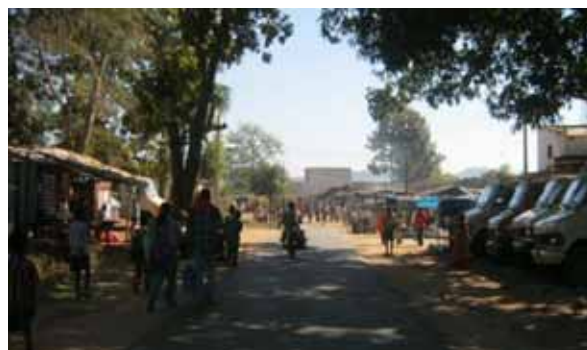
Built up area/Road side villages

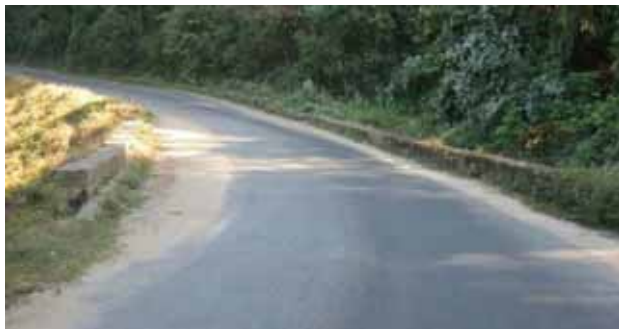
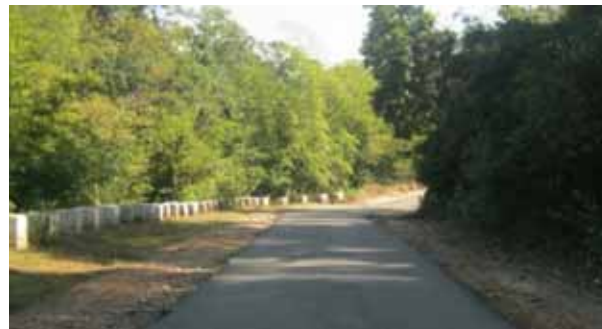
In this section, accident prone area as per directed by OWD are at chainages Km 98+150 (Horizontal bend after a vertical crest), Km 128+500 and Km 129+000 (Sharp curve), landslide area at Km 132+050 and also at hair pin bend (chainages are given above).

Accident prone area

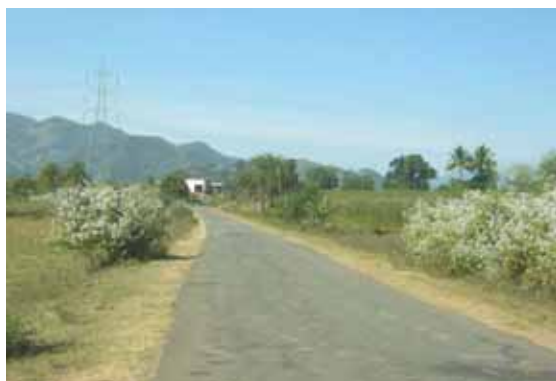
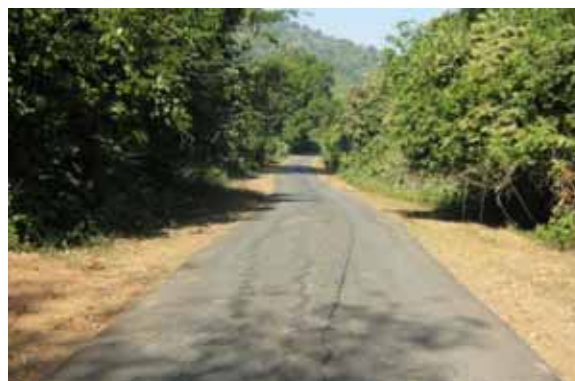
Road marking missing

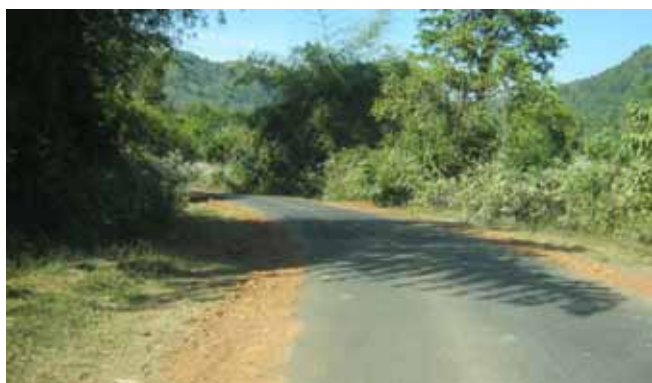
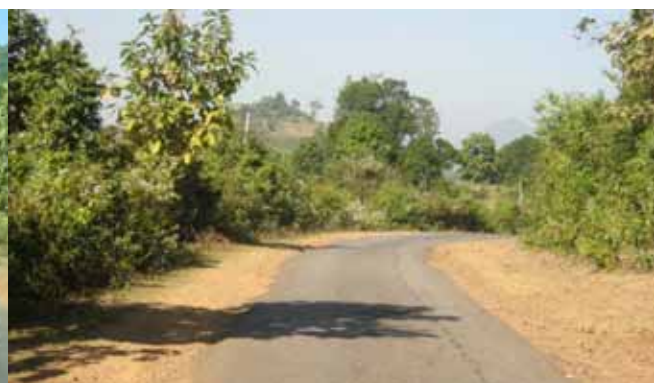
Km 3+400

Km 14+800

Sharp Curves on Project Road

| Reasons for concern: | Curves on high embankment without safety barriers noted <ul style="list-style-type: none"> • Run-off accidents on high embankments will lead to fatalities |

| Recommendations: | Provide curve warning signs, chevron signs, delineators and speed limit sign as appropriate <i>Refer to Appendix III for guidelines on situations where to install the above.</i> |
| Recommendations: | <ul style="list-style-type: none"> • Improve the line of sight by removing trees from the shoulder and cut down vegetation which hampers visibility along the curves |
| Recommendations: | Provide metal beam crash barrier with delineators on sharp curves in high embankment <i>Refer to Appendix III for guidelines on situations where to install the above</i> |

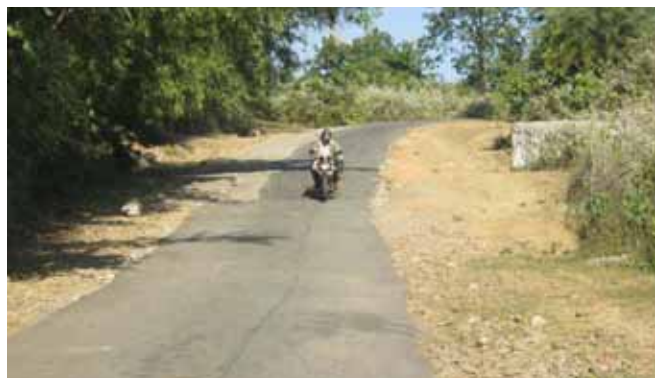
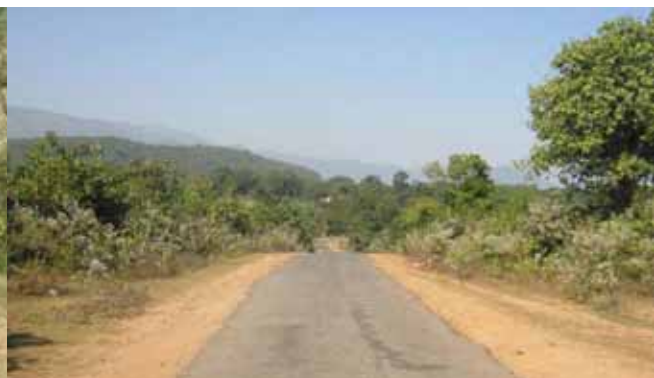
The horizontal bend after a vertical crest were observed at chainages mm 20+500 and mm 31+350 and reverse curves were observed on chainages km 18+300 and km 19+500.

Km 20+500

Km 31+350

Horizontal bend after a vertical crest

| Recommendations: | Provide curve warning signs, chevron signs, delineators and speed limit sign as appropriate Provide traffic calming measures on approaches to the vertical crest <i>Refer to Appendix III for guidelines on situations where to install the above</i> |

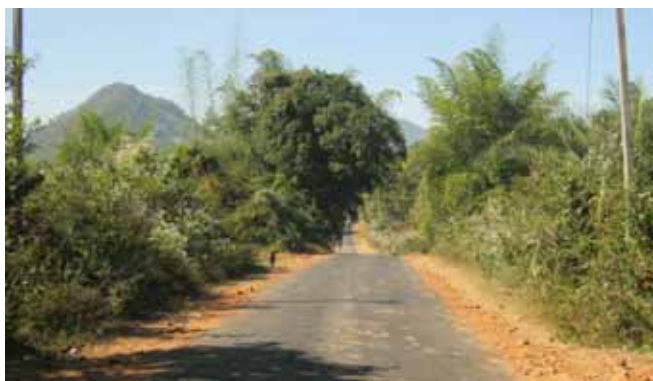
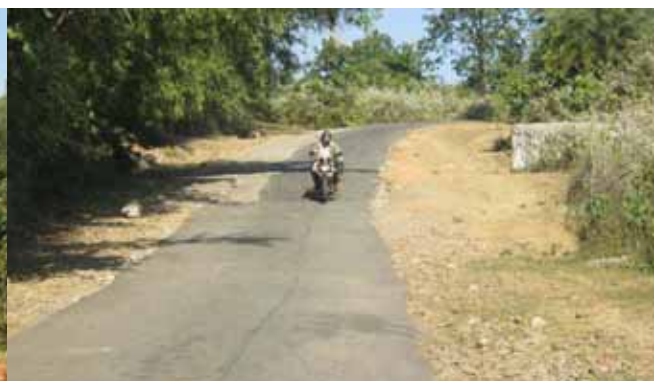
It has been noted that on few locations (Km 0+300, Km 20+500 and Km 31+200), desired sight distance/visibility for safe maneuver of vehicles are not available due to few sub-standard vertical gradient. At chainage 20+500, road leads to a sudden dip after a horizontal curve bend, which is significantly hazardous.

Km 0+300

Km 20+500

Unsafe Steep Gradient

Recommendations: **Desirable** – Correct the vertical gradient to achieve safe forward visibility
Essential - Provide **curve warning signs, chevron signs, delineators and speed limit sign** as appropriate.

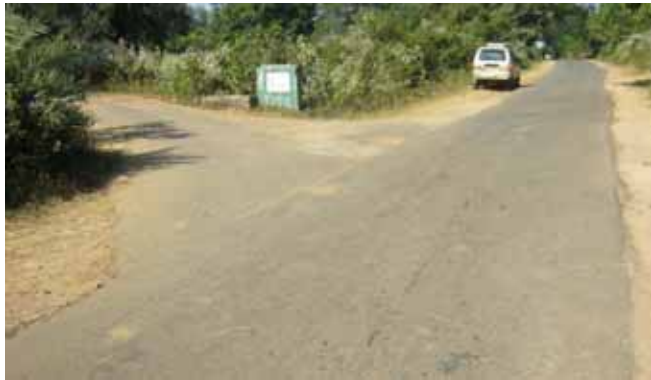
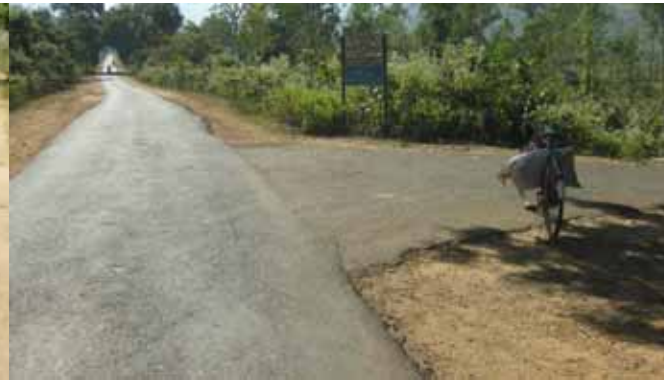
Km 11+400

Km 15+500

Side roads perpendicular to Main Road

This is a major hazard observed on most of the 3-armed uncontrolled junctions. The major reasons for poor visibility at junctions on this road are due to 1) Overgrown vegetation or presence of trees and 3) poor layout of the side roads.

No traffic signs or road markings are observed on any of the junctions, the presence of which would have informed and warned the road user of the layout ahead. Poor delineation may result in late braking behaviour by road users who are required to stop, or wish to make turns. In the worst case, it can also result in collisions at high speeds.

High approach speeds were observed by motorcyclists turning from side roads into the main carriageway and no traffic calming measures/ warning is provided on the side road. Coupled with inadequate visibility, in the worst case, this may result in right angle collision with vehicles coming from the major road leading to serious injury or fatal accidents.

- Recommendations:**
- Provide road humps on the side at junctions having history of accidents
 - Provide raised markings on the entry to the side road
 - Provide adequate warning signs on major road and side road

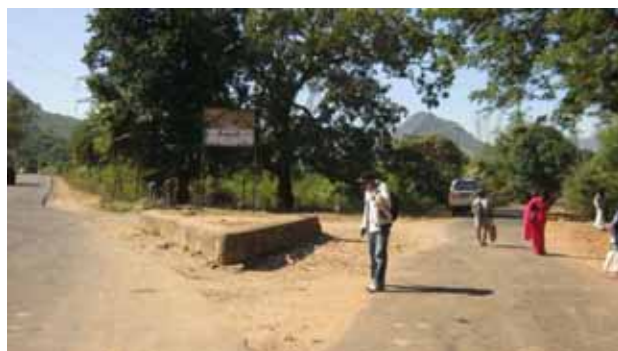
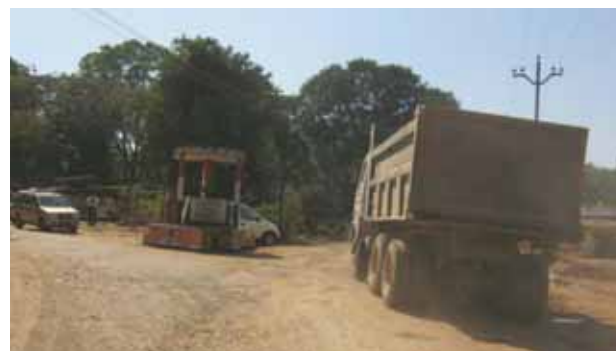
Km 0+000

Km 33+200

Major Junction

| Reasons for concern: | Provision of VRUs Pedestrians and cyclists observed at the junction, but no separate provisions have been made. Pedestrians are particularly vulnerable at such junctions having high approach speed. |

| Recommendations: | <ul style="list-style-type: none">• Provide traffic calming measures on the minor road• Provide warning signs on the minor road• Provide information signs and road markings at the junction to warn the road user of the layout <p><i>Refer to Appendix III for guidelines for design of road humps</i></p> |
| Recommendations: | Provide designated bus stop at a safer location so that required visibility is available for road users approaching from all arms of the junction <p><i>Refer to Appendix III for guidelines for design of bus bays and on-street bus stops</i></p> |
| Recommendations: | Provide footpaths or well-maintained wide shoulders to segregate pedestrians from high speed traffic at the junction approaches; <p><i>Refer to Appendix III for standard layouts of 3-arm junctions.</i></p> |

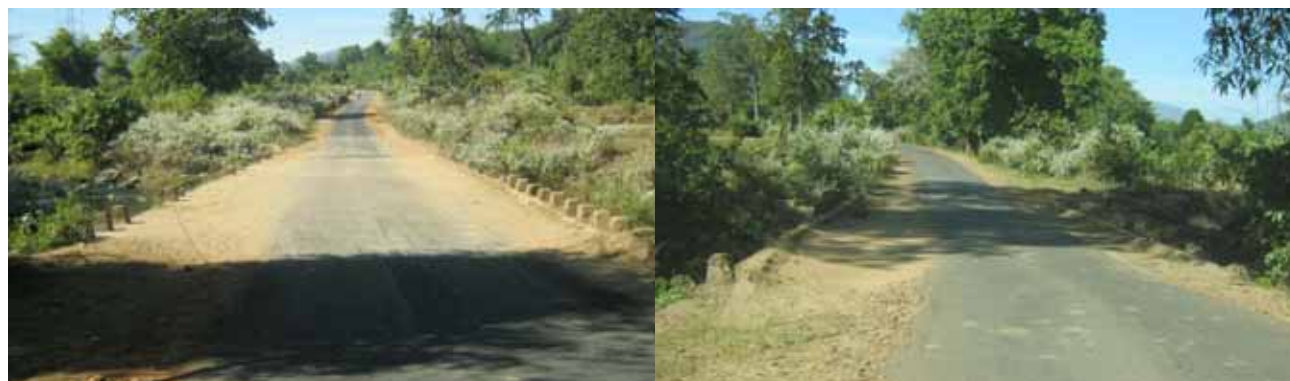
Km 0+500

Km 5+850

Reasons for concern: The bridge/ culvert parapets on the edge of the road adjacent to high speed traffic movement will be hazardous, particularly at dark conditions, and needs to be illuminated for a driver to judge the position of such road side hazard.

Reasons for concern: **Absence of traffic signs and road markings**
 In the absence of adequate warning signs and reflective markings, the road layout and the hazard will not be clear for the road user, particularly during night conditions and in worst conditions, this will lead to serious injury/ fatal accidents

Reasons for concern: **High approach speed**
 In the absence of any warning of the layout ahead, vehicles will tend to drive faster and approach the hazard in high speed. This may cause head-on or run-off collision.

Recommendations: Provide crash barriers on either approaches of the structures with delineators

- Provide curve warning sign in addition to crash barrier with delineators
- Provide edge lane markings
- Provide hazard markers on either edge of the parapets

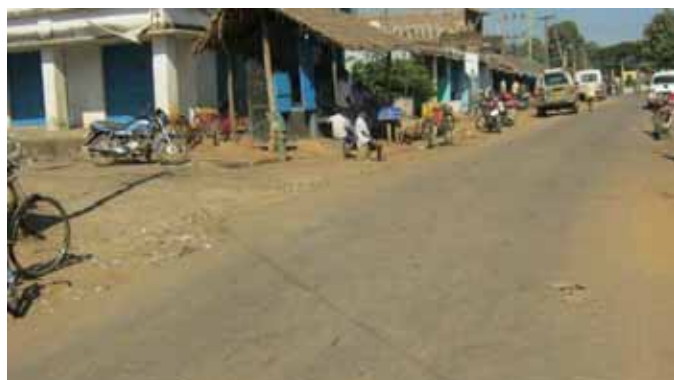
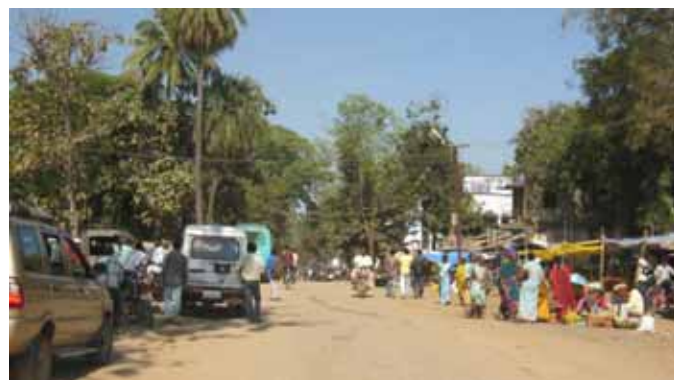
Km 17+000 (Kumardhameri village)

Km 31+800 (Bissam Cuttack village)

Built up areas/Road side villages

| Recommendations: | Provide gateway signs with speed restriction on start and end of BUA, additionally provide rumble strips, speed humps, or speed tables as traffic calming measures. Provide pedestrian crossings (either marked or speed tables), footpaths, and streetlights. Refer to Appendix III for treatment options for roadside villages. |
| Recommendations: | Provided bus-bays with proper signage and road markings. |
| Recommendations: | Regulate roadside commercial activities and remove encroachment, if any. |

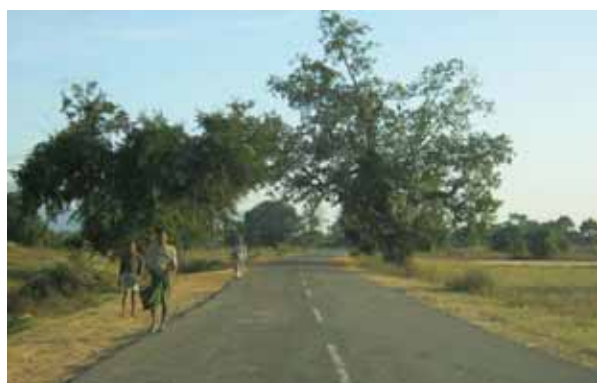
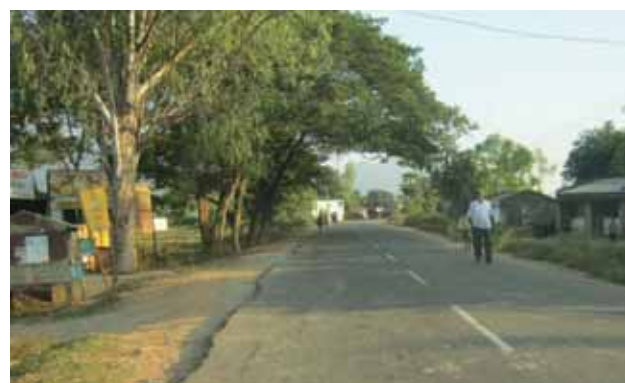
Road Marking

It has been noted that centre line markings were provided on few sections, but is in a deteriorated state and hence is not performing its function. No edge lines are provided on his road section. Retro reflective material is not provided on parapets of the culverts/bridges and also the road side objects are not been marked to warn the drivers while driving at night.

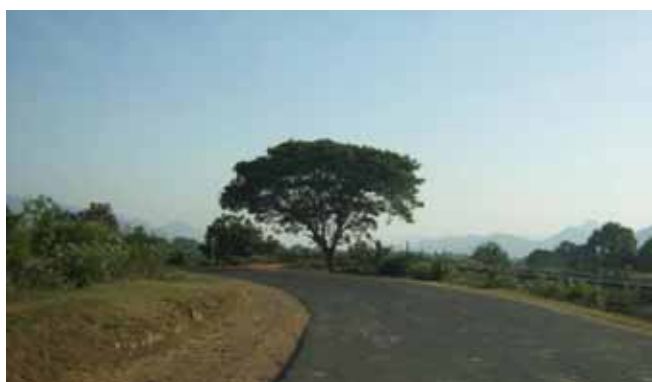
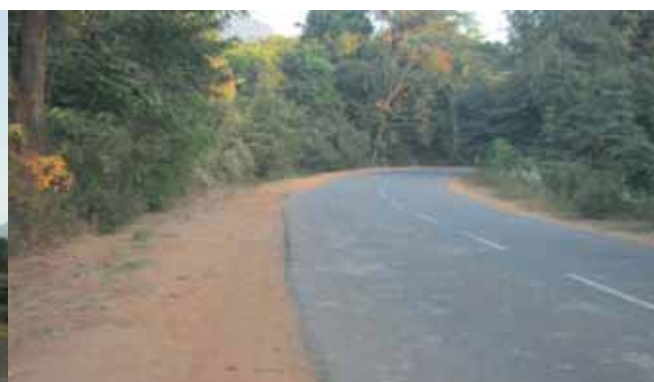
Km 4+500

Km 19+100

Sharp Curves

| Reasons for concern: | Curves on high embankment without safety barriers noted <ul style="list-style-type: none"> • Run-off accidents on high embankments will lead to fatalities |

| Recommendations: | Provide curve warning signs, chevron signs, delineators and speed limit sign as appropriate <i>Refer to Appendix III for guidelines on situations where to install the above</i> |
| Recommendations: | <ul style="list-style-type: none"> • Improve the line of sight by removing trees from the shoulder and cut down vegetation which hampers visibility along the curves |
| Recommendations: | Provide metal beam crash barrier with delineators on sharp curves in high embankment |

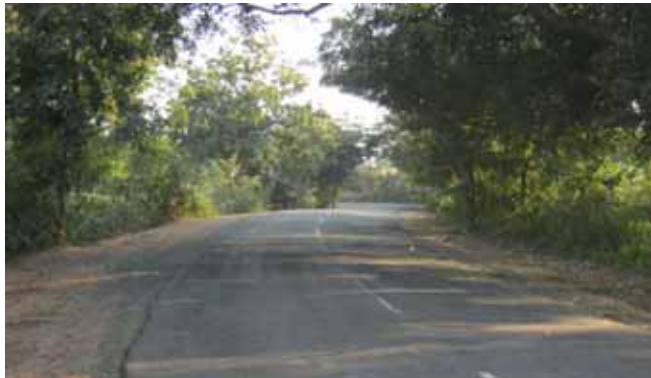
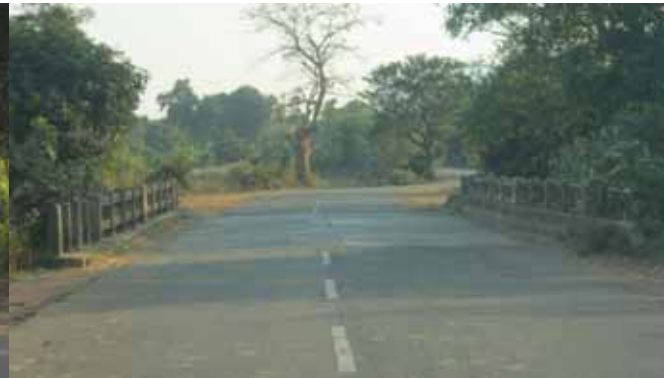
Km 14+100

Km 18+400

Reverse Curves

Recommendations: Provide **curve warning signs, chevron signs, delineators and speed limit sign** as appropriate

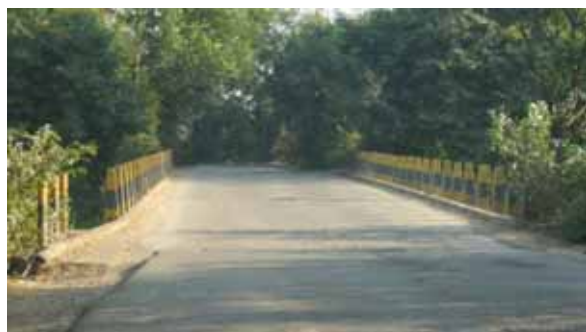
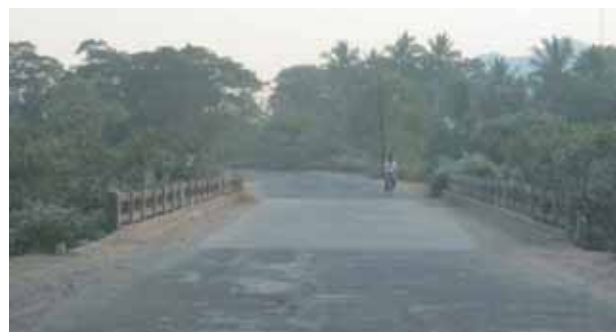
The bridge parapets adjacent to road will be hazardous and these bridges have damaged parapets and hence may cause accident in future. There is no any crash barrier and protection towards the approaching to the bridge.

Km 9+400

Km 23+800

Bridge Parapets and Approaches

Reasons for concern: The bridge/ culvert parapets on the edge of the road adjacent to high speed traffic movement will be hazardous, particularly at dark conditions, and needs to be illuminated for a driver to judge the position of such road side hazard.

Recommendations: Provide crash barriers on either approaches of the structures with delineators

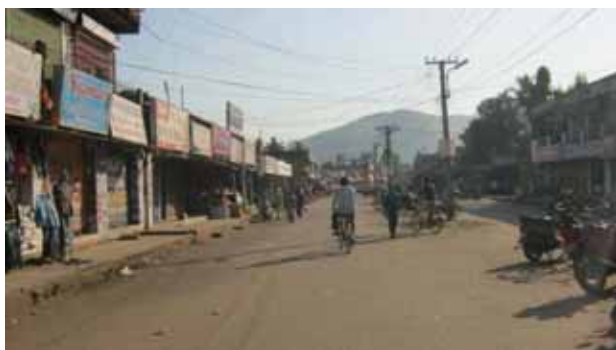
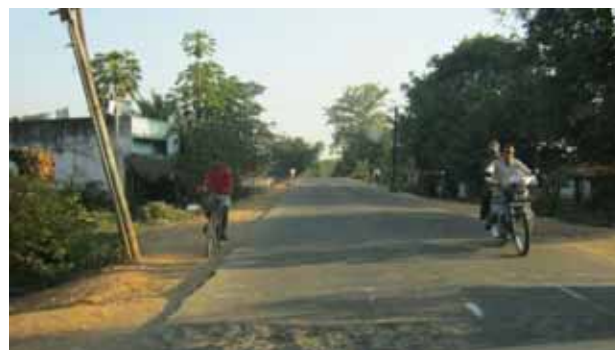
Km 0+000 (Rayagada)

Km 14+800 (Jamadeipada village)

Built up area/Road side villages

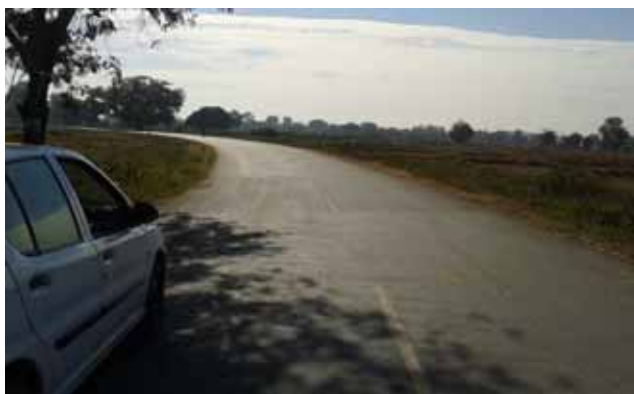
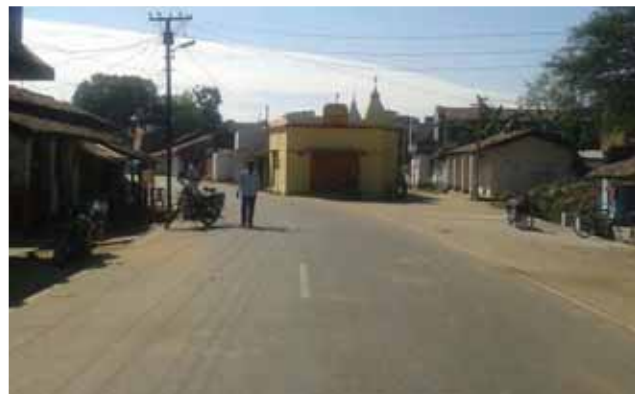
During the course of assessment, the consultant has carried out average speed and spot speed survey. The average speed and maximum speed were noted for one trial run on the road during 12:00 hrs to 13:00 hrs, from Km 328+000 to Km 316+900. An average speed of 65 km/ hour and a maximum speed of 70 km/ hour was noted during this survey. A spot speed was conducted on approach of the curve at Km 312+000, and the 85th percentile speed was found to be 61 kmph.

Sharp curve at Km 312+000 and Km 316+000 (in BUA)

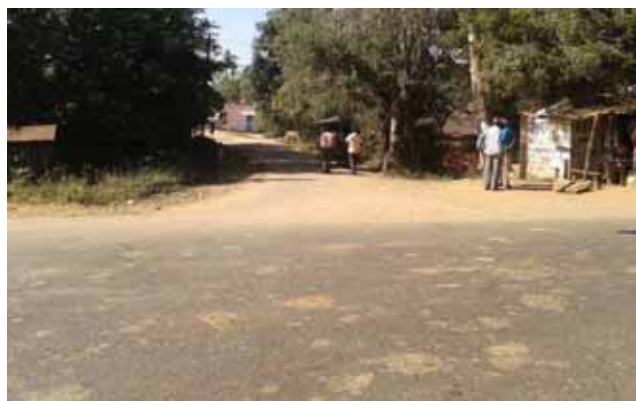
Restricted visibility from access road due to buildings and trees on corners, Km 312+900

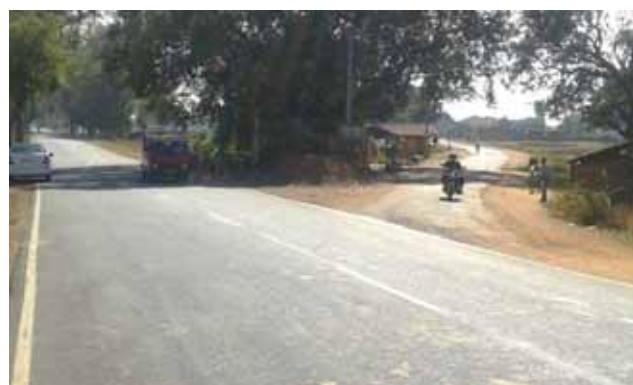
Access road joining NH-49 at skew angle, Km 319+800
