**Government of Odisha (GOO)
Chief Engineer, World Bank Projects, Odisha
Odisha State Roads Project**

**Consultancy Services for
Road Sector Institutional Development
Loan # 7577-IN**

**ROAD INFRASTRUCTURE
SAFETY MANAGEMENT REVIEW**

VOLUME I - REPORT

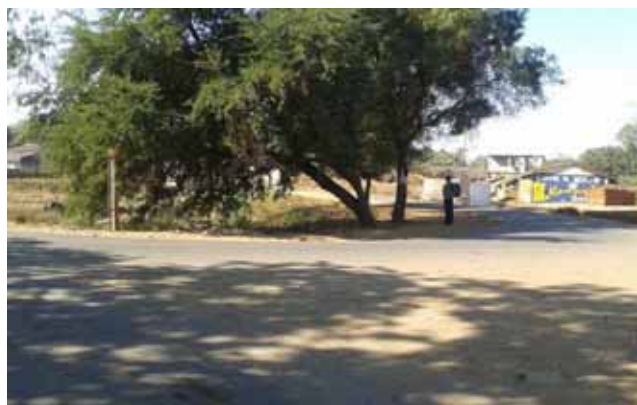
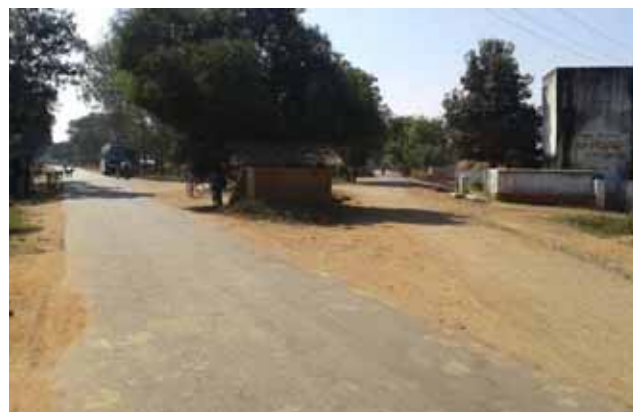
- NH-49 intersects with SH-24 (Kuchinda – Bamra road) at this place forming a y-type junction
- There is no control over traffic movement at this junction
- There are buildings in the middle of intersection forming island which obstructs visibility
- Lack of street lights

Km 310+200, intersection of NH-49 with SH-24 – built up area and buildings in the middle of intersection

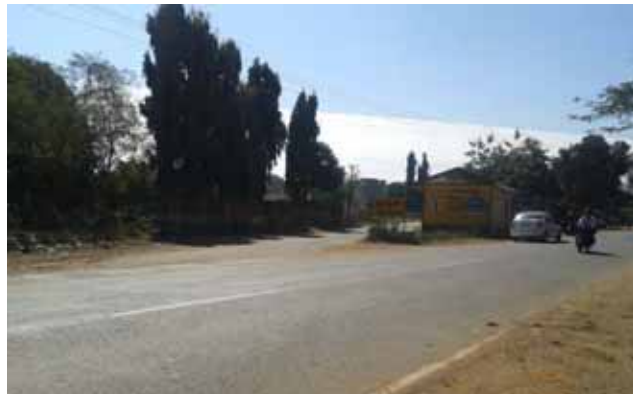
- A major town road of Kuchinda intersects with NH-49 at this place
- Lack of street lights

Km 314+600, intersection of NH-49 with Kuchinda town road (north of Kuchinda)

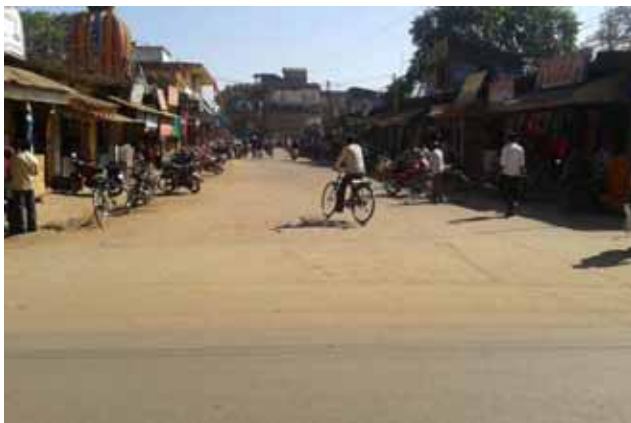
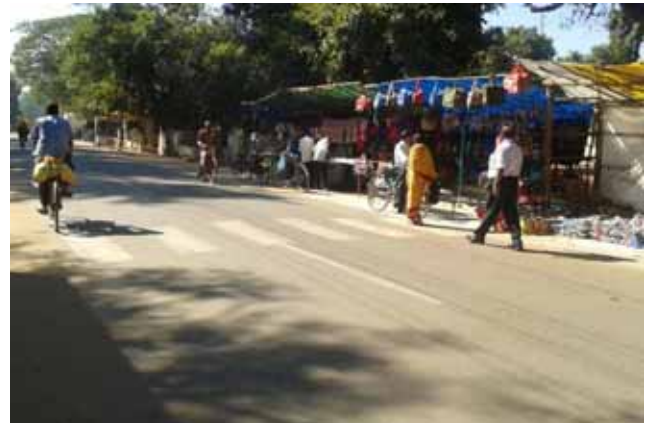
- At this place Kuchinda-Kusumi Road (MDR) joins with NH-49
- There is no control on traffic movement at this junction
- The shoulders are encroached by roadside vendors and the buildings are very near the road edge

Km 315+200, intersection of NH-49 with MDR (Kuchinda-Kusumi Road)

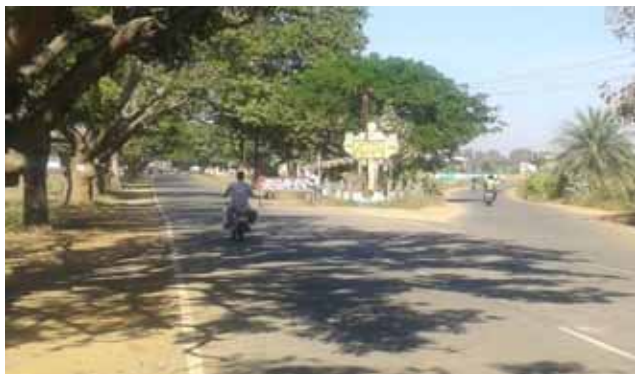
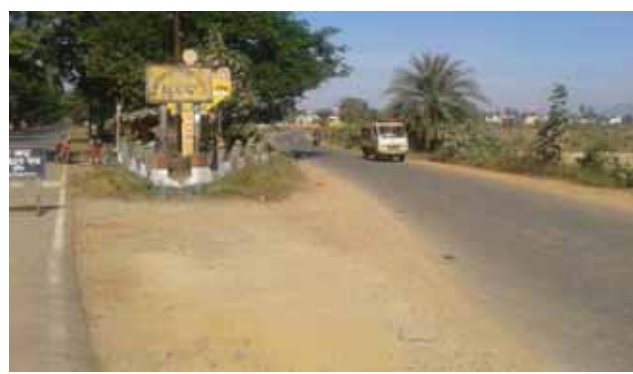
- A major town road of Kuchinda intersects with NH-49 at this place
- This is a y-type non-standard junction without any provision for traffic control
- There is an island with buildings and trees at the intersection which restricts the visibility of two approaches

Km 316+900, intersection of NH-49 with Kuchinda town road (south of Kuchinda) – non-standard island with buildings and trees obstructing visibility

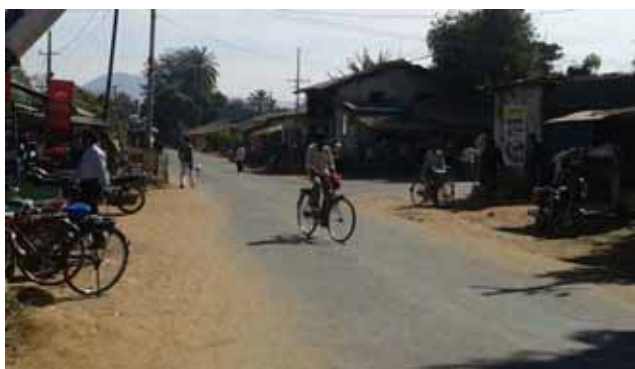
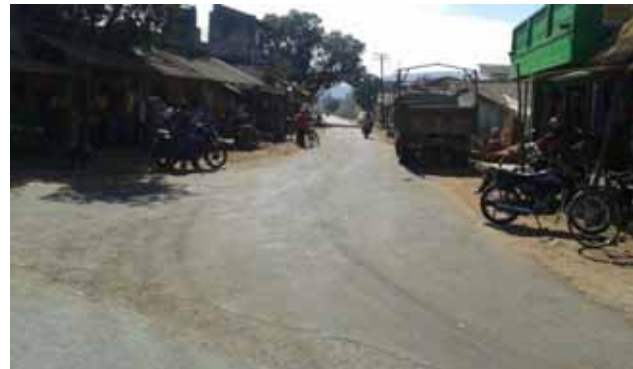
- Bhojpur-Jamankira road (MDR) joins NH-49 at this place.
- The visibility from all the three approaches of the intersection is severely restricted due to the buildings quite close the road edge.
- There is no control on traffic movement at this junction

Km 328+300, intersection of NH-49 with MDR (Bhojpur-Jamankira road)

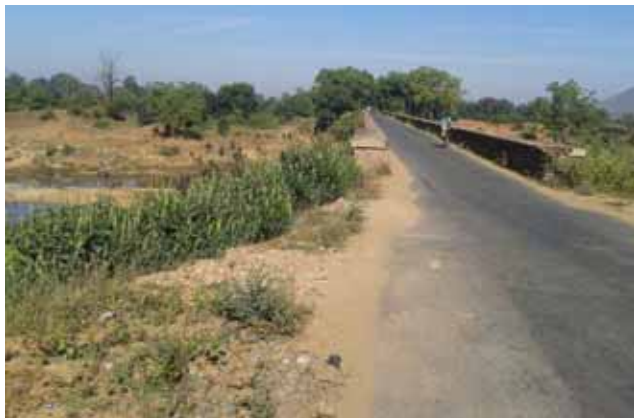
Bridge at Km 313+300, no edge protection on approaches

| Recommendations: | Provide crash barriers on either approaches of the structures with delineators <i>Refer to Appendix III for guidelines to treatments on approaches to bridges</i> |

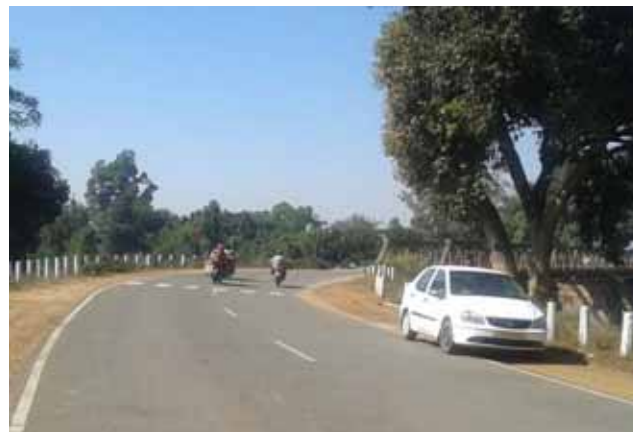
Bridge at Km 317+400, Sharp curve on approaches

| Recommendations: | Improve delineation of the approach curve by providing, <ul style="list-style-type: none">• Chevron signs and curve warning signs• Edge marking and continuous center line <i>Refer to Appendix III for guidelines to treatments on approaches to bridges</i> |

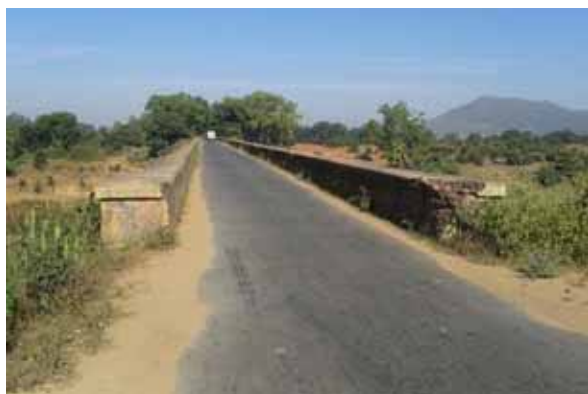
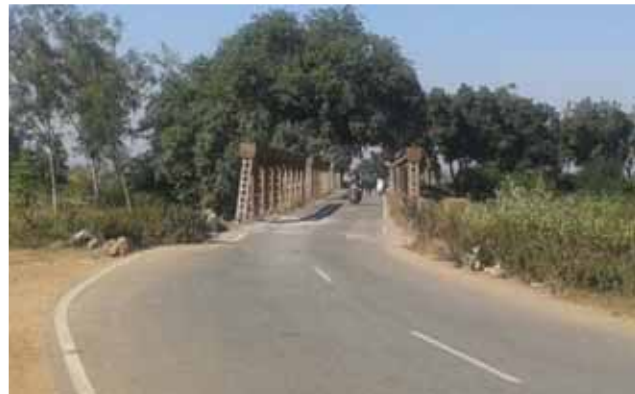
Parapets of bridge not delineated, Km 313+300 and Km 317+400

| Reasons for concern: | No delineation of bridge parapets The bridge parapets adjacent to high speed traffic movement are hazardous especially at night if not delineated as the driver cannot judge the position of such road side hazards. |

| Recommendations: | Provide edge line markings and Object Hazard Marker (OHM) on both sides and for both approaches (i.e. Four numbers of OHM for each structure). <i>Refer to Appendix III for guidelines for installation of object hazard markers</i> |

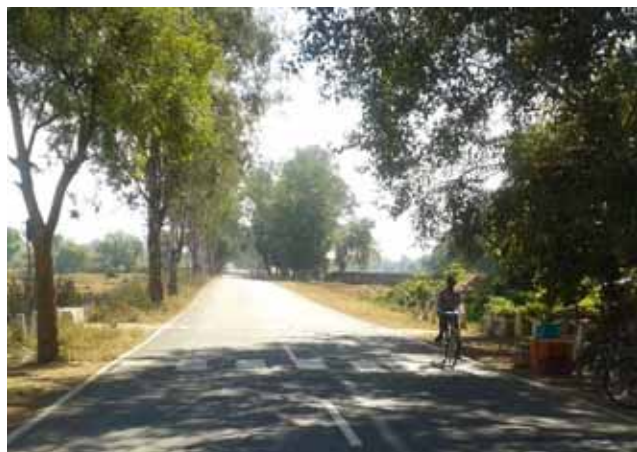
| Reasons for concern: | <ul style="list-style-type: none">• The road side objects like trees, street light or other poles, buildings, and unprotected deep drains which are near the edge of road needs to be protected and/or delineated.• At night time it becomes very difficult for drivers to judge the position of such road side hazard.• If the road side objects are not protected and/or illuminated there are chances of driver losing control and hitting these objects which may result into fatal accident. |

Trees very near the road edge, Km 319-320

| Recommendations: | Desirable: <ul style="list-style-type: none">• Remove Trees/ street lighting poles from the road shoulders• Remove encroachments from the right of way• Provide crash barriers on locations where trees acts as a significant hazard and where the space is available to install crash barrier Essential: <ul style="list-style-type: none">• Delineate the hazards by installing OHMs or painting of the trees in black and white strips• Remove encroachments on at least 2m from the road edge |

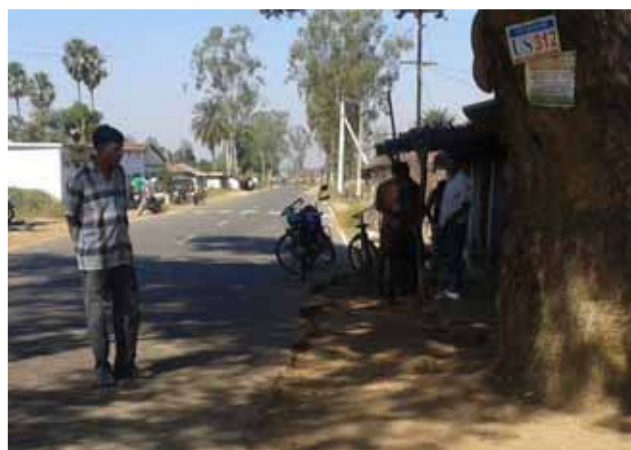
Buildings and poles very near the road edge in BUA, Km 321-322

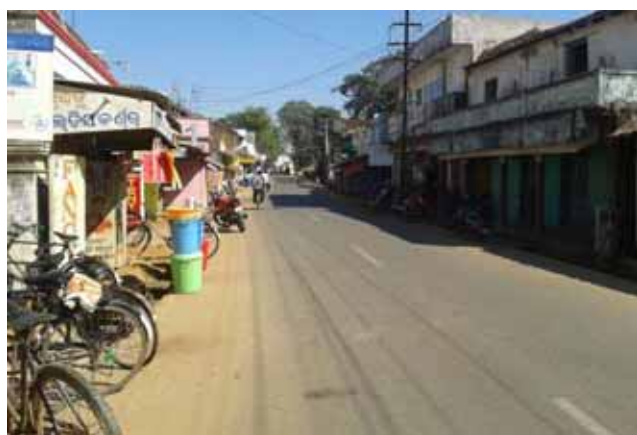
On-street parking and commercial activities on road in Kuchinda, Km 14+000 to 16+000

- No speed limit signs provided
- On street parking hampers the visibility and resulting in unsafe situations
- On street bus stops observed, which hampers visibility and unsafe overtaking maneuvers.

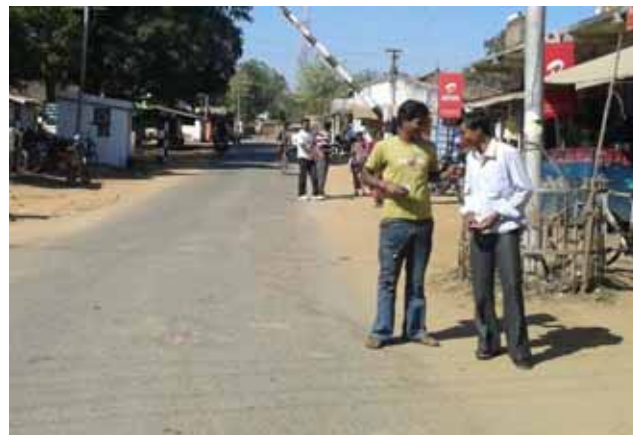
Buildings near the road edge in Bhojpur, Km 328+000 to 328+300

Recommendations: Regulate roadside commercial activities and remove encroachments, if any.

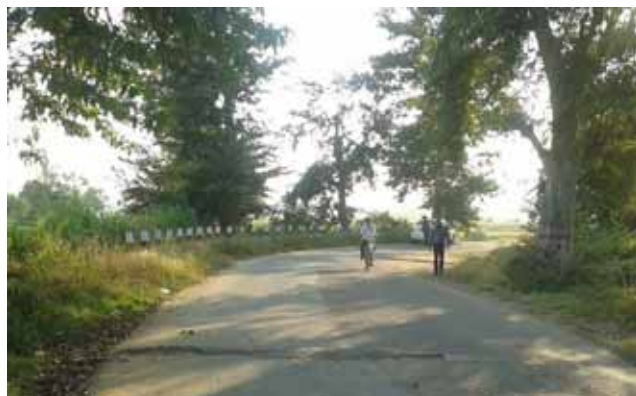
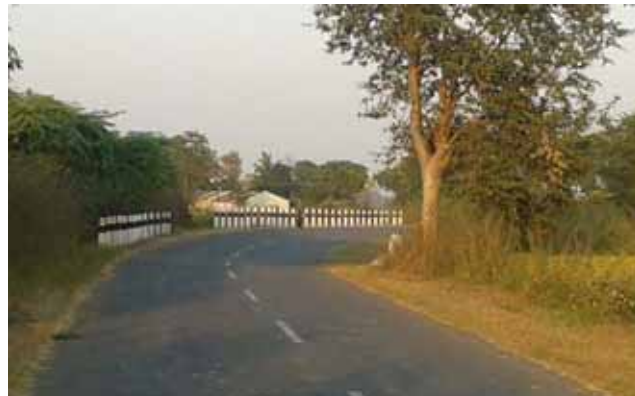
Image 1.1: Sharp curve with restricted visibility at Km 0+400 and Km 3+800

| Recommendations: | Provide curve warning signs, chevron signs, delineators and speed limit sign as appropriate <i>Refer to Appendix III for guidelines on treatment on curves.</i> |

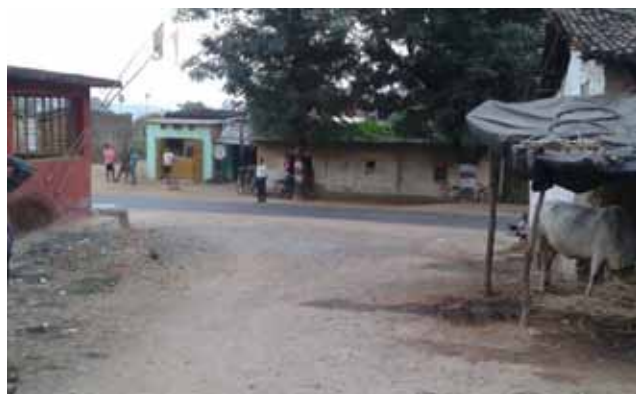
Restricted visibility from access road due to buildings on corners, Km 6+500

This is a major hazard observed on most of the 3-armed uncontrolled junctions. The major reasons for poor visibility at such junctions on SH-15 are due to buildings on the corners.

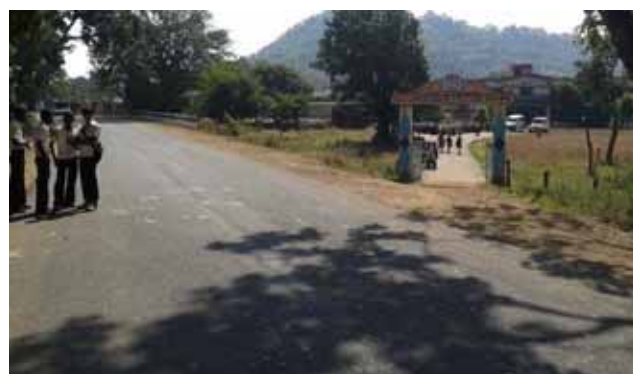
Access road joining SH-15 at skew angle and with steep gradient, Km 24+200

- It has been observed that on few junctions, the level difference between the side road and major road and the vertical profile of the side road joins the edge of main carriageway in an unsafe manner.

Recommendations: Correct the vertical alignment of side road so that vehicles approaching from side roads has adequate length on the side road to slow down/ stop before entering into the main carriageway.

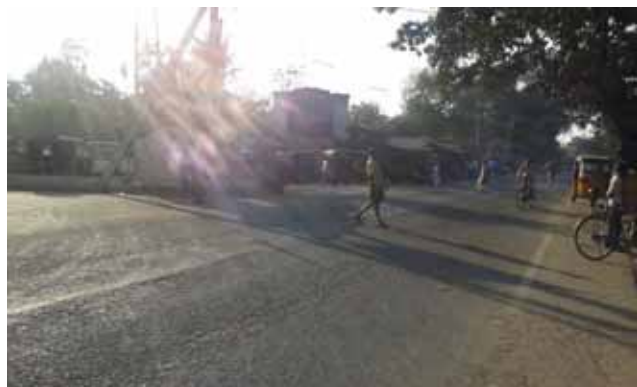
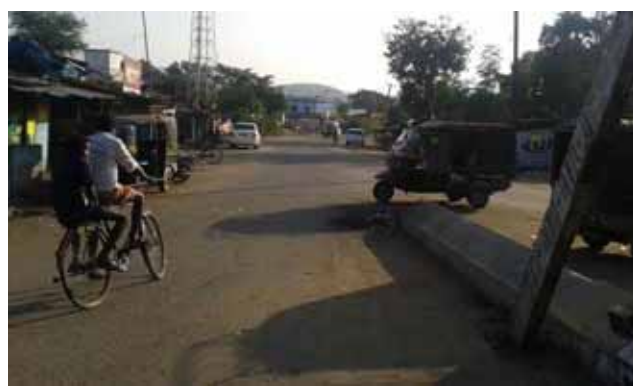
- NH-42 is having 2-lanes and carries significant motorized traffic, whereas SH-15 is having intermediate lane with less motorized traffic but significant amount of non-motorized traffic.
- There are no street lights or facilities for pedestrian crossing and footpath.

Km 0+000 Intersection of SH-15 with NH-42 –
building in the middle of intersection, vehicles parked on road and presence of VRUs

- There are no parking spaces provided and vehicles are parked on road encroaching the road and shoulder space.
- This hampers visibility at the junction and force pedestrians to move into the centre of the road resulting in hazardous situation.

Recommendations: Remove the encroachment/obstruction and provide splitter islands to enable safe movement of motorized and non-motorized traffic.

Recommendations: Provide designated parking spaces for vehicles.

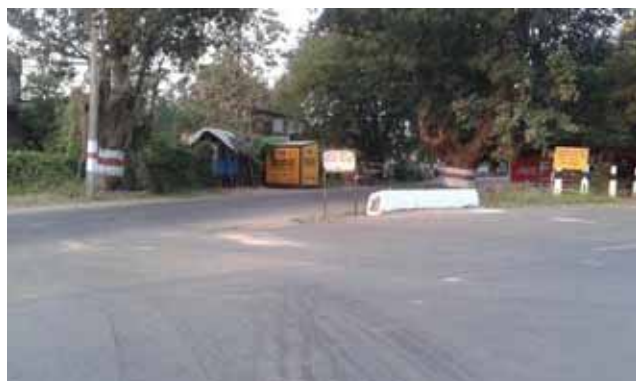
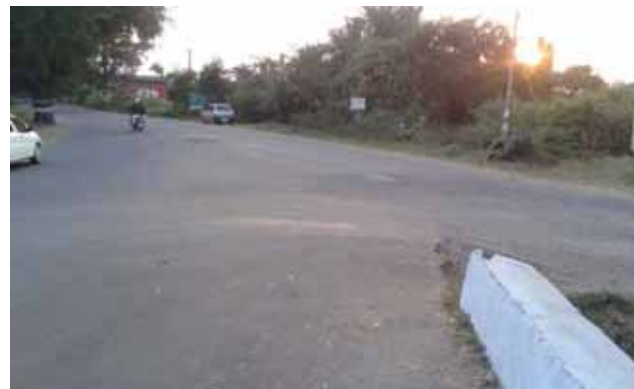
Km 5+100 intersection of SH-15 with link road - lack of road markings and delineation

| Recommendations: | <ul style="list-style-type: none"> • Provide edge line markings, centerline markings and other road markings pertaining to junction control. <p><i>Refer to Appendix III for guidelines for traffic signs and road markings on 3-arm intersection</i></p> |

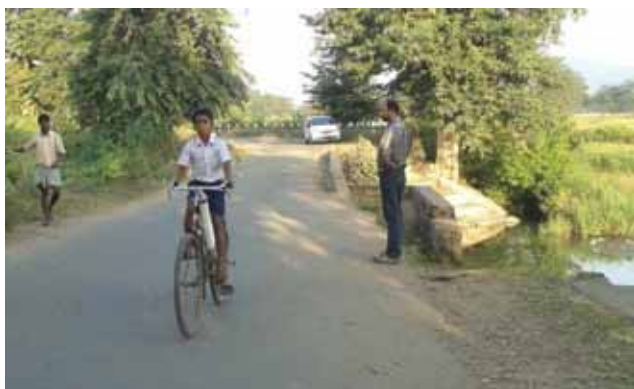
Culvert at Km 0+400, sharp curve at the approach

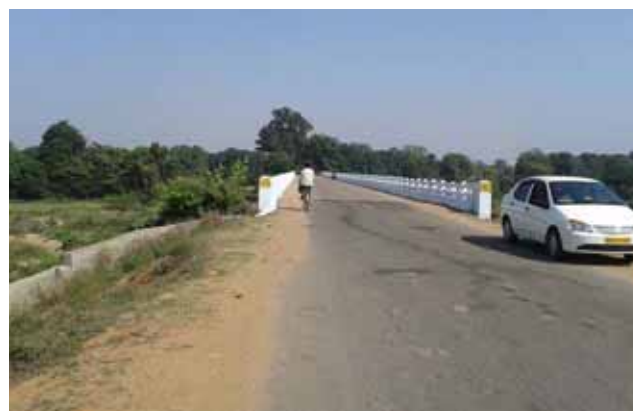
Bridge at Km 20+600, No protection on approaches

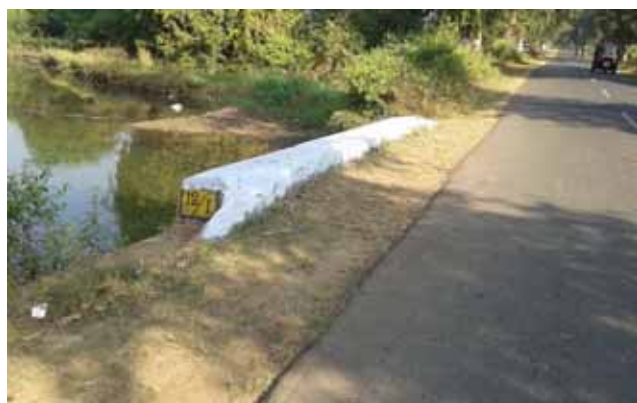
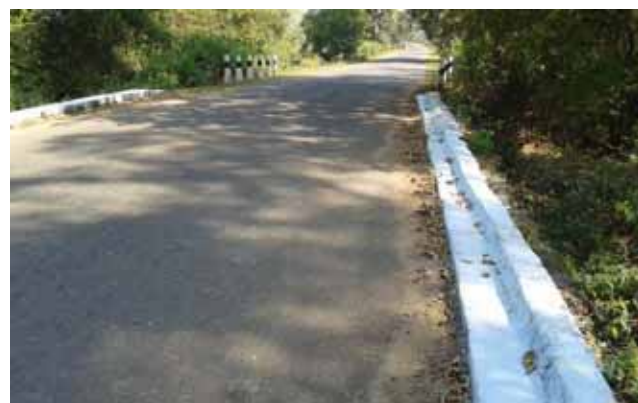
No parapets on Culvert/Bridge highly unsafe for VRUs as well as other traffic, Km 12+000 and Km 20+000

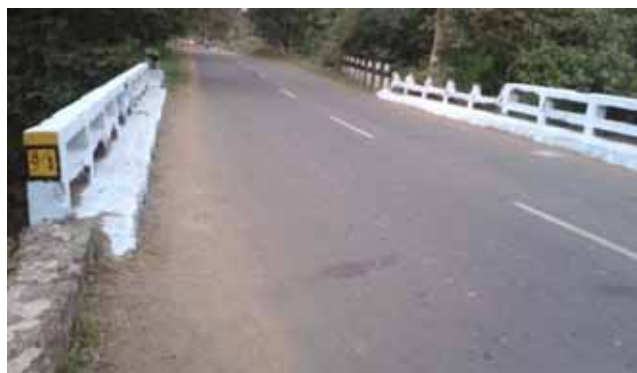
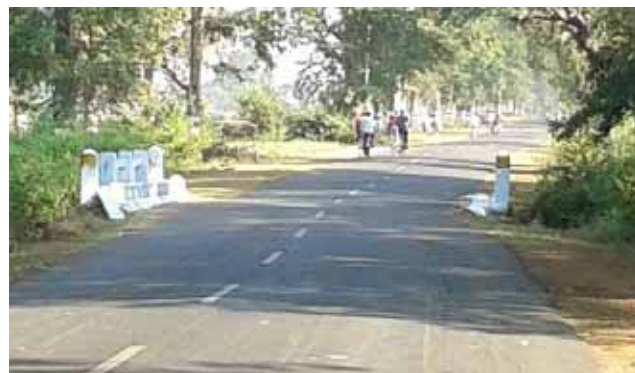
Parapets of Culvert/Bridge not delineated, Km 8+500 and Km 11+700

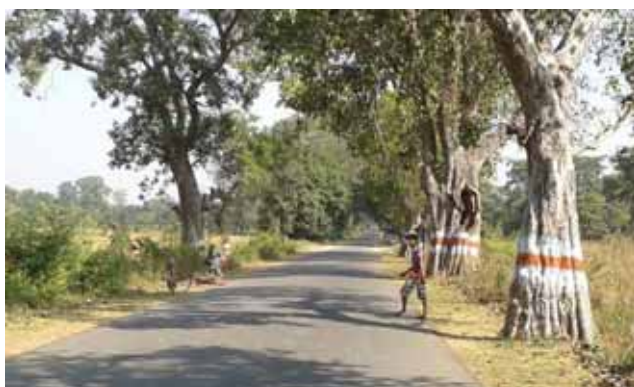
Tree very near the road edge, Km 19-20

- Delineate the hazards by installing OHMs or painting of the trees in black and white strips
- Remove encroachments on at least 2m from the road edge

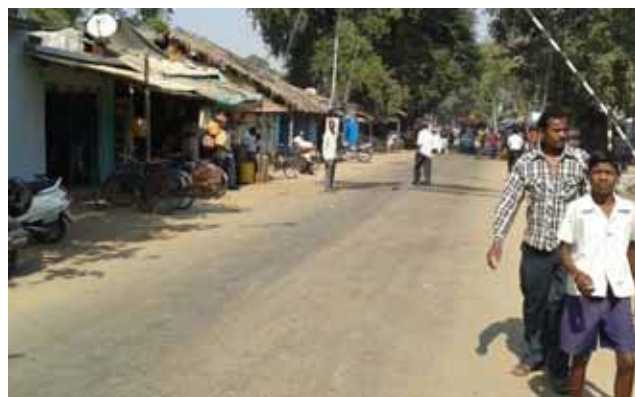
Buildings very near the road edge in BUA, Km 23-24

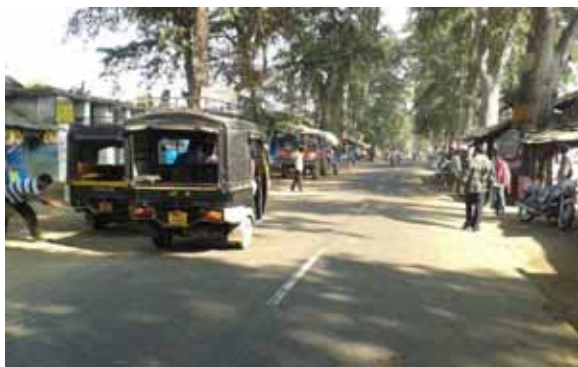
On-street parking and commercial activities on road in BUA, Km 15.600 to 15.900

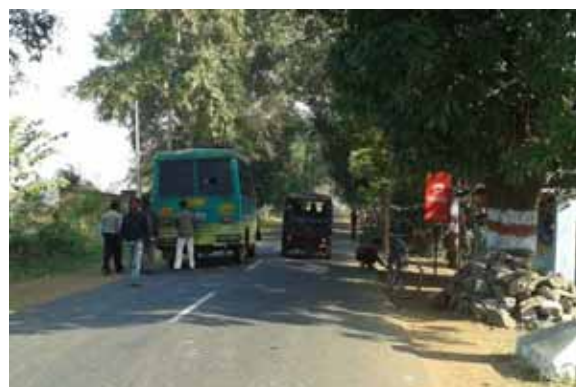
Buses stopping on the road in BUA, Km 9+900 to 10+000

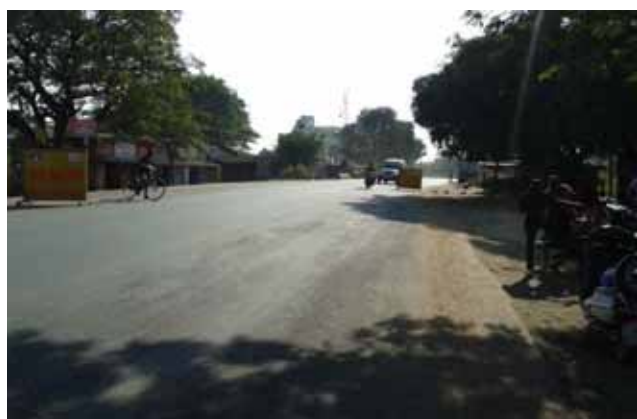
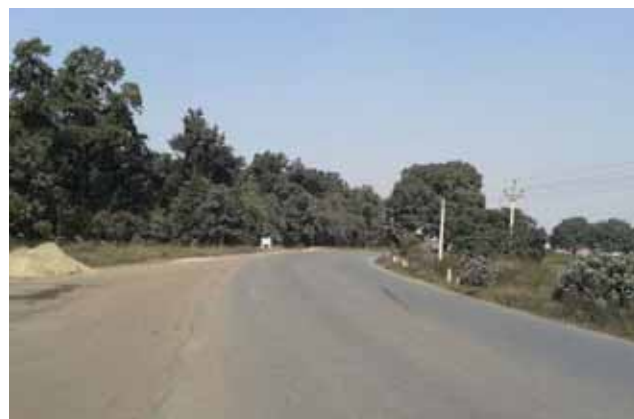
Lack of any road markings on the stretch from Km 6+000 to 7+000 and Km 36+000 to 37+000

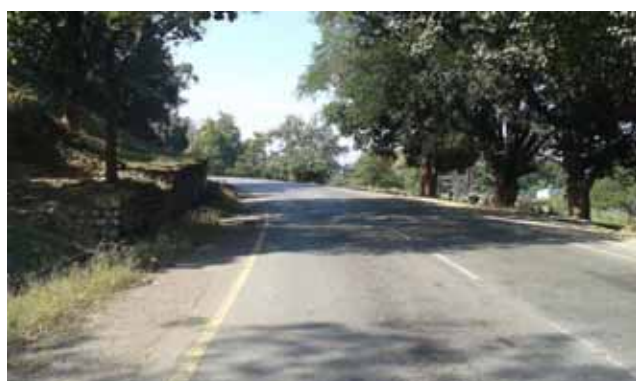
Sharp curve where visibility is obstructed due to wall and trees (on LHS), Km 107+800

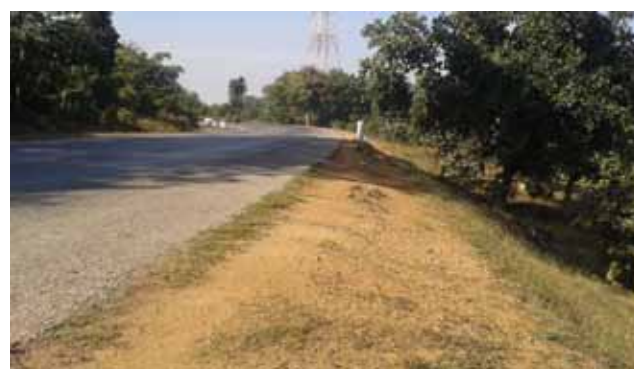
Sharp curve with high embankment without any protection on outer edge, Km 93+600

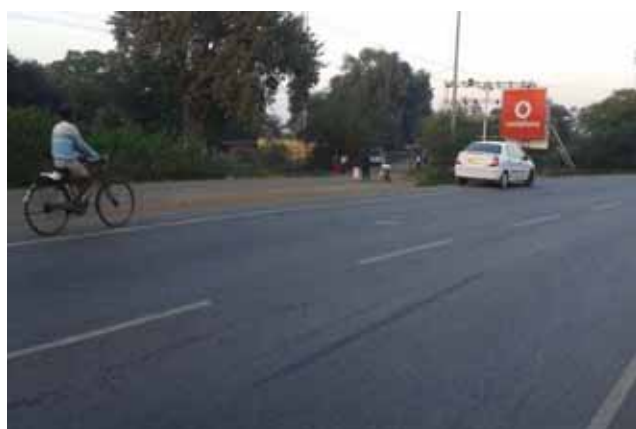
Side Road joining SH-10 at acute angle, Km 149+800

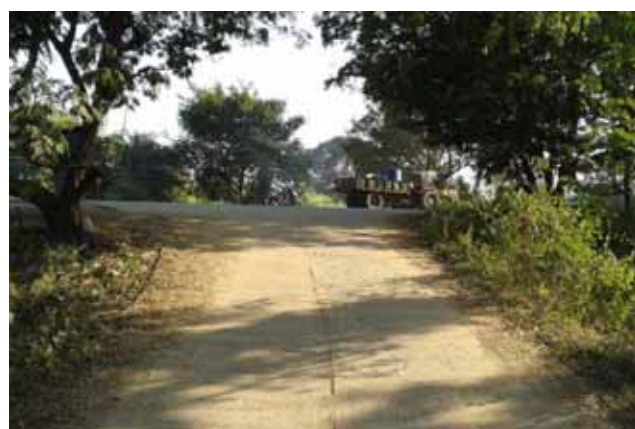
Side Road joining SH-10 at steep gradient, Km 12+900

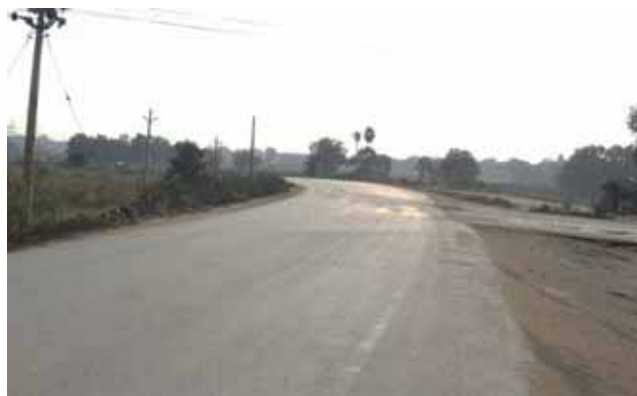
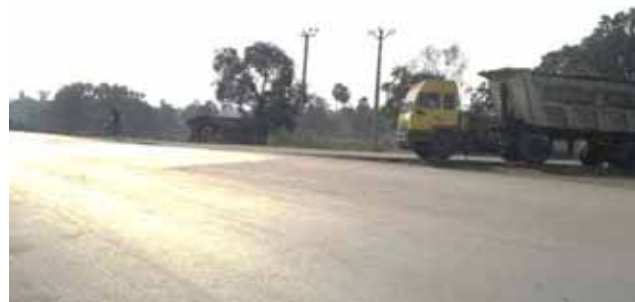
Side road joining SH-10 on curve, Km 35+800

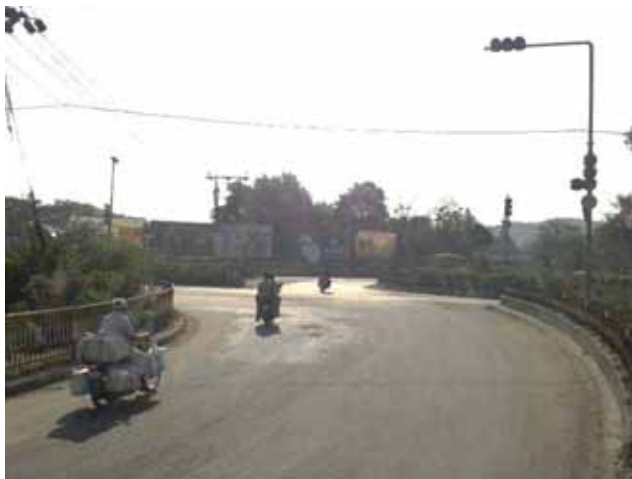
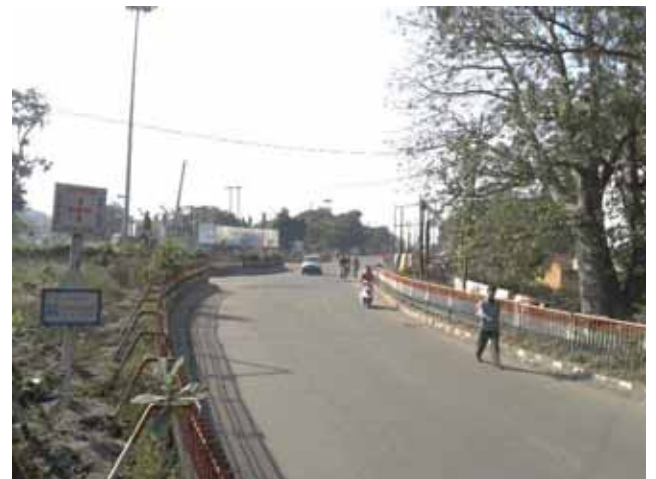
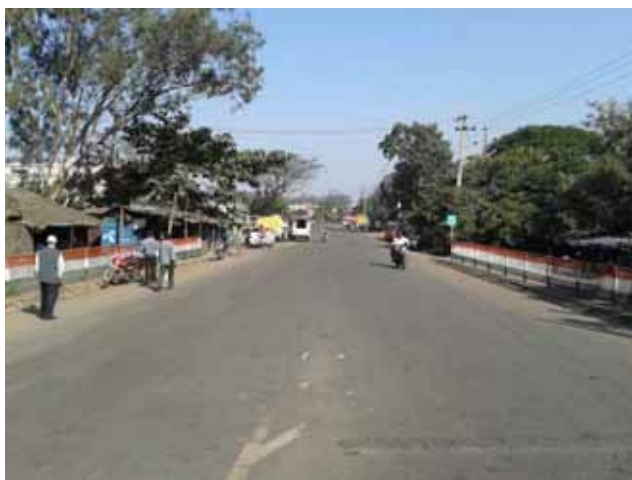
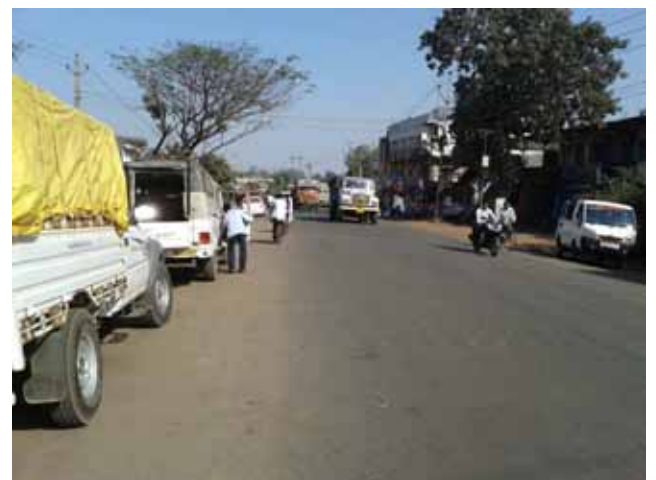
- Junction layout is fine.
- Busy junction of NH6 with SH10, having significant movement of heavy vehicles
- Traffic signal lights provided, but in not synchronized
- Footpaths are provided in the junction area on all the approaches, but there are no facility for pedestrian crossing
- There are no encroachments in the junction area on SH-10 approach, however the footpaths are encroached with trees and small shops
- Street lights are provided on the approaches of the junction

Round-about at Km 4+922, commercial establishments and on-street parking on its approach

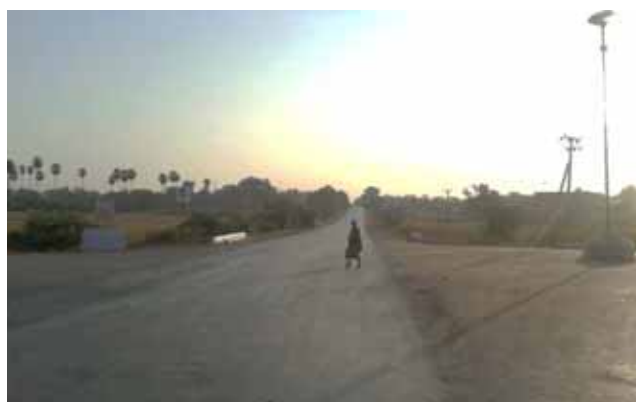
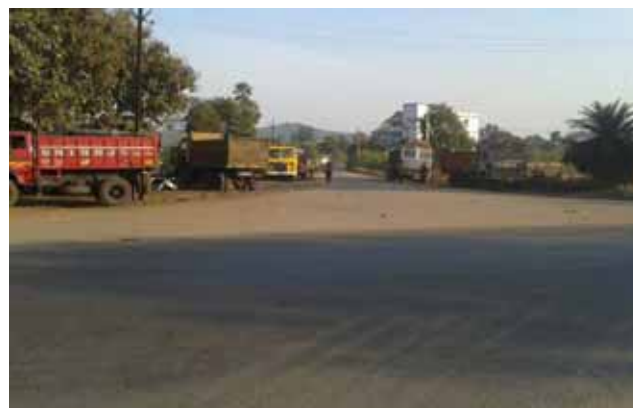
- Junction layout is non-standard and has no established control over the traffic movement

Km 83+800, intersection of SH-10 with Sundargarh town road

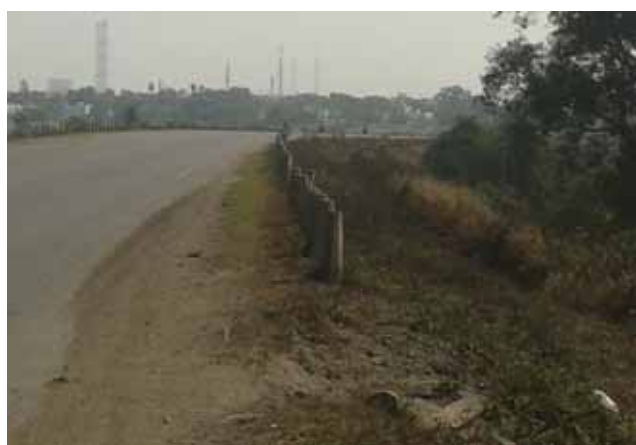
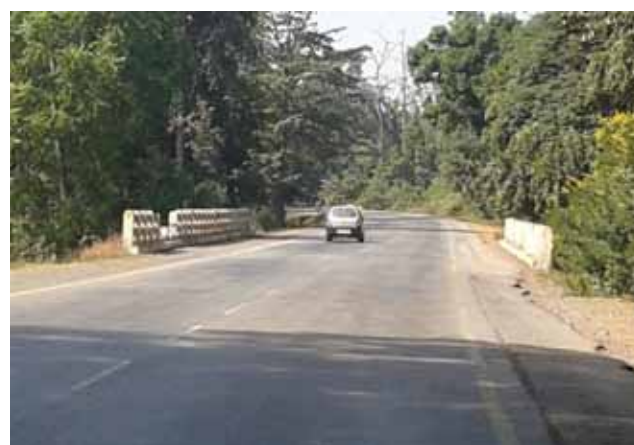
No edge protection on approaches of ROB at Km 49+900 and Bridge at Km 101+600

Recommendations: Provide crash barriers on either approaches of the structures with delineators
Refer to Appendix III for guidelines to treatments on approaches to bridges

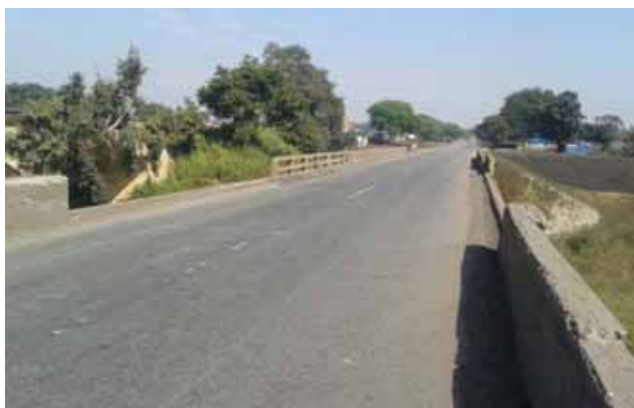
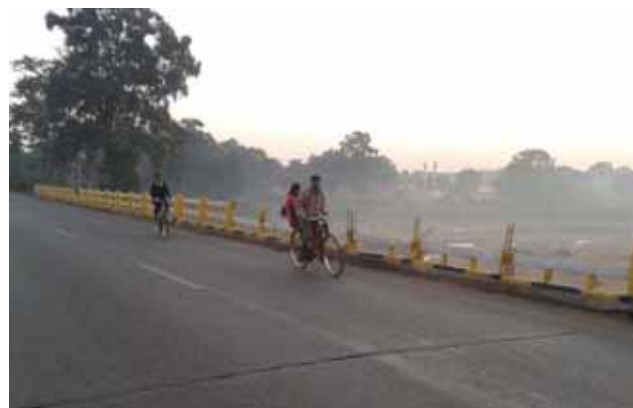
*Broken parapets of Bridge highly unsafe for VRUs as well as other traffic,
Km 117+100 and Km 154+200*

The absence of parapet on bridge/culvert increases the risk of vehicles falling on to the canal. In the context of high speed traffic movement observed on SH-10, the absence of parapets at such locations is hazardous for traffic, especially for VRUs.

Recommendations: Provide continuous parapets on all culverts and bridges.

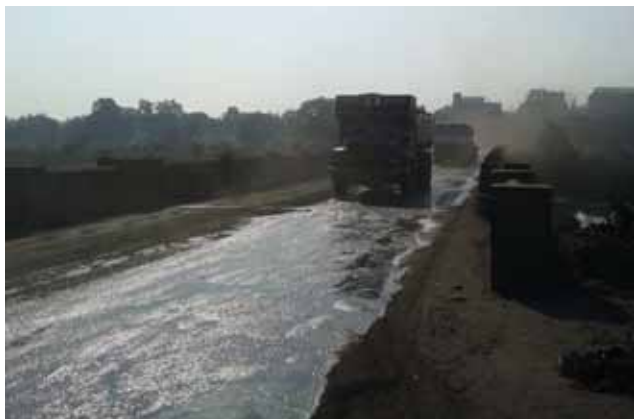
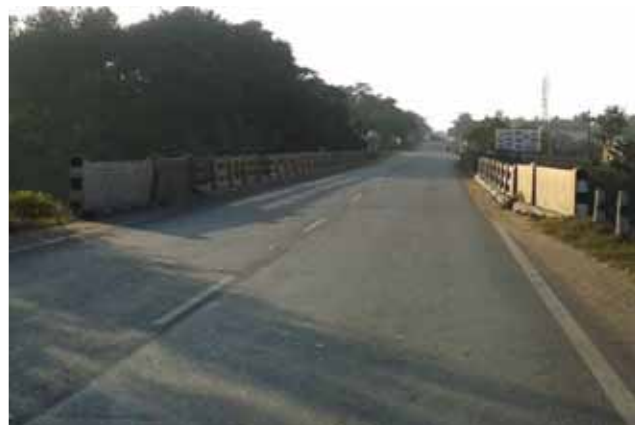
Parapets of Bridge not delineated, Km 32+200 and Km 165+400

- The bridge parapets adjacent to high speed traffic movement are hazardous especially at night if not delineated as the driver cannot judge the position of such road side hazards.

- Provide edge line markings and Object Hazard Marker (OHM) on both sides and for both approaches (i.e. Four numbers of OHM for each structure)

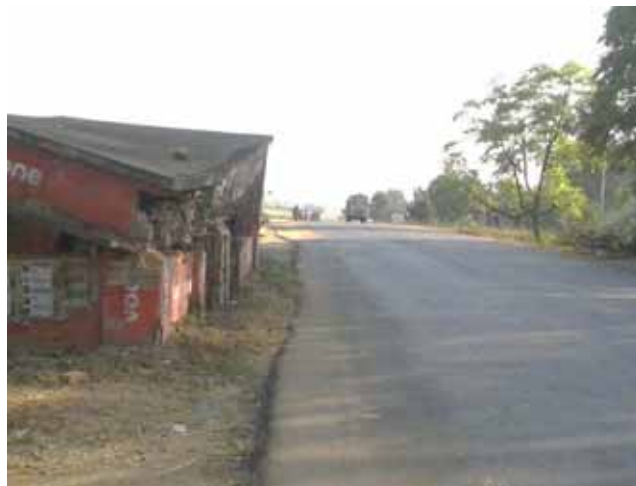
Building (LHS) and Tree (RHS) very near to the road edge,
Km 60+000 to 61+000

Reasons for concern: Roadside objects constitute a significant hazard, if the driver loses control and will result in major injuries/ fatalities

- Remove Trees/ street lighting poles from the road shoulders
- Remove encroachments from the right of way
- Provide crash barriers on locations where trees acts as a significant hazard and where the space is available to install crash barrier

- Delineate the hazards by installing OHMs or painting of the trees in black and white strips
- Remove encroachments on at least 2m from the road edge

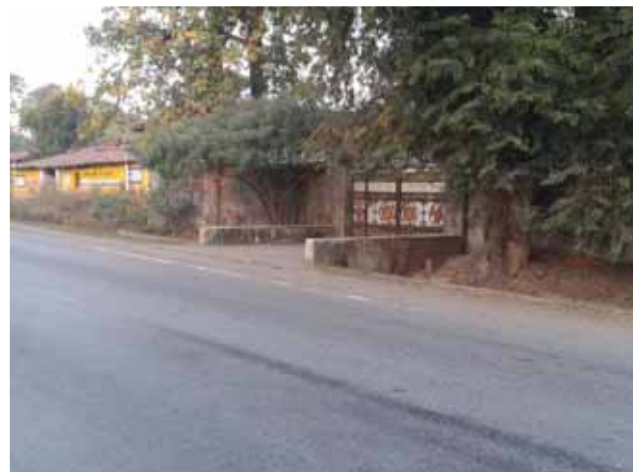
Deep drain and property access very near to the road
edge, Km 74+000 to 75+000

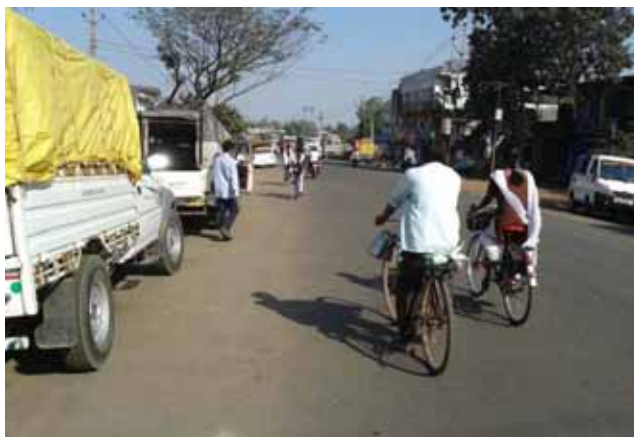
Vehicles parked on road in BUA, Km 5-6

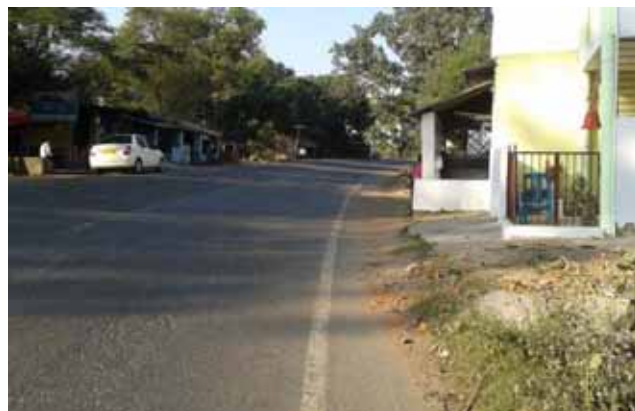
Buildings very close to edge of road in BUA, Km 62-63
Talpatia village

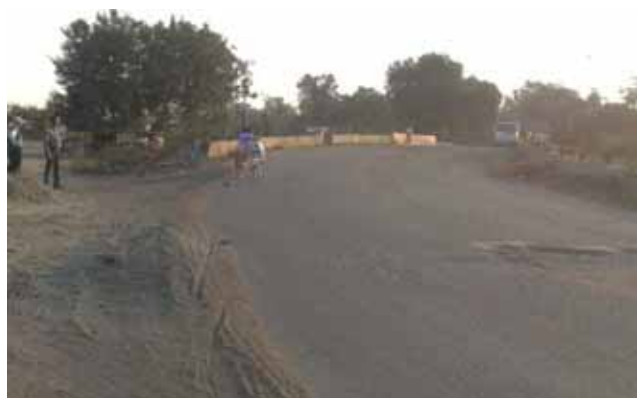
- ROB is at the end of a sharp curve (radius <75m) and there is an access road merging with SH-10 at this location
- No traffic calming measures on major road and side road

As informed by engineers from OWD, the approach to the ROB is a black-spot location having frequent number of accidents, especially during night conditions.

Access Road (on Left), ROB and Sharp Curve.

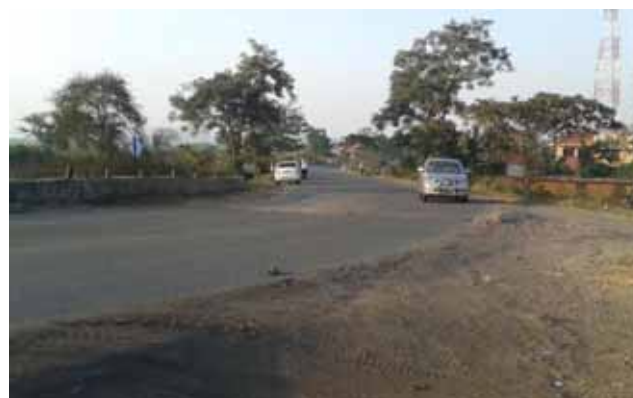
Traffic approaching sharp curve and ROB
(view from the Access Road)

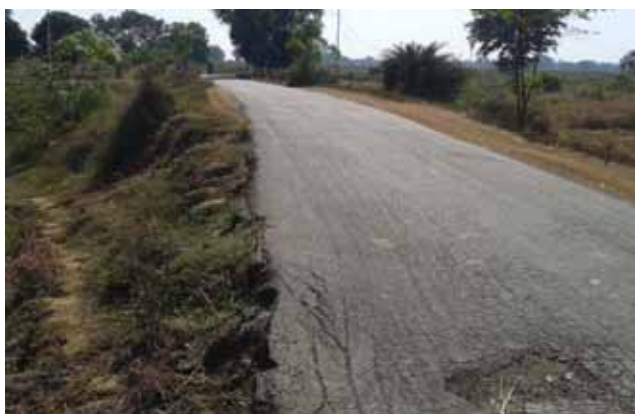
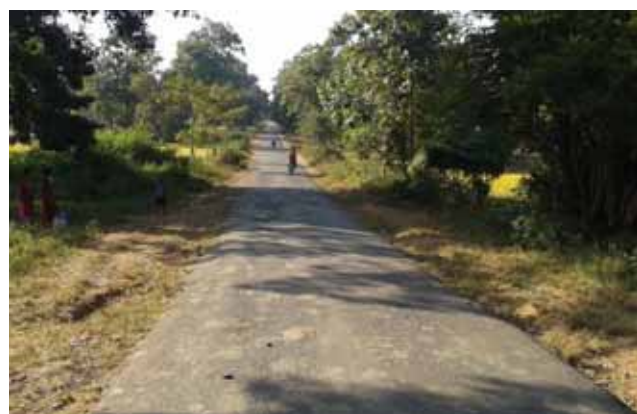
Poor condition of earthen shoulder, Km 155-156 and Km 191-192

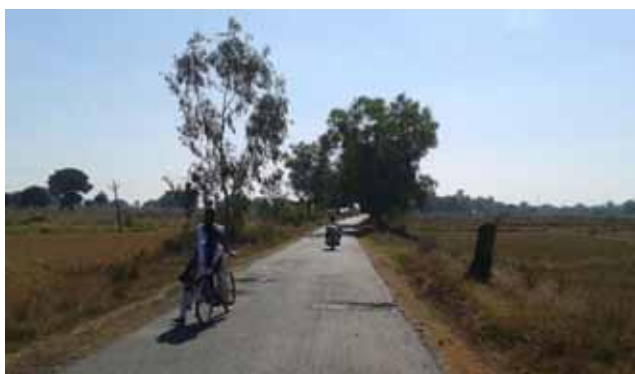
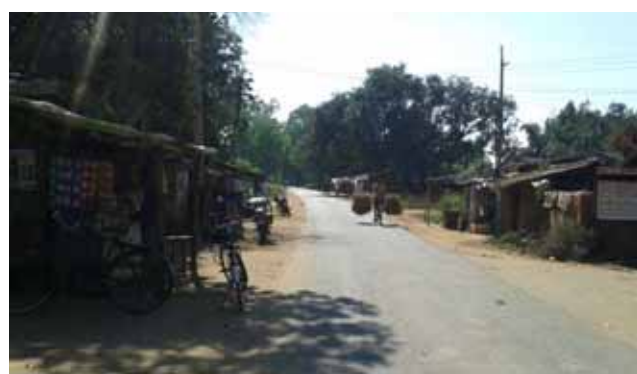
Photographs of SH-24 in rural and urban areas where no road markings are provided (Km 154 to 155, and Km 155 to 156)

- Recommendations:**
- Provide edge line with thermoplastic material throughout the road.
 - Provide centre line with thermoplastic material on intermediate lane road (refer to IRC: 35-1997 for details).
 - Provide edge and centre line RRPMs on sharp curves

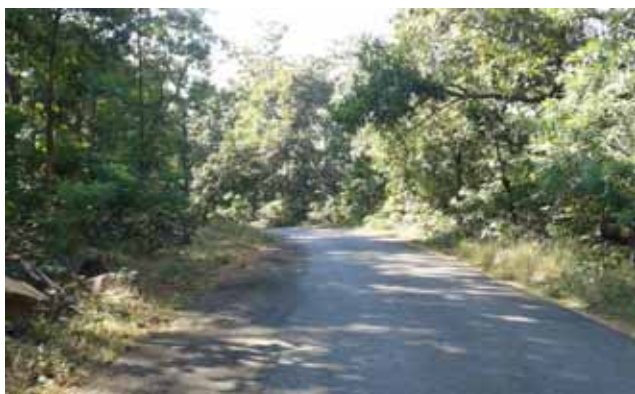
Sharp curve with restricted visibility in forest/ghat section at Km 174+900

| Recommendations: | <ul style="list-style-type: none"> • Improve the line of sight by removing trees from the shoulder and cut down vegetation which hampers visibility along the curves • Provide “no-overtaking” mandatory signs • Provide extra widening (sealed shoulder) |

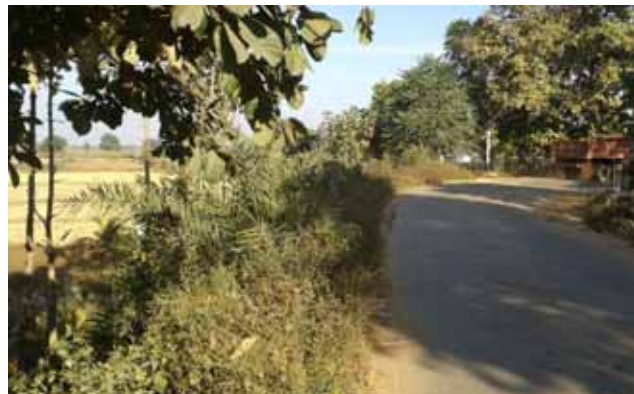
The sharp curve after the railway crossing in Bamra is on high embankment without any edge protection and the condition of earthen shoulder is very poor, hence there is high risk of run-off accidents at this location.

Sharp curve on high embankment without edge protection near railway crossing at Bamra (Km 198+700)

| Reasons for concern: | Curves on high embankment without safety barriers noted <ul style="list-style-type: none"> • Run-off accidents on high embankments will lead to fatalities |

| Recommendations: | Provide metal beam crash barrier with delineators on sharp curves in high embankment <i>Refer to Appendix III for guidelines on situations where to install the above</i> |

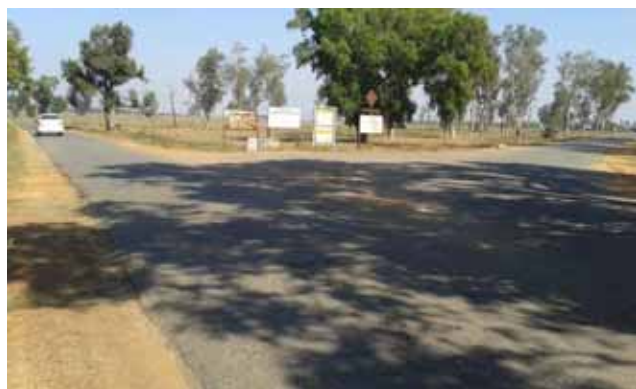
Side road joining at skew angle Km 157+400

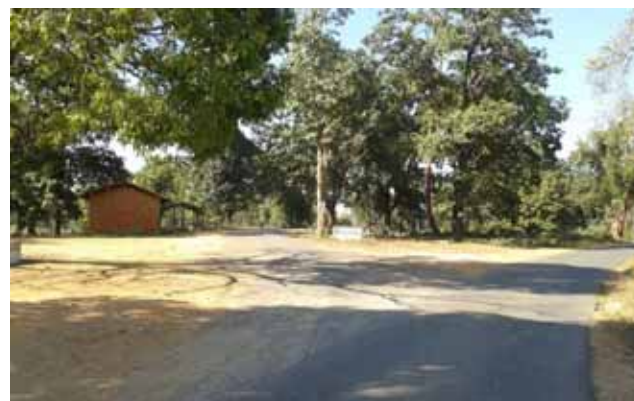
Side road joining on curve, Km 170+100

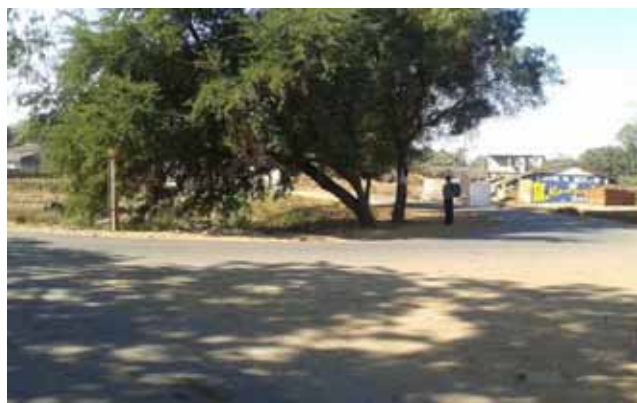
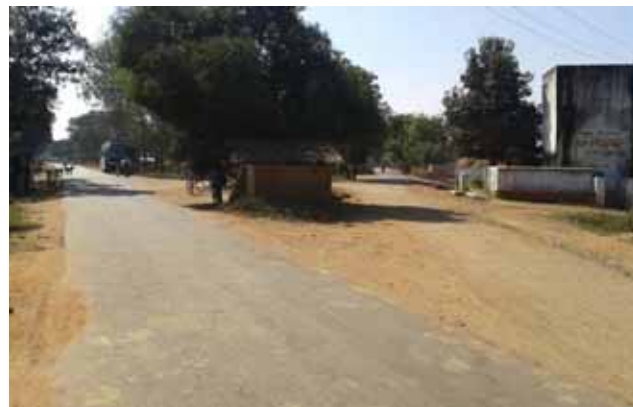
- SH-24 intersects with SH-31 (Gariamal-Bamra road), and a town road forming a 4-arm intersection in the heart of Bamra town.
- There is no control over traffic movement on this junction.
- The buses were observed stopping on the road near the intersection obstructing visibility and smooth flow of traffic.

Km 154+200, intersection of SH-24 with NH-49– built up area and buildings in the middle of intersection

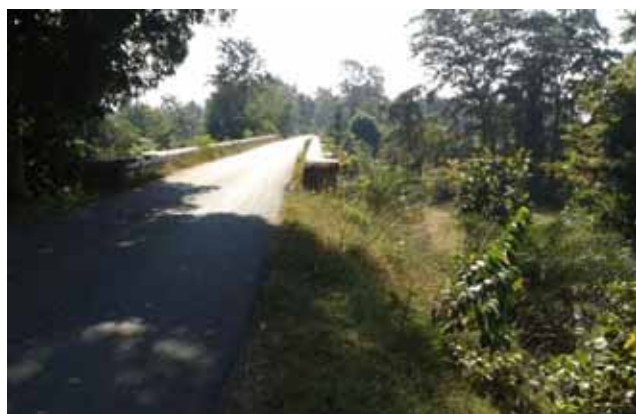
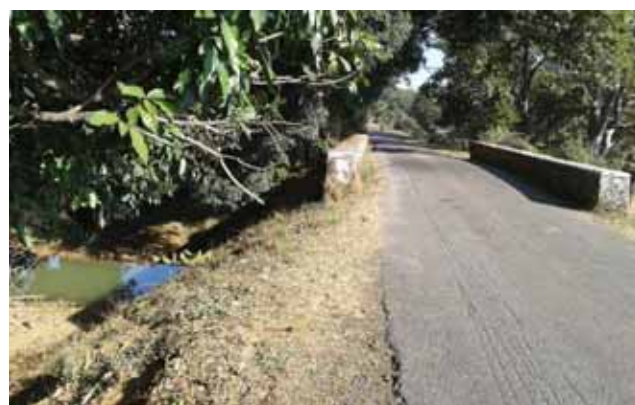
Unprotected approach to bridge with high embankment, Km 164+700 and Km 187+700
