**Government of Odisha (GOO)
Chief Engineer, World Bank Projects, Odisha
Odisha State Roads Project**

**Consultancy Services for
Road Sector Institutional Development
Loan # 7577-IN**

**ROAD INFRASTRUCTURE
SAFETY MANAGEMENT REVIEW**

VOLUME I - REPORT

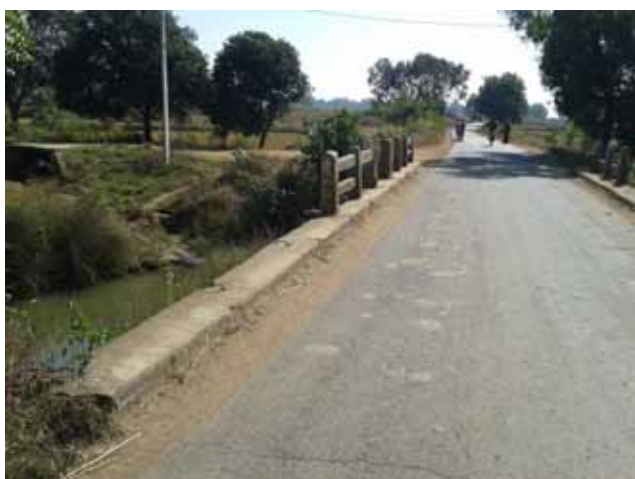
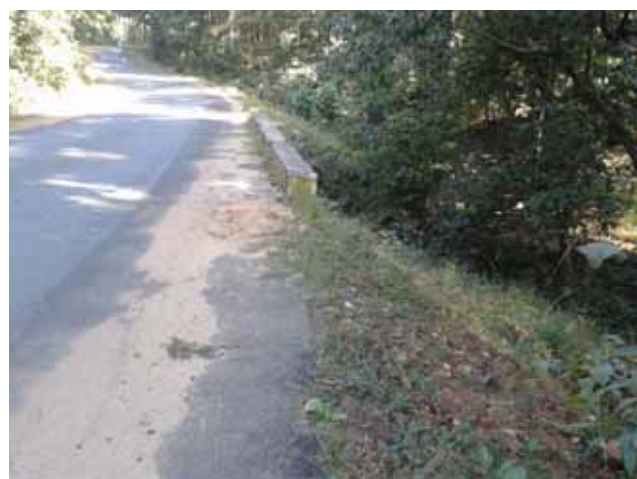
*No parapets on Culvert/Bridge highly unsafe for VRUs as well as other traffic,
Km 155+200 and Km 175+000*

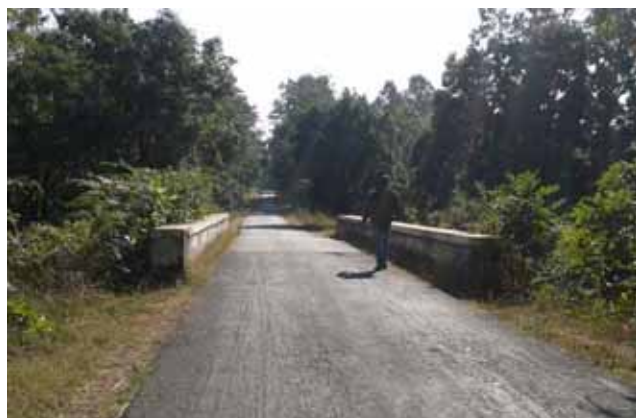
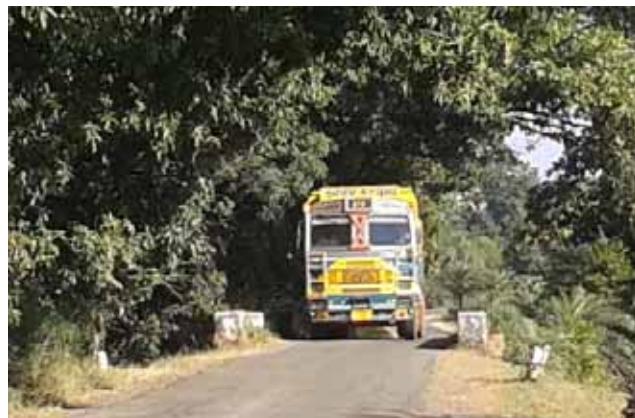
Parapets of Culvert/Bridge not delineated, Km 172+700 and Km 187+700

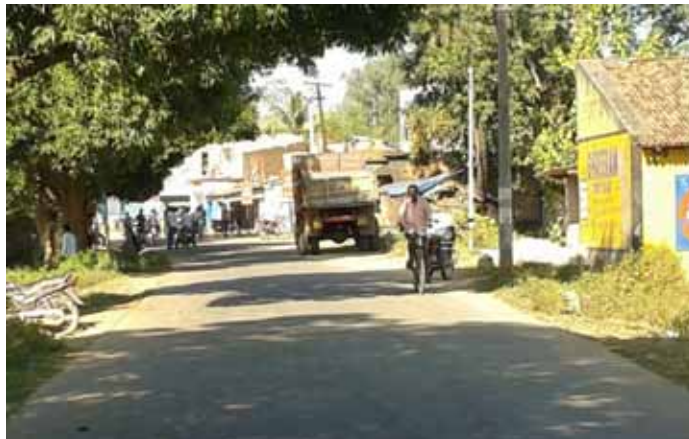
Poles very near the road edge in BUA, Km 169+000-169+700

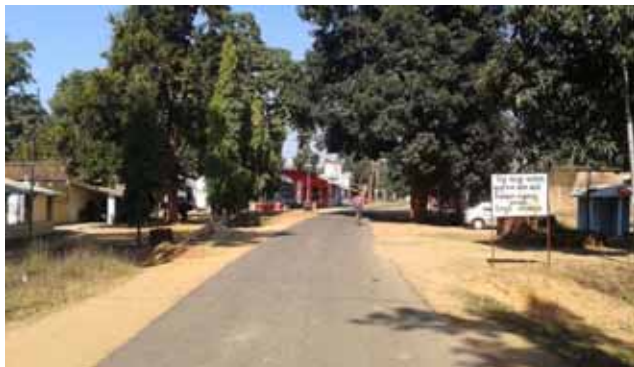
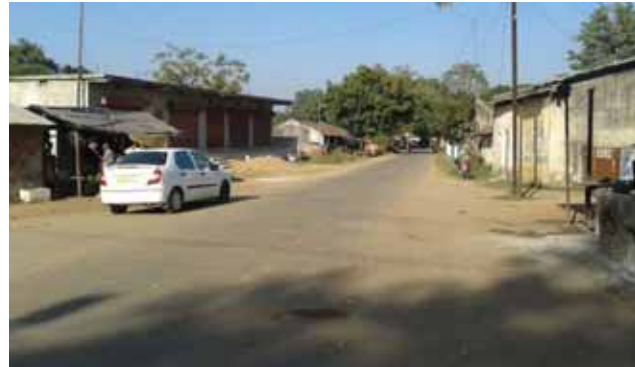
- Km 156+300 to 156+700
- Km 159+500 to 159+700
- Km 165+000 to 165+200
- Km 169+000 to 169+700 (Kesaibahal)
- Km 195+100 to 196+600 (Bamra)
- Kesaibahal and Bamra are the only two major town/village on the section of SH-24 assessed.
- At none of the above mentioned locations the street lights are provided.

Built up area of Kesaibahal and Bamra village

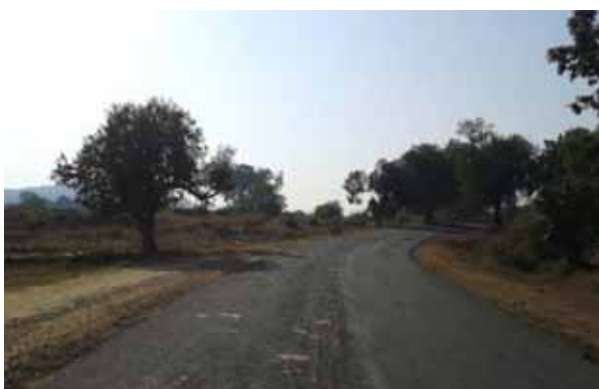
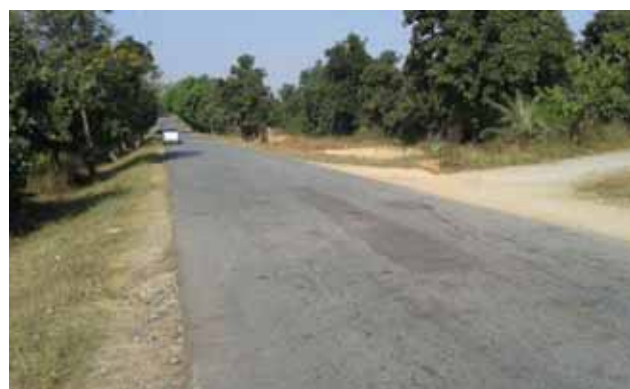
Lack of any road markings on the stretch from Km 0+000 to 1+000 and Km 6+000 to 7+000

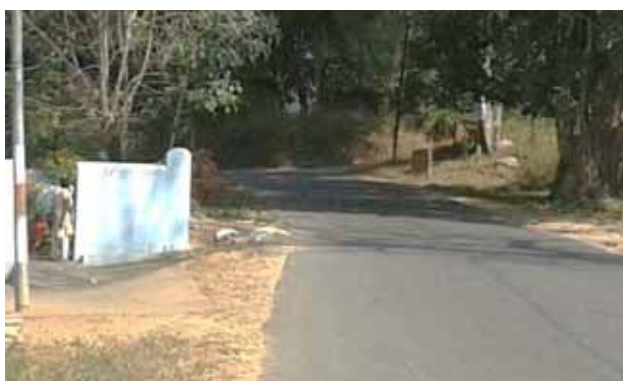
As the sharp curve at Km 16+200 is on gradient, fast moving vehicles were observed overtaking the slow vehicles. Due to BUA of Sabdega village, there are buildings on the inner edge of curve which restricts the visibility of approaching traffic. There is a side road merging with SH-31 at the curve. In this situation the risk of head-on collision of overtaking vehicles, and collision with the vehicles entering from side road is more. Photographs of sharp curve with unsafe situation are given below.

Sharp curve with gradient, side road, and restricted visibility in BUA at Km 16+200

Recommendations: Provide all the curve treatments mentioned above in addition to traffic calming measures and speed restriction signs in the BUA

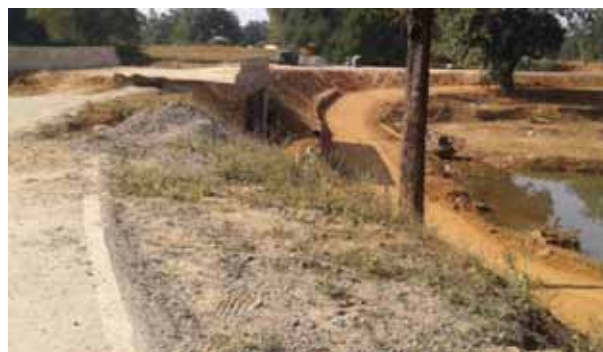
Sharp curve on high embankment without edge protection near approaching culvert (under construction), Km 31+800

Recommendations: Provide crash barrier on the outer edge with delineators.
Refer to Appendix III for guidelines on situations where to install the above

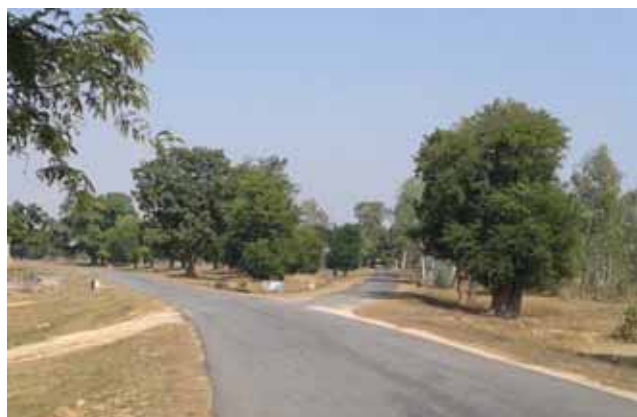
Side road joining at skew angle Km 21+000

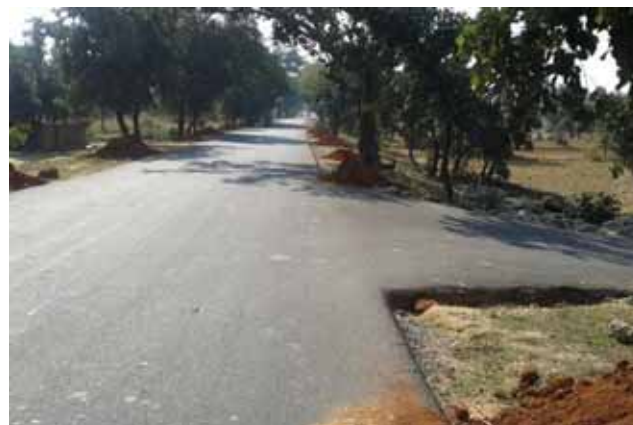
Side road joining with steep gradient, Km 9+000

It has been observed that on few junctions, the level difference between the side road and major road and the vertical profile of the side road joins the edge of main carriageway in an unsafe manner.

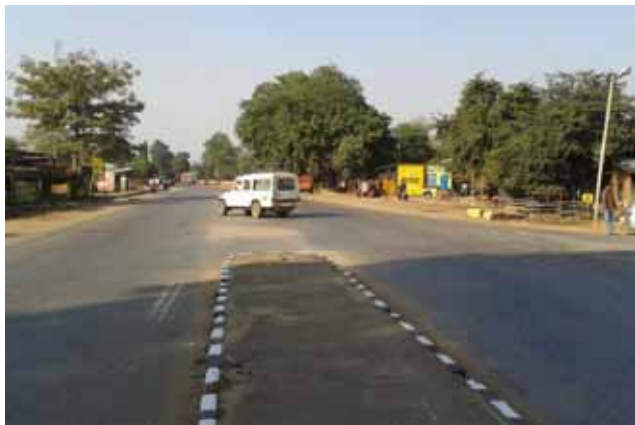
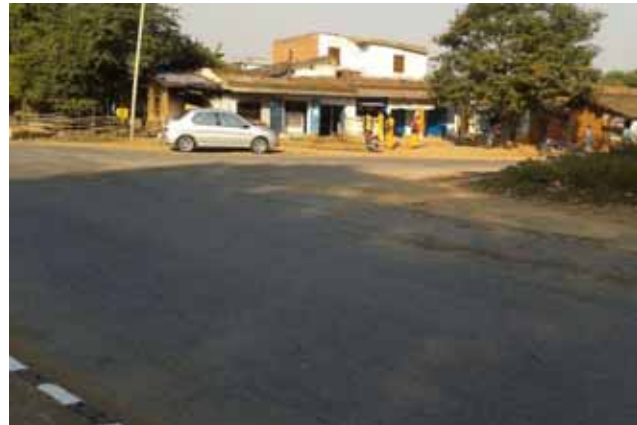
Km 0+000, intersection of SH-31 with NH-10

- SH-31 takes off from this place, i.e. Km 91+300 of SH-10 (Sudargarh-Rourkela road) forming a 3-arm intersection.
- At this intersection all the approaches are divided by provision of median, and the acceleration and deceleration lanes are also provided but there are no islands to guide the turning traffic
- The edge lines and other lane markings pertaining to intersection layout are missing
- There are no traffic signs and direction signs at this intersection
- There is built-up area with a few small shops/hotel at the intersection
- The intersection is free from any encroachment and on-street parking, however buses stop on the road near intersection obstructing the flow and visibility of through traffic.
- There is no footpath or pedestrian crossing at this junction.

| Reasons for concern: | Poor Junction layout The junction layout at both the junctions is non-standard and has no control over the traffic movement. It is confusing who has priority in such a situation. This encourages lawless traffic movement and is hazardous. |

| Recommendations: | <ul style="list-style-type: none">• Provide road markings pertaining to junction layout• Provide acceleration and deceleration lanes on both the approaches• Provide channelization to control the traffic movement, at junctions without splitter islands <p><i>Refer to Appendix III for standard layout of 3-arm junction.</i></p> |

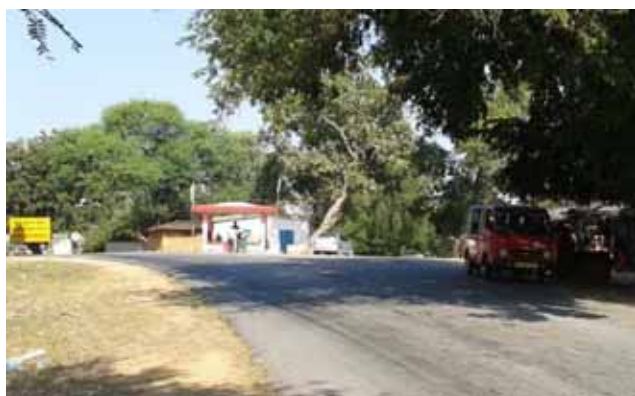
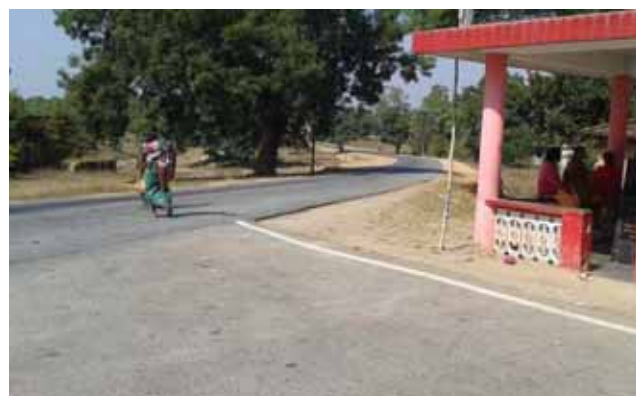
Km 23+800, intersection of SH-31 with

- SH-31 intersects with MDR connecting Talsara with Luhakera near Orissa/Chattisgarh border.
- The layout of this intersection is non-standard y-type on the horizontal curve.
- There is no control over traffic movement and the building in middle of intersection obstructs the visibility of approaching traffic.
- There are no direction signs and the layout is confusing as the MDR looks like major road and the SH-31 is joining from RHS.
- There is no built up area at the intersection except the building in the middle of intersection.
- There were few auto-rickshaws parked on the road.
- There is no provision for VRUs at this intersection.
- There are no street lights at this intersection.

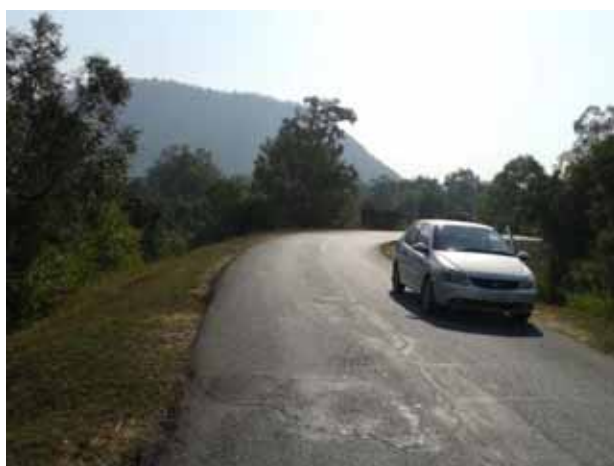
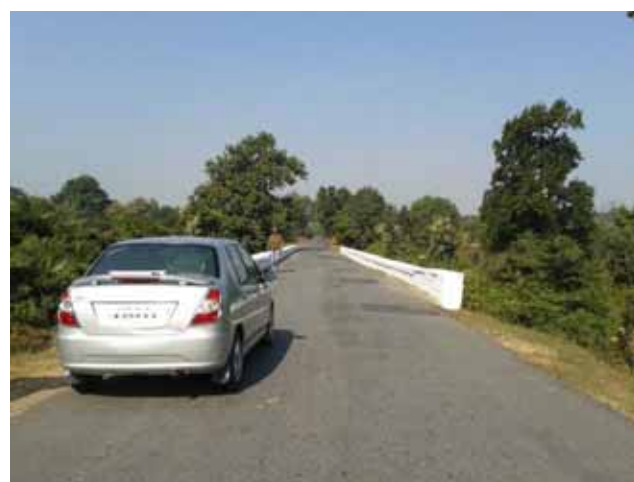
Unprotected approach to bridge with high embankment, Km 6+100

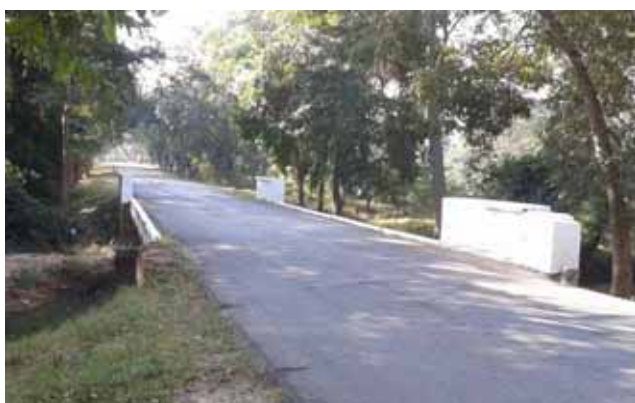
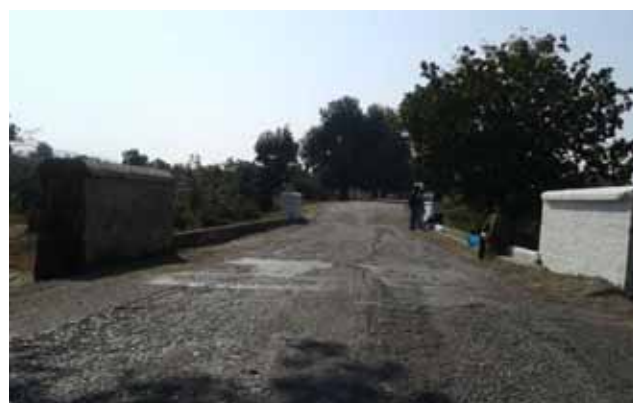
Parapets on Culvert/Bridge highly unsafe for VRUs as well as other traffic, Km 2+700 and Km 8+800

| Reasons for concern: | <p>Broken or missing parapets</p> <p>The absence of parapet on bridge/culvert increases the risk of vehicles falling in to the drain. The absence of parapets at such locations is hazardous for traffic, especially for VRUs.</p> |

| Recommendations: | <p>Provide continuous parapets on all culverts and bridges.</p> |

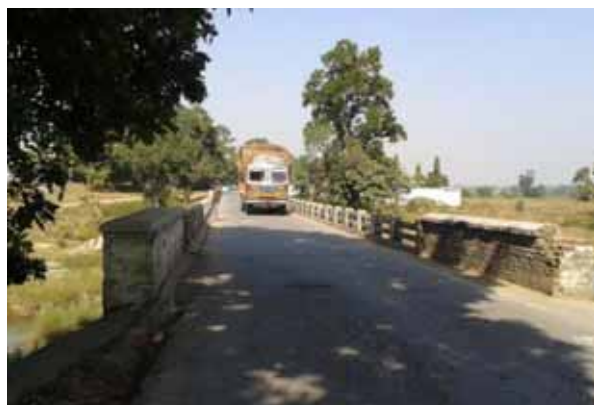
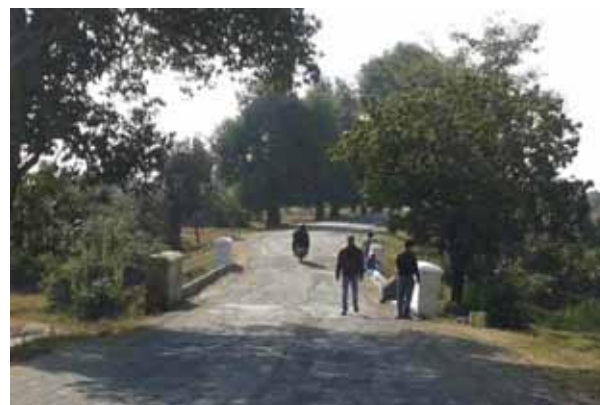
Parapets of Culvert/Bridge not delineated, Km 13+700 and Km 8+800

| Reasons for concern: | <p>No delineation of culvert/bridge parapets</p> <ul style="list-style-type: none"> The culvert/bridge parapets adjacent to high speed traffic movement are hazardous especially at night if not delineated as the driver cannot judge the position of such road side hazards. |

| Recommendations: | <ul style="list-style-type: none"> Provide edge line markings and Object Hazard Marker (OHM) on both sides and for both approaches (i.e. Four numbers of OHM for each structure) <p><i>Refer to Appendix III for guidelines for installation of object hazard markers</i></p> |

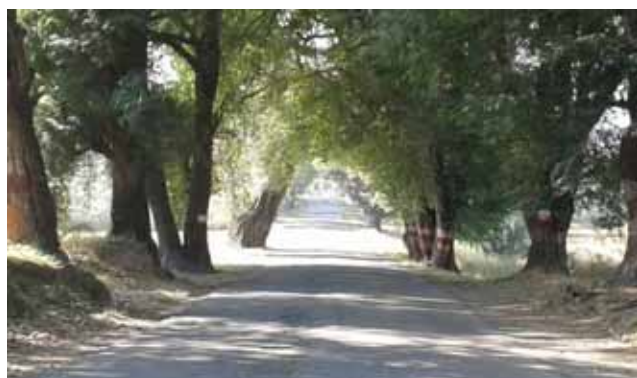
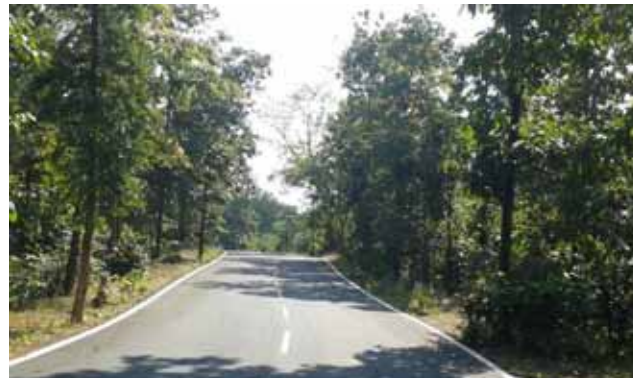
Trees very near to road edge Km 4+000 to 5+000, and in forest area Km 29+000 to 30+000

| Recommendations: | <p>Desirable:</p> <ul style="list-style-type: none"> Remove Trees/ street lighting poles from the road shoulders Provide crash barriers on locations where trees acts as a significant hazard and where the space is available to install crash barrier |

- Delineate the hazards by installing OHMs or painting of the trees in black and white strips
- Provide reflectors on Street lighting poles

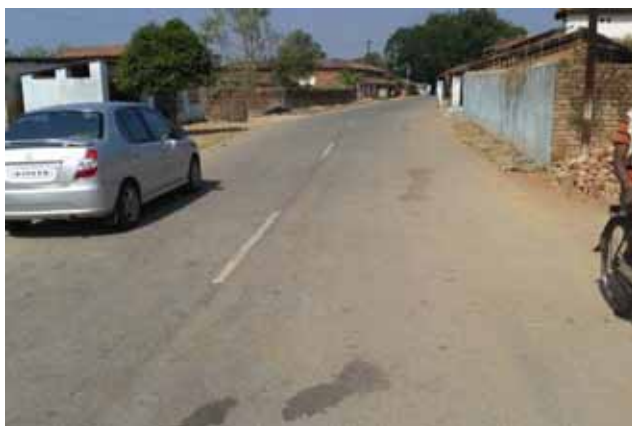
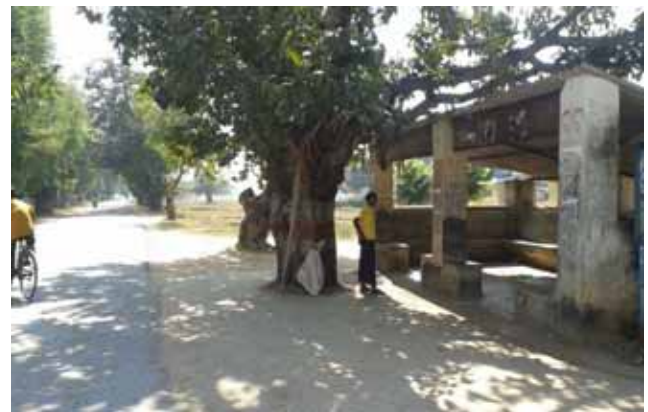
All the above listed BUA on SH-31 are small villages, but the presence of VRUs and their interaction with high speed traffic is significant. At few BUAs the buildings and boundary wall are very close to the road edge. There is no facility for VRUs such as pedestrian crossing or footpath in any of the above listed BUAs. At none of the above mentioned locations the street lights are provided.

Built up area from 27+000 to 27+400 and Km 20+400 to 20+600 – buildings very near to road edge, and access to bus stop obstructed by tree

- No traffic calming measures are provided to slow down vehicles approaching at high speeds to the built up area
- Significant pedestrians including school children are noted, but no separate pedestrian facilities are provided along the road inside the BUA or to cross the road
- No street lights are provided in the BUA
- Significant number of access roads within the BUA, the visibility of which has been hampered due to shops/ establishments on all corners of the junction
- No road markings or warning signs to warn/ inform the road user of the built up nature of the area ahead
- No speed limit signs provided
- On street parking hampers the visibility and resulting in unsafe situations
- On street bus stops observed, which hampers visibility and unsafe overtaking

- Recommendations:**
- Provide Gateway signs at before start and after the end of BUA
 - Provide pedestrian crossings, wherever deemed necessary
 - Provide footpaths in urban areas
 - Provide well maintained wide shoulders (min. 2m wide), free of encroachments and overgrown vegetation in roadside villages in rural areas
 - Provide STOP' signs with road humps on all access roads in roadside villages in rural areas
 - Provide 'School Ahead' and 'SLOW' signs on appropriate locations near schools
 - Provide designated parking spaces, where it deems necessary
 - Provide Bus Bays/ Bus Stops as appropriate, with associated road markings and traffic signs

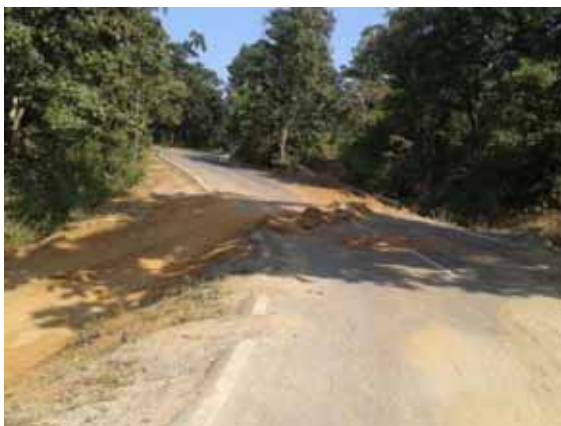
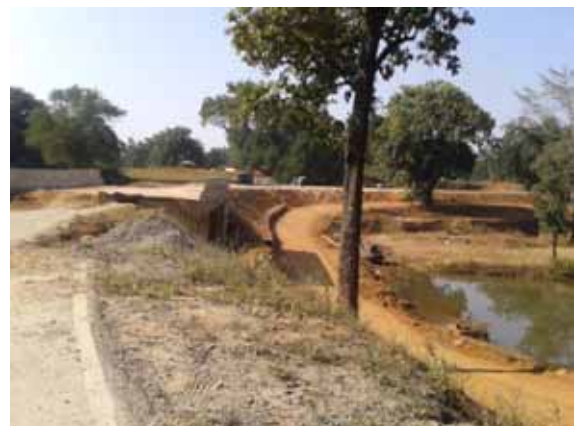
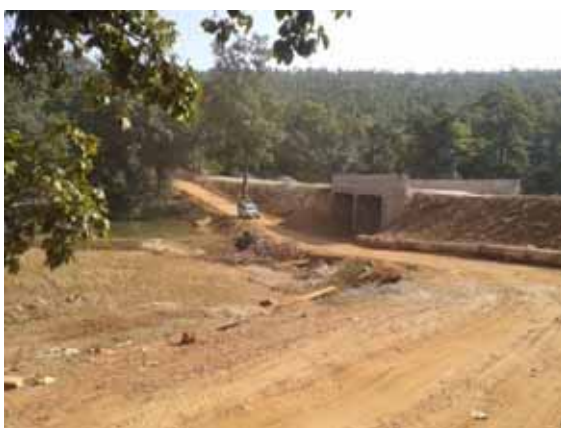
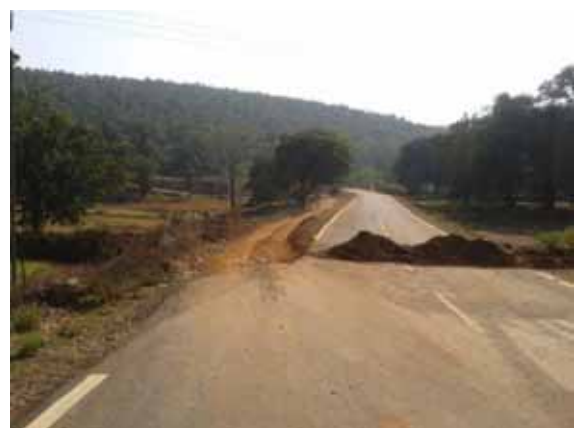
Km 31+800 – Traffic diversion at the site of construction of culvert

- The traffic diversion is very unsafe for traffic as there are no warning signs and delineators.
- During night time the site is very hazardous as there is no provision for illumination of the site.

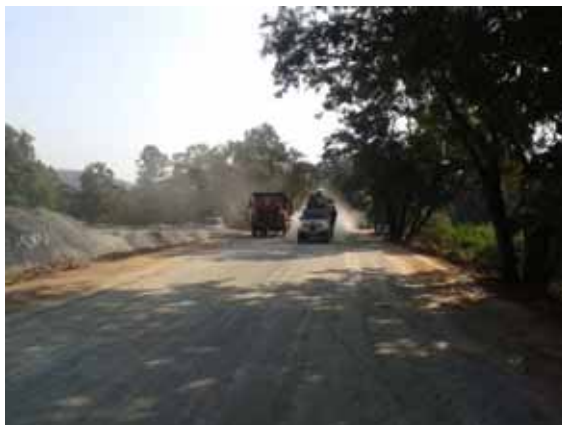
Road construction Km 35+000 to 36+000

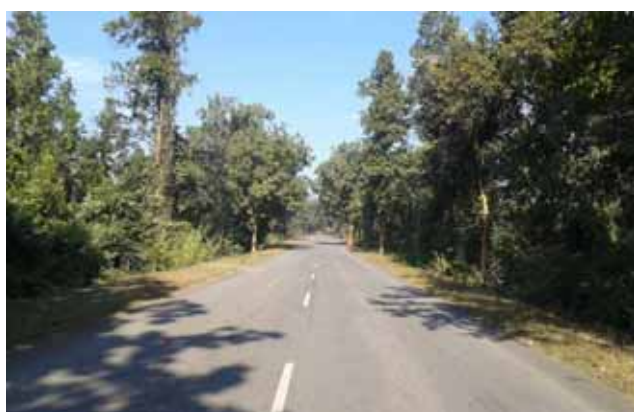
Lack of edge line in the stretch from Km 4+000 to 5+000

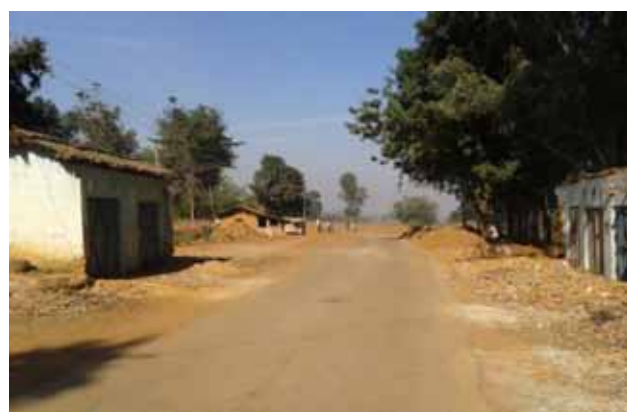
Lack of center line and edge line in the stretch from Km 12+000 to 13+000

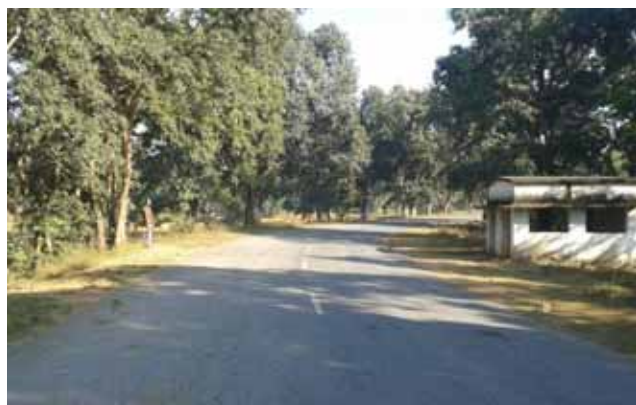
Sharp curve with restricted visibility due to building,
Km 3+800

| Recommendations: | Provide curve warning signs, chevron signs, delineators and speed limit sign as appropriate <i>Refer to Appendix III for guidelines on situations where to install the above.</i> |

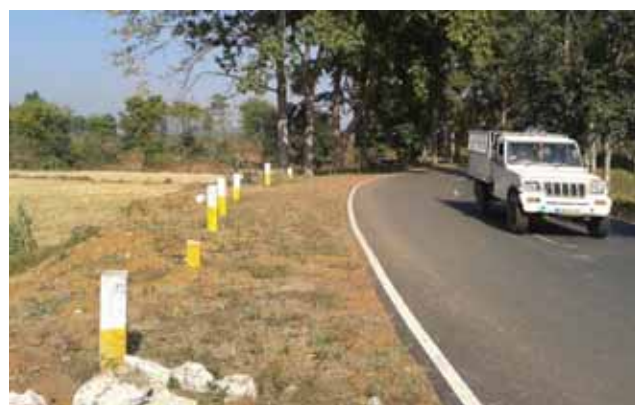
Sharp curve on high embankment without edge
protection, Km 9+200

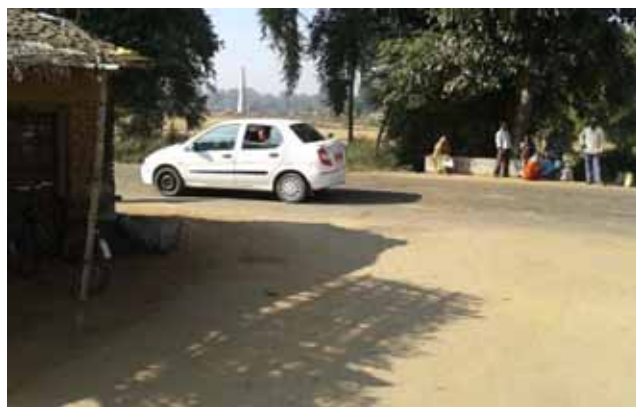
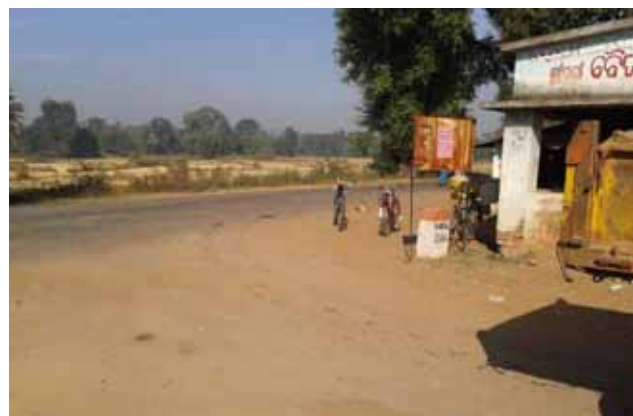
Side road joining at Km 7+100 – visibility restricted due to buildings on both the corners(view from side road)

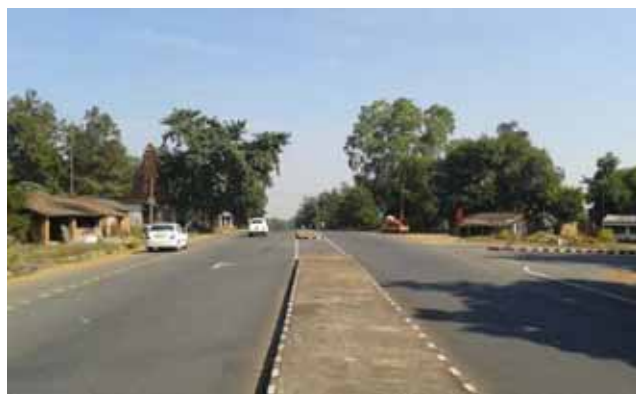
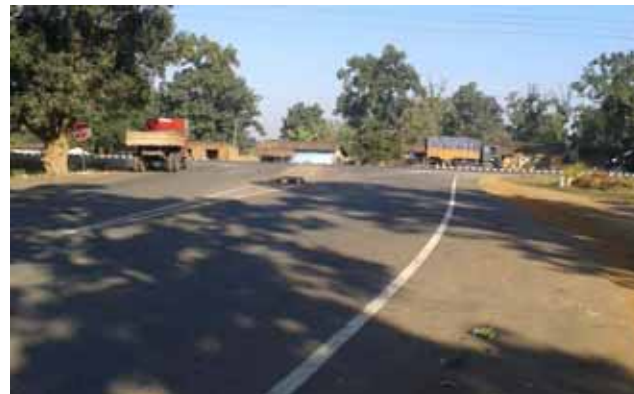
Km 0+000, intersection of SH-31 with SH-10

- SH-31 takes off from this place, i.e. Km 107+700 of SH-10 (Sudargarh-Rourkela road) forming a 3-arm intersection.
- At this intersection all the approaches are divided by providing median, and the acceleration and deceleration lanes are also provided but there are no islands to guide the turning traffic.
- The edge lines are provided but lane markings pertaining to intersection layout are missing.
- There are no traffic signs and direction signs at this intersection.
- There is no built-up area, except a few small shops/hotel at the intersection. The intersection is thus free from any encroachment and on-street parking.
- No footpaths or pedestrian crossings are provided at this intersection.
- No street lights are provided at this intersection.

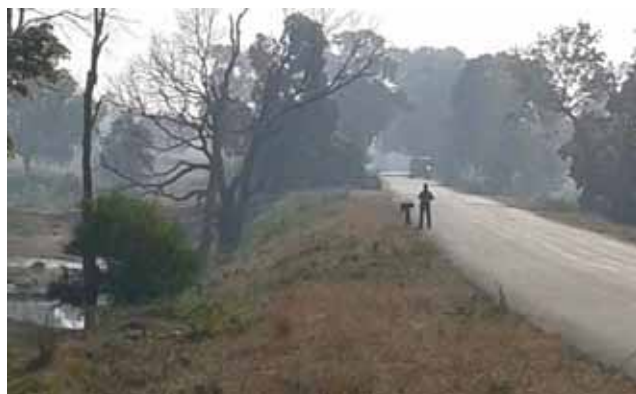
Unprotected approach to bridge with high embankment, Km 6+500

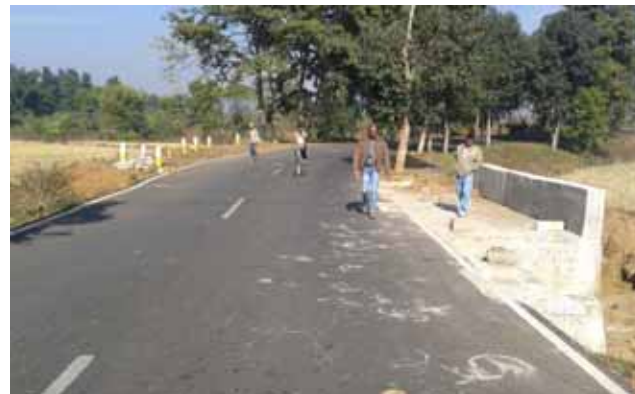
Unprotected approach to culvert under construction – lack of warning signs and barricades, Km 9+200

Recommendations: Provide warning sign for construction activity and barricades to protect the traffic from deep ditch.

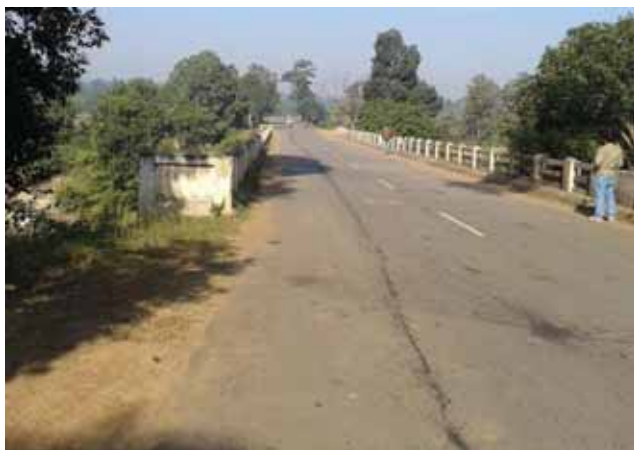
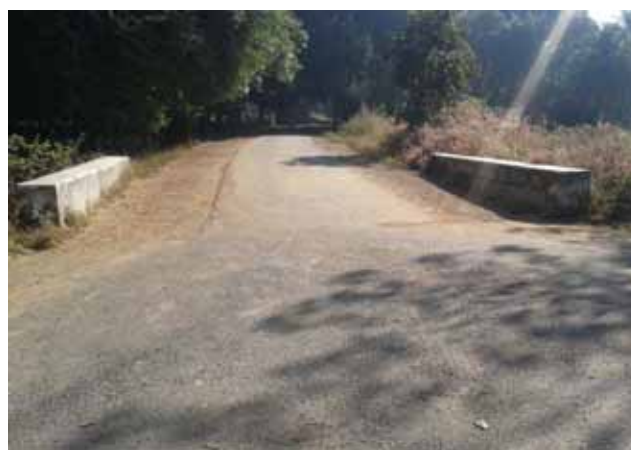
Parapets of culvert/bridge not delineated, Km 6+500 and Km 9+400

- The culvert/bridge parapets adjacent to high speed traffic movement are hazardous especially at night if not delineated as the driver cannot judge the position of such road side hazards.

Provide edge line markings and Object Hazard Marker (OHM) on both sides and for both approaches (i.e. Four numbers of OHM for each structure)

Refer to Appendix III for guidelines for installation of object hazard markers

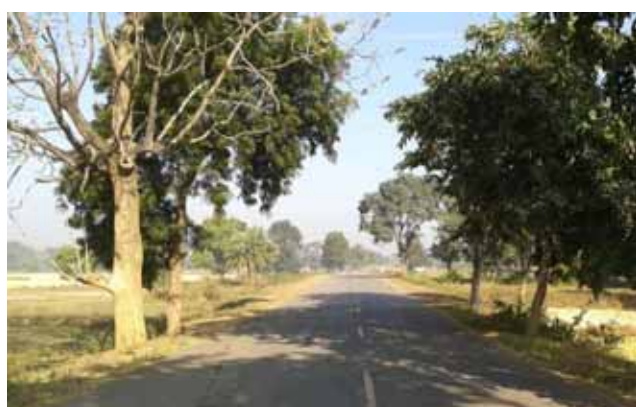
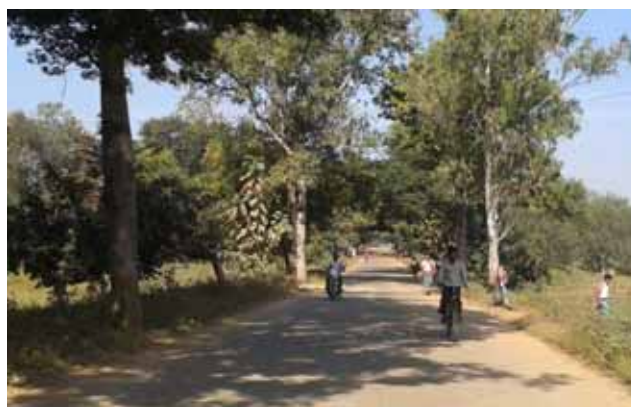
The trees observed near road edge were in the range of 1 to 3m in the stretch from Km 7+000 to 8+000 and near the Bamra town as shown in photographs below. Except for these two stretches the trees were noted to be greater than 3m away from the road edge.

Trees near the road edge, Km 7+000 to 8+000 and near Bamra town

- Remove Trees from the road shoulders
- Provide crash barriers on locations where trees acts as a significant hazard and where the space is available to install crash barrier

- Delineate the hazards by installing OHMs or painting of the trees in black and white strips

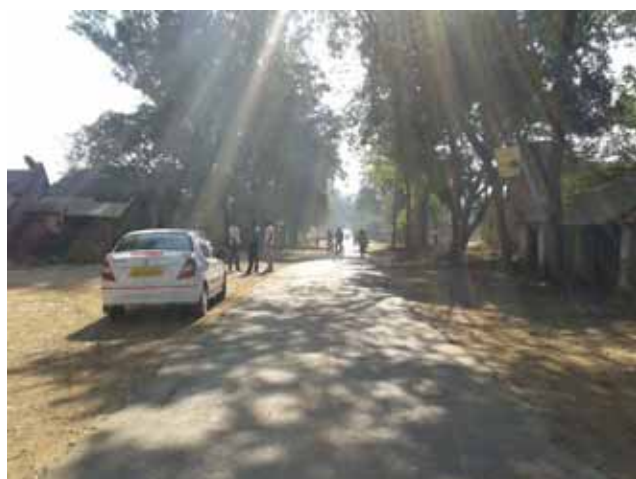
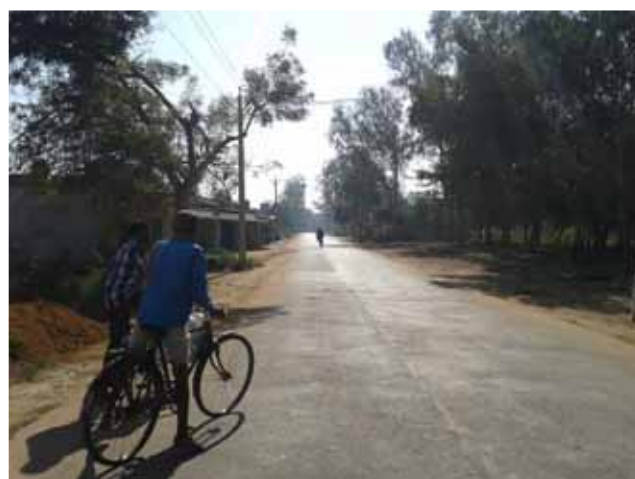
There are no built-up areas on this road section except the stretch of road (Km 13+600 to Km 14+000) passing through Bamra town. At this location, the section of road observed to be congested due to shops and residences on both sides of the road. There are no facilities for VRUs such as pedestrian crossing or footpath in this BUA.

Built-up area of Bamra

Recommendations: Regulate roadside commercial activities and remove encroachments, if any.

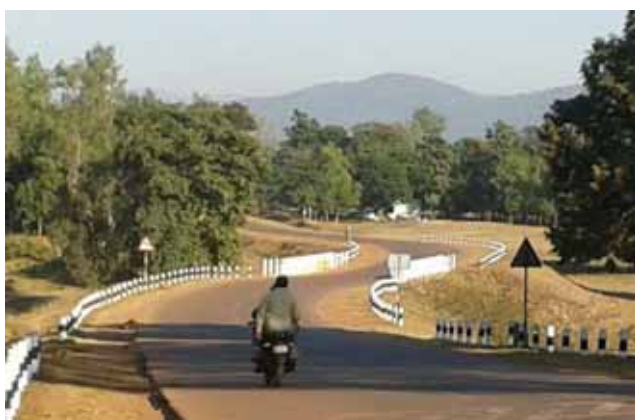
Reverse curve at Km 42+850

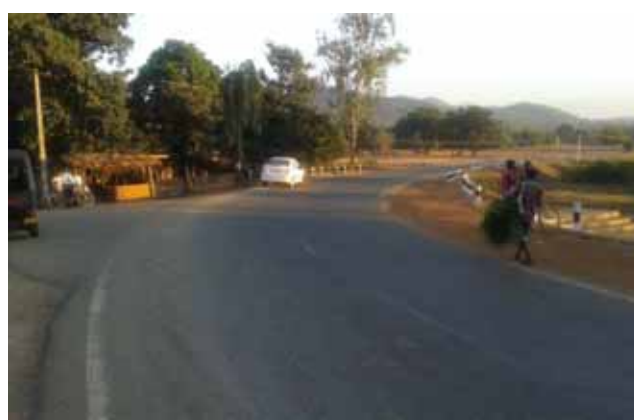
Sharp curve with BUA and access road (LHS),
Km 27+900

Recommendations: Provide all the curve treatments mentioned above in addition to traffic calming measures and speed restriction signs in the BUA

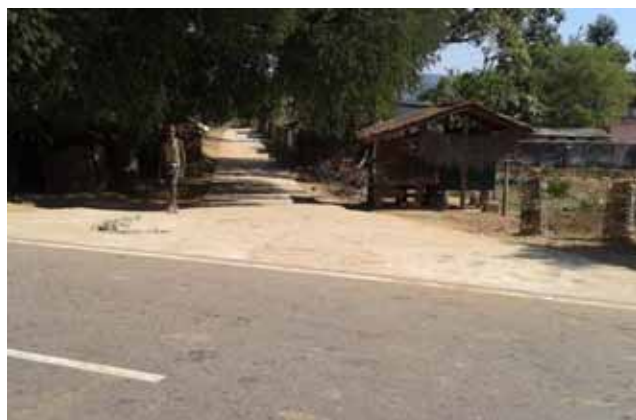
Side road joining with steep gradient at Km 27+000

- It has been observed that on few junctions, the level difference between the side road and major road and the vertical profile of the side road joins the edge of main carriageway in an unsafe manner.

- Recommendations:**
- Correct the vertical alignment of side road so that vehicles approaching from side roads has adequate length on the side road to slow down/ stop before entering into the main carriageway

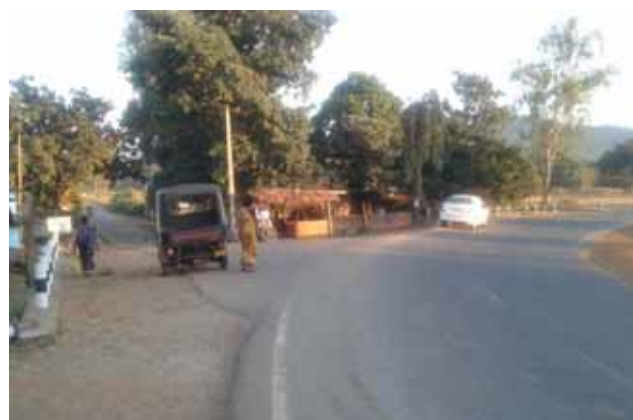
Side road joining on curve at Km 27+900

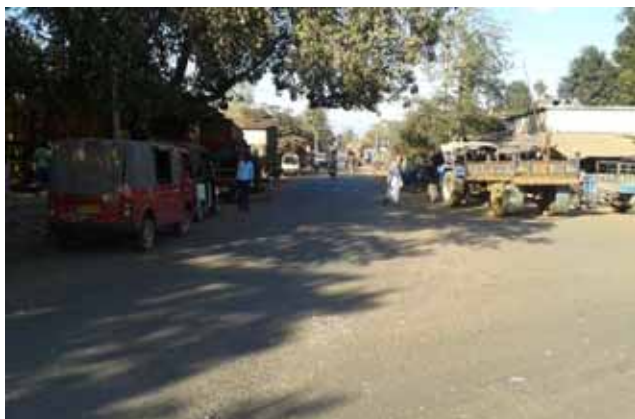
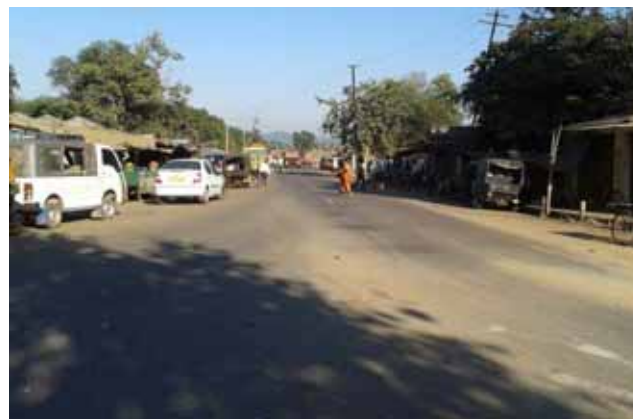
Km 48+500, intersection of SH-10A with NH-520

- The layout of this intersection is non-standard Y-type and no control has been established
- Many vehicles are parked on the road obstructs visibility of approaching traffic.
- There is main market of Lahunipara village around this intersection and hence there are many shops and roadside hotels encroaching the shoulders.
- Buses and 4-wheeler passenger vehicles were observed stopping on the road for passenger pickup/drop-off.
- There are no provisions for VRUs at this intersection despite of significant number of VRUs present.

- The junction layout at both the junctions is non-standard and has no control over the traffic movement.
- It is confusing who has priority in such a situation. This encourages lawless traffic movement and is hazardous.

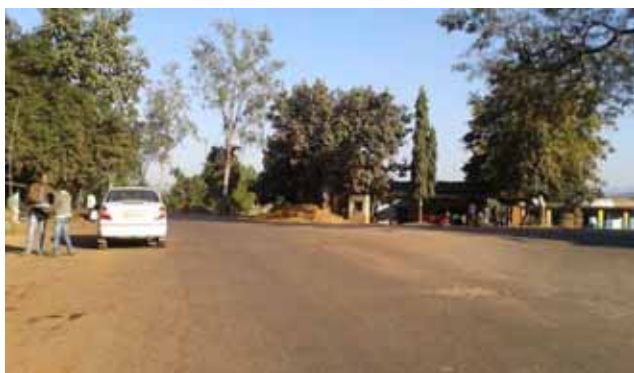
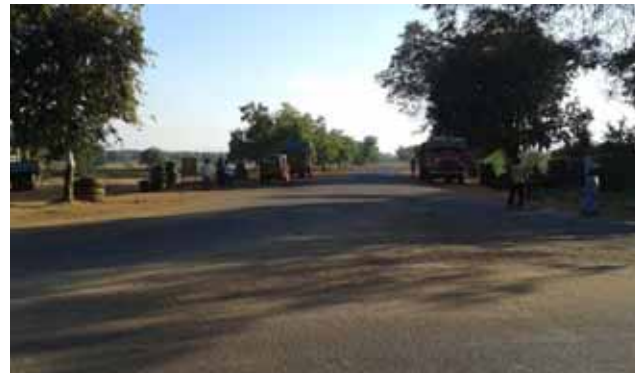
Km 43+200, intersection of SH-10A with Kaleiposh-Koida ODR

- The layout of this intersection is non-standard, and there is no control over traffic movement.
- There are no lane markings or traffic channelization at this intersection.
- The direction sign board is on the arm of Kaleiposh-Koida road which is not visible to traffic approaching from Lahunipada arm of SH-10A.
- There is no provision for VRUs at this intersection.

- Recommendations:**
- Provide direction signs to guide the traffic through the junction layout.
- Refer to Appendix III for guidelines for traffic signs and road markings on 3-arm intersection*

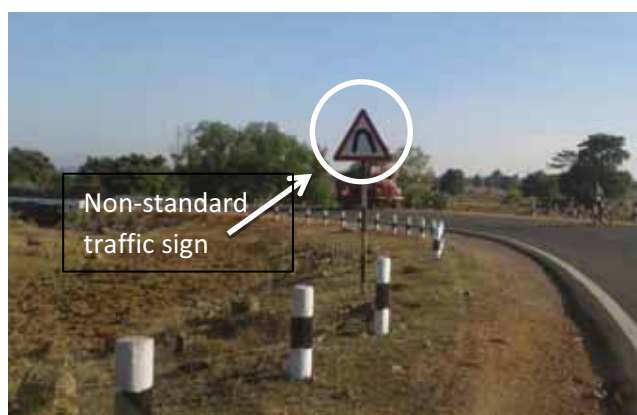
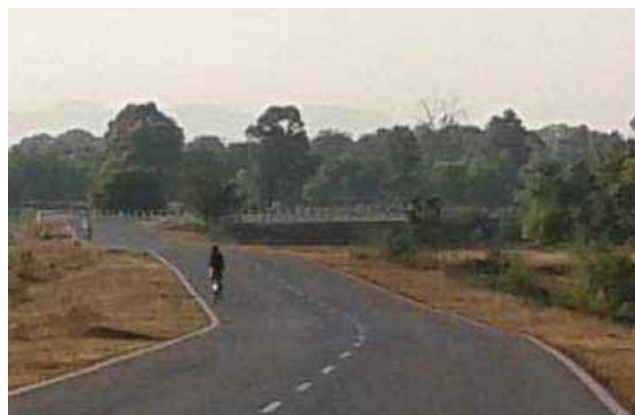
Approach to bridge with sharp curve, Km 46+900 and Km 33+500

- In the absence of adequate warning signs and reflective markings, the road layout and the hazard will not be clear for the road user, particularly during night conditions and in worst conditions, this will lead to serious injury/ fatal

- On outer edge of these curves Concrete Guard Posts (CGP) are provided to delineate the curve. As per international standards and practices, any concrete structure which is near the edge of road and larger by 10cm X 10cm in cross section is hazardous to the traffic. As the CGP provided on SH-10A are larger by 10cm X 10cm in cross section these may be cause serious injury to the road user if the vehicle loses control negotiating the curve.

- Recommendation:**
- Provide curve warning sign in addition to crash barrier with delineators
 - Provide chevrons to delineate the alignment of sharp curve
 - Provide edge lane markings
 - Provide hazard markers on either edge of the parapets

- Recommendation:**
- Provide bar marking on either approaches to make vehicles slow down, in addition to curve warning signs and advisory speed limits
 - In case the location has a history of accidents, provide speed tables/ humps on either approaches

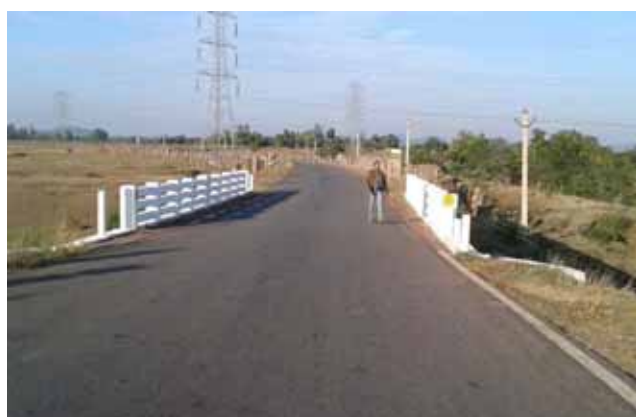
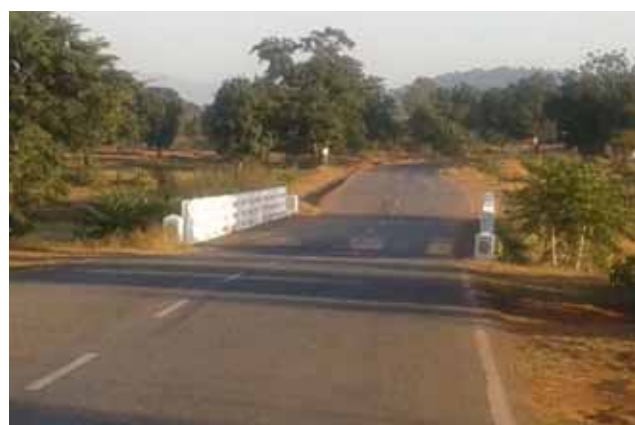
Parapets of Culvert/Bridge not delineated, Km 38+500 and Km 30+200

- The bridge parapets adjacent to high speed traffic movement are hazardous especially at night if not delineated as the driver cannot judge the position of such road side hazards.

- Provide edge line markings and Object Hazard Marker (OHM) on both sides and for both approaches (ie. Four numbers of OHM for each structure)

Refer to Appendix II for guidelines for installation of object hazard markers.

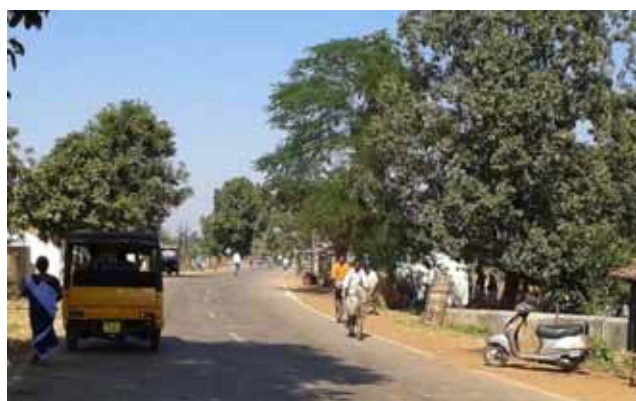
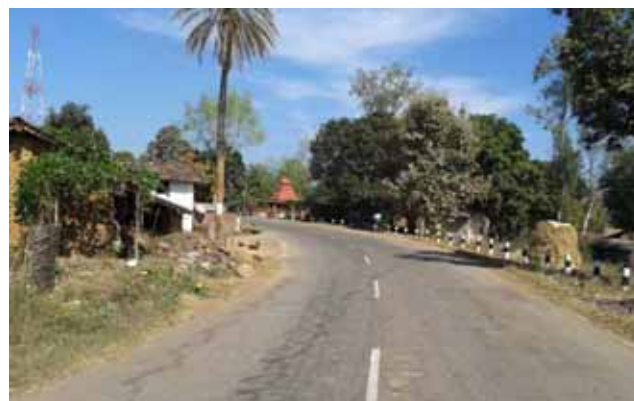
At all the above listed BUAs, the presence of VRUs and their interaction with SH-10A is significant. At few BUAs, the marked cross-walk for pedestrians is provided but there is no provision for footpath. At none of the above mentioned locations the street lights are provided. There are no bus-bays and hence the buses were observed stopping on the road obstructing visibility and the smooth flow of traffic. Some of the BUAs are on sharp horizontal curve which may be dangerous with traffic moving at high speed.

Built-up area on sharp curves, Km 23+600 to 23+400 and Km 21+600 to 21+300

- No traffic calming measures are provided to slow down vehicles approaching at high speeds to the built up area
- Significant pedestrians including school children are noted, but no separate pedestrian facilities are provided along the road inside the BUA or to cross the road (except marked cross walk at few locations)
- Significant number of access roads within the BUA, the visibility of which has been hampered due to shops/ establishments on all corners of the junction
- No road markings or warning signs to warn/ inform the road user of the built

- No speed limit signs provided
- On street parking and bus stops were observed, which hampers visibility and leads to unsafe overtaking maneuvers.

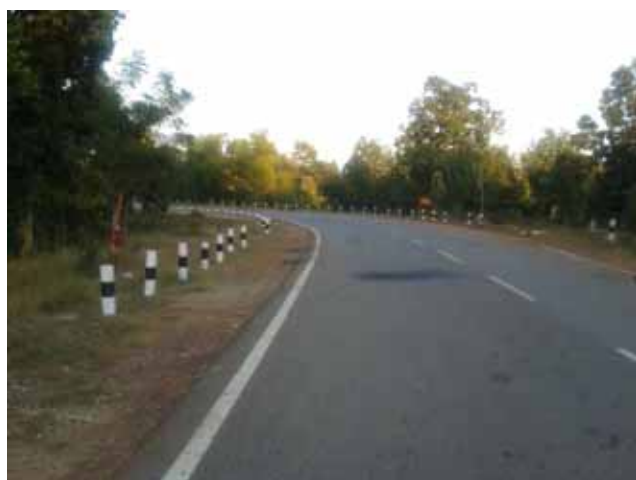
- Reverse curve at Km 27+000 where the radius of two curves noted to be less than 75m and the two curves are less than 100m apart
- There is a structure/building on outer edge of the curve which is very near to the road edge (at a distance of 2 to 3m)
- There is a culvert in between the two curves with partial parapet, however the depth of drain is shallow.
- Although for delineation of the curve, CGP are provided these may not be visible during night time.

1st curve of the reverse curve

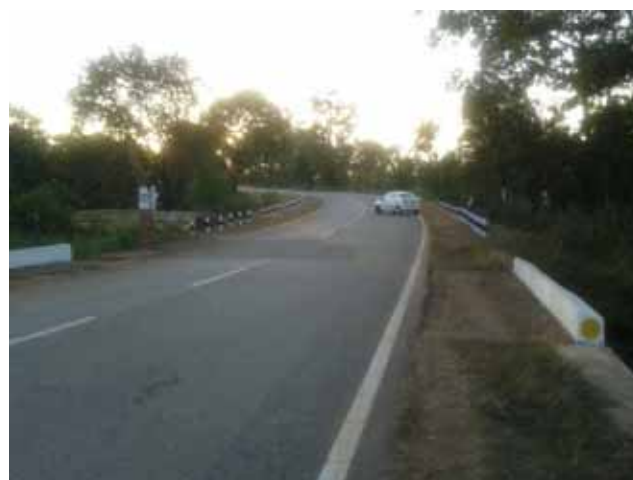
2nd curve of the reverse curve

Building very near to road edge

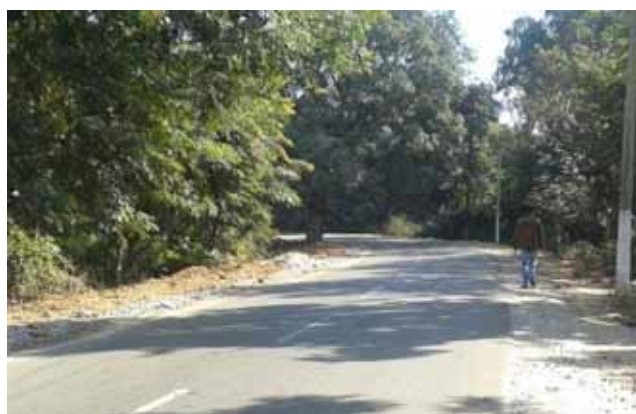
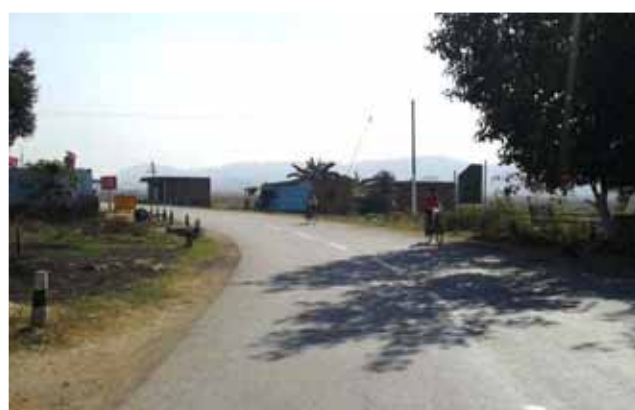
Project road has above listed sharp curves, where it is required for the approaching vehicle to slow down by more than 20 km/ hour from the approach speed.

Sharp curve at Km 0+200 and Km 5+900

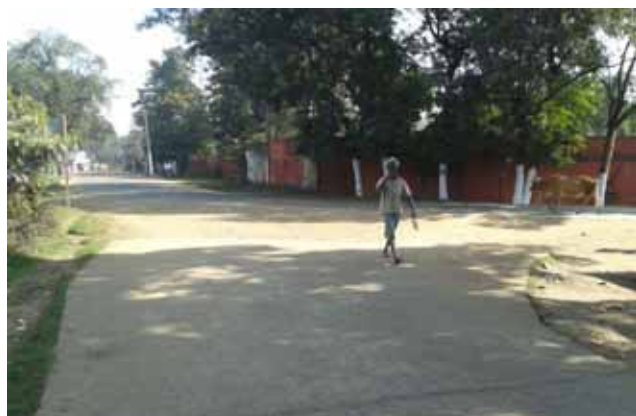
Side road joining on curve, Km 3+600
(view from side road)

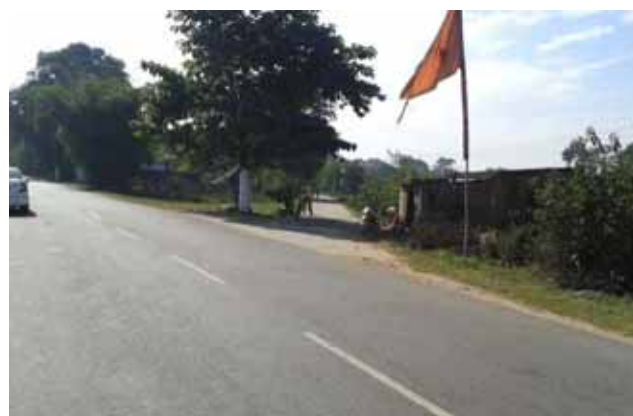
Side road joining at acute angle, Km 4+600
