**Government of Odisha (GOO)
Chief Engineer, World Bank Projects, Odisha
Odisha State Roads Project**

**Consultancy Services for
Road Sector Institutional Development
Loan # 7577-IN**

**ROAD INFRASTRUCTURE
SAFETY MANAGEMENT REVIEW**

VOLUME I - REPORT

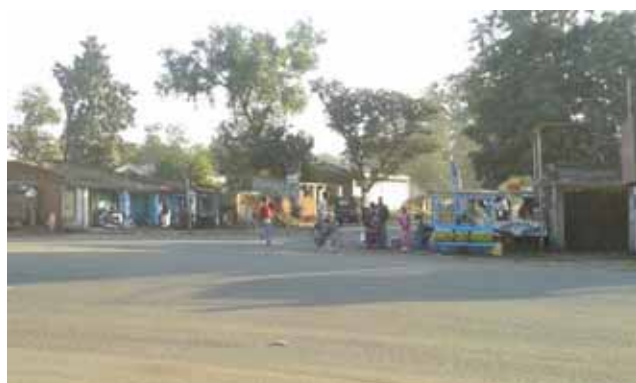
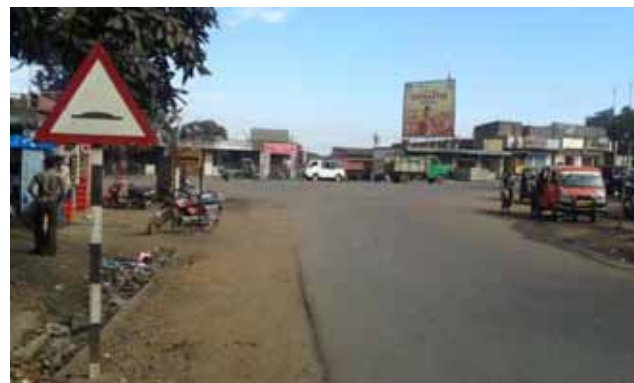
Km 0+000, intersection of MDR-26 with SH-10

- At this intersection there is no control over traffic movement despite of movement of heavy vehicles on both the SH-10 and MDR-26.
- No traffic signs or road markings at the junction to control, warn and inform the road user
- No facilities for VRUs were provided
- Junction is heavily built-up, and on street parking were observed
- As there are no bus bays/ designated bus stop, buses were observed to be stopping on the main road obstructing the visibility of approaching traffic.

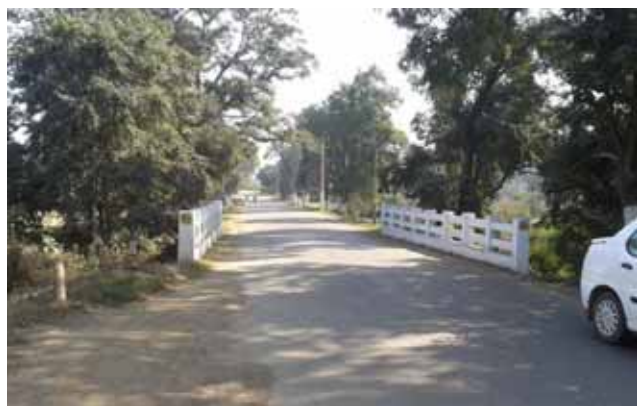
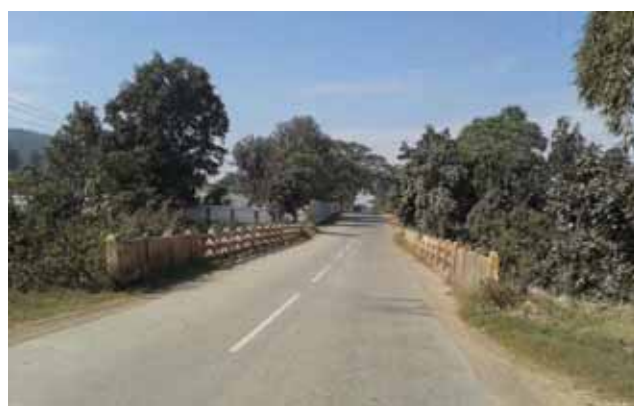
Parapets of Culvert/Bridge not delineated, Km 3+300 and Km 9+300

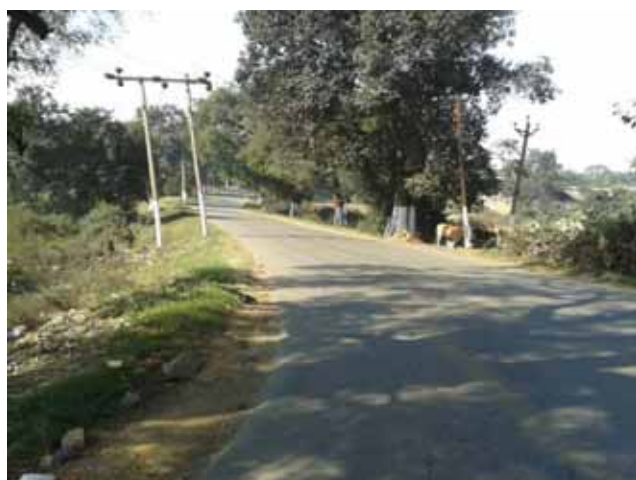
Trees and poles very near to road edge
Km 3+000 to Km 4+000

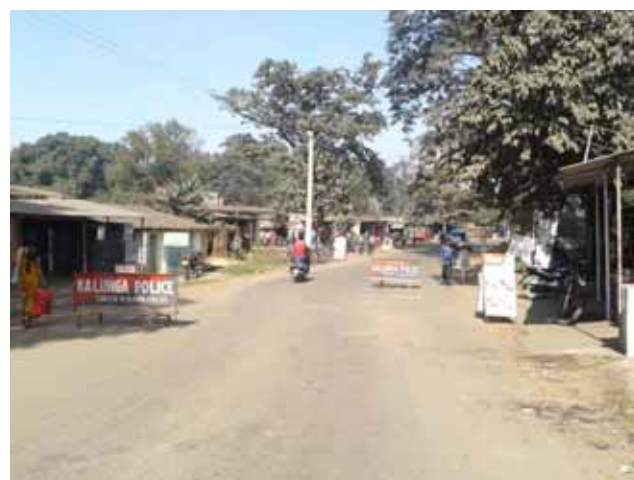
Buildings very near to road edge in BUA
Km 3+000 to Km 4+000

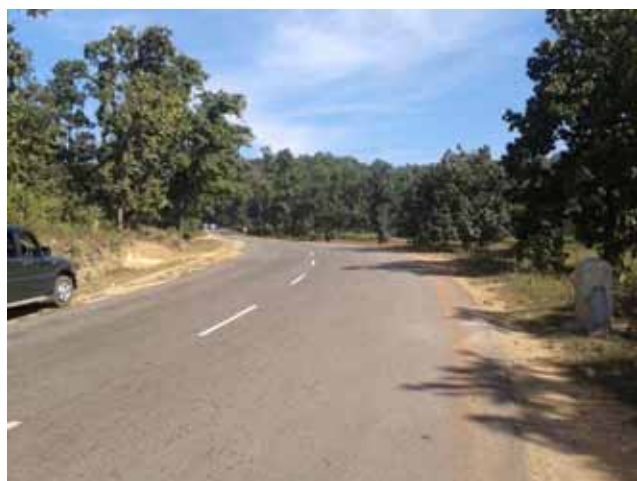
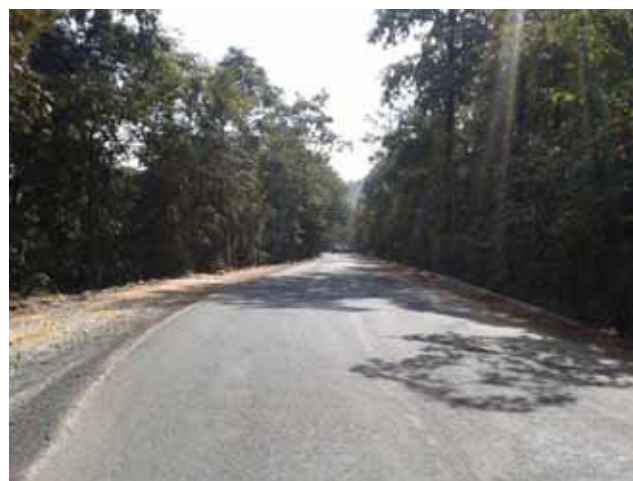
Lack of delineation in the stretch of (i) Km 34+000 to 35+000, and (ii) Km 30+000 to 31+000

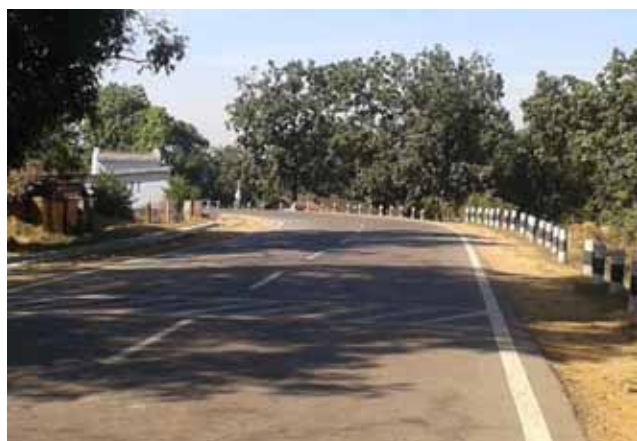
Sharp curve at Km 39+900

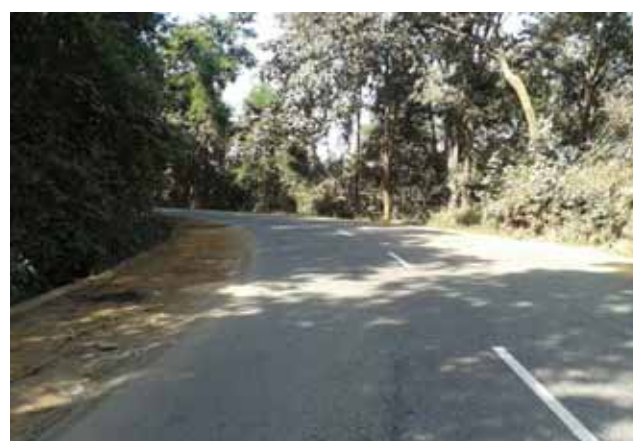
Sharp curve in ghat section at Km 30+200

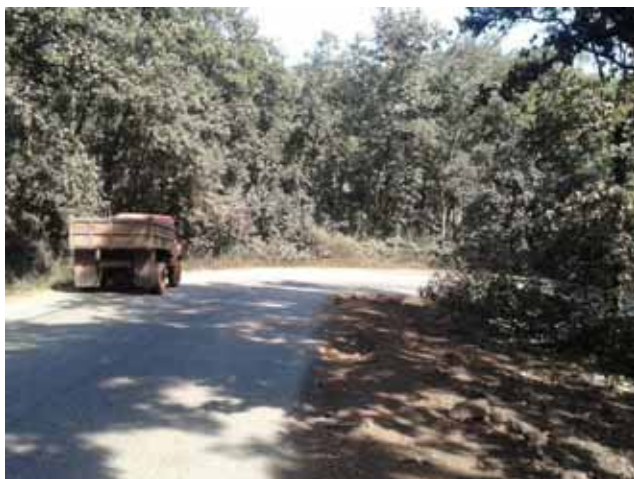
Hairpin bend with steep gradient at Km 22+100

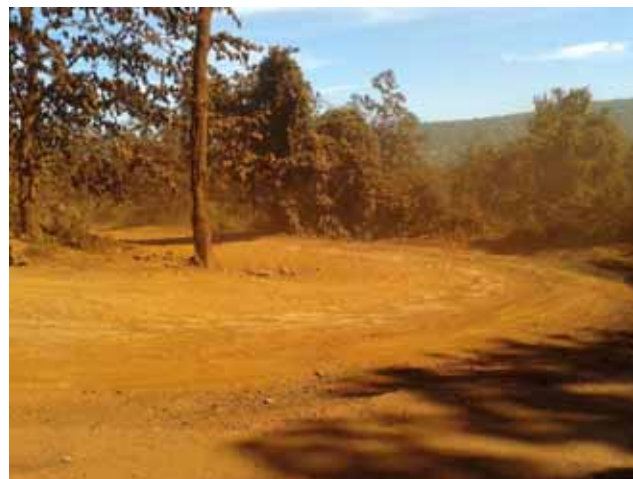
Hairpin bend with poor road condition at Km 11+400

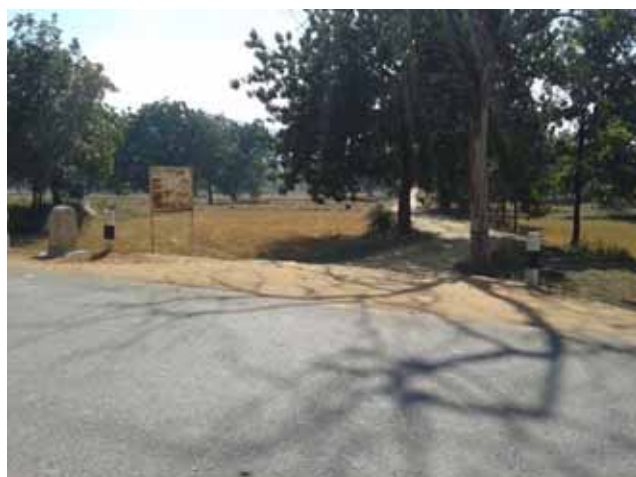
Side road joining with steep gradient Km 36+800

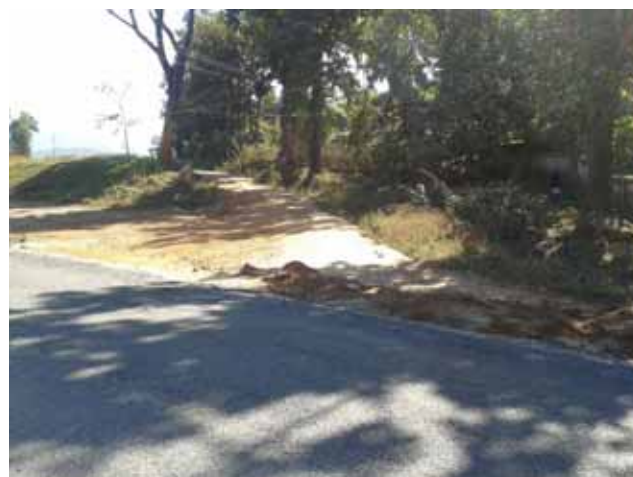
Side road joining at skew angle Km 24+350

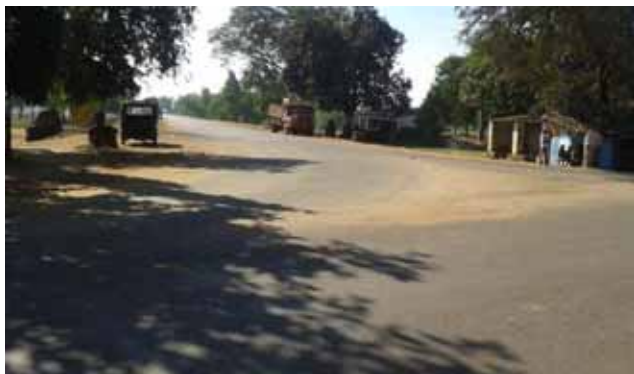
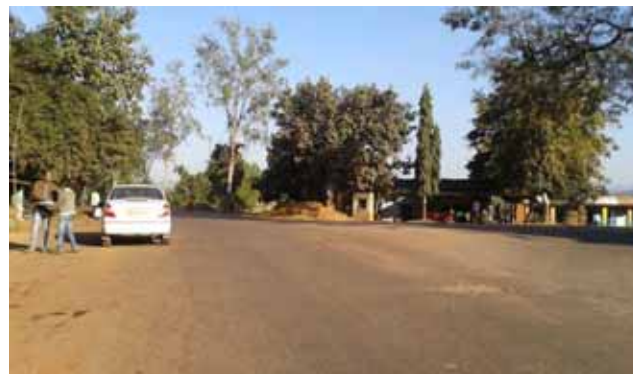
- Poor layout and inadequate traffic control
- No facilities for VRUs at this junction
- The direction sign board is on the arm of Kaleiposh-Koida road which is not visible to traffic approaching from Lahunipada arm of SH-10A.
- Street-lights were not provided

Km 41+200, intersection of ODR with SH-10A

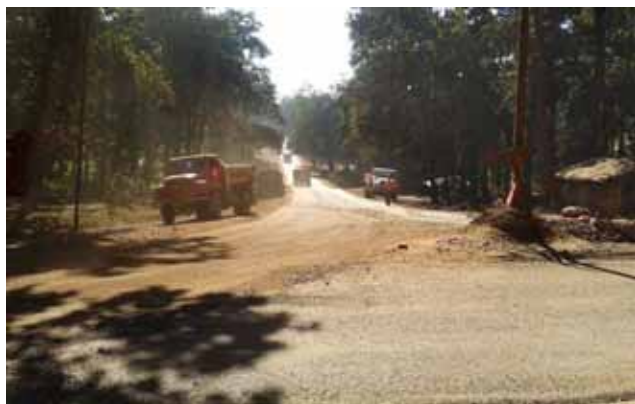
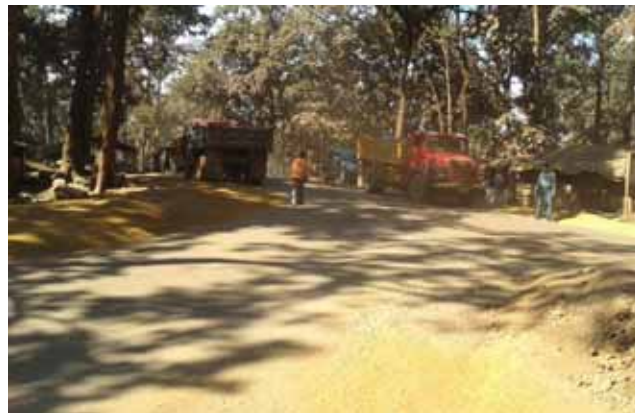
- This is a 3-arm intersection of ODR with Barsuan road.
- The junction layout is poor and no control over traffic movement despite of heavy movement of trucks on both the ODR and Barsuan road.
- There are no direction signs or advance warning signs for intersection.

- The condition of road surface is very poor at this intersection.
- There is no built-up area at the intersection except small roadside hotels near the intersection.
- There is no provision for VRUs at this intersection.

Km 23+650, intersection of ODR with Barsuan road

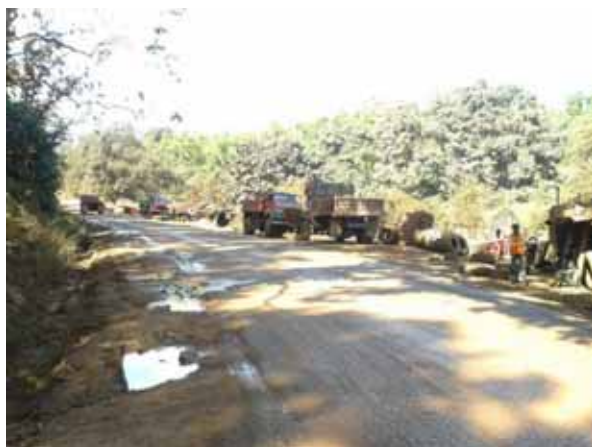
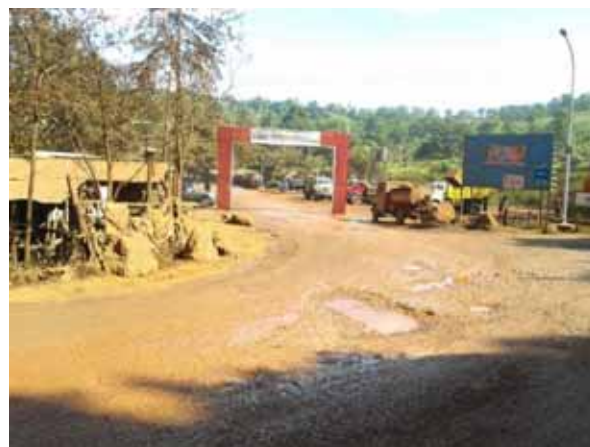
- This is a 3-arm intersection of ODR with road leading to Jindal mines and township.
- At this intersection there is no control over traffic movement despite of heavy movement of trucks on both the ODR and the road leading to mines.
- There are no direction signs or advance warning signs for intersection.
- The condition of road surface is very poor at this intersection.
- There are shops and roadside hotels at the intersection which are encroaching on the shoulder of road.
- There were many trucks parked on the approach of intersection due to shops and roadside hotel.
- There is no provision for VRUs at this intersection.

Km 14+000, intersection of ODR with road leading to Jindal mines and township – trucks parked on approach and gate of mines and township

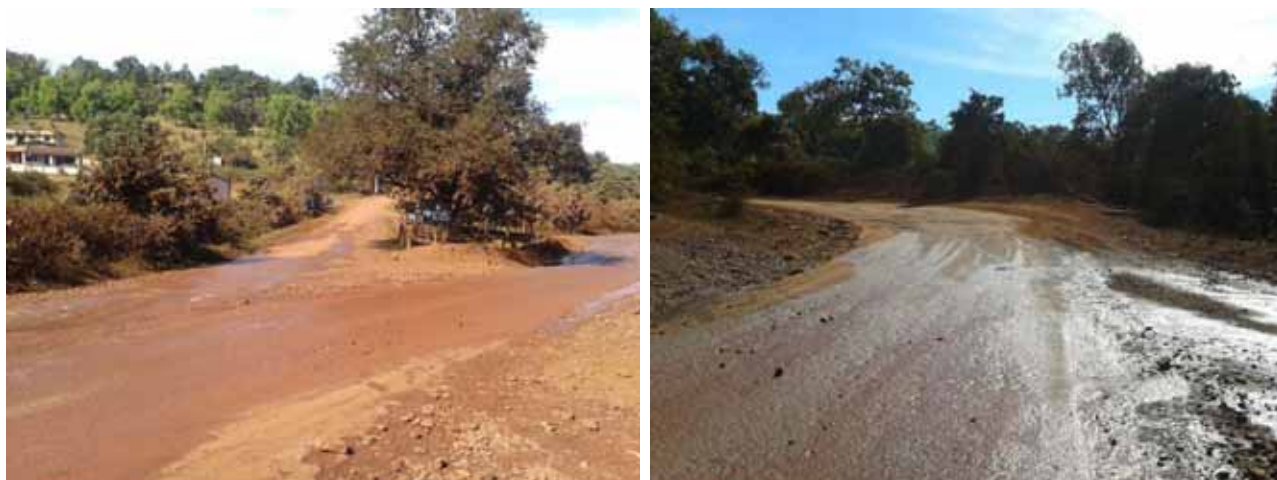
- This is a 3-arm intersection of ODR with road leading to mines of SAIL.
- The layout of this intersection is Y-type with a non-standard central island.
- The intersection is located very near to a hairpin bend where visibility of approaching traffic is severely restricted.
- There are no direction signs or advance warning signs for intersection.
- There is no built-up area around this intersection.
- There is no provision for VRUs at this intersection.

Km 13+600, Intersection of ODR with road from SAIL mines – trees in the central island and approach to intersection descending from the hairpin bend

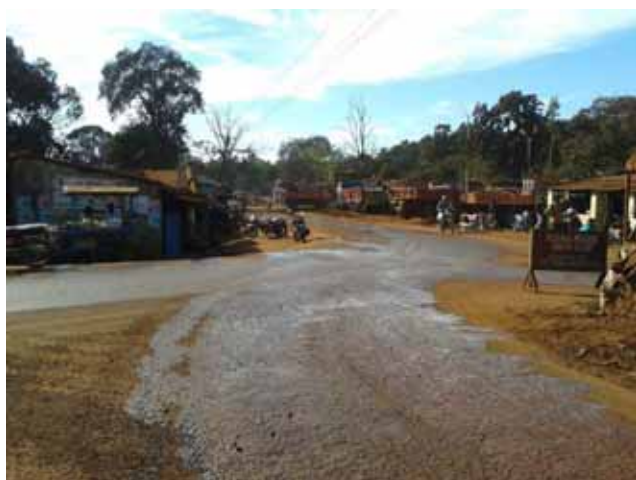
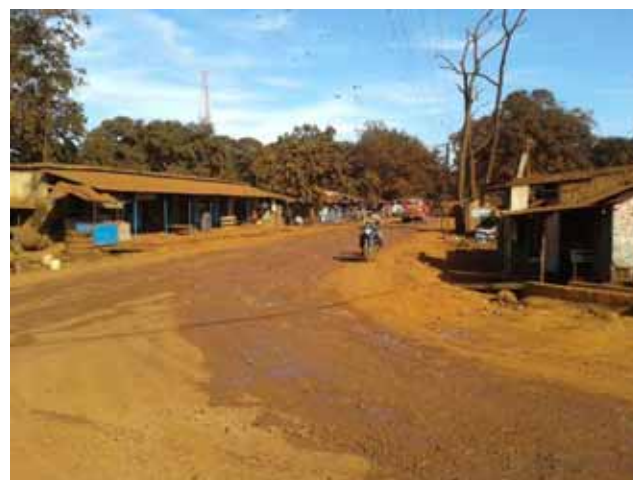
- This is a 3-arm intersection (within Koida town) of ODR with road leading to Joda town.
- There are no traffic island and lane markings to guide the traffic through layout of the intersection.
- As the intersection is within BUA of Koida town there is commercial area around and the buildings are very near to the road edge.
- There is on-street parking on all the approaches of intersection and the buses were observed stopping on the road obstructing the visibility of approaching traffic.
- There is no provision for VRUs at this intersection.
- There are no street-lights at this junction.

Km 0+000, intersection of ODR with Joda road in Koida

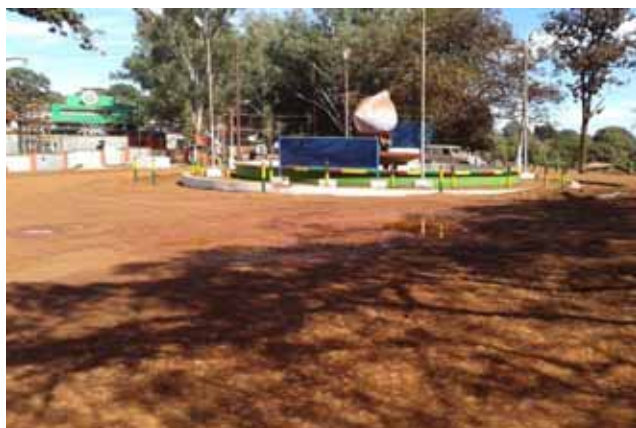
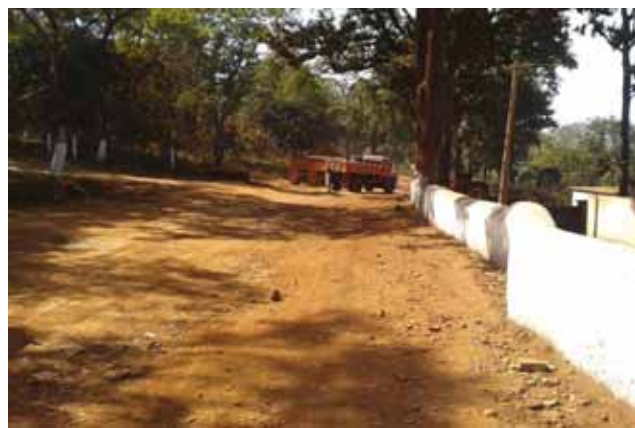
- This is a 3-arm intersection of ODR with road leading to Tensa township and mines.
- There is a round-about at the intersection.
- The condition of road surface is very poor and there are no lane markings or direction signs to guide the traffic through the intersection.
- The boundary wall of township is very close to the road edge.
- Two other access roads of SAIL guest house are joining ODR near the round-about without any warning or direction signs.
- There is no provision for VRUs at this intersection.

Km 12+350, intersection of ODR with township road – round-about and an approach

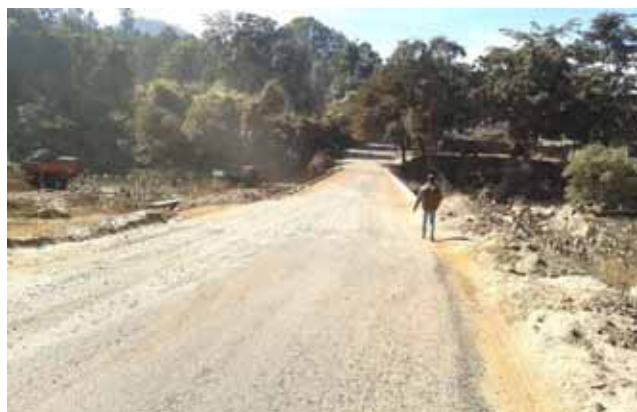
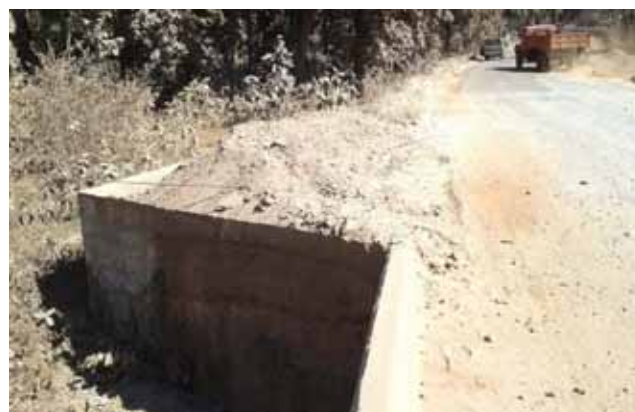
There is a causeway at **Km 24+000** where approaches are not protected and there are no parapets which may be hazardous for traffic.

Unprotected approaches to the causeway, Km 24+000

- If a vehicle approaching or traveling on the causeway loses control, it will fall into the ditch/drain in the absence of any protection, which may result into serious injuries or may prove to be fatal.

- Provide metal crash barriers on both the approaches and on the causeway (which will serve the purpose of parapet, but also allow the high water to overflow) with delineators.

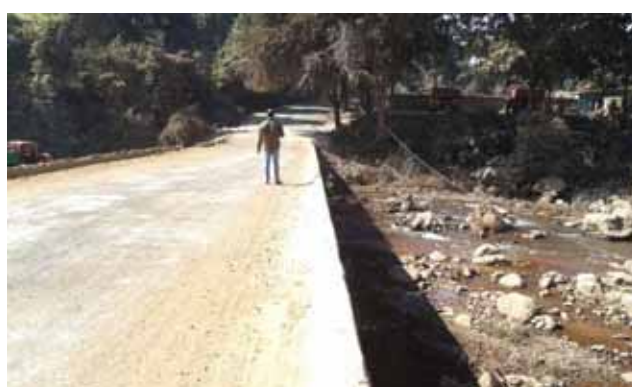
No delineation or edge protection on the causeway, Km 24+000

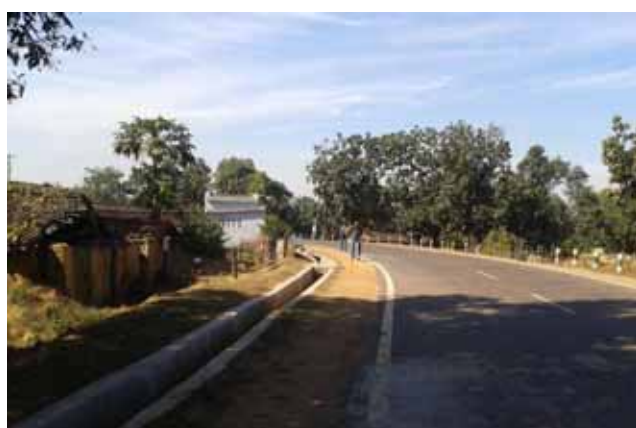
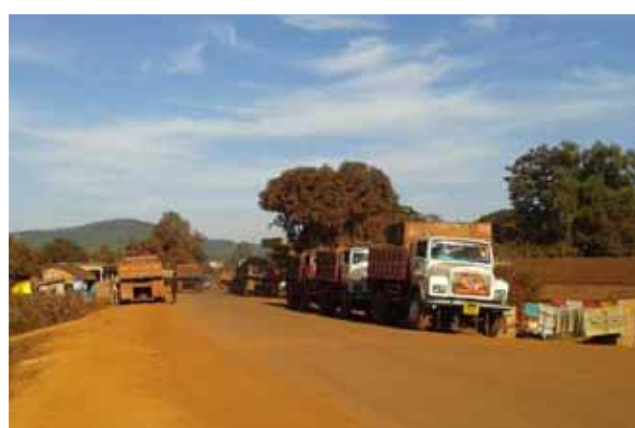
The presence of VRUs and their interaction with ODR is significant on all these BUAs on ODR. There is no facility for VRUs such as pedestrian crossing or footpath and there are no street lights in these BUAs. There are no bus-bays and hence the buses were observed stopping on the road obstructing visibility and the smooth flow of traffic.

Built-up area from Km 40+300 to 40+000 and Km 1+000 to 0+000 (Koida)

- No traffic calming measures are provided to slow down vehicles approaching at high speeds to the built up area
- Significant pedestrians including school children are noted, but no separate pedestrian facilities are provided along the road inside the BUA or to cross the road
- Significant number of access roads within the BUA, the visibility of which has been hampered due to shops/ establishments on all corners of the junction
- No road markings or warning signs to warn/ inform the road user of the built up nature of the area ahead
- No speed limit signs provided
- On street parking hampers the visibility and resulting in unsafe situations
- On street bus stops observed, which hampers visibility and unsafe overtaking maneuvers.

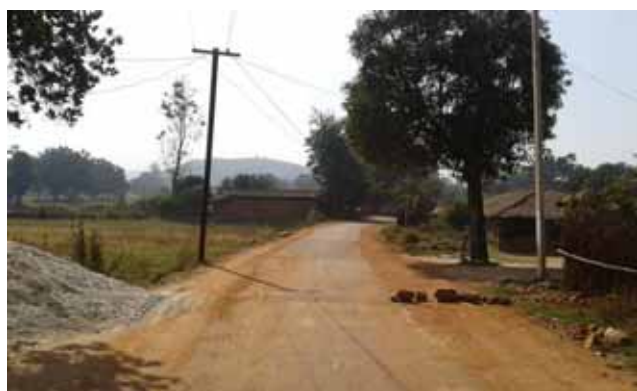
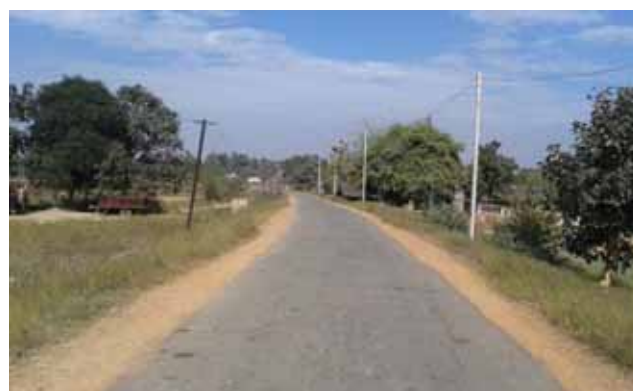
Lack of delineation on the entire stretch of road.
Photographs of stretches (i) Km 6+000 to 7+000, and (ii) Km 4+000 to 5+000

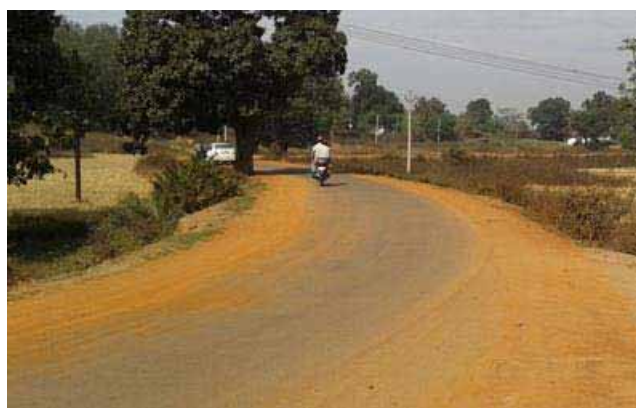
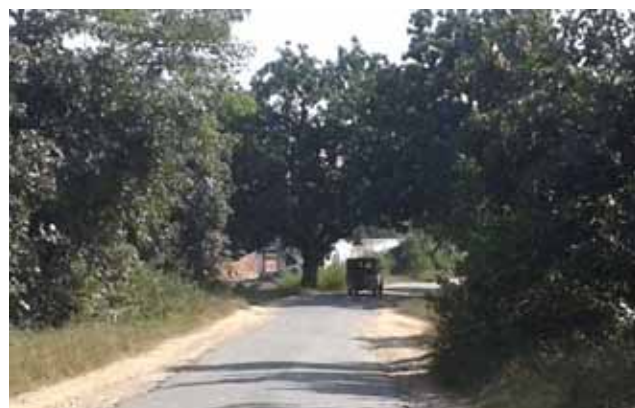
Project road has above listed sharp curves, where it is required for the approaching vehicle to slow down by more than 10-15 km/ hour from the approach speed.

Sharp curve at Km 6+200 and Km 2+400

| Recommendations: | Provide curve warning signs, chevron signs, delineators and speed limit sign as appropriate <i>Refer to Appendix III for guidelines on situations where to install the above</i> |

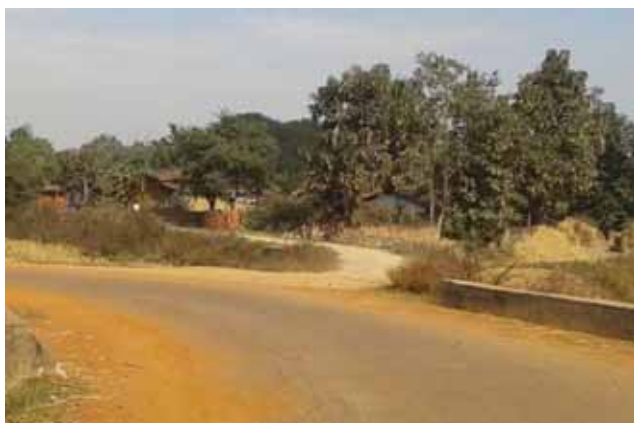
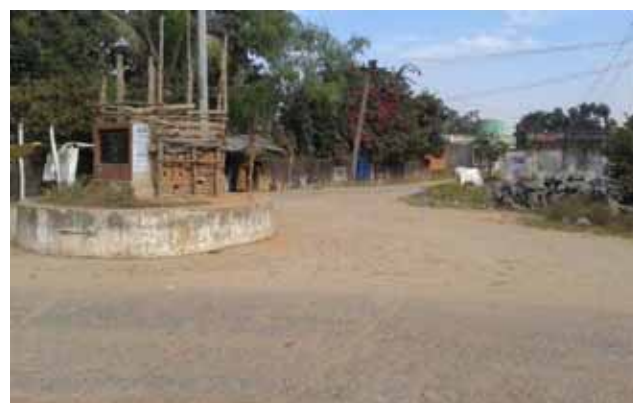
Side road joining Garjan Road at Km 6+200 and Km 4+200

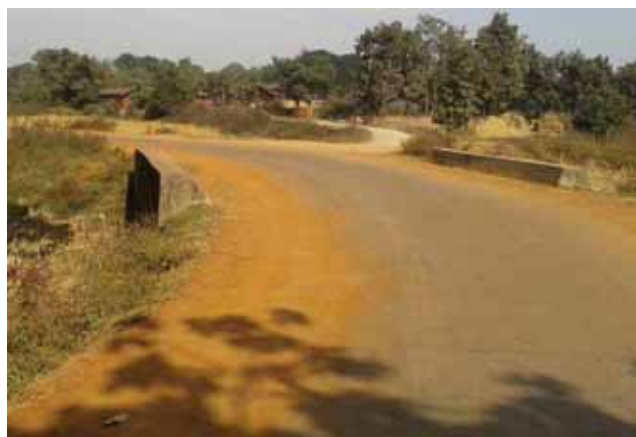
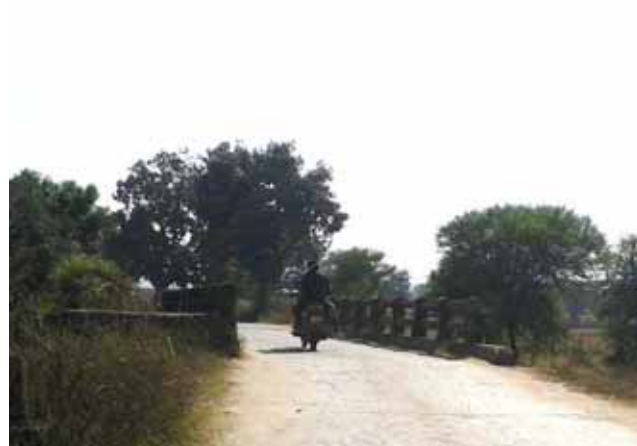
Parapets of Culvert/Bridge not delineated, Km 6+200 and Km 0+600

- The culvert/bridge parapets adjacent to high speed traffic movement are hazardous especially at night if not delineated as the driver cannot judge the position of such road side hazards.

- Provide edge line markings and Object Hazard Marker (OHM) on both sides and for both approaches (i.e. Four numbers of OHM for each structure)

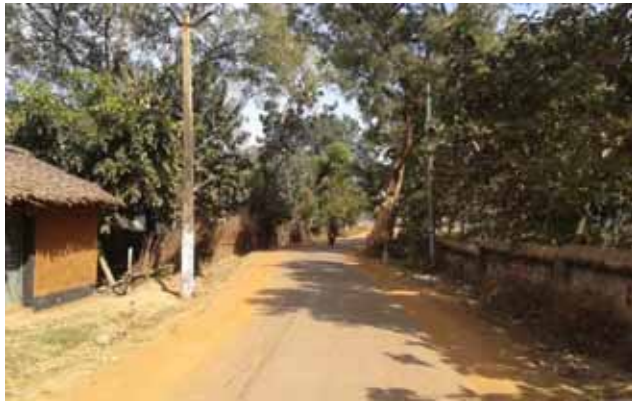
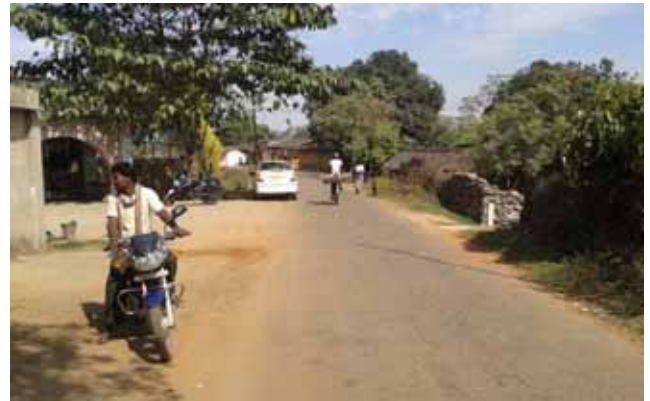
There were several road side objects observed on Garjan Road such as, trees and poles or buildings (in BUA) close to the edge of road.

Trees, poles and buildings very near to road edge in BUA

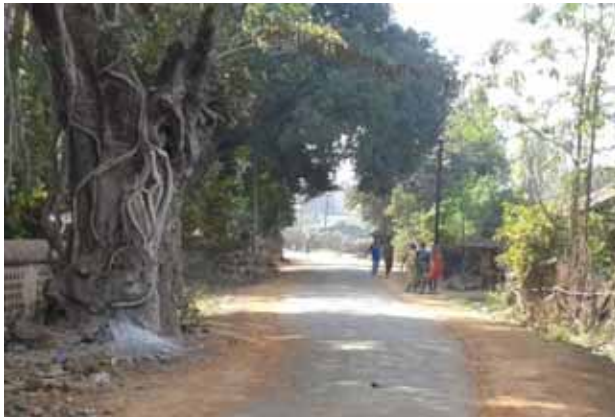
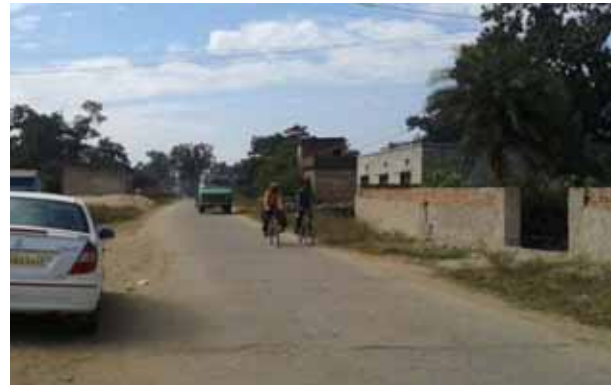
As the road assessed is a village road and all the above listed BUAs are small villages, congestion and on-street parking are less significant, however the presence of VRUs and their interaction with the road is significant. In these BUAs the buildings are very close to the road edge, and there is no facility for VRUs

such as pedestrian crossing or footpath. In such situation the risk of VRUs being involved in accident with motorized traffic is high.

BUA at Km 7+300 and Km 1+000

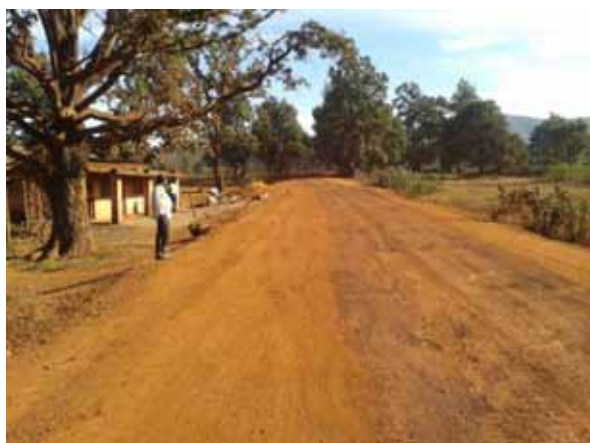
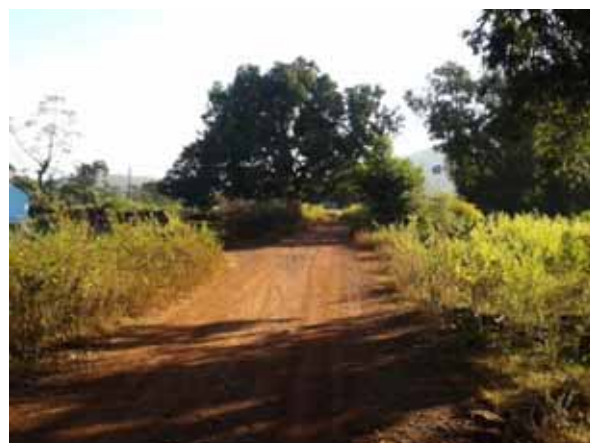
Poor road condition and lack of delineation on (i) Koida-Patmunda Road, and (ii) Koida-Khajurdihi Road.

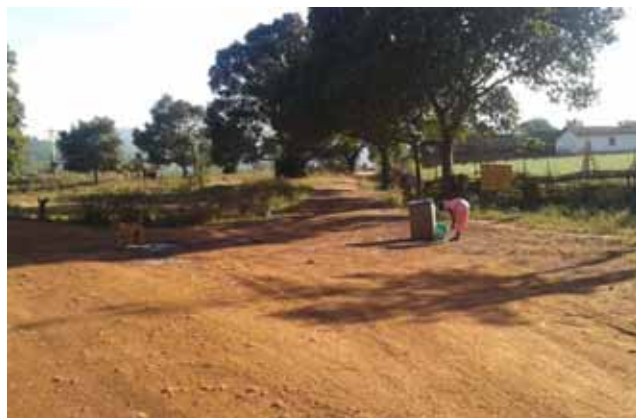
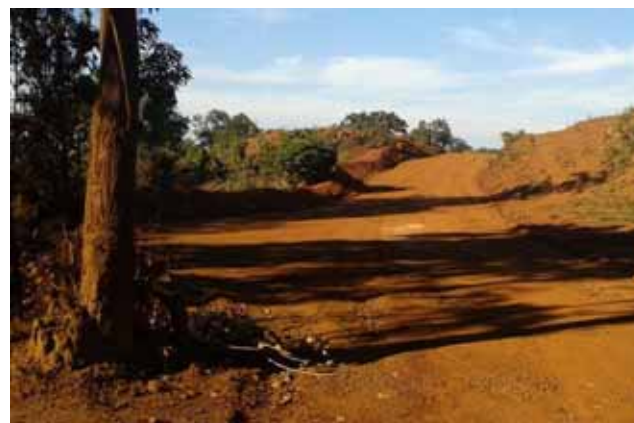
Side road joining with Patmunda/Khajurdihi Road at Km 2+150 and Km 3+400

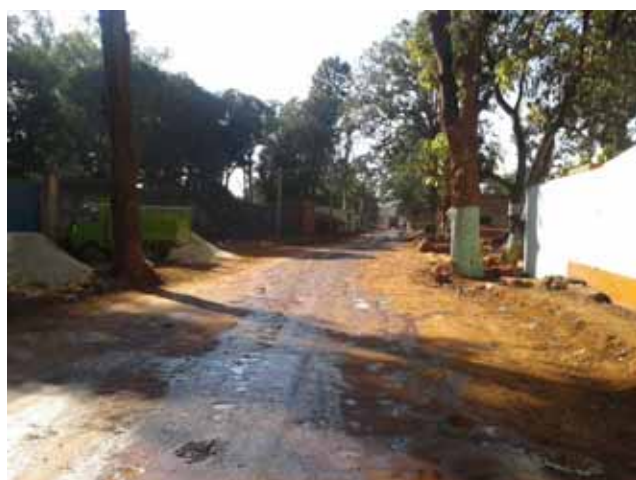
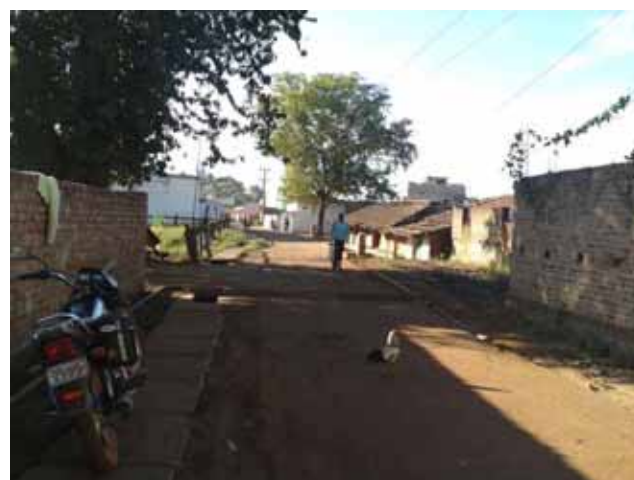
There are several road side objects observed on this road such as, trees and poles or buildings (in BUA) close to the edge of road.

Trees and buildings very near to road edge in BUA

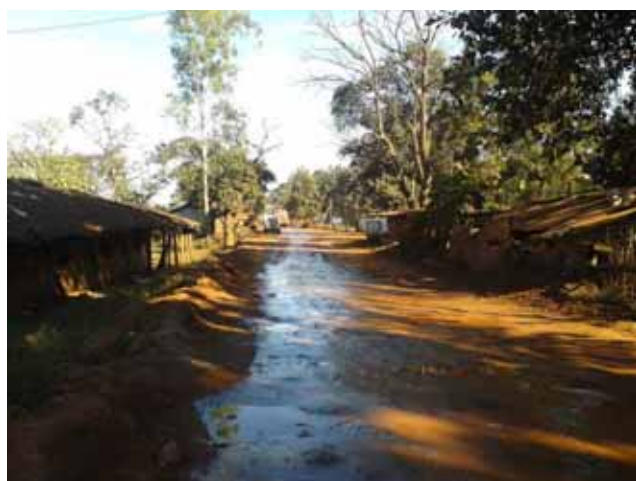
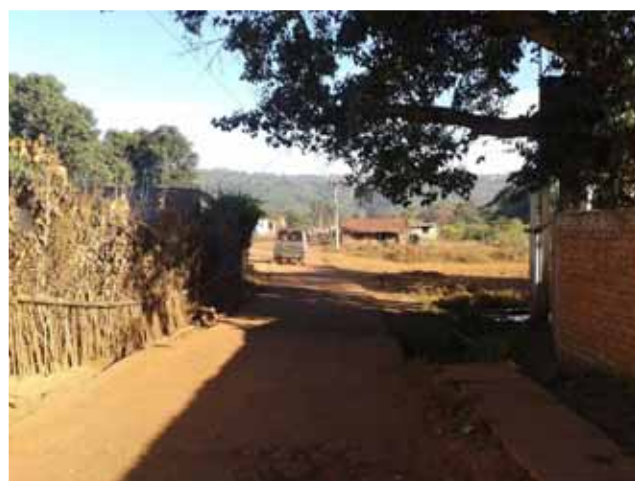
BUA at Km 0+000 and Km 7+700 on Koida-Patmunda Road

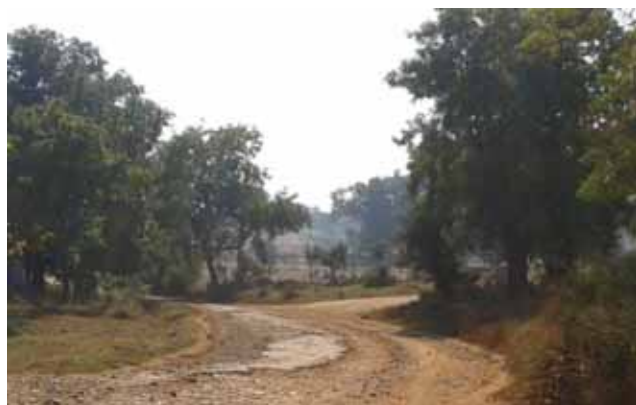
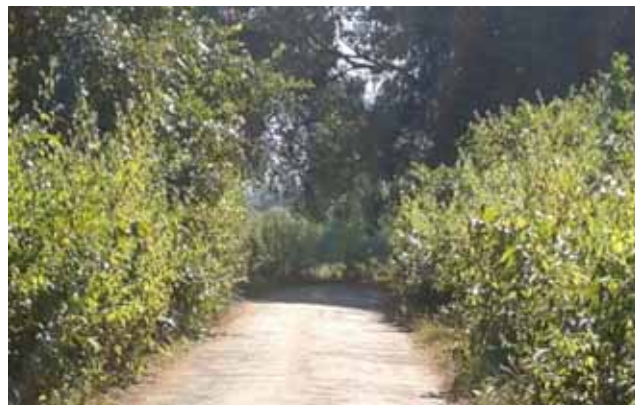
Project road has above listed sharp curves, where it is required for the approaching vehicle to slow down by more than 10-15 km/ hour from the approach speed.

Sharp curves at Km 2+200 and Km 14+900

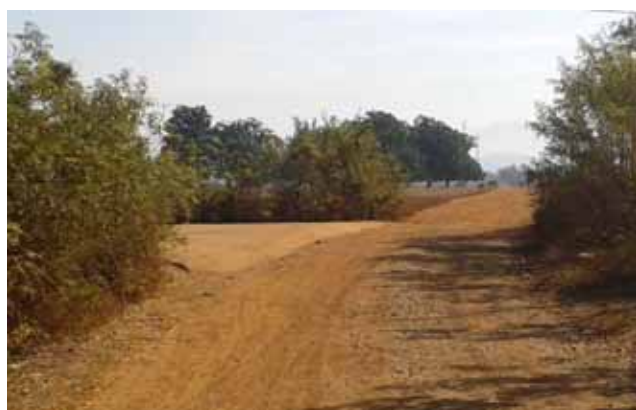
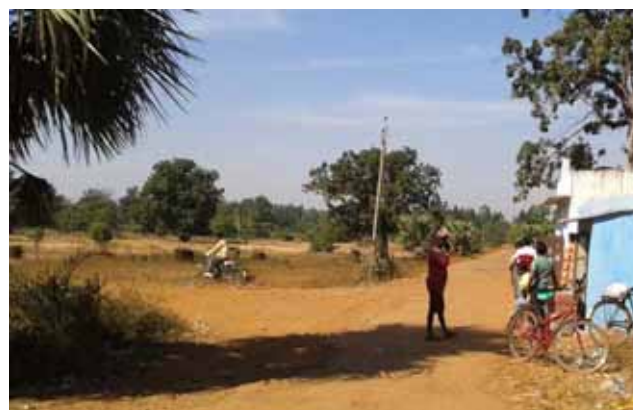
Side road joining Waterfall Road at Km 0+900 and Km 8+800

Reasons for concern: **Inadequate Visibility**

This is a major hazard observed on most of the 3-armed uncontrolled junctions. The major reasons for poor visibility at such junctions on SH-10 are due to encroachments.

Recommendations: Remove encroachments at least from the visibility triangle required for such junctions.

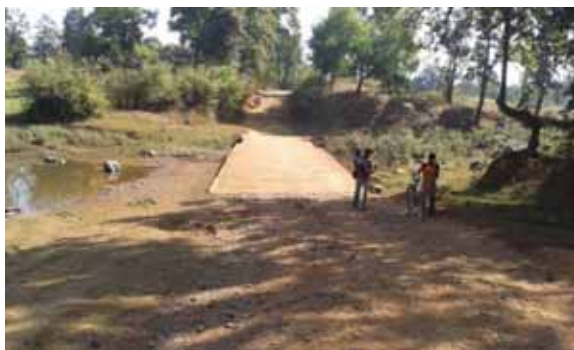
No parapets at low level bridge, Km 8+250

The absence of parapet on bridge/culvert increases the risk of vehicles falling in to the drain. In the context of significant movement of VRUs on this road, the absence of parapets is hazardous for them.

- Provide continuous parapets on all culverts and bridges.
- On low level bridge or causeway provide w-beam crash barrier.

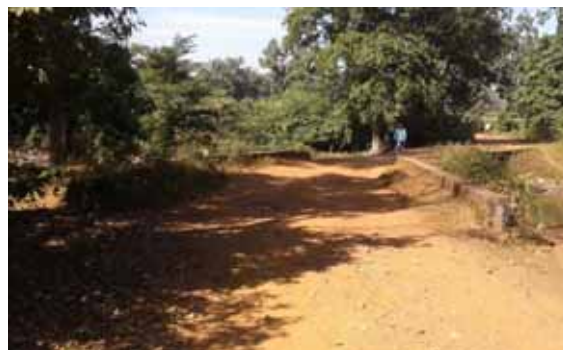
Parapets broken on culvert at Km 11+200

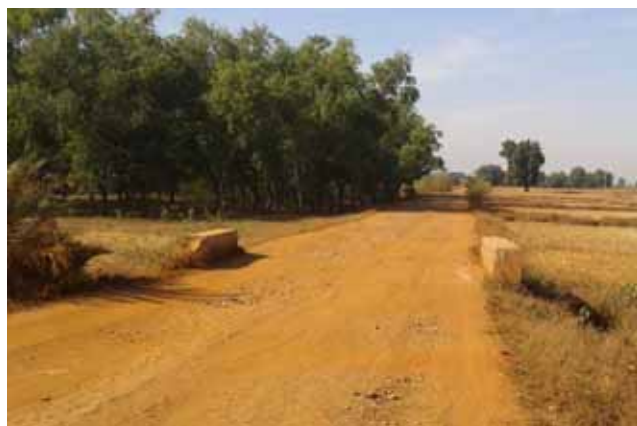
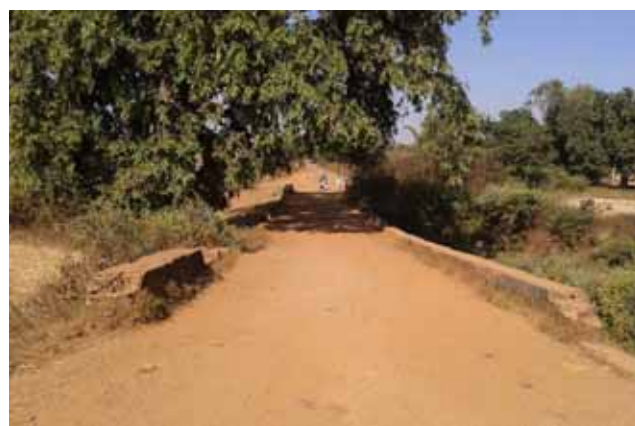
Parapets of Culvert/Bridge not delineated, Km 0+500 and Km 4+500

- The bridge parapets adjacent to high speed traffic movement are hazardous especially at night if not delineated as the driver cannot judge the position of such road side hazards.

- Recommendations:**
- Provide edge line markings and Object Hazard Marker (OHM) on both sides and for both approaches (ie. Four numbers of OHM for each structure)

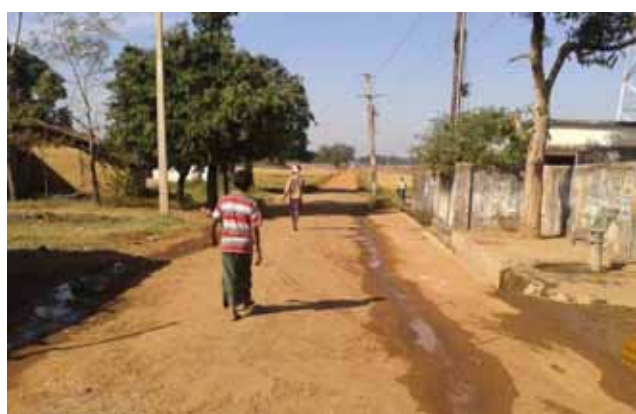
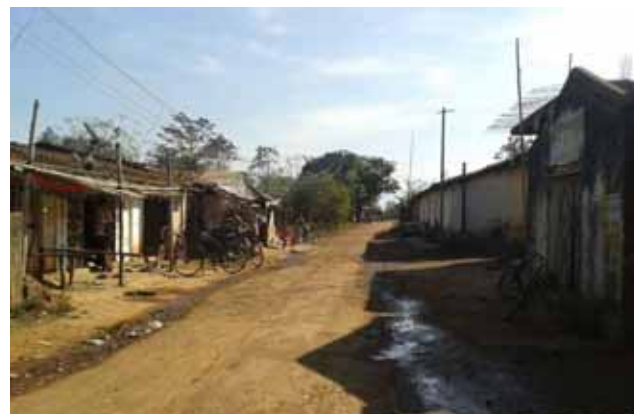
Poles and buildings very near to road edge in BUA

- The road side objects like, trees, street light or other poles, and buildings which are near the edge of road needs to be protected and delineated.
- At night time it becomes very difficult for drivers to judge the position of such road side hazard. If the road side objects are not protected and/or illuminated there are chances of driver losing control and hitting these objects.
- In BUA, due to buildings very near to road edge there is no space left for pedestrians and other VRUs for movement along the road. This increases the risk for VRUs.

- Delineate the hazards by installing OHMs or painting of the trees in black and white strips
- Remove encroachments on at least 2m from the road edge
- In BUA where buildings are very near the road edge provide traffic calming measures. Provide wide shoulders free of encroachments for movement of VRUs.

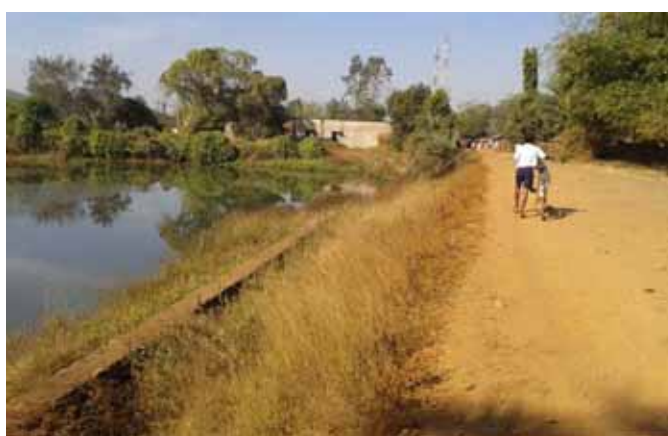
Pond near the road without delineation or any edge protection,
Km 2+200

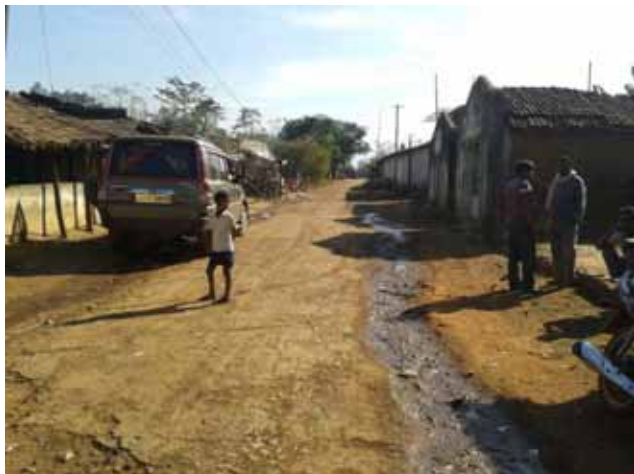
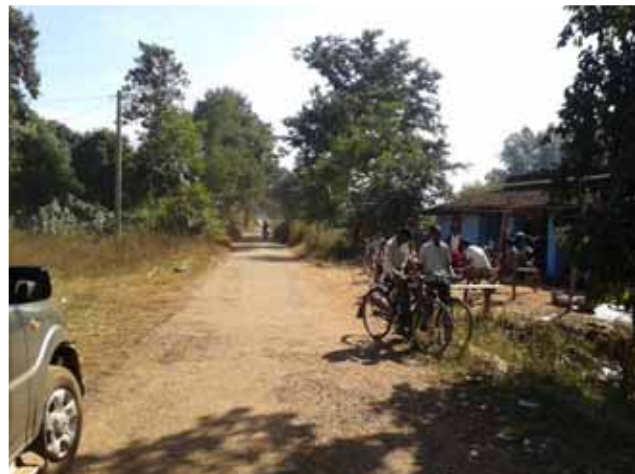
BUA at Km 1+800 and Km 6+900

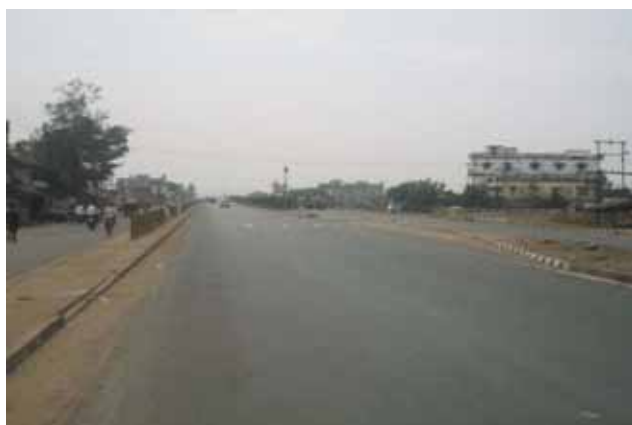
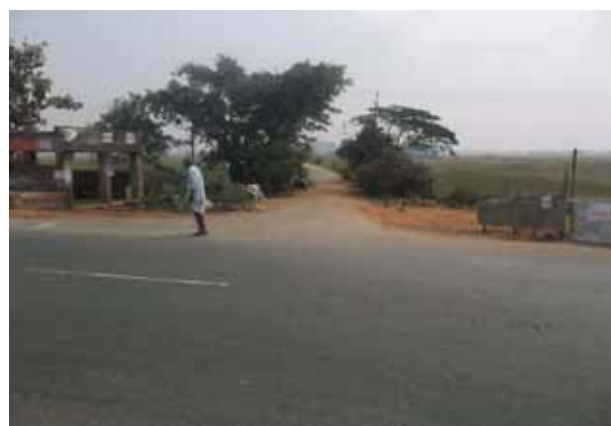
Absence of Centre line and edge line road marking at Km 225+480 and Km 219+500 respectively

Centre line is present at most of the stretches but edge line road markings were not provided, the presence of which should delineate the road, particularly during night conditions

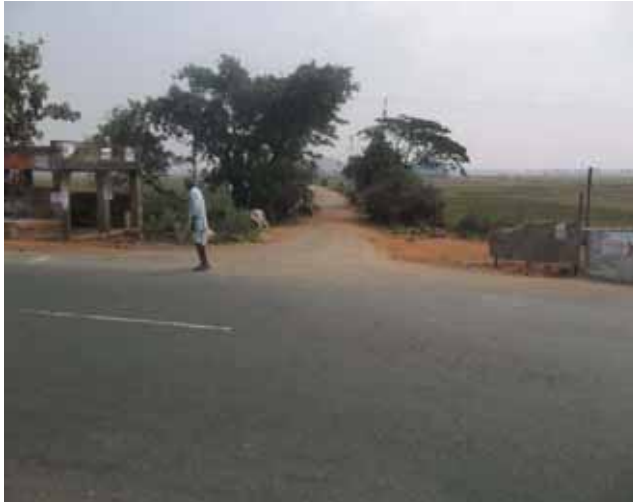
Side road with poor visibility due to vegetation at Km 225+200

This is a major hazard observed on most of the 3-armed uncontrolled junctions. The major reasons for poor visibility at such junctions on the road are due to buildings/encroachments on the corners.

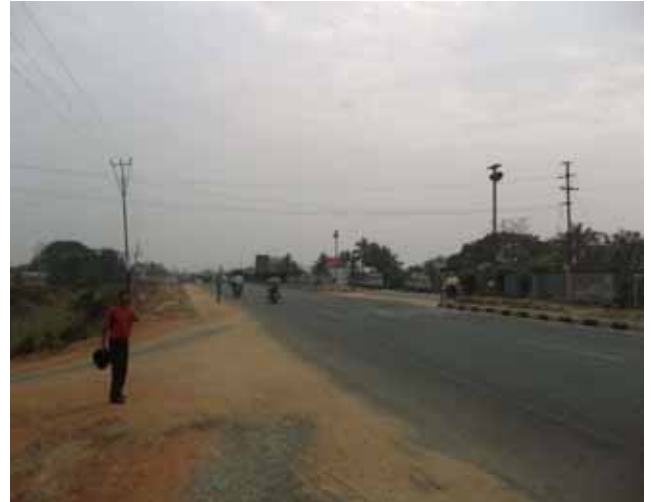
Level difference between side road and main road at Km 251+800

It has been observed that at a few junctions, the level differential between the side road and major road and the vertical profile of the side road joining the edge of main carriageway are in an unsafe manner.

- Recommendations:**
- Correct the vertical alignment of side road so that vehicles approaching from side roads has adequate length on the side road to slow down/ stop before entering into the main carriageway.

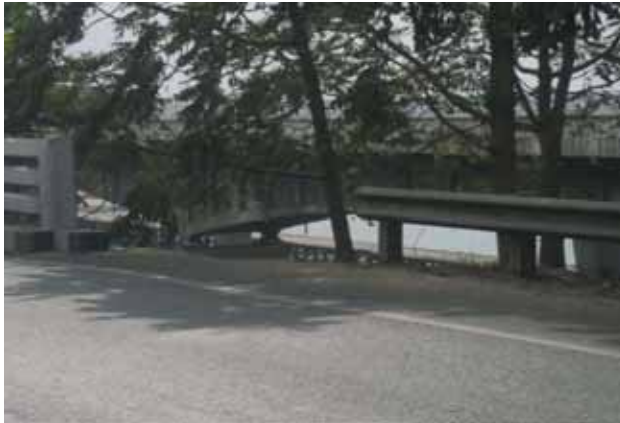
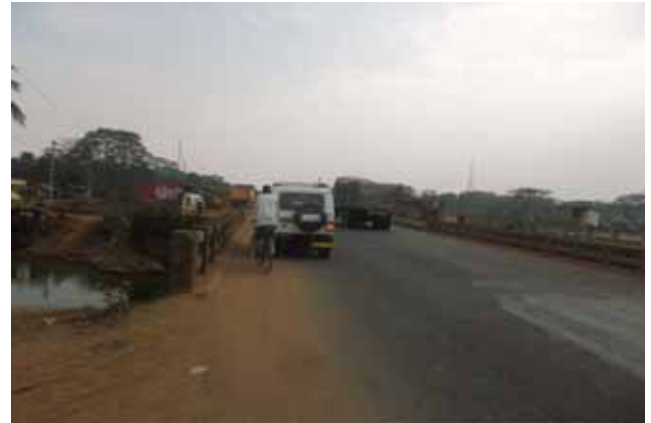
- Sharp Curve on approaches;
- No protection on outside curve;

Unsafe Approach to Bridge at Km 253+000 and Km 271+200 respectively

In the absence of adequate warning signs and reflective markings, the road layout and the hazard will not be clear for the road user, particularly during night conditions which may lead to serious injuries/ fatal accidents

- Provide curve warning signs in addition to crash barriers with delineators
- Provide edge lane markings
- Provide hazard markers on the edges of the parapets

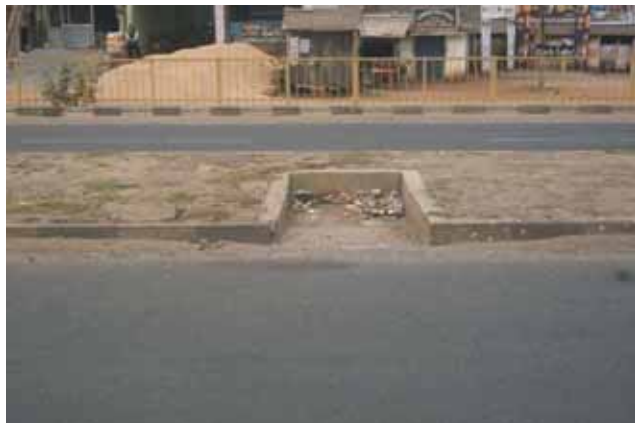
Drain located near to pavement edge at Km 219+100

The road side objects like trees and street lighting poles, buildings and unprotected deep drains pose significant safety hazard. At night time it becomes very difficult for drivers to judge the position of such hazards, in the absence of proper delineation.

- Delineate the hazards by installing OHMs or painting of the trees in black and white strips
- Remove encroachments on at least 3m from the road edge
