**Government of Odisha (GOO)
Chief Engineer, World Bank Projects, Odisha
Odisha State Roads Project**

**Consultancy Services for
Road Sector Institutional Development
Loan # 7577-IN**

**ROAD INFRASTRUCTURE
SAFETY MANAGEMENT REVIEW**

VOLUME I - REPORT

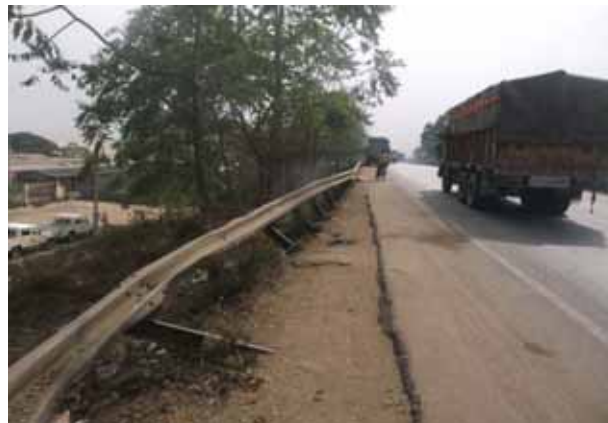
Project road has several trees and street light poles very near to the pavement edge which are hazardous for fast moving traffic. At some sections, the crash barriers are damaged probably due to accidents need to be fixed.

Broken crash barrier at Km 250+300

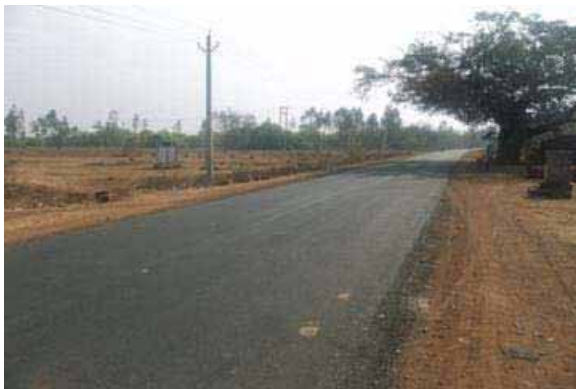
Absence of center line road marking at
Km 11+200

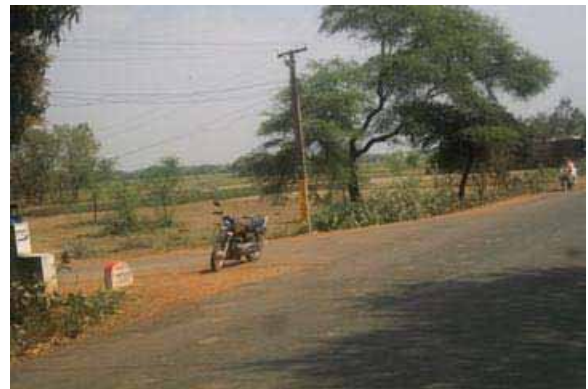
Absence of road marking at
Km 35+300

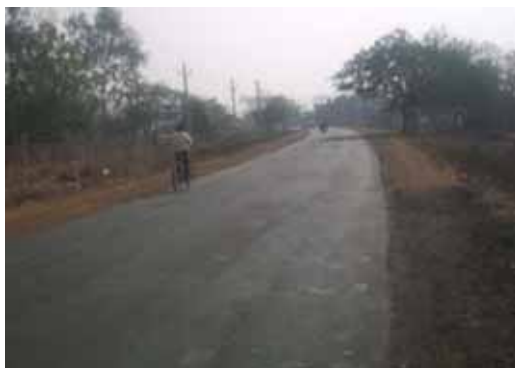
Curve at Km 6+500

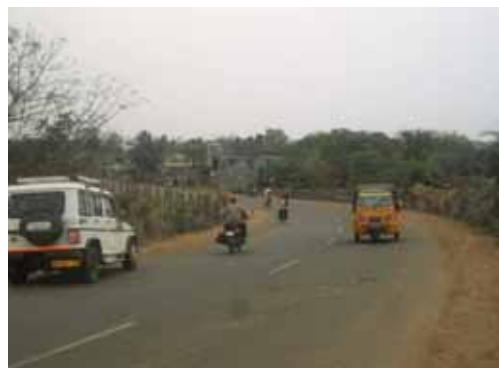
Curve at Km 51+640

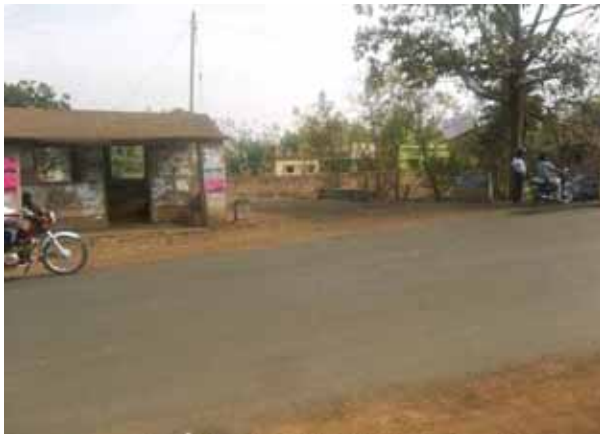
Perpendicular side road at Km 11+320

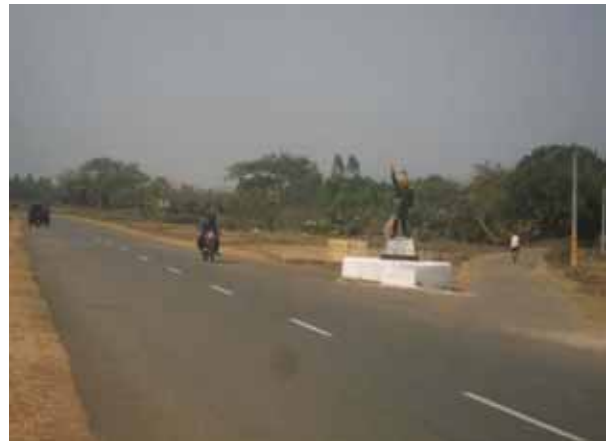
Skewed side road at Km 30+100

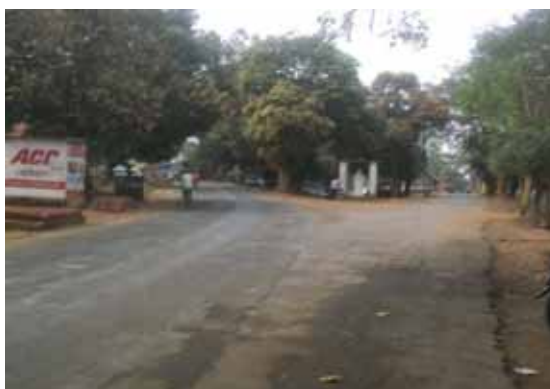
Km 40+100

- Poor layout of the junction with no established traffic control
- Junction area has moderate commercial activity and the level of encroachment is medium
- Big trees and statue obstructs the visibility for vehicles coming from side road
- Street lighting is not provided

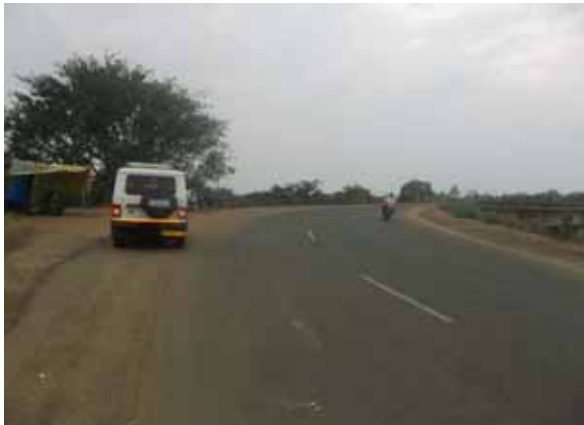
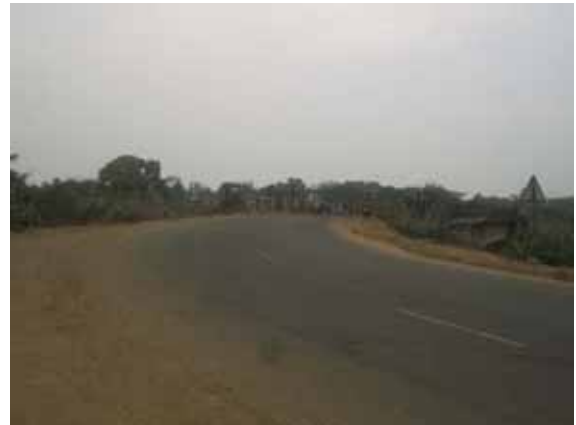
At chainage 51+640, a curve leads to a bridge on both approaches in high embankment, but it has been observed that no safety measures have been provided.

Approach to Major Bridge at high embankment at Km 51+640

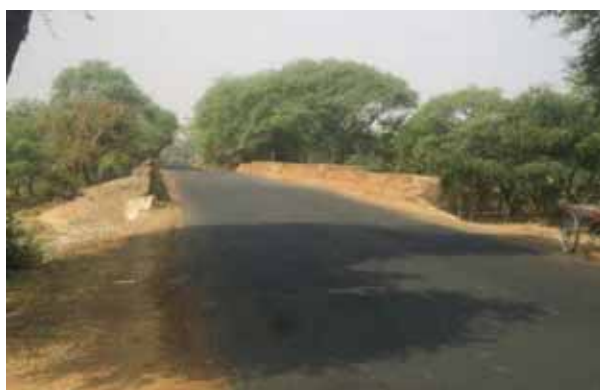
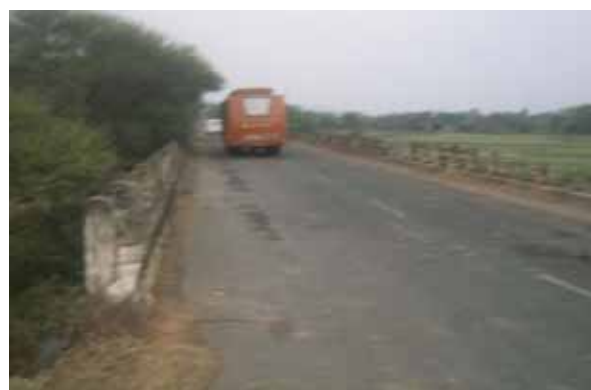
At the following chainages parapet wall was either broken or found missing. In the event of a vehicle loses control, the resultant injury will be fatal or major, due to the presence of water body.

Absence of OHM and broken parapet wall at Km 14+750 and at Km 49+350 respectively

The absence of parapet on bridge/culvert increases the risk of vehicles falling in to the drain. In the context of high speed traffic movement observed on the road, the absences of parapets at such locations are hazardous for traffic, especially for VRUs.

- Install Object Hazard Marker (OHM) on both sides and for both approaches (i.e. four numbers of each OHM for each structure).

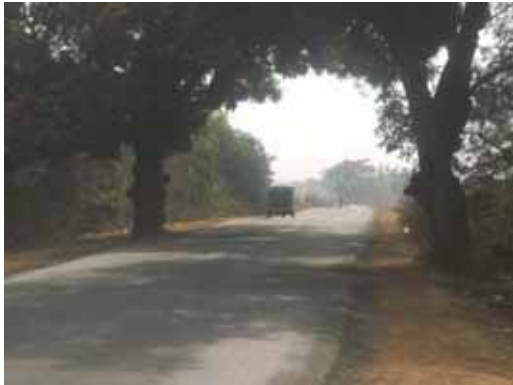
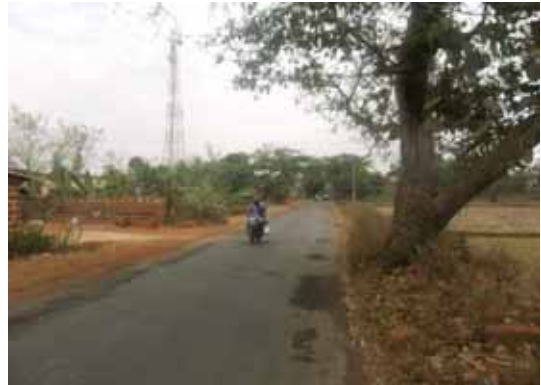
Trees near pavement edge

Reasons for concern: The road side objects like trees, street light or other poles, buildings, and unprotected deep drains which are near the edge of road needs to be. At night time it becomes very difficult for drivers to judge the position of such road side hazard. If the road side objects are not protected and/or illuminated there are chances of driver losing control and hitting these objects which may result into fatal accident.

- Remove Trees/ street lighting poles from the road shoulders
- Remove encroachments from the right of way
- Provide crash barriers on locations where trees acts as a significant hazard and where the space is available to install crash barrier

- Delineate the hazards by installing OHMs or painting of the trees in black and white strips
- Remove encroachments on at least 2m from the road edge

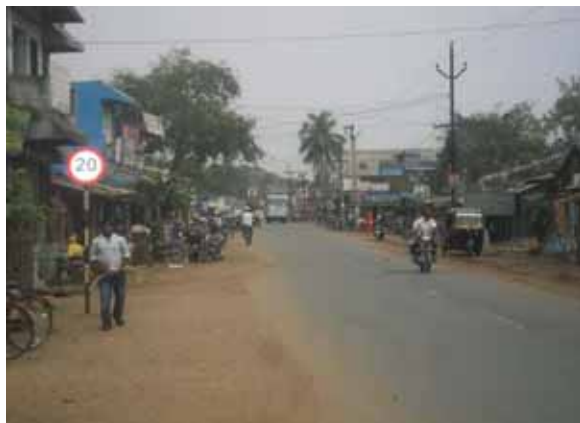
Commercial Area at Km 53+800

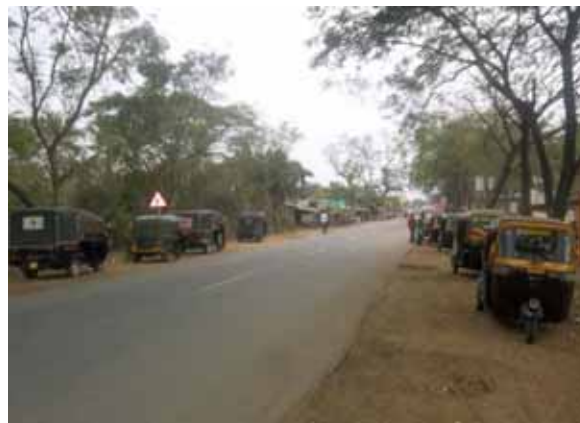
On street parking at Km 49+800

- Hazardous on-street parking observed on commercial/ encroachment zones, which hampers the visibility of oncoming vehicles and resulting in unsafe situations.

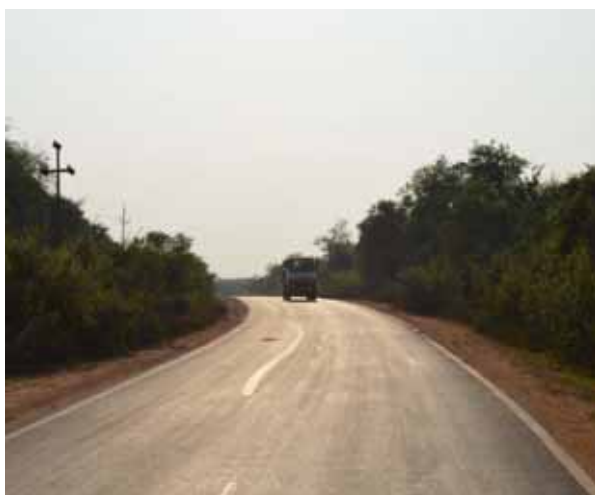
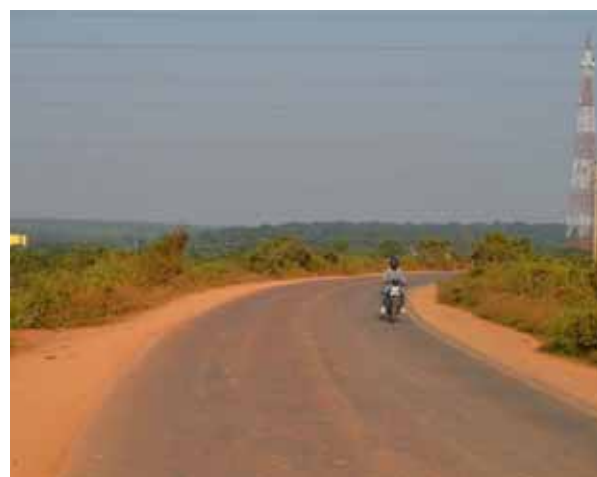
Sharp Curves on Project Road at Km 3+300 and Km 4+000

Recommendations: Provide **curve warning signs, chevron signs, delineators and speed limit sign** as appropriate

Recommendations: Provide crash barriers on the outer edge on such curves.

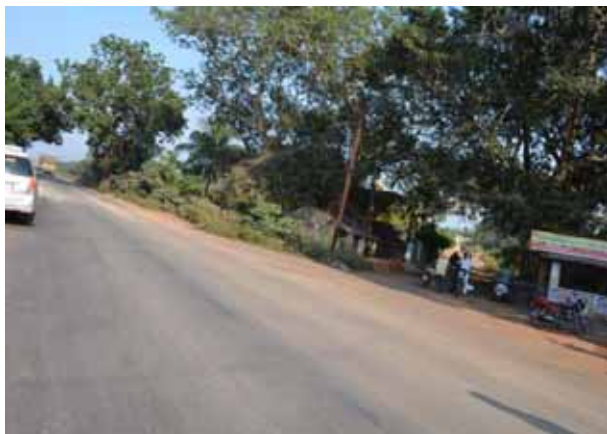
Skewed Side Road at Km 5+800

This is a major hazard observed on most of the 3-armed uncontrolled junctions. The major reasons for poor visibility at such junctions on MDR-77 are due to buildings/ shops on the corners and overgrown vegetation.

Recommendations: Remove encroachments at least from the visibility triangle required for such junctions.

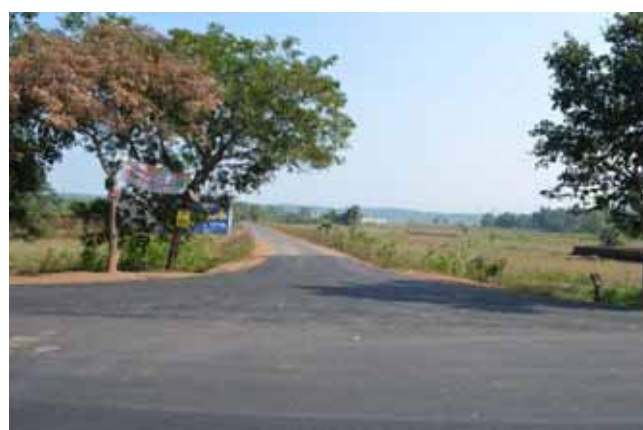
Side roads perpendicular to Major Road at Km 16+900

No traffic signs or road markings are observed on any of such junctions, the presence of which would have informed and warned the road user of the layout ahead.

Recommendations: Provide traffic signs and road markings pertaining to junction control

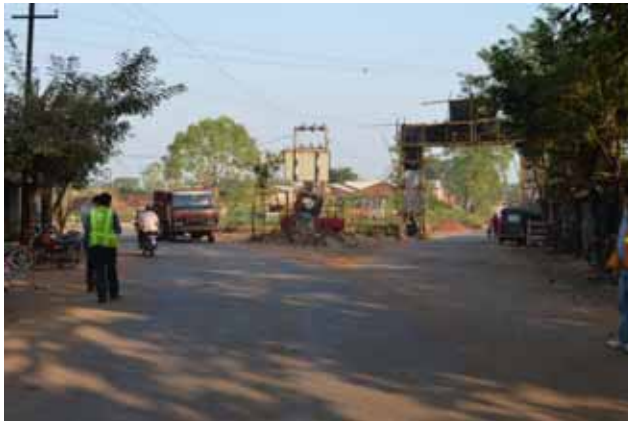
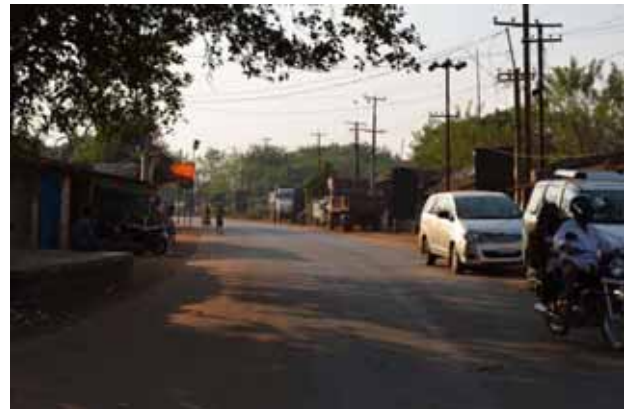
- Significant number of two wheelers, pedestrians and cyclists use the junction;
- Non-standard central traffic islands/ splitter were provided. Garbage is dumped near central traffic island; and
- Street light is absent.

- The junction layout is non-standard and has no control over the traffic movement. It is confusing who has priority in such a situation. This encourages lawless traffic movement and is hazardous. The existing central island is non-standard and hampers visibility at the junction.

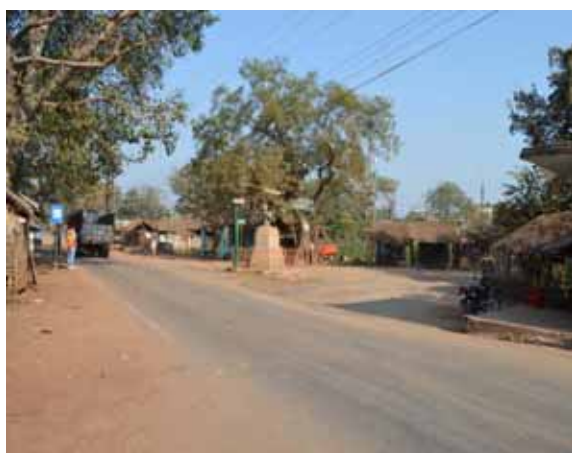
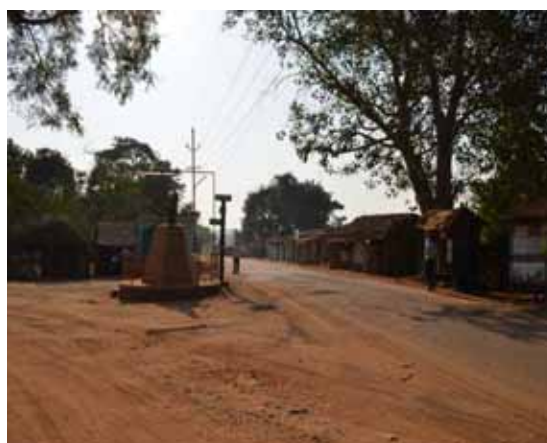
- Significant number of two wheelers, pedestrians and cyclists use the junction;
- Non-standard central traffic islands/ splitter were provided. Garbage is dumped near central traffic island; and
- Street light is absent.

- The junction layout is non-standard and has no control over the traffic movement. It is confusing who has priority in such a situation. This encourages lawless traffic movement and is hazardous. The existing central island is non-standard and hampers visibility at the junction.

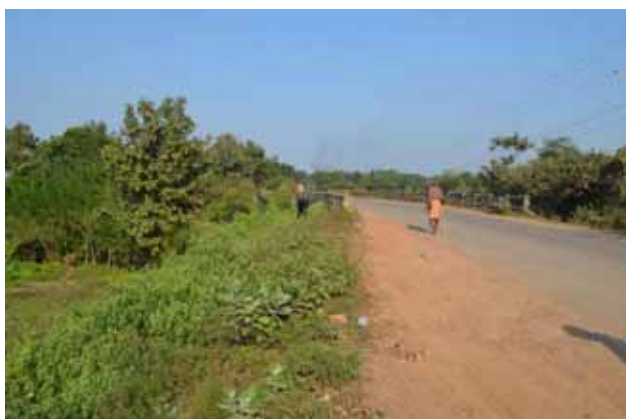
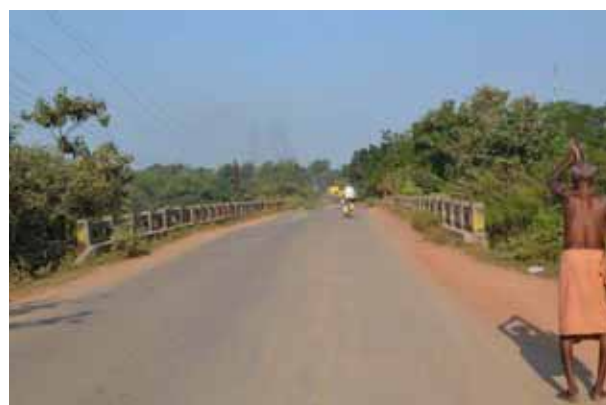
Approach to Major Bridge at high embankment at Km 51+640

In the absence of adequate warning signs and reflective markings, the road layout and the hazard will not be clear for the road user, particularly during night conditions

- Recommendation:**
- Provide curve warning sign in addition to crash barrier with delineators
 - Provide edge lane markings
 - Provide hazard markers on either edge of the parapets

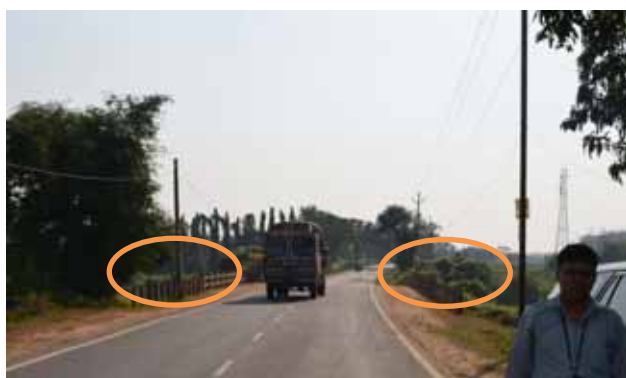
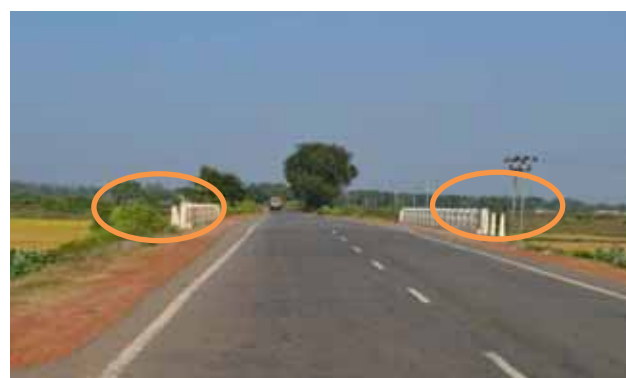
Absence of OHM at Km 12+500 and Km 19+500

Reasons for concern: The bridge/ culvert parapets on the edge of the road adjacent to high speed traffic movement will be hazardous, particularly at dark conditions, and needs to be illuminated for a driver to judge the position of such road side hazard.

Recommendations: Install Object Hazard Marker (OHM) on both sides and for both approaches (i.e. Four numbers of each OHM for each structure.

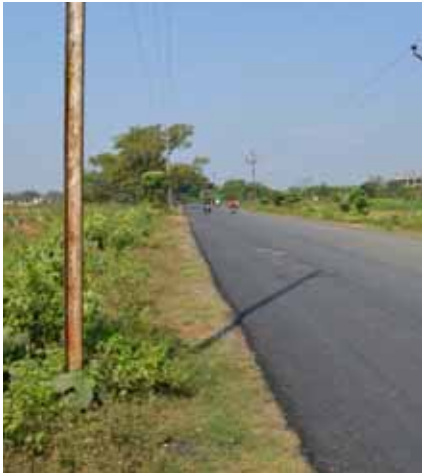
Tree and street light pole near pavement edge

- Delineate the hazards by installing OHMs or painting of the trees in black and white strips

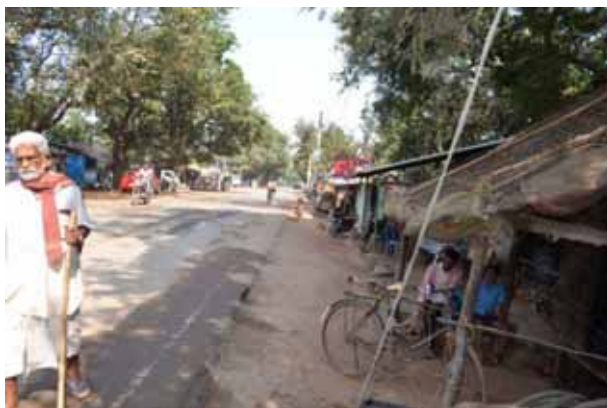
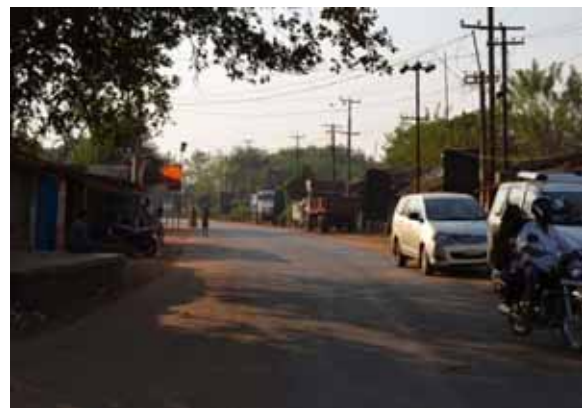
- Roadside villages observed on this ODR.

Built up Sections at Km 24+000 and Km 0+000
