**Government of Odisha (GOO)
Chief Engineer, World Bank Projects, Odisha
Odisha State Roads Project**

**Consultancy Services for
Road Sector Institutional Development
Loan # 7577-IN**

**ROAD INFRASTRUCTURE
SAFETY MANAGEMENT REVIEW**

VOLUME I - REPORT

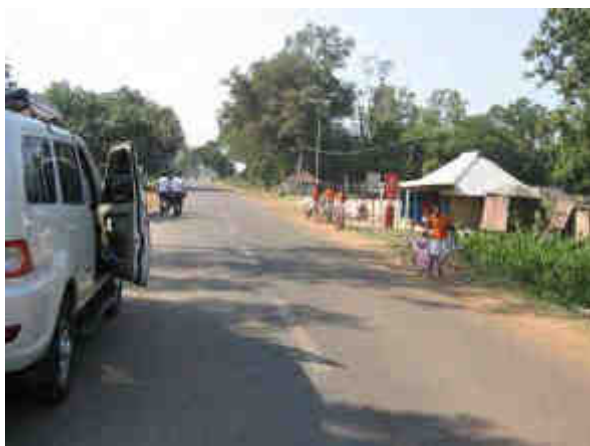
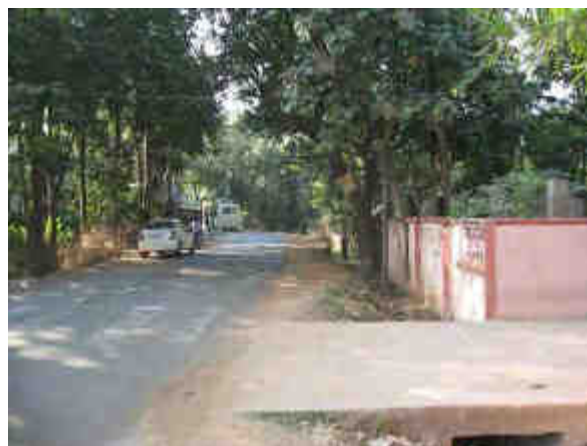
3.3.1.1. Delineation of the road

Reasons for concern: Centerline and edge line road markings are absent in the some sections of the road section.

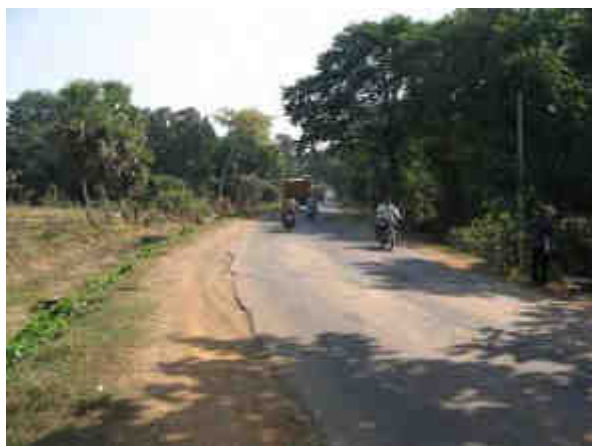
Ch: 1+500

Horizontal curves of radius less than 200 m were observed at Km. 1+500; 6+700; 7+400; 8+400; 8+750; 8+850; 9+150; 20+170; 21+500; 22+300; 23+050; 23+300; 25+160; 26+150

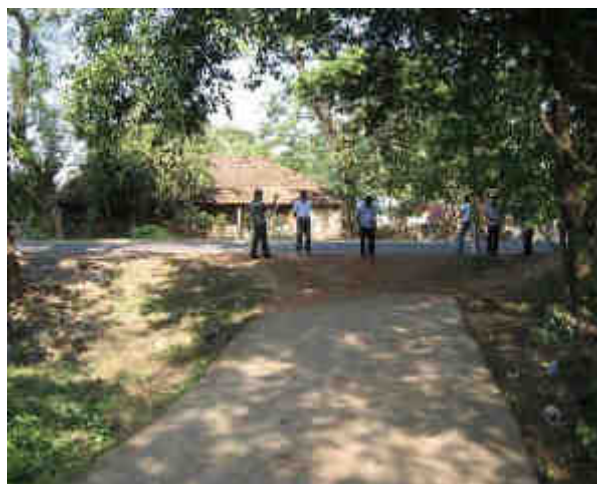
Ch: 6+700

Location of Side roads at skew with the major road

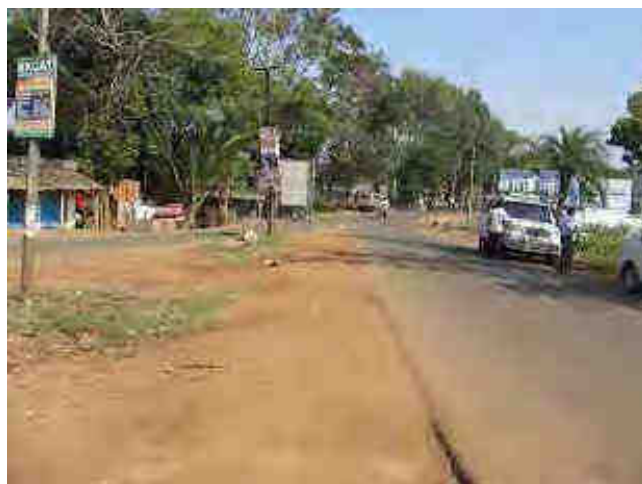
Two major junctions at Ch: 7+400 and Ch: 8+700 were located along this road. In both the cases, the junctions are located at the end of a sharp curve with limited visibility.

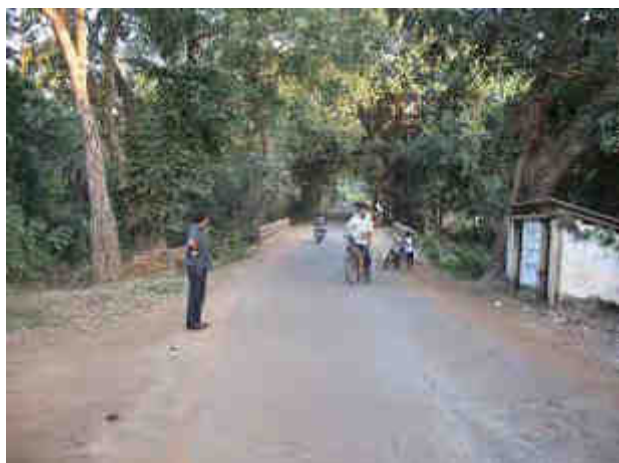
Ch: 23+050

The unprotected bridge approaches of three minor bridges present along the road at the chainages shown below:

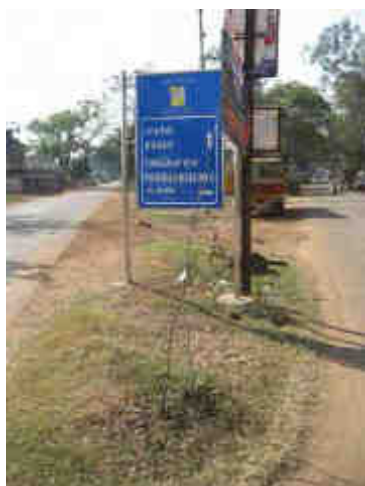
Ch: 7+400

Along the road, there are road side objects like electricity poles, signs, trees were present at significant number of locations.

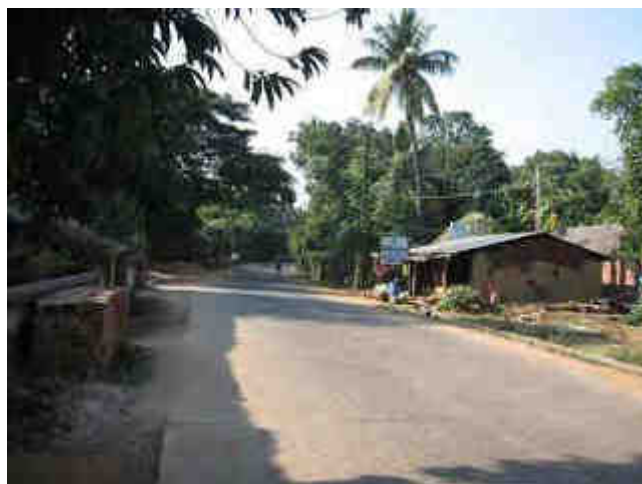
Ch: 9+500

There are many small hamlets along the road. The presence of houses/ schools along the road generates vehicular traffic / pedestrians / cyclists on the road in the stretches. The roadside villages, which are particularly exposed to hazards were observed on the following chainages:

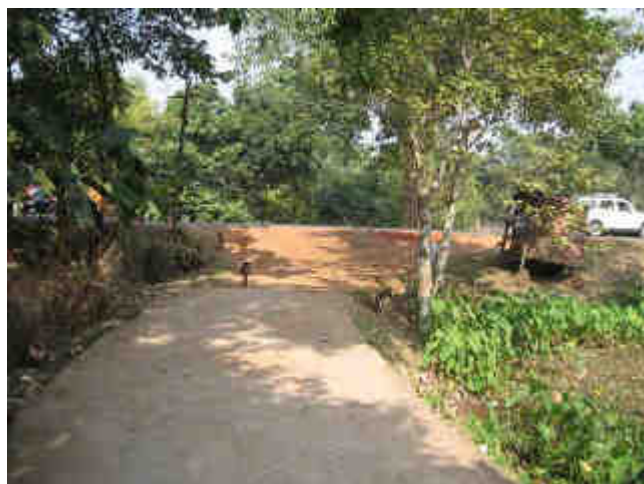
Ch: 4+300

Location of Side roads at skew with the major road

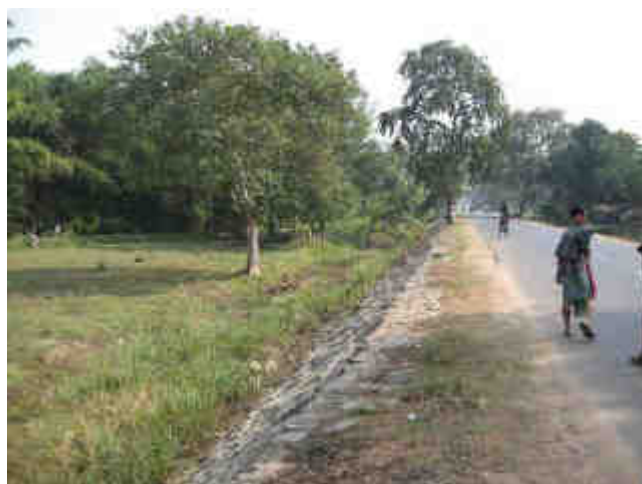
Ch: 10+100

Along the road, road side objects like electricity poles, signs, trees are present at significant number of locations.

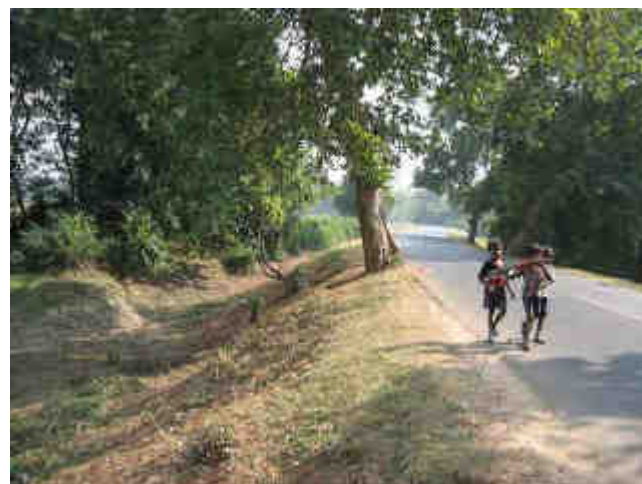
Ch: 10+700

Reasons for concern: Roadside objects constitute a significant hazard, if the driver loses control and will result in major injuries/ fatalities

- Remove Trees/ street lighting poles from the road shoulders
- Remove encroachments from the right of way
- Provide crash barriers on locations where trees acts as a significant hazard and where the space is available to install crash barrier

- Delineate the hazards by installing OHMs or painting of the trees in black and white strips
- Remove encroachments on at least 2m from the road edge

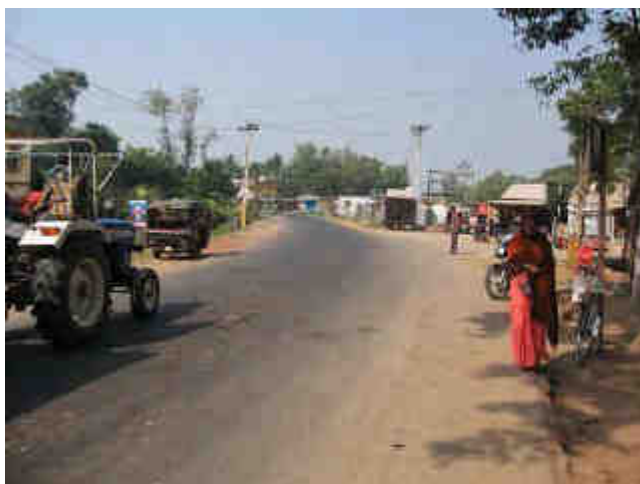
Ch: 6+600

- Significant pedestrians including school children are noted, but no separate pedestrian facilities are provided along the road inside the BUA or to cross the road
- Significant number of access roads within the BUA, the visibility of which has been hampered due to shops/ establishments on all corners of the junction
- No traffic calming measures are provided to slow down vehicles approaching at high speeds to the built up area
- No speed limit signs provided
- Street lighting not provided on some of the roadside villages

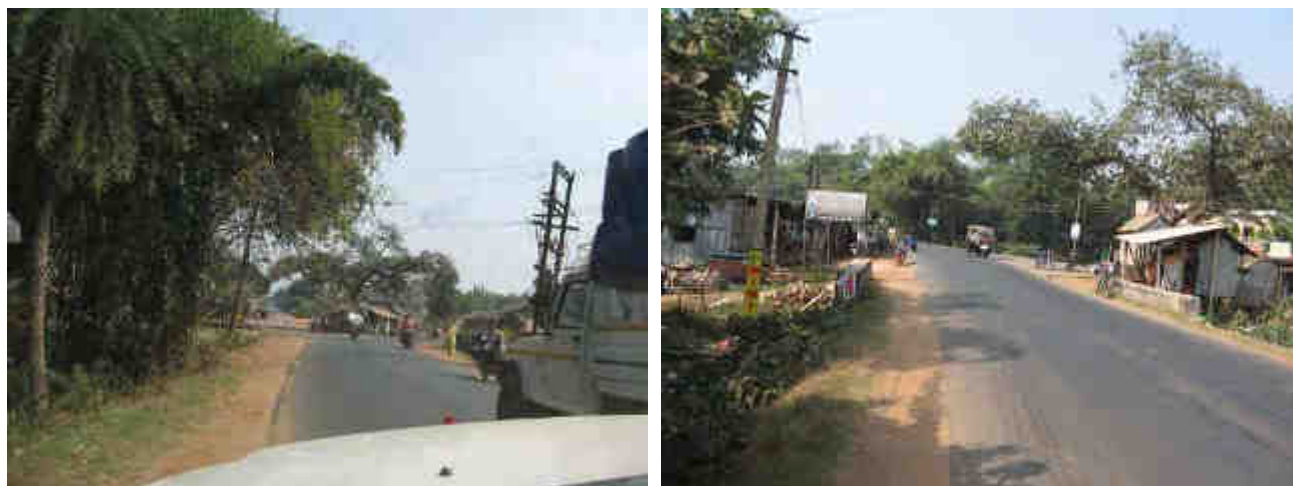
Ch: 3+600

It was informed by OWD, that this junction near Nachimpur village Chainage:3+600 is a black spot. This is a three arm uncontrolled junction on a curve after a long straight section.

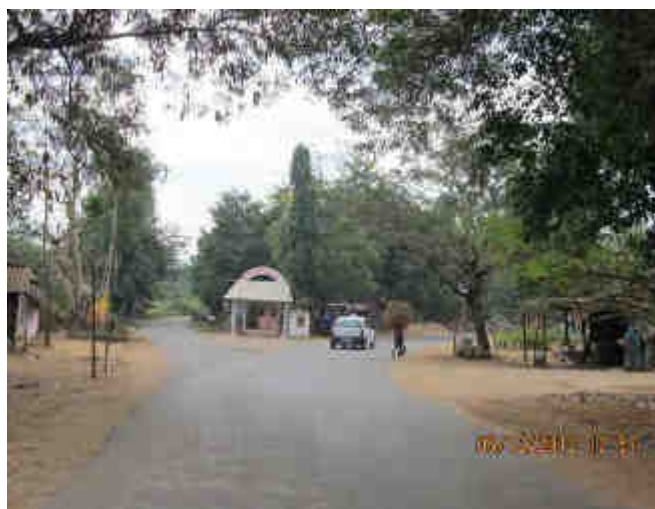
Skewed Side road at Km 28+850

Reasons for concern:	Inadequate Visibility <p>This is a major hazard observed on most of the 3-armed uncontrolled junctions. The major reasons for poor visibility at such junctions on SH-15 are due to buildings/ encroachments on the corners.</p>
Recommendations:	<p>Remove encroachments at least from the visibility triangle required for such junctions.</p>
Reasons for concern:	Poor delineation <p>No traffic signs or road markings are observed on any of such junctions, the presence of which would have informed and warned the road user of the layout ahead. Poor delineation may result in sudden braking behavior by road users who are required to stop, or wish to make turns. In the worst case, it can also result in rear-end collisions at high speeds.</p>
Recommendations:	<ul style="list-style-type: none">• Provide warning signs to provide drivers of advance notice of the upcoming junction• Provide Give Way/ Stop signs as applicable, on side roads• Provide Give Way/ Stop road marking at side roads <p>Refer to Appendix III for typical 3-arm junctions layouts with appropriate road markings and traffic signs.</p>

Reasons for concern:	High approach speeds <p>High approach speeds were observed by traffic turning from side roads into the main carriageway and no traffic calming measures/ warning is provided on the side road. Coupled with inadequate visibility, in the worst case, this may result in right angle collision with vehicles coming from the major road leading to serious injury or fatal accidents.</p>
Recommendations:	<ul style="list-style-type: none">• Provide road humps on the side road at junctions having history of accidents• Provide raised markings on the entry to the side road• Provide adequate warning signs on major road and side road <p>Refer to Appendix III for standard details of road humps.</p>
Reasons for concern:	Poor Geometry <p>It has been observed that on few junctions, the level difference between the side road and major road and the vertical profile of the side road joins the edge of main carriageway in an unsafe manner. This requires special skills from the drivers of vehicles coming from the side road to stop/ slow down before they enter into the main carriageway at the junction and most of the drivers in such circumstances tend to drive into the major road without stopping/ slowing down. This may lead to collisions resulting in major injury/ fatalities.</p>

Recommendations:	<p>Correct the vertical alignment of side road so that vehicles approaching from side roads has adequate length on the side road to slow down/ stop before entering into the main carriageway.</p> <p>Refer to Appendix III for safe geometrical arrangements of junction with side road.</p>

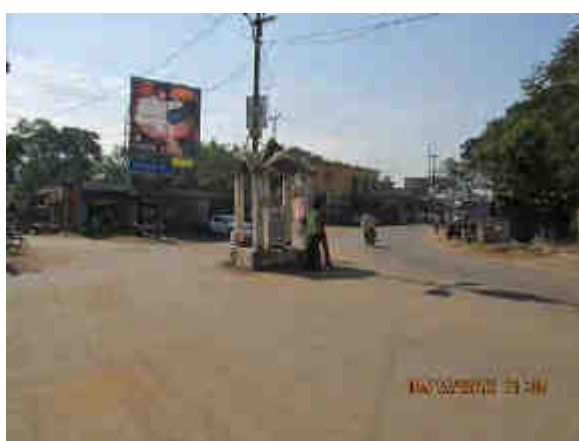
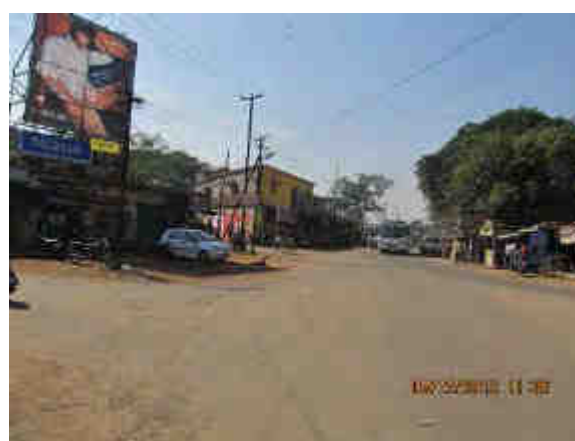
Km 11+700

- Junction point of two ODRs and one VR with SH65;
- Junction is built-up with shops and consequently on-street parking pose a problem;
- Heavy two wheelers, pedestrians, cyclists are present on the junction;
- Layout of the junction is poor with no established traffic control and a non-standard central island is present obstructing the sight of the approaching traffic; and
- Street lighting is provided, but no traffic signs or road markings to warn, delineate and establish junction control.

The junction layout is non-standard and has no control over the traffic movement. It is confusing who has priority in such a situation. This encourages lawless traffic movement and is hazardous. The existing central island is non-standard and hampers visibility at the junction.

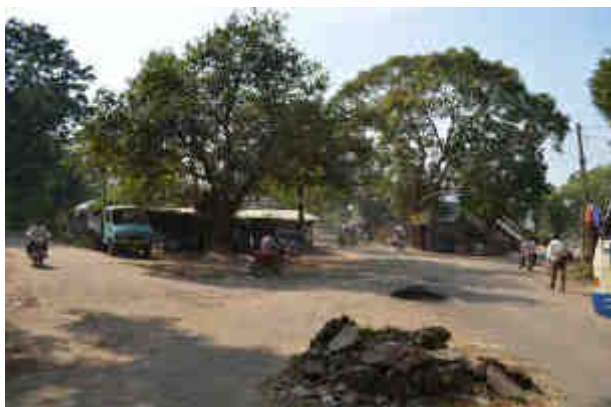
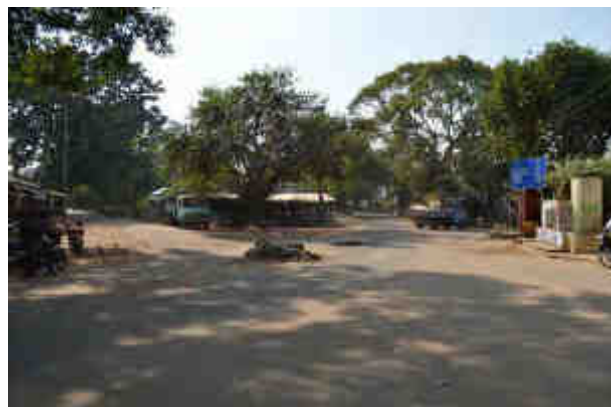
Km 75+700

- Poor junction layout;
- Priority is not established;
- Shops noted around the corners and approaches of the junction;
- No designated bus stop provided, leading to buses stopping in hazardous manner;
- No road markings or traffic signs (direction, warning and informatory) are provided; and
- Street lighting and provision for VRUs are not provided.

No traffic signs and markings are provided at the junction and its approaches to delineate and establish control. The absence of road markings and appropriate signs will encourage drivers to behave in a hazardous manner in the junction and create unsafe situation.

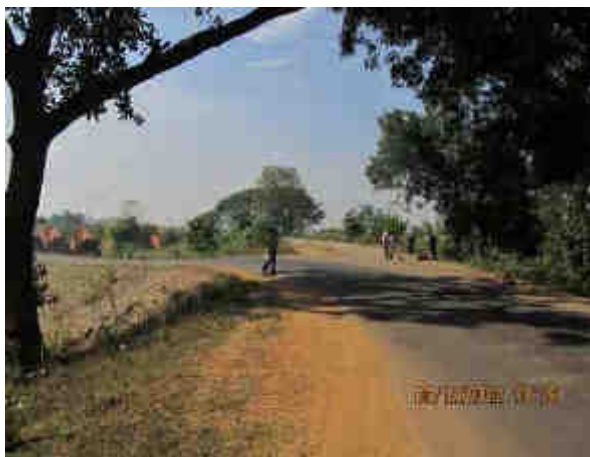
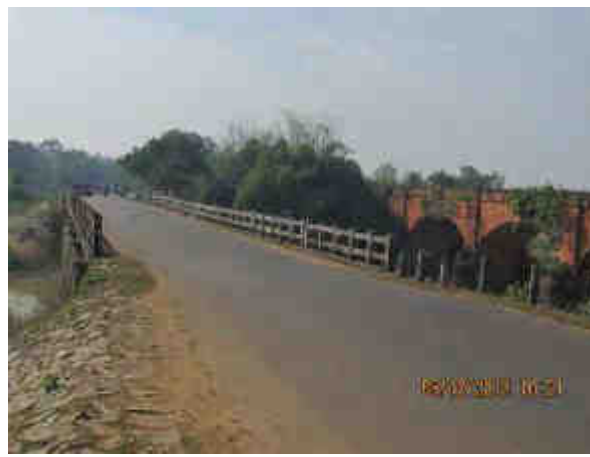
Approach to Bridge at high embankment at Km 5+700

At chainage 5+700, approach to bridge is found. Major issues observed are as given below:

- Sharp Curve on approaches;
- No protection on outside curve;
- Very high embankment; and
- No road markings and traffic signs to delineate and inform the road user of the impending hazards

Reasons for concern: **Poor Delineation**
In the absence of adequate warning signs and reflective markings, the road layout and the hazard will not be clear for the road user, particularly during night conditions and in worst conditions, this will lead to serious injury/ fatal accidents.

Reasons for concern: **High approach speed**
In the absence of any warning of the layout ahead, vehicles will tend to drive faster and approach the hazard in high speed. This may cause head-on or run-off collision.

Recommendations: Provide crash barriers on either approaches to the bridge with delineators

- Provide curve warning sign in addition to crash barrier with delineators
- Provide edge lane markings
- Provide hazard markers on either edge of the parapets

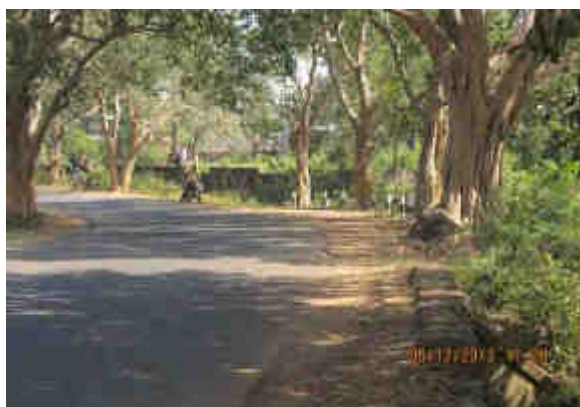
At the following chainages, parapet wall is broken or no parapet wall at all, water bodies along these structures are hazardous and can increase the severity of accident.

Broken Parapet wall at Km 13+600

Recommendations: Provide continuous parapets on all culverts and bridges.

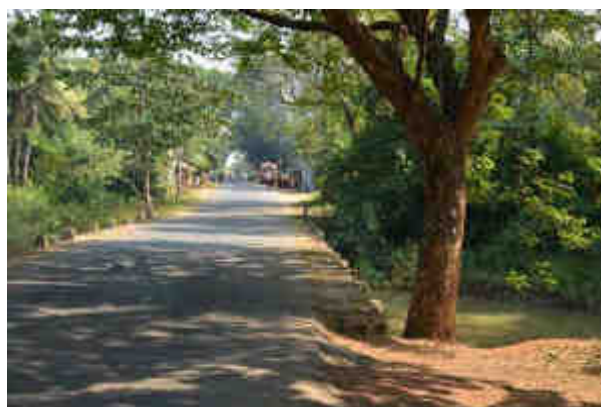
Absence of Parapet wall at Km 41+150

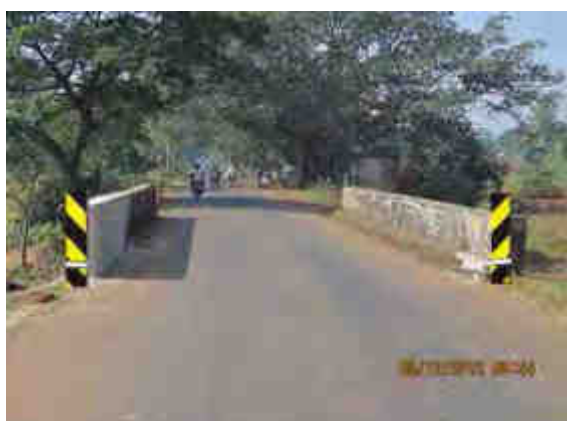
Culvert at Km 2+600

Reasons for concern: The bridge/ culvert parapets on the edge of the road adjacent to high speed traffic movement will be hazardous, particularly at dark conditions, and needs to be illuminated for a driver to judge the position of such road side hazard.

Recommendations: Install Object Hazard Marker (OHM) on both sides and for both approaches (i.e. Four numbers of each OHM for each structure.

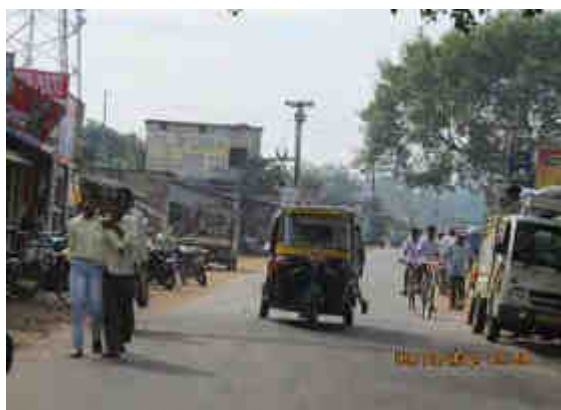
Tigria Village at Km 26+100

Roadside villages are particularly hazardous points on a rural road network. SH 65 has many such roadside villages, where the vulnerable road users, including school children are particularly at risk from high speed traffic. It is important to inform the road user in advance of the impending roadside village and if necessary, traffic calming measures needs to be provided for improved speed management through such villages/ built up areas.

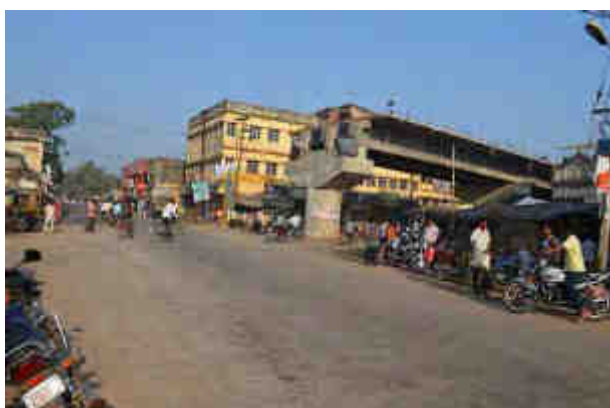
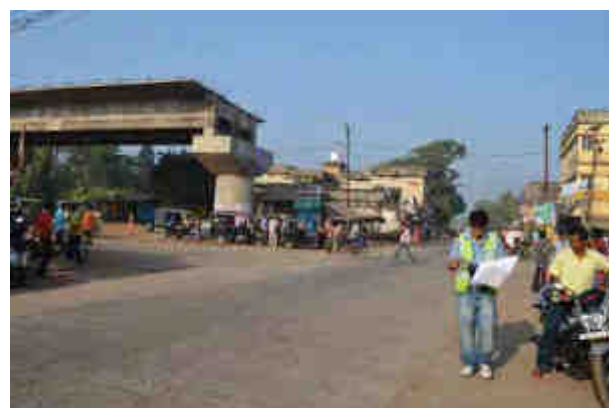
Km 11+700

- The layout of the junction is poor, and no junction control has been established;
- Junction is heavily built-up with commercial establishments
- High presence of pedestrians and cyclists, but no separate provisions has been made which forces pedestrians and cyclists to mix with the motor traffic on the road to travel within the junction area; and
- Street light is provided.

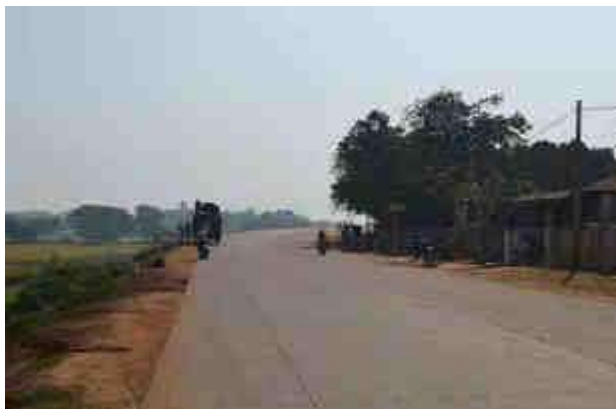
- At chainage 8+600, a curve leads to a bridge on both approaches in high embankment, but it has been observed that no safety measures has been provided.

Approach to Major Bridge at high embankment

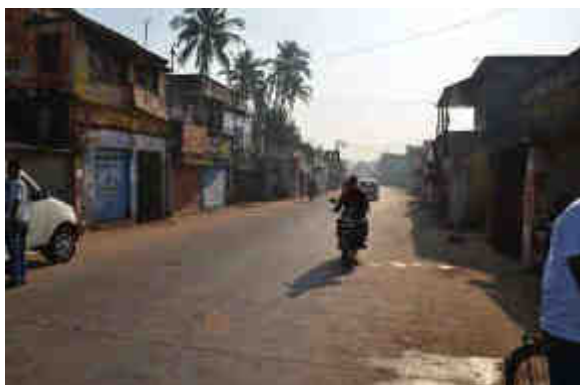
- Most of the villages have schools along the roads, but no separate provisions (wide shoulders of footpaths and safe crossing points) are provided for school children to cross or walk along the road in a safe manner
- On street Parking was observed, which hampers visibility
- Roadside is heavily encroached, leaving little or no space for pedestrians to walk along the road in a safe manner. In addition, encroachments encourage parking on the road, which further hampers visibility and create hazardous situations.

Commercial Area at Km 2+000

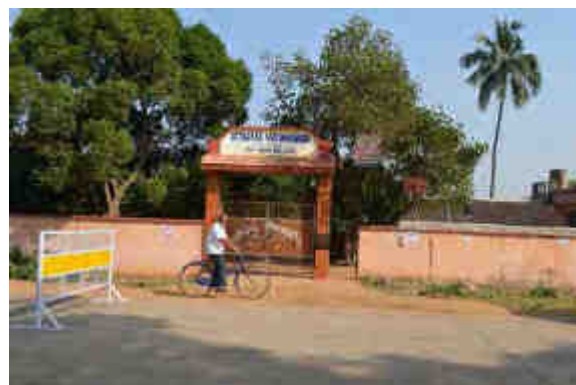
School at Km 8+400 in Biribati Village

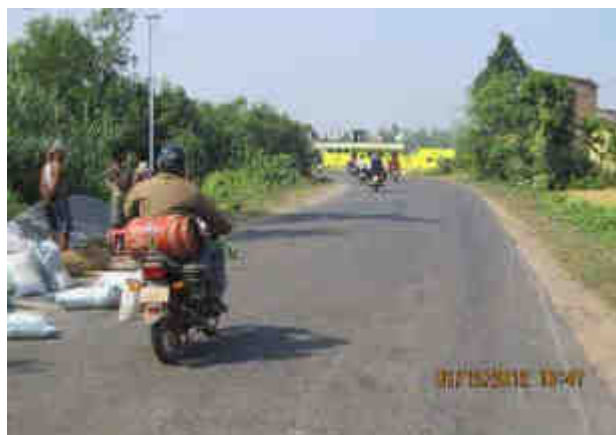
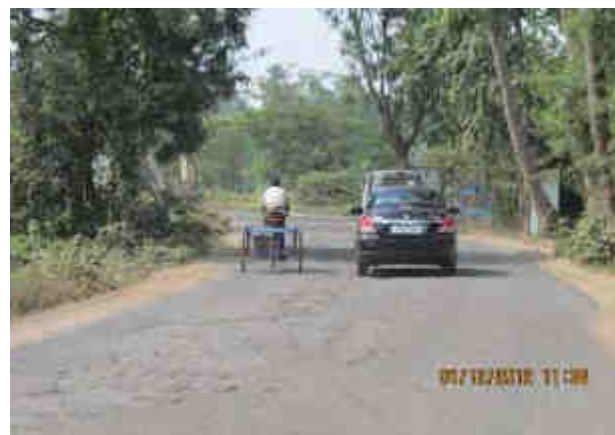
Sharp Curves on Project Road at Km 17+300 and Km 22+900

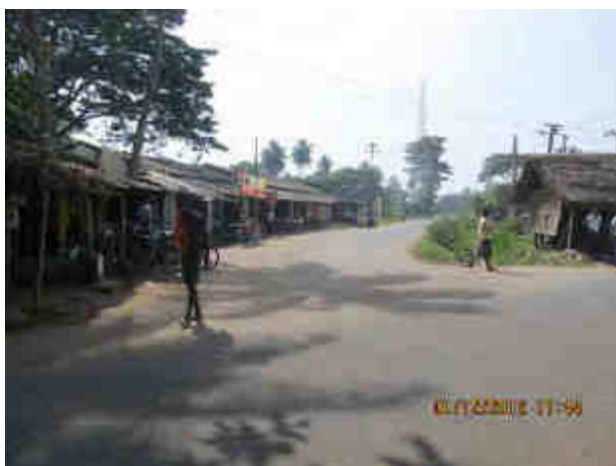
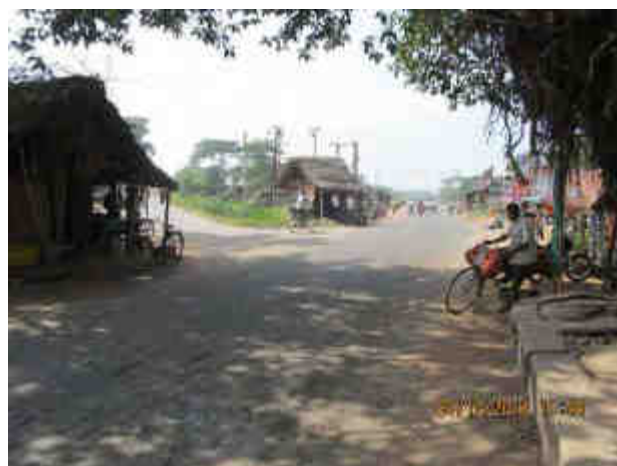
Skewed Side Road at Km 24+100

This is a major hazard observed on most of the 3-armed uncontrolled junctions. The

No traffic signs or road markings are observed on any of such junctions, the presence of which would have informed and warned the road user of the layout ahead. . In the worst case, it can also result in rear-end collisions at high speeds.

High approach speeds were observed by traffic turning from side roads into the main carriageway and no traffic calming measures/ warning is provided on the side road. Coupled with inadequate visibility, in the worst case, this may result in right angle collision with vehicles coming from the major road leading to serious injury or fatal accidents.

It has been observed that on few junctions, the level difference between the side road and major road is greater than 1m and the vertical profile of the side road joins the edge of main carriageway in an unsafe manner.

Recommendations: Remove encroachments at least from the visibility triangle required for such junctions.

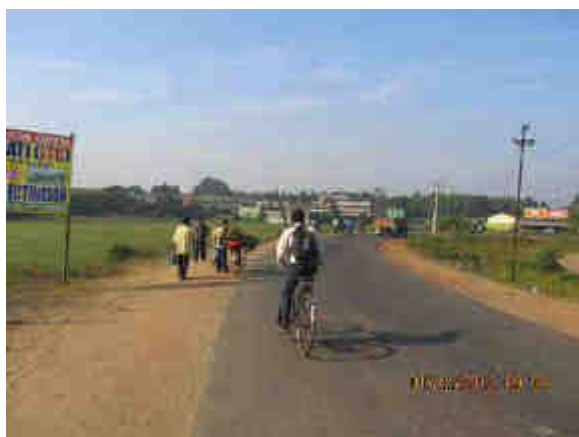
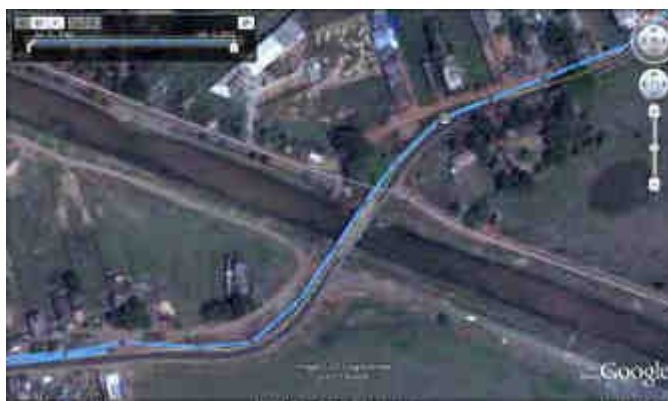
4.3.3.5 Approach to Bridges (Chainage 2+300)

Reasons for concern: Unprotected high embankment

In the absence of adequate warning signs and reflective markings, the road layout and the hazard will not be clear for the road user, particularly during night conditions and in worst conditions, this will lead to serious injury/ fatal accidents

Recommendations: Provide crash barriers on either approaches of the structures with delineators

- Provide curve warning sign in addition to crash barrier with delineators
- Provide edge lane markings
- Provide hazard markers on either edge of the parapets

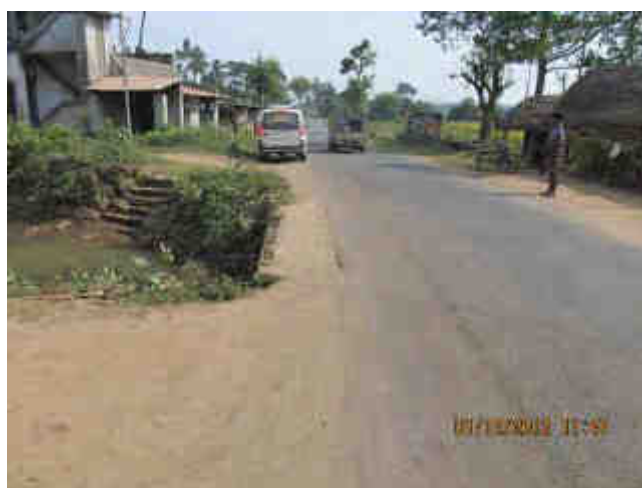
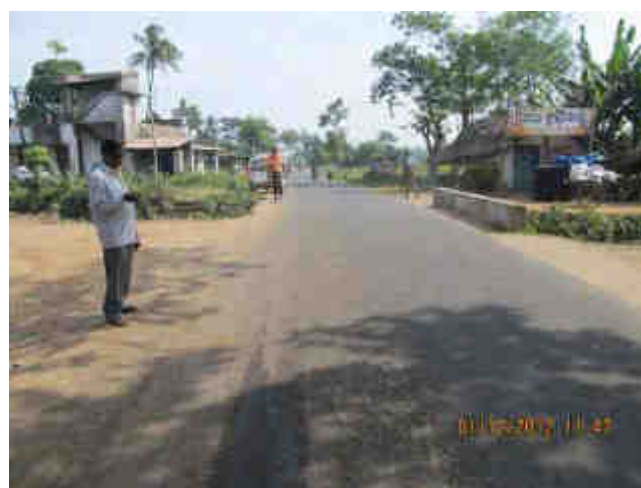
At the following chainages parapet wall was either broken or found missing. In the event of a vehicle loses control, the resultant injury will be fatal or major, due to the presence of water body.

absence of parapet wall at Km 24+800

Broken or missing parapets

The absence of parapet on bridge/culvert increases the risk of vehicles falling in to the drain. In the context of high speed traffic movement observed on SH-10, the absences of parapets at such locations are hazardous for traffic, especially for VRUs.

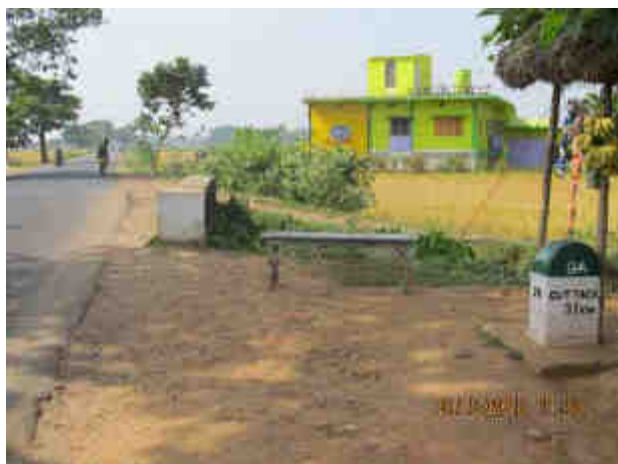
Km 26+000

There is no hazard marker present on structures and major/minor bridges. Such locations are

The bridge/ culvert parapets on the edge of the road adjacent to high speed traffic movement will be hazardous, particularly at dark conditions, and needs to be delineated for a driver to judge the position of such road side hazard.

Install Object Hazard Marker (OHM) on both sides and for both approaches (i.e. Four numbers of each OHM for each structure).

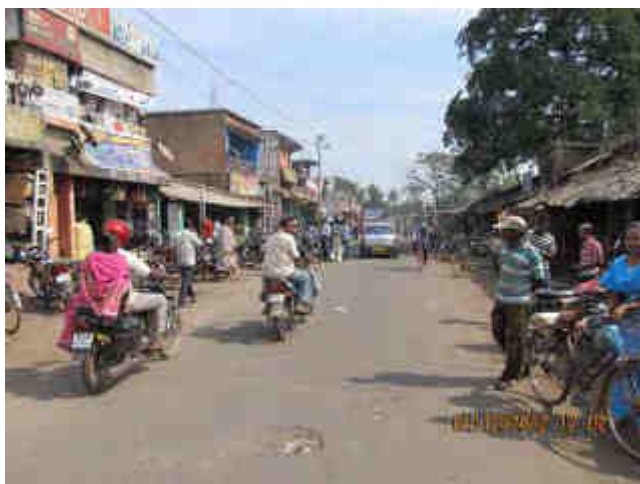
- Primary schools are observed in many roadside villages
- On street Parking and on street bus stops are observed
- Significant pedestrians/ school children, cyclists, motorcycles are present
- Very high encroachments are observed
- Visibility is hampered due to structures present along the road and stopped vehicles, buses on the road

Nishint Kunj Commercial Area at Km 27+400

Reasons for concern: High level of encroachment on certain village zone hinders visibility, forces pedestrians and cyclists to mix with the motor traffic leading to hazardous situations.

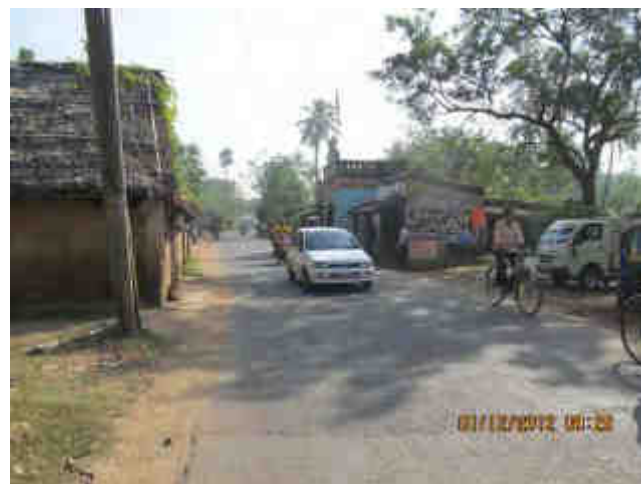
Built up area at Km 7+000

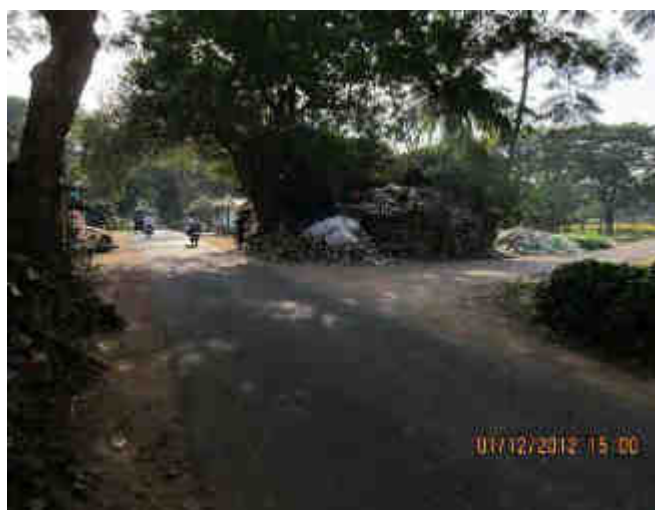
Perpendicular Side Road at Km 5+500

This is a major hazard observed on most of the 3-armed uncontrolled junctions. The major reasons for poor visibility at such junctions on SH-15 are due to buildings/shops on the corners.

No traffic signs or road markings are observed on any of such junctions, the presence of which would have informed and warned the road user of the layout ahead.

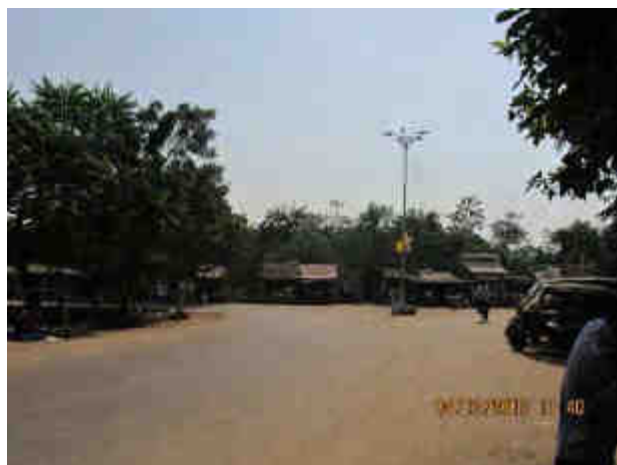
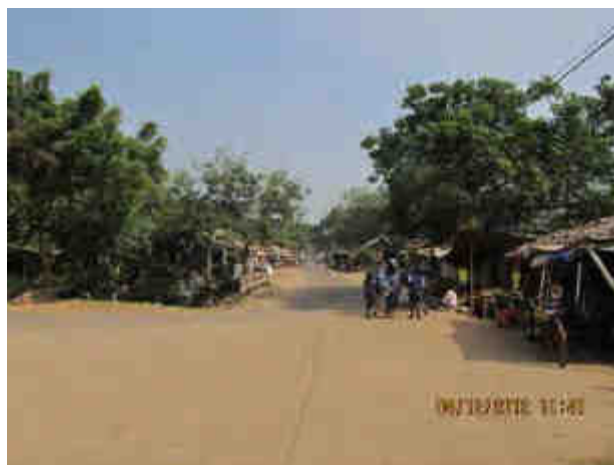
- One arm of the junction is approach of minor bridge
- Side road is on outside curve, 90° curve
- Approach to bridge on one arm of the junction is not protected
- Significant number of two wheelers, pedestrians and cyclists use the junction.
- No traffic islands/ splitter islands were provided for safe and effective maneuver of traffic

The junction layout is non-standard and has no control over the traffic movement. It is confusing who has priority in such a situation. This encourages lawless traffic movement and is hazardous. The existing central island is non-standard and hampers visibility at the junction.

- Recommendations:**
- Re-design the junction after traffic studies and considering the requirements of all road users
 - A roundabout will work better in this situation, but require detail study and design.

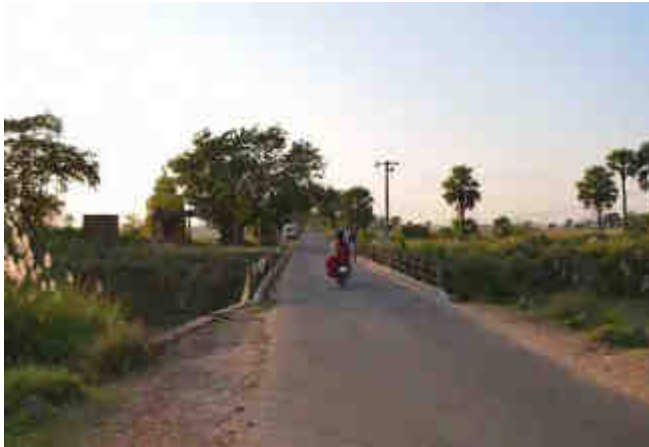
Missing bridge approach protection at Km 9+600

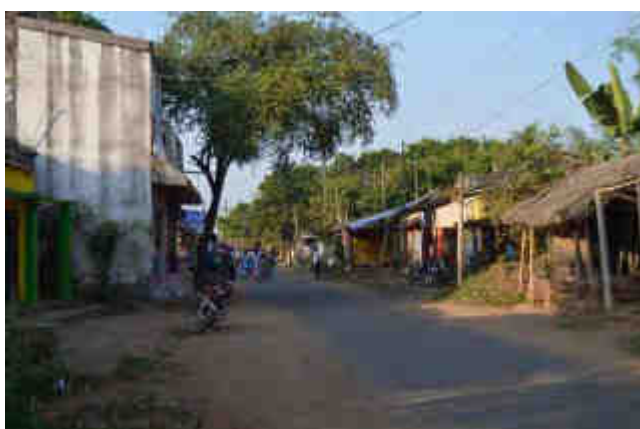
Built up area at Km 4+200

- In villages/town wherever schools are present, ‘School Ahead’ and ‘Slow’ warning signs are not provided on either approaches.
- On street Parking and on street bus stops are observed
- Significant pedestrians/ school children, cyclists, motorcycles are present
- Very high encroachments are present
- Visibility is hampered due to structures present along the road and stopped vehicles, buses on the road

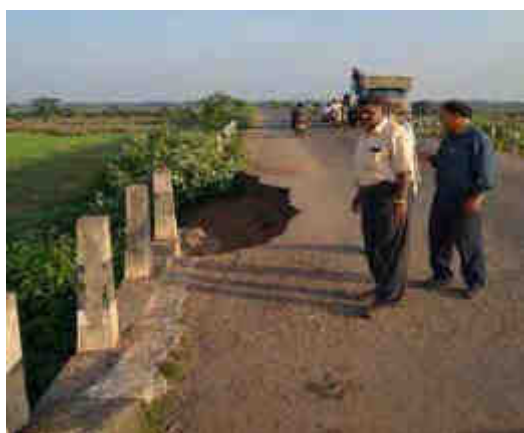
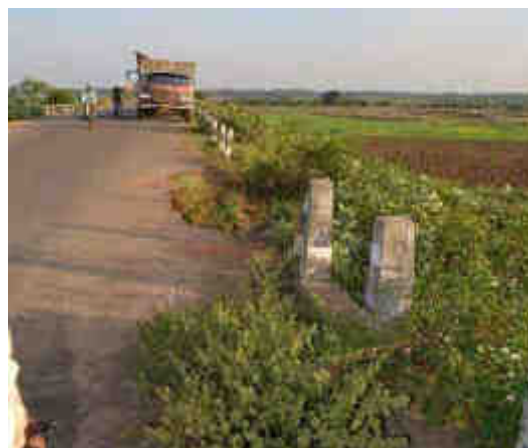
Damaged Road Edge and Approach Slab at chainage 6+100

- Two major bridges are connected by intermediate lane at high embankment
- Pavement is broken on both side
- Broken pavement is not visible from a distance ahead
- High speeds observed on the approaches to this bridge
- Broken section is used by pedestrians and cattle to get down on sides of the road

Reasons for concern: Broken pavement is not visible from distance, road is straight thus high speed is observed which is very dangerous for fast moving traffic , in particular for two wheelers. Small vehicles may fall into ditch and bigger vehicles may undergo overturning.

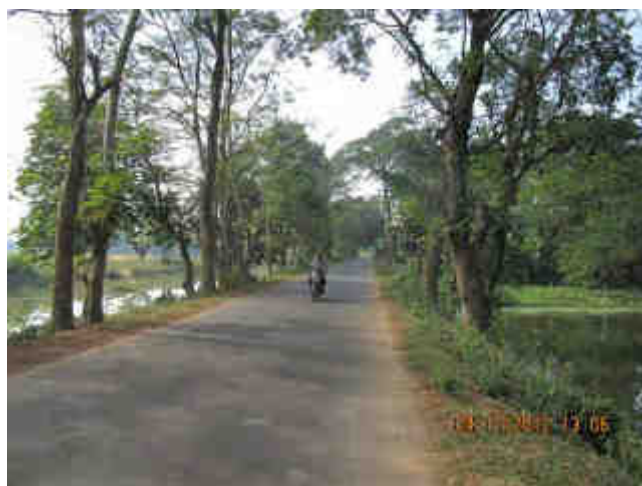
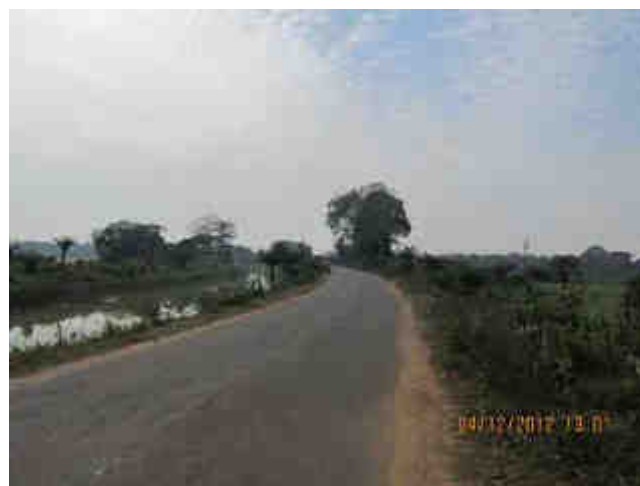
- Project road is along the irrigation canal
- Embankment is high throughout the road
- At some locations project road have water bodies on both side of project road

Road with high embankment and water bodies on either side at Km 6+200 and 3+400;

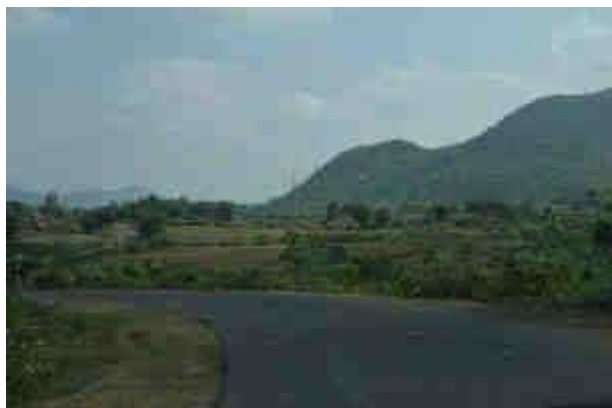
Km 273+150

During the course of assessment, the consultant has carried out average speed and spot speed survey. The average speed and maximum speed were noted for one trial run on the road during 10 hrs to 3 hrs, from Km 270+000 to 320+000. An average speed of 36.30 km/ hour and a maximum speed of 63.5 km/ hour is noted during this survey. A spot speed was conducted at location Km 313+000, and the 85th percentile speed at this location was found to be 50 km/hr. Curves having radius in the range of 100m to 120m were observed on the following locations:

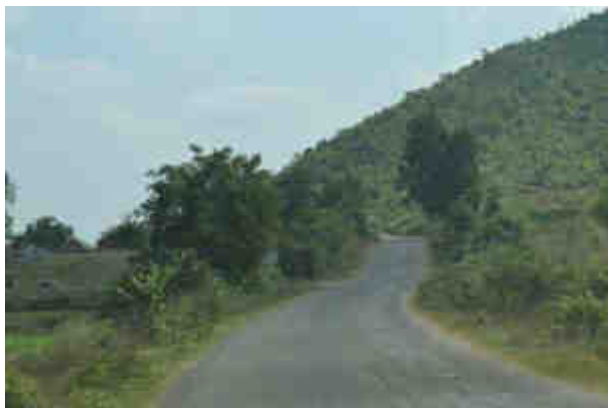
These are observed at chainages Km 272+770 and Km 316+300;

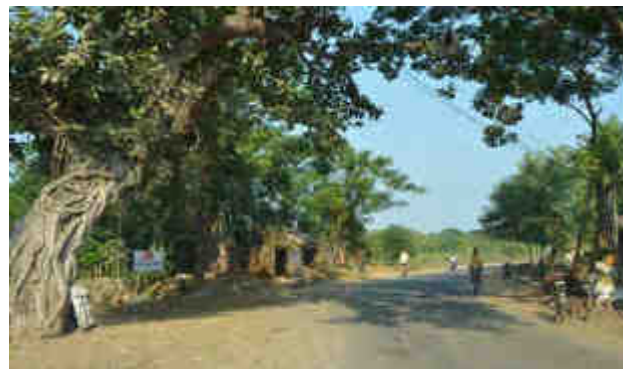
Km 302+350

Inadequate Visibility

This is a major hazard observed on most of the 3-armed uncontrolled junctions. The major reasons for poor visibility at junctions on this road are due to 1) Encroachments at Junctions 2) Overgrown vegetation or presence of trees and 3) poor layout of the side roads.

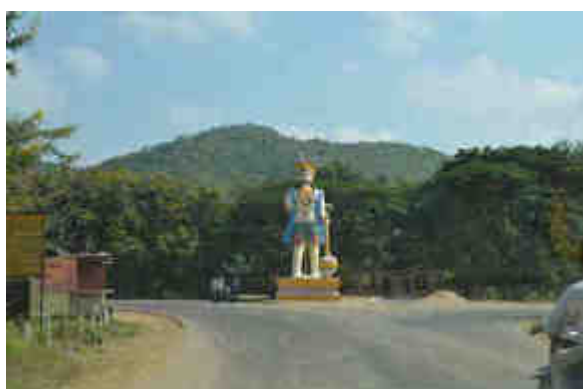
Km 270+700

- In this section of road all the major junctions are 3-arm uncontrolled junction.
- Medium to high encroachments
- Commercial activities nearer to the road edge.
- Street lights is missing

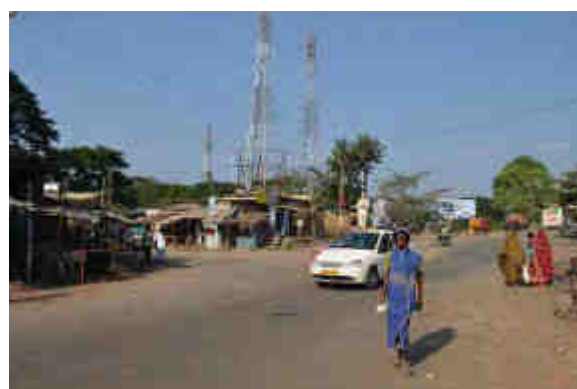
Km 303+700

Pedestrians and cyclists observed at the junction, but no separate provisions have been made. Pedestrians are particularly vulnerable at such junctions having high approach speed.

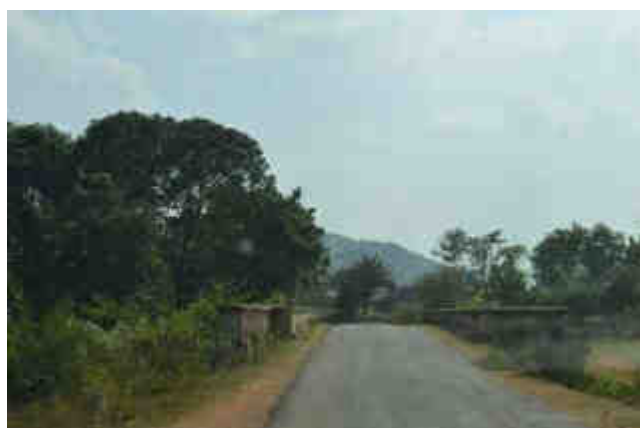
Km 282+680

The bridge/ culvert parapets on the edge of the road adjacent to high speed traffic movement will be hazardous, particularly at dark conditions, and needs to be illuminated for a driver to judge the position of such road side hazard.

Recommendations: Install Object Hazard Marker (OHM) on both sides and for both approaches (i.e. Four numbers of each OHM for each structure.

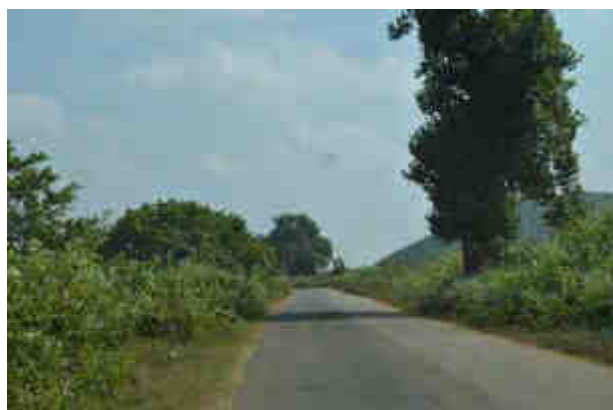
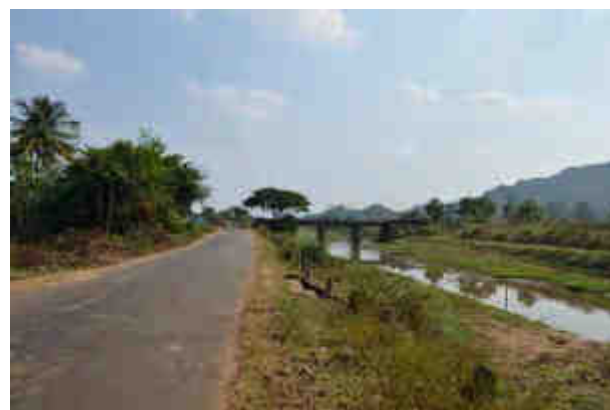
Trees/ Embankment are on the edges of the carriageway

Reasons for concern: The road side objects like trees, street light or other poles, buildings, and unprotected deep drains which are near the edge of road needs to be. At night time it becomes very difficult for drivers to judge the position of such road side hazard. If the road side objects are not protected and/or illuminated there are chances of driver losing control and hitting these objects which may result into fatal accident.

Recommendations: Either remove such objects or provide crash barrier where such objects are <2m from the edge of road.

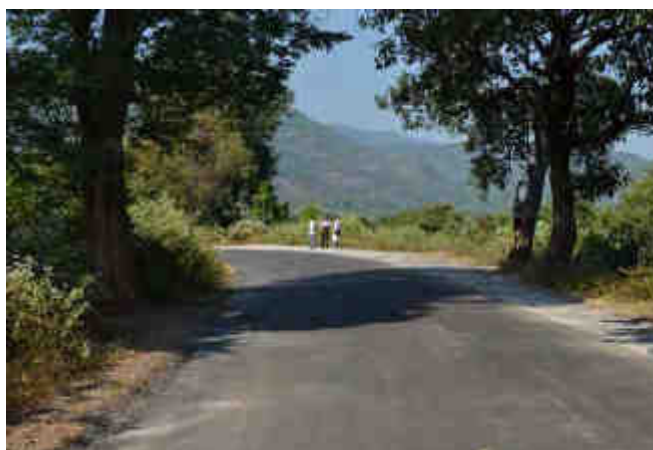
Km 41+160

Reasons for concern: Curves on high embankment without safety barriers noted

Recommendations: Provide **curve warning signs, chevron signs, delineators and speed limit sign** as appropriate

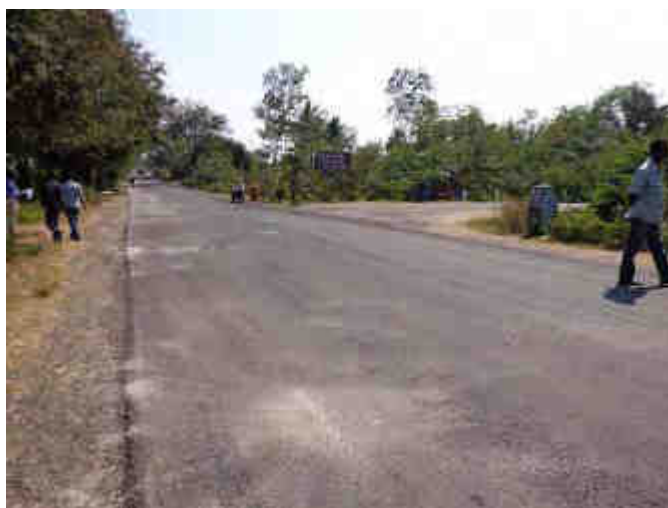
Km 41+900

Reasons for concern: **Inadequate Visibility**
This is a major hazard observed on most of the 3-armed uncontrolled junctions. The major reasons for poor visibility at junctions on this road are due to 1) Encroachments at Junctions 2) Overgrown vegetation or presence of trees and 3) poor layout of the side roads.

- No traffic signs or road markings are observed on any of the junctions, the presence of which would have informed and warned the road user of the layout ahead.

Recommendations: Provide traffic signs and road markings pertaining to junction control.

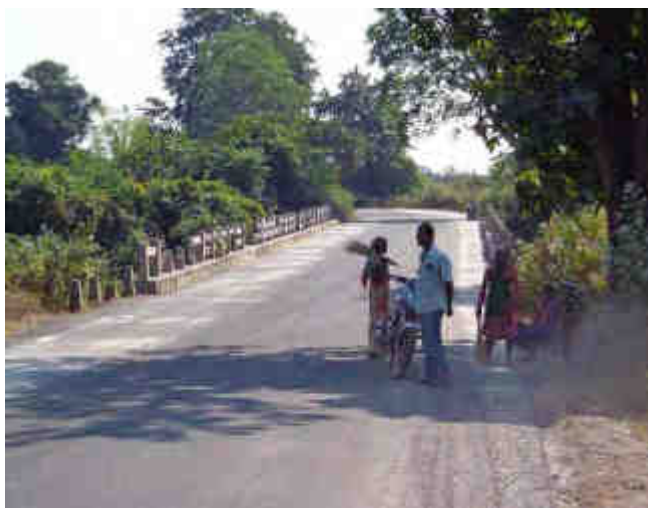
Km 41+450

The bridge parapets adjacent to road will be hazardous and few bridges have damaged parapets and hence may cause accident in future.

Reasons for concern: The bridge/ culvert parapets on the edge of the road adjacent to high speed traffic movement will be hazardous, particularly at dark conditions, and needs to be illuminated for a driver to judge the position of such road side hazard.

Recommendations: Install Object Hazard Marker (OHM) on both sides and for both approaches (ie. Four numbers of each OHM for each structure).
