**Government of Odisha (GOO)
Chief Engineer, World Bank Projects, Odisha
Odisha State Roads Project**

**Consultancy Services for
Road Sector Institutional Development
Loan # 7577-IN**

**ROAD INFRASTRUCTURE
SAFETY MANAGEMENT REVIEW**

VOLUME I - REPORT

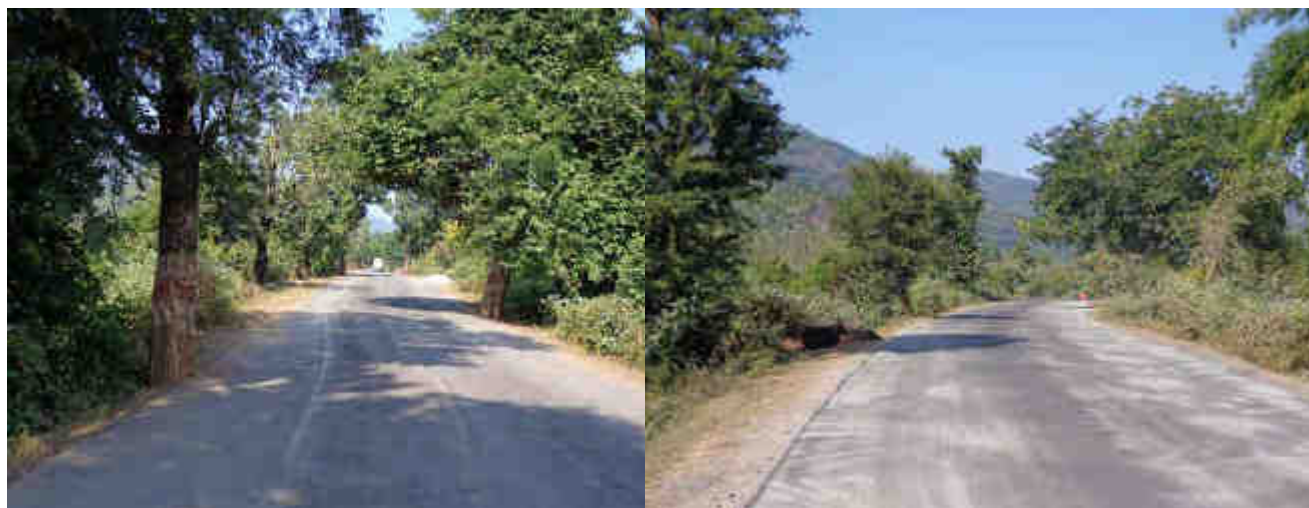
Road side objects present along this stretch of road are few trees and high embankment.

Reasons for concern: The road side objects like trees, street light or other poles, buildings, and unprotected deep drains which are near the edge of road needs to be. At night time it becomes very difficult for drivers to judge the position of such road side hazard. If the road side objects are not protected and/or illuminated there are chances of driver losing control and hitting these objects which may result into fatal accident.

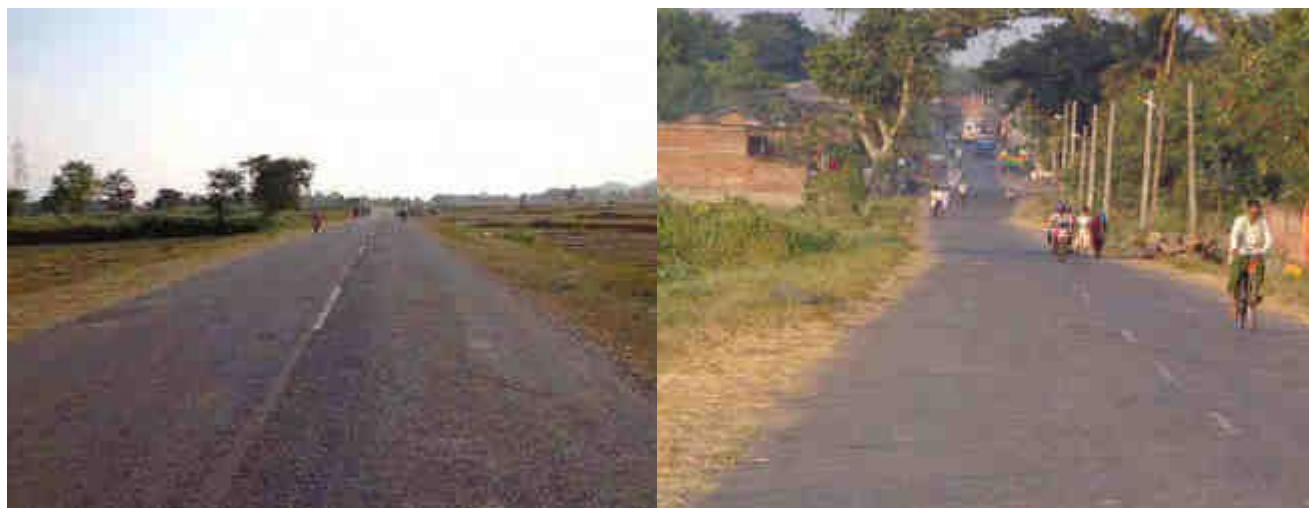
Reasons for concern: Centerline and edgeline road markings are not provided in many sections of the road.

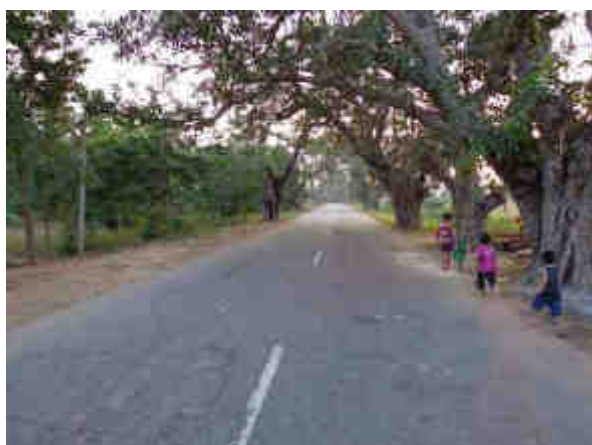
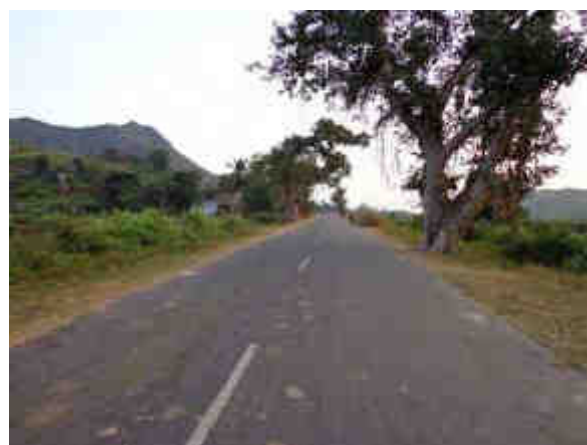
Road side objects present along this stretch of road are few trees. Trees are on the edges of the carriageway, which has no any protection.

Trees are on the edges of the carriageway

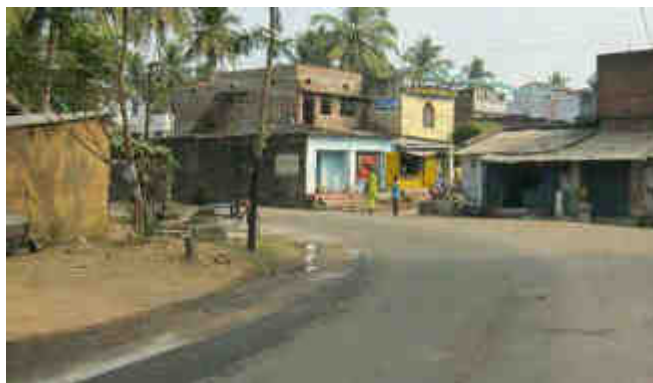
Km 0+700

Reasons for concern:	No warning signs/ delineation to inform the road user to make him/her slow down to negotiate the curve in a safe speed, which may lead to: <ul style="list-style-type: none"> • Potential run-off accidents • Potential head-on collisions
Recommendations:	Provide curve warning signs, chevron signs, delineators and speed limit sign as appropriate <i>Refer to Appendix III for guidelines on treatment of curves.</i>
Reasons for concern:	Poor visibility on the curve due to trees and overgrown vegetation, which can lead to head-on collisions
Recommendations:	<ul style="list-style-type: none"> • Improve the line of sight by removing trees from the shoulder and cut down vegetation which hampers visibility along the curves
Reasons for concern:	Curves on high embankment without safety barriers noted <ul style="list-style-type: none"> • Run-off accidents on high embankments will lead to fatalities

Recommendations:	Provide metal beam crash barrier with delineators on sharp curves in high embankment <i>Refer to Appendix III for guidelines on situations where to install the above</i>

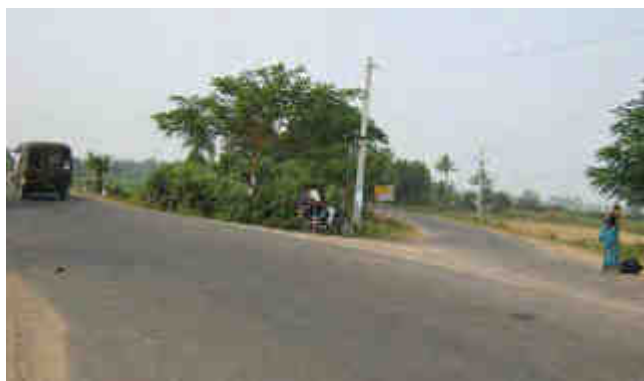
Km 2+400

This is a major hazard observed on most of the 3-armed uncontrolled junctions. The major reasons for poor visibility at junctions on this road are due to 1) Encroachments at Junctions 2) Overgrown vegetation or presence of trees and 3) poor layout of the side roads.

No traffic signs or road markings are observed on any of the junctions, the presence of which would have informed and warned the road user of the layout ahead.

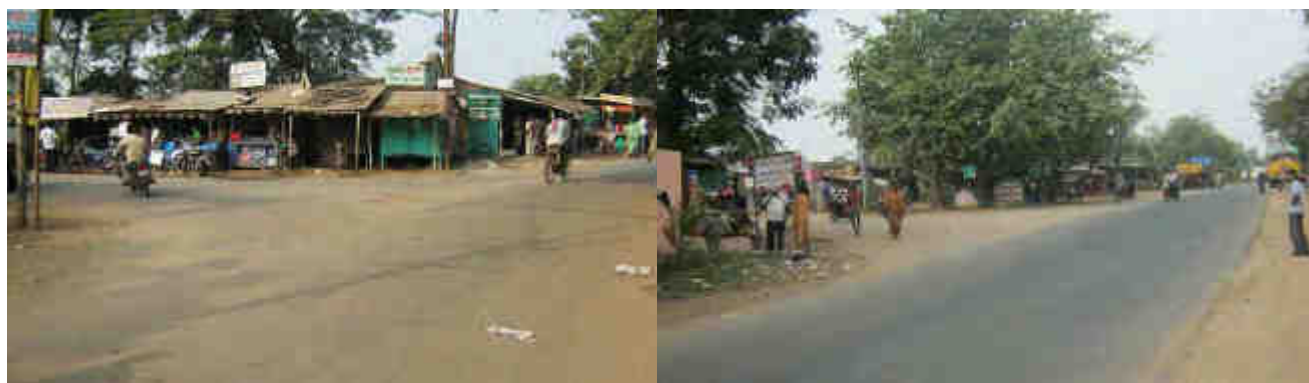
- In this section of road all the major junctions are 3-arm uncontrolled junction.
- Street lights is missing

- Recommendations:**
- Re-design the junction layout

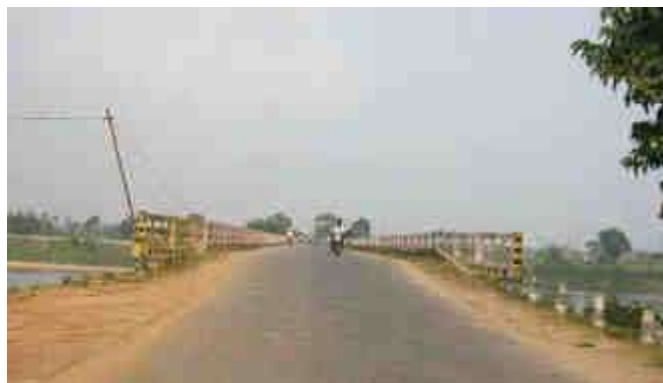
Km 4+700

Reasons for concern: The bridge/ culvert parapets on the edge of the road adjacent to high speed traffic movement will be hazardous, particularly at dark conditions, and needs to be illuminated for a driver to judge the position of such road side hazard.

Recommendations: Install Object Hazard Marker (OHM) on both sides and for both approaches (i.e. Four numbers of each OHM for each structure.

Recommendations: Provide crash barriers on either approaches of the structures with delineators

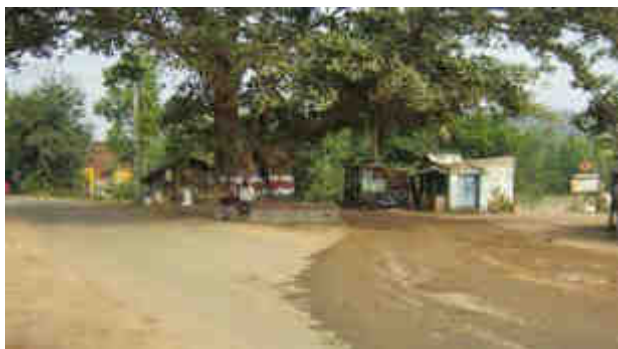
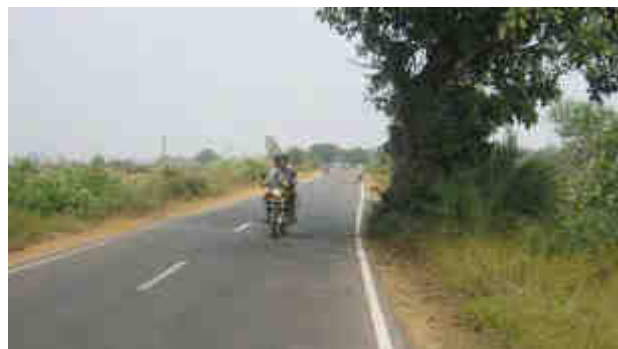
Trees are on the edges of the carriageway

The road side objects like trees, street light or other poles, buildings, and unprotected deep drains which are near the edge of road. At night time it becomes very difficult for drivers to judge the position of such road side hazard. If the road side objects are not protected and/or illuminated there are chances of driver losing control and hitting these objects which may result into fatal accident.

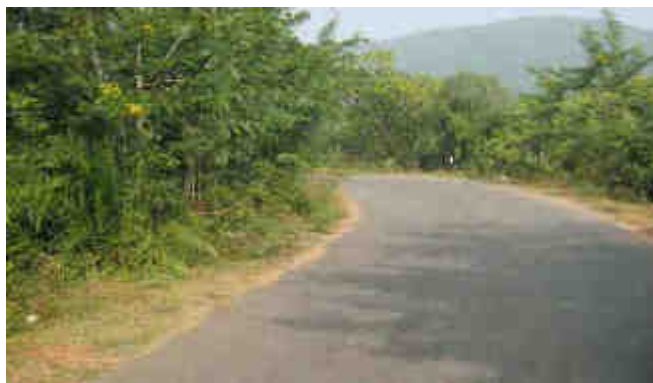
Km 6+600

Reasons for concern:	No warning signs/ delineation to inform the road user to make him/her slow down to negotiate the curve in a safe speed, which may lead to: <ul style="list-style-type: none"> • Potential run-off accidents • Potential head-on collisions
Recommendations:	Provide curve warning signs, chevron signs, delineators and speed limit sign as appropriate <i>Refer to Appendix III for guidelines on treatment of curves.</i>
Reasons for concern:	Poor visibility on the curve due to trees and overgrown vegetation, which can lead to head-on collisions
Recommendations:	<ul style="list-style-type: none"> • Improve the line of sight by removing trees from the shoulder and cut down vegetation which hampers visibility along the curves
Reasons for concern:	Curves on high embankment without safety barriers noted <ul style="list-style-type: none"> • Run-off accidents on high embankments will lead to fatalities

Recommendations:	Provide metal beam crash barrier with delineators on sharp curves in high embankment <i>Refer to Appendix III for guidelines on situations where to install the above</i>

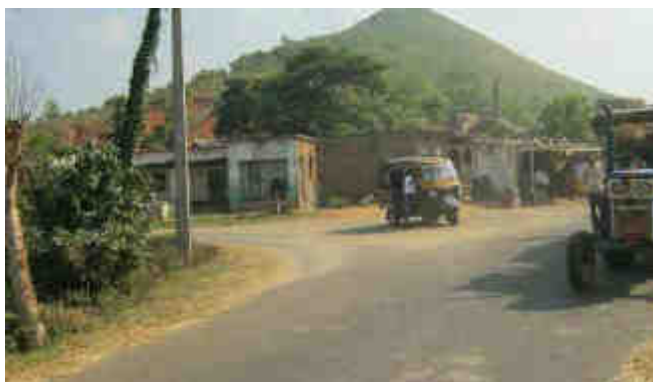
Km 17+200

This is a major hazard observed on most of the 3-armed uncontrolled junctions. The major reasons for poor visibility at junctions on this road are due to 1) Encroachments at Junctions 2) Overgrown vegetation or presence of trees and 3) poor layout of the side roads.

No traffic signs or road markings are observed on any of the junctions, the presence of which would have informed and warned the road user of the layout ahead.

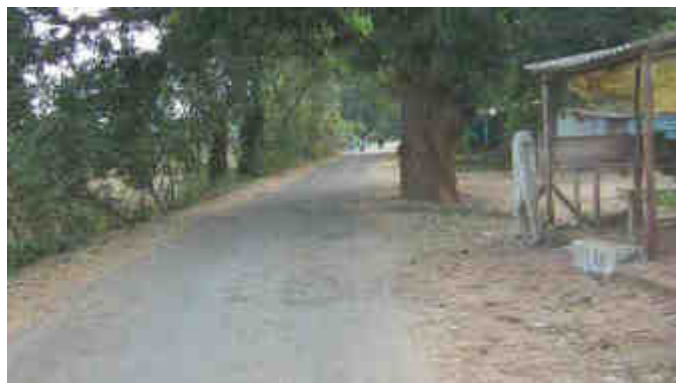
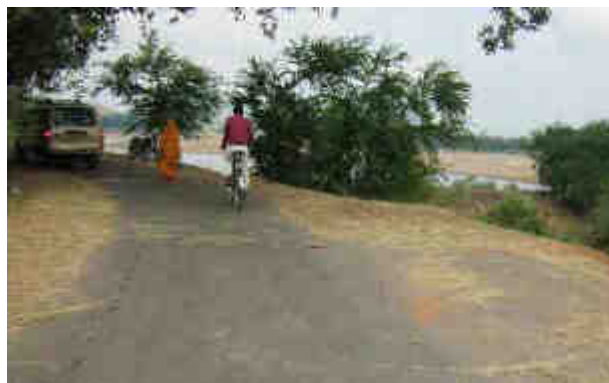
Road side objects are on the edges of the carriageway

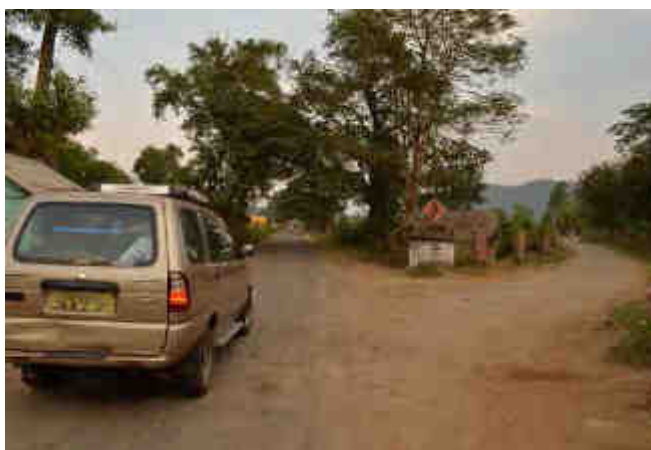
Km 18+000

Reasons for concern:	Inadequate Visibility This is a major hazard observed on most of the 3-armed uncontrolled junctions. The major reasons for poor visibility at junctions on this road are due to 1) Encroachments at Junctions 2) Overgrown vegetation or presence of trees and 3) poor layout of the side roads.
Recommendations:	<ul style="list-style-type: none">• Improve visibility by clearing vegetation;• Remove encroachments at least from the visibility triangle required for such junctions. <p><i>Refer to Appendix III for guidelines on visibility triangle of junctions.</i></p>
Reasons for concern:	Poor delineation No traffic signs or road markings are observed on any of the junctions, the presence of which would have informed and warned the road user of the layout ahead.
Recommendations:	Provide traffic signs and road markings pertaining to junction control. <i>Refer to Appendix III for guidelines on traffic signs and road markings at junctions</i>

Reasons for concern:	Poor Geometry It has been observed that on few junctions, the level difference between the side road and major road and the vertical profile of the side road joins the edge of main carriageway in an unsafe manner.
Recommendations:	<ul style="list-style-type: none">• Correct the vertical alignment of side road so that vehicles approaching from side roads has adequate length on the side road to slow down/ stop before entering into the main carriageway <p><i>Refer to Appendix III for guidelines on safer vertical profile of side roads at junctions</i></p>

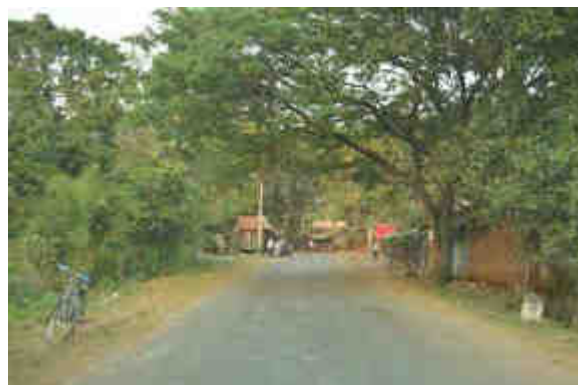
Km 0+000

Pedestrians and cyclists observed at the junction, but no separate provisions have been made. Pedestrians are particularly vulnerable at such junctions having high approach speed.

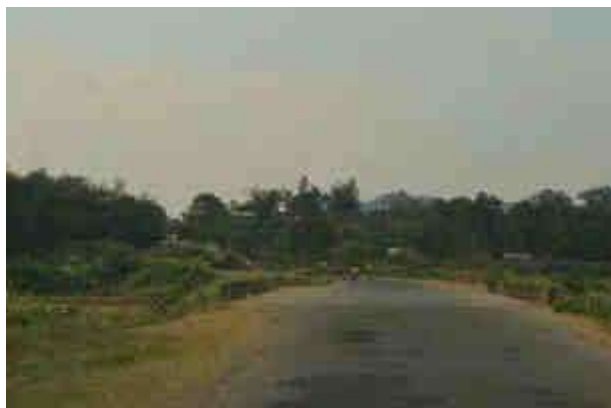
Km 19+720

Reasons for concern: The bridge/ culvert parapets on the edge of the road adjacent to high speed traffic movement will be hazardous, particularly at dark conditions, and needs to be illuminated for a driver to judge the position of such road side hazard.

Reasons for concern: **Absence of traffic signs and road markings**
 In the absence of adequate warning signs and reflective markings, the road layout and the hazard will not be clear for the road user, particularly during night conditions and in worst conditions, this will lead to serious injury/ fatal accidents

Recommendations: Install Object Hazard Marker (OHM) on both sides and for both approaches (i.e. Four numbers of each OHM for each structure.

Refer to Appendix III for guidelines for installation of object hazard markers

Recommendations: Provide crash barriers on either approaches of the structures with delineators
Refer to Appendix III for guidelines to treatments on approaches to bridges

- Provide curve warning sign in addition to crash barrier with delineators
- Provide edge lane markings
- Provide hazard markers on either edge of the parapets

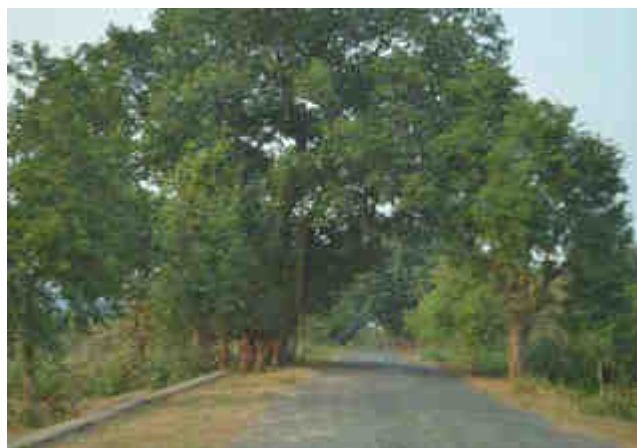
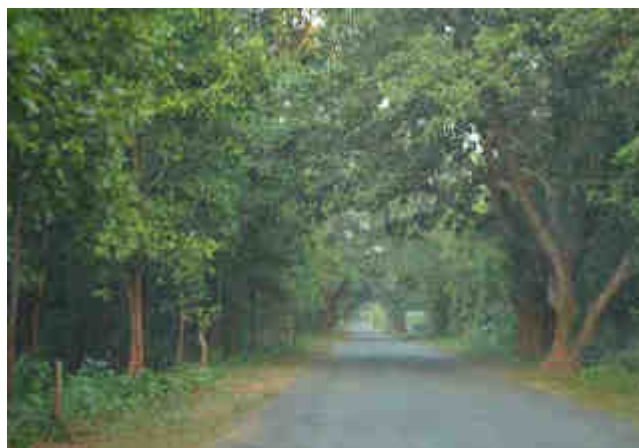
Trees are on the edges of the carriageway

Reasons for concern: The road side objects like trees, street light or other poles, buildings, and unprotected deep drains which are near the edge of road. At night time it becomes very difficult for drivers to judge the position of such road side hazard. If the road side objects are not protected and/or illuminated there are chances of driver losing control and hitting these objects which may result into fatal accident.

Recommendations: Either remove such objects or provide crash barrier where such objects are <2m from the edge of road.

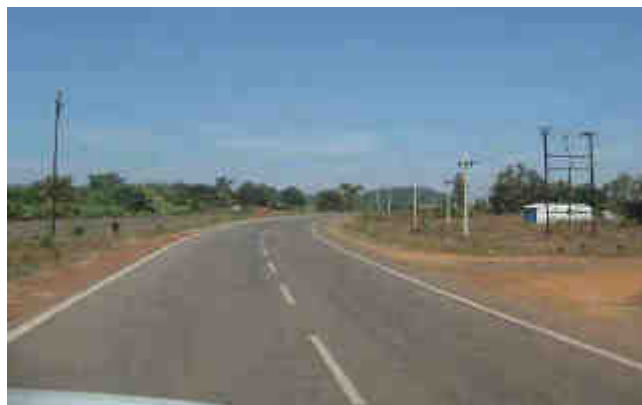
Ch: 8+300

Reasons for concern:	No warning signs/ delineation to inform the road user to make him/her slow down to negotiate the curve in a safe speed, which may lead to: <ul style="list-style-type: none"> • Potential run-off accidents • Potential head-on collisions
Recommendations:	Provide curve warning signs, chevron signs, delineators and speed limit sign as appropriate <i>Refer to Appendix III for guidelines on treatments of curves.</i>
Reasons for concern:	Poor visibility on the curve due to trees and overgrown vegetation, which can lead to head-on collisions

Reasons for concern: Curves on high embankment without safety barriers noted

Recommendations: Provide metal beam crash barrier with delineators on sharp curves in high embankment

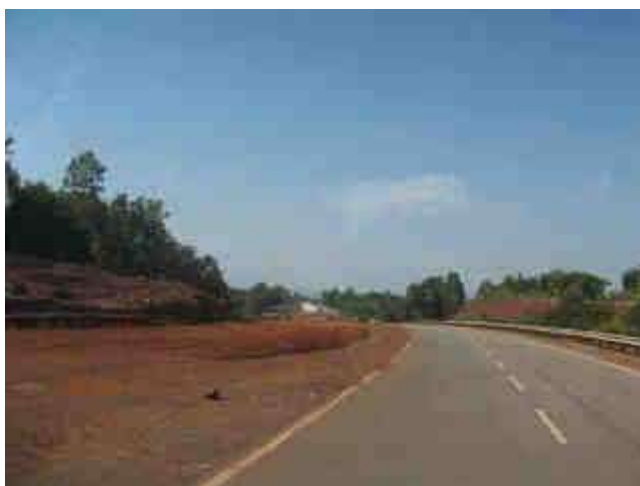
Ch: 15+800

Reasons for Concern: **Insufficient sight distance**
 The sight distance on a vertical crest is limited in day light and even less in night time. The presence of a horizontal bend after a vertical crest decreases the sight distance available further for the driver to react and could be a potential unsafe location. The vertical deflection of the alignment prevents the road user from being prepared to negotiate the curve and could lead to run off accidents.

Recommendations **Desirable:** Provide advance curve warning signs, no overtaking pavement markings chevrons and delineators.

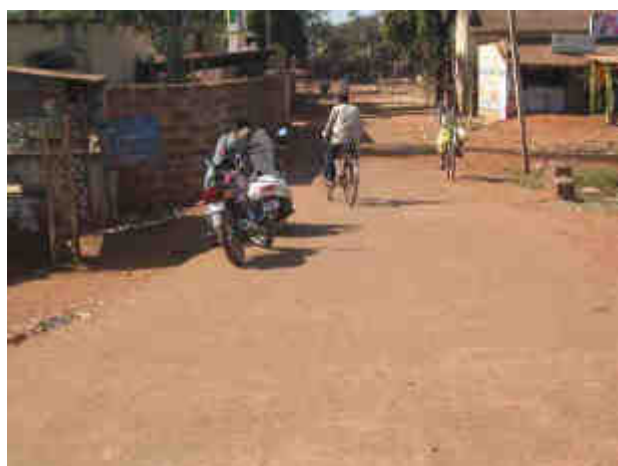
Ch: 22+100

This is a major hazard observed on most of the 3-armed uncontrolled junctions. The major reasons for poor visibility at junctions on this road are due to:

- No traffic signs or road markings are observed on any of such junctions, the presence of which would have informed and warned the road user of the layout ahead.
- Poor delineation may result in sudden braking behavior by road users who are required to stop, or wish to make turns. In the worst case, it can also result in rear-end collisions at high speeds.

- High approach speeds were observed by traffic turning from side roads into the main carriageway and no traffic calming measures/ warning is provided on the side road.
- Coupled with inadequate visibility, in the worst case, this may result in **right angle collision** with vehicles coming from the major road leading to serious injury or fatal accidents.

It has been observed that on few junctions, the level difference between the side road and major road and the vertical profile of the side road joins the edge of main carriageway in an unsafe manner.

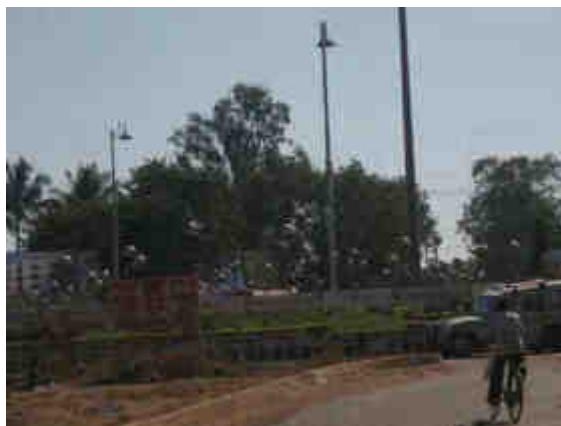
Ch: 15+000

- The junction layout is non-standard and has no control over the traffic movement. It is confusing who has priority in such a situation. This encourages lawless traffic movement and is hazardous. The existing central island is non-standard and hampers visibility at the junction.

- No direction signs to guide the traffic through the junction layout which may lead to hazardous driving and may lead to rear-end collision.

- Footpaths in the intersection area are encroached by overgrown vegetation or the commercial establishments.
- No provision for crossing by pedestrians/bicycles despite of significant presence of pedestrians and bicyclists.
- Pedestrians were observed using the road for commuting, instead of the footpath, and this expose them to the fast moving traffic which can lead to crashes resulting in serious injuries.

- No parking spaces provided for commercial vehicles and vehicles are parked encroaching the road and shoulder space, hampering visibility.
- This forces pedestrians to move into the centre of the road resulting in hazardous situation.

- Recommendations:**
- Remove encroachments from the footpaths.
 - Provide pedestrian crossings at appropriate locations for safe crossing by pedestrians and bicycles.

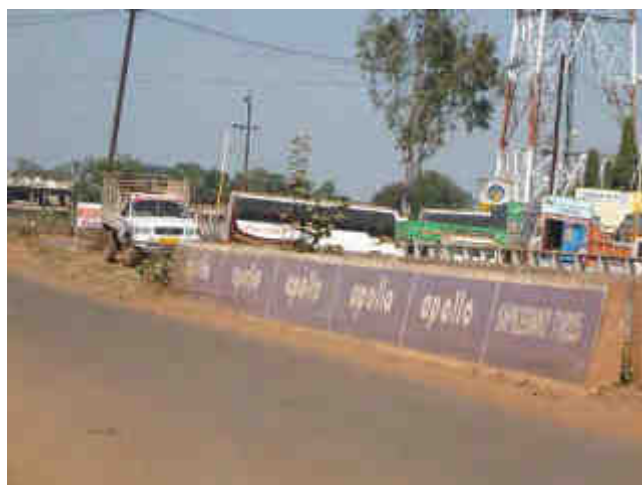
Ch: 2+100

At following locations the parapets of bridge/culvert were found either missing or broken resulting in highly hazardous situation for VRUs and motorized road users.

- The bridge parapets adjacent to high speed traffic movement are hazardous especially at night if not delineated as the driver cannot judge the position of such road side hazards.

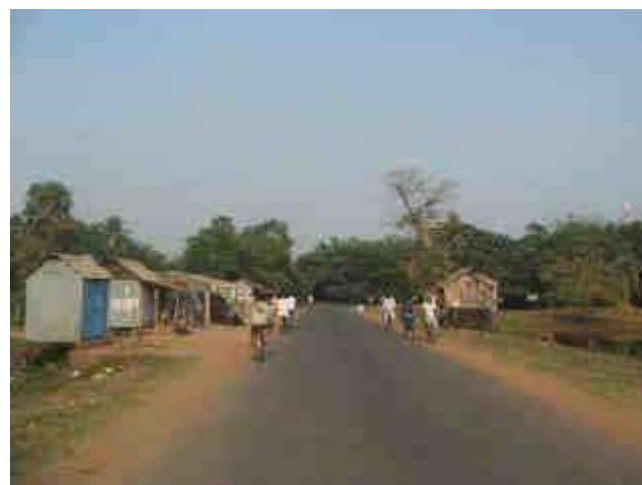
Ch: 5+500

Centerline / edge line road markings are absent in the road section, the presence of which could have delineated the road during night conditions and encourages the driver to keep to the designated lanes

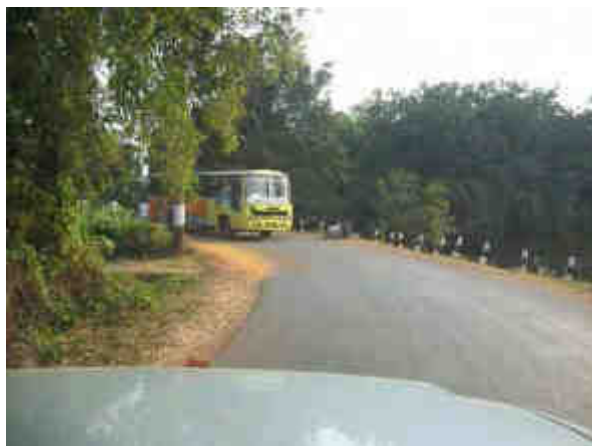
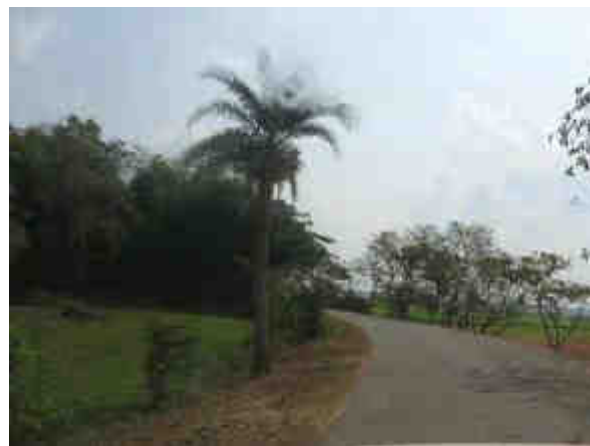
Horizontal curves of radius less than 250 m were observed at chainages 0+300, 0+700, 1+400, 2+500, 3+800, 5+100, 5+200, 5+500, 5+800, 6+400, 9+900, 12+600, 15+600, 25+100,; 29+100 and 31+200.

Reasons for concern:	No warning signs/ delineation to inform the road user to make him/her slow down to negotiate the curve in a safe speed, which may lead to <ul style="list-style-type: none"> • Potential run-off accidents • Potential head-on collisions
Recommendations:	Provide curve warning signs, chevron signs, delineators and speed limit sign as appropriate <i>Refer to Appendix III for guidelines on situations where to install the above</i>
Reasons for concern:	Poor visibility on the curve due to trees and overgrown vegetation, which can lead to head-on collisions
Recommendations:	<ul style="list-style-type: none"> • Improve the line of sight by removing trees from the shoulder and cut down vegetation which hampers visibility along the curves
Reasons for concern:	Curves on high embankment without safety barriers noted <ul style="list-style-type: none"> • Run-off accidents on high embankments will lead to fatalities

Recommendations:	Provide metal beam crash barrier with delineators on sharp curves in high embankment <i>Refer to Appendix III for guidelines on situations where to install the above</i>

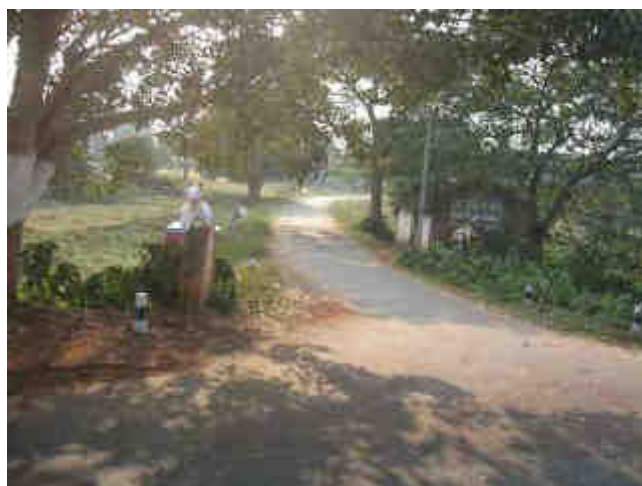
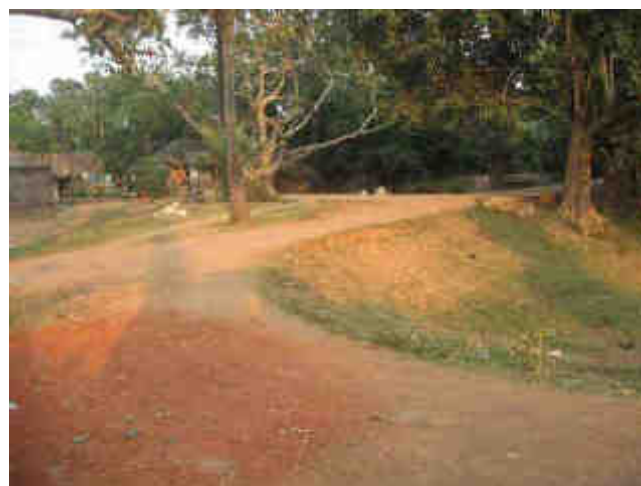
Km. 0+300; 0+600; 1+200; 1+300; 2+100; 3+300; 3+900; 4+100; 4+400; 4+600; 5+400; 5+600; 6+100; 6+500; 6+900; 7+300; 7+500; 7+900; 8+200; 8+600; 9+200; 9+300; 9+350; 9+400; 9+900; 10+860; 11+300; 11+600; 11+950; 12+100; 12+400; 12+500; 12+650; 12+800; 13+100; 13+500; 13+700; 13+950; 14+300; 14+400; 14+700; 15+100; 15+400; 16+400; 16+800; 16+950; 17+200; 17+400; 18+200; 18+500; 18+600; 18+800; 21+100; 22+700; 22+900; 23+100; 23+200; 23+300; 23+450; 23+500; 23+550; 23+750; 24+050; 24+150; 26+100; 26+800; 26+850; 27+850; 28+900; 29+800; 30+400; 30+700; 30+900; 31+500; 32+400; 32+500; 32+900

This is a major hazard observed on most of the 3-armed uncontrolled junctions. The major reasons for poor visibility at junctions on this road are due to

- No traffic signs or road markings are observed on any of such junctions, the presence of which would have informed and warned the road user of the

- High approach speeds were observed by traffic turning from side roads into the main carriageway and no traffic calming measures/ warning is provided on the side road.
- Coupled with inadequate visibility, in the worst case, this may result in **right angle collision** with vehicles coming from the major road leading to serious injury or fatal accidents.

It has been observed that on few junctions, the level difference between the side road and major road and the vertical profile of the side road joins the edge of main carriageway in an unsafe manner.

Recommendations: • Provide traffic signs and road markings pertaining to junction control

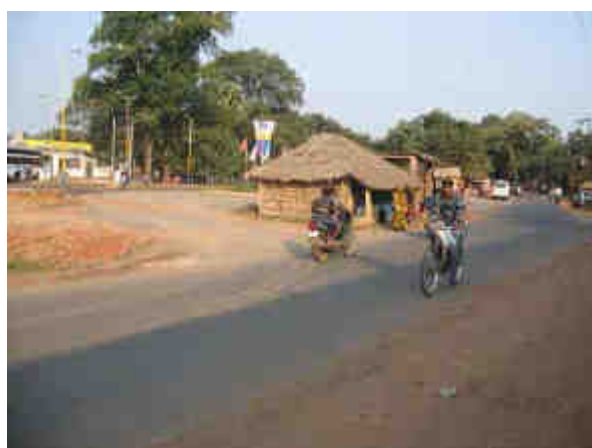
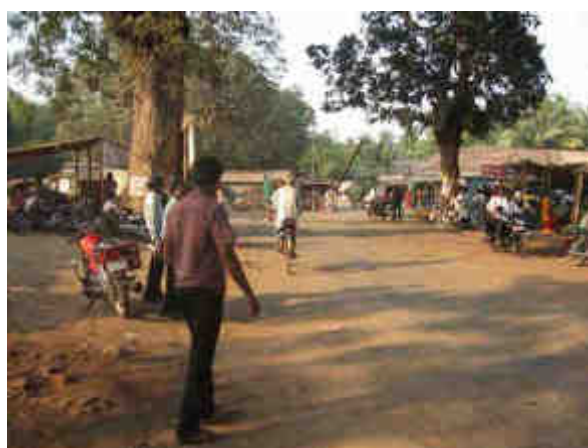
- 7+000
- 7+250

Reasons for concern:	Poor Junction layout <ul style="list-style-type: none">• The junction layout is non-standard and has no control over the traffic movement. It is confusing who has priority in such a situation. This encourages lawless traffic movement and is hazardous.
Recommendations:	<ul style="list-style-type: none">• Re-design the junction after traffic studies and considering the requirements of all road users.

Reasons for concern:	Poor delineation <ul style="list-style-type: none">• Traffic signs and road markings are absent in any of the arms of the junctions, the presence of which would have informed and warned the road user of the layout ahead.
Recommendations:	<ul style="list-style-type: none">• Provide edge line markings, centerline markings and other junction road markings pertaining to junction control.

Reasons for concern:	Provision for VRUs <ul style="list-style-type: none">• Pedestrian space in the intersection area is encroached by commercial establishments.• Pedestrians were observed using the road for commuting, instead of the footpath/ shoulders, and this expose them to the fast moving traffic which can lead to crashes resulting in serious injuries.
Recommendations:	<ul style="list-style-type: none">• Remove encroachments from the shoulder and provide a 2m wide shoulder space free of encroachments

Reasons for concern:	On-street Parking <ul style="list-style-type: none">• No parking spaces provided for commercial vehicles and vehicles are parked encroaching the road and shoulder space, hampering visibility.• This forces pedestrians to move into the centre of the road resulting in hazardous situation.
Recommendations:	<ul style="list-style-type: none">• Provide designated parking spaces for commercial vehicles

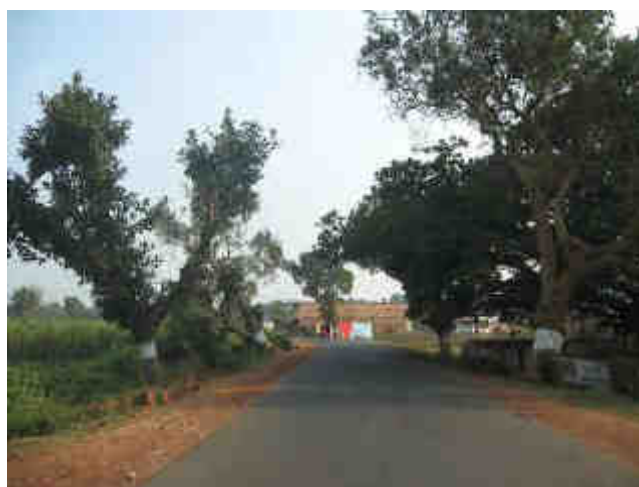
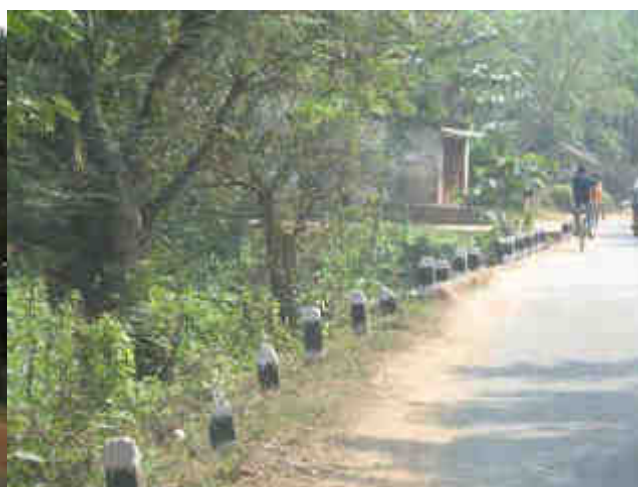
- 2+900
- 17+700
- 3+600
- 18+500
- 13+250
- 23+150

Reasons for concern:	Roadside objects constitute a significant hazard, if the driver loses control and will result in major injuries/ fatalities
Recommendations:	<p>Desirable:</p> <ul style="list-style-type: none"> • Remove Trees/ street lighting poles from the road shoulders • Remove encroachments from the right of way • Provide crash barriers on locations where trees acts as a significant hazard and where the space is available to install crash barrier <p>Essential:</p> <ul style="list-style-type: none"> • Delineate the hazards by installing OHMs or painting of the trees in black and white strips • Remove encroachments on at least 2m from the road edge

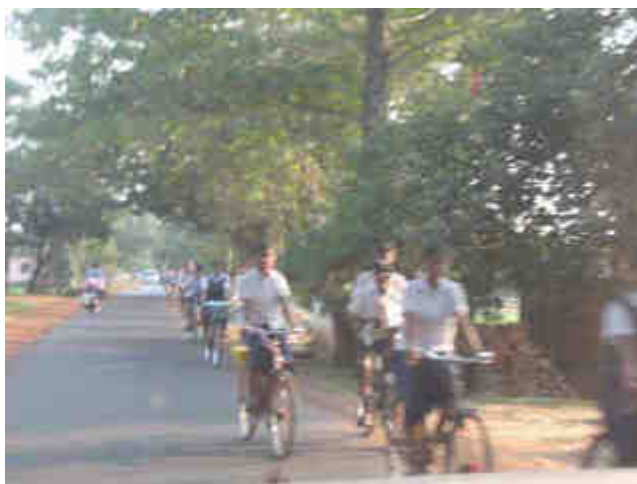
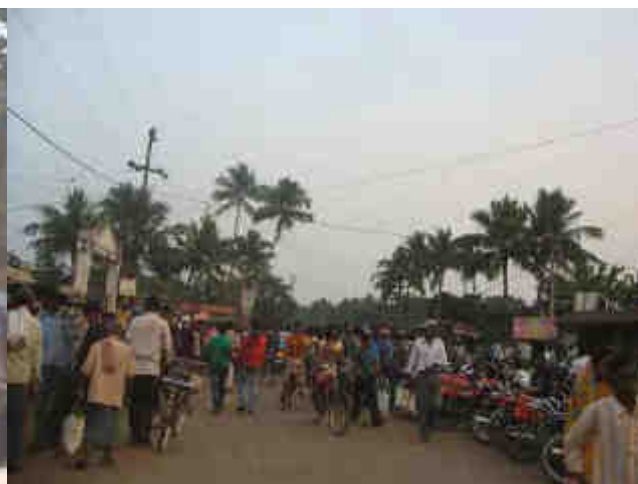
- 6+300
- 6+900
- 10+100
- 20+000
- 22+100
- 23+300
- 24+500
- 26+000

- No traffic calming measures are provided to slow down vehicles approaching at high speeds to the built up area
- Significant pedestrians including school children are noted, but no separate pedestrian facilities are provided along the road inside the BUA or to cross the road
- Significant number of access roads within the BUA, the visibility of which has been hampered due to shops/ establishments on all corners of the junction
- On road bus stops and on-street parking which hampers visibility and encourage dangerous overtaking
- No road markings or warning signs to warn/ inform the road user of the built up nature of the area ahead
- No speed limit signs provided
- The shared usage of road space by the different modes of vehicle puts at risk the safety of vulnerable road users (pedestrians and cyclists).

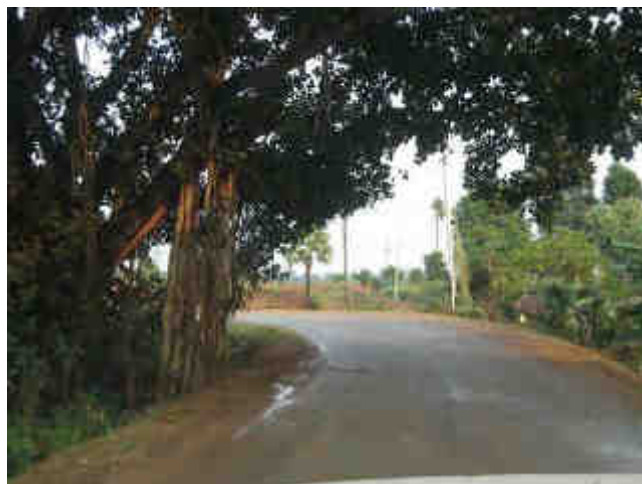
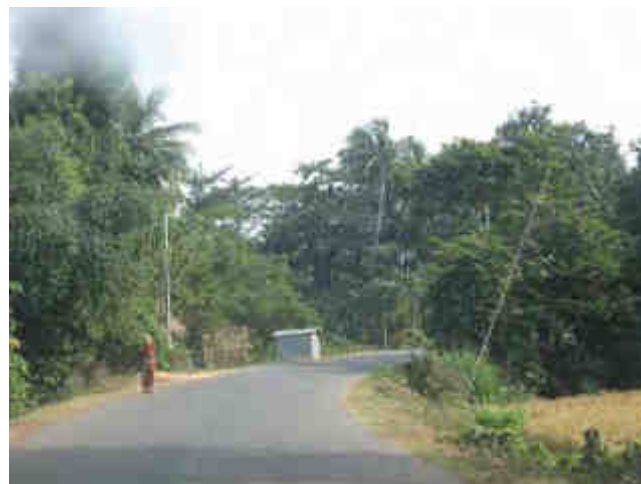
Horizontal curves of radius less than 200 m were observed at Km. 2+100; 3+100; 3+800; 4+700; 5+020; 19+950; 20+400; 22+400; 22+600; 23+700; 23+900; 24+100; 24+700; 32+300; 32+700; 33+000; 33+700; 36+400.

Reasons for concern: Curves on high embankment without safety barriers noted, which may lead to run-off accidents, which can result in fatalities/ major injuries

Recommendations: Provide **curve warning signs, chevron signs, delineators and speed limit sign** as appropriate

Recommendations: Provide metal beam crash barrier with delineators on sharp curves in high embankment

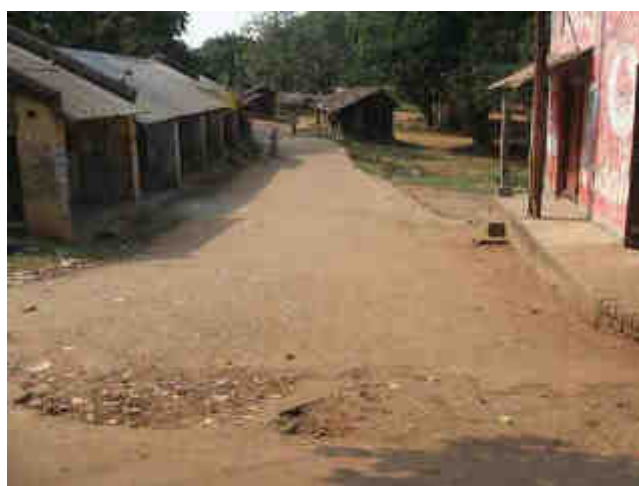
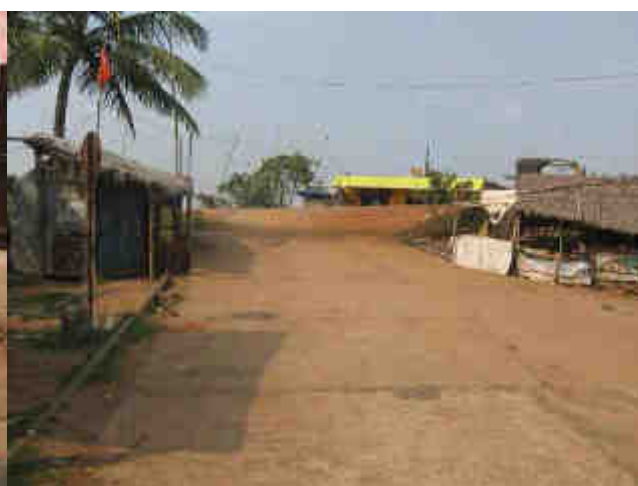
Km. 2+400; 2+500; 2+700; 2+900; 9+100; 19+100; 19+200; 19+400; 20+000, 21+600; 21+850; 22+300; 22+400; 23+600; 23+900; 24+700; 24+800; 26+750; 26+800; 27+700; 27+950; 29+400; 29+500; 30+100; 30+300; 30+700; 33+300; 35+100; 35+600; 36+800; 37+700; 37+800; 38+200; 38+900; 41+900; 42+700; 42+750; 43+400; 45+300; 45+700; 46+500; 47+600

This is a major hazard observed on most of the 3-armed uncontrolled junctions. The major reasons for poor visibility at junctions on this road are due to

- No traffic signs or road markings are observed on any of such junctions, the presence of which would have informed and warned the road user of the layout ahead.
- Poor delineation may result in sudden braking behavior by road users who are required to stop, or wish to make turns. In the worst case, it can also result in rear-end collisions at high speeds.

- High approach speeds were observed by traffic turning from side roads into the main carriageway and no traffic calming measures/ warning is provided on the side road.
- Coupled with inadequate visibility, in the worst case, this may result in **right angle collision** with vehicles coming from the major road leading to serious injury or fatal accidents.

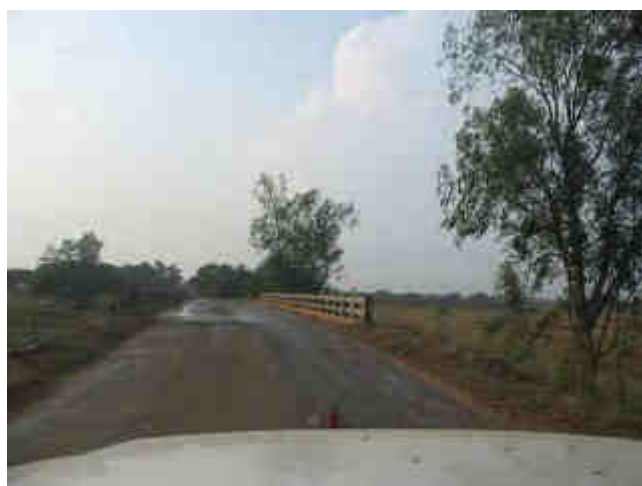
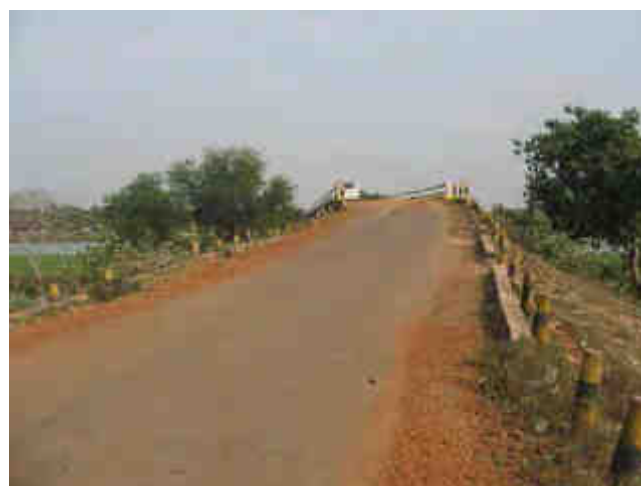
In the existing situation, there are many minor bridges culverts along the road, the approaches of which are not protected. The following are the chainages:

- 0+900
- 1+800
- 47+600

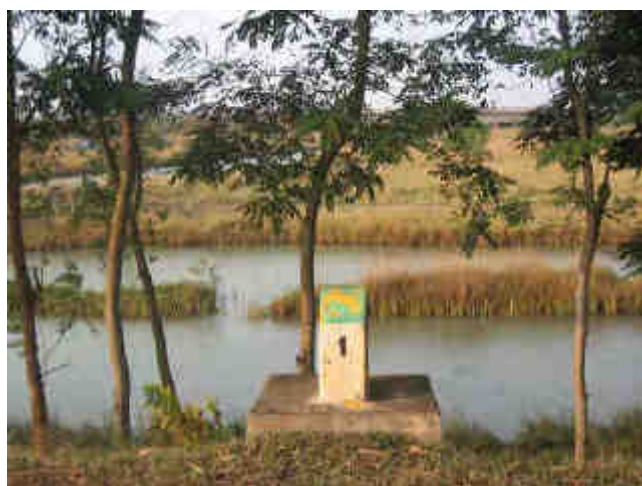
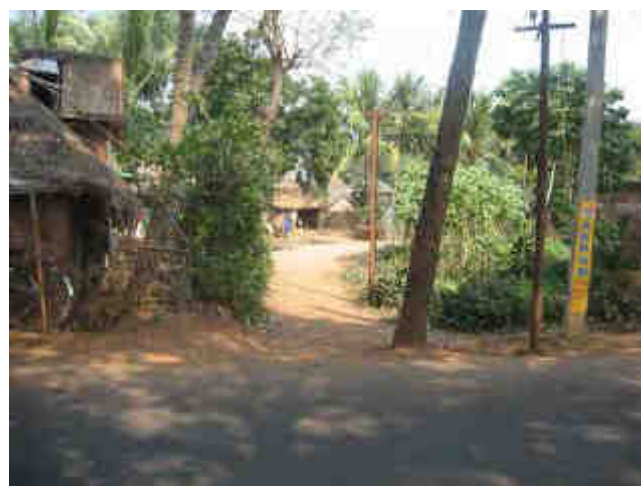
Hazardous road side objects such as trees and Poles (Telephone & Street lighting) were observed nearer to the edge on this road.

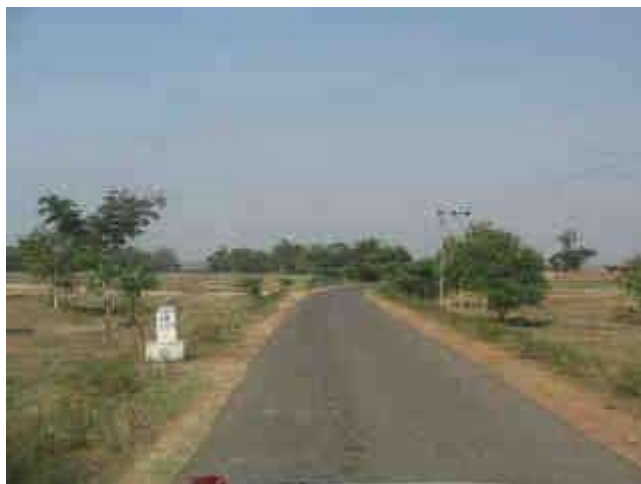
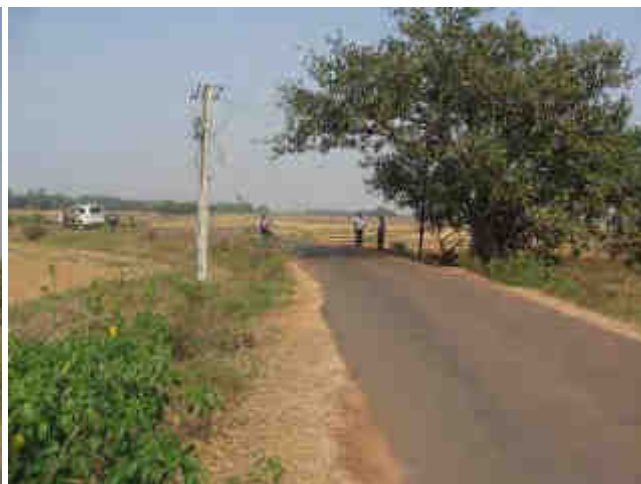
Horizontal curves of radius less than 100 m were observed at Km.2+400; 3+100; 3+400; 4+400; 6+200; 6+500; 7+100; 7+200; 7+400; 8+100; 8+300; 8+500; 13+500; 14+500; 14+700; 15+100; 15+400.

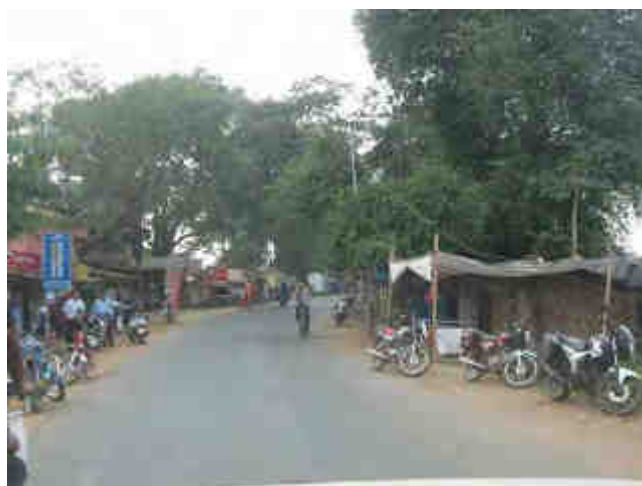
Ch: 4+100

Horizontal curves of radius less than 100 m were observed at Km.4+100; 4+600; 7+200; 7+800; 8+000

Reasons for concern: Curves on high embankment without safety barriers noted

Recommendations: Provide **curve warning signs, chevron signs, delineators and speed limit sign** as appropriate

Recommendations: Provide metal beam crash barrier with delineators on sharp curves in high embankment

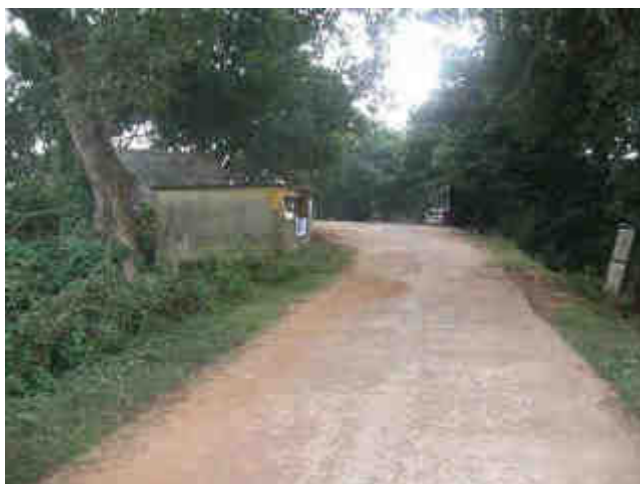
Ch: 7+200

Location of Side roads at skew with the major road

Inadequate Visibility

This is a major hazard observed on most of the 3-armed uncontrolled junctions. The major reasons for poor visibility at junctions on this road are due to

- No traffic signs or road markings are observed on any of such junctions, the presence of which would have informed and warned the road user of the layout ahead.

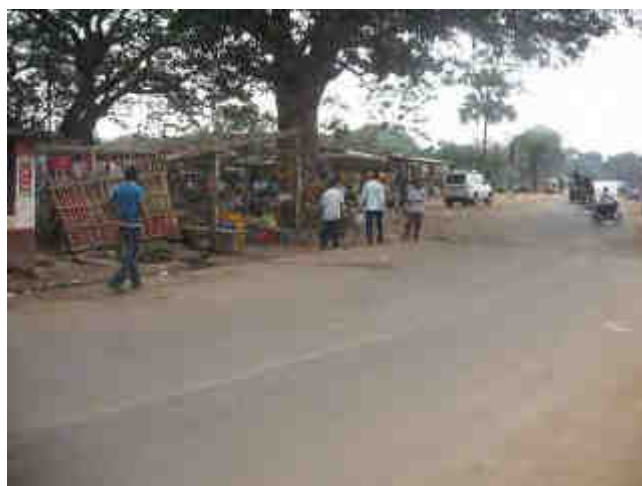
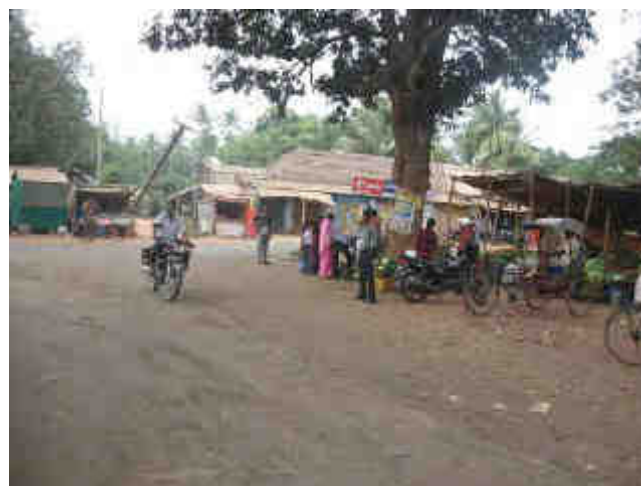
Ch: 8+000

There is a major junction along this road at Baruan, Ch: 8+000.

- The junction layout is non-standard and has no control over the traffic movement. It is confusing who has priority in such a situation. This encourages lawless traffic movement and is hazardous.

- No direction signs to guide the traffic through the junction layout which may lead to hazardous driving and may lead to rear-end collision.

- Shoulders in the junction area are encroached by shops and other such establishments.
- Pedestrians were observed using the road for commuting, instead of the footpath, and this expose them to the fast moving traffic which can lead to crashes resulting in serious injuries.

- Remove encroachments from the shoulders
- Provide a well maintained 2m wide shoulder space for pedestrians in rural areas

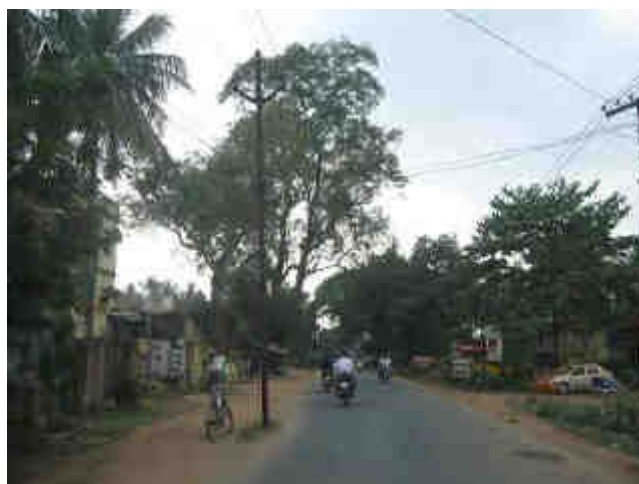
Ch: 0+500

Roadside objects constitute a significant hazard, if the driver loses control and will result in major injuries/ fatalities

- Remove Trees/ street lighting poles from the road shoulders
- Remove encroachments from the right of way
- Provide crash barriers on locations where trees acts as a significant hazard and where the space is available to install crash barrier

- Delineate the hazards by installing OHMs or painting of the trees in black and white strips
- Remove encroachments on at least 2m from the road edge

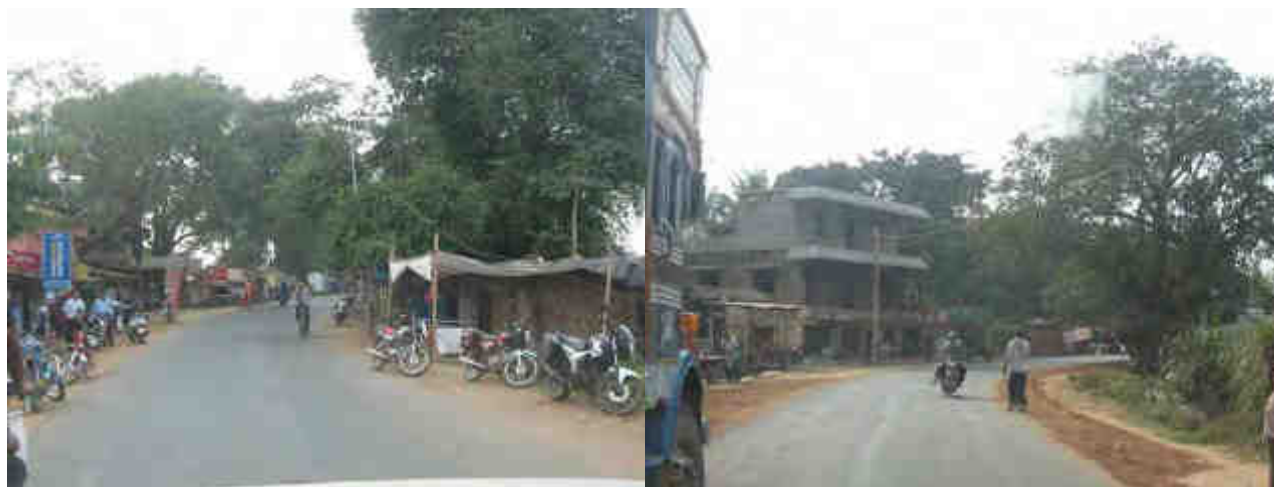
Ch: 4+100

- No traffic calming measures are provided to slow down vehicles approaching at high speeds to the built up area
- Significant number of pedestrians were noted, but no separate facilities are provided
- Access roads within the BUA, the visibility of which has been hampered due to shops/ establishments on all corners of the junction
- No road markings or warning signs to warn/ inform the road user of the built up nature of the area ahead
- No speed limit signs provided
- The shared usage of road space by the different modes of vehicle puts at risk the safety of vulnerable road users.
