**Government of Odisha (GOO)
Chief Engineer, World Bank Projects, Odisha
Odisha State Roads Project**

**Consultancy Services for
Road Sector Institutional Development
Loan # 7577-IN**

**ROAD INFRASTRUCTURE
SAFETY MANAGEMENT REVIEW**

VOLUME I - REPORT

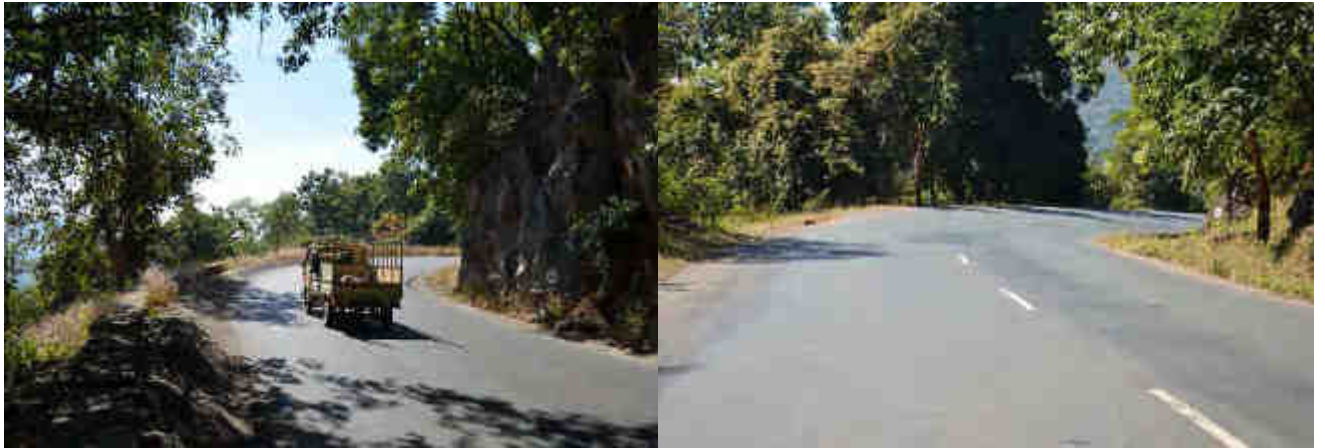
A. Curve with Valley on outside the curve

Reasons for concern (3): On outer edge of some of these curves, Concrete Guard Posts (CGP) are provided to protect the errant vehicles. As per international standards and practices, any concrete structure which is near the edge of road and larger by 10cm X 10cm in cross section is hazardous to the traffic.

Recommendations: Provide **curve warning signs, chevron signs, delineators and speed limit sign** as appropriate

Recommendations: For delineation, at all these sharp curves provide chevron signs.

Recommendations: Provide crash barriers on the outer edge on such curves.

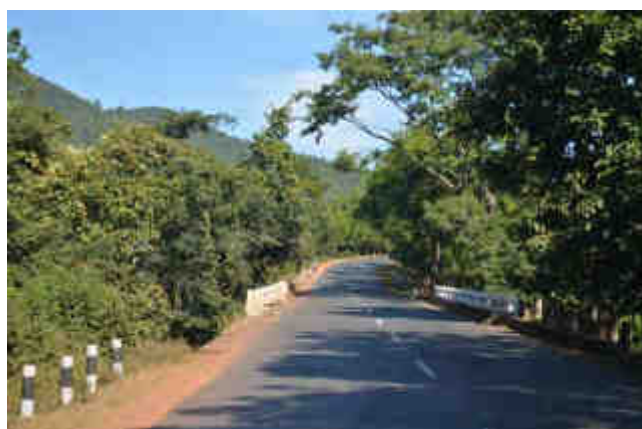
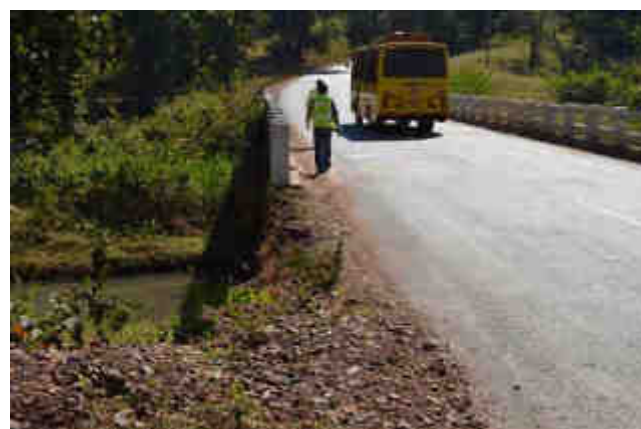
Absence of OHM and absence of approach protection at Km 461+800 and Km 470+250

In the absence of adequate warning signs and reflective markings, the road layout and the hazard will not be clear for the road user, particularly during night conditions, and in worst conditions, this will lead to serious injury/ fatal accidents

Reasons for concern (3): The bridge/ culvert parapets on the edge of the road adjacent to high speed traffic movement will be hazardous, particularly at dark conditions, and needs to be delineated for a driver to judge the position of such road side hazard.

Recommendations: Provide crash barriers on either approaches of the structures with delineators

- Recommendation:**
- Provide curve warning sign in addition to crash barrier with delineators
 - Provide edge line markings
 - Provide hazard markers on either end of the parapets

- Recommendations:** Install Object Hazard Marker (OHM) on both sides and for both approaches (i.e. Four numbers of OHM for each structure.

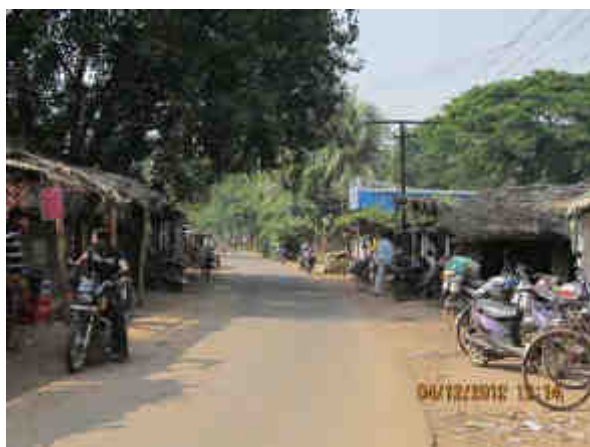
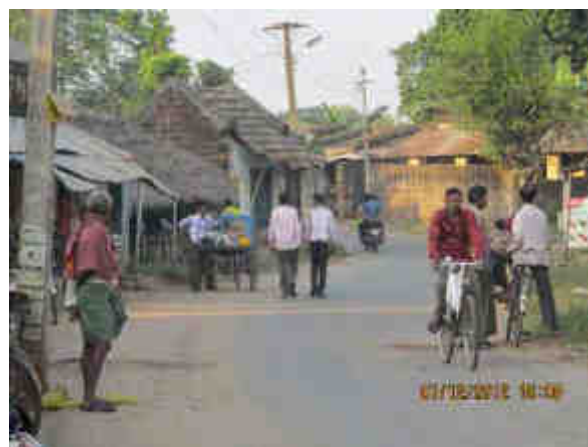
- No traffic calming measures are provided to slow down vehicles approaching at high speeds to the built up area
- Significant pedestrians are observed, but no separate pedestrian facilities are provided along the road inside the BUA or to cross the road
- No road markings or warning signs to warn/ inform the road user of the built up nature of the area ahead
- No speed limit signs provided
- On street parking and structures hamper the visibility, and resulting in unsafe situations
- On road bus stops observed, which hampers visibility and unsafe overtaking maneuvers.

- Recommendations:**
- Provide warning signs at before start and after the end of BUA
 - Provide pedestrian crossings, wherever deemed necessary
 - Provide well maintained wide shoulders (min. 2m wide), free of encroachments and overgrown vegetation in roadside villages in rural areas respectively
 - Provide STOP signs with road humps on all access roads in roadside villages in rural areas
 - Provide 'SLOW' signs (traffic calming measure) on appropriate locations near schools
 - Provide designated parking spaces, where it deemed necessary
 - Provide Bus Bays/ Bus Stops as appropriate, with associated road markings and traffic signs

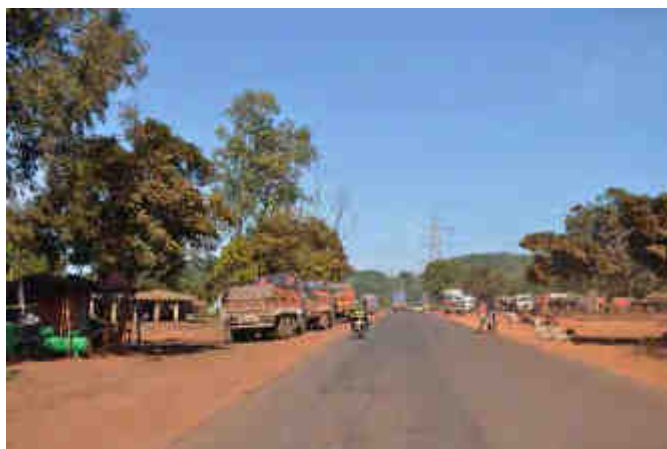
At chainage 473+000 truck resting area is present which is used by trucks before entering into Ghat section and after coming from Ghat section in the opposite direction.

Reasons for concern: Absence of proper entry/exit is created for trucks in resting areas which can lead to collision between vehicles moving on NH and vehicles leaving/entering the resting area.

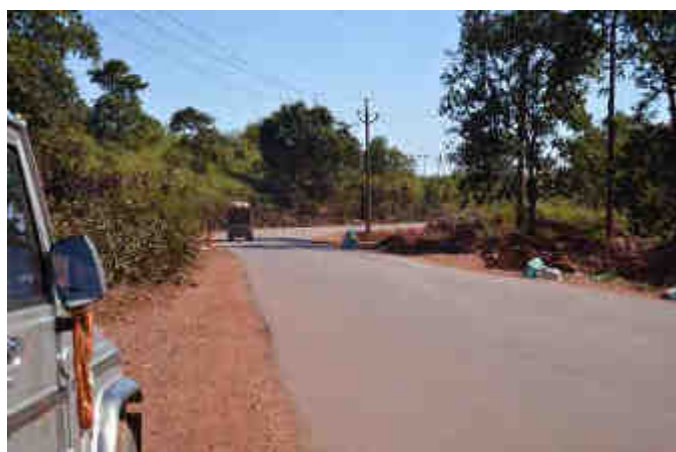
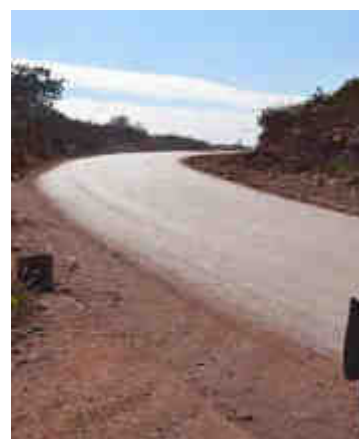
Sharp Curves (radius less than 100-150 m) are observed at following locations –

- Reasons for concern:** No warning signs/ delineation to inform the road user to make him/her slow down to negotiate the curve in a safe speed
- Potential run-off accidents

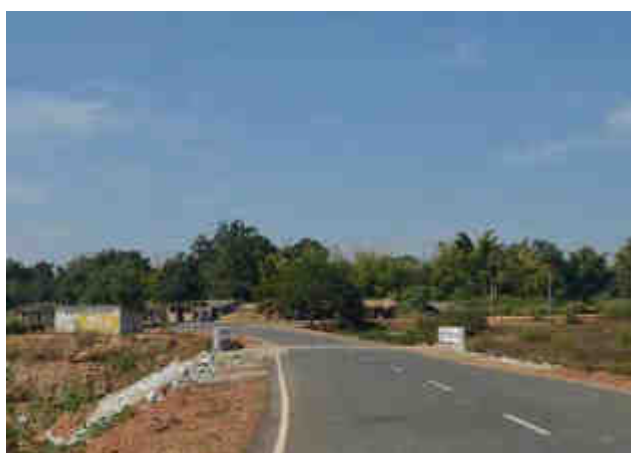
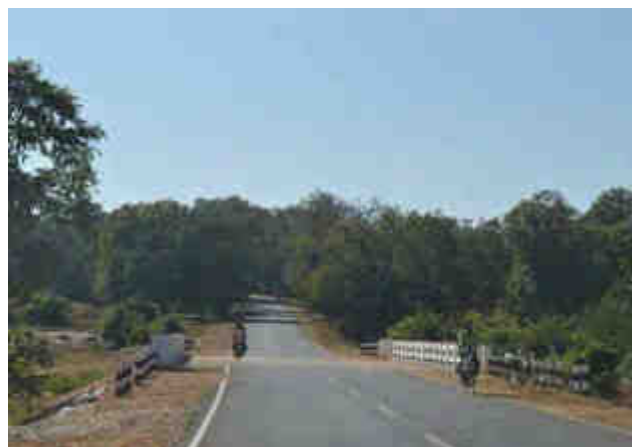
Absence of OHM on structure at Km 76+000 and Km 94+600

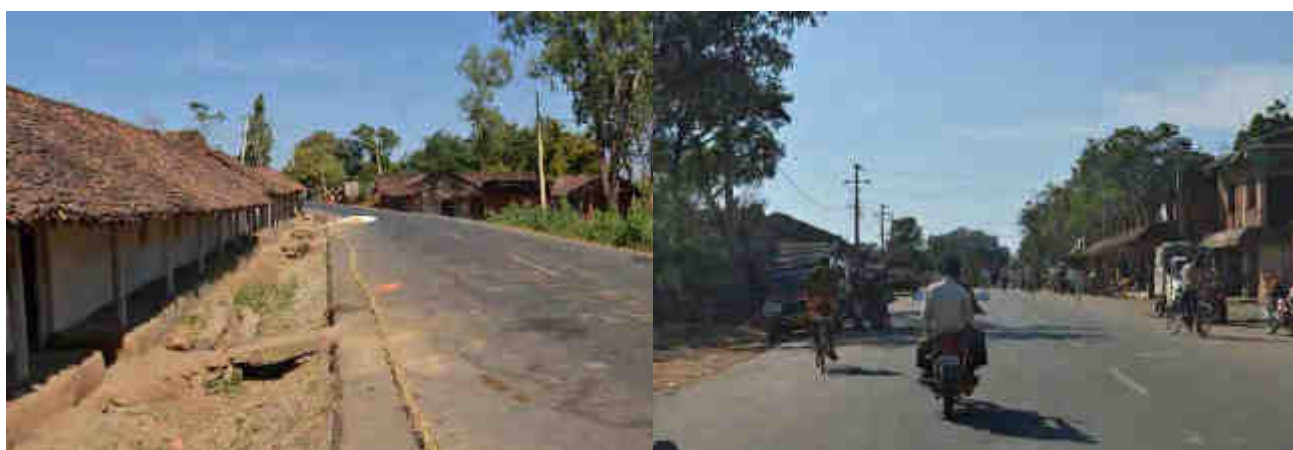
Village Barbil at 72+500 and Town Dhenkikote (99+000)

- In villages/town wherever schools are present, warning sign “School Ahead” and “Slow” are not provided on either approaches.
- Significant pedestrians/ school children, cyclists, motorcycles are present
- Very high encroachments are present Locations of built up area and villages are-

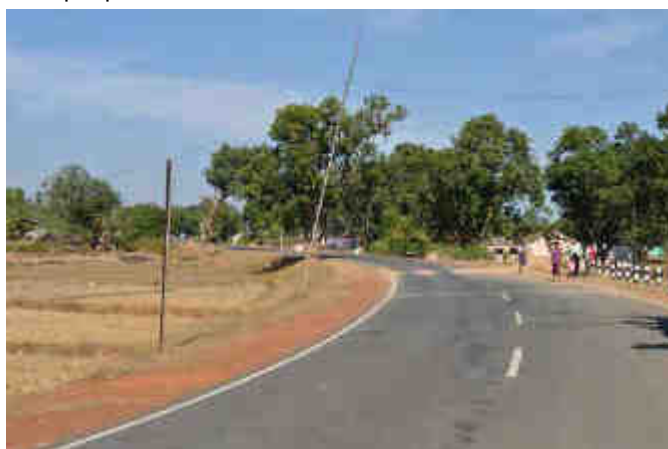
- Location 87+200 have some past accident record history.
- A curve is present with good visibility
- Super elevation is not proper

Reasons for concern:	Profile Correction On curve proper super elevation is not provided thus vehicles negotiating curve have chance to run off
Recommendations:	Correct the profile of the curve by providing the designed super elevation.
Reason for concern	Concrete Guard Post Most of the curves have concrete guard post on outside curve to protect the vehicles from falling into ditch, which is not appropriate as per standard guidelines. These concrete guards post are not effective during night.
Recommendations:	<ul style="list-style-type: none"> • Provide crash barrier on outside curve with high embankment • Provide proper chevron signage for delineation

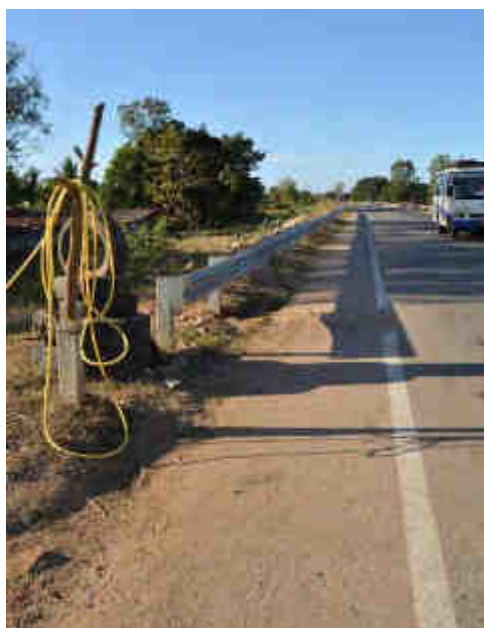
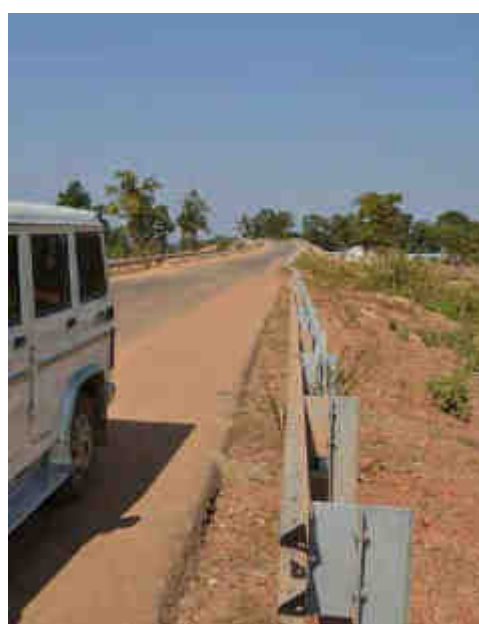
Crash Barrier very near to pavement edge

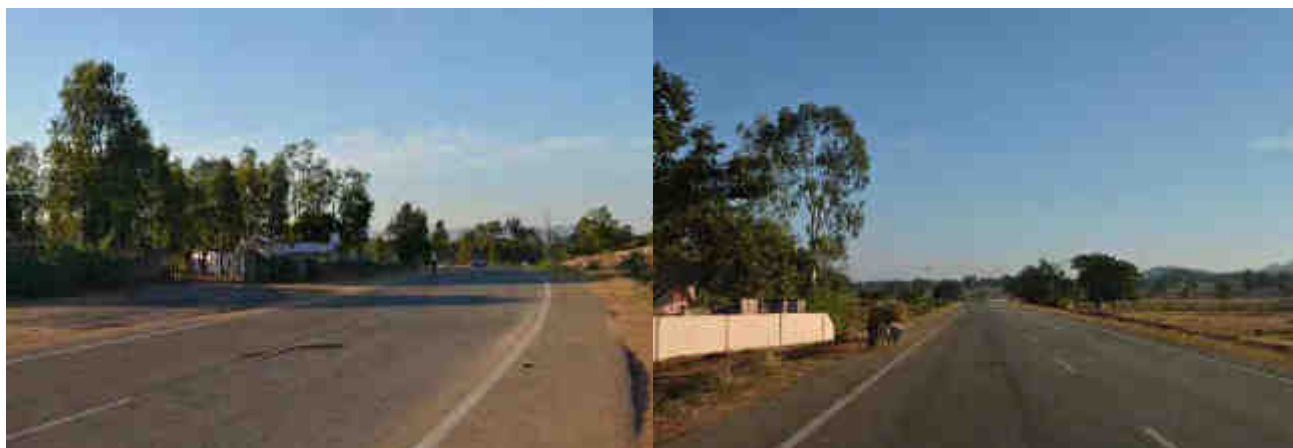
Section I

- In villages/ town wherever schools are present, warning sign “School Ahead” and “Slow” are not provided on either approaches.
- Significant pedestrians/ school children, cyclists, motorcycles are present

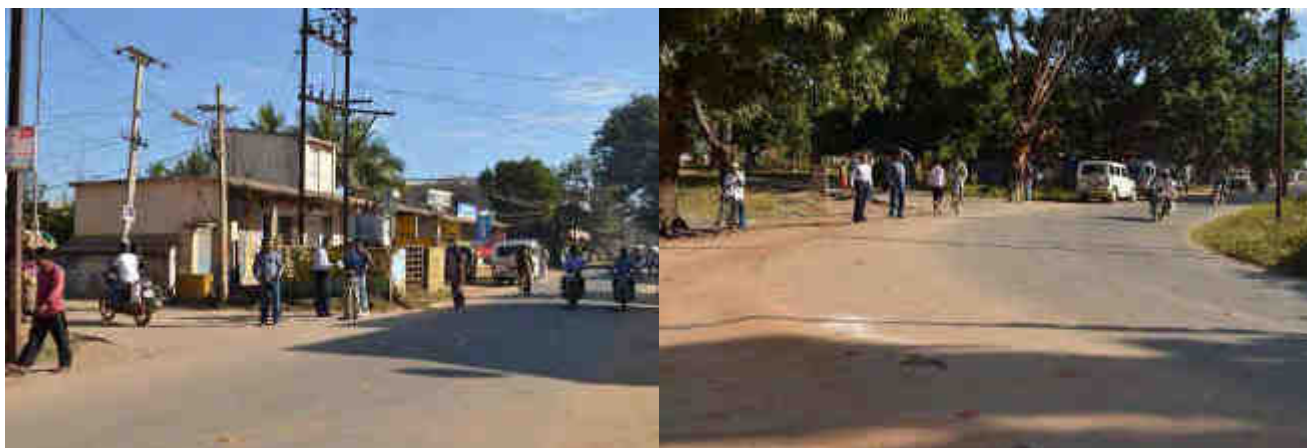
Minor Junctions at Km 0+700 and at 1+670

This is a major hazard observed on most of the 3-armed uncontrolled junctions. The major reasons for poor visibility at such junctions on ROAD are due to buildings on the corners.

No traffic signs or road markings are observed on any of such junctions, the presence of which would have informed and warned the road user of the layout ahead.

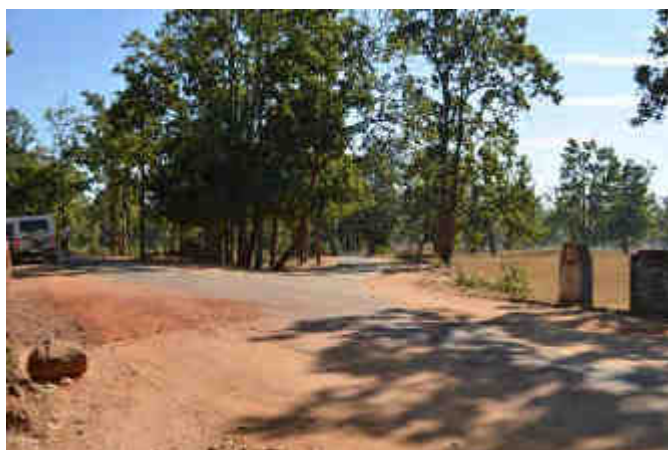
Skewed Side Road

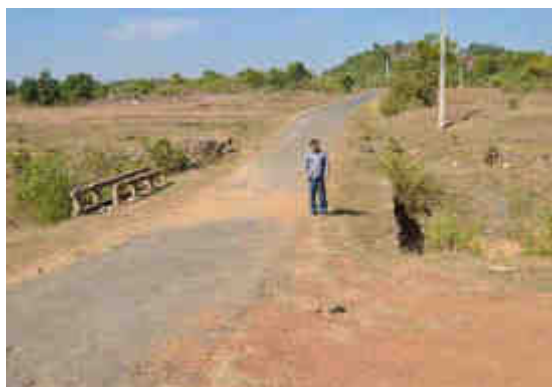
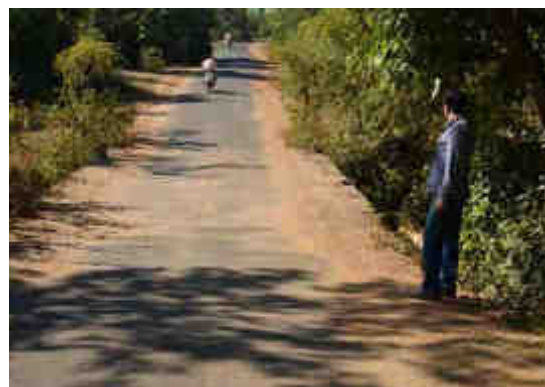
Absence of protection and OHM on structure at Km 7+400 and Km 10+300

Reasons for concern: The bridge/ culvert parapets on the edge of the road adjacent to high speed traffic movement will be hazardous, particularly at dark conditions, and needs to be illuminated for a driver to judge the position of such road side hazard.

Reasons for concern: **Broken or missing parapets**
 The absence of parapet on bridge/culvert increases the risk of vehicles falling in to the drain. In the context of high speed traffic movement observed on SH-10, the absences of parapets at such locations are hazardous for traffic, especially for VRUs.

Recommendations: Install Object Hazard Marker (OHM) on both sides and for both approaches (i.e. Four numbers of each OHM for each structure).
Refer to Appendix III for guidelines on installing OHM.

Recommendations: Provide continuous parapets on all culverts and bridges.

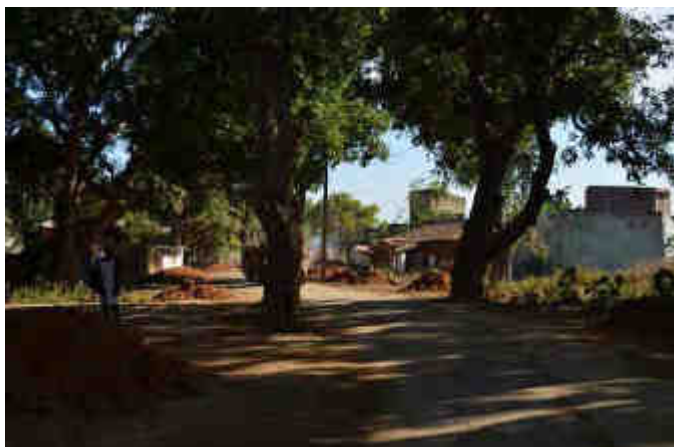
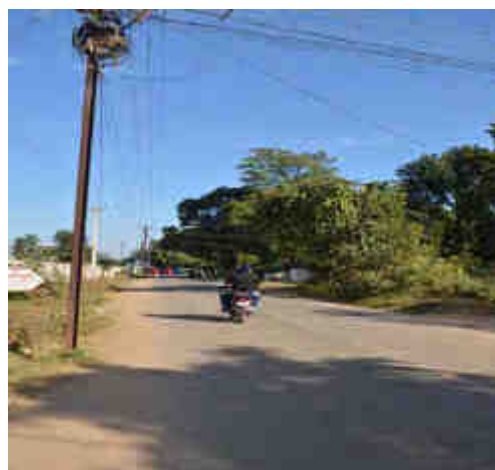
Several trees and street pole near pavement edge

The road side objects like trees, street light or other poles, buildings, and unprotected deep drains which are near the edge of road needs to be. At night time it becomes very difficult for drivers to judge the position of such road side hazard. If the road side objects are not protected and/or illuminated there are chances of driver losing control and hitting these objects which may result into fatal accident.

- Remove Trees/ street lighting poles from the road shoulders
- Remove encroachments from the right of way
- Provide crash barriers on locations where trees acts as a significant hazard and where the space is available to install crash barrier

- Delineate the hazards by installing OHMs or painting of the trees in black and white strips
- Remove encroachments on at least 2m from the road edge

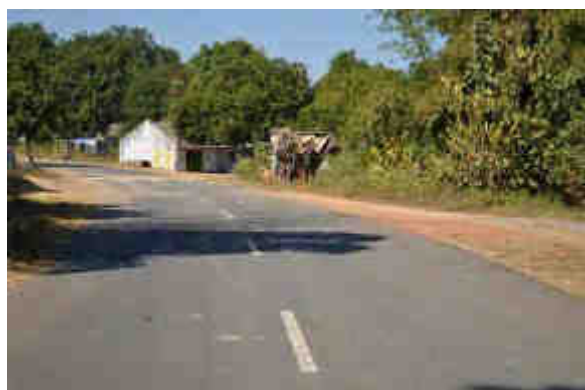
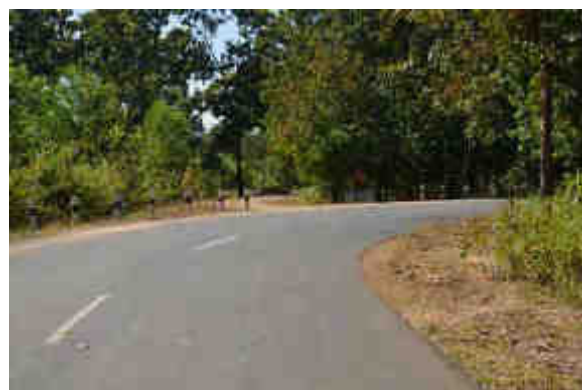
Sharp Curves on Project Road at Km 41+400 and Km 45+800

Reasons for concern: On outer edge of some of these curves Concrete Guard Posts (CGP) are provided to protect the errant vehicles. As per international standards and practices, any concrete structure which is near the edge of road and larger by 10cm X 10cm in cross section is hazardous to the traffic.

Recommendations: Provide **curve warning signs, chevron signs, delineators and speed limit sign** as appropriate

Recommendations: For delineation at all these sharp curves provide chevron signs.

Recommendations: Provide crash barriers on the outer edge on such curves.

Recommendations: Provide continuous delineation on all curves

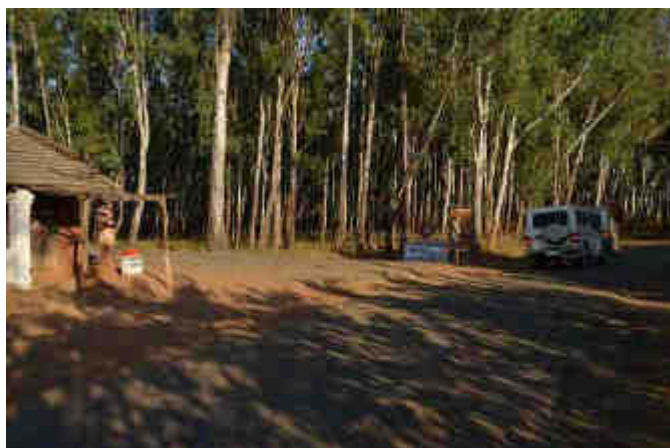
Minor Junctions at Km 63+400

This is a major hazard observed on most of the 3-armed uncontrolled junctions. The major reasons for poor visibility at such junctions on road are due to buildings on the corners.

No traffic signs or road markings are observed on any of such junctions, the presence of which would have informed and warned the road user of the layout ahead.

Recommendations:	Provide traffic signs and road markings pertaining to junction control. <i>Refer to Appendix III for guidelines on traffic signs and road markings at junctions</i>
Reasons for concern:	High approach speeds High approach speeds were observed by traffic turning from side roads into the main carriageway and no traffic calming measures/ warning is provided on the side road.
Recommendations:	<ul style="list-style-type: none">• Provide road humps on the side at junctions having history of accidents• Provide raised markings on the entry to the side road• Provide adequate warning signs on major road and side road <i>Refer to Appendix III for guidelines on traffic calming measures.</i>
Reasons for concern:	Poor Geometry It has been observed that on few junctions, the level difference between the side road and major road and the vertical profile of the side road joins the edge of main carriageway in an unsafe manner.

Recommendations:	Correct the vertical alignment of side road so that vehicles approaching from side roads has adequate length on the side road to slow down/ stop before entering into the main carriageway. <i>Refer to Appendix III for guidelines on safer vertical profile of side roads at junctions.</i>

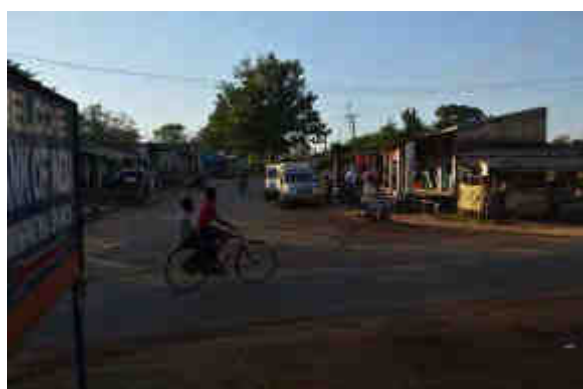
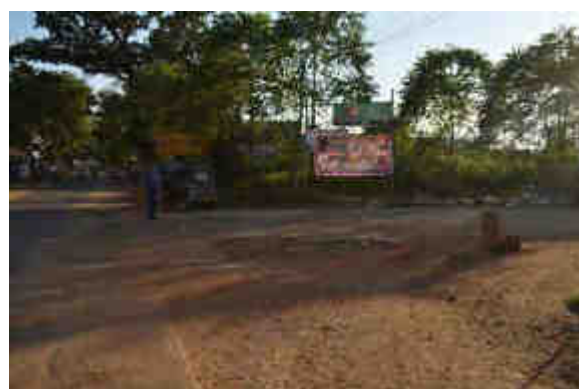
- This junction is intersection of ODR and SH
- Significant two wheelers, pedestrians, cyclists are present on the junction.
- No traffic islands are present for safe and effective maneuver of traffic.
- Street light is not present on the junction.

Reasons for concern:	<p>Poor Junction layout</p> <p>The junction layout is non-standard and has no control over the traffic movement. It is confusing who has priority in such a situation. This encourages lawless traffic movement and is hazardous. The existing central island is non-standard and hampers visibility at the junction.</p>
Recommendations:	<p>Re-design the junction after traffic studies and considering the requirements of all road users.</p> <p><i>Refer to Appendix III for standard layouts of 3-arm junctions</i></p>
Reasons for concern:	<p>Poor delineation</p> <p>Traffic signs and road markings are absent in any of the arms of the junctions, the presence of which would have informed and warned the road user of the layout ahead</p>
Recommendations:	<p>Establish control in the junction by providing Give Way and Stop signs, edge markings and other road markings pertaining to junction control</p>

Reasons for concern:	<p>Provision for VRUs</p> <p>Significant presence of pedestrians and cyclists noted, but no provisions have been provided. Pedestrians were observed using the road for commuting and this expose them to the fast moving traffic which can lead to crashes resulting in serious injuries.</p>
Recommendations:	<p>Provide wide shoulders/ footpaths for pedestrians to commute in the junctions without interfering with the motorized traffic</p>

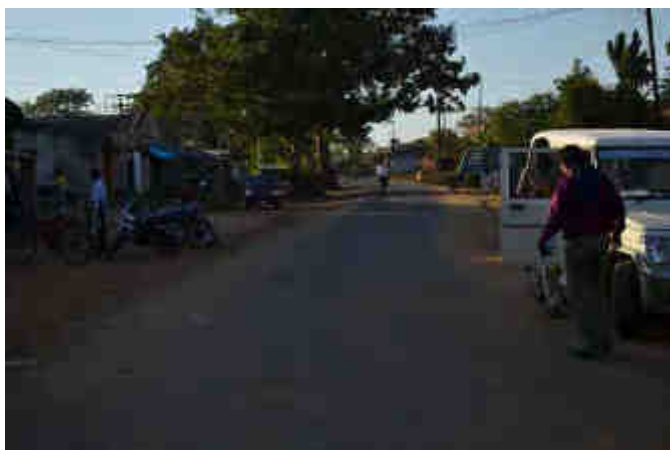
- In villages/town wherever schools are present, warning sign “School Ahead” and “Slow” are not provided on either approaches.
- Significant pedestrians/ school children, cyclists, motorcycles are present.

Built up area at Km 67+000

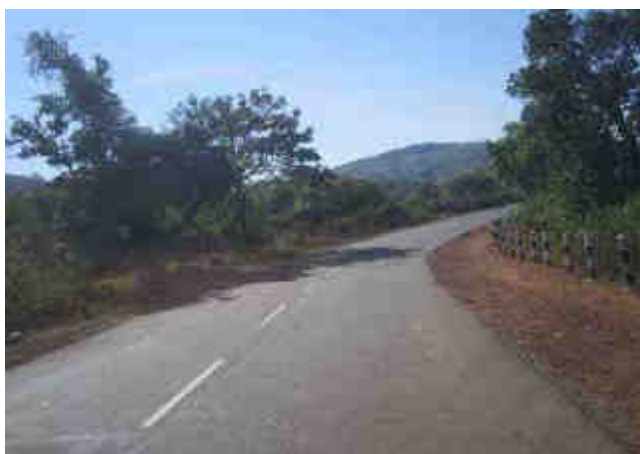
Ch: 392+700

Horizontal curves of radius less than 100m were observed at Km.380+400; 382+100; 382+350; 382+750; 382+900; 383+080; 388+320; 388+700; 389+250; 391+400; 392+700; 393+850; 397+100; 397+500; 398+900; 399+200; 399+700; 403+600.

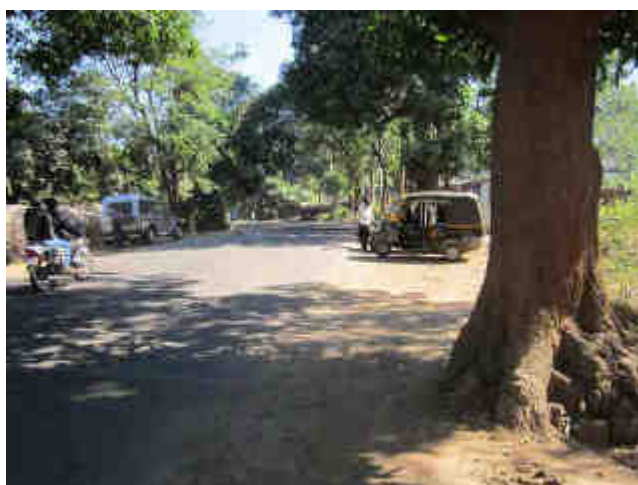
Ch: 383+500

At Chainage 383+500 horizontal bend after a vertical crest is found.

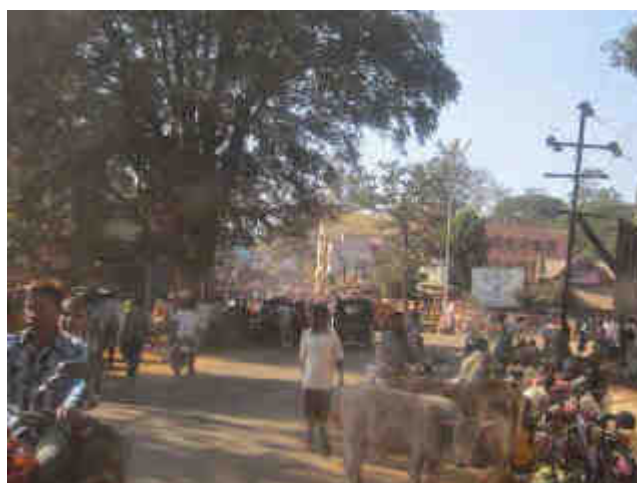
Ch: 401+100

A major junction at chainage 401+100 is found.

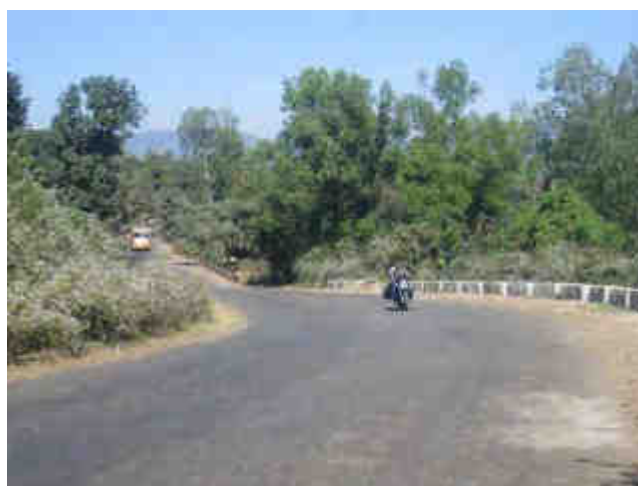
Ch: 384+500

At chainage 384+500 vertical Sag curve is found.

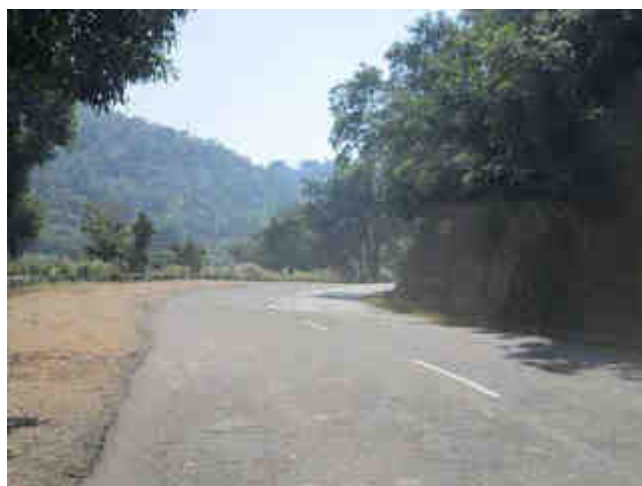
Ch: 472+500

8.3.2.1. Delineation of the road

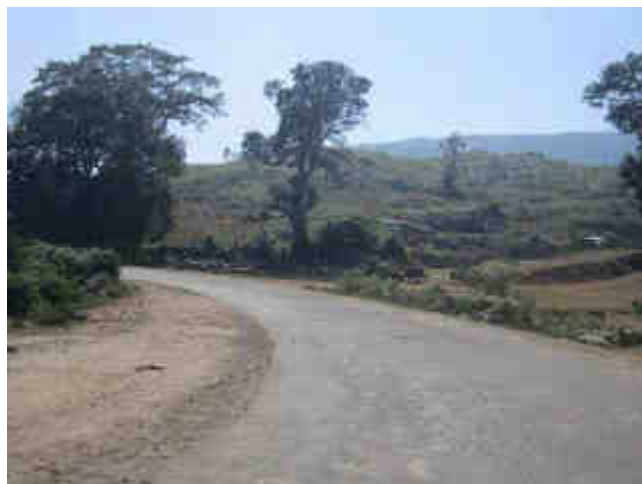
Ch:457+000

Horizontal curves of radius less than 100m were observed at significant number of location along the project road.

Reasons for concern:	No warning signs/ delineation to inform the road user to make him/her slow down to negotiate the curve in a safe speed, which may lead to: <ul style="list-style-type: none"> • Potential run-off accidents • Potential head-on collisions
Recommendations:	Provide curve warning signs, chevron signs, delineators and speed limit sign as appropriate <i>Refer to Appendix III for guidelines on treatment of curves.</i>
Reasons for concern:	Poor visibility on the curve due to trees and overgrown vegetation, which can lead to head-on collisions
Recommendations:	<ul style="list-style-type: none"> • Improve the line of sight by removing trees from the shoulder and cut down vegetation which hampers visibility along the curves
Reasons for concern:	Curves on high embankment without safety barriers noted <ul style="list-style-type: none"> • Run-off accidents on high embankments will lead to fatalities

Recommendations:	Provide metal beam crash barrier with delineators on sharp curves in high embankment <i>Refer to Appendix III for guidelines on situations where to install the above</i>

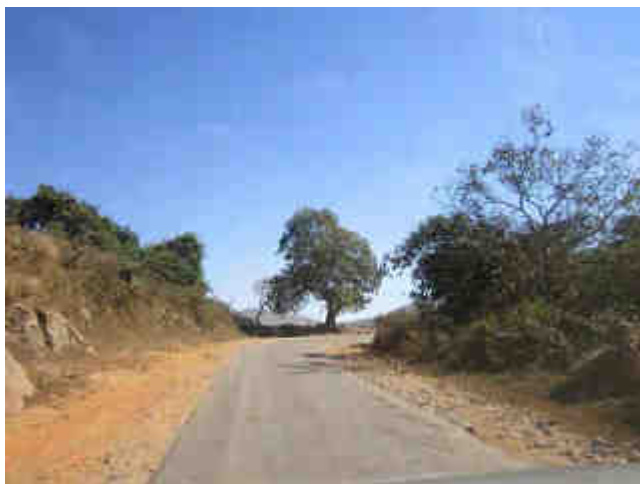
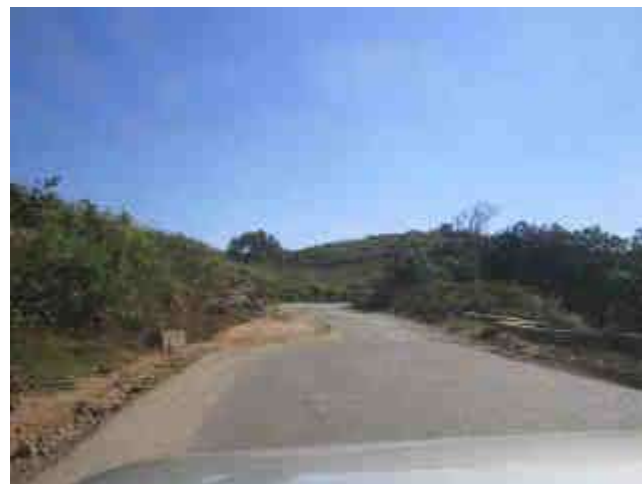
Ch: 453+000 - 454+000

In the existing situation, there are many instances of horizontal bends after a vertical crest at 453+000 – 454+000 (4).

The sight distance on a vertical crest is limited in day light and even less in night time. The presence of a horizontal bend after a vertical crest decreases the sight distance available further for the driver to react and could be a potential unsafe location. The vertical deflection of the alignment prevents the road user from being prepared to maneuver required to negotiate the curve and could lead to run off accidents.

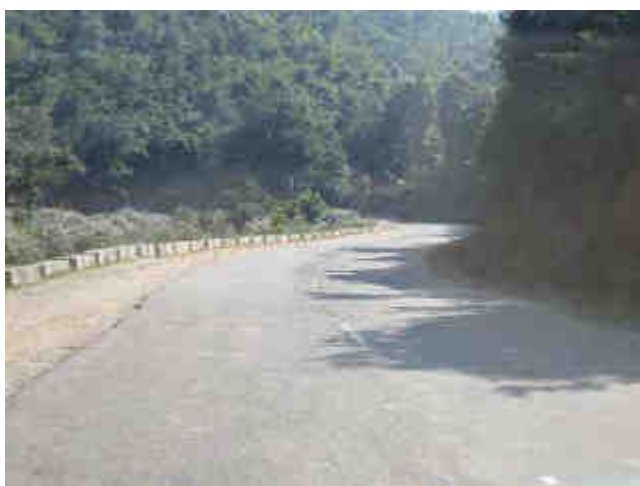
In the existing situation, there are two reverse curves along the road at Chainages, Ch: 433+500 & 452+000.

Reasons for Concern:	Successive changes of horizontal elevation The change of horizontal elevation of the alignment because of two successive curves may sometime lead a speeding errant vehicle to a run – off accident.
Recommendations	The provision of guard posts along the points of maximum curvature of the two curves.

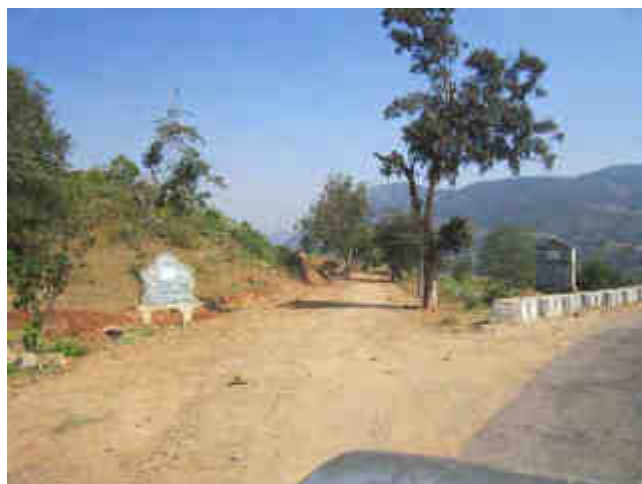
Ch: 462+000

Km 455+830; 462+000

Reasons for concern:	Inadequate Visibility This is a major hazard observed on most of the 3-armed uncontrolled junctions. The major reasons for poor visibility at junctions on this road are due to
-----------------------------	---

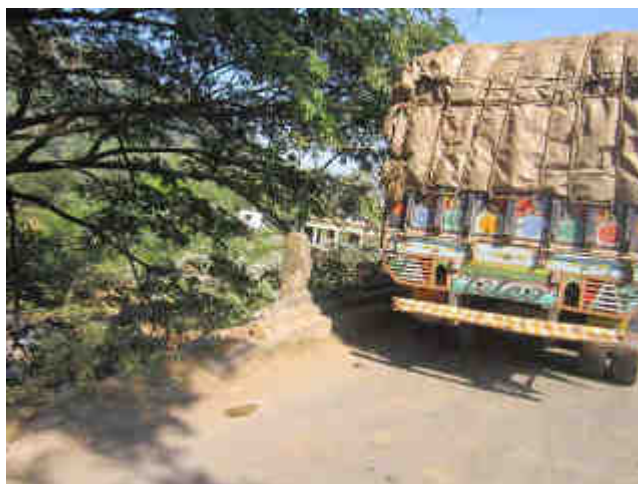
Ch:466+500

In the existing situation, there is only one approach to bridge / culvert at Ch: 466+500, which is unsafe.

Reasons for concern:	Unprotected high embankment If a vehicle lose control while approaching the bridge, run-off accidents may occur which may lead to multiple fatalities/ major juries
Recommendations:	Provide crash barriers on either approaches of the structures with delineators <i>Refer to Appendix III for guidelines to treatments on approaches to bridges</i>

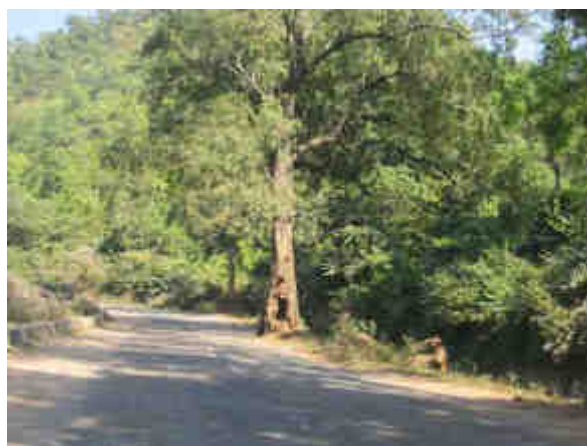
Road side objects like electricity poles, pool, trees are found at significant number of location on the project road.

Reasons for concern:	Roadside objects constitute a significant hazard, if the driver loses control and will result in major injuries/ fatalities
Recommendations:	Desirable: <ul style="list-style-type: none">• Remove Trees/ street lighting poles from the road shoulders• Provide crash barriers on locations where trees acts as a significant hazard and where the space is available to install crash barrier

- Delineate the hazards by installing OHMs or painting of the trees in black and white strips
- Remove encroachments on at least 2m from the road edge

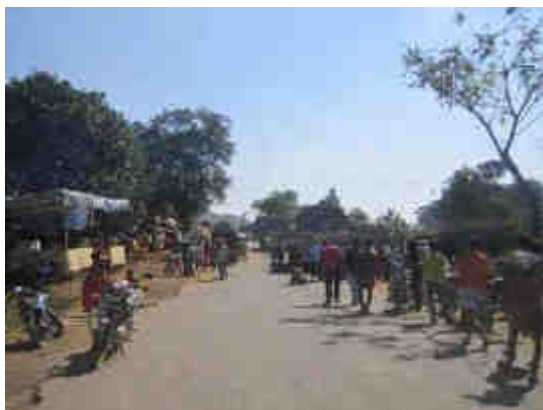
In the existing situation, there are two road side villages at Ch: 455+400 & 466+600.

- No traffic calming measures are provided to slow down vehicles approaching at high speeds to the built up area
- Significant pedestrians including school children are noted, but no separate pedestrian facilities are provided along the road inside the BUA or to cross the road
- No road markings or warning signs to warn/ inform the road user of the built up nature of the area ahead
- No speed limit signs provided
- On street parking hampers the visibility and resulting in unsafe situations
- On street bus stops observed, which hampers visibility and unsafe overtaking maneuvers.

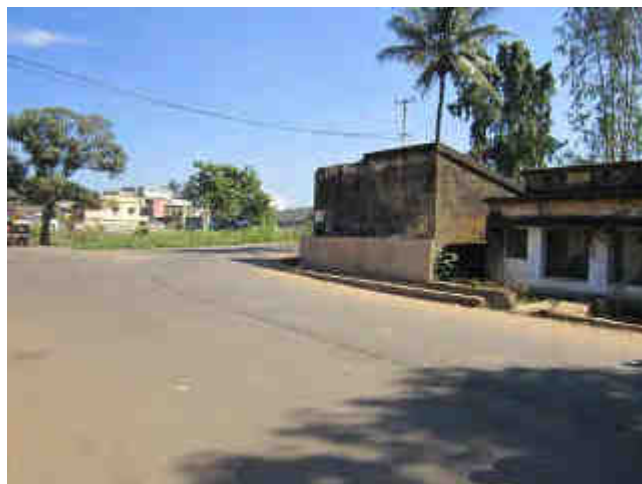
Ch: 3+700

8.4.1.1. Delineation of the road

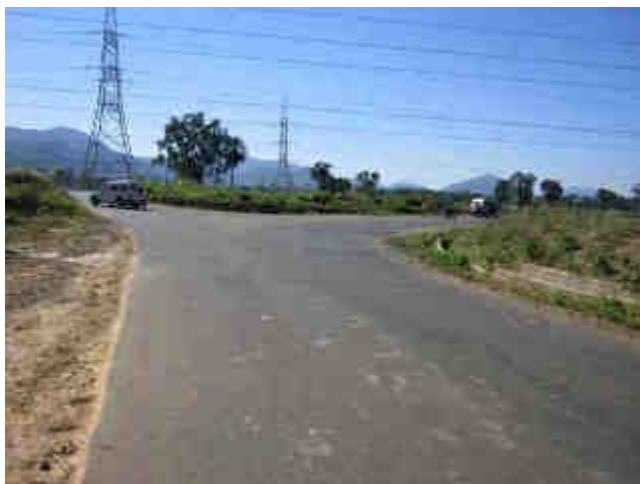
Ch: 2+160

Horizontal curves of radius less than 250m were observed at Km. 2+160; 3+700; 5+700; 6+600; 7+700; 8+400; 8+900; 9+600; 11+000; 11+390; 12+200

Reasons for concern:	No warning signs/ delineation to inform the road user to make him/her slow down to negotiate the curve in a safe speed, which may lead to: <ul style="list-style-type: none"> • Potential run-off accidents • Potential head-on collisions
Recommendations:	Provide curve warning signs, chevron signs, delineators and speed limit sign as appropriate <i>Refer to Appendix III for guidelines on treatment of curves.</i>
Reasons for concern:	Poor visibility on the curve due to trees and overgrown vegetation, which can lead to head-on collisions
Recommendations:	<ul style="list-style-type: none"> • Improve the line of sight by removing trees from the shoulder and cut down vegetation which hampers visibility along the curves
Reasons for concern:	Curves on high embankment without safety barriers noted <ul style="list-style-type: none"> • Run-off accidents on high embankments will lead to fatalities

Recommendations:	Provide metal beam crash barrier with delineators on sharp curves in high embankment <i>Refer to Appendix III for guidelines on situations where to install the above</i>

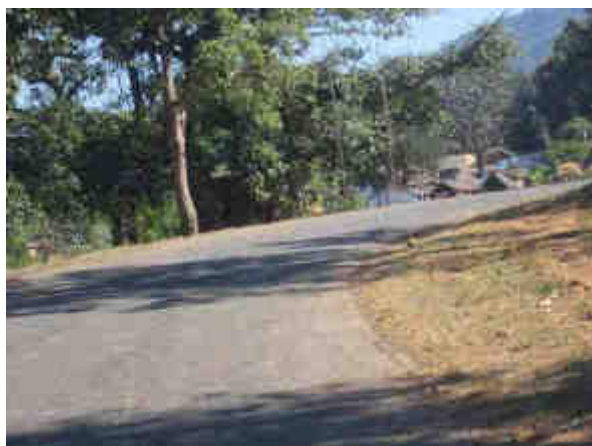
Ch: 10+000

The horizontal bend after a vertical crest were observed at the following chainages:

The sight distance on a vertical crest is limited in day light and even less in night time. The presence of a horizontal bend after a vertical crest decreases the sight distance available further for the driver to react and could be a potential unsafe location. The vertical deflection of the alignment prevents the road user from being prepared to maneuver required to negotiate the curve and could lead to run off accidents.

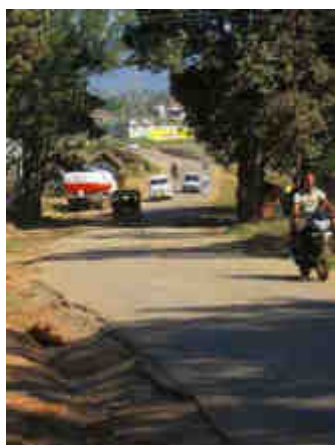
Ch: 4+800

In the existing situation, there are three instances of reverse curves along the road at the following Chainages.

Recommendations The provision of guard posts along the points of maximum curvature of the two curves and provide continuous warning signs and chevron signs to warn road users.

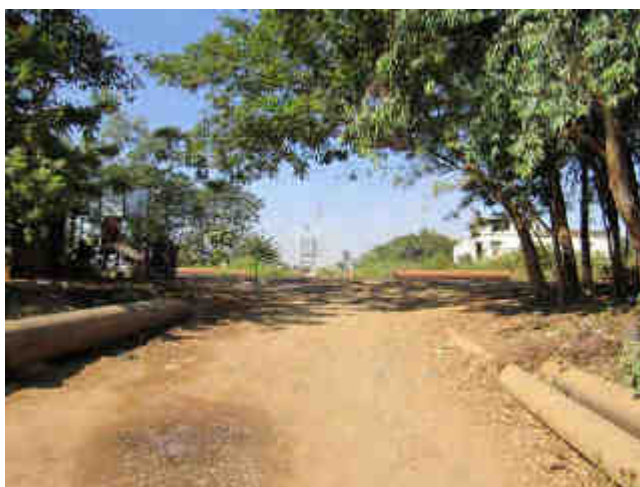
Ch: 1+300

Km 1+300; 1+350; 4+550; 4+800; 5+500; 5+800; 13+950; 14+300; 14+390; 15+200

This is a major hazard observed on most of the 3-armed uncontrolled junctions. The major reasons for poor visibility at junctions on this road are due to

- Recommendations:**
- Improve visibility by clearing vegetation;
 - Remove encroachments at least from the visibility triangle required for such junctions.

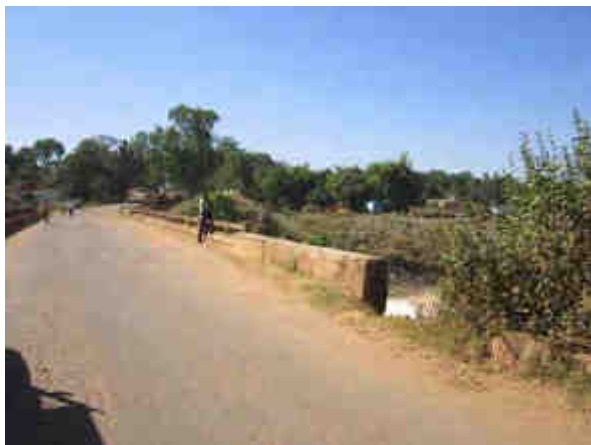
Ch: 4+700

The unprotected bridge approaches of two minor bridges present along the road at the chainages shown below:

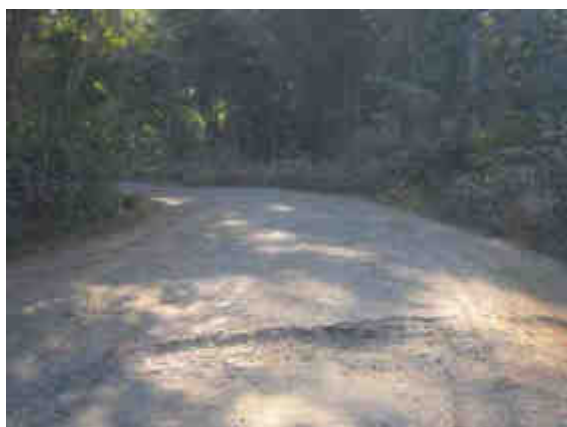
Ch: 41+700

Horizontal curves of radius less than 150m were observed at significant number of location along the road.

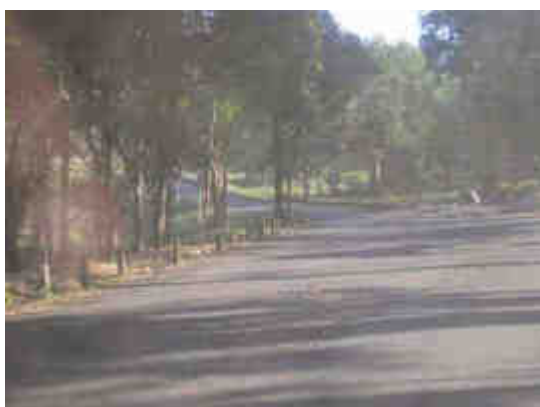
Ch: 40+900

The following are the chainages of the instances of the horizontal bend after a vertical crest:

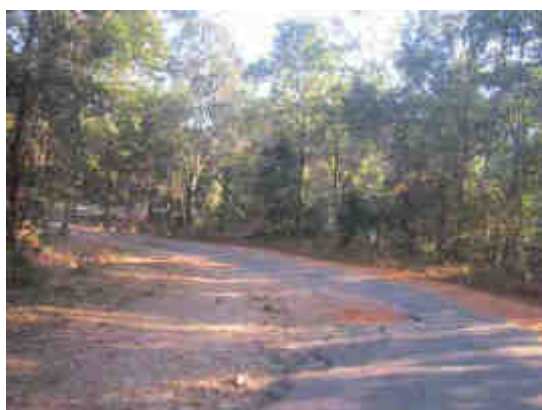
Ch: 37+300

In the existing situation, there are two reverse curves located along the road at the chainages:

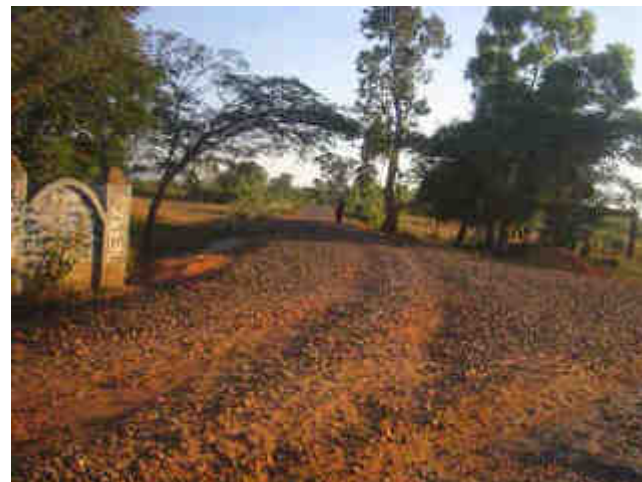
Ch: 26+900

Location of Side roads at skew with the major road

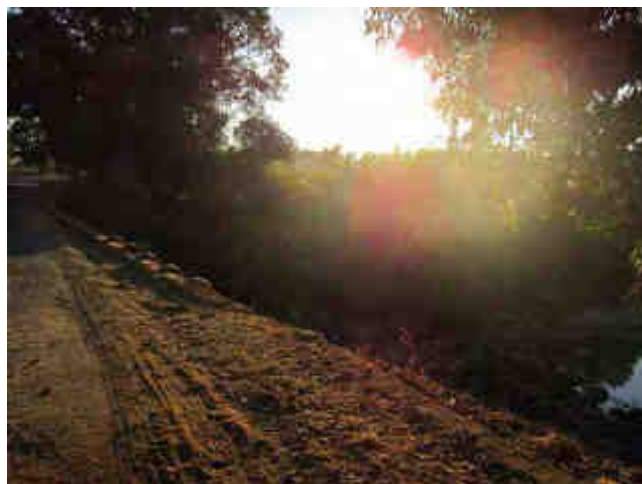
Ch: 26+700

The unprotected bridge approaches of two minor bridges present along the road at the chainages shown below:

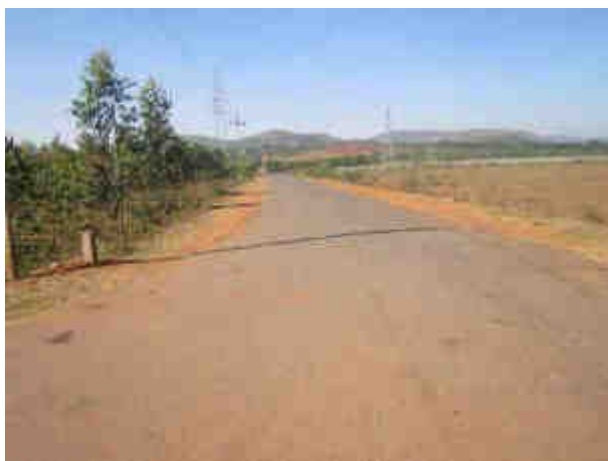
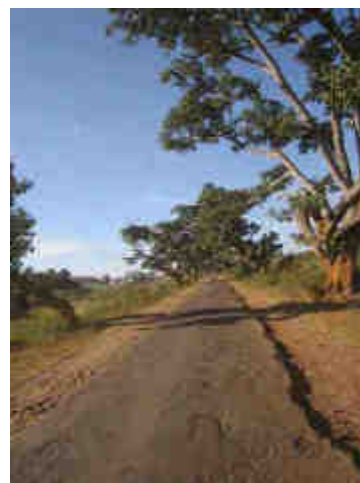
8.5.2.1. Delineation of the road

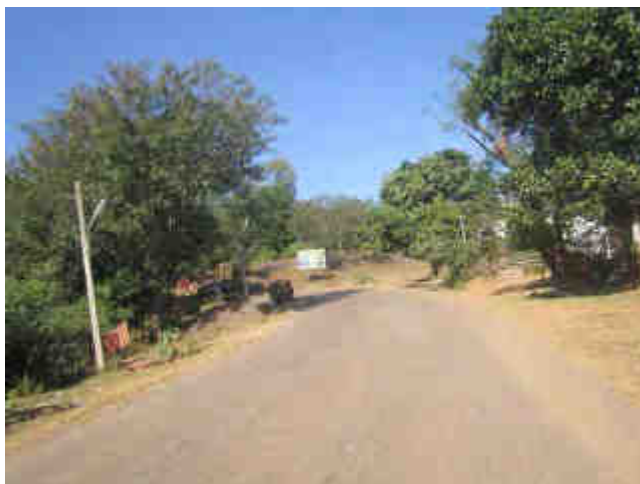
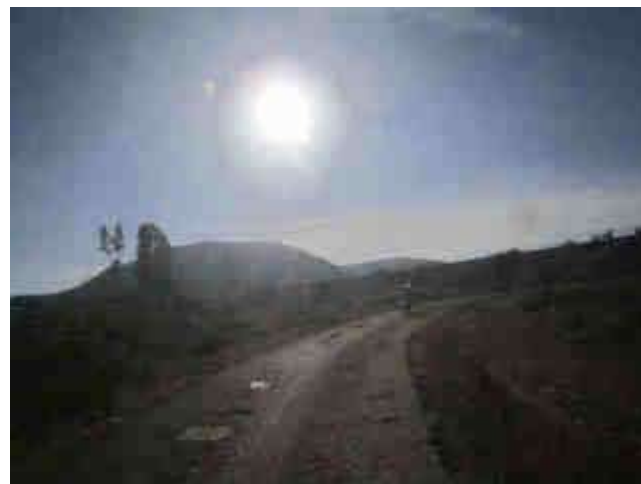
Horizontal curves of radius less than 100m were observed at Km. 0+650; 1+500; 1+850; 2+800; 3+400; 3+600; 4+100; 4+300; 5+580; 6+600; 7+140; 7+880; 8+100; 8+260; 9+020; 9+500; 10+250; 11+920; 12+200; 16+250; 16+800; 20+600; 21+700; 22+900; 23+300; 23+500; 23+950; 24+600; 24+900; 25+100; 25+500; 25+800; 27+500; 28+300; 28+650; 28+750; 30+100; 30+850+ 31+250; 31+450; 32+300; 36+850; 37+150; 38+800; 42+400; 44+300; 44+550; 44+900;

Reasons for concern: Curves on high embankment without safety barriers noted

Recommendations: Provide **curve warning signs, chevron signs and delineators** as appropriate
Refer to Appendix III for guidelines on treatment at curves.

Recommendations: Provide metal beam crash barrier with delineators on sharp curves in high embankment

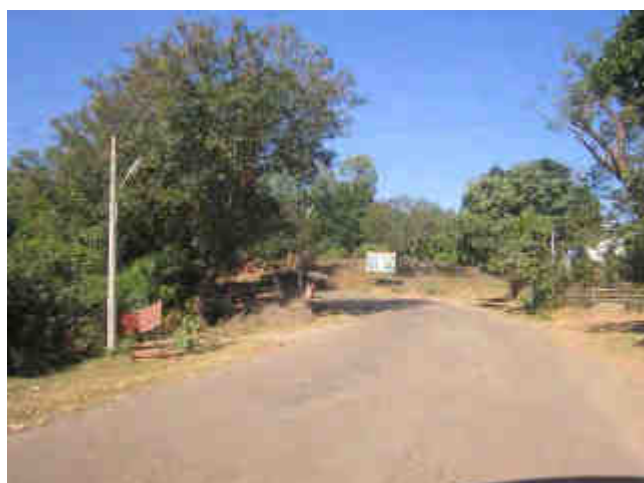
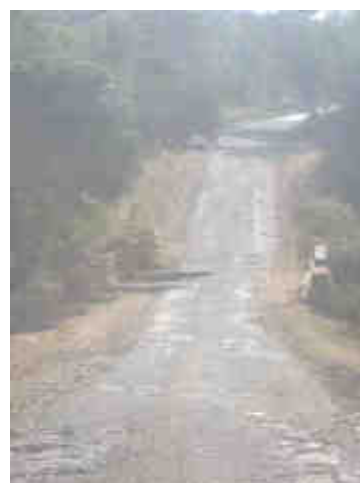
The following are the chainages of the instances of the horizontal bend after a vertical crest:

The sight distance on a vertical crest is limited in day light and even less in night time. The presence of a horizontal bend after a vertical crest decreases the sight distance available further for the driver to react and could be a potential unsafe location. The vertical deflection of the alignment prevents the road user from being prepared to maneuver required to negotiate the curve and could lead to run off accidents.
