**Government of Odisha (GOO)
Chief Engineer, World Bank Projects, Odisha
Odisha State Roads Project**

**Consultancy Services for
Road Sector Institutional Development
Loan # 7577-IN**

**ROAD INFRASTRUCTURE
SAFETY MANAGEMENT REVIEW**

VOLUME I - REPORT

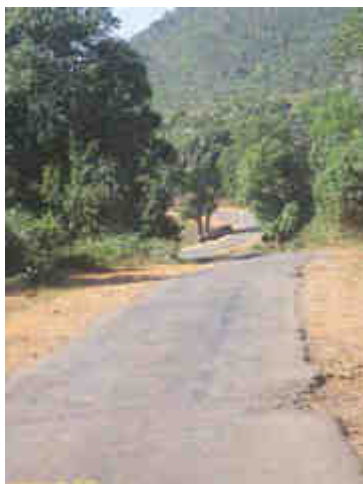
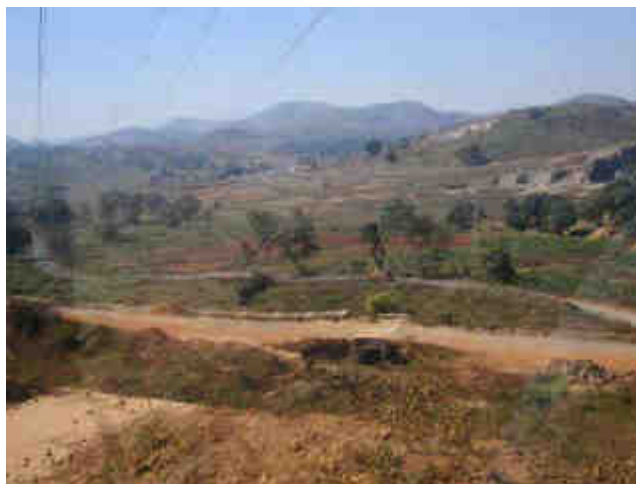
Reverse curve is found at following locations:

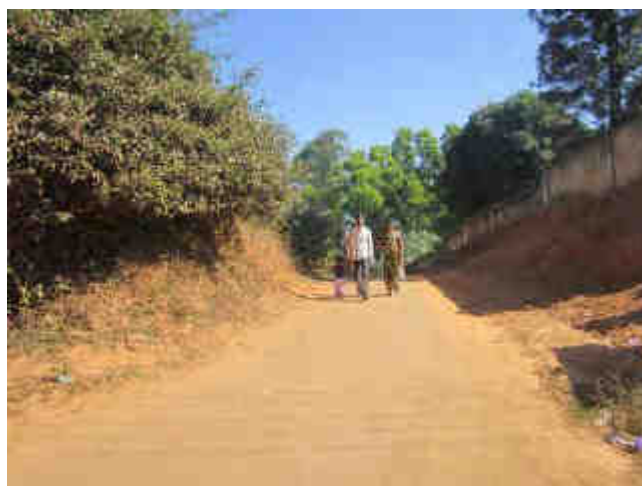
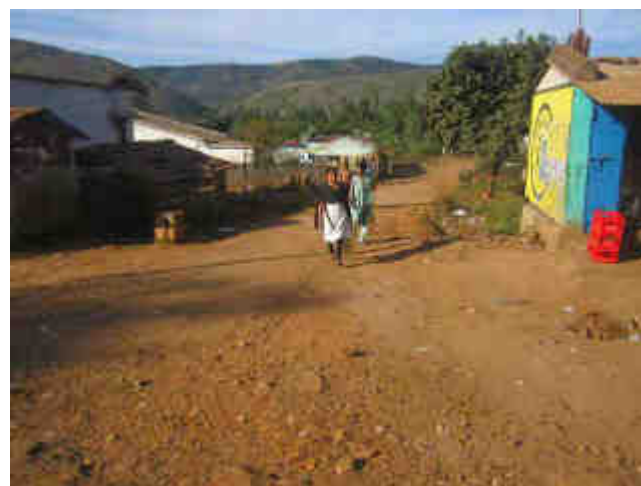
Location of Side roads at skew with the major road

This is a major hazard observed on most of the 3-armed uncontrolled junctions. The major reasons for poor visibility at junctions on this road are due to

- No traffic signs or road markings are observed on any of such junctions, the presence of which would have informed and warned the road user of the layout ahead.

It has been observed that on few junctions, the level difference between the side road and major road and the vertical profile of the side road joins the edge of main carriageway in an unsafe manner.

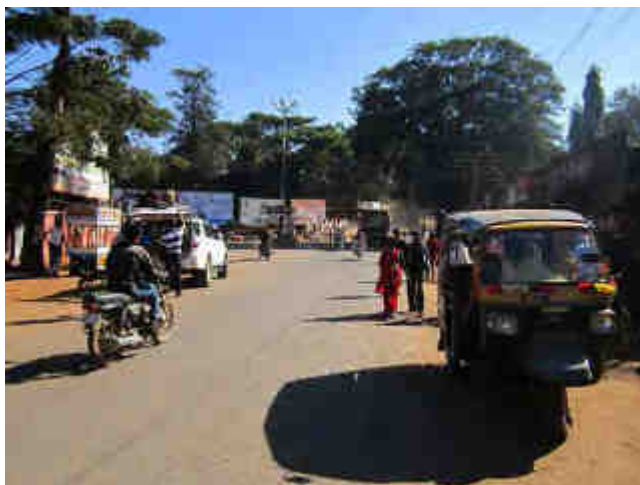
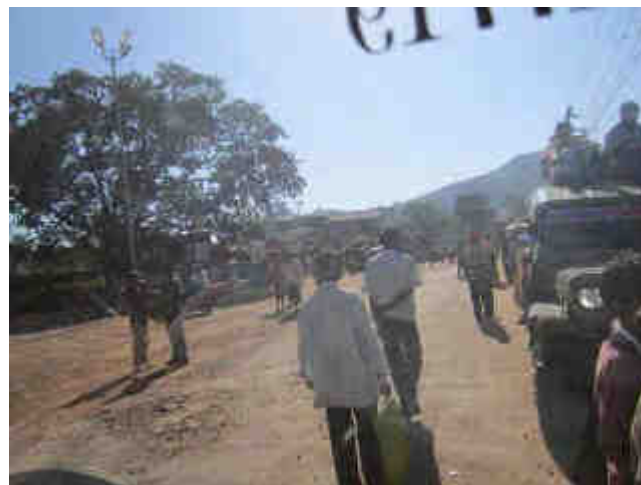
In the existing situation, there are two major junctions along this road at the following Chainages,

- The junction layout is non-standard and has no control over the traffic movement. It is confusing who has priority in such a situation. This encourages lawless traffic movement and is hazardous. The existing central island is non-standard and hampers visibility at the junction.

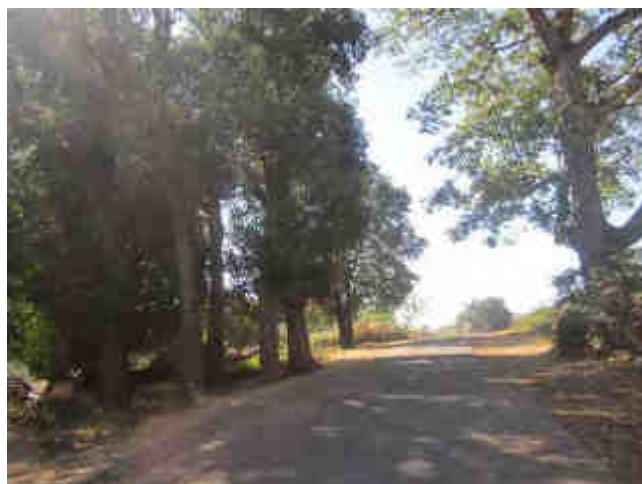
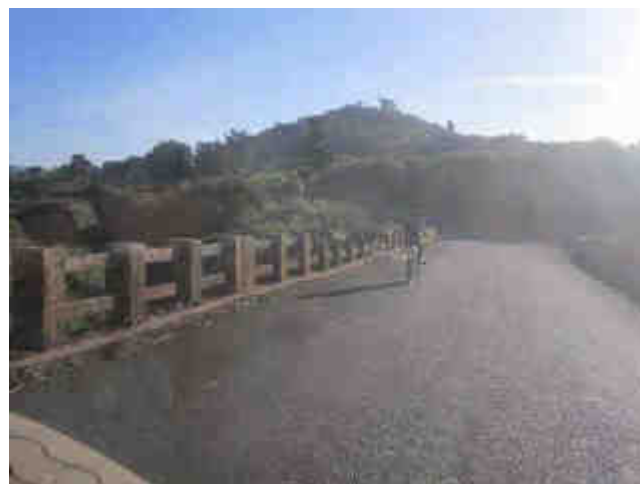
Along the road there are many road size hazards like trees and street light poles were present.

Reasons for concern:	Roadside objects constitute a significant hazard, if the driver loses control and will result in major injuries/ fatalities
-----------------------------	---

- Remove Trees/ street lighting poles from the road shoulders
- Provide crash barriers on locations where trees acts as a significant hazard and where the space is available to install crash barrier

- Delineate the hazards by installing OHMs or painting of the trees in black and white strips
- Remove encroachments on at least 2m from the road edge

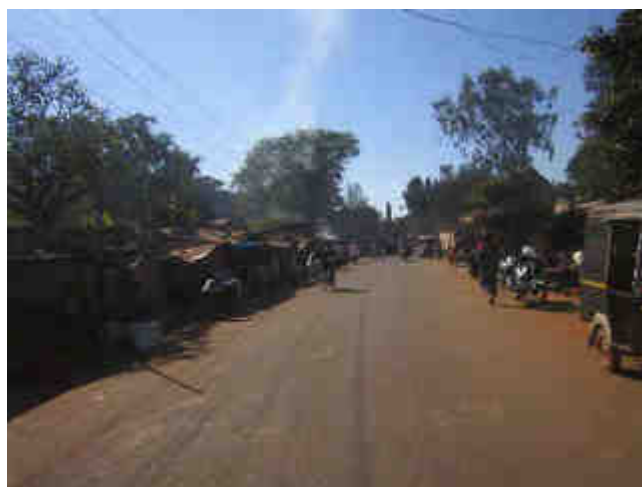
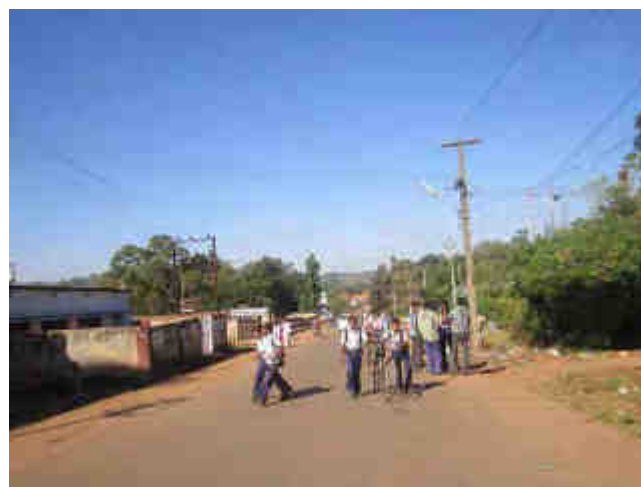
- No traffic calming measures are provided to slow down vehicles approaching at high speeds to the built up area
- Significant pedestrians including school children are noted, but no separate pedestrian facilities are provided along the road inside the BUA or to cross the road
- No road markings or warning signs to warn/ inform the road user of the built up nature of the area ahead
- No speed limit signs provided

- Provide Gateway signs at before start and after the end of BUA. Provide a Gateway effect on approaches to road side villages.
- Provide well maintained wide shoulders (min. 2m wide), free of encroachments and overgrown vegetation in roadside villages in rural areas
- Provide 'School Ahead' and 'SLOW' signs on appropriate locations near schools
- Provide appropriate warning signs various hazards encountered inside the roadside village
- Provide adequate traffic calming measures

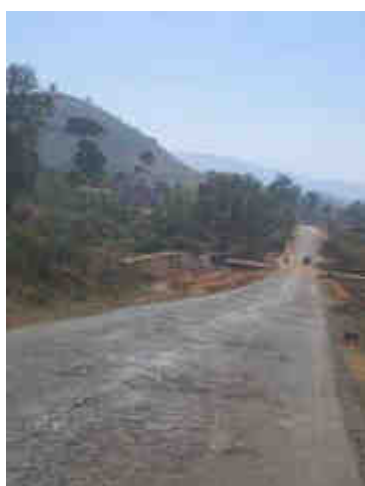
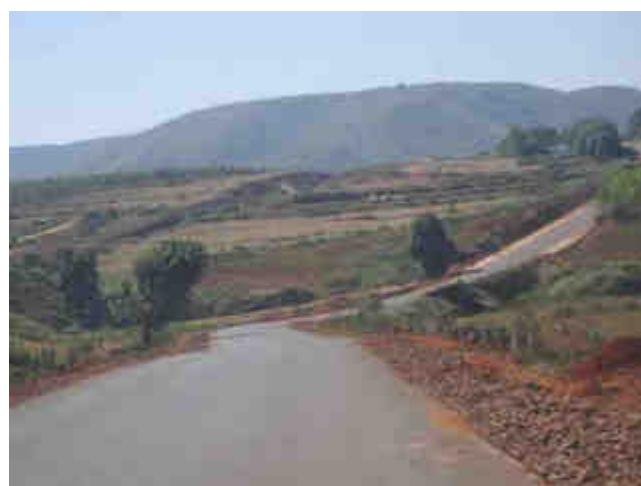
Reasons for Concern:	Simultaneous change in horizontal and vertical alignment The abrupt change of horizontal and vertical alignment may be difficult to negotiate for an errant vehicle and lead to unsafe condition.
Recommendations	The provision of retro – reflective guard posts along the entire sag curve with provisions of advanced warning signs and pavement markings to delineate the center and edge line of the road.

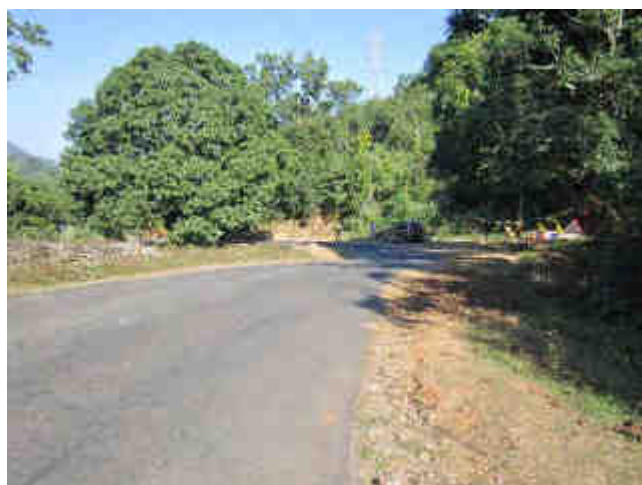
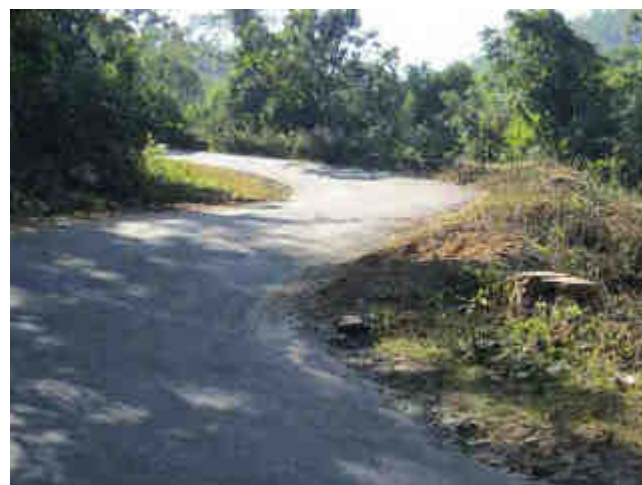
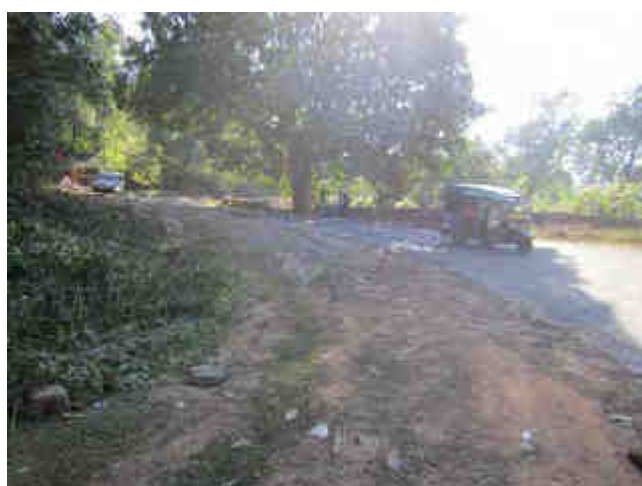
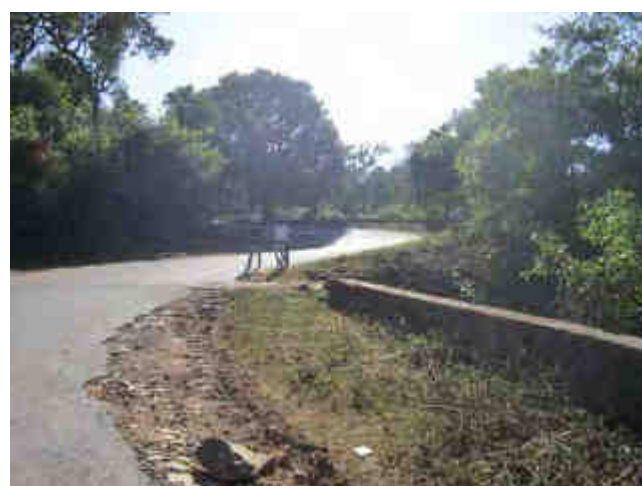
Ch: 64+300 – 64+500

It was pointed out by OWD that the stretch of 1 km road from Ch: 64+000 – Ch: 65+0000 is the location of many accidents. After the reconnaissance, it was found that there are thirteen (13) curves in this stretch of

1 km with varying gradient and sharp curves. It was also found that there is end protection on the valley side of the road and some accident impact traces were found on the hill side of the road.

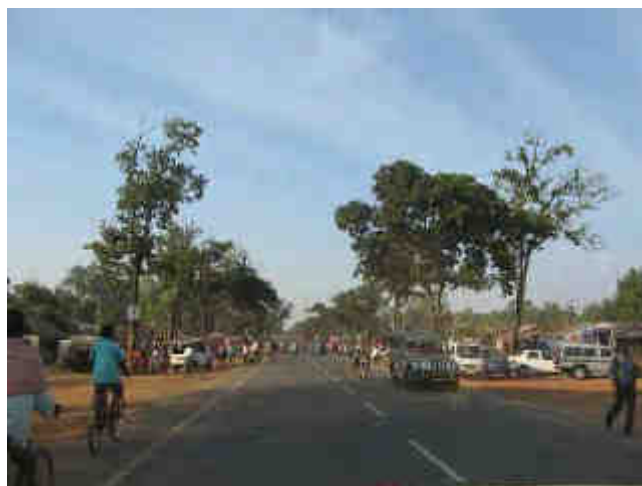
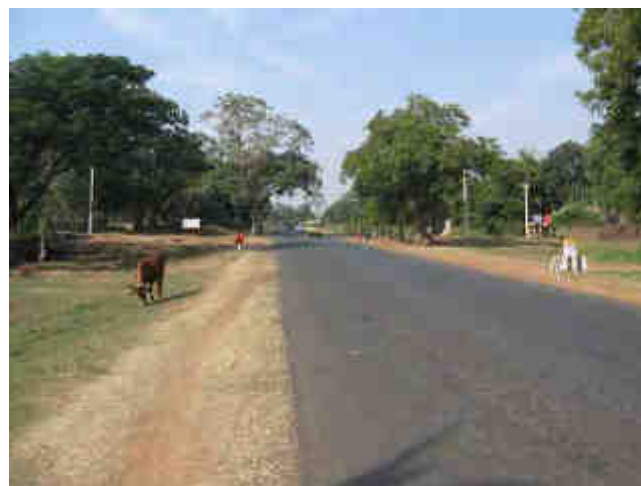
Reasons for concern: Centerline / edge line road markings are absent in some of the sections of the project road, the presence of which should have delineated the road, particularly during night conditions

- Recommendations:**
- Provide edge line and centre line with thermoplastic material on whole length of the road (refer to IRC: 35-1997 for details)
 - Provide edge and centre line RRPMs on sharp curves

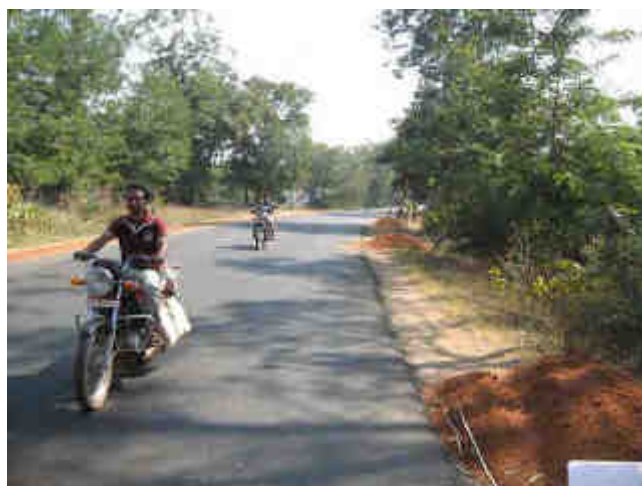
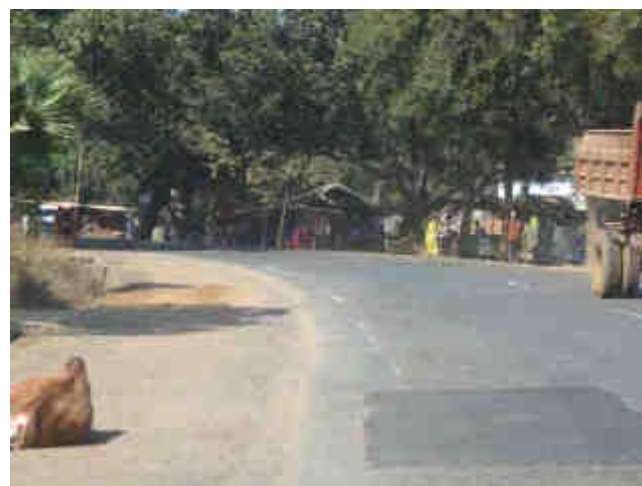
Horizontal curves of radius less than 200 m were observed at Chainages: 0+950; 1+750; 2+300; 3+750; 6+210; 7+570; 9+500; 10+150; 11+100; 22+700; 51+550; 71+700; 73+500

Reasons for concern: Curves on high embankment without safety barriers noted

Recommendations: Provide **curve warning signs, chevron signs, delineators and speed limit sign** as appropriate

Recommendations: Provide metal beam crash barrier with delineators on sharp curves in high embankment

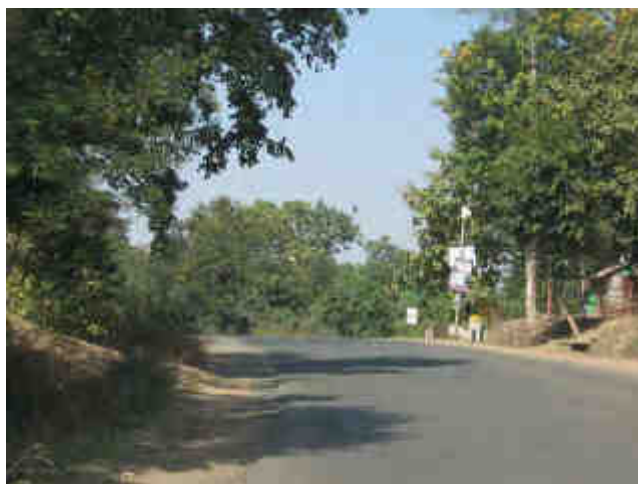
Ch: 29+000

In the existing situation, there is one instance of horizontal bends occurring after a vertical crest at Chainage, Ch: 29+000.

The sight distance on a vertical crest is limited in day light and even less in night time. The presence of a horizontal bend after a vertical crest decreases the sight distance available further for the driver to react and could be a potential unsafe location.

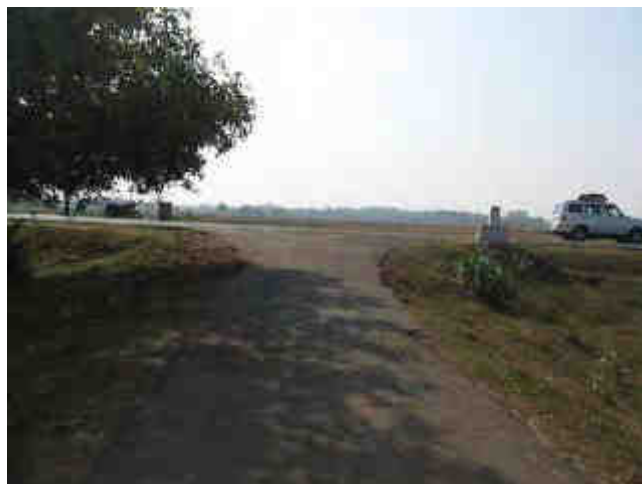
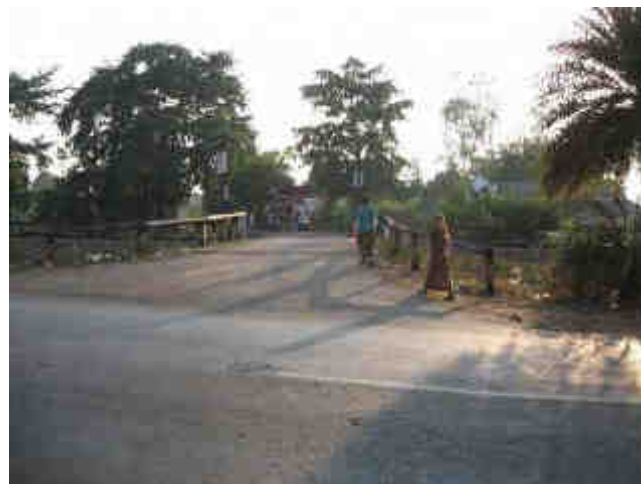
Km. 4+300; 10+200; 10+300; 13+550; 13+600; 27+334; 29+000; 31+100; 31+200; 31+700; 40+800; 41+200; 42+400; 43+300; 44+800; 45+600; 45+800; 47+700; 50+200; 52+500; 53+700; 55+900; 56+669; 57+980; 57+363; 57+541; 57+729; 57+934; 58+003; 59+640; 61+359; 61+592; 62+068; 63+229; 65+439; 68+063; 69+210; 69+450; 70+218; 70+680; 70+715; 71+752; 71+935; 73+003; 74+419; 76+129; 76+363;

This is a major hazard observed on most of the 3-armed uncontrolled junctions. The major reasons for poor visibility at junctions on this road are due to

- No traffic signs or road markings are observed on any of such junctions, the presence of which would have informed and warned the road user of the layout ahead.
- Poor delineation may result in sudden braking behavior by road users who are required to stop, or wish to make turns. In the worst case, it can also result in rear-end collisions at high speeds.

- High approach speeds were observed by traffic turning from side roads into the main carriageway and no traffic calming measures/ warning is provided on the side road.
- Coupled with inadequate visibility, in the worst case, this may result in **right angle collision** with vehicles coming from the major road leading to serious

It has been observed that on few junctions, the level difference between the side road and major road and the vertical profile of the side road joins the edge of main carriageway in an unsafe manner.

- Recommendations:**
- Provide road humps on the side road at junctions having history of accidents
 - Provide raised markings on the entry to the side road
 - Provide adequate warning signs on major road and side road

- Recommendations:** Correct the vertical alignment of side road so that vehicles approaching from side roads has adequate length on the side road to slow down/ stop before entering into the main carriageway.

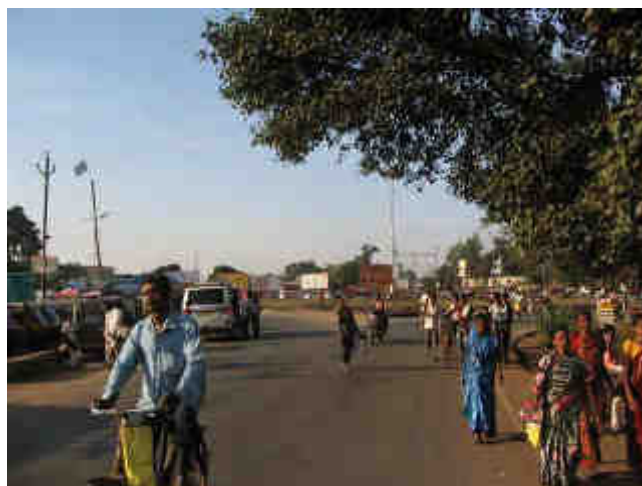
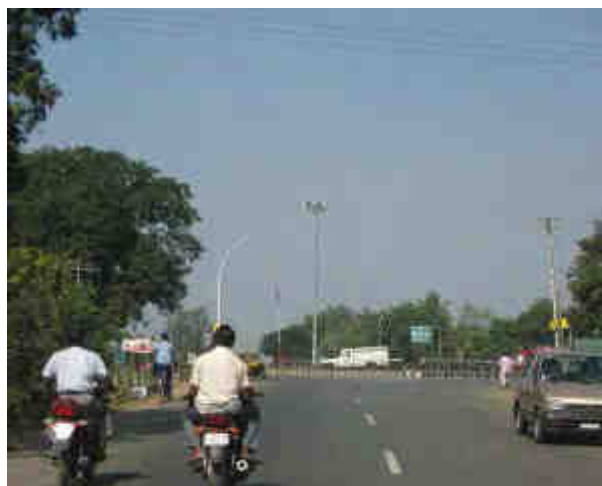
- 0+000
- 30+050
- 31+965
- 34+210

- The junction layout is non-standard and has no control over the traffic movement. It is confusing who has priority in such a situation. This encourages lawless traffic movement and is hazardous. The existing central island is non-standard and hampers visibility at the junction.

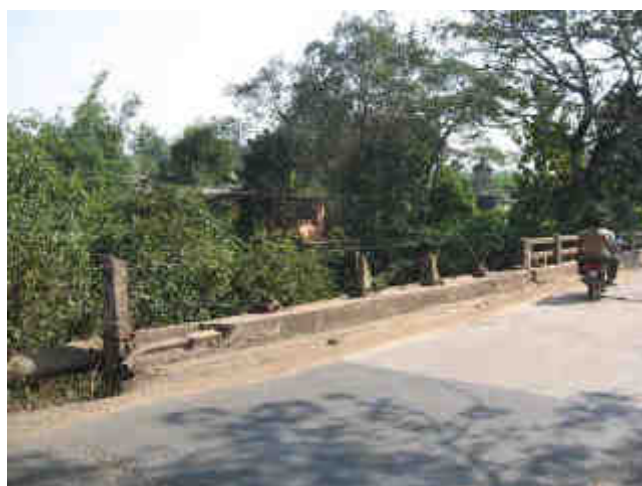
Ch: 29+500

- The bridge parapets adjacent to high speed traffic movement are hazardous especially at night if not delineated as the driver cannot judge the position of such road side hazards.

- Provide edge line markings and Object Hazard Marker (OHM) on both sides and for both approaches (i.e. Four numbers of OHM for each

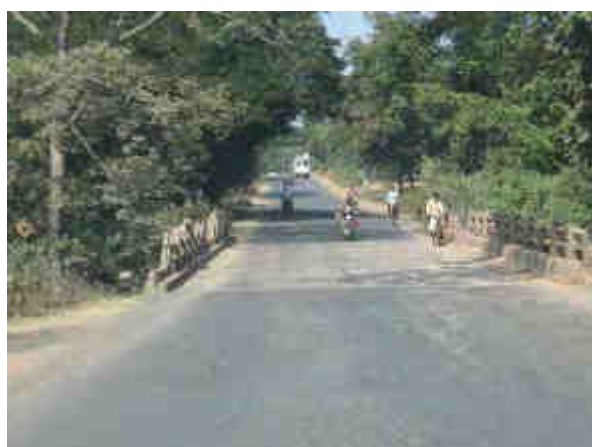
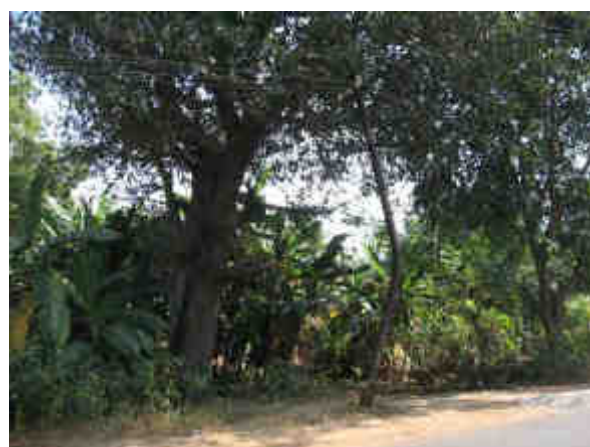
Roadside objects constitute a significant hazard, if the driver loses control and will result in major injuries/ fatalities

- Remove Trees/ street lighting poles from the road shoulders
- Remove encroachments from the right of way
- Provide crash barriers on locations where trees acts as a significant hazard and where the space is available to install crash barrier

- Delineate the hazards by installing OHMs or painting of the trees in black and white strips
- Remove encroachments on at least 2m from the road edge

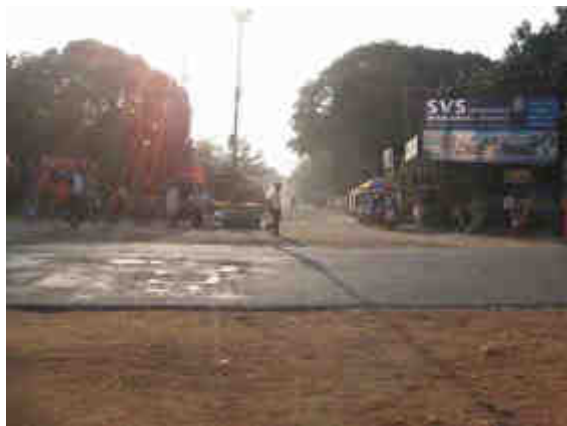
Ch: 69+500

- No traffic calming measures are provided to slow down vehicles approaching at high speeds to the built up area
- Significant pedestrians including school children are noted, but no separate pedestrian facilities are provided along the road inside the BUA or to cross the road
- Significant number of access roads within the BUA, the visibility of which has been hampered due to shops/ establishments on all corners of the junction
- On road bus stops which hampers visibility and encourage dangerous overtaking
- No road markings or warning signs to warn/ inform the road user of the built up nature of the area ahead
- No speed limit signs provided
- On street parking hampers the visibility and resulting in unsafe situations

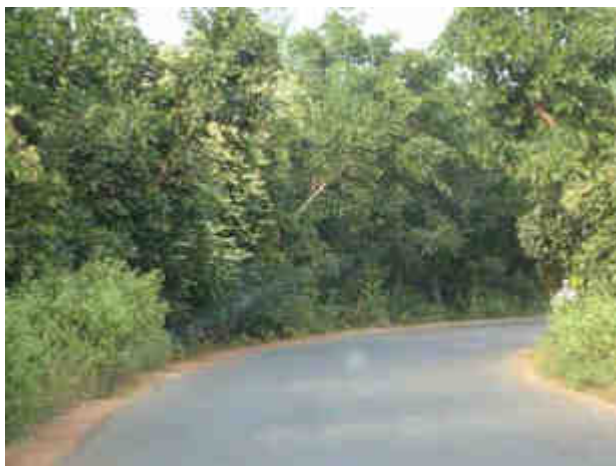
Ch: 49+700

Horizontal curves of radius less than 200 m were observed at Km. 48+800; 49+700; 64+400; 67+300; 70+200; 70+700; 73+600; 91+000

Recommendations: Provide **curve warning signs, chevron signs, delineators and speed limit sign** as appropriate
Refer to Appendix III for guidelines on treatment of curves.

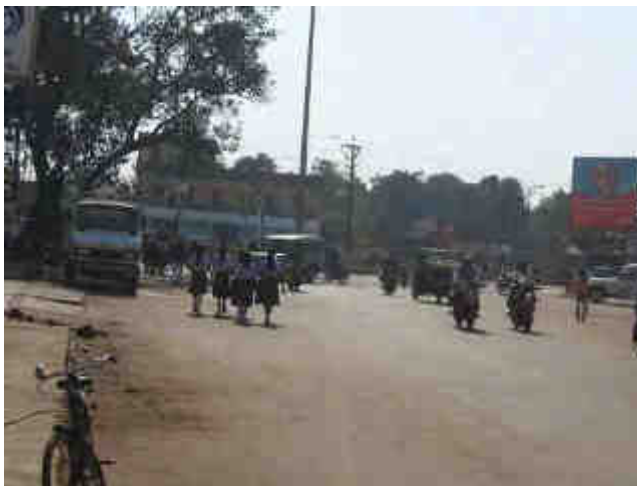
Ch: 87+300

Reasons for concern:	Poor Junction layout <ul style="list-style-type: none">• The junction layout is non-standard and has no control over the traffic movement. It is confusing who has priority in such a situation. This encourages lawless traffic movement and is hazardous. The existing central island is non-standard and hampers visibility at the junction.
Recommendations:	<ul style="list-style-type: none">• Re-design the junction after traffic studies and considering the requirements of all road users. <p><i>Refer to the Appendix III for guideline to standard layout of 3-arm junctions.</i></p>
Reasons for concern:	Direction Signs <ul style="list-style-type: none">• No direction signs to guide the traffic through the junction layout which may lead to hazardous driving and may lead to rear-end collision.
Recommendations:	<ul style="list-style-type: none">• Provide direction signs on approaches to the junction to guide the traffic through the junction layout. <p><i>Refer to Appendix III for guidelines on road markings & traffic signs at 3-arm junctions.</i></p>

Reasons for concern:	Poor delineation <ul style="list-style-type: none">• Traffic signs and road markings are absent in any of the arms of the junctions, the presence of which would have informed and warned the road user of the layout ahead.
Recommendations:	<ul style="list-style-type: none">• Provide edge line markings, centerline markings and other junction road markings pertaining to junction control. <p><i>Refer to Appendix III for guidelines on road markings & traffic signs at 3-arm junction</i></p>
Reasons for concern:	Provision for VRUs <ul style="list-style-type: none">• Shoulder space in the junction area is encroached by overgrown vegetation or the commercial establishments.• No provision for crossing by pedestrians/bicycles despite of significant presence of pedestrians and bicyclists.
Recommendations:	<ul style="list-style-type: none">• Remove encroachments from the shoulders.• Provide well maintained 2m wide shoulders at junction zone free of encroachments. <p><i>Refer to Appendix III for guidelines for safe treatments in roadside villages</i></p>

Reasons for concern:	On-street Parking <ul style="list-style-type: none">• No parking spaces provided for commercial vehicles and vehicles are parked encroaching the road and shoulder space, hampering visibility.• This forces pedestrians to move into the centre of the road resulting in hazardous situation.
Recommendations:	<ul style="list-style-type: none">• Provide designated parking spaces for commercial vehicles

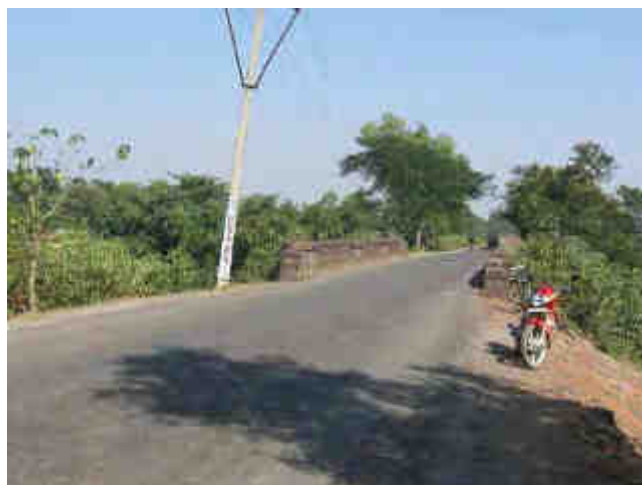
Ch: 86+500

Reasons for concern:	Unprotected high embankment If a vehicle lose control while approaching the bridge, run-off accidents may occur which may lead to multiple fatalities/ major injuries
Recommendations:	Provide crash barriers on either approaches of the structures with delineators <i>Refer to Appendix III for guidelines to treatments on approaches to bridges</i>

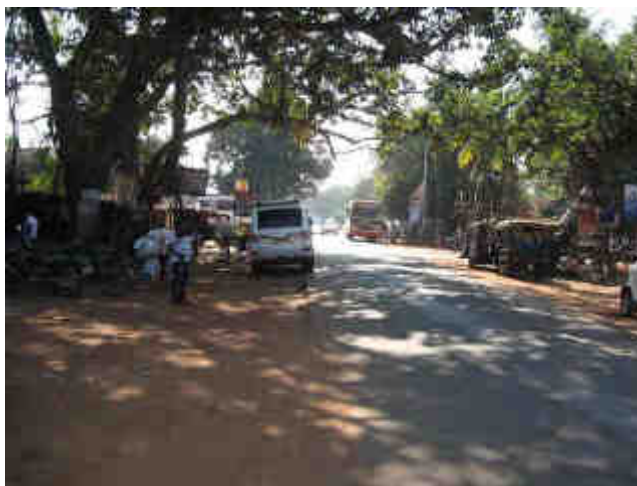
Ch: 68+500

- No traffic calming measures are provided to slow down vehicles approaching at high speeds to the built up area
- Significant pedestrians including school children are noted, but no separate pedestrian facilities are provided along the road inside the BUA or to cross the road
- On road bus stops which hampers visibility and encourage dangerous overtaking
- No road markings or warning signs to warn/ inform the road user of the built up nature of the area ahead
- No speed limit signs provided
- On street parking hampers the visibility and resulting in unsafe situations
- On street bus stops observed, which hampers visibility and unsafe

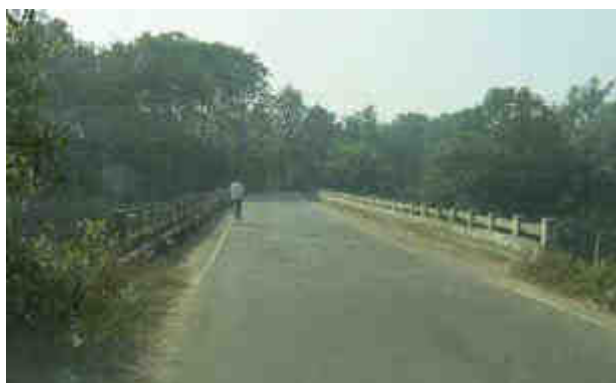
Km 13+300

Bridge/ Culverts

Reasons for concern: The bridge/ culvert parapets on the edge of the road adjacent to high speed traffic movement will be hazardous, particularly at dark conditions, and needs to be illuminated for a driver to judge the position of such road side hazard.

Recommendations: Install Object Hazard Marker (OHM) on both sides and for both approaches (i.e. Four numbers of each OHM for each structure.

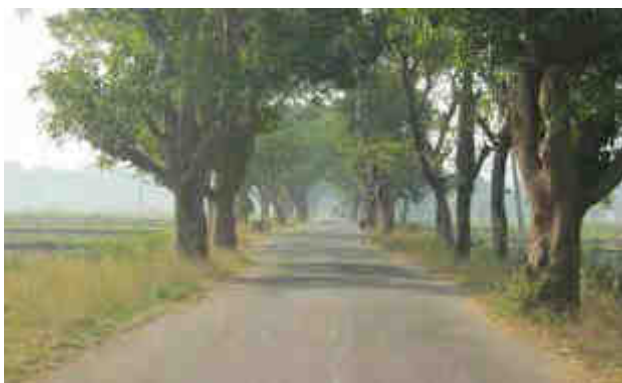
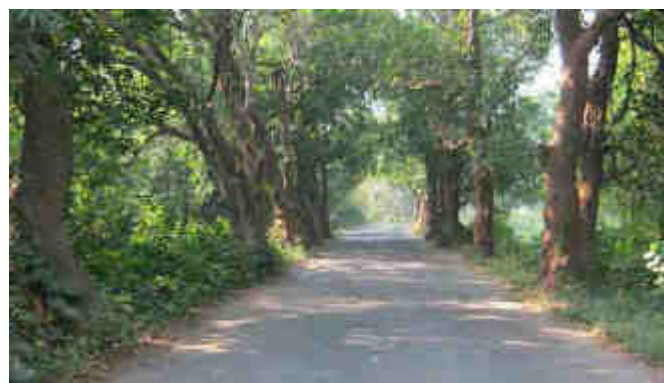
Road side objects present along this stretch of road are mainly trees. Lots of trees are on the edges of the carriageway from Km 2+000 to Km 40+000, which has no any protection. Some of them protected by providing studs near the trees but it is not sufficient.

The road side objects like trees, street light or other poles, buildings, and unprotected deep drains which are near the edge of road needs to be. At night time it becomes very difficult for drivers to judge the position of such road side hazard. If the road side objects are not protected and/or illuminated there are chances of driver losing control and hitting these objects which may result into fatal accident.

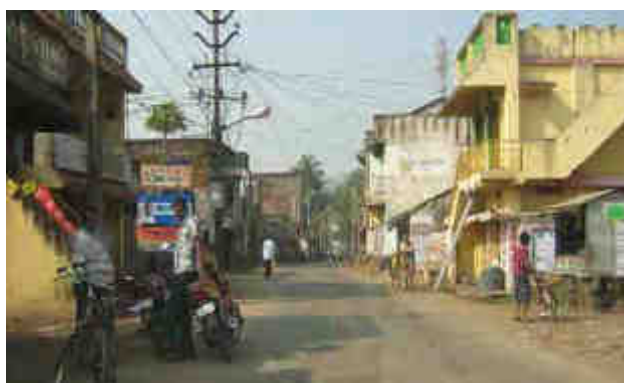
Km 11+200 (Sarankul village)

Built up area/ Road side villages

Recommendations: Provide gateway signs with speed restriction on start and end of BUA, additionally provide rumble strips, speed humps, or speed tables as traffic calming measures. Provide pedestrian crossings (either marked or speed tables), footpaths, and streetlights.

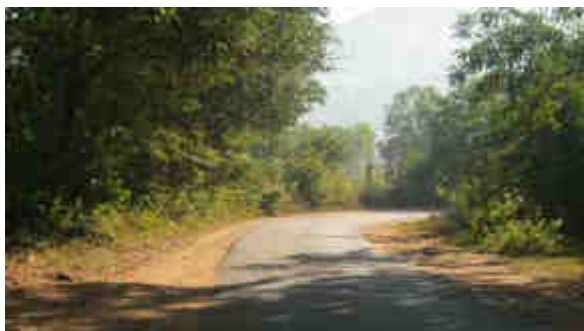
Km 127+200

Sharp Curves on Project Road

Reasons for concern:	No warning signs/ delineation to inform the road user to make him/her slow down to negotiate the curve in a safe speed. This may lead to <ul style="list-style-type: none"> • Potential run-off accidents • Potential head-on collisions
Recommendations:	Provide curve warning signs, chevron signs, delineators and speed limit sign as appropriate <i>Refer to Appendix III for guidelines on situations where to install the above</i>
Reasons for concern:	Poor visibility on the curve due to trees and overgrown vegetation, which can lead to head-on collisions
Recommendations:	<ul style="list-style-type: none"> • Improve the line of sight by removing trees from the shoulder and cut down vegetation which hampers visibility along the curves
Reasons for concern:	Curves on high embankment without safety barriers noted <ul style="list-style-type: none"> • Run-off accidents on high embankments will lead to fatalities

Recommendations:	Provide metal beam crash barrier with delineators on sharp curves in high embankment <i>Refer to Appendix III for guidelines on situations where to install the above</i>
Reasons for concern:	On two lane roads, the constricted width will cause the rear of trucks/ big vehicles

Recommendations: Provide extra widening on sharp curves, with ‘no overtaking’ markings (refer to IRC 35 for details)

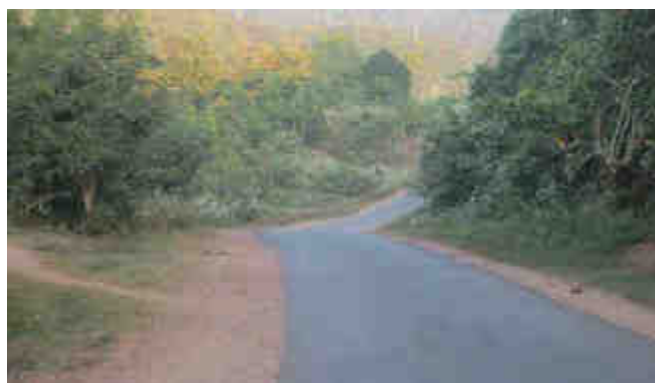
The ‘horizontal bend after a vertical crest’ situations were observed at chainages Km 98+150, Km 126+700 and Km 129+000. This situation is particularly hazardous, particularly, if this geometry follows after a long straight section. The drivers tend to expect a straight section after the vertical crest and may not be able to negotiate the horizontal bend after the vertical crest, if appropriate safety measures are not provided. The reverse curves were observed on the chainages Km 85+500, Km 128+280, Km 141+500, Km 143+200 and Km 154+400.

Horizontal bend after a vertical crest

Recommendations: Provide **curve warning signs, chevron signs, SLOW Signs** as appropriate
Refer to Appendix III for guidelines on situations where to install the above

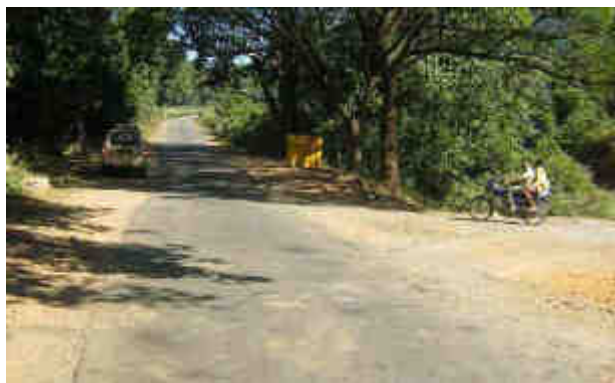
Km 86+900

Side roads Perpendicular and skewed to Main Road

This is a major hazard observed on most of the 3-armed uncontrolled junctions. The major reasons for poor visibility at junctions on this road are due to 1) Encroachments at Junctions 2) Overgrown vegetation or presence of trees and 3) poor layout of the side roads.

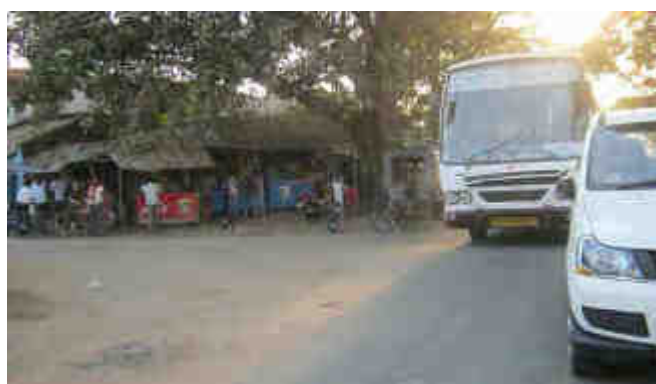
Km 122+100

Major 3-arm Junctions

Reasons for concern:	Poor Junction layout The junction layout is non-standard and no traffic control has been established through road markings/ signs and traffic signals
Recommendations:	<ul style="list-style-type: none">• Re-design the junction layout after detail traffic studies• Provide splitter islands to enable safe movement of motorized and non-motorized traffic <p><i>Refer to Appendix III for standard layouts of 3-arm junctions.</i></p>
Reasons for concern:	Poor delineation No road markings and traffic signs are provided to establish safe movement of traffic. No direction signs are provided. Direction signs are important on the approaches to major junctions to inform the road user of the routes ahead.
Recommendations:	<ul style="list-style-type: none">• Provide advance direction and direction signs to inform the road user;• Provide Give Way/ STOP signs on the minor road at appropriate locations before it merges into the major road;• Provide edge lines; and• Provide Splitter islands using road markings to establish improved traffic control. <p><i>Refer to Appendix III for guidelines for traffic signs and road markings on 3-arm junctions.</i></p>

Reasons for concern:	High approach speed Traffic coming from the Rayagada side and traffic merging on to the major road It has been observed that vehicles, in particular motorcycles, approach the junction at high speed. At the worst case, this may lead to crashes resulting in serious injury or fatality.
Recommendations:	<ul style="list-style-type: none">• Provide traffic calming measures on the minor road• Provide warning signs on the minor road• Provide information signs and road markings at the junction to warn the road user of the layout <p><i>Refer to Appendix III for guidelines for design of road humps.</i></p>
Reasons for concern:	On street Bus stop Buses stops at the mouth of the junction in the minor road hampering visibility
Recommendations:	Provide designated bus stop at a safer location so that required visibility is available for road users approaching from all arms of the junction. <i>Refer to Appendix III for guidelines for design of bus bays and on-street bus stops.</i>

Reasons for concern:	Provision of VRUs Pedestrians and cyclists observed at the junction, but no separate provisions have been made. Pedestrians are particularly vulnerable at such junctions having high approach speed.
Recommendations:	Provide footpaths to segregate pedestrians from high speed traffic at the junction

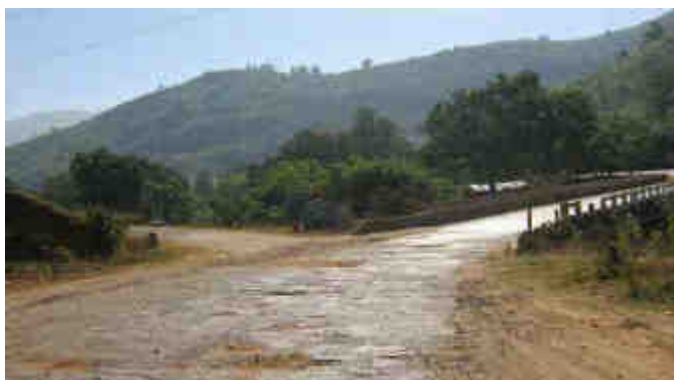
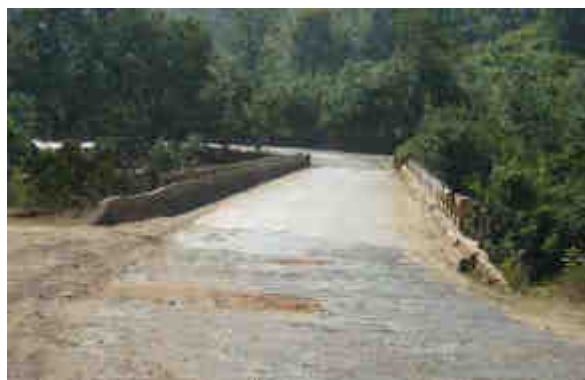
At chainage Km 80+200, sharp curve approaching a bridge on high embankment.

Bridge/Culverts

In the absence of adequate warning signs and reflective markings, the road layout and the hazard will not be clear for the road user, particularly during night conditions and in worst conditions, this will lead to serious injury/ fatal accidents

Recommendations: Provide crash barriers on either approaches of the structures with delineators.

- Provide curve warning sign in addition to crash barrier with delineators
- Provide edge lane markings
- Provide hazard markers on either edge of the parapets

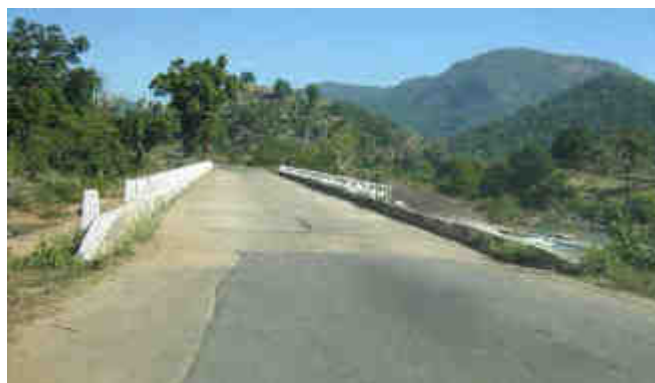
Km 85+500

Road side hazards-Parapet of narrow culverts/bridges

Refer to Appendix III for guidelines for installation of object hazard markers.

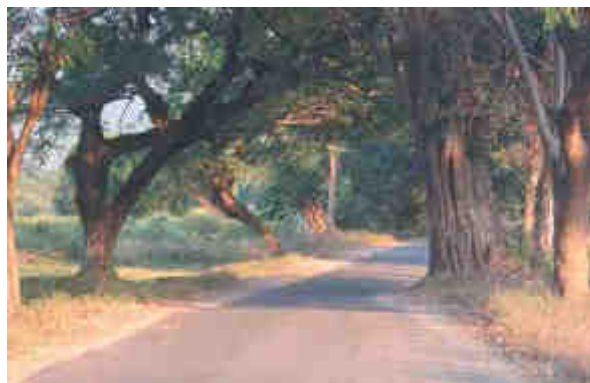
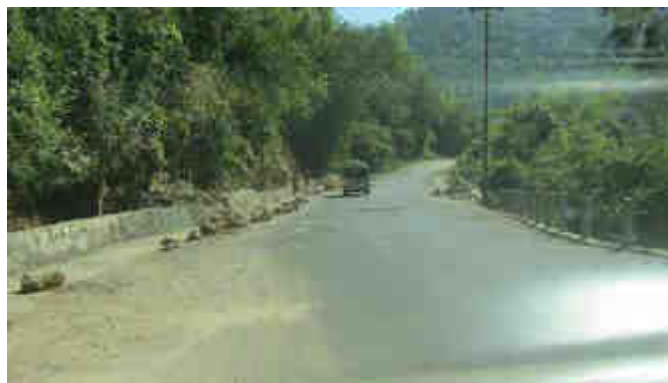
It has been noted that huge trees near to road edge pose a significant hazard in this road section, which is one of the major hazard identified in this road section.

Road side hazards-Trees and high embankment

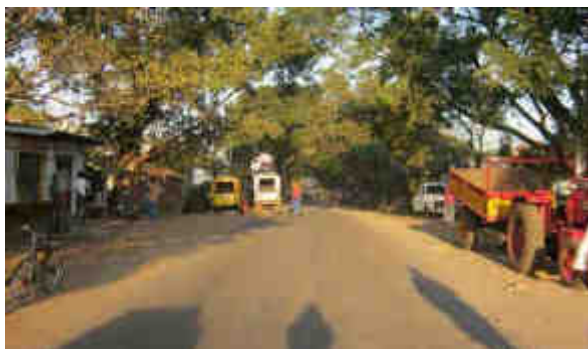
Km 122+000 (Kolsara village)

Built up area/Road side villages

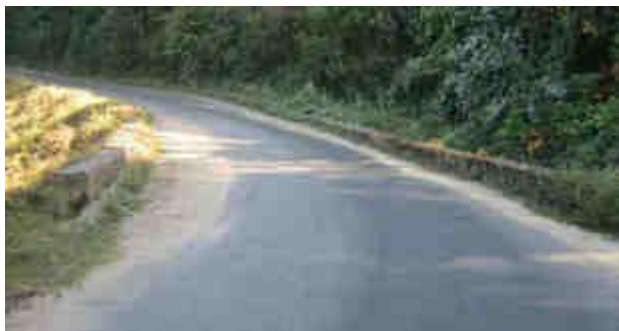
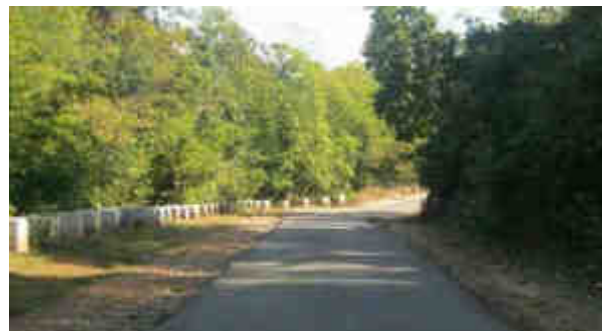
In this section, accident prone area as per directed by OWD are at chainages Km 98+150 (Horizontal bend after a vertical crest), Km 128+500 and Km 129+000 (Sharp curve), landslide area at Km 132+050 and also at hair pin bend (chainages are given above).

Accident prone area

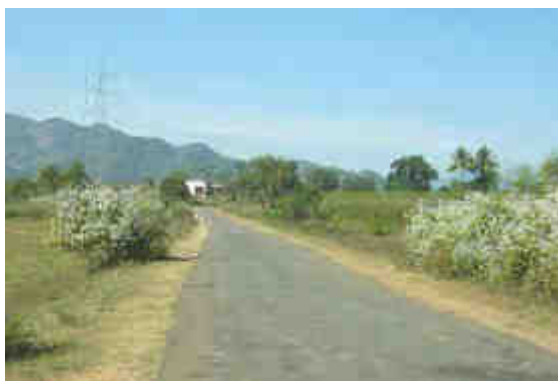
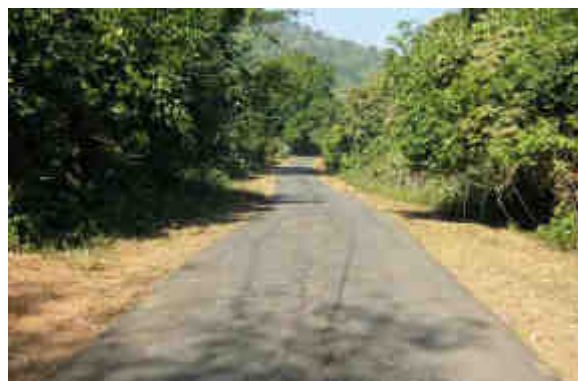
Road marking missing

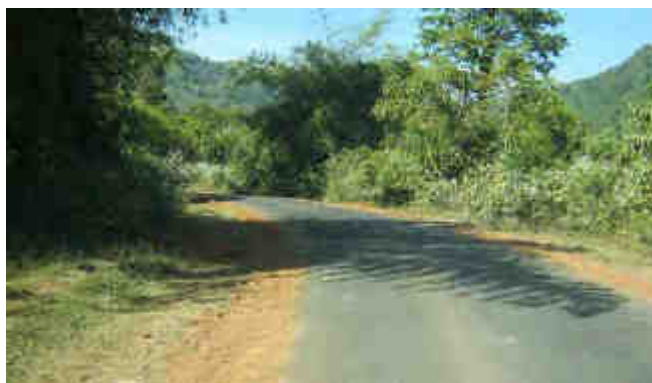
Km 3+400

Sharp Curves on Project Road

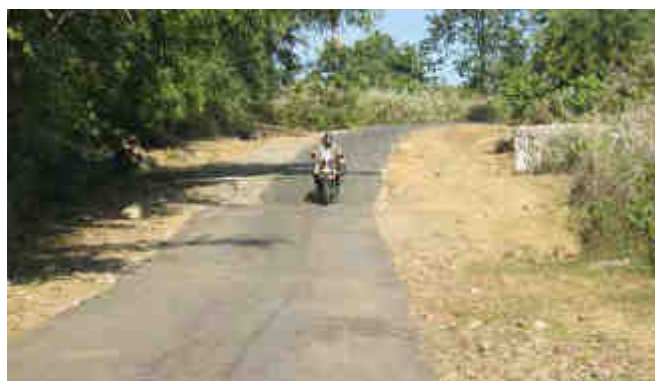
Km 20+500

Horizontal bend after a vertical crest

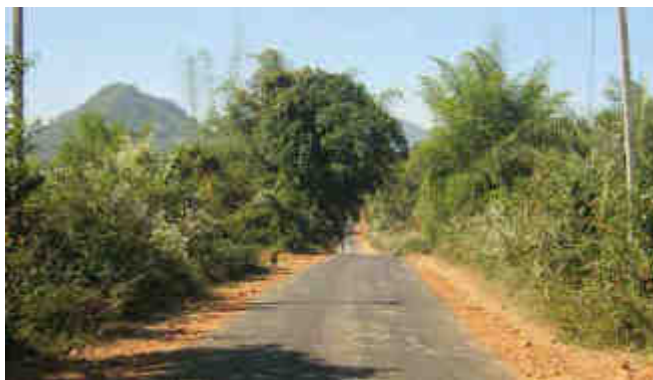
Km 0+300

It has been noted that on few locations (Km 0+300, Km 20+500 and Km 31+200), desired sight distance/visibility for safe maneuver of vehicles are not available due to few sub-standard vertical gradient. At chainage 20+500, road leads to a sudden dip after a horizontal curve bend, which is significantly hazardous.

Unsafe Steep Gradient

Recommendations: **Desirable** – Correct the vertical gradient to achieve safe forward visibility
Essential - Provide **curve warning signs, chevron signs, delineators and speed limit sign** as appropriate.

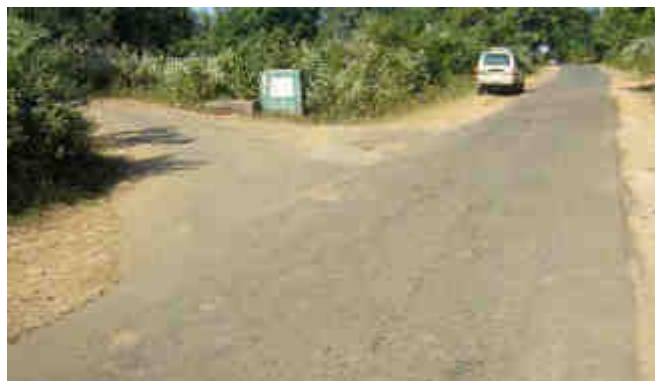
Km 11+400

Side roads perpendicular to Main Road

This is a major hazard observed on most of the 3-armed uncontrolled junctions. The major reasons for poor visibility at junctions on this road are due to 1) Overgrown vegetation or presence of trees and 3) poor layout of the side roads.

No traffic signs or road markings are observed on any of the junctions, the presence of which would have informed and warned the road user of the layout ahead. Poor delineation may result in late braking behaviour by road users who are required to stop, or wish to make turns. In the worst case, it can also result in collisions at high speeds.

High approach speeds were observed by motorcyclists turning from side roads into the main carriageway and no traffic calming measures/ warning is provided on the side road. Coupled with inadequate visibility, in the worst case, this may result in right angle collision with vehicles coming from the major road leading to serious injury or fatal accidents.

- Recommendations:**
- Provide road humps on the side at junctions having history of accidents
 - Provide raised markings on the entry to the side road
 - Provide adequate warning signs on major road and side road

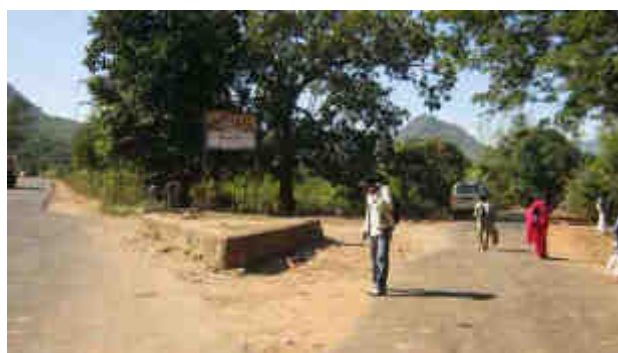
Km 0+000

Major Junction

Reasons for concern:	High approach speed Traffic coming from the Rayagada side and traffic merging on to the major road travel in high approach speeds at this junction due to the poor junction layout. At the worst case, this may lead to crashes resulting in serious injury or fatality
Recommendations:	<ul style="list-style-type: none">• Provide traffic calming measures on the minor road• Provide warning signs on the minor road• Provide information signs and road markings at the junction to warn the road user of the layout <p><i>Refer to Appendix III for guidelines for design of road humps</i></p>
Reasons for concern:	On street Bus stop Buses stops at the mouth of the junction in the minor road hampering visibility
Recommendations:	Provide designated bus stop at a safer location so that required visibility is available for road users approaching from all arms of the junction <p><i>Refer to Appendix III for guidelines for design of bus bays and on-street bus stops</i></p>

Reasons for concern:	Provision of VRUs Pedestrians and cyclists observed at the junction, but no separate provisions have been made. Pedestrians are particularly vulnerable at such junctions having high approach speed.
Recommendations:	Provide footpaths or well-maintained wide shoulders to segregate pedestrians from high speed traffic at the junction approaches; <p><i>Refer to Appendix III for standard layouts of 3-arm junctions.</i></p>

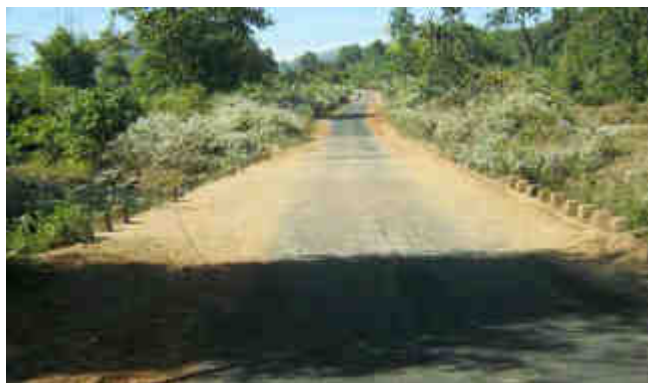
Km 0+500

The road section has few numbers of submersible bridges, where parapets are not provided due to the nature of their function. However, if sufficient warning/ delineation are not provided, these locations can become potentially hazardous, in particular, if the submersible bridge follows after a bend.

Reasons for concern: The bridge/ culvert parapets on the edge of the road adjacent to high speed traffic movement will be hazardous, particularly at dark conditions, and needs to be illuminated for a driver to judge the position of such road side hazard.

Reasons for concern: **Absence of traffic signs and road markings**
 In the absence of adequate warning signs and reflective markings, the road layout and the hazard will not be clear for the road user, particularly during night conditions and in worst conditions, this will lead to serious injury/ fatal accidents

Reasons for concern: **High approach speed**
 In the absence of any warning of the layout ahead, vehicles will tend to drive faster and approach the hazard in high speed. This may cause head-on or run-off collision.

- Recommendations:**
- Provide edge line markings with RRPMs on the approaches to the submersible bridges
 - Provide advance warning signs
 - Provide 'SLOW' traffic signs boards

Recommendations: Provide crash barriers on either approaches of the structures with delineators

- Recommendation:**
- Provide curve warning sign in addition to crash barrier with delineators
 - Provide edge lane markings
 - Provide hazard markers on either edge of the parapets

- Recommendation:**
- Provide bar marking on either approaches to make vehicles slow down, in addition to curve warning signs and advisory speed limits
 - In case the location has a history of accidents, provide speed tables/ humps on either approaches
