**Government of Odisha (GOO)
Chief Engineer, World Bank Projects, Odisha
Odisha State Roads Project**

**Consultancy Services for
Road Sector Institutional Development
Loan # 7577-IN**

**ROAD INFRASTRUCTURE
SAFETY MANAGEMENT REVIEW**

VOLUME I - REPORT

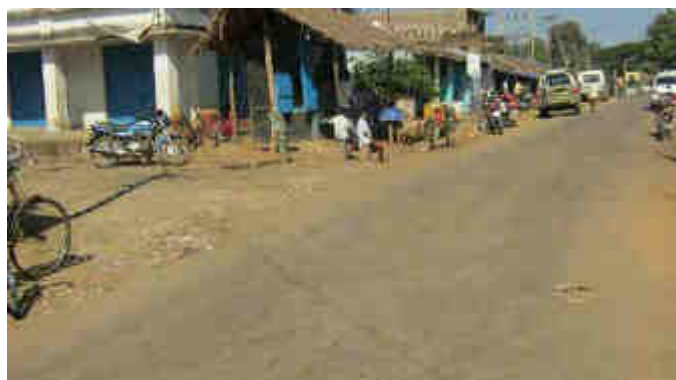
Km 17+000 (Kumardhameri village)

Built up areas/Road side villages

Reasons for concern:	Accidents between high speed motorized traffic and VRUs in BUA are more likely as pedestrians and cyclists use road in absence of footpath and proper shoulder. Absence of street light worsens the situation for VRUs during night hours.
Recommendations:	Provide gateway signs with speed restriction on start and end of BUA, additionally provide rumble strips, speed humps, or speed tables as traffic calming measures. Provide pedestrian crossings (either marked or speed tables), footpaths, and streetlights. Refer to Appendix III for treatment options for roadside villages.
Reasons for concern:	Buses are stopping on the road obstructing the through traffic. There are chances of head-on collision of overtaking vehicles.
Recommendations:	Provided bus-bays with proper signage and road markings.
Reasons for concern:	Road side commercial activities result into parking and encroachment.

Recommendations:	Regulate roadside commercial activities and remove encroachment, if any.

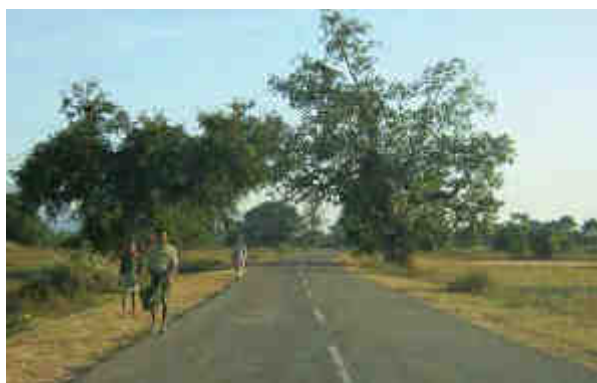
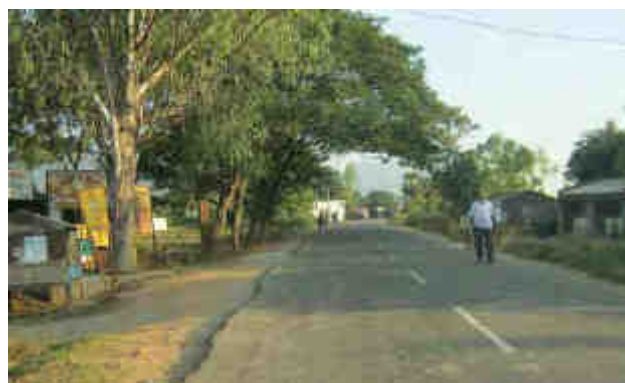
Road Marking

It has been noted that centre line markings were provided on few sections, but is in a deteriorated state and hence is not performing its function. No edge lines are provided on his road section. Retro reflective material is not provided on parapets of the culverts/bridges and also the road side objects are not been marked to warn the drivers while driving at night.

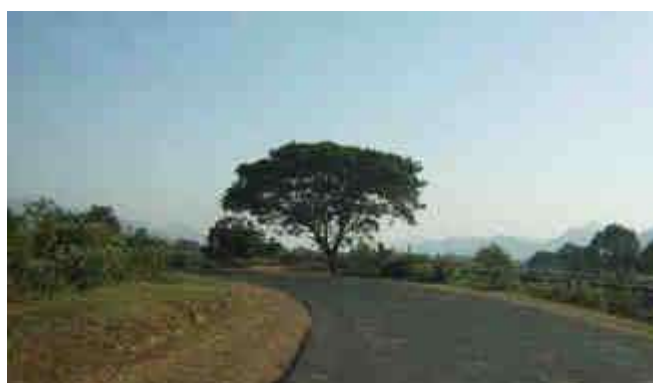
Km 4+500

Sharp Curves

Reasons for concern:	No warning signs/ delineation to inform the road user to make him/her slow down to negotiate the curve in a safe speed <ul style="list-style-type: none"> • Potential run-off accidents • Potential head-on collisions
Recommendations:	Provide curve warning signs, chevron signs, delineators and speed limit sign as appropriate <i>Refer to Appendix III for guidelines on situations where to install the above</i>
Reasons for concern:	Poor visibility on the curve due to trees and overgrown vegetation, which can lead to head-on collisions
Recommendations:	<ul style="list-style-type: none"> • Improve the line of sight by removing trees from the shoulder and cut down vegetation which hampers visibility along the curves
Reasons for concern:	Curves on high embankment without safety barriers noted <ul style="list-style-type: none"> • Run-off accidents on high embankments will lead to fatalities

Recommendations:	Provide metal beam crash barrier with delineators on sharp curves in high embankment

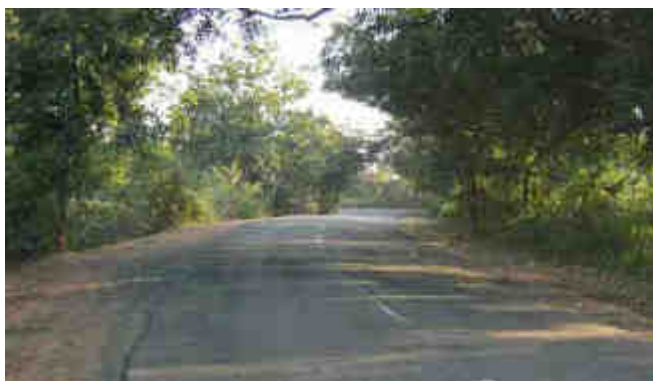
Km 14+100

Reverse Curves

Recommendations: Provide **curve warning signs, chevron signs, delineators and speed limit sign** as appropriate

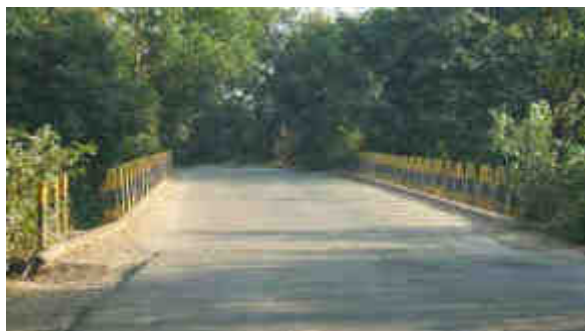
Km 9+400

The bridge parapets adjacent to road will be hazardous and these bridges have damaged parapets and hence may cause accident in future. There is no any crash barrier and protection towards the approaching to the bridge.

Reasons for concern: The bridge/ culvert parapets on the edge of the road adjacent to high speed traffic movement will be hazardous, particularly at dark conditions, and needs to be illuminated for a driver to judge the position of such road side hazard.

Reasons for concern: **Absence of traffic signs and road markings**
 In the absence of adequate warning signs and reflective markings, the road layout and the hazard will not be clear for the road user, particularly during night conditions and in worst conditions, this will lead to serious injury/ fatal accidents

Reasons for concern: **High approach speed**
 In the absence of any warning of the layout ahead, vehicles will tend to drive faster and approach the hazard in high speed. This may cause head-on or run-off collision.

Recommendations: Install Object Hazard Marker (OHM) on both sides and for both approaches (ie. Four numbers of each OHM for each structure).

Recommendations: Provide crash barriers on either approaches of the structures with delineators

- Provide curve warning sign in addition to crash barrier with delineators
- Provide edge lane markings
- Provide hazard markers on either edge of the parapets

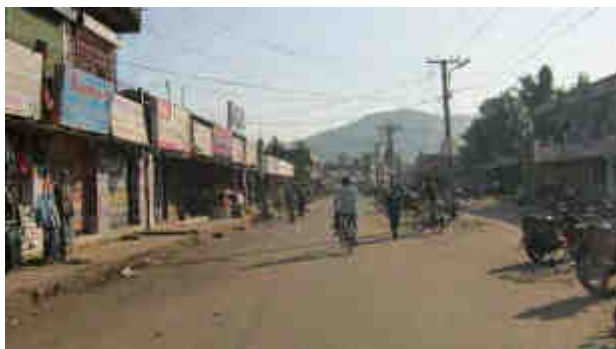
Km 0+000 (Rayagada)

Built up area/Road side villages

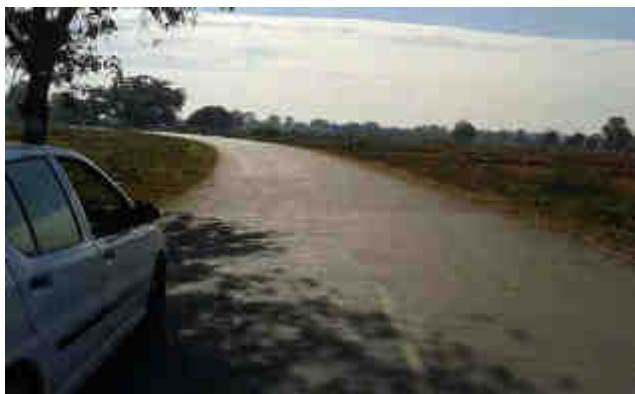
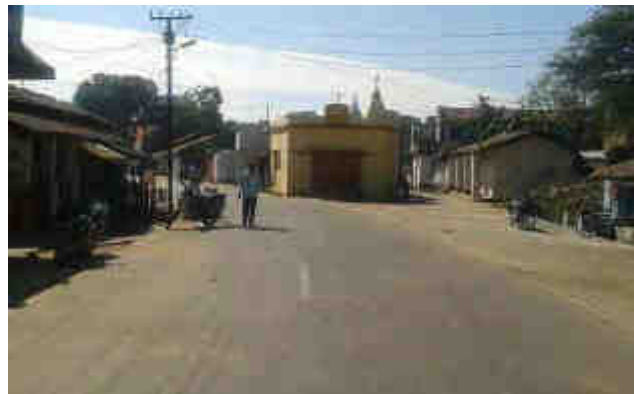
During the course of assessment, the consultant has carried out average speed and spot speed survey. The average speed and maximum speed were noted for one trial run on the road during 12:00 hrs to 13:00 hrs, from Km 328+000 to Km 316+900. An average speed of 65 km/ hour and a maximum speed of 70 km/ hour was noted during this survey. A spot speed was conducted on approach of the curve at Km 312+000, and the 85th percentile speed was found to be 61 kmph.

Sharp curve at Km 312+000 and Km 316+000 (in BUA)

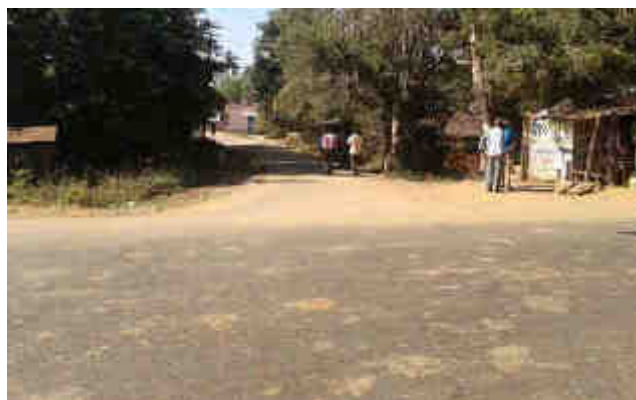
Restricted visibility from access road due to buildings and trees on corners, Km 312+900

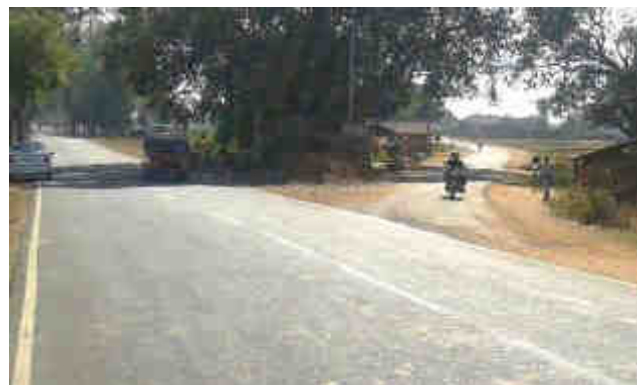
Access road joining NH-49 at skew angle, Km 319+800

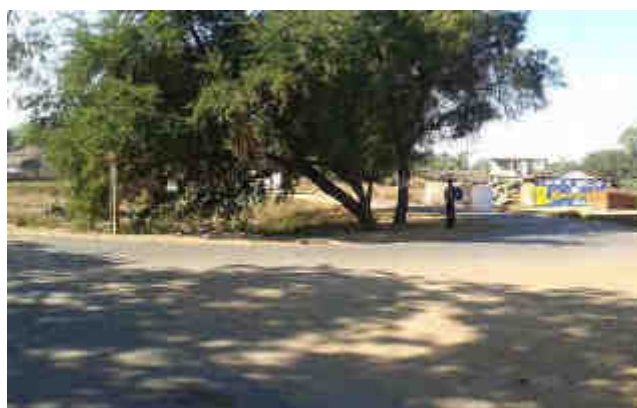
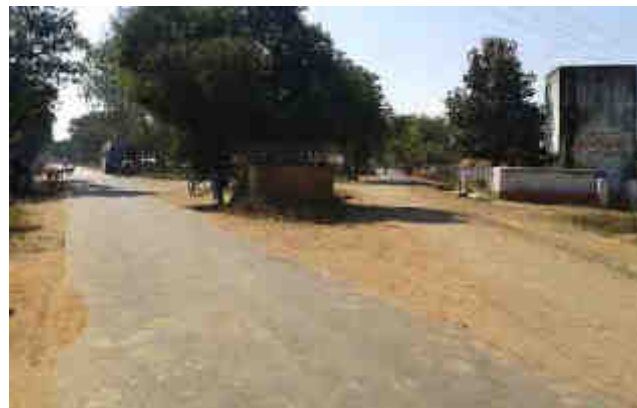
- NH-49 intersects with SH-24 (Kuchinda – Bamra road) at this place forming a y-type junction
- There is no control over traffic movement at this junction
- There are buildings in the middle of intersection forming island which obstructs visibility
- Lack of street lights

Km 310+200, intersection of NH-49 with SH-24 – built up area and buildings in the middle of intersection

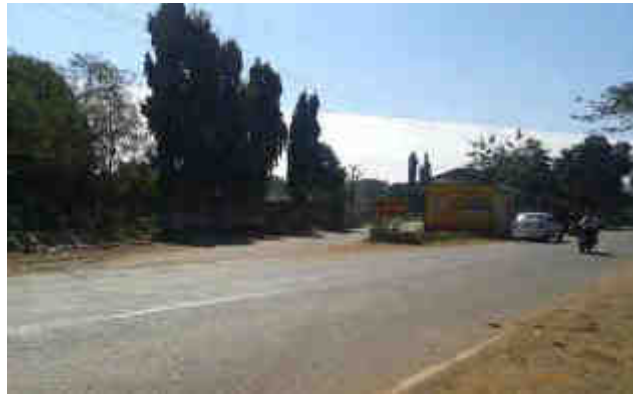
- A major town road of Kuchinda intersects with NH-49 at this place
- Lack of street lights

Km 314+600, intersection of NH-49 with Kuchinda town road (north of Kuchinda)

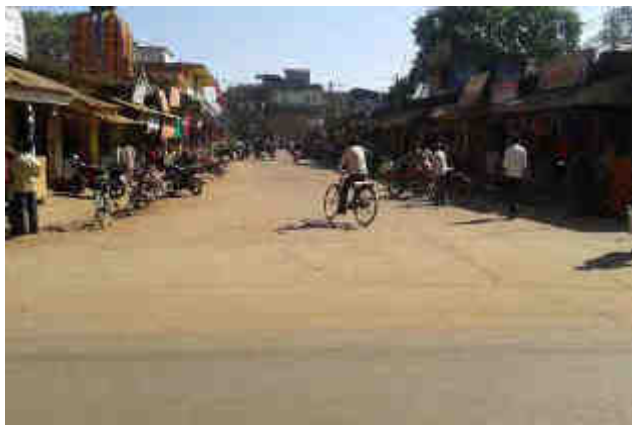
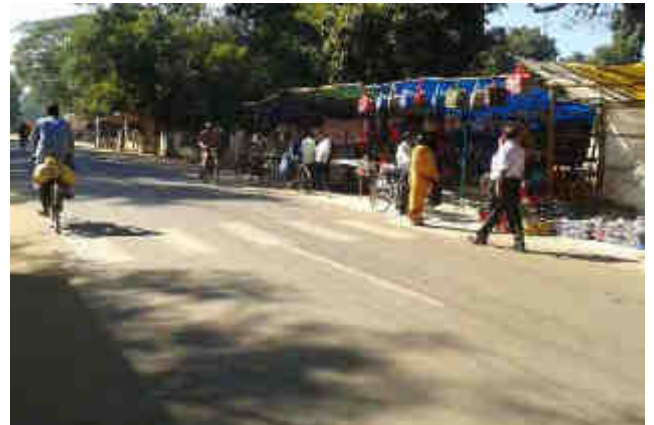
- At this place Kuchinda-Kusumi Road (MDR) joins with NH-49
- There is no control on traffic movement at this junction
- The shoulders are encroached by roadside vendors and the buildings are very near the road edge

Km 315+200, intersection of NH-49 with MDR (Kuchinda-Kusumi Road)

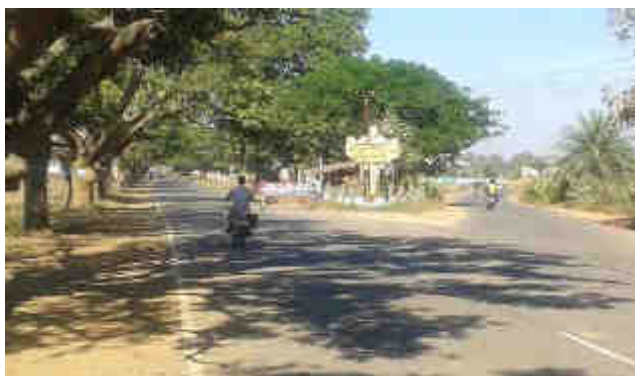
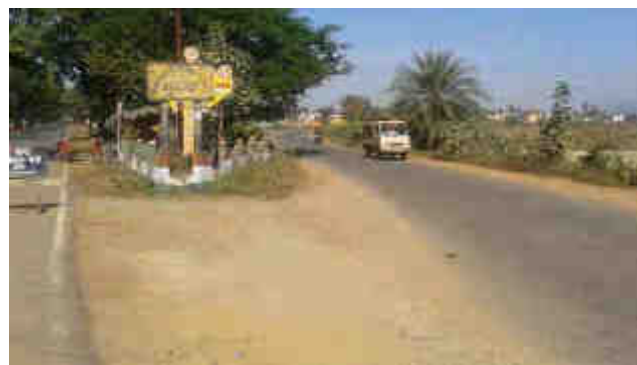
- A major town road of Kuchinda intersects with NH-49 at this place
- This is a y-type non-standard junction without any provision for traffic control
- There is an island with buildings and trees at the intersection which restricts the visibility of two approaches

Km 316+900, intersection of NH-49 with Kuchinda town road (south of Kuchinda) – non-standard island with buildings and trees obstructing visibility

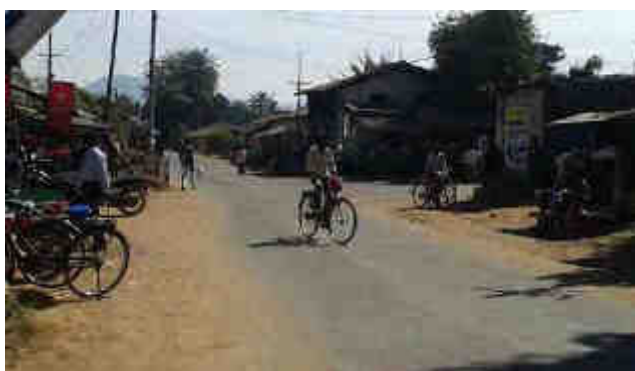
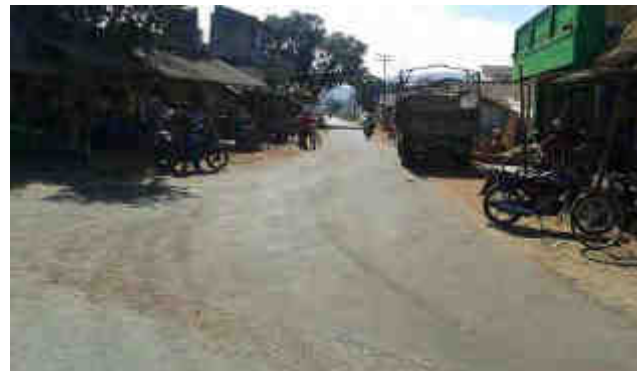
Km 328+300, intersection of NH-49 with MDR (Bhojpur-Jamankira road)

- Bhojpur-Jamankira road (MDR) joins NH-49 at this place.
- The visibility from all the three approaches of the intersection is severely restricted due to the buildings quite close the road edge.
- There is no control on traffic movement at this junction

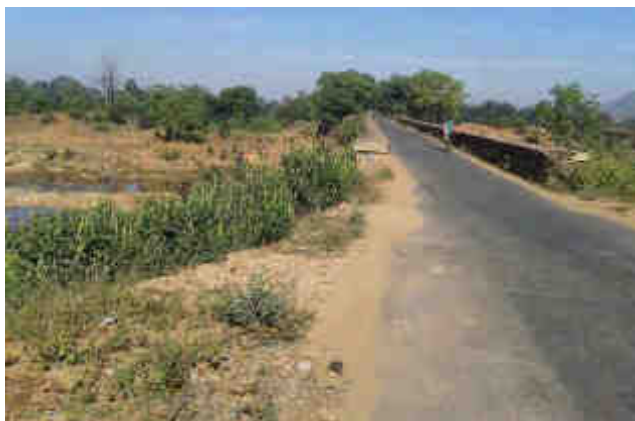
Bridge at Km 313+300, no edge protection on approaches

Recommendations: Provide crash barriers on either approaches of the structures with delineators
Refer to Appendix III for guidelines to treatments on approaches to bridges

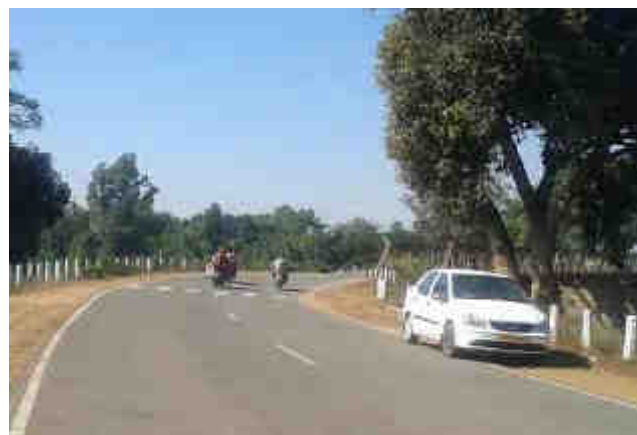
Bridge at Km 317+400, Sharp curve on approaches

Recommendations: Improve delineation of the approach curve by providing,

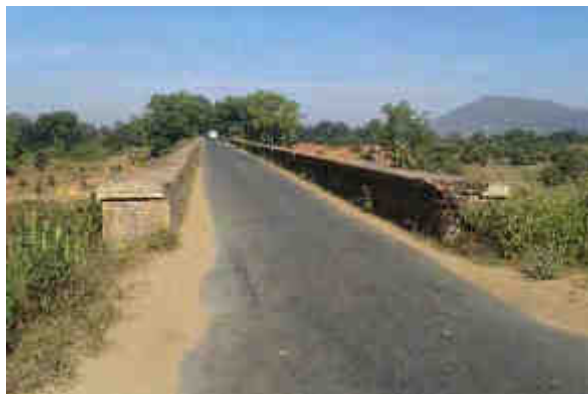
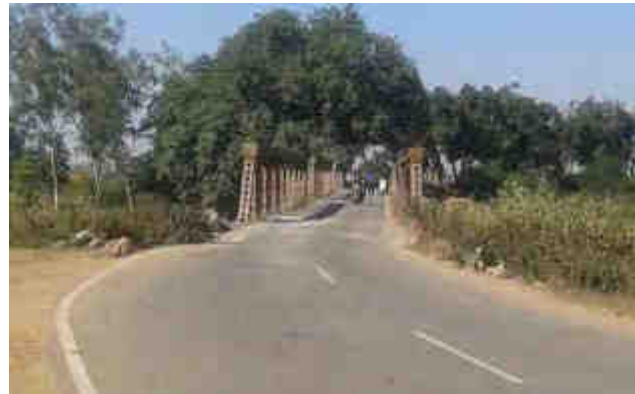
Parapets of bridge not delineated, Km 313+300 and Km 317+400

Reasons for concern:	No delineation of bridge parapets The bridge parapets adjacent to high speed traffic movement are hazardous especially at night if not delineated as the driver cannot judge the position of such road side hazards.
Recommendations:	Provide edge line markings and Object Hazard Marker (OHM) on both sides and for both approaches (i.e. Four numbers of OHM for each structure). <i>Refer to Appendix III for guidelines for installation of object hazard markers</i>

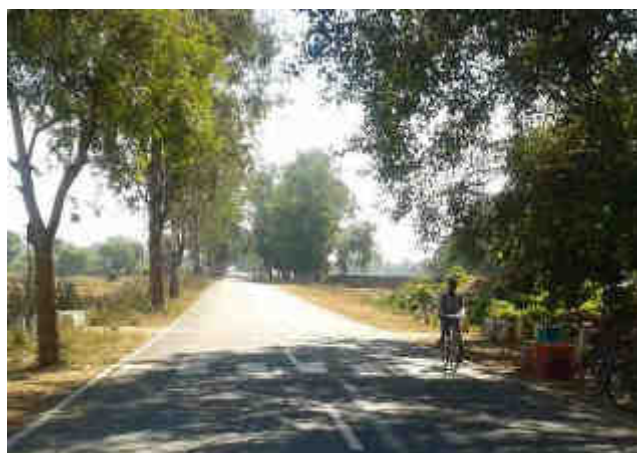
Reasons for concern:	<ul style="list-style-type: none">• The road side objects like trees, street light or other poles, buildings, and unprotected deep drains which are near the edge of road needs to be protected and/or delineated.• At night time it becomes very difficult for drivers to judge the position of such road side hazard.• If the road side objects are not protected and/or illuminated there are chances of driver losing control and hitting these objects which may result into fatal accident.
Recommendations:	<p>Desirable:</p> <ul style="list-style-type: none">• Remove Trees/ street lighting poles from the road shoulders• Remove encroachments from the right of way• Provide crash barriers on locations where trees acts as a significant hazard and where the space is available to install crash barrier <p>Essential:</p> <ul style="list-style-type: none">• Delineate the hazards by installing OHMs or painting of the trees in black and white strips• Remove encroachments on at least 2m from the road edge

Trees very near the road edge, Km 319-320

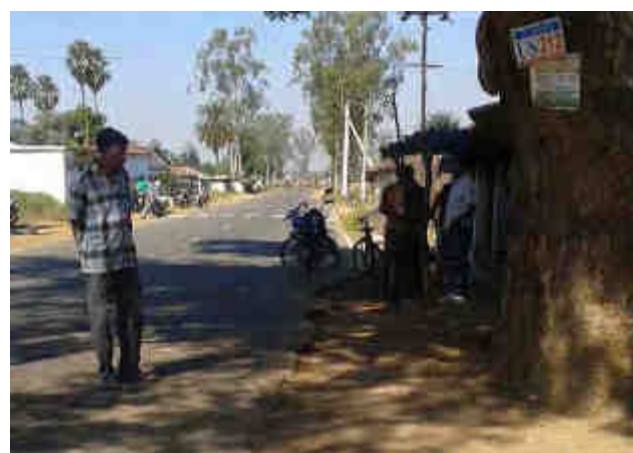
Buildings and poles very near the road edge in BUA, Km 321-322

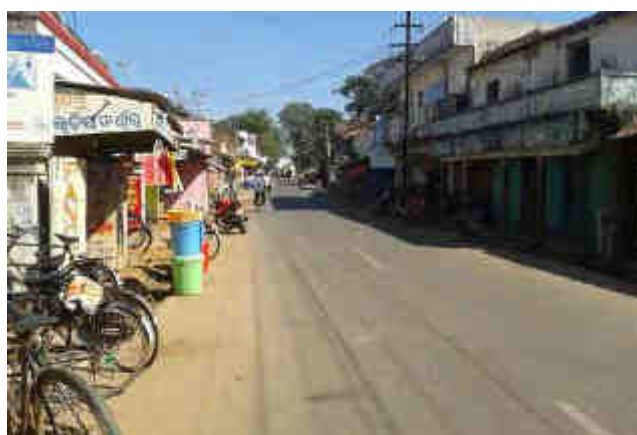
On-street parking and commercial activities on road in Kuchinda, Km 14+000 to 16+000

- No speed limit signs provided
- On street parking hampers the visibility and resulting in unsafe situations
- On street bus stops observed, which hampers visibility and unsafe overtaking maneuvers.

Recommendations: Regulate roadside commercial activities and remove encroachments, if any.

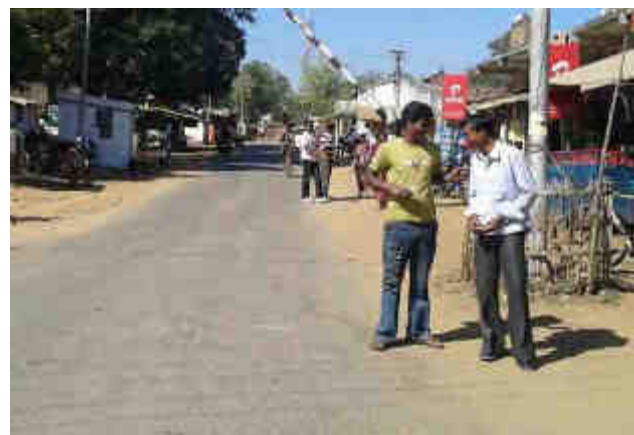
Buildings near the road edge in Bhojpur, Km 328+000 to 328+300

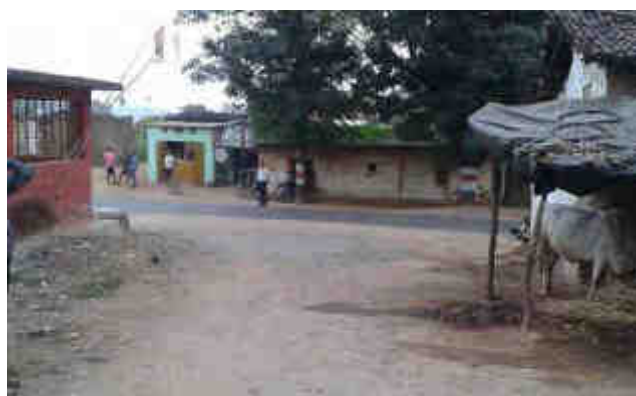
Restricted visibility from access road due to buildings on corners, Km 6+500

This is a major hazard observed on most of the 3-armed uncontrolled junctions. The major reasons for poor visibility at such junctions on SH-15 are due to buildings on the corners.

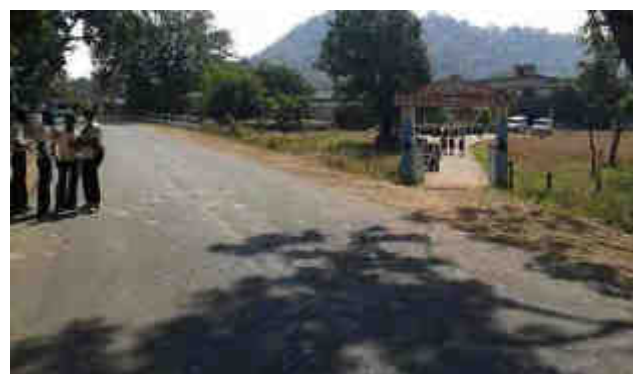
Access road joining SH-15 at skew angle and with steep gradient, Km 24+200

- It has been observed that on few junctions, the level difference between the side road and major road and the vertical profile of the side road joins the edge of main carriageway in an unsafe manner.

Recommendations: Correct the vertical alignment of side road so that vehicles approaching from side roads has adequate length on the side road to slow down/ stop before entering into the main carriageway.

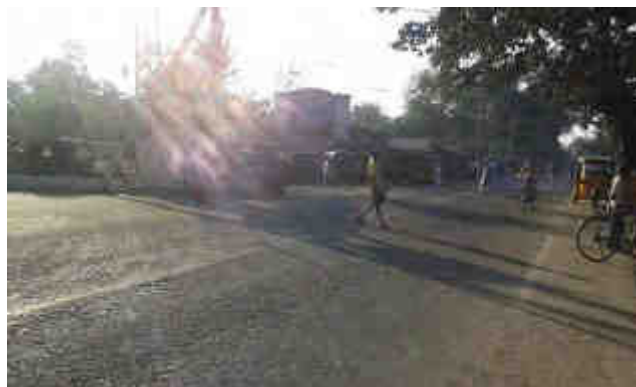
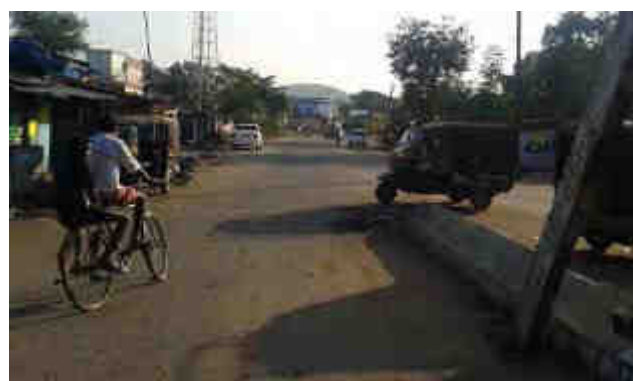
- NH-42 is having 2-lanes and carries significant motorized traffic, whereas SH-15 is having intermediate lane with less motorized traffic but significant amount of non-motorized traffic.
- There are no street lights or facilities for pedestrian crossing and footpath.

Km 0+000 Intersection of SH-15 with NH-42 –
building in the middle of intersection, vehicles parked on road and presence of VRUs

- There is no provision for walking along or crossing the road by pedestrians/bicycles despite of significant presence of pedestrians and bicyclists.
- Pedestrians were observed using the road for commuting and this expose them to the fast moving traffic which can lead to crashes resulting in serious injuries.

- There are no parking spaces provided and vehicles are parked on road encroaching the road and shoulder space.
- This hampers visibility at the junction and force pedestrians to move into the centre of the road resulting in hazardous situation.

Recommendations: Remove the encroachment/obstruction and provide splitter islands to enable safe movement of motorized and non-motorized traffic.

Recommendations: • Remove encroachments from the shoulder space.
• Provide pedestrian crossings at appropriate locations for safe crossing by pedestrians and bicycles.

Recommendations: Provide designated parking spaces for vehicles.

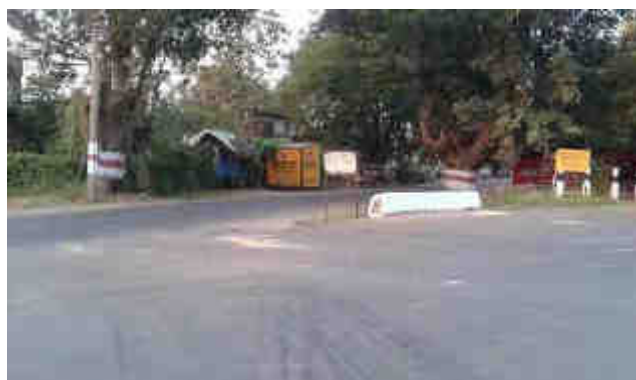
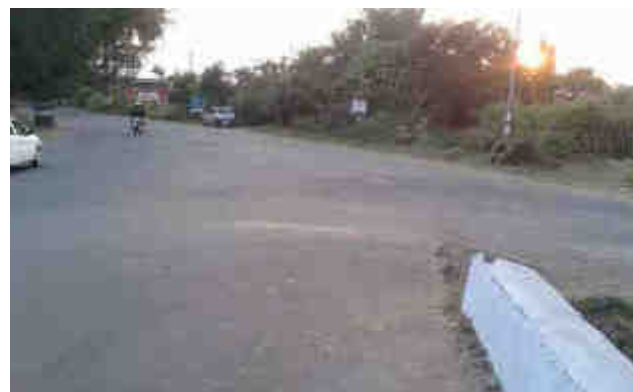
Km 5+100 intersection of SH-15 with link road - lack of road markings and delineation

Reasons for concern:	<p>Poor layout</p> <p>The junction is a non-standard Y-junction. The layout is confusing to the road user to decide the route to take in the absence of any direction signs and traffic control.</p>
Recommendations:	<ul style="list-style-type: none"> • Re-design the junction layout • Provide splitter islands to enable safe movement of motorized and non-motorized traffic <p><i>Refer to Appendix III for standard layouts of 3-arm junctions</i></p>
Reasons for concern:	<p>Poor delineation</p> <ul style="list-style-type: none"> • Traffic signs and road markings are absent in any of the arms, the presence of which would have informed and warned the road user of the layout ahead
Recommendations:	<ul style="list-style-type: none"> • Provide edge line markings, centerline markings and other road markings pertaining to junction control. <p><i>Refer to Appendix III for guidelines for traffic signs and road markings on 3-arm intersection</i></p>

Reasons for concern:	<p>Direction Signs</p> <p>There are no proper direction signs to guide the traffic through the junction layout which may result in to frequent or sudden stopping of vehicles and may lead to rear-end collision.</p>
Recommendations:	<p>Provide proper direction signs to guide the traffic through the junction layout.</p>
Reasons for concern:	<p>Provision for VRUs</p> <p>There is no provision for walking along or crossing the road by pedestrians/bicycles.</p>
Recommendations:	<ul style="list-style-type: none"> • Remove encroachments from the shoulder space. • Provide pedestrian crossings at appropriate locations for safe crossing by pedestrians and bicycles. <p><i>Refer to Appendix III for guidelines for design pedestrian crossing on approach to the 3-arm junction.</i></p>

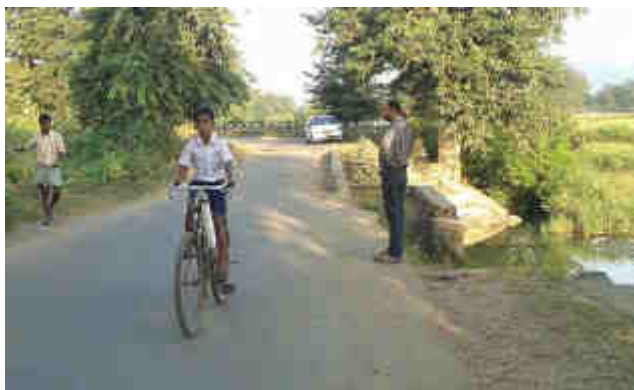
Culvert at Km 0+400, sharp curve at the approach

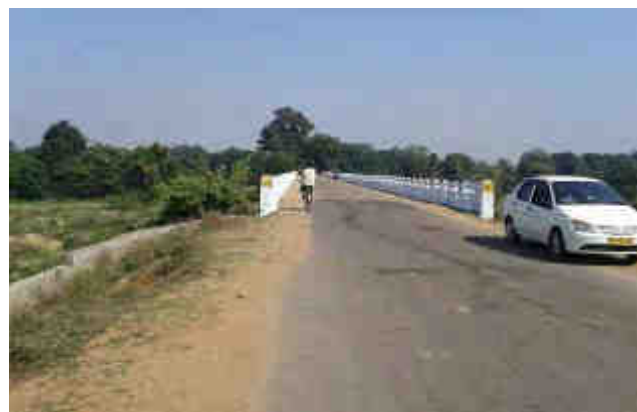
Bridge at Km 20+600, No protection on approaches

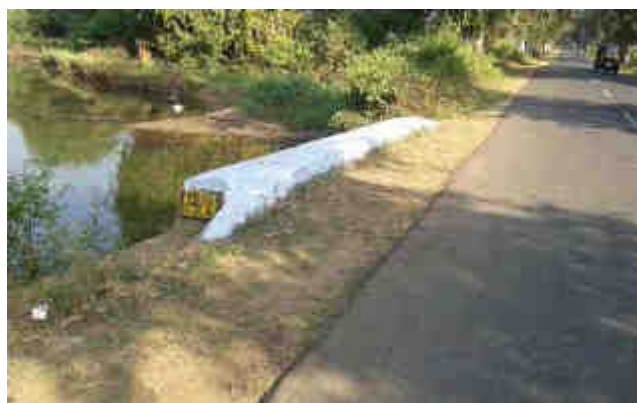
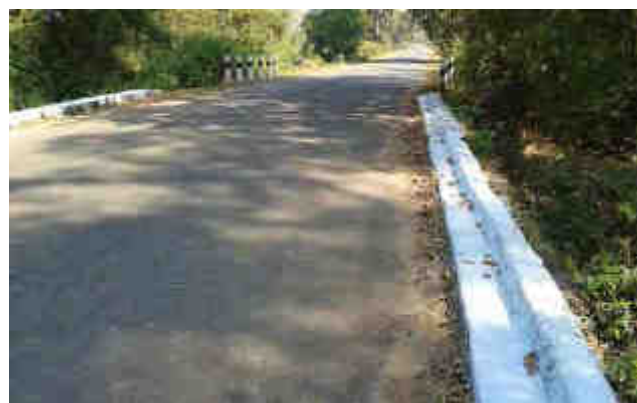
No parapets on Culvert/Bridge highly unsafe for VRUs as well as other traffic, Km 12+000 and Km 20+000

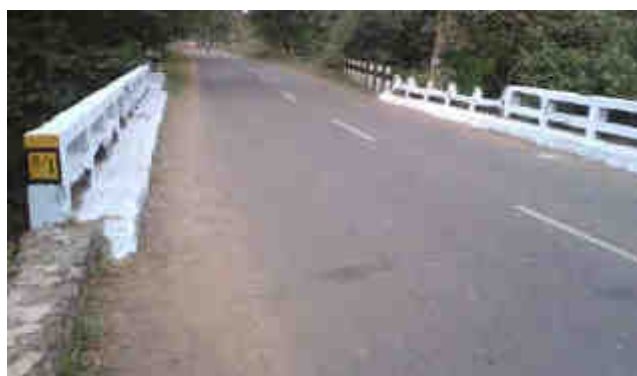
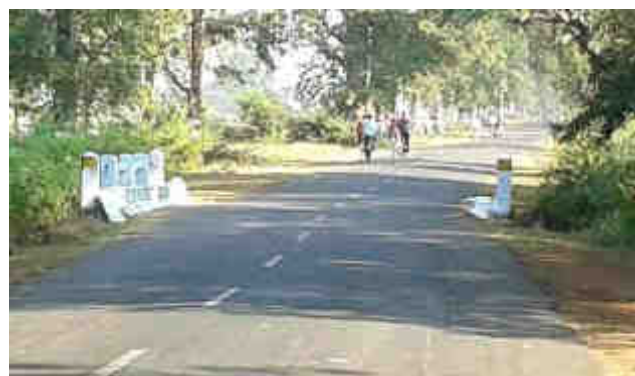
Parapets of Culvert/Bridge not delineated, Km 8+500 and Km 11+700

The culvert/ bridge parapets adjacent to high speed traffic movement are hazardous especially at night if not delineated as the driver cannot judge the position of such road side hazards.

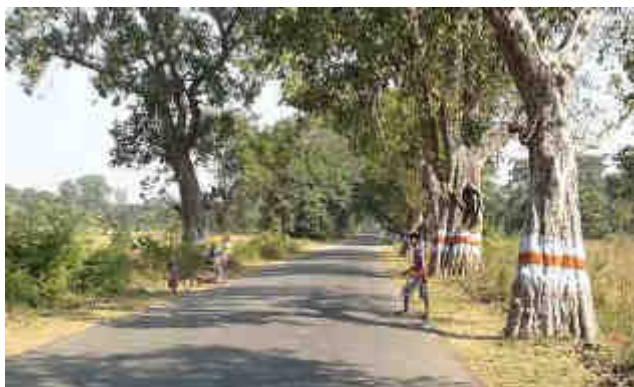
Tree very near the road edge, Km 19-20

- Delineate the hazards by installing OHMs or painting of the trees in black and white strips
- Remove encroachments on at least 2m from the road edge

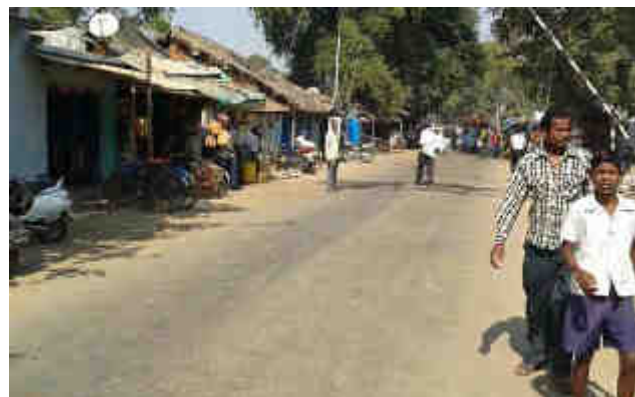
Buildings very near the road edge in BUA, Km 23-24

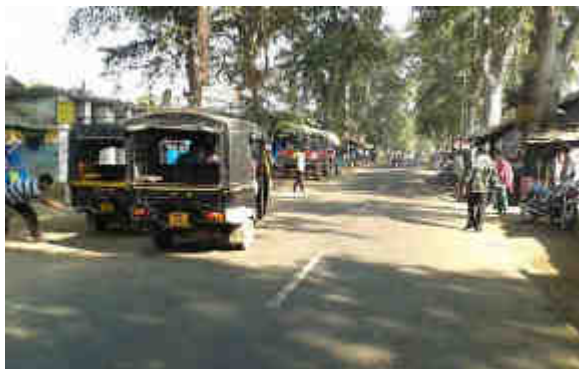
On-street parking and commercial activities on road in BUA, Km 15.600 to 15.900

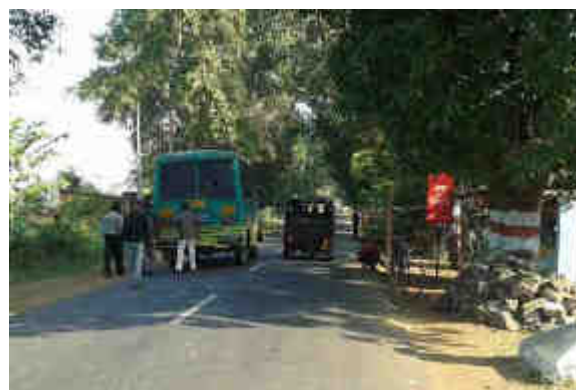
Buses stopping on the road in BUA, Km 9+900 to 10+000

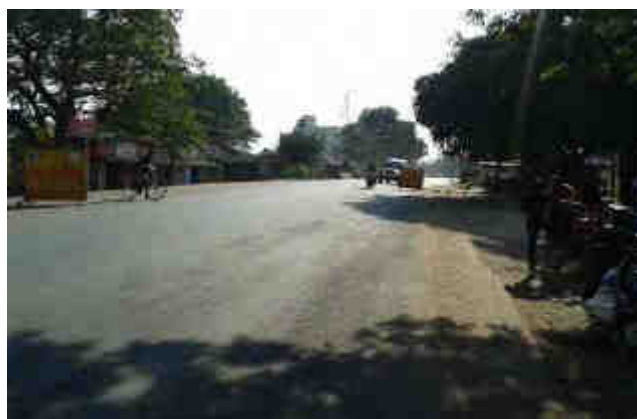
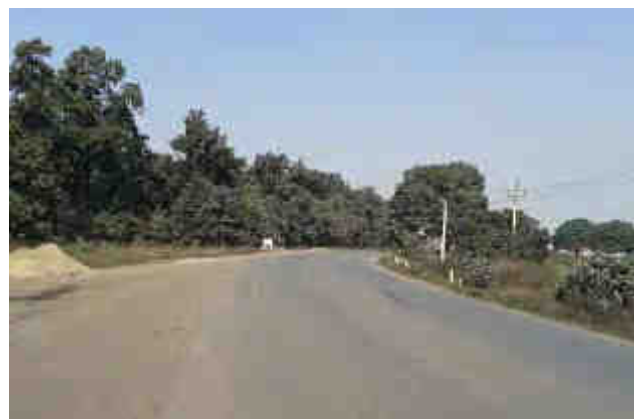
Lack of any road markings on the stretch from Km 6+000 to 7+000 and Km 36+000 to 37+000

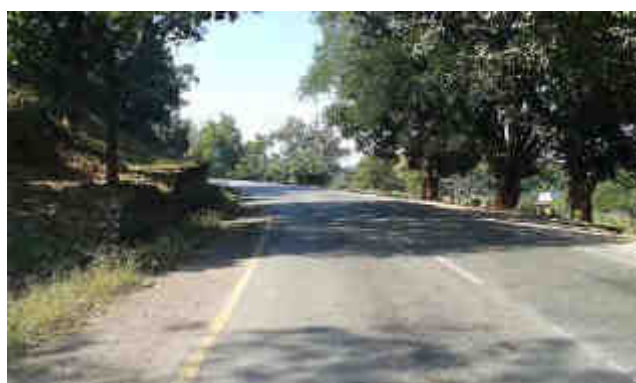
Sharp curve where visibility is obstructed due to wall and trees (on LHS), Km 107+800

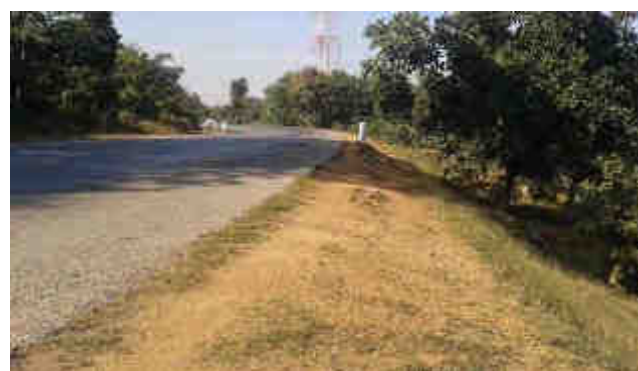
Sharp curve with high embankment without any protection on outer edge, Km 93+600

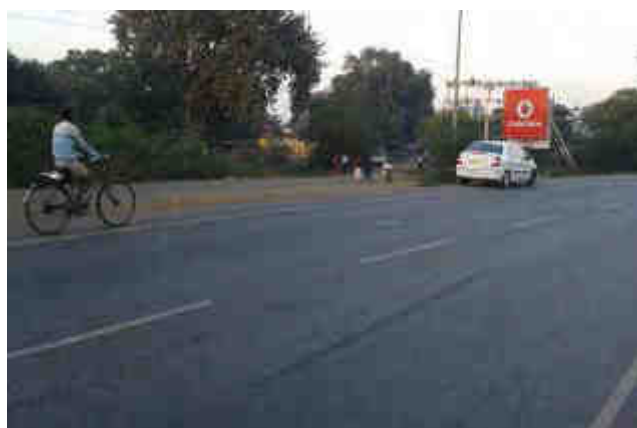
Side Road joining SH-10 at acute angle, Km 149+800

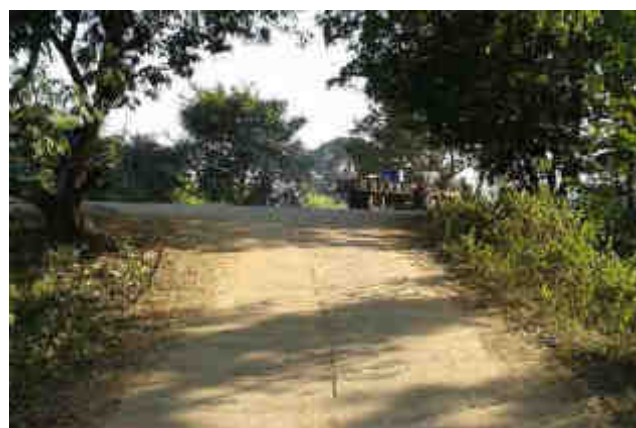
Side Road joining SH-10 at steep gradient, Km 12+900

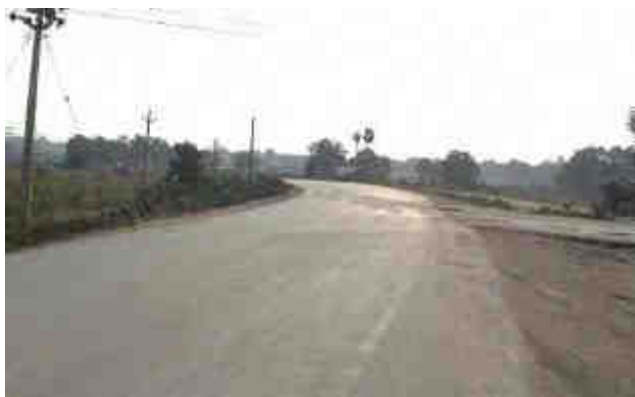
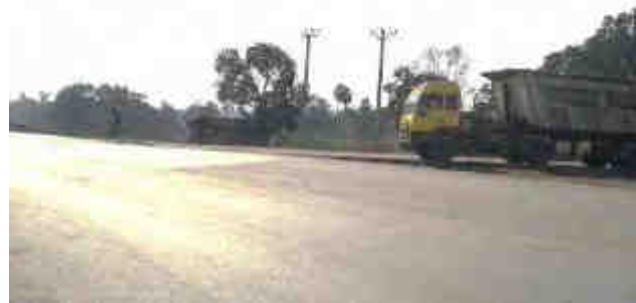
Side road joining SH-10 on curve, Km 35+800

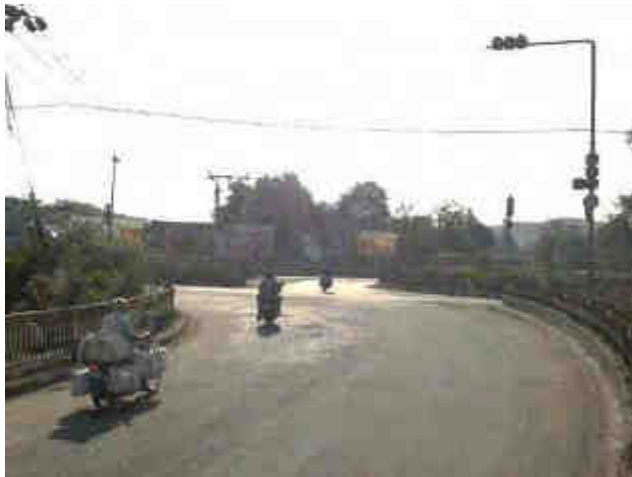
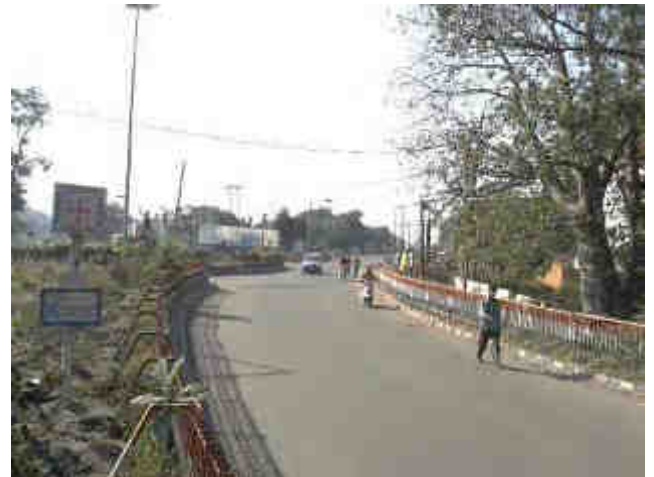
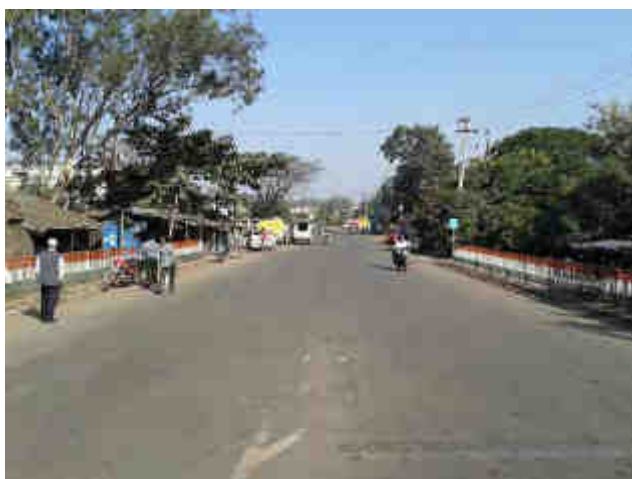
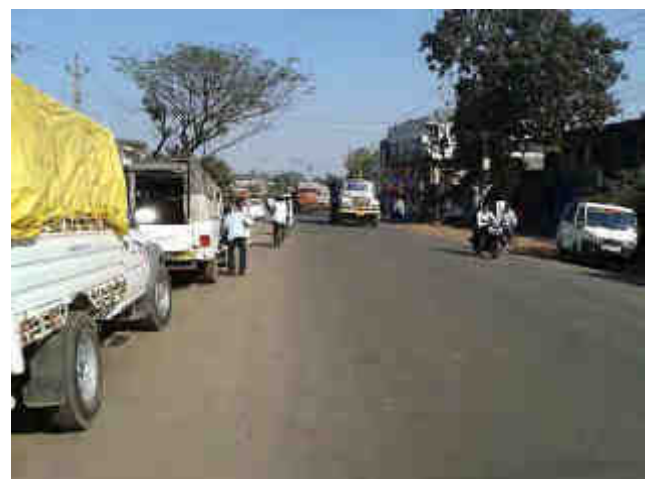
- Junction layout is fine.
- Busy junction of NH6 with SH10, having significant movement of heavy vehicles
- Traffic signal lights provided, but in not synchronized
- Footpaths are provided in the junction area on all the approaches, but there are no facility for pedestrian crossing
- There are no encroachments in the junction area on SH-10 approach, however the footpaths are encroached with trees and small shops
- Street lights are provided on the approaches of the junction

Round-about at Km 4+922, commercial establishments and on-street parking on its approach

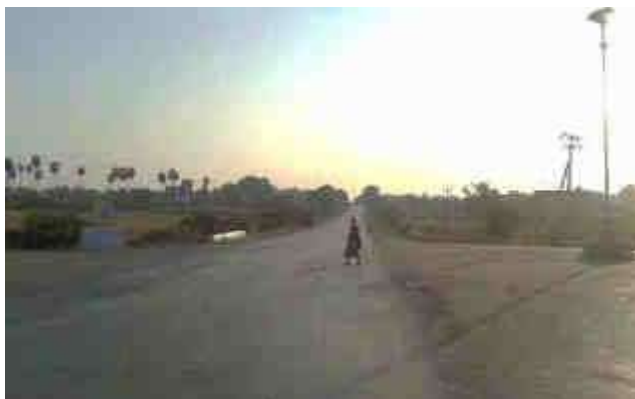
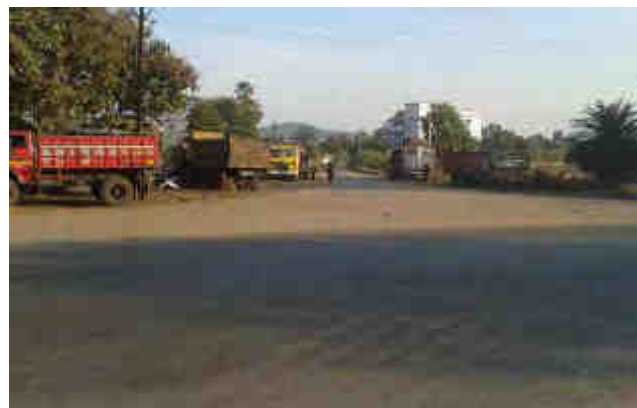
Km 83+800, intersection of SH-10 with Sundargarh town road

- Junction layout is non-standard and has no established control over the traffic movement

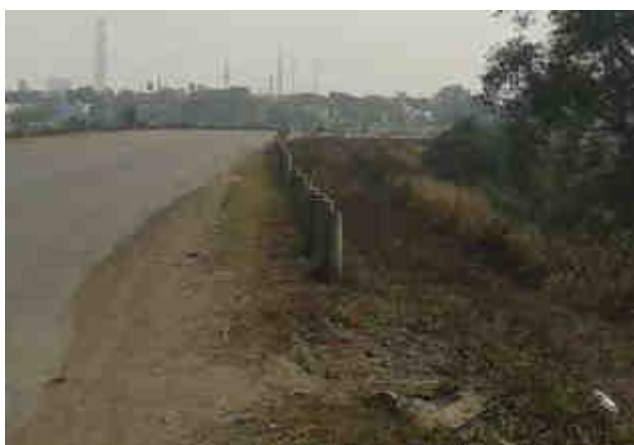
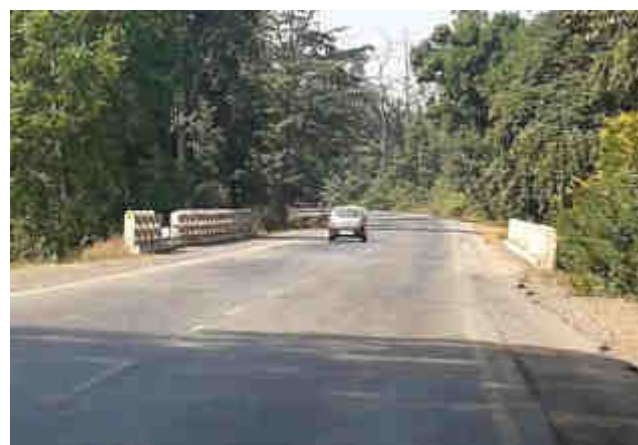
No edge protection on approaches of ROB at Km 49+900 and Bridge at Km 101+600

Recommendations: Provide crash barriers on either approaches of the structures with delineators
Refer to Appendix III for guidelines to treatments on approaches to bridges

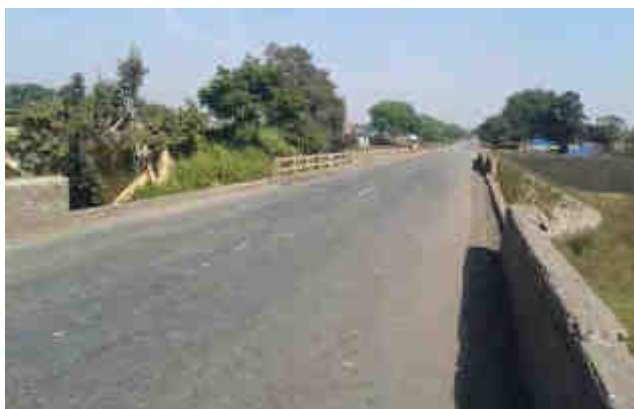
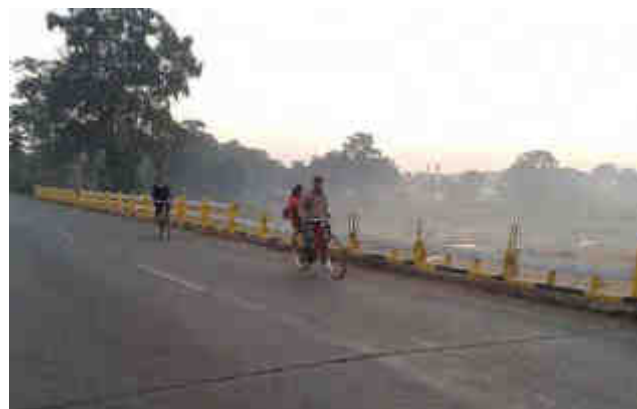
*Broken parapets of Bridge highly unsafe for VRUs as well as other traffic,
 Km 117+100 and Km 154+200*

The absence of parapet on bridge/ culvert increases the risk of vehicles falling on to the canal. In the context of high speed traffic movement observed on SH-10, the absence of parapets at such locations is hazardous for traffic, especially for VRUs.

Recommendations: Provide continuous parapets on all culverts and bridges.

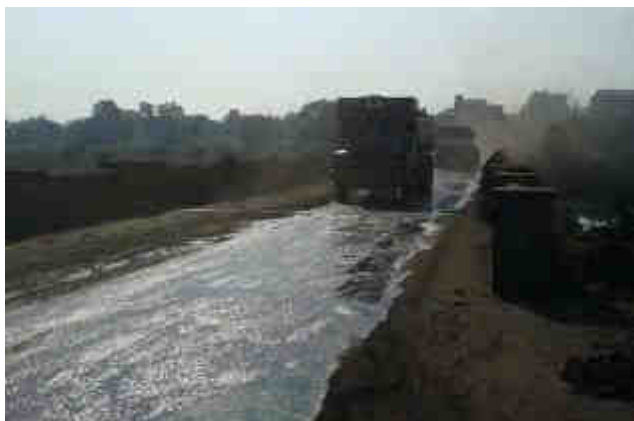
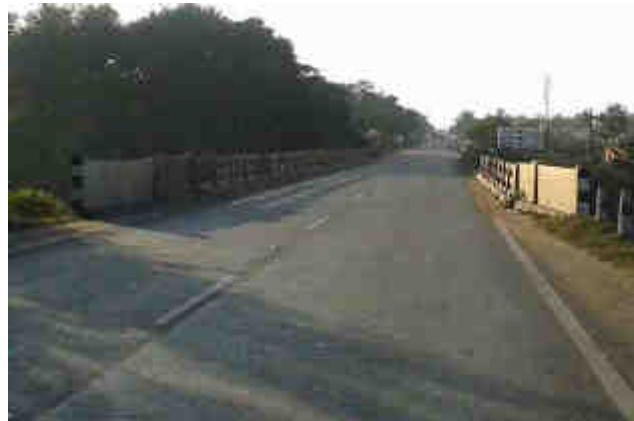
Parapets of Bridge not delineated, Km 32+200 and Km 165+400

- The bridge parapets adjacent to high speed traffic movement are hazardous especially at night if not delineated as the driver cannot judge the position of such road side hazards.

- Provide edge line markings and Object Hazard Marker (OHM) on both sides and for both approaches (i.e. Four numbers of OHM for each structure)

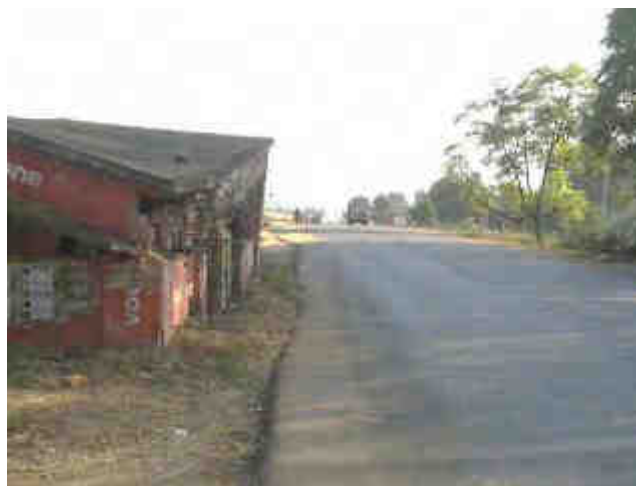
Building (LHS) and Tree (RHS) very near to the road edge,
 Km 60+000 to 61+000

Reasons for concern: Roadside objects constitute a significant hazard, if the driver loses control and will result in major injuries/ fatalities

- Remove Trees/ street lighting poles from the road shoulders
- Remove encroachments from the right of way
- Provide crash barriers on locations where trees acts as a significant hazard and where the space is available to install crash barrier

- Delineate the hazards by installing OHMs or painting of the trees in black and white strips
- Remove encroachments on at least 2m from the road edge

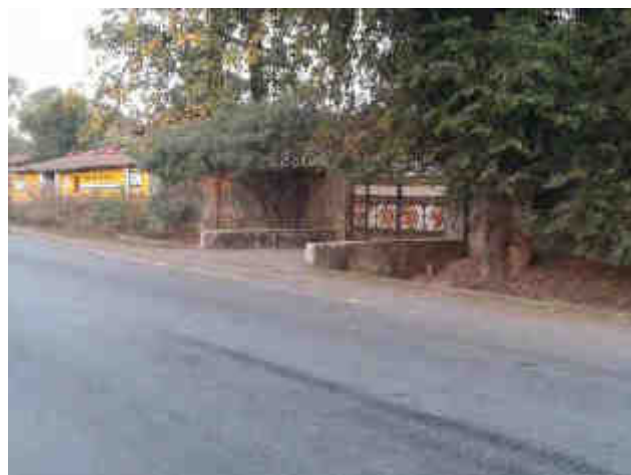
Deep drain and property access very near to the road
 edge, Km 74+000 to 75+000

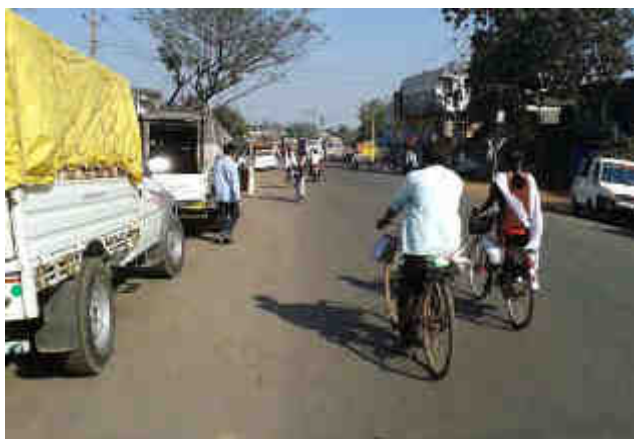
Vehicles parked on road in BUA, Km 5-6

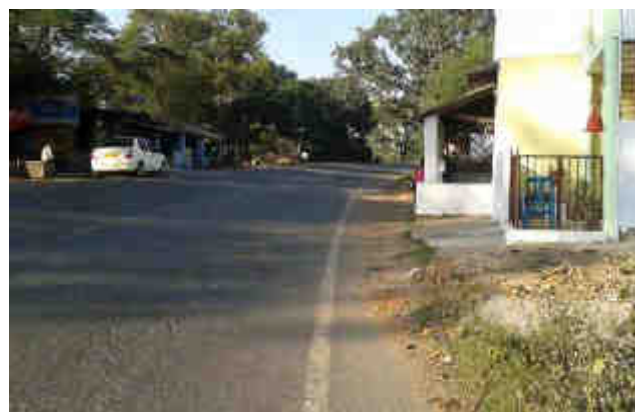
Buildings very close to edge of road in BUA, Km 62-63 Talpatia village

- No traffic calming measures are provided to slow down vehicles approaching at high speeds to the built up area
- Significant pedestrians including school children are noted, but no separate pedestrian facilities are provided along the road inside the BUA or to cross the road
- No road markings or warning signs to warn/ inform the road user of the built up nature of the area ahead
- No speed limit signs provided
- On street parking hampers the visibility and resulting in unsafe situations
- On street bus stops observed, which hampers visibility and unsafe overtaking maneuvers.

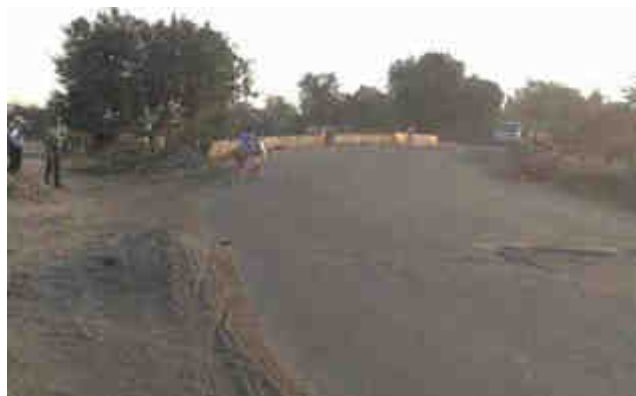
- ROB is at the end of a sharp curve (radius <75m) and there is an access road merging with SH-10 at this location
- No traffic calming measures on major road and side road

As informed by engineers from OWD, the approach to the ROB is a black-spot location having frequent number of accidents, especially during night conditions.

Access Road (on Left), ROB and Sharp Curve.
