**Government of Odisha (GOO)
Chief Engineer, World Bank Projects, Odisha
Odisha State Roads Project**

**Consultancy Services for
Road Sector Institutional Development
Loan # 7577-IN**

**ROAD INFRASTRUCTURE
SAFETY MANAGEMENT REVIEW**

VOLUME I - REPORT

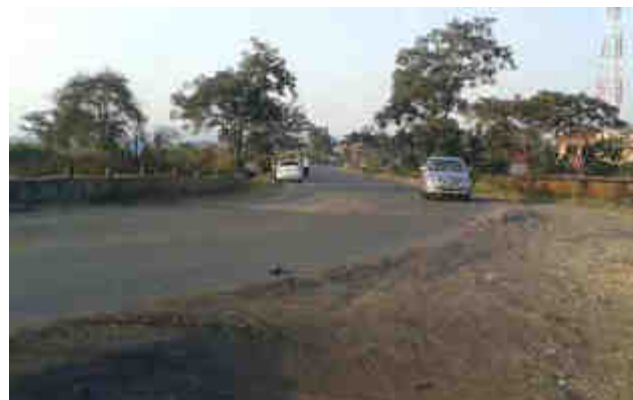
Traffic approaching sharp curve and ROB
(view from the Access Road)

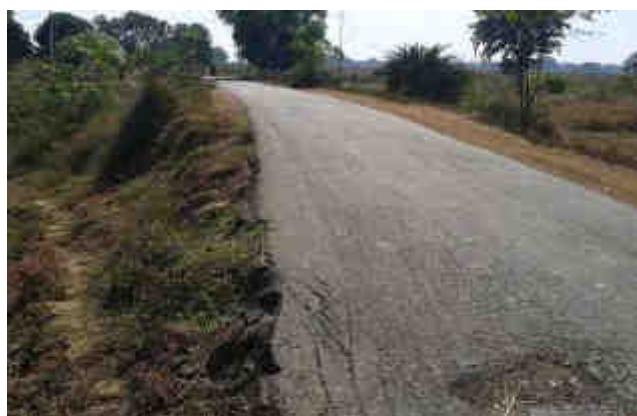
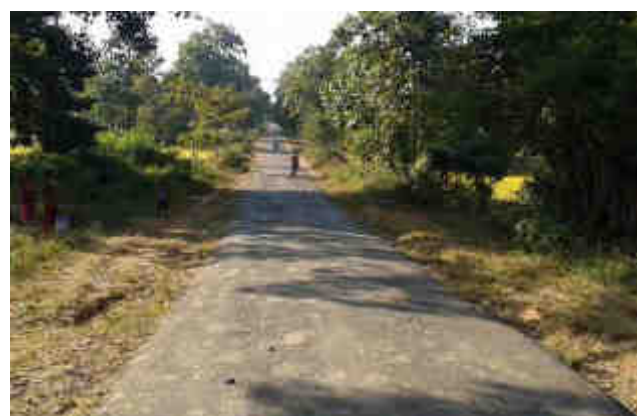
Poor condition of earthen shoulder, Km 155-156 and Km 191-192

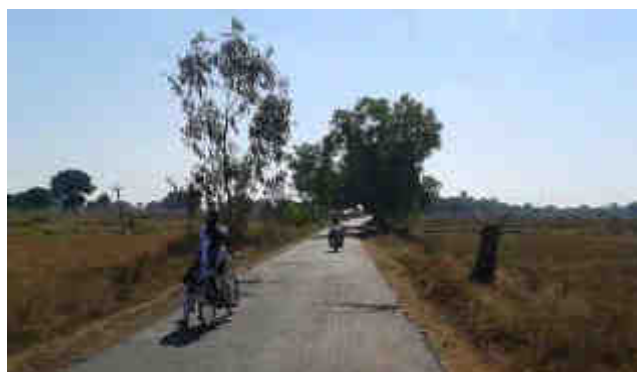
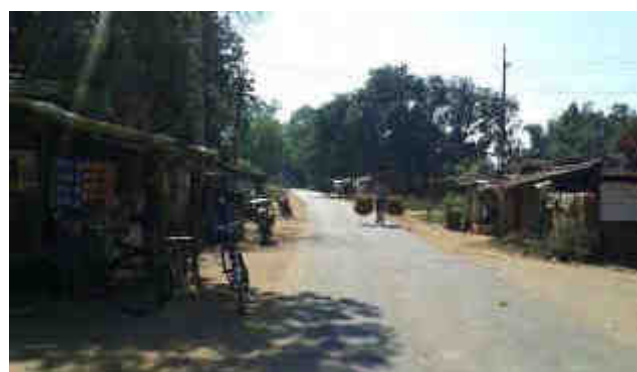
Photographs of SH-24 in rural and urban areas where no road markings are provided (Km 154 to 155, and Km 155 to 156)

- Recommendations:**
- Provide edge line with thermoplastic material throughout the road.
 - Provide centre line with thermoplastic material on intermediate lane road (refer to IRC: 35-1997 for details).
 - Provide edge and centre line RRPMs on sharp curves

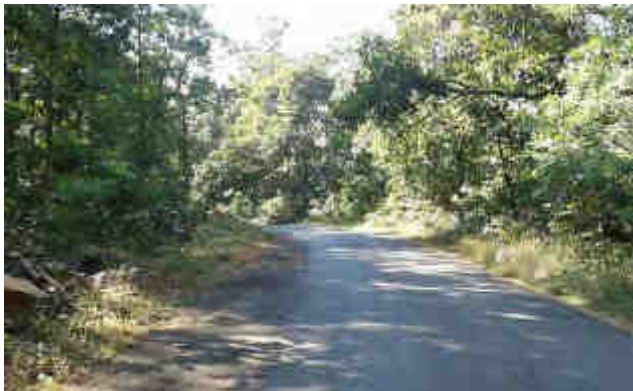
Sharp curve with restricted visibility in forest/ghat section at Km 174+900

Reasons for concern:	Unexpectedly sharp horizontal bends will lead to crashes when drivers try to negotiate them at high speed. On SH-24 where a number of sharp curves are in the forest/ghat section with severely restricted visibility the vehicles can lose control and this can result in serious injuries or fatalities. Possible type of collisions are: <ul style="list-style-type: none"> • Potential run-off accidents • Potential head-on collisions
Recommendations:	Provide curve warning signs, chevron signs, delineators and speed limit sign as appropriate <i>Refer to Appendix III for guidelines on treatment on curves.</i>
Reasons for concern:	Curves on high embankment without safety barriers noted <ul style="list-style-type: none"> • Run-off accidents on high embankments will lead to fatalities
Recommendations:	Provide metal beam crash barrier with delineators on sharp curves in high embankment <i>Refer to Appendix III for guidelines on situations where to install the above</i>

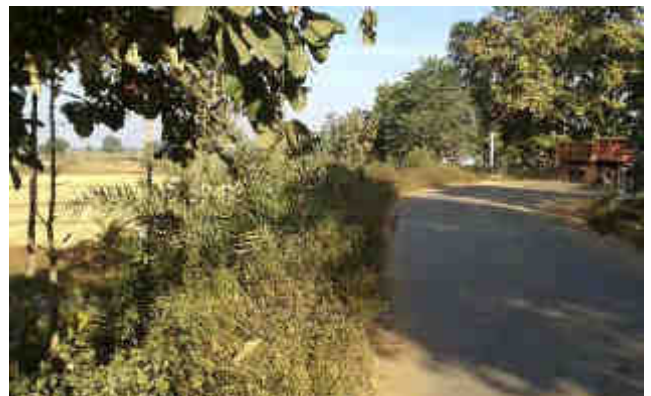
The sharp curve after the railway crossing in Bamra is on high embankment without any edge protection and the condition of earthen shoulder is very poor, hence there is high risk of run-off accidents at this location.

Sharp curve on high embankment without edge protection near railway crossing at Bamra (Km 198+700)

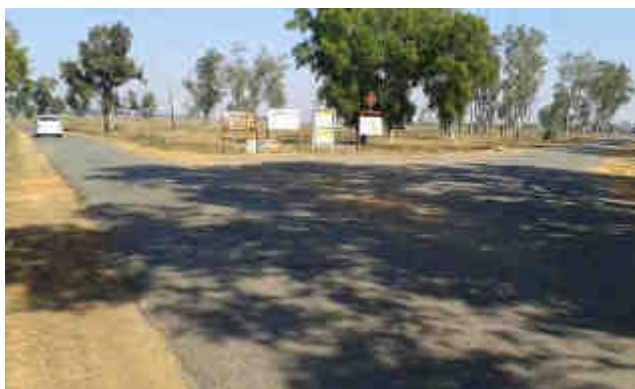
Side road joining at skew angle Km 157+400

Reasons for concern:	<p>Inadequate Visibility</p> <p>This is a major hazard observed on most of the 3-armed uncontrolled junctions. The major reasons for poor visibility at such junctions on SH-24 are due to buildings or trees on the corners.</p>
Recommendations:	<p>Remove encroachments at least from the visibility triangle required for such junctions.</p> <p><i>Refer to Appendix III for guidelines on visibility triangle of junctions.</i></p>
Reasons for concern:	<p>Poor delineation</p> <ul style="list-style-type: none"> • No traffic signs or road markings are observed on any of such junctions, the presence of which would have informed and warned the road user of the layout ahead.
Recommendations:	<p>Provide traffic signs and road markings pertaining to junction control</p> <p><i>Refer to Appendix III for guidelines on traffic signs and road markings at junctions</i></p>
Reasons for concern:	<p>High approach speeds</p> <ul style="list-style-type: none"> • High approach speeds were observed by traffic turning from side roads into the main carriageway and no traffic calming measures/ warning is provided on the side road.

Recommendations:	<ul style="list-style-type: none"> • Provide road humps on the side at junctions having history of accidents • Provide raised markings on the entry to the side road • Provide adequate warning signs on major road and side road <p><i>Refer to Appendix III for guidelines on traffic calming measures.</i></p>

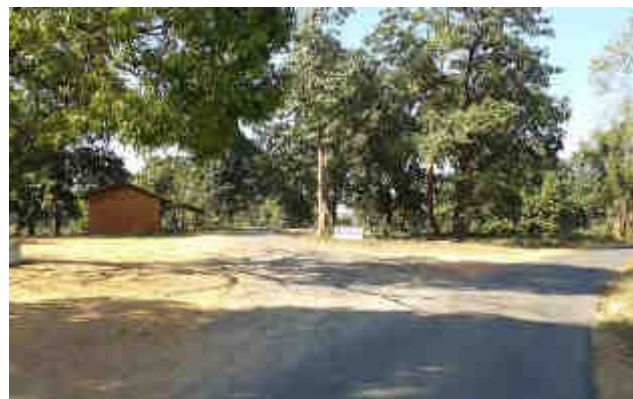
Side road joining on curve, Km 170+100

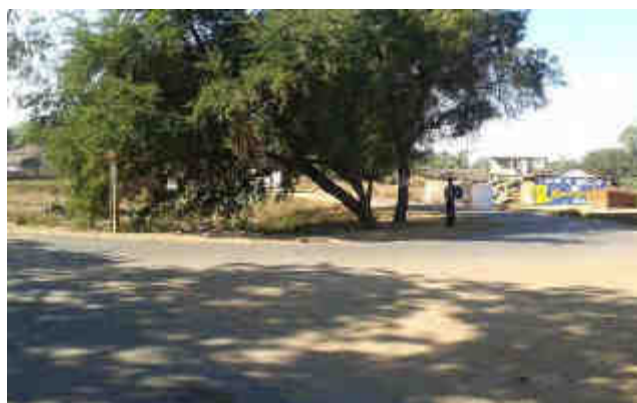
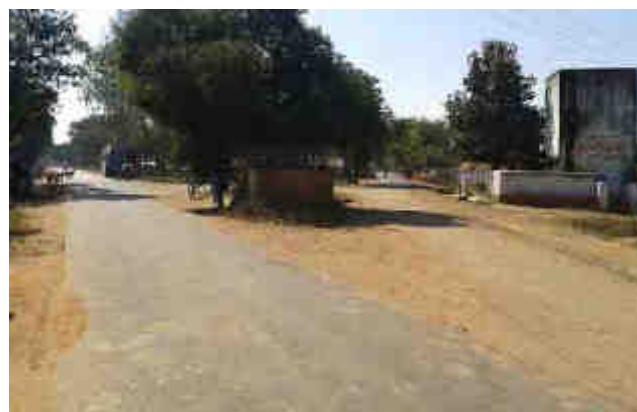
Km 154+200, intersection of SH-24 with NH-49– built up area and buildings in the middle of intersection

The junction layout at both the junctions is non-standard and has no control over the traffic movement. It is confusing who has priority in such a situation. This encourages lawless traffic movement and is hazardous. The existing central island is non-standard and hampers visibility at the junction.

- Recommendations:** Remove the buildings and trees and provide traffic island for smooth flow of traffic
- Refer to the Appendix III for guidelines on visibility triangle at junctions.*

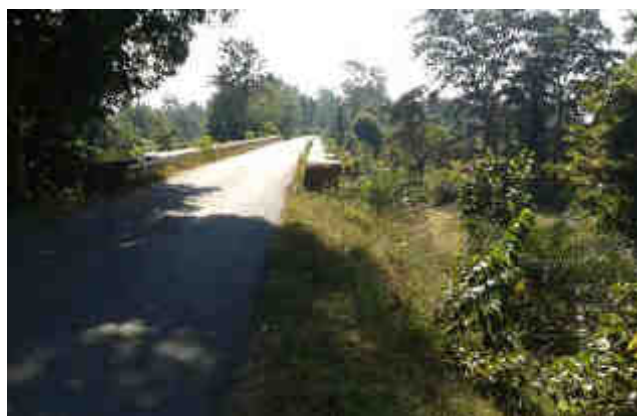
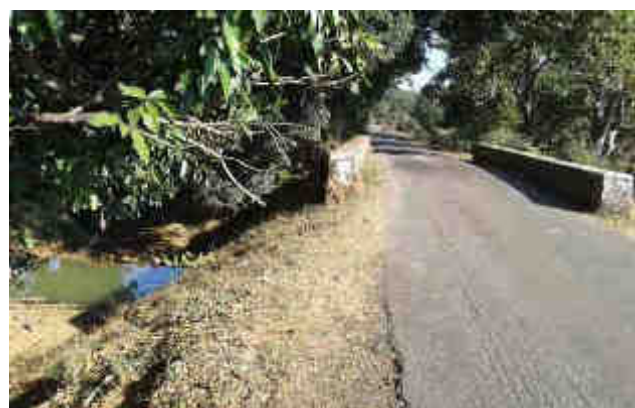
Unprotected approach to bridge with high embankment, Km 164+700 and Km 187+700

Recommendations: Provide crash barriers on either approaches of the structures with delineators
Refer to Appendix III for guidelines to treatments on approaches to bridges.

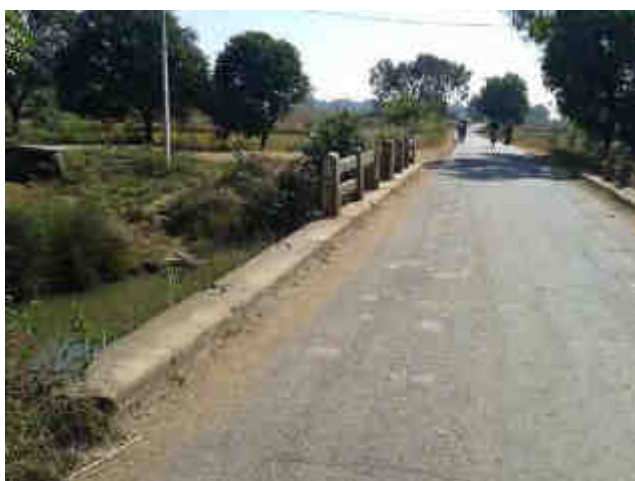
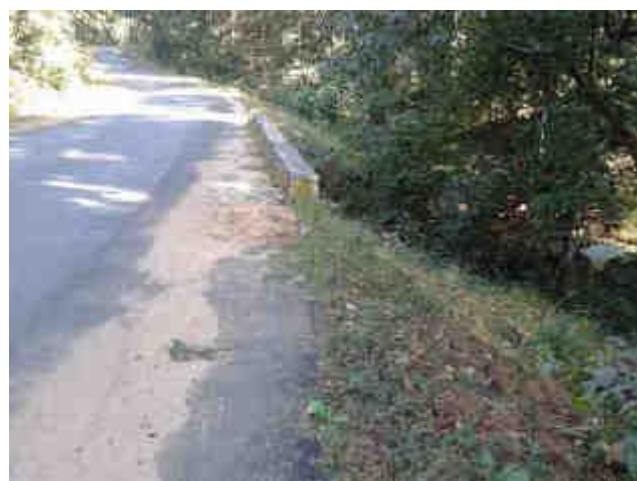
*No parapets on Culvert/Bridge highly unsafe for VRUs as well as other traffic,
Km 155+200 and Km 175+000*

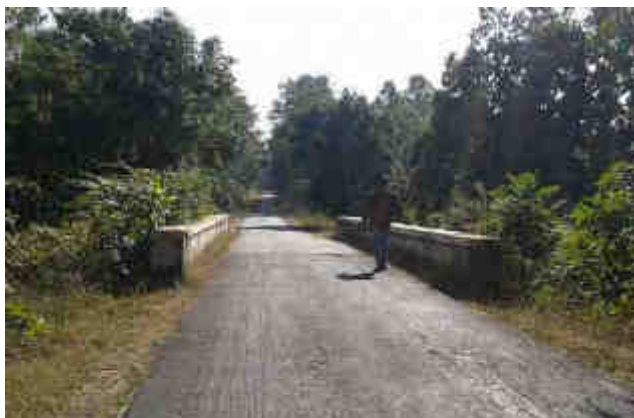
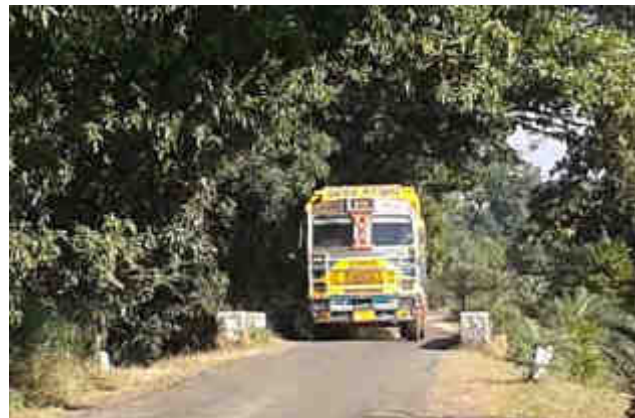
Parapets of Culvert/Bridge not delineated, Km 172+700 and Km 187+700

Reasons for concern:	No delineation of culvert/bridge parapets The culvert/ bridge parapets adjacent to high speed traffic movement are hazardous especially at night if not delineated as the driver cannot judge the position of such road side hazards.
Recommendations:	<ul style="list-style-type: none">• Provide edge line markings and Object Hazard Marker (OHM) on both sides and for both approaches (i.e. Four numbers of OHM for each structure) <p><i>Refer to Appendix III for guidelines for installation of object hazard markers</i></p>
Reasons for concern:	Broken or missing parapets The absence of parapet on bridge/culvert increases the risk of vehicles falling in to the drain. The absence of parapets at such locations is hazardous for traffic, especially for VRUs.
Recommendations:	<ul style="list-style-type: none">• Provide continuous parapets on all culverts and bridges.

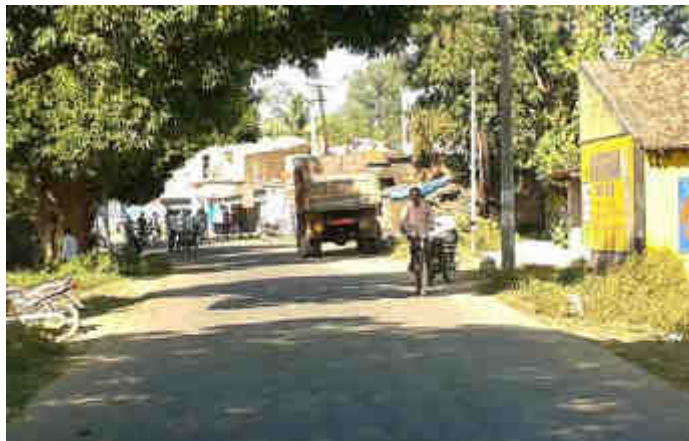
Poles very near the road edge in BUA, Km 169+000-169+700

- The road side objects like, street light or other poles, and buildings which are near the edge of road needs to be protected and delineated.
- At night time it becomes very difficult for drivers to judge the position of such road side hazard.
- If the road side objects are not protected and/or illuminated there are chances of driver losing control and hitting these objects which may result into fatal accident.

- Remove street lighting poles from the road shoulders
- Remove encroachments from the right of way
- Provide crash barriers on locations where trees acts as a significant hazard and where the space is available to install crash barrier

- Delineate the hazards by installing OHMs or painting of the trees in black and white strips
- Remove encroachments on at least 2m from the road edge

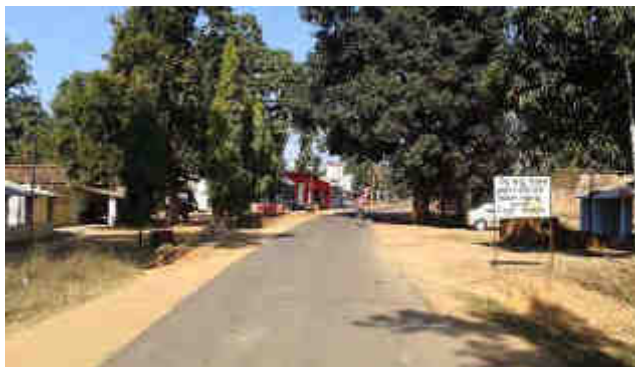
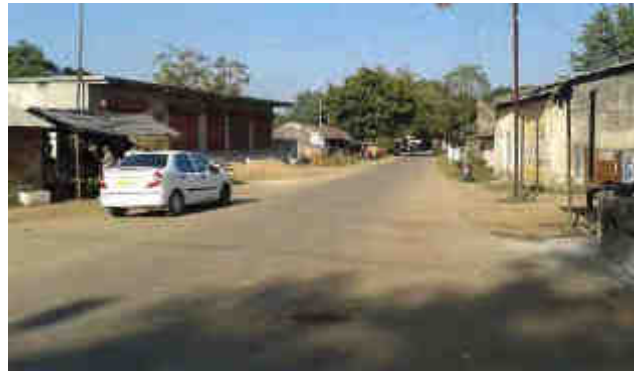
Built up area of Kesaibahal and Bamra village

- No traffic calming measures are provided to slow down vehicles approaching at high speeds to the built up area
- Significant pedestrians including school children are noted, but no separate pedestrian facilities are provided along the road inside the BUA or to cross the road
- No road markings or warning signs to warn/ inform the road user of the built up nature of the area ahead
- No speed limit signs provided

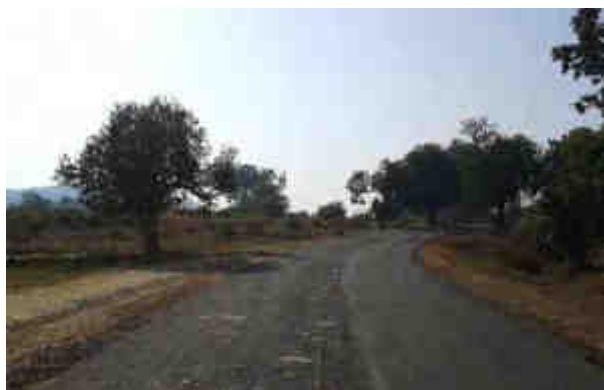
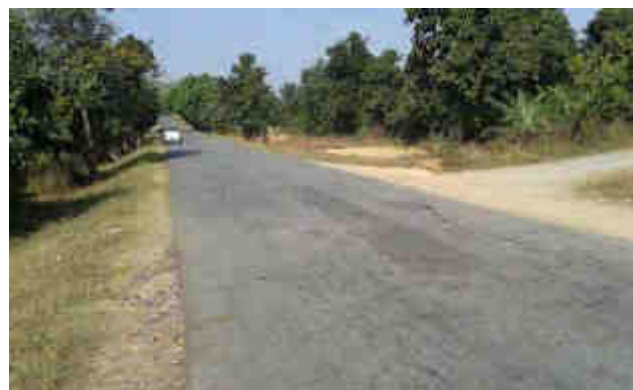
Lack of any road markings on the stretch from Km 0+000 to 1+000 and Km 6+000 to 7+000

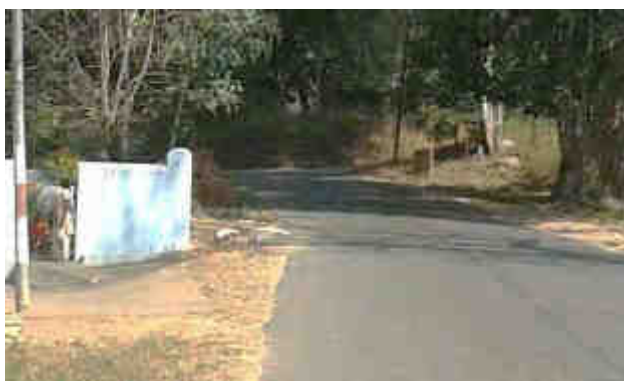
As the sharp curve at Km 16+200 is on gradient, fast moving vehicles were observed overtaking the slow vehicles. Due to BUA of Sabdega village, there are buildings on the inner edge of curve which restricts the visibility of approaching traffic. There is a side road merging with SH-31 at the curve. In this situation the risk of head-on collision of overtaking vehicles, and collision with the vehicles entering from side road is more. Photographs of sharp curve with unsafe situation are given below.

Sharp curve with gradient, side road, and restricted visibility in BUA at Km 16+200

Recommendations: Provide all the curve treatments mentioned above in addition to traffic calming measures and speed restriction signs in the BUA

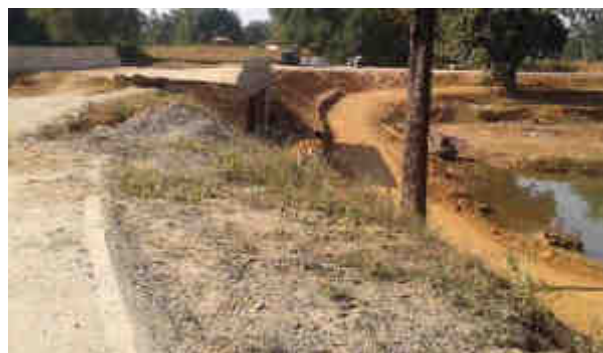
Sharp curve on high embankment without edge protection near approaching culvert (under construction), Km 31+800

Recommendations: Provide crash barrier on the outer edge with delineators.
Refer to Appendix III for guidelines on situations where to install the above

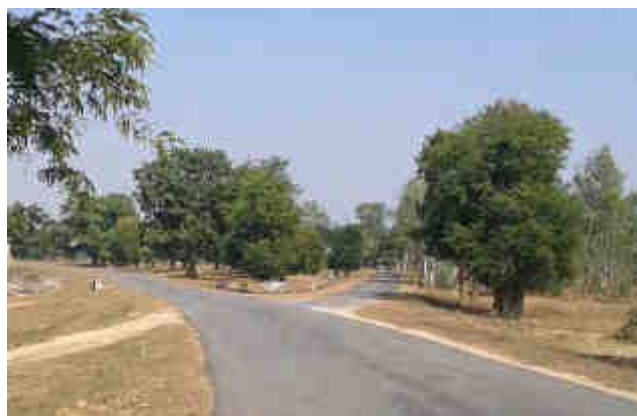
Side road joining at skew angle Km 21+000

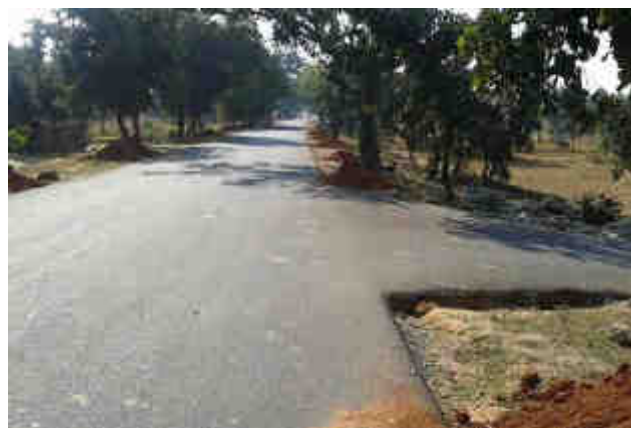
Side road joining with steep gradient, Km 9+000

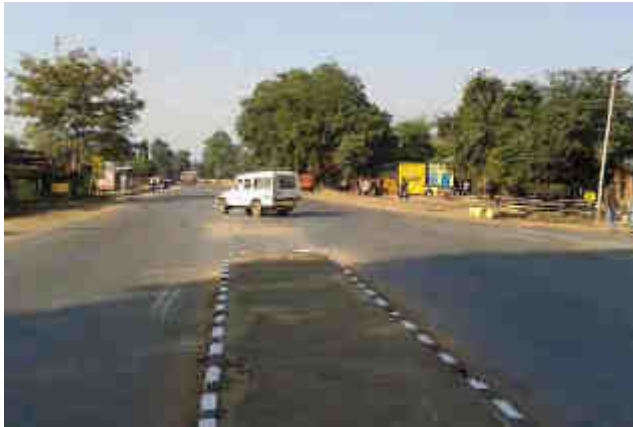
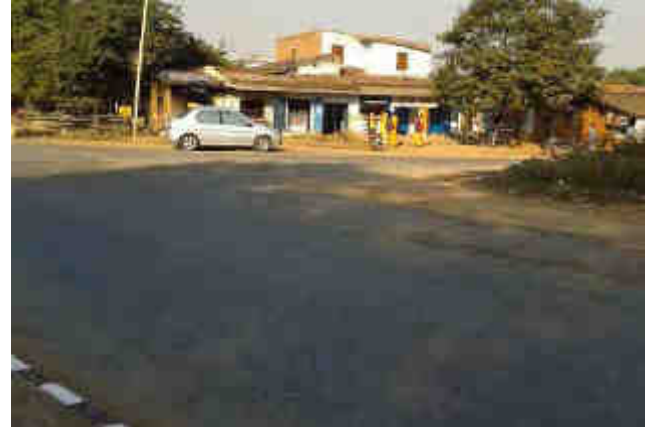
Km 0+000, intersection of SH-31 with NH-10

- SH-31 takes off from this place, i.e. Km 91+300 of SH-10 (Sudargarh-Rourkela road) forming a 3-arm intersection.
- At this intersection all the approaches are divided by provision of median, and the acceleration and deceleration lanes are also provided but there are no islands to guide the turning traffic
- The edge lines and other lane markings pertaining to intersection layout are missing
- There are no traffic signs and direction signs at this intersection
- There is built-up area with a few small shops/ hotel at the intersection
- The intersection is free from any encroachment and on-street parking, however buses stop on the road near intersection obstructing the flow and visibility of through traffic.
- There is no footpath or pedestrian crossing at this junction.

Reasons for concern: **Poor Junction layout**
The junction layout at both the junctions is non-standard and has no control over the traffic movement. It is confusing who has priority in such a situation. This encourages lawless traffic movement and is hazardous.

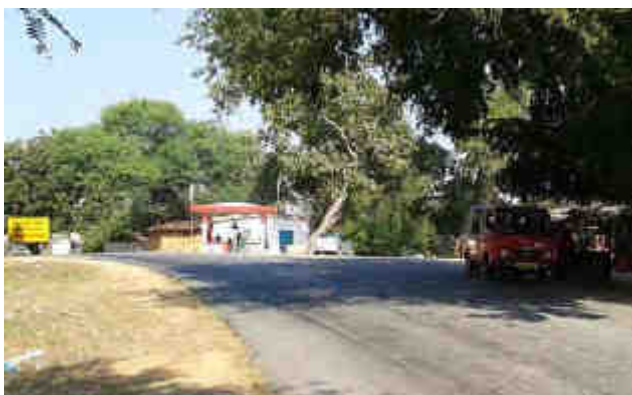
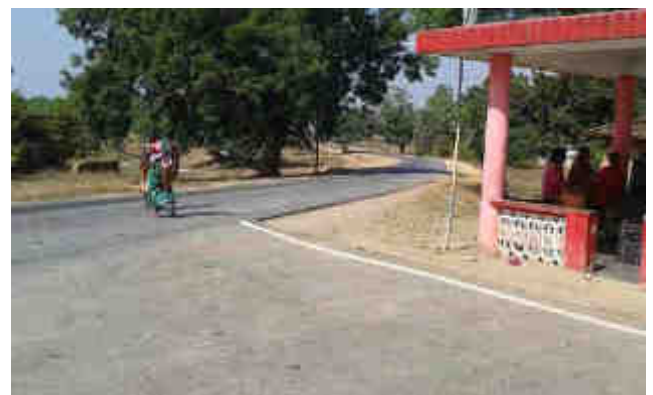
Km 23+800, intersection of SH-31 with

- SH-31 intersects with MDR connecting Talsara with Luhakera near Orissa/ Chattisgarh border.
- The layout of this intersection is non-standard y-type on the horizontal curve.
- There is no control over traffic movement and the building in middle of intersection obstructs the visibility of approaching traffic.
- There are no direction signs and the layout is confusing as the MDR looks like major road and the SH-31 is joining from RHS.
- There is no built up area at the intersection except the building in the middle of intersection.
- There were few auto-rickshaws parked on the road.
- There is no provision for VRUs at this intersection.
- There are no street lights at this intersection.

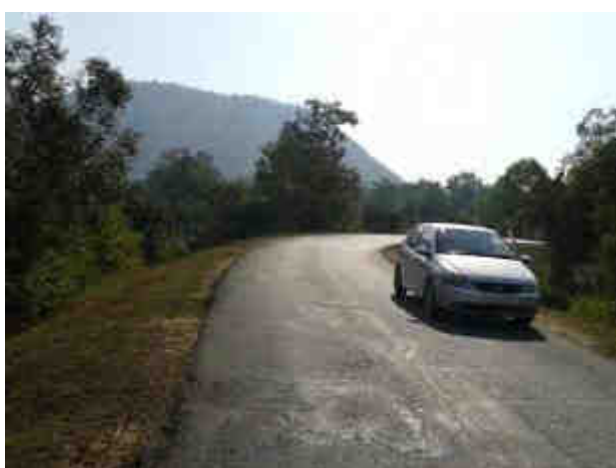
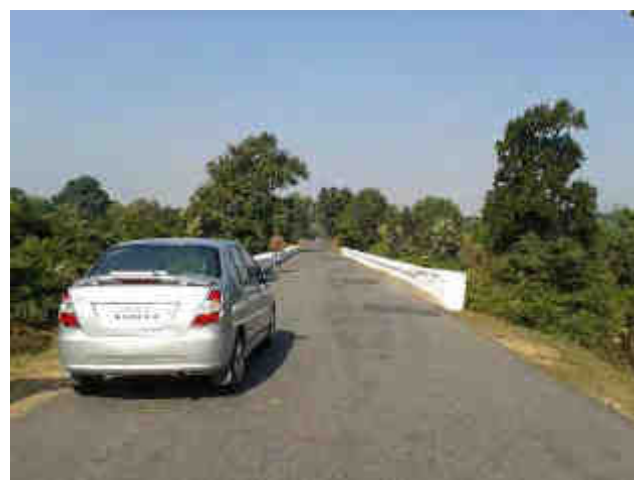
Unprotected approach to bridge with high embankment, Km 6+100

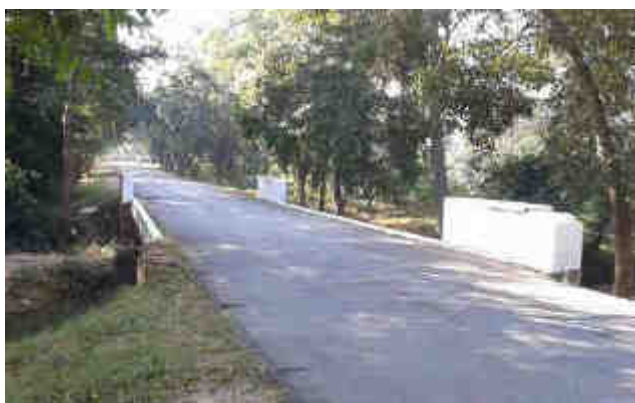
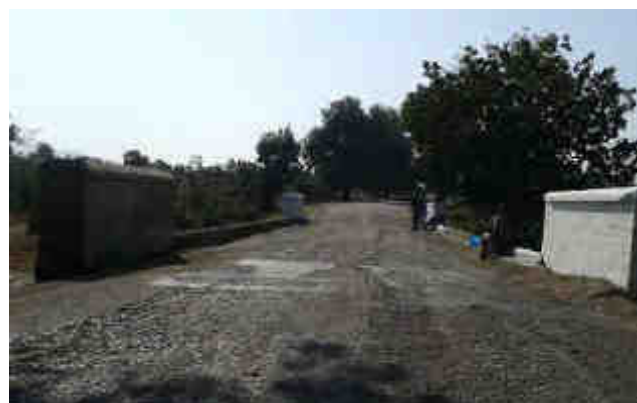
Parapets on Culvert/Bridge highly unsafe for VRUs as well as other traffic, Km 2+700 and Km 8+800

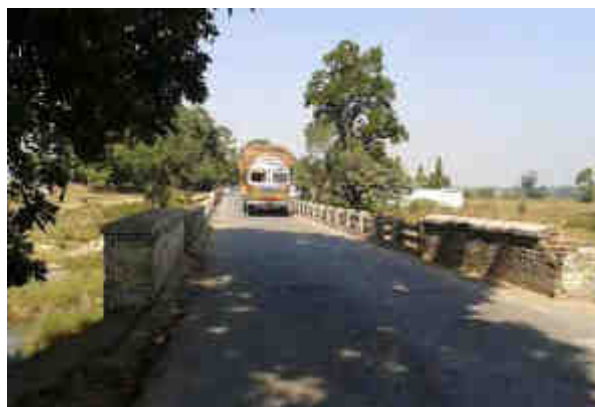
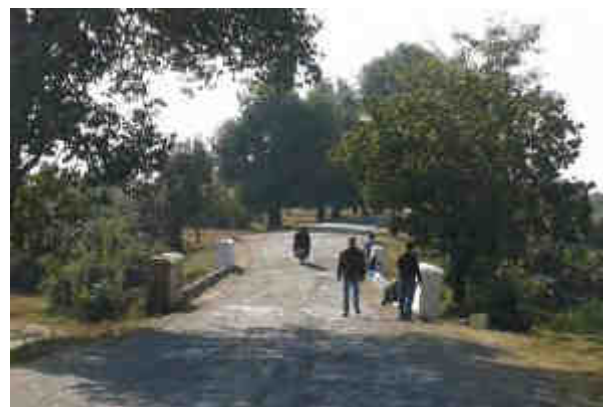
Parapets of Culvert/Bridge not delineated, Km 13+700 and Km 8+800

Reasons for concern:	<p>No delineation of culvert/bridge parapets</p> <ul style="list-style-type: none"> The culvert/bridge parapets adjacent to high speed traffic movement are hazardous especially at night if not delineated as the driver cannot judge the position of such road side hazards.
Recommendations:	<ul style="list-style-type: none"> Provide edge line markings and Object Hazard Marker (OHM) on both sides and for both approaches (i.e. Four numbers of OHM for each structure) <p><i>Refer to Appendix III for guidelines for installation of object hazard markers</i></p>
Reasons for concern:	<p>Broken or missing parapets</p> <p>The absence of parapet on bridge/culvert increases the risk of vehicles falling in to the drain. The absence of parapets at such locations is hazardous for traffic, especially for VRUs.</p>
Recommendations:	<p>Provide continuous parapets on all culverts and bridges.</p>

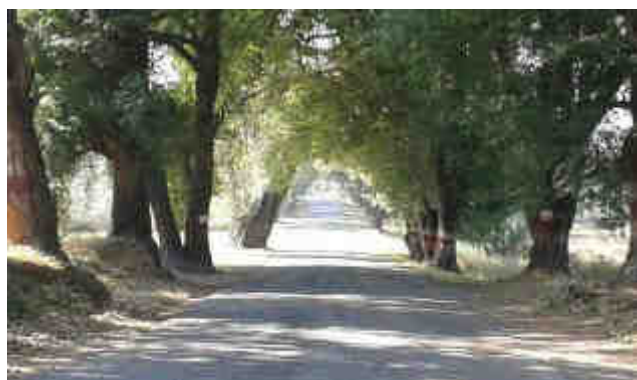
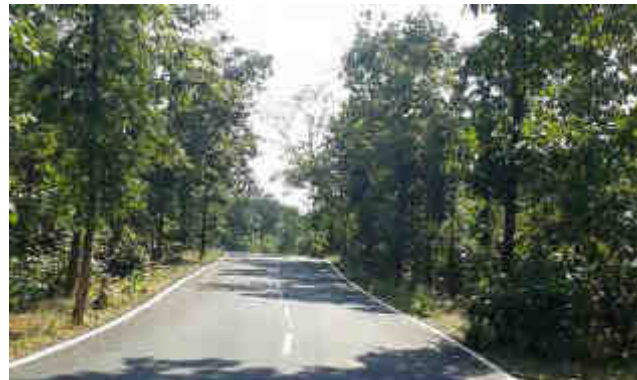
Trees very near to road edge Km 4+000 to 5+000, and in forest area Km 29+000 to 30+000

Reasons for concern:	<p>In the event of driver losing control, crashes with trees and other road side objects will lead to fatalities</p> <p>In the absence of delineation of road side objects, it is difficult to judge the road side objects and keep a safe distance during dark hours</p>
Recommendations:	<p>Desirable:</p> <ul style="list-style-type: none"> Remove Trees/ street lighting poles from the road shoulders Provide crash barriers on locations where trees acts as a significant hazard and where the space is available to install crash barrier

- Delineate the hazards by installing OHMs or painting of the trees in black and white strips
- Provide reflectors on Street lighting poles

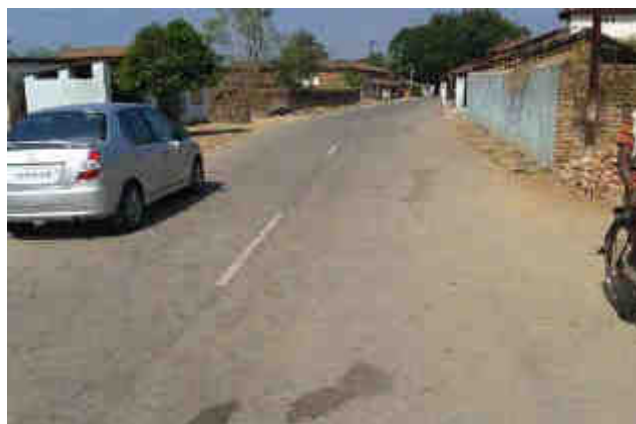
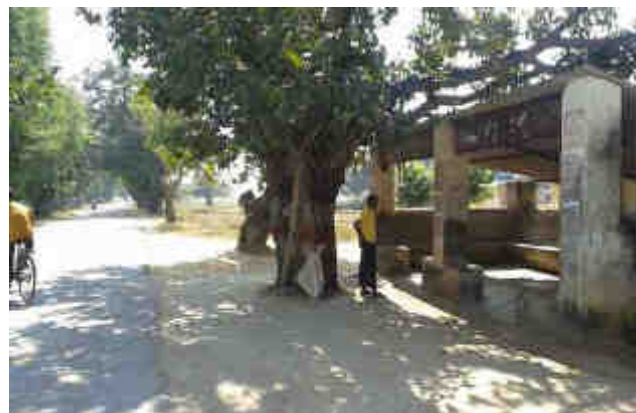
All the above listed BUA on SH-31 are small villages, but the presence of VRUs and their interaction with high speed traffic is significant. At few BUAs the buildings and boundary wall are very close to the road edge. There is no facility for VRUs such as pedestrian crossing or footpath in any of the above listed BUAs. At none of the above mentioned locations the street lights are provided.

Built up area from 27+000 to 27+400 and Km 20+400 to 20+600 – buildings very near to road edge, and access to bus stop obstructed by tree

- No traffic calming measures are provided to slow down vehicles approaching at high speeds to the built up area
- Significant pedestrians including school children are noted, but no separate pedestrian facilities are provided along the road inside the BUA or to cross the road
- No street lights are provided in the BUA
- Significant number of access roads within the BUA, the visibility of which has been hampered due to shops/ establishments on all corners of the junction
- No road markings or warning signs to warn/ inform the road user of the built up nature of the area ahead
- No speed limit signs provided
- On street parking hampers the visibility and resulting in unsafe situations
- On street bus stops observed, which hampers visibility and unsafe overtaking

- Recommendations:**
- Provide Gateway signs at before start and after the end of BUA
 - Provide pedestrian crossings, wherever deemed necessary
 - Provide footpaths in urban areas
 - Provide well maintained wide shoulders (min. 2m wide), free of encroachments and overgrown vegetation in roadside villages in rural areas
 - Provide STOP' signs with road humps on all access roads in roadside villages in rural areas
 - Provide 'School Ahead' and 'SLOW' signs on appropriate locations near schools
 - Provide designated parking spaces, where it deems necessary
 - Provide Bus Bays/ Bus Stops as appropriate, with associated road markings and traffic signs

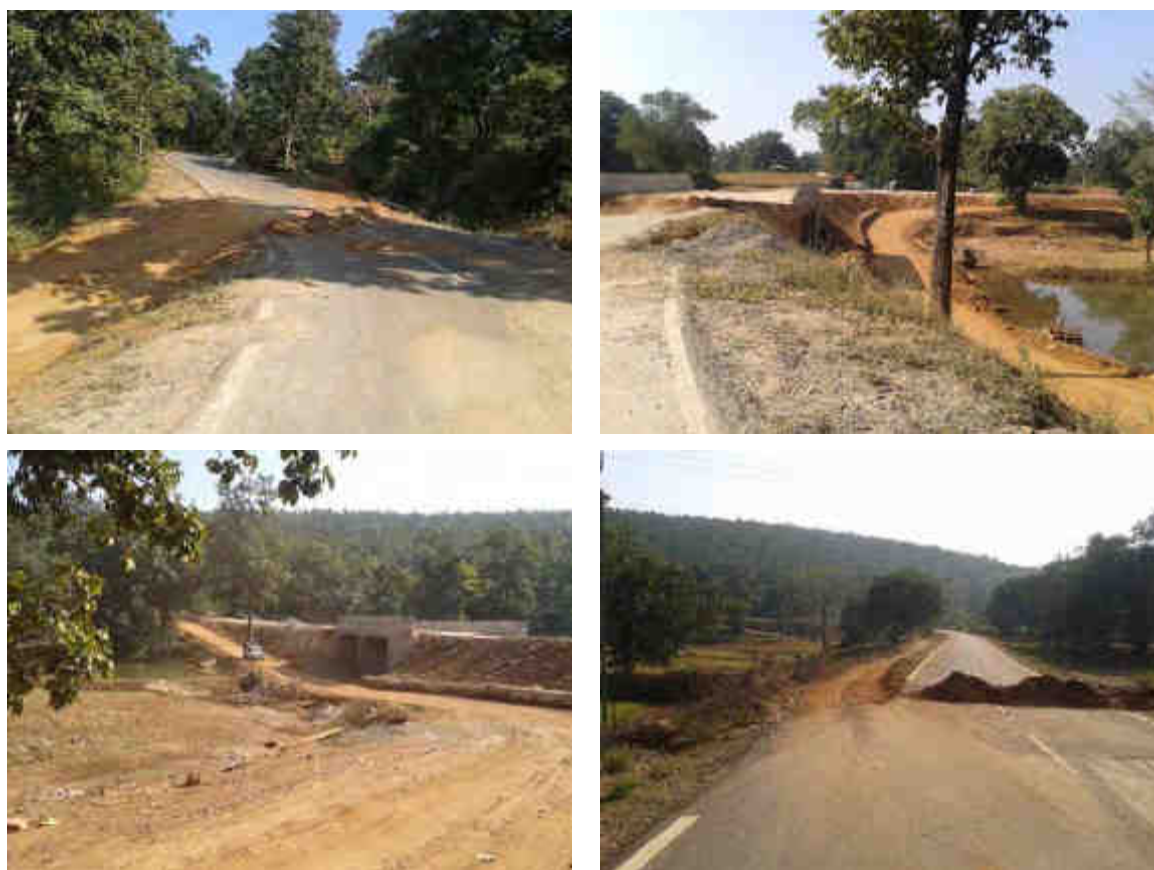
Km 31+800 – Traffic diversion at the site of construction of culvert

- The traffic diversion is very unsafe for traffic as there are no warning signs and delineators.
- During night time the site is very hazardous as there is no provision for illumination of the site.

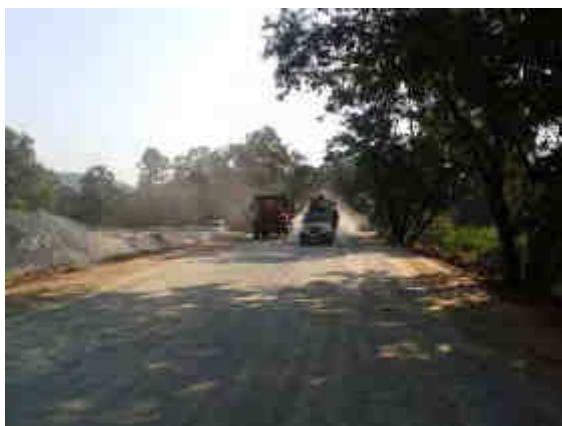
Road construction Km 35+000 to 36+000

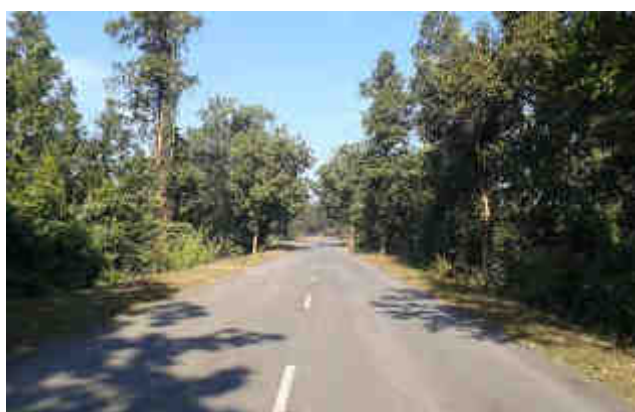
Lack of edge line in the stretch from Km 4+000 to 5+000

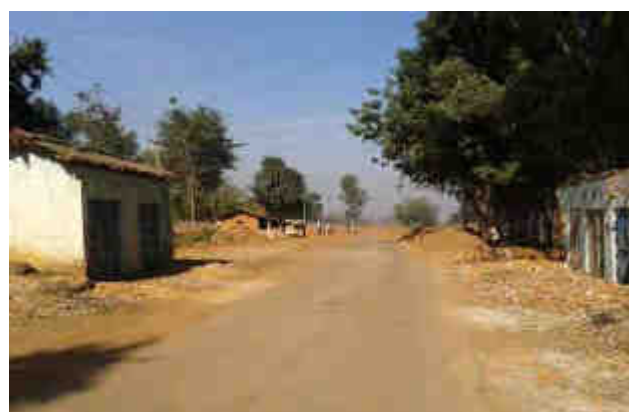
Lack of center line and edge line in the stretch from Km 12+000 to 13+000

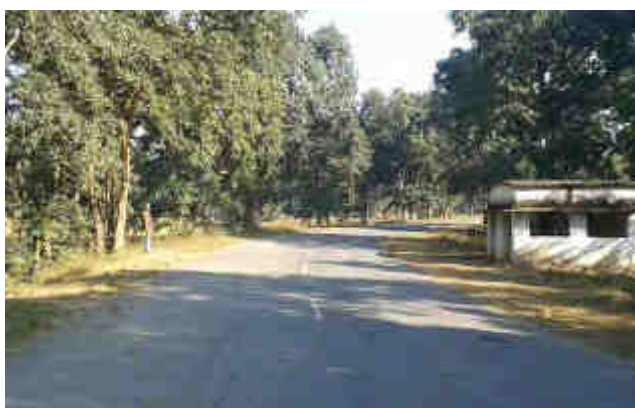
Sharp curve with restricted visibility due to building, Km 3+800

Reasons for concern:	<p>No warning signs/ delineation to inform the road user to make him/ her slow down to negotiate the curve in a safe speed, which in the worst case may lead to:</p> <ul style="list-style-type: none"> • Potential run-off accidents • Potential head-on collisions
Recommendations:	<p>Provide curve warning signs, chevron signs, delineators and speed limit sign as appropriate</p> <p><i>Refer to Appendix III for guidelines on situations where to install the above.</i></p>
Reasons for concern:	<p>Overtaking on such curves may lead to head-on collision</p>
Recommendations:	<ul style="list-style-type: none"> • Provide “no-overtaking” mandatory signs • Provide continuous centerline • Provide extra widening (sealed shoulder)
Reasons for concern:	<p>Sharp curve with high embankment (Km 9+200) without safety barrier</p> <ul style="list-style-type: none"> • Run-off accidents on high embankments will lead to fatalities

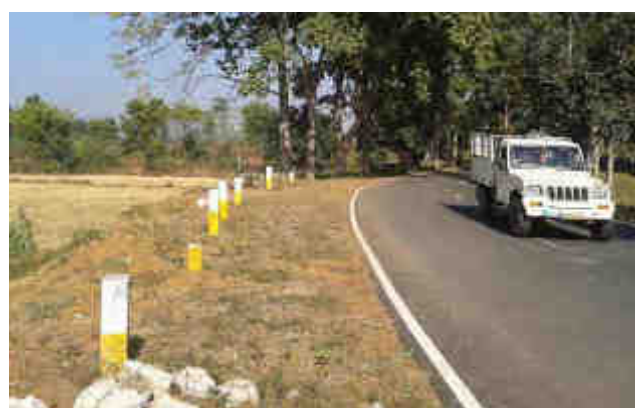
Sharp curve on high embankment without edge protection, Km 9+200

Recommendations:	<p>Provide metal beam crash barrier with delineators on sharp curves in high embankment</p>

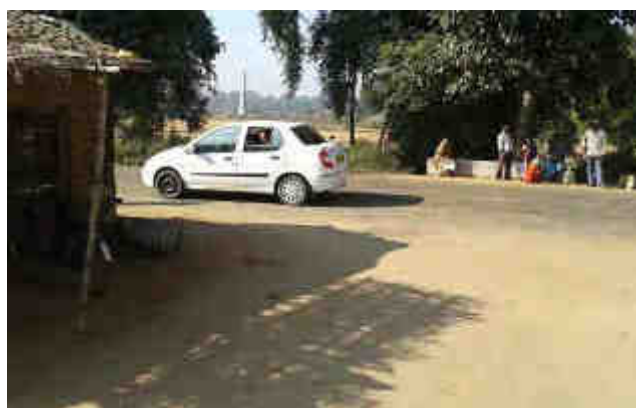
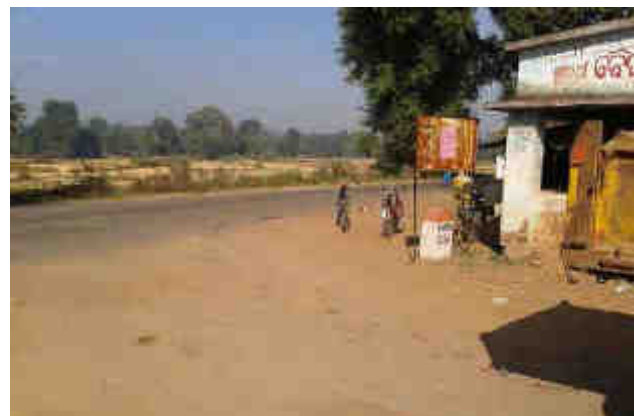
Side road joining at Km 7+100 – visibility restricted due to buildings on both the corners(view from side road)

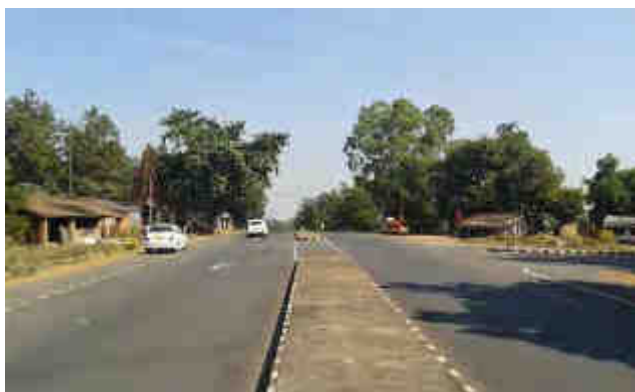
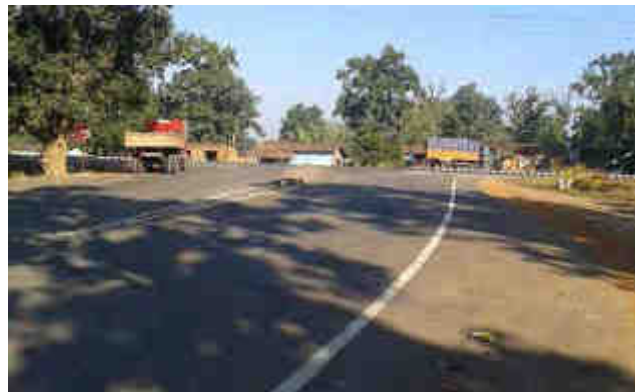
Km 0+000, intersection of SH-31 with SH-10

- SH-31 takes off from this place, i.e. Km 107+700 of SH-10 (Sudargarh-Rourkela road) forming a 3-arm intersection.
- At this intersection all the approaches are divided by providing median, and the acceleration and deceleration lanes are also provided but there are no islands to guide the turning traffic.
- The edge lines are provided but lane markings pertaining to intersection layout are missing.
- There are no traffic signs and direction signs at this intersection.
- There is no built-up area, except a few small shops/hotel at the intersection. The intersection is thus free from any encroachment and on-street parking.
- No footpaths or pedestrian crossings are provided at this intersection.
- No street lights are provided at this intersection.

The channelization at the junction has been provided in the form of splitter islands, however some of these are non-standard type and unsafe for pedestrians.

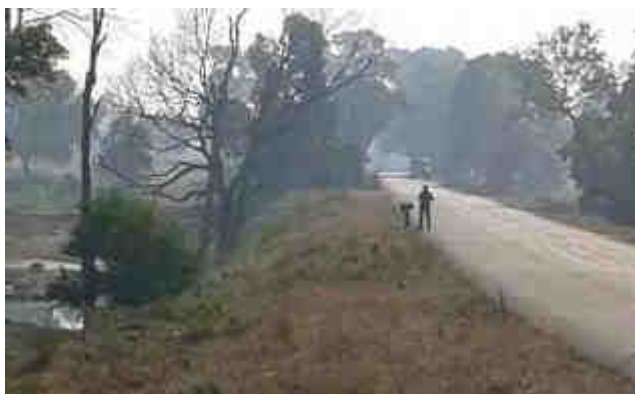
Unprotected approach to bridge with high embankment, Km 6+500

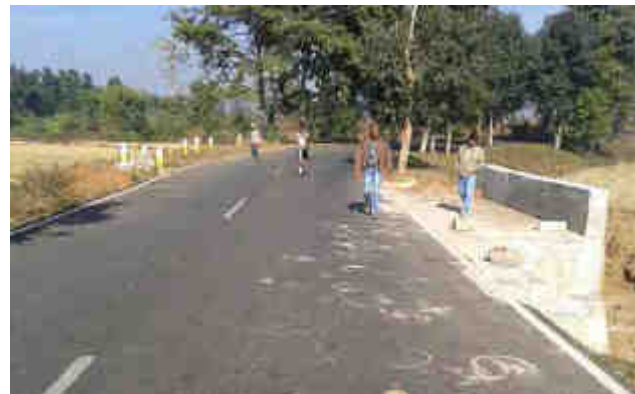
Unprotected approach to culvert under construction – lack of warning signs and barricades, Km 9+200

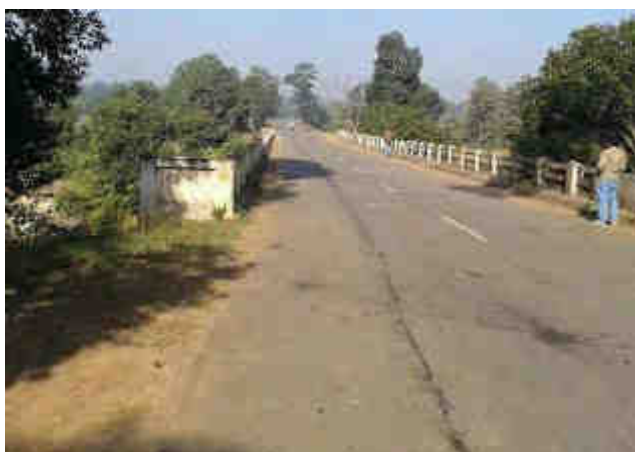
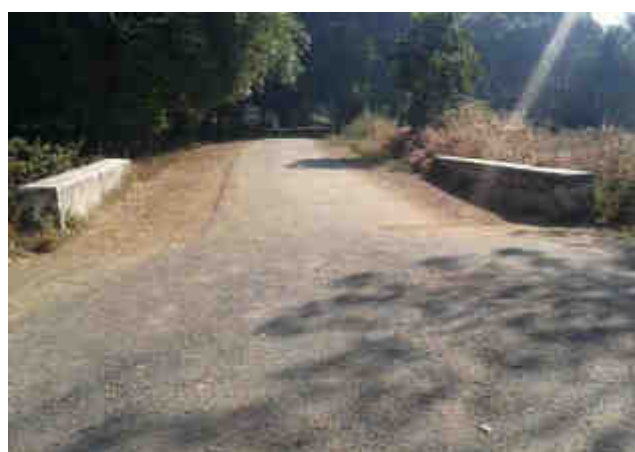
Parapets of culvert/bridge not delineated, Km 6+500 and Km 9+400

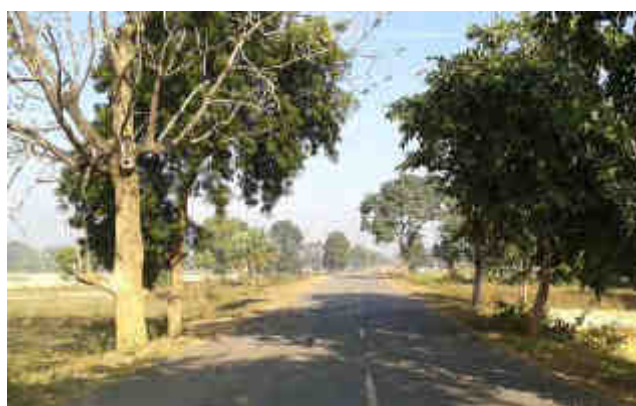
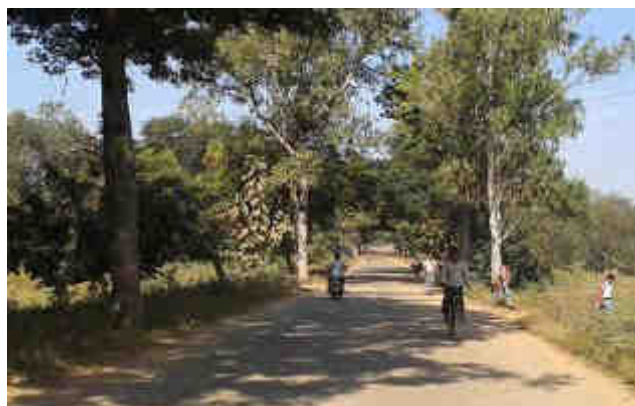
The trees observed near road edge were in the range of 1 to 3m in the stretch from Km 7+000 to 8+000 and near the Bamra town as shown in photographs below. Except for these two stretches the trees were noted to be greater than 3m away from the road edge.

Trees near the road edge, Km 7+000 to 8+000 and near Bamra town

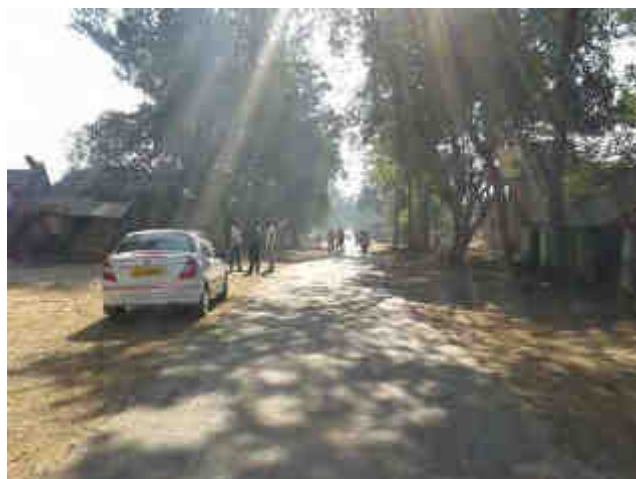
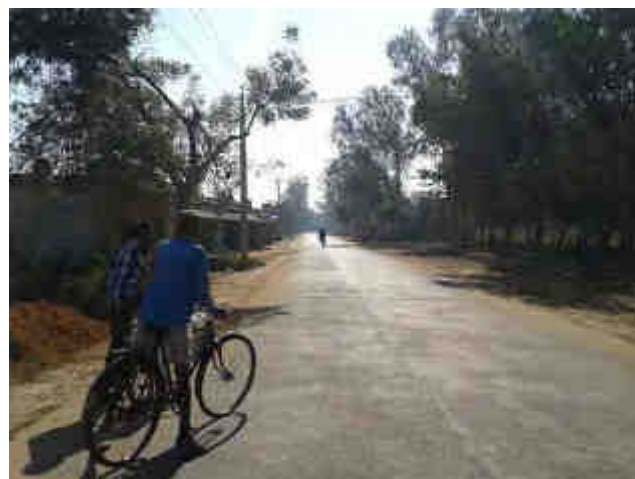
Built-up area of Bamra

There are no built-up areas on this road section except the stretch of road (Km 13+600 to Km 14+000) passing through Bamra town. At this location, the section of road observed to be congested due to shops and residences on both sides of the road. There are no facilities for VRUs such as pedestrian crossing or footpath in this BUA.

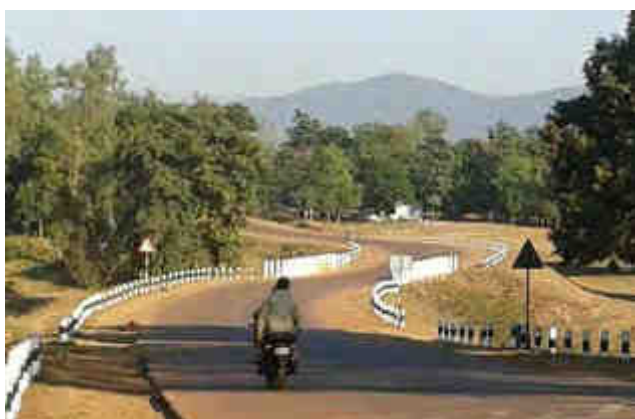
Reverse curve at Km 42+850

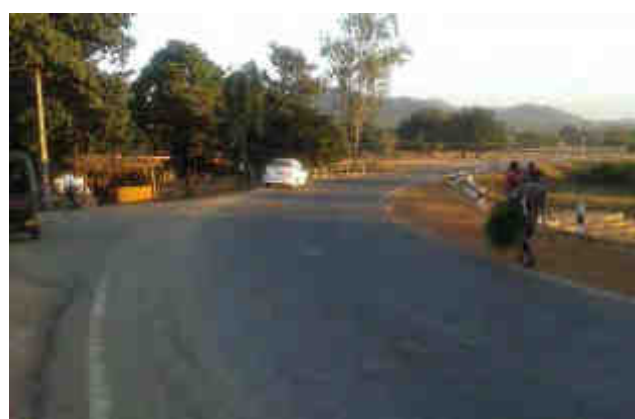
Sharp curve with BUA and access road (LHS),
Km 27+900

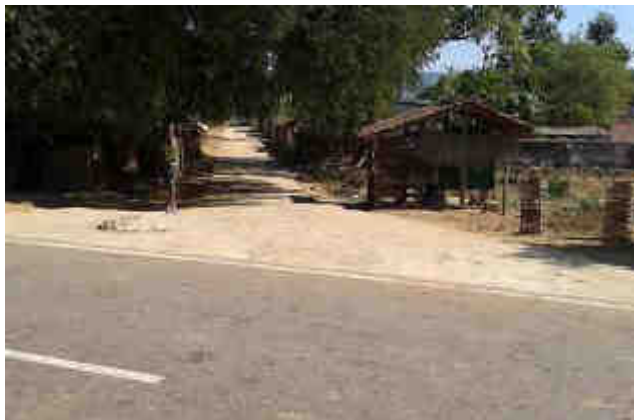
Side road joining with steep gradient at Km 27+000

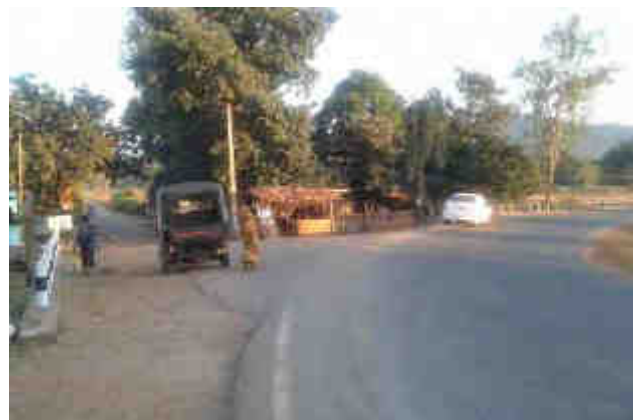
Side road joining on curve at Km 27+900

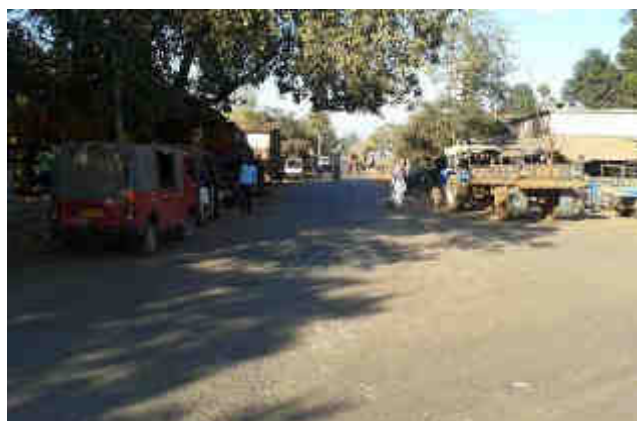
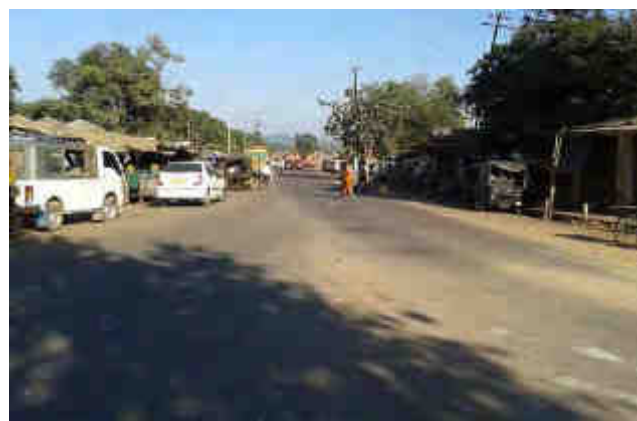
Km 48+500, intersection of SH-10A with NH-520

- The layout of this intersection is non-standard Y-type and no control has been established
- Many vehicles are parked on the road obstructs visibility of approaching traffic.
- There is main market of Lahunipara village around this intersection and hence there are many shops and roadside hotels encroaching the shoulders.
- Buses and 4-wheeler passenger vehicles were observed stopping on the road for passenger pickup/drop-off.
- There are no provisions for VRUs at this intersection despite of significant number of VRUs present.
