**Government of Odisha (GOO)
Chief Engineer, World Bank Projects, Odisha
Odisha State Roads Project**

**Consultancy Services for
Road Sector Institutional Development
Loan # 7577-IN**

**ROAD INFRASTRUCTURE
SAFETY MANAGEMENT REVIEW**

VOLUME I - REPORT

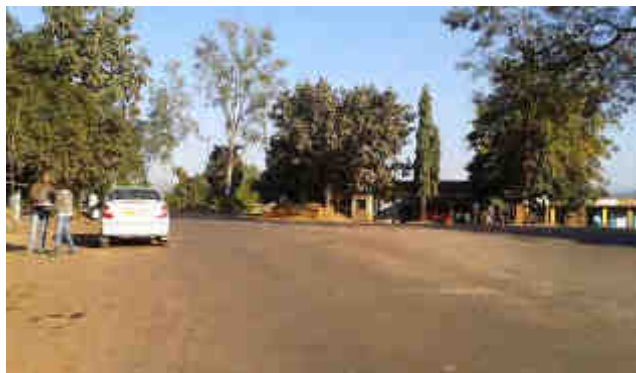
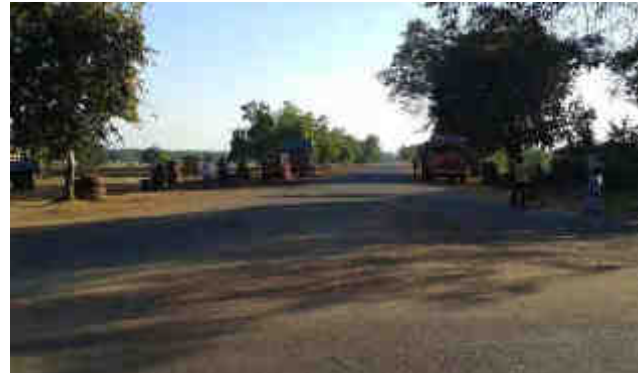
Km 43+200, intersection of SH-10A with Kaleiposh-Koida ODR

- The layout of this intersection is non-standard, and there is no control over traffic movement.
- There are no lane markings or traffic channelization at this intersection.
- The direction sign board is on the arm of Kaleiposh-Koida road which is not visible to traffic approaching from Lahunipada arm of SH-10A.
- There is no provision for VRUs at this intersection.

- The junction layout at both the junctions is non-standard and has no control over the traffic movement.
- It is confusing who has priority in such a situation. This encourages lawless traffic movement and is hazardous.

- Recommendations:**
- Provide direction signs to guide the traffic through the junction layout.
- Refer to Appendix III for guidelines for traffic signs and road markings on 3-arm intersection*

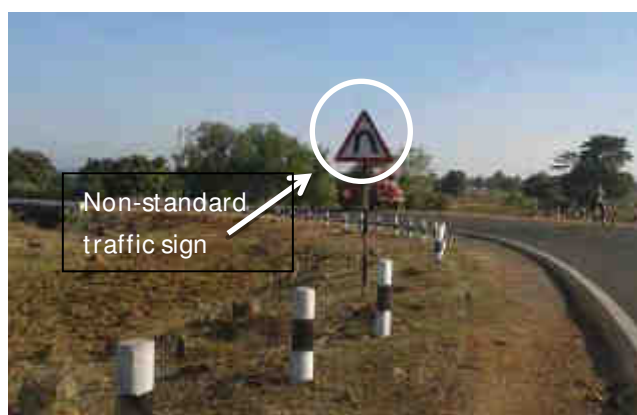
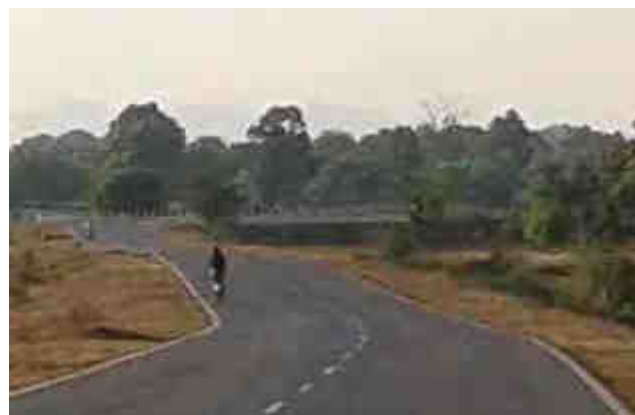
Approach to bridge with sharp curve, Km 46+900 and Km 33+500

- In the absence of adequate warning signs and reflective markings, the road layout and the hazard will not be clear for the road user, particularly during night conditions and in worst conditions, this will lead to serious injury/ fatal

- On outer edge of these curves Concrete Guard Posts (CGP) are provided to delineate the curve. As per international standards and practices, any concrete structure which is near the edge of road and larger by 10cm X 10cm in cross section is hazardous to the traffic. As the CGP provided on SH-10A are larger by 10cm X 10cm in cross section these may cause serious injury to the road user if the vehicle loses control negotiating the curve.

- Recommendation:**
- Provide curve warning sign in addition to crash barrier with delineators
 - Provide chevrons to delineate the alignment of sharp curve
 - Provide edge lane markings
 - Provide hazard markers on either edge of the parapets

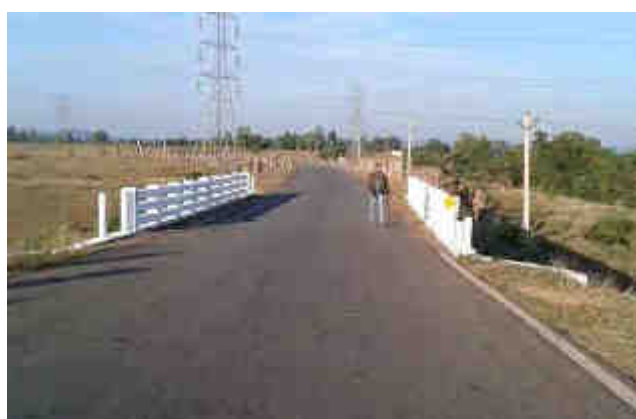
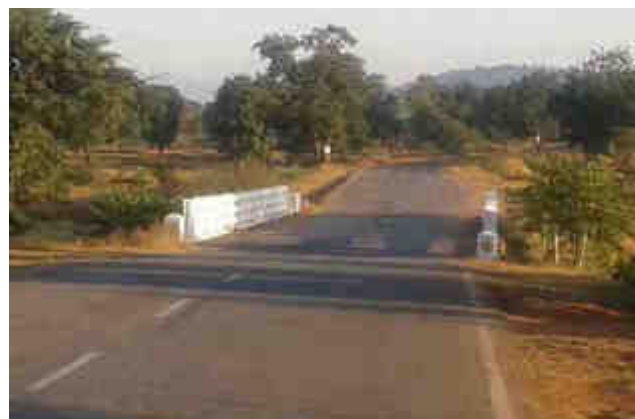
Parapets of Culvert/ Bridge not delineated, Km 38+500 and Km 30+200

Reasons for concern:	No delineation of bridge parapets <ul style="list-style-type: none">The bridge parapets adjacent to high speed traffic movement are hazardous especially at night if not delineated as the driver cannot judge the position of such road side hazards.
Recommendations:	<ul style="list-style-type: none">Provide edge line markings and Object Hazard Marker (OHM) on both sides and for both approaches (ie. Four numbers of OHM for each structure) <p><i>Refer to Appendix II for guidelines for installation of object hazard markers.</i></p>

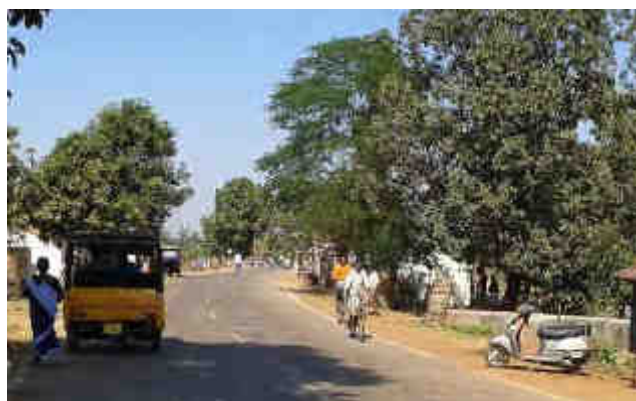
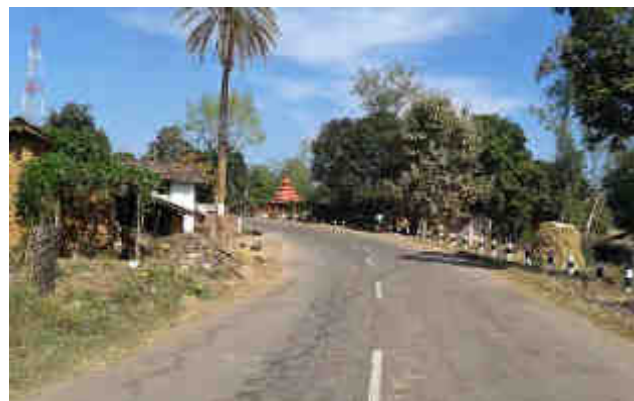
Built-up area on sharp curves, Km 23+600 to 23+400 and Km 21+600 to 21+300

Reasons for concern:	<ul style="list-style-type: none">No traffic calming measures are provided to slow down vehicles approaching at high speeds to the built up areaSignificant pedestrians including school children are noted, but no separate pedestrian facilities are provided along the road inside the BUA or to cross the road (except marked cross walk at few locations)Significant number of access roads within the BUA, the visibility of which has been hampered due to shops/ establishments on all corners of the junctionNo road markings or warning signs to warn/ inform the road user of the built
-----------------------------	---

- up nature of the area ahead
- No speed limit signs provided
- On street parking and bus stops were observed, which hampers visibility and leads to unsafe overtaking maneuvers.

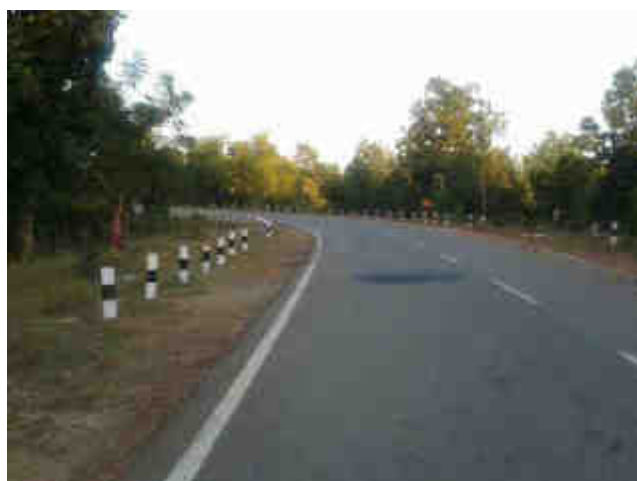
- Reverse curve at Km 27+000 where the radius of two curves noted to be less than 75m and the two curves are less than 100m apart
- There is a structure/building on outer edge of the curve which is very near to the road edge (at a distance of 2 to 3m)
- There is a culvert in between the two curves with partial parapet, however the depth of drain is shallow.
- Although for delineation of the curve, CGP are provided these may not be visible during night time.

1st curve of the reverse curve

- On outer edge of these curves Concrete Guard Posts (CGP) are provided to delineate the curve. These may not be visible (not retro-reflective) during night time.
- As per international standards and practices, any concrete structure which is near the edge of road and larger by 10cm X 10cm in cross section is hazardous to the traffic. As the CGP provided on SH-10A are larger by 10cm X 10cm in cross section these may be cause serious injury to the road user if the vehicle loses control negotiating the curve.

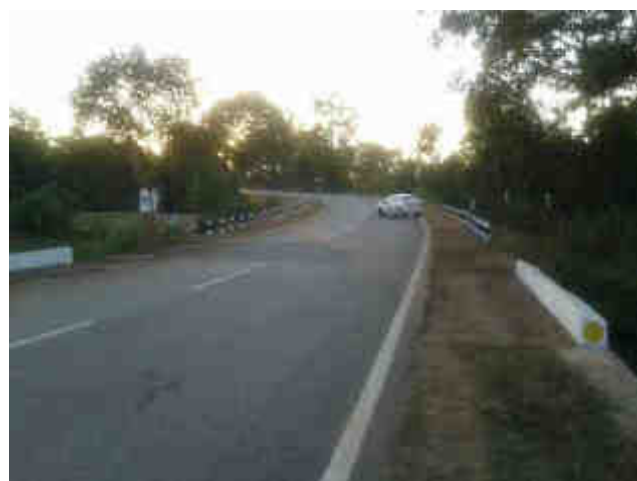
2nd curve of the reverse curve

Building very near to road edge

It was observed that the traffic approaching the curve was at higher speeds. In such situation the driver may not judge the alignment, lose control and hit the building.

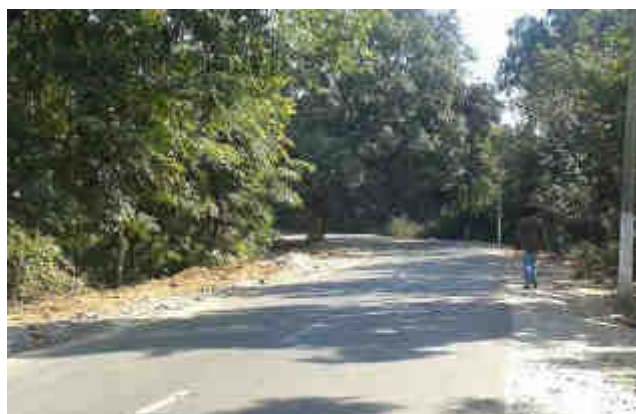
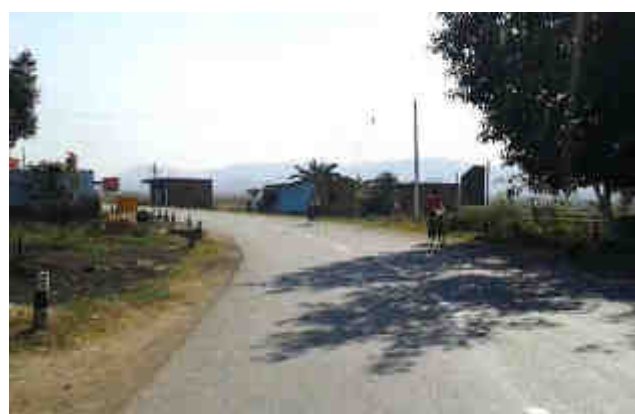
Sharp curve at Km 0+200 and Km 5+900

Reasons for concern:	No warning signs/ delineation to inform the road user to make him/her slow down to negotiate the curve in a safe speed <ul style="list-style-type: none"> • Potential run-off accidents • Potential head-on collisions
Recommendations:	Provide curve warning signs, chevron signs, delineators and speed limit sign as appropriate <i>Refer to Appendix III for guidelines on situations where to install the above.</i>
Reasons for concern:	Poor visibility on the curve due to trees and overgrown vegetation, which can lead to head-on collisions
Recommendations:	<ul style="list-style-type: none"> • Improve the line of sight by removing trees from the shoulder and cut down vegetation which hampers visibility along the curves
Reasons for concern:	Curves on high embankment without safety barriers noted. In the event of vehicles losing control, run-off accidents may happen leading to fatalities/ major injuries.

Recommendations:	Provide metal beam crash barrier with delineators on sharp curves in high embankment <i>Refer to Appendix III for guidelines on situations where to install the above.</i>

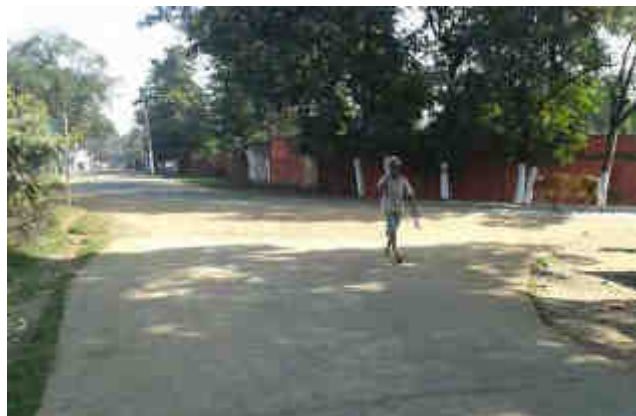
Side road joining on curve, Km 3+600
(view from side road)

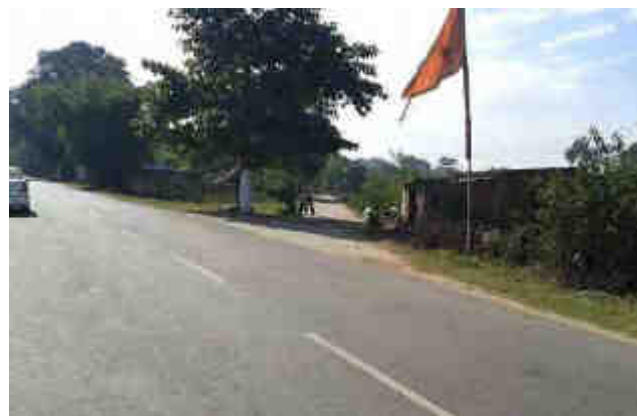
Side road joining at acute angle, Km 4+600

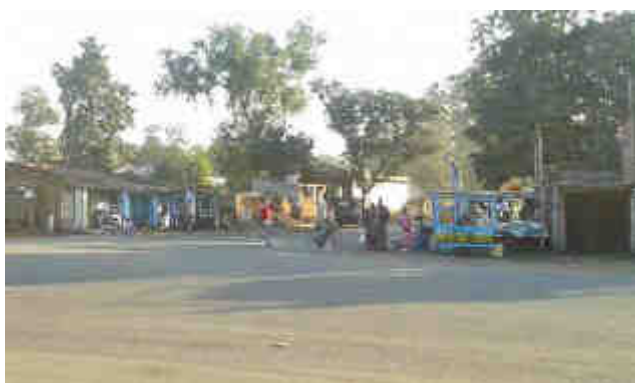
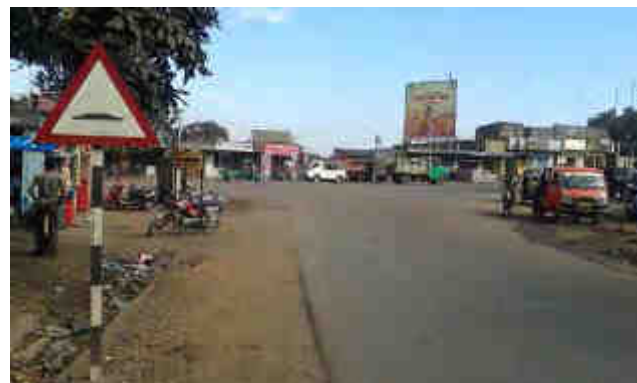
Km 0+000, intersection of MDR-26 with SH-10

- At this intersection there is no control over traffic movement despite of movement of heavy vehicles on both the SH-10 and MDR-26.
- No traffic signs or road markings at the junction to control, warn and inform the road user
- No facilities for VRUs were provided
- Junction is heavily built-up, and on street parking were observed
- As there are no bus bays/ designated bus stop, buses were observed to be stopping on the main road obstructing the visibility of approaching traffic.

- Recommendations:**
- Provide direction signs on approaches to the junction to guide the traffic through the junction layout.

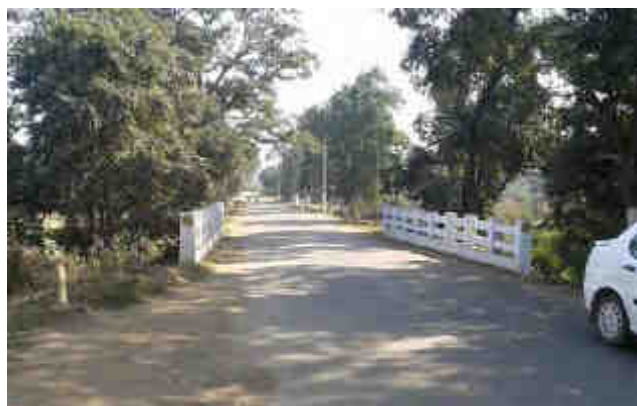
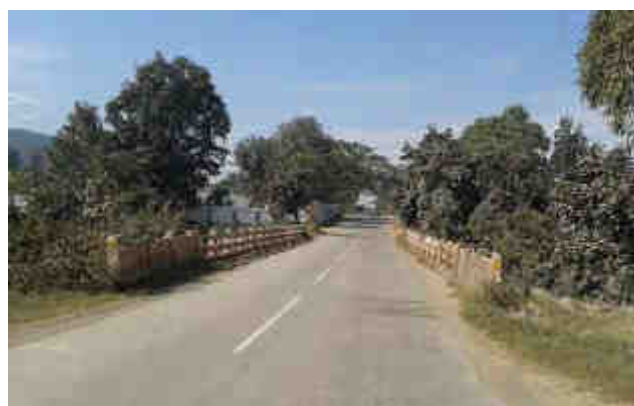
Parapets of Culvert/Bridge not delineated, Km 3+300 and Km 9+300

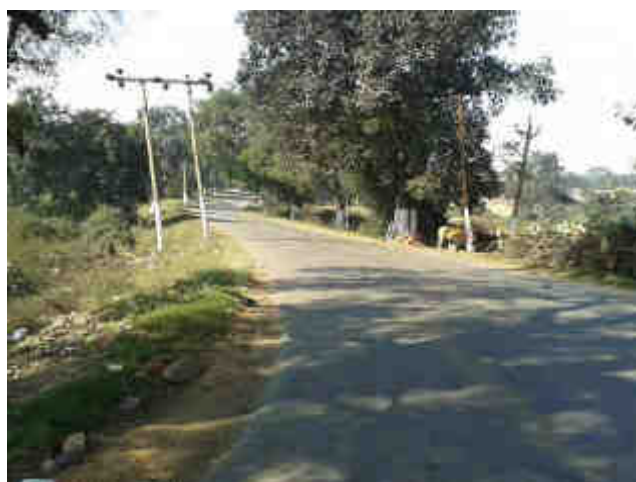
Trees and poles very near to road edge
 Km 3+000 to Km 4+000

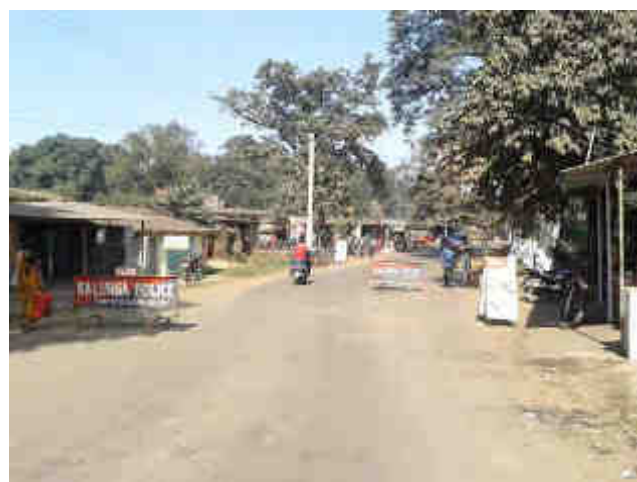
Buildings very near to road edge in BUA
 Km 3+000 to Km 4+000

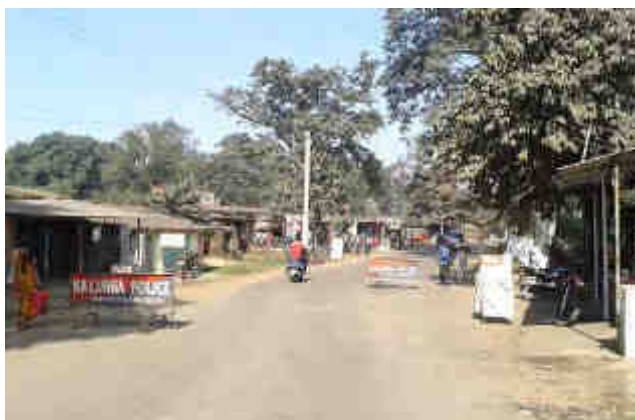
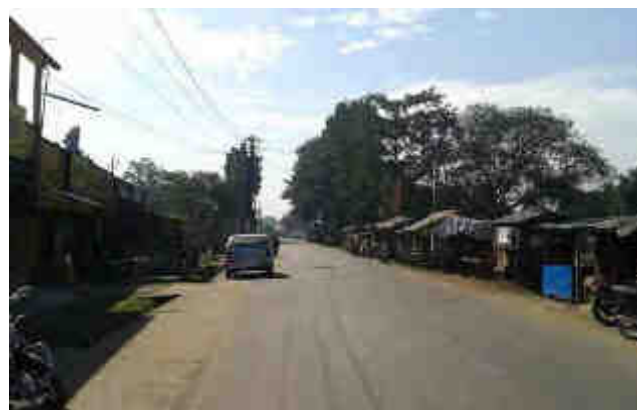
Built-up area of Kalunga town

Due to proximity to Rourkela and Kalunga Industrial Estate, there are many small industries on MDR-26 from **Km 0+800 to 3+600**. The BUA of Kalunga village is from **Km 3+600 to Km 5+000**. In both of these stretches there are a number of side roads (including industries access roads) join the MDR-26 without any proper treatment at the junction. In the Kalunga village there are commercial buildings on both the side which are very near to the road edge. Many vehicles were parked on both sides of road in the stretch passing through Kalunga village. There is no facility for VRUs such as pedestrian crossing or footpath in these BUAs. At none of the above mentioned locations the street lights are provided. There are no bus-bays and hence the buses were observed stopping on the road obstructing visibility and the smooth flow of traffic.

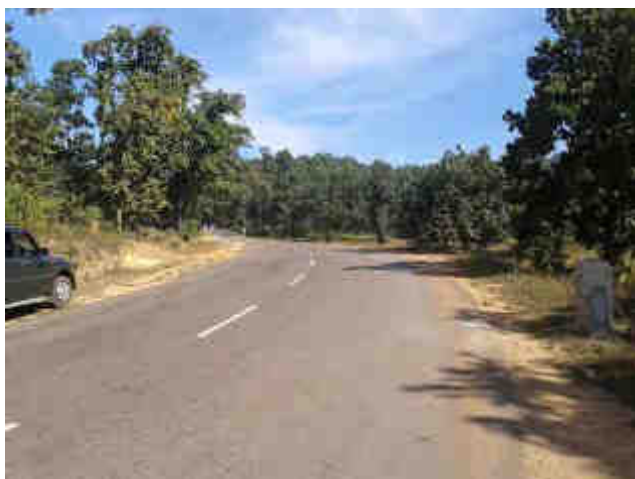
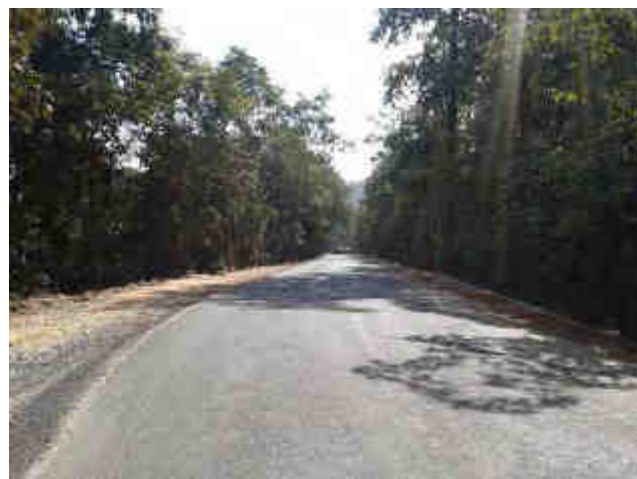
Lack of delineation in the stretch of (i) Km 34+000 to 35+000, and (ii) Km 30+000 to 31+000

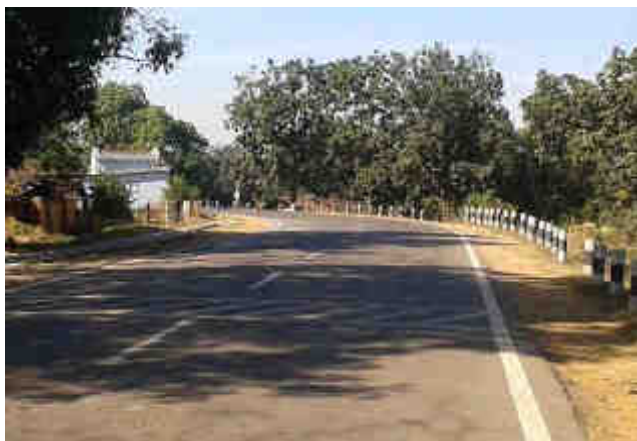
Sharp curve at Km 39+900

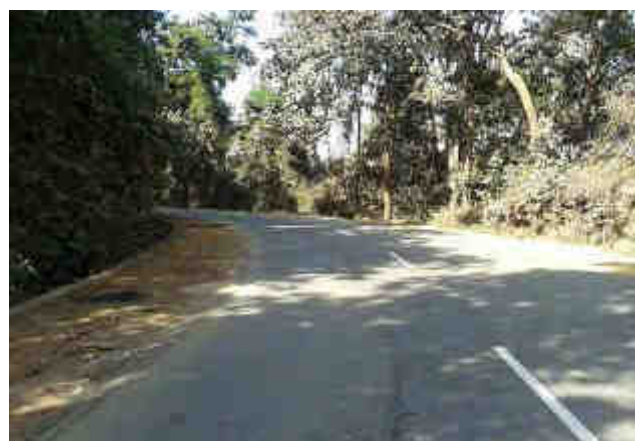
Sharp curve in ghat section at Km 30+200

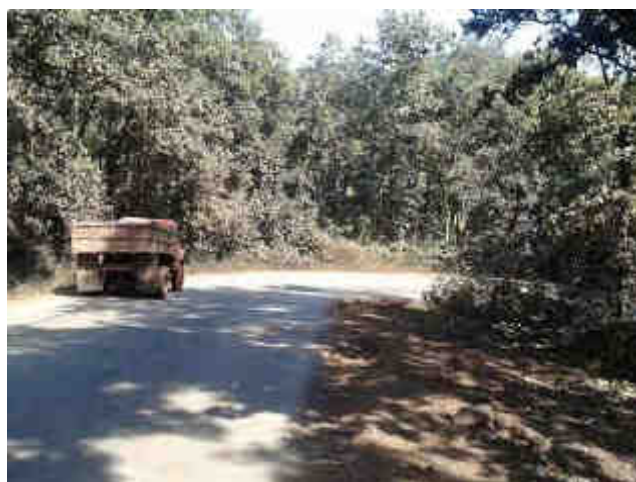
Hairpin bend with steep gradient at Km 22+100

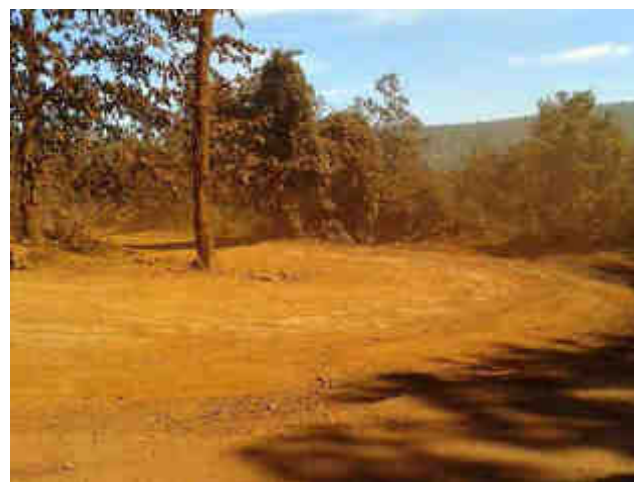
Hairpin bend with poor road condition at Km 11+400

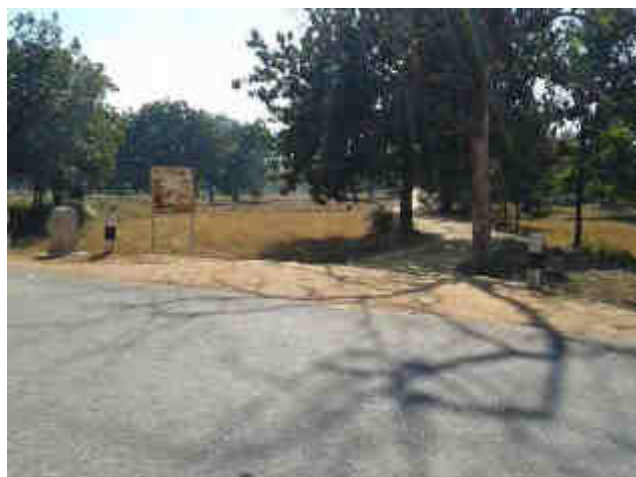
Side road joining with steep gradient Km 36+800

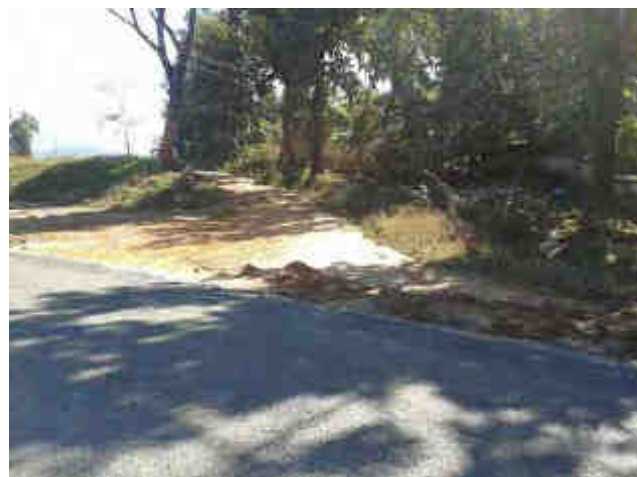
Side road joining at skew angle Km 24+350

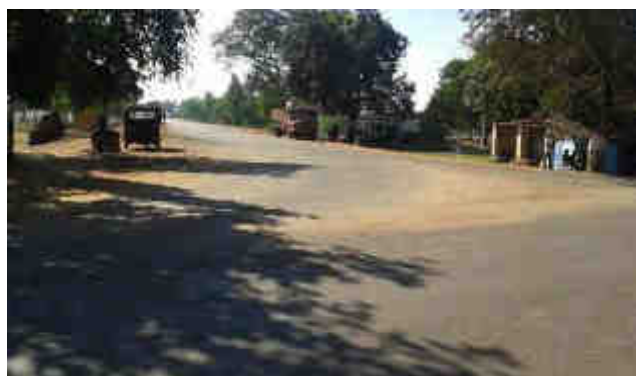
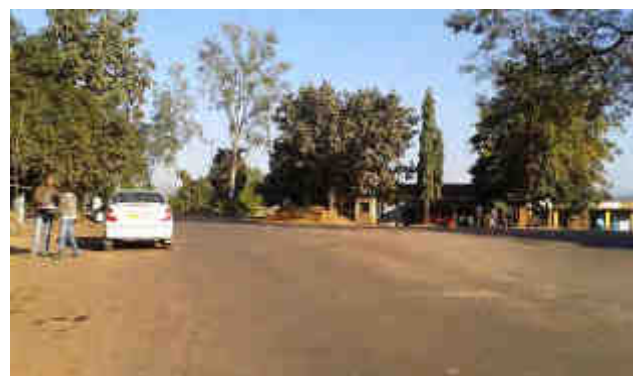
Km 41+200, intersection of ODR with SH-10A

- Poor layout and inadequate traffic control
- No facilities for VRUs at this junction
- The direction sign board is on the arm of Kaleiposh-Koida road which is not visible to traffic approaching from Lahunipada arm of SH-10A.
- Street-lights were not provided

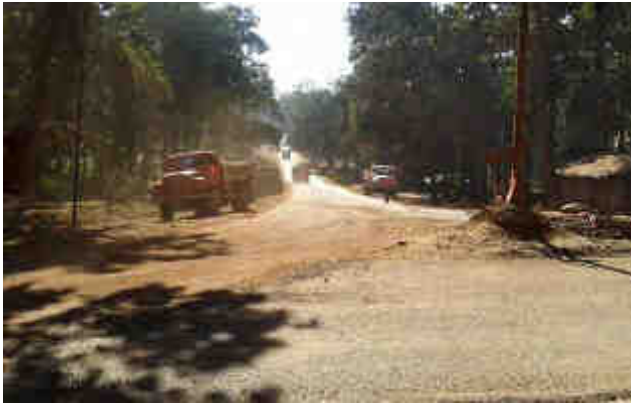
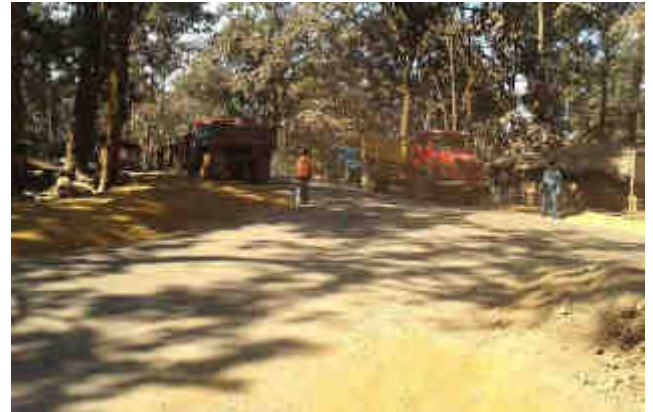
Km 23+650, intersection of ODR with Barsuan road

- This is a 3-arm intersection of ODR with Barsuan road.
- The junction layout is poor and no control over traffic movement despite of heavy movement of trucks on both the ODR and Barsuan road.
- There are no direction signs or advance warning signs for intersection.

- The condition of road surface is very poor at this intersection.
- There is no built-up area at the intersection except small roadside hotels near the intersection.
- There is no provision for VRUs at this intersection.

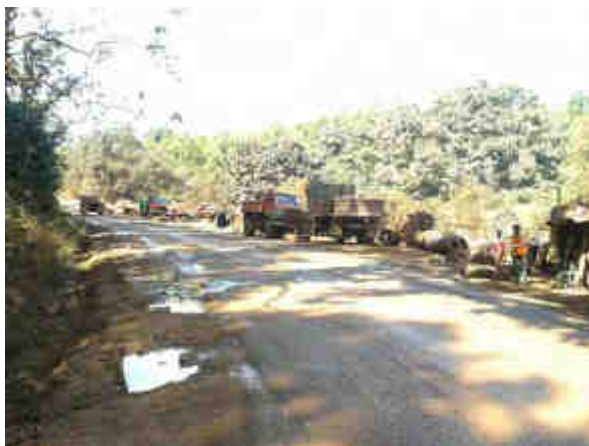
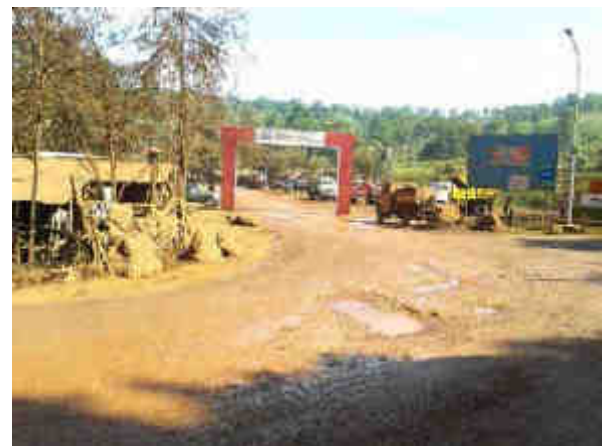
- This is a 3-arm intersection of ODR with road leading to Jndal mines and township.
- At this intersection there is no control over traffic movement despite of heavy movement of trucks on both the ODR and the road leading to mines.
- There are no direction signs or advance warning signs for intersection.
- The condition of road surface is very poor at this intersection.
- There are shops and roadside hotels at the intersection which are encroaching on the shoulder of road.
- There were many trucks parked on the approach of intersection due to shops and roadside hotel.
- There is no provision for VRUs at this intersection.

Km 14+000, intersection of ODR with road leading to Jndal mines and township – trucks parked on approach and gate of mines and township

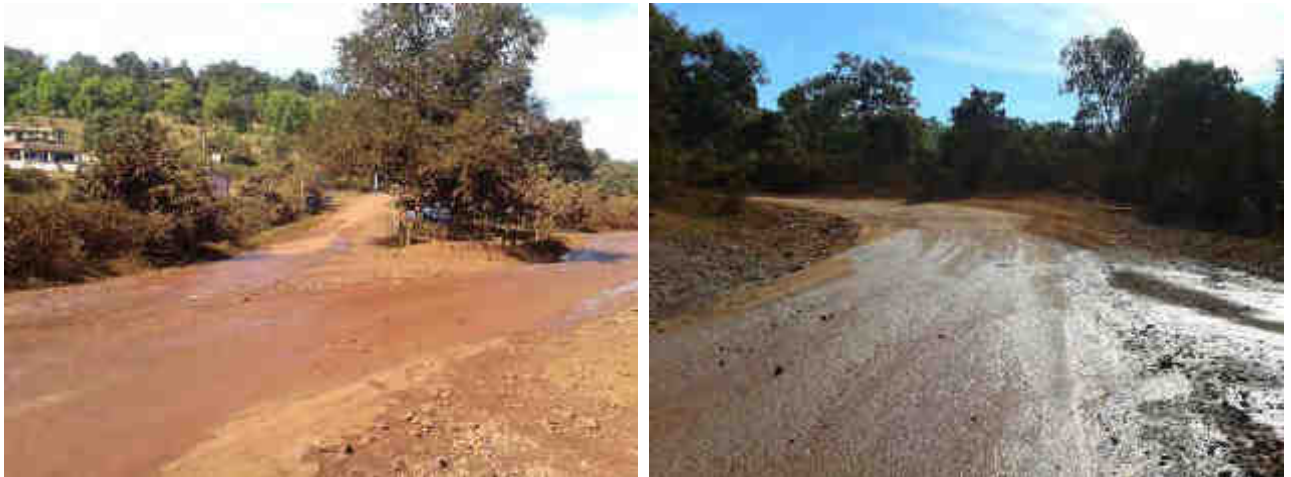
- This is a 3-arm intersection of ODR with road leading to mines of SAIL.
- The layout of this intersection is Y-type with a non-standard central island.
- The intersection is located very near to a hairpin bend where visibility of approaching traffic is severely restricted.
- There are no direction signs or advance warning signs for intersection.
- There is no built-up area around this intersection.
- There is no provision for VRUs at this intersection.

Km 13+600, Intersection of ODR with road from SAIL mines – trees in the central island and approach to intersection descending from the hairpin bend

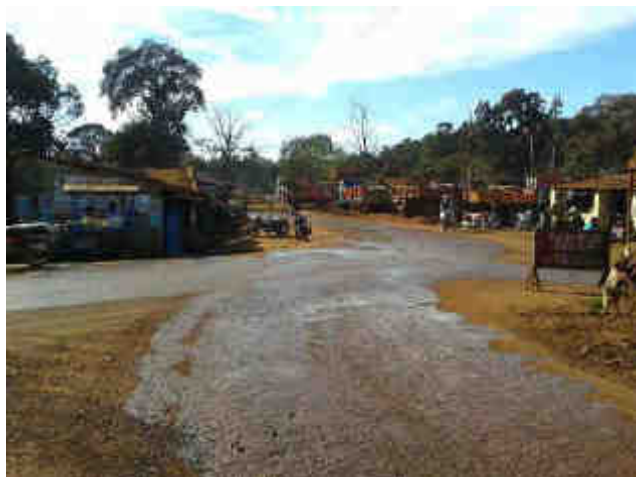
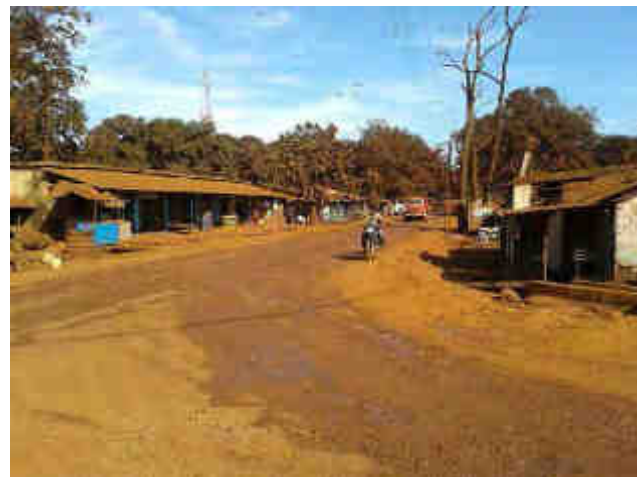
- This is a 3-arm intersection (within Koida town) of ODR with road leading to Joda town.
- There are no traffic island and lane markings to guide the traffic through layout of the intersection.
- As the intersection is within BUA of Koida town there is commercial area around and the buildings are very near to the road edge.
- There is on-street parking on all the approaches of intersection and the buses were observed stopping on the road obstructing the visibility of approaching traffic.
- There is no provision for VRUs at this intersection.
- There are no street-lights at this junction.

Km 0+000, intersection of ODR with Joda road in Koida

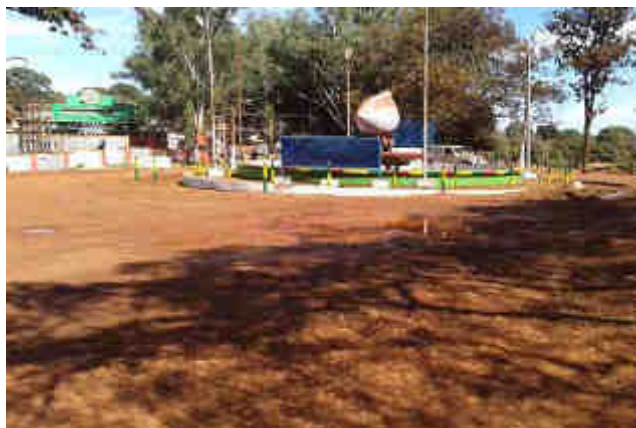
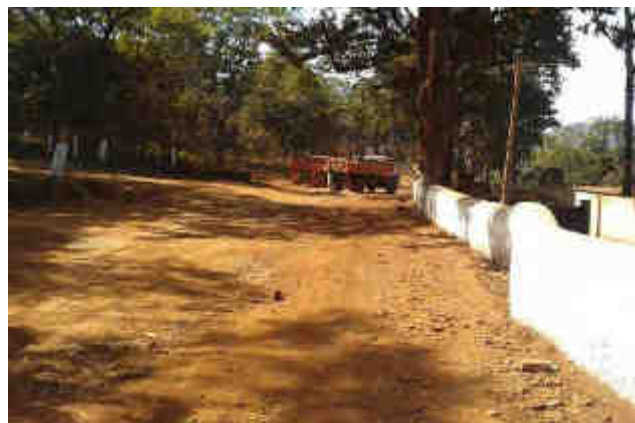
- This is a 3-arm intersection of ODR with road leading to Tensa township and mines.
- There is a round-about at the intersection.
- The condition of road surface is very poor and there are no lane markings or direction signs to guide the traffic through the intersection.
- The boundary wall of township is very close to the road edge.
- Two other access roads of SAIL guest house are joining ODR near the round-about without any warning or direction signs.
- There is no provision for VRUs at this intersection.

Km 12+350, intersection of ODR with township road – round-about and an approach

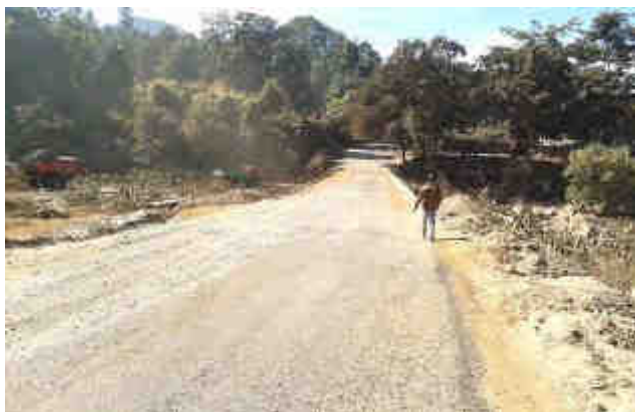
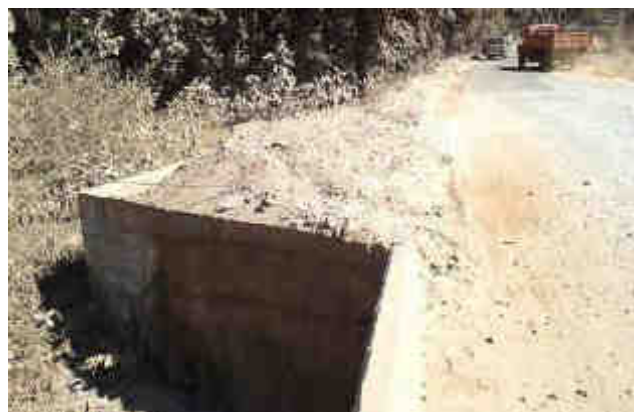
There is a causeway at **Km 24+000** where approaches are not protected and there are no parapets which may be hazardous for traffic.

Unprotected approaches to the causeway, Km 24+000

- If a vehicle approaching or traveling on the causeway loses control, it will fall into the ditch/drain in the absence of any protection, which may result into serious injuries or may prove to be fatal.

- Provide metal crash barriers on both the approaches and on the causeway (which will serve the purpose of parapet, but also allow the high water to overflow) with delineators.

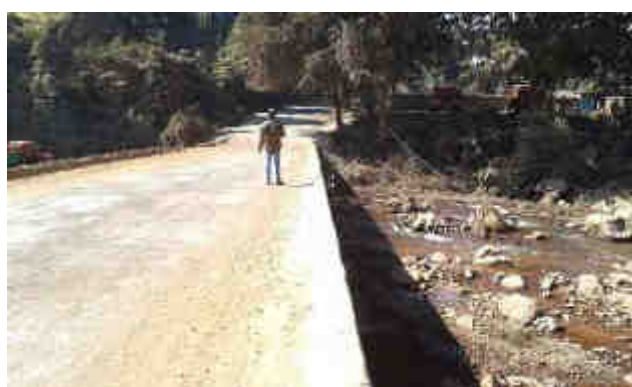
No delineation or edge protection on the causeway, Km 24+000

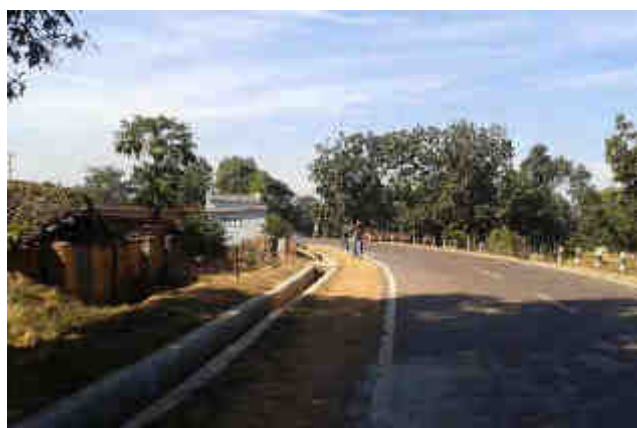
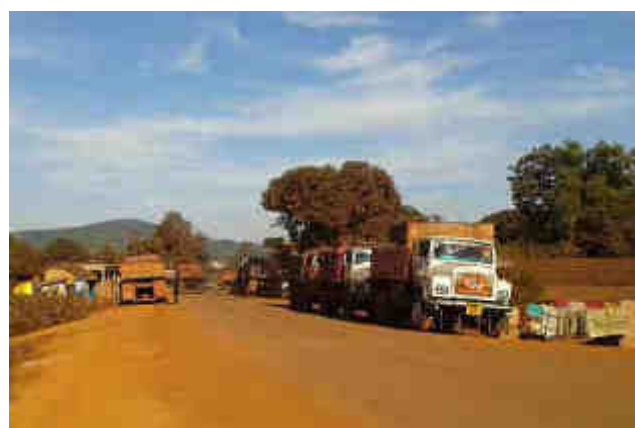
The presence of VRUs and their interaction with ODR is significant on all these BUAs on ODR. There is no facility for VRUs such as pedestrian crossing or footpath and there are no street lights in these BUAs. There are no bus-bays and hence the buses were observed stopping on the road obstructing visibility and the smooth flow of traffic.

Built-up area from Km 40+300 to 40+000 and Km 1+000 to 0+000 (Koida)

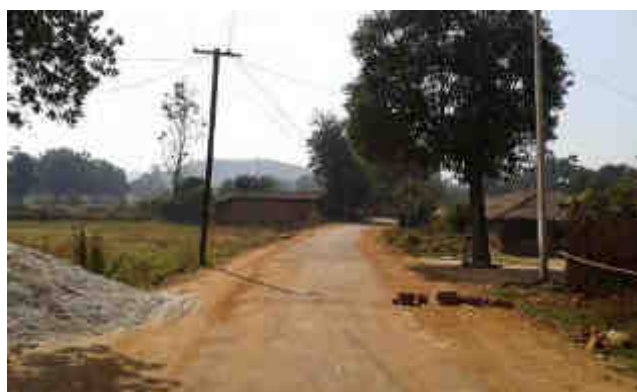
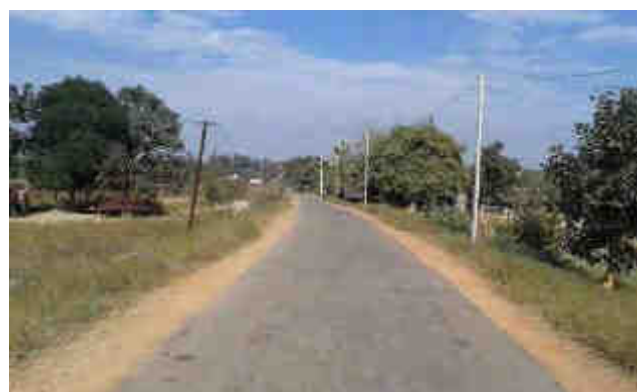
Lack of delineation on the entire stretch of road.
Photographs of stretches (i) Km 6+000 to 7+000, and (ii) Km 4+000 to 5+000

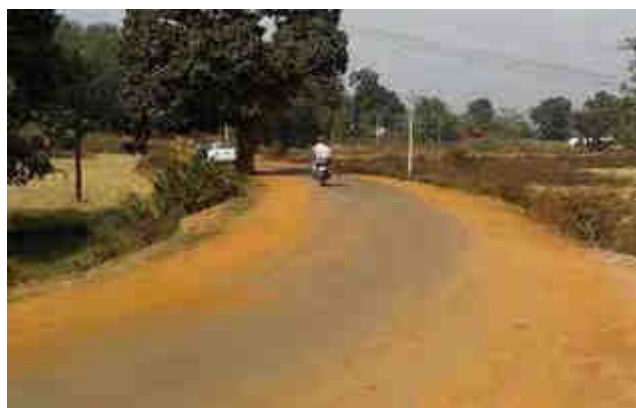
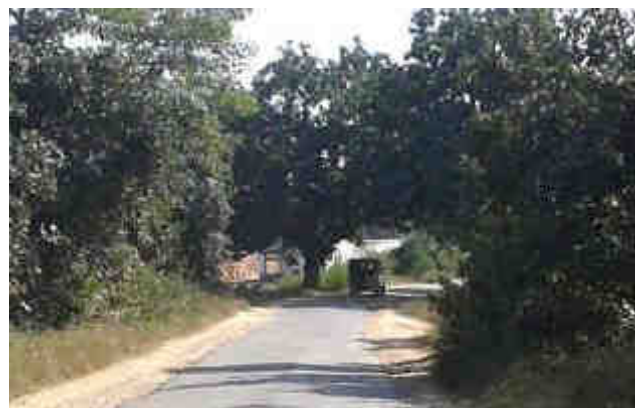
Sharp curve at Km 6+200 and Km 2+400

Reasons for concern:	No warning signs/ delineation to inform the road user to make him/her slow down to negotiate the curve in a safe speed
Recommendations:	Provide curve warning signs, chevron signs, delineators and speed limit sign as appropriate <i>Refer to Appendix III for guidelines on situations where to install the above</i>
Reasons for concern:	Poor visibility on the curve due to trees and overgrown vegetation, which can lead to head-on collisions
Recommendations:	<ul style="list-style-type: none"> ● Improve the line of sight by removing trees from the shoulder and cut down vegetation which hampers visibility along the curves
Reasons for concern:	Sharp curves in BUA VRUs in the BUA are at high risk as they share space with the high speed traffic
Recommendations:	Provide all the curve treatments mentioned above in addition to traffic calming measures and speed restriction signs in the BUA

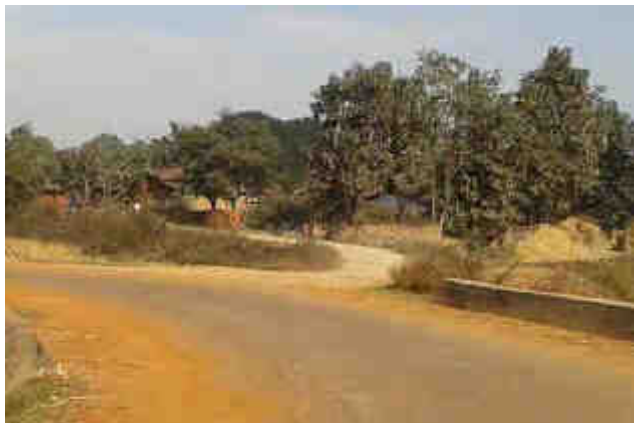
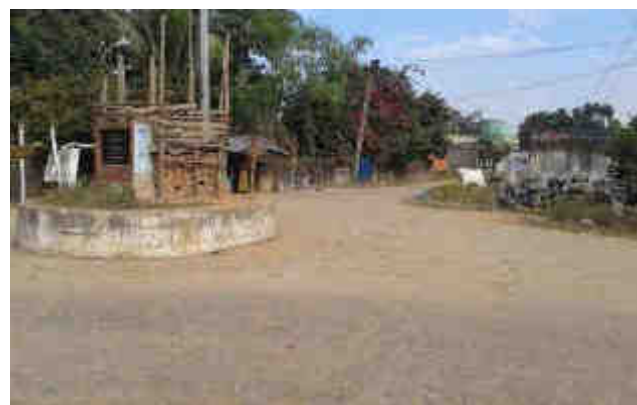
Side road joining Garjan Road at Km 6+200 and Km 4+200

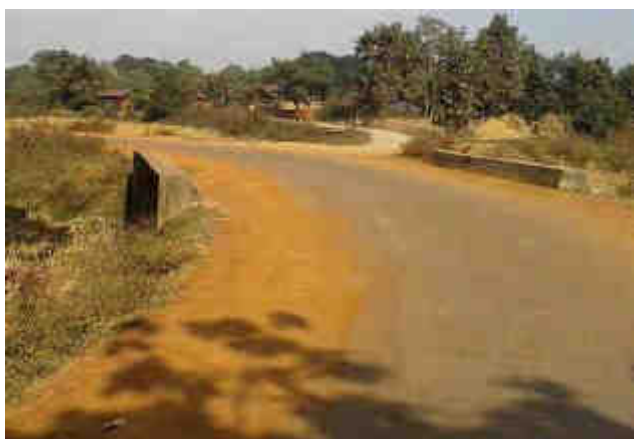
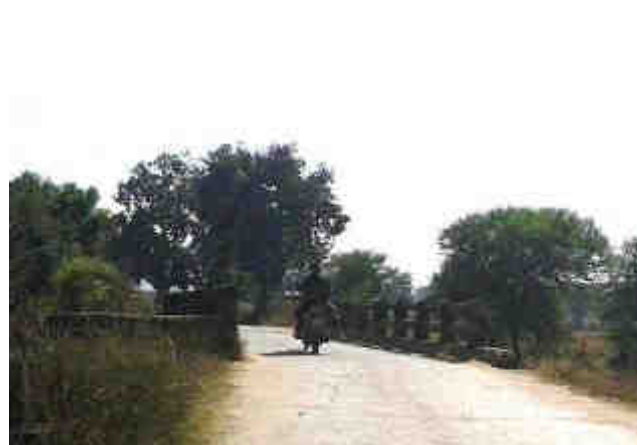
Parapets of Culvert/Bridge not delineated, Km 6+200 and Km 0+600

- The culvert/ bridge parapets adjacent to high speed traffic movement are hazardous especially at night if not delineated as the driver cannot judge the position of such road side hazards.

- Provide edge line markings and Object Hazard Marker (OHM) on both sides and for both approaches (i.e. Four numbers of OHM for each structure)

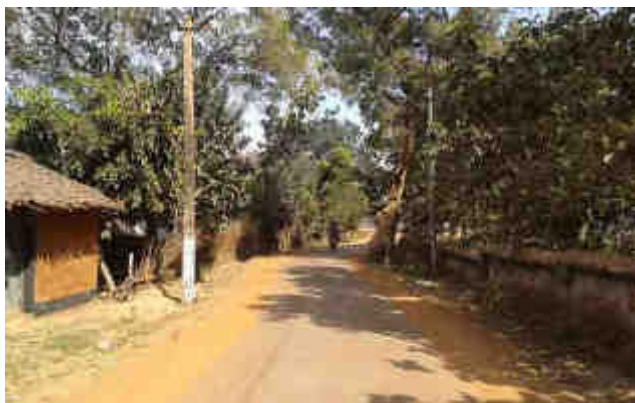
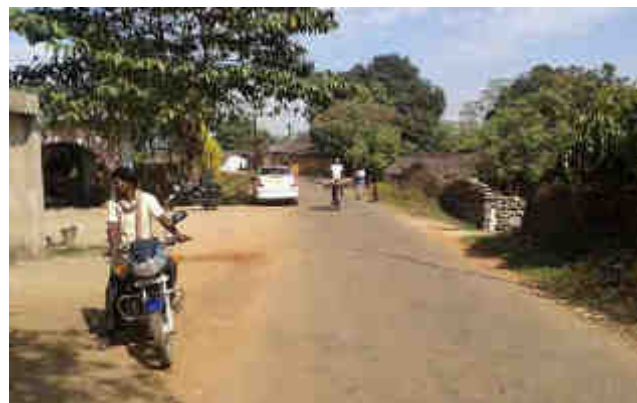
Trees, poles and buildings very near to road edge in BUA

- The road side objects like, trees, street light or other poles, and buildings which are near the edge of road needs to be protected and delineated.
- At night time it becomes very difficult for drivers to judge the position of such road side hazard.
- If the road side objects are not protected and/or illuminated there are chances of driver losing control and hitting these objects.
- In BUA, due to buildings very near to road edge there is no space left for pedestrians and other VRUs for movement along the road. This increases the risk for VRUs.

- Remove Trees/ street lighting poles from the road shoulders
- Remove encroachments from the right of way
- Provide crash barriers on locations where trees acts as a significant hazard and where the space is available to install crash barrier

- Delineate the hazards by installing OHMs or painting of the trees in black and white strips
- Remove encroachments on at least 2m from the road edge
- In BUA where buildings are very near the road edge provide traffic calming measures and footpaths or wide shoulder for along movement of VRUs.

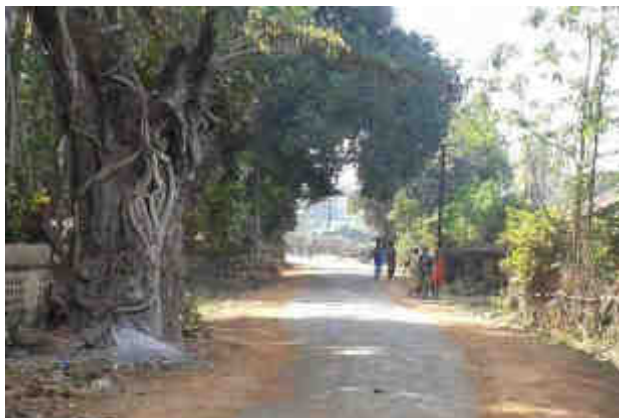
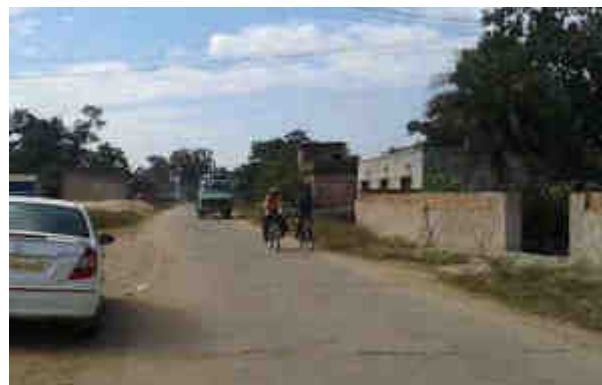
As the road assessed is a village road and all the above listed BUAs are small villages, congestion and on-street parking are less significant, however the presence of VRUs and their interaction with the road is significant. In these BUAs the buildings are very close to the road edge, and there is no facility for VRUs

such as pedestrian crossing or footpath. In such situation the risk of VRUs being involved in accident with motorized traffic is high.

BUA at Km 7+300 and Km 1+000

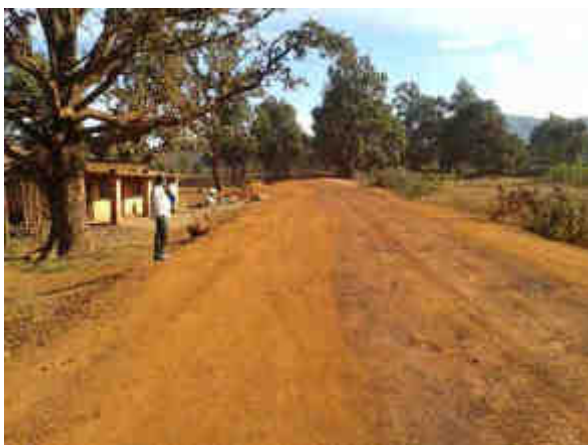
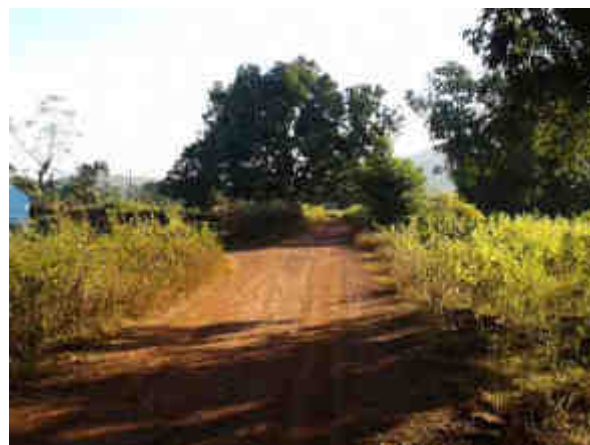
Poor road condition and lack of delineation on (i) Koida-Patmunda Road, and (ii) Koida-Khajurdihi Road.

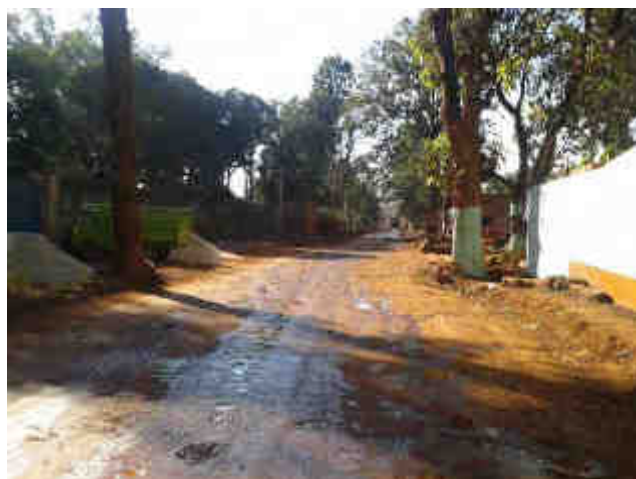
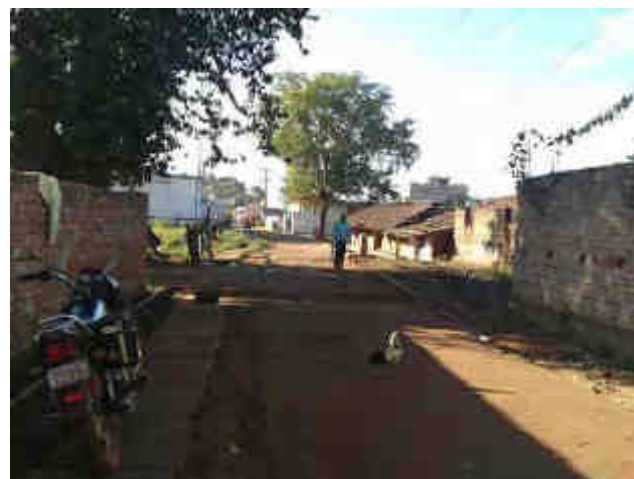
Trees and buildings very near to road edge in BUA

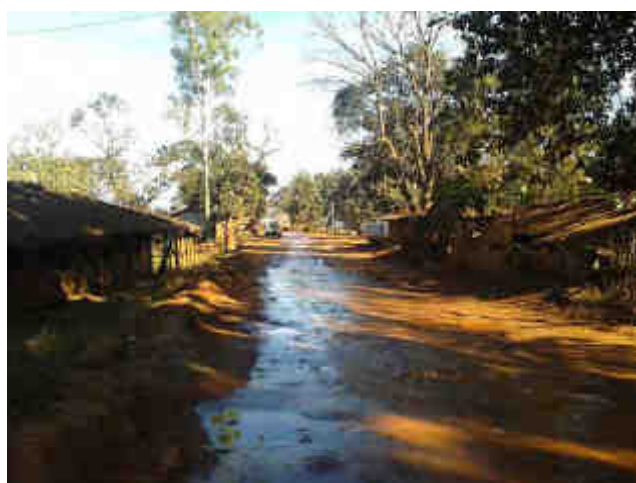
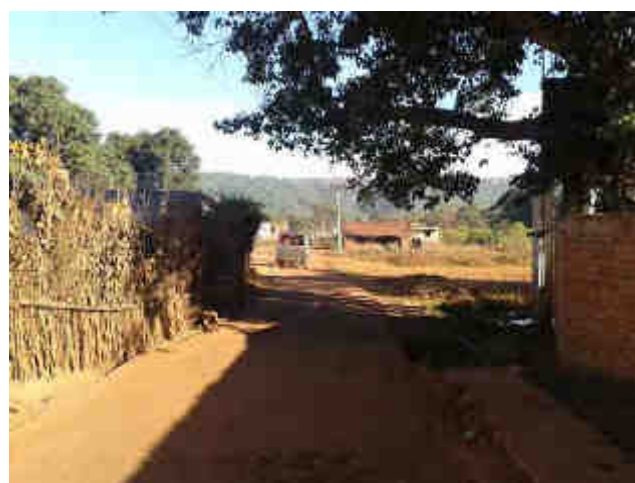
BUA at Km 0+000 and Km 7+700 on Koida-Patmunda Road

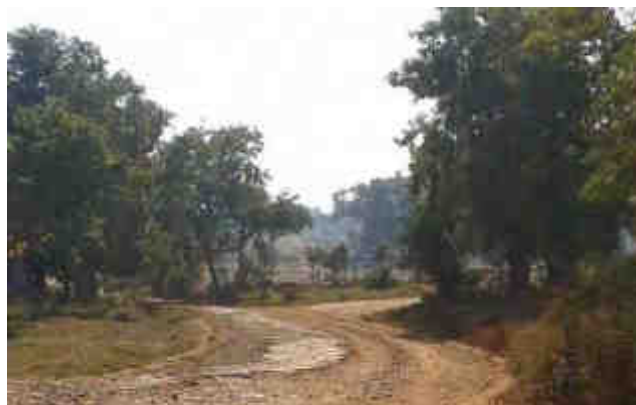
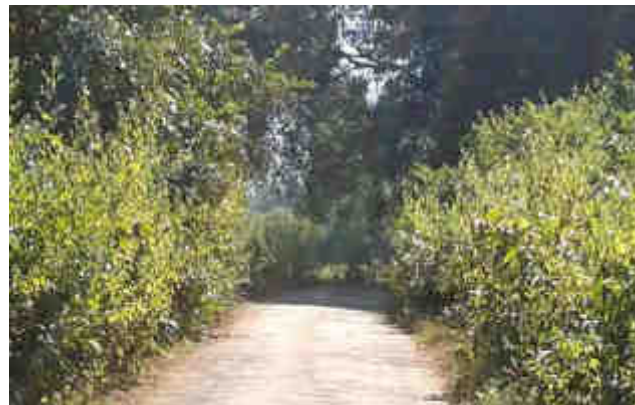
Sharp curves at Km 2+200 and Km 14+900
