**Government of Odisha (GOO)
Chief Engineer, World Bank Projects, Odisha
Odisha State Roads Project**

**Consultancy Services for
Road Sector Institutional Development
Loan # 7577-IN**

**ROAD INFRASTRUCTURE
SAFETY MANAGEMENT REVIEW**

VOLUME I - REPORT

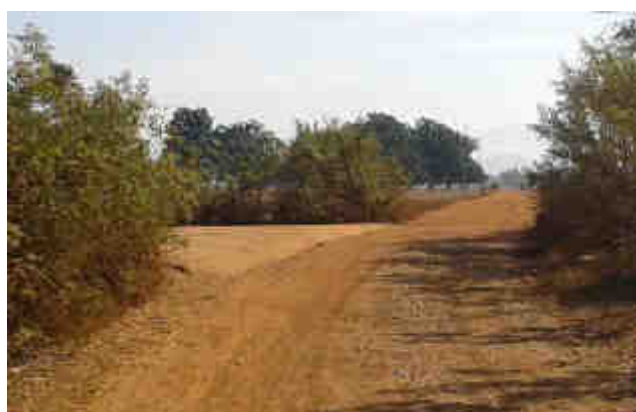
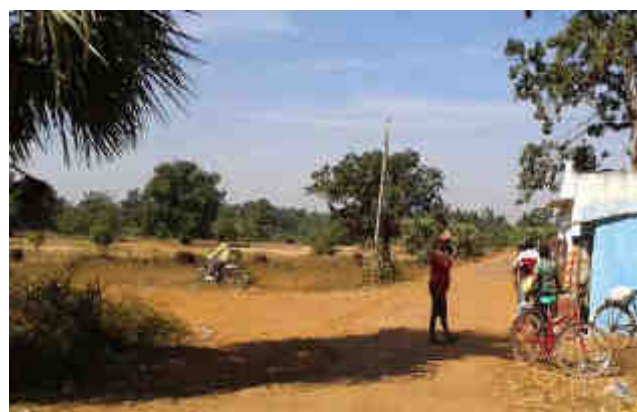
Side road joining Waterfall Road at Km 0+900 and Km 8+800

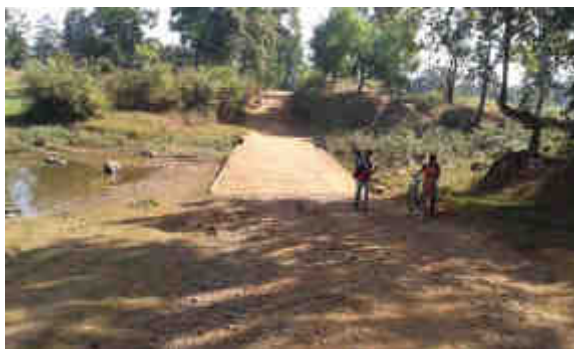
No parapets at low level bridge, Km 8+250

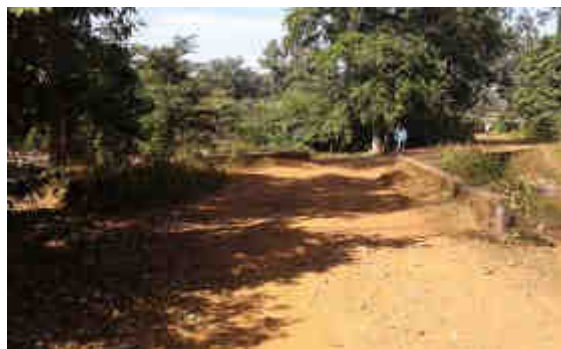
Parapets broken on culvert at Km 11+200

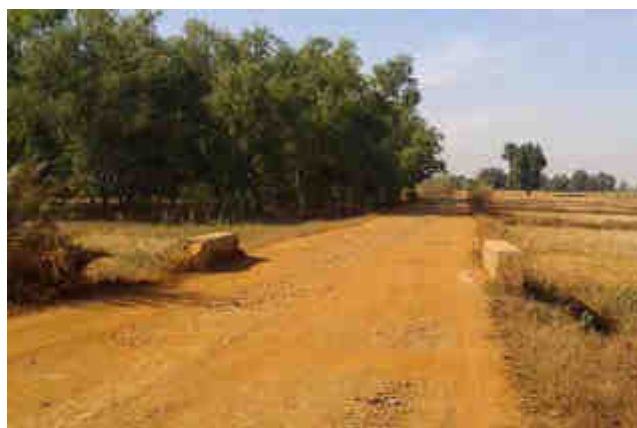
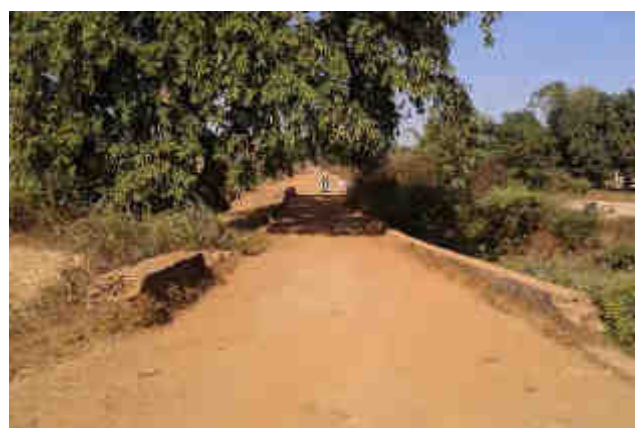
Parapets of Culvert/ Bridge not delineated, Km 0+500 and Km 4+500

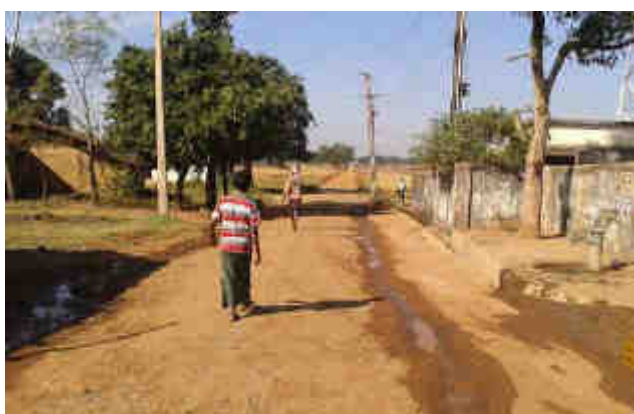
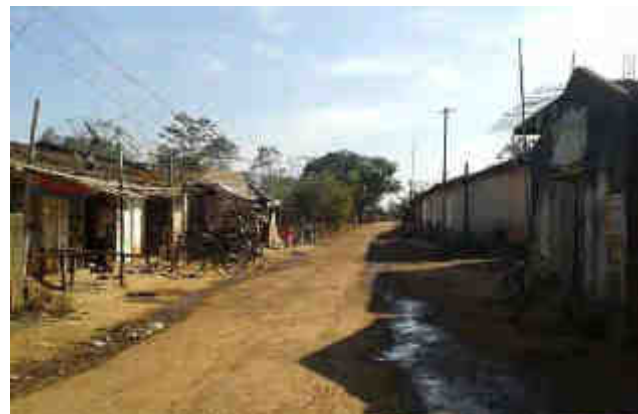
Poles and buildings very near to road edge in BUA

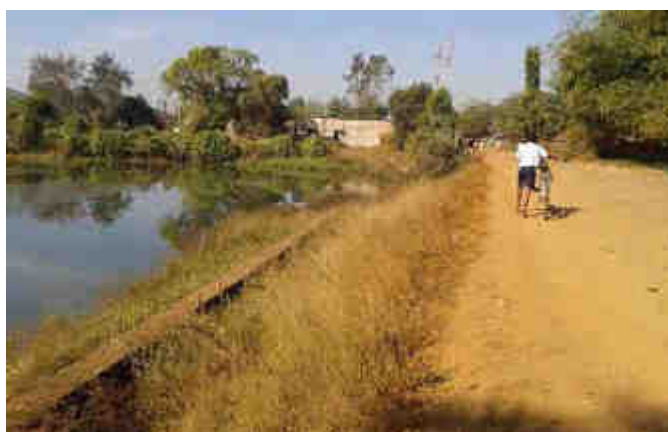
At **Km 2+200** there is a pond on RHS which is very near to the edge of road and there is no delineation or protection on the road edge.

Pond near the road without delineation or any edge protection,
Km 2+200

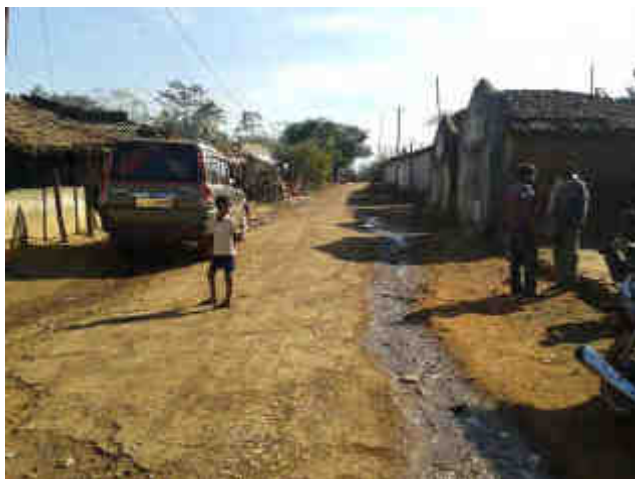
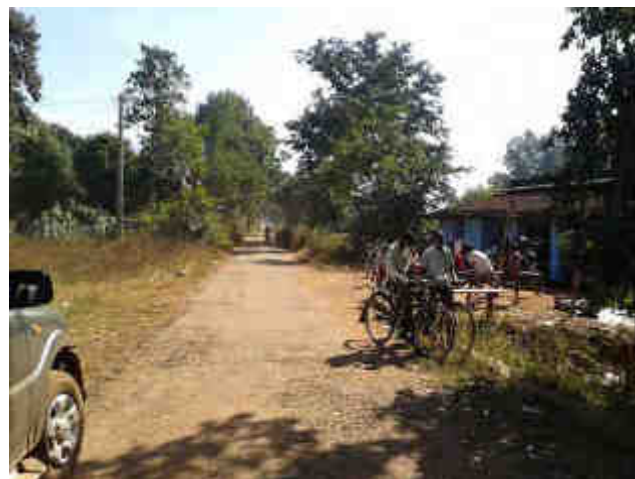
BUA at Km 1+800 and Km 6+900

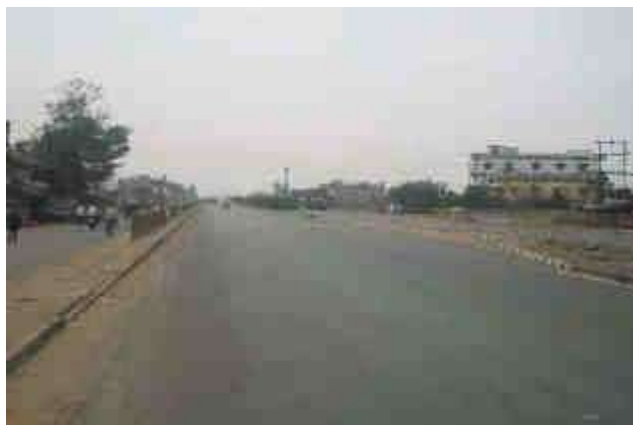
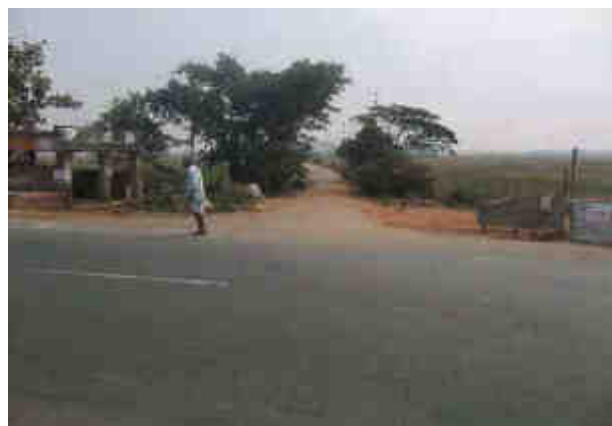
Absence of Centre line and edge line road marking at Km 225+480 and Km 219+500 respectively

Centre line is present at most of the stretches but edge line road markings were not provided, the presence of which should delineate the road, particularly during night conditions

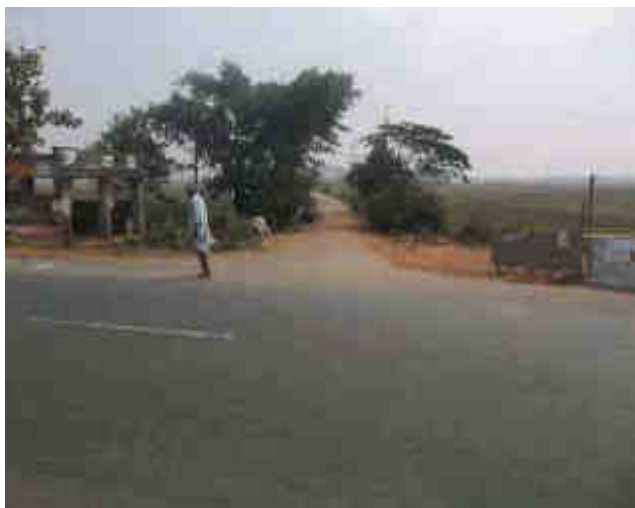
Side road with poor visibility due to vegetation at Km 225+200

This is a major hazard observed on most of the 3-armed uncontrolled junctions. The major reasons for poor visibility at such junctions on the road are due to buildings/encroachments on the corners.

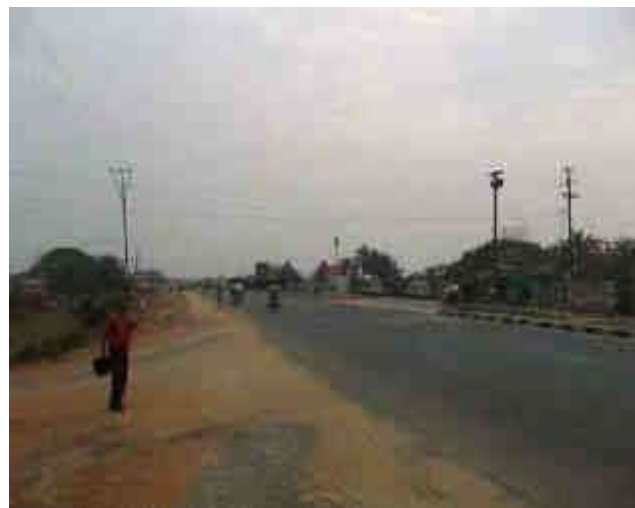
Level difference between side road and main road at Km 251+800

It has been observed that at a few junctions, the level differential between the side road and major road and the vertical profile of the side road joining the edge of main carriageway are in an unsafe manner.

- Recommendations:**
- Correct the vertical alignment of side road so that vehicles approaching from side roads has adequate length on the side road to slow down/ stop before entering into the main carriageway.

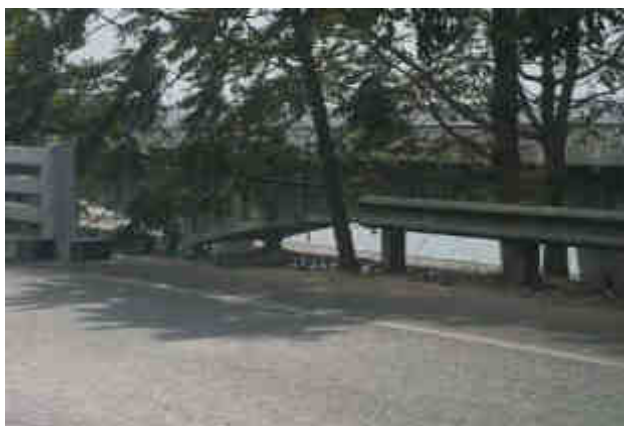
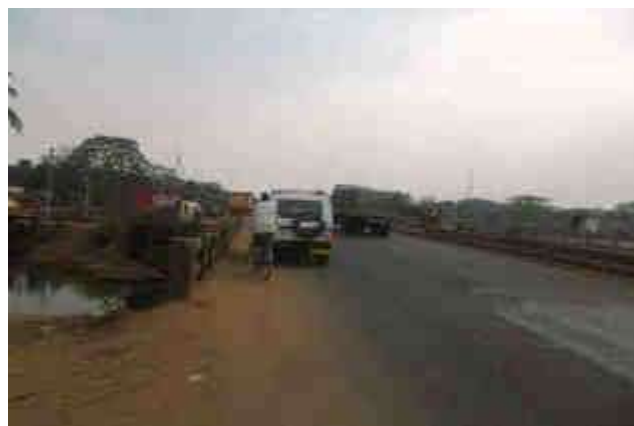
- Sharp Curve on approaches;
- No protection on outside curve;

Unsafe Approach to Bridge at Km 253+000 and Km 271+200 respectively

In the absence of adequate warning signs and reflective markings, the road layout and the hazard will not be clear for the road user, particularly during night conditions which may lead to serious injuries/ fatal accidents

- Provide curve warning signs in addition to crash barriers with delineators
- Provide edge lane markings
- Provide hazard markers on the edges of the parapets

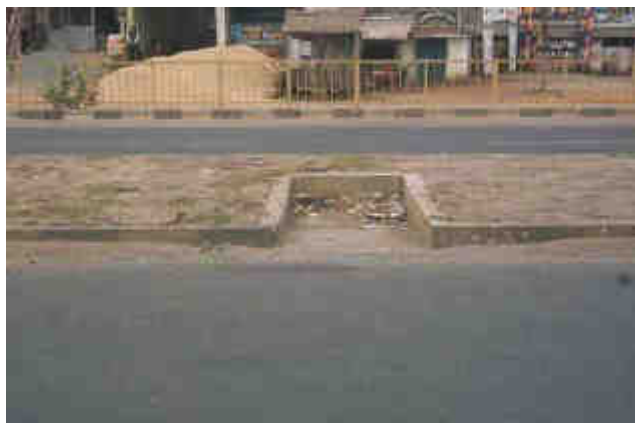
Drain located near to pavement edge at Km 219+100

The road side objects like trees and street lighting poles, buildings and unprotected deep drains pose significant safety hazard. At night time it becomes very difficult for drivers to judge the position of such hazards, in the absence of proper delineation.

- Remove Trees/ street lighting poles from the road shoulders
- Remove encroachments from the right of way
- Provide crash barriers on locations where trees acts as a significant hazard and where the space is available to install crash barrier

- Delineate the hazards by installing OHMs or painting of the trees in black and white strips
- Remove encroachments on at least 3m from the road edge

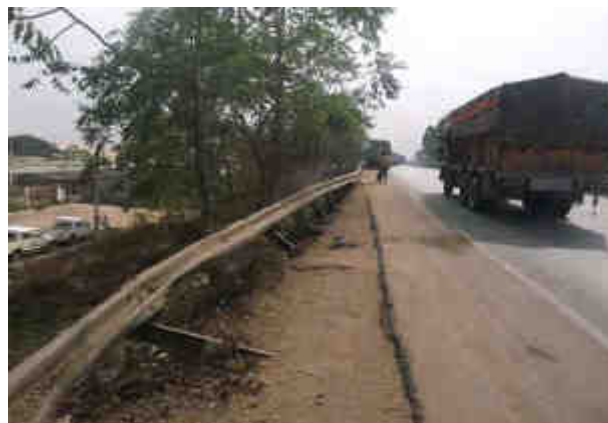
Project road has several trees and street light poles very near to the pavement edge which are hazardous for fast moving traffic. At some sections, the crash barriers are damaged probably due to accidents need to be fixed.

Broken crash barrier at Km 250+300

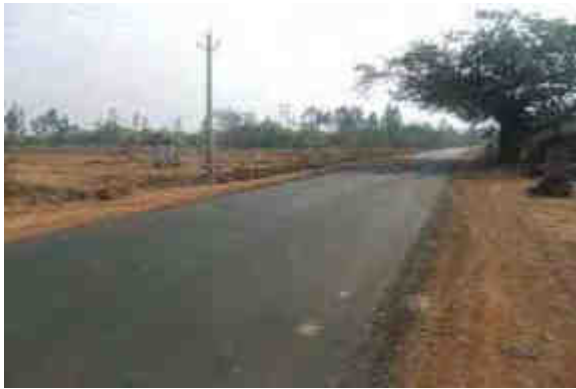
Absence of center line road marking at
Km 11+200

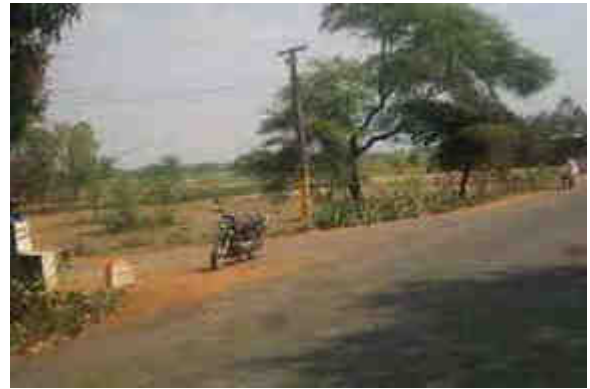
Absence of road marking at
Km 35+300

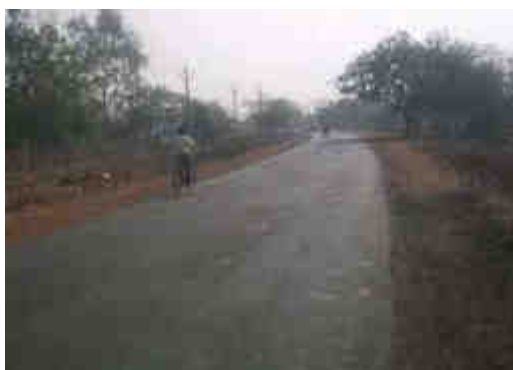
Curve at Km 6+500

Reasons for concern:	No warning signs/ delineation to inform the road user to make him/her slow down to negotiate the curve in a safe speed. In the worst case, this may lead to <ul style="list-style-type: none">• Potential run-off accidents• Potential head-on collisions
Recommendations:	<ul style="list-style-type: none">• Provide curve warning signs, chevron signs, delineators and speed limit sign as appropriate Refer to <i>Appendix III</i> for curve treatments.
Reasons for concern:	Poor visibility on the curve due to trees and overgrown vegetation , which can lead to head-on collisions
Recommendations:	<ul style="list-style-type: none">• Improve the line of sight by removing trees from the shoulder and cut down vegetation which hampers visibility along the curves
Reasons for concern:	On outer edge of some of these curves Concrete Guard Posts (CGP) are provided to protect the errant vehicles. As per international standards and practices, any concrete structure which is near the edge of road and larger by 10cm X 10cm in cross section is hazardous to the traffic.

Recommendations:	Provide chevron signs for delineation at all the curves
Reasons for concern:	On the curves with high embankment and without any protection on outer edge, there is high risk of run-off accidents.
Recommendations:	Provide metal beam crash barriers with delineators on sharp curves in high embankment <i>Refer to Appendix III for guidelines on situations where to install the above</i>
Reasons for concern:	Dangerous overtaking on sharp curves may lead to head-on collisions
Recommendations:	Provide 'no overtaking' traffic signs along with no overtaking lines on full length of the curve

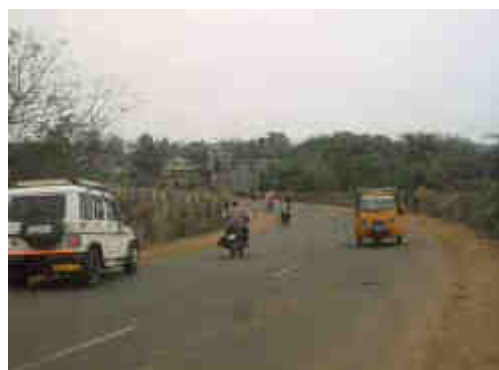
Curve at Km 51+640

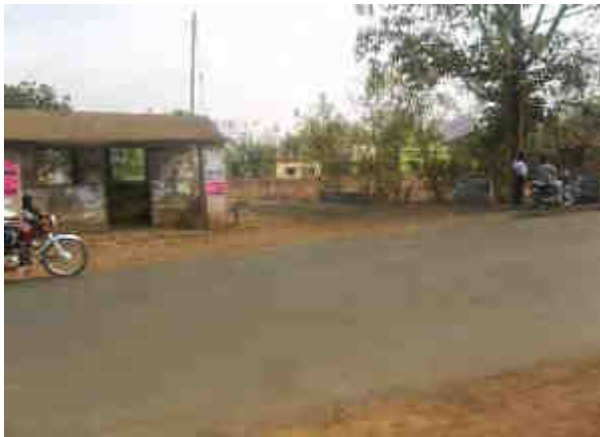
Perpendicular side road at Km 11+320

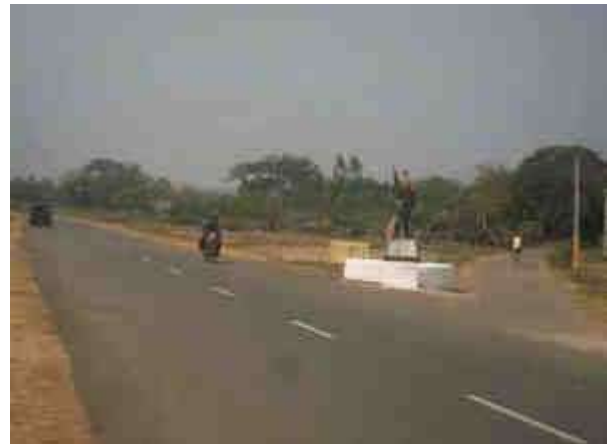
Skewed side road at Km 30+100

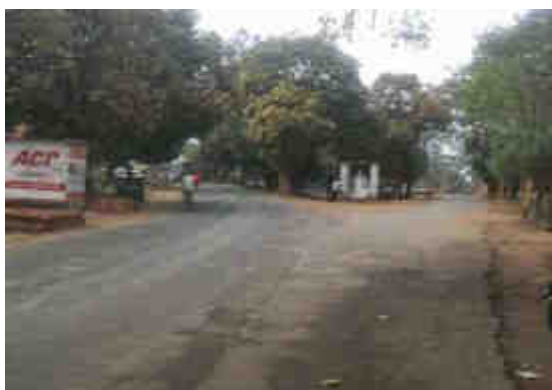
Km 40+100

- Poor layout of the junction with no established traffic control
- Junction area has moderate commercial activity and the level of encroachment is medium
- Big trees and statue obstructs the visibility for vehicles coming from side road
- Street lighting is not provided

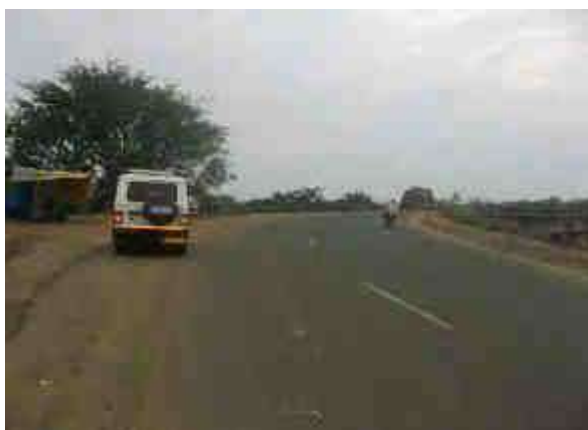
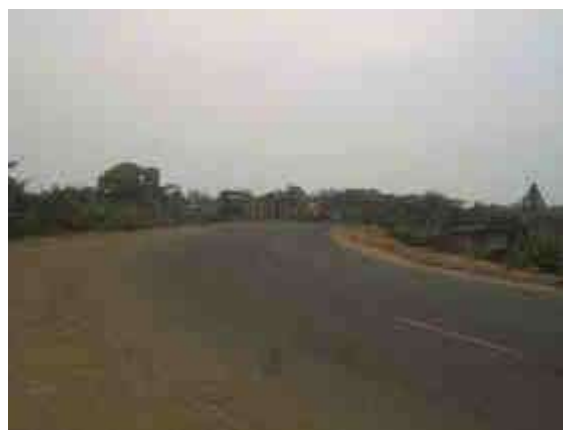
At chainage 51+640, a curve leads to a bridge on both approaches in high embankment, but it has been observed that no safety measures have been provided.

Approach to Major Bridge at high embankment at Km 51+640

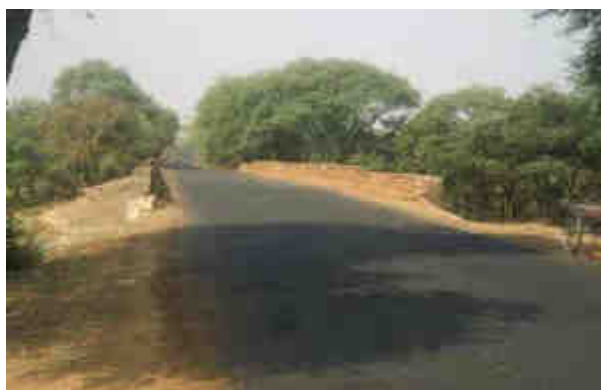
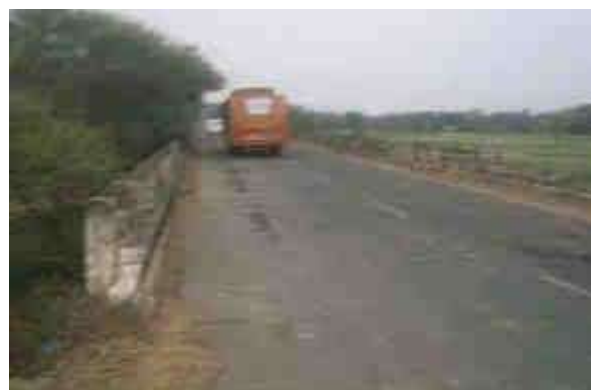
At the following chainages parapet wall was either broken or found missing. In the event of a vehicle loses control, the resultant injury will be fatal or major, due to the presence of water body.

Absence of OHM and broken parapet wall at Km 14+750 and at Km 49+350 respectively

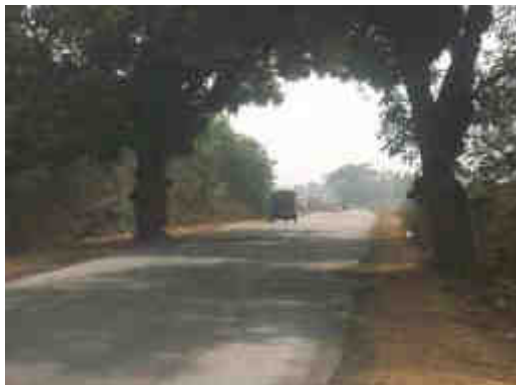
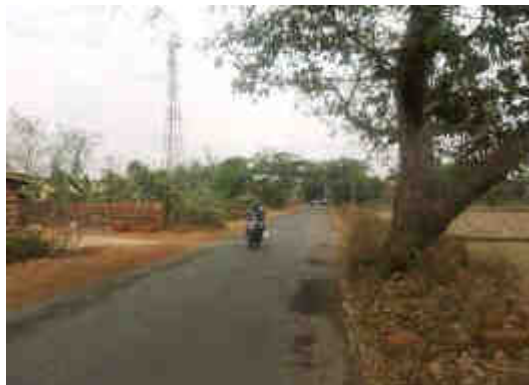
Project road have many locations where trees and street poles are very near to pavement edge.

Trees near pavement edge

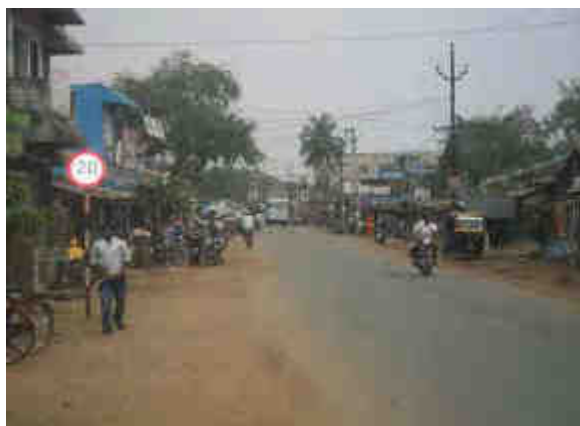
Commercial Area at Km 53+800

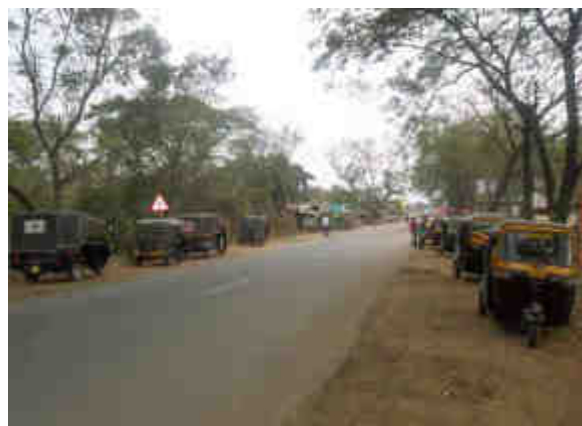
On street parking at Km 49+800

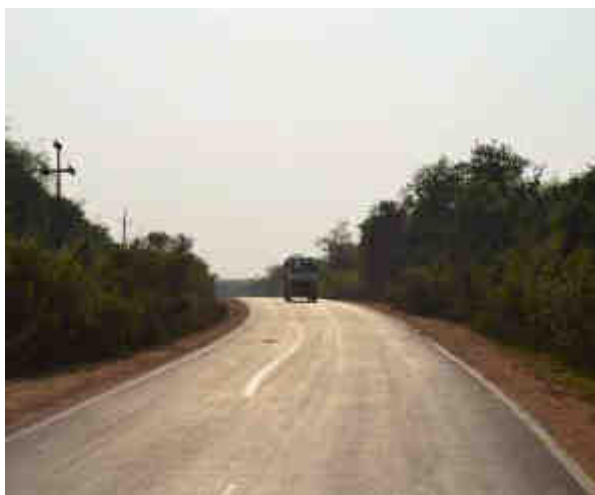
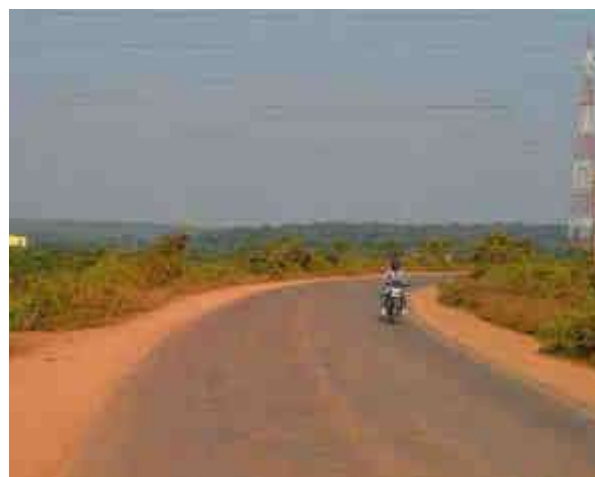
Sharp Curves on Project Road at Km 3+300 and Km 4+000

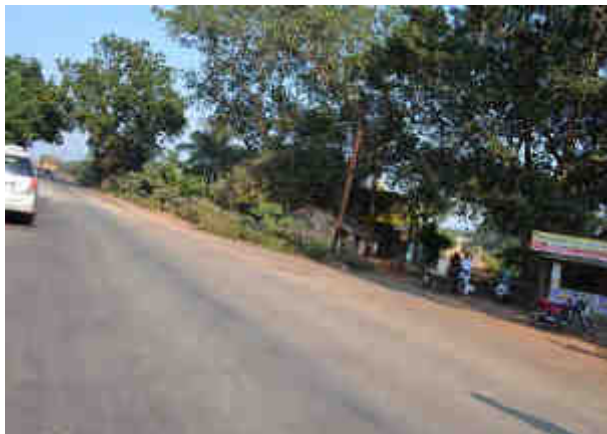
Skewed Side Road at Km 5+800

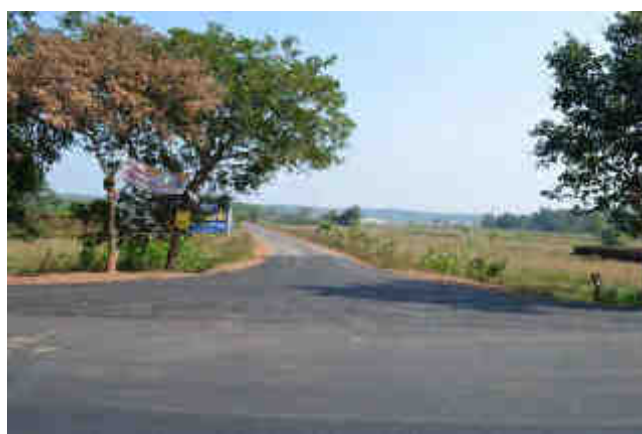
Side roads perpendicular to Major Road at Km 16+900

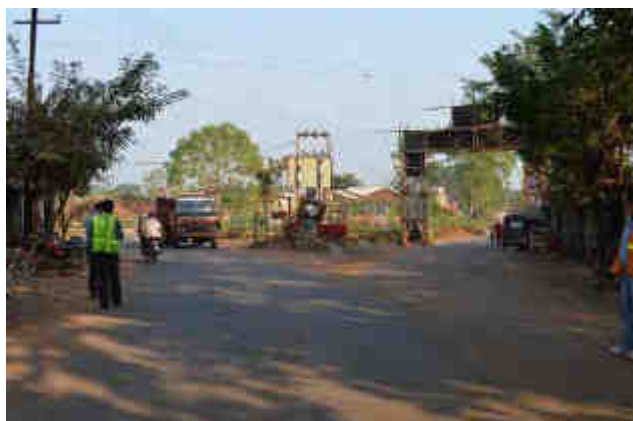
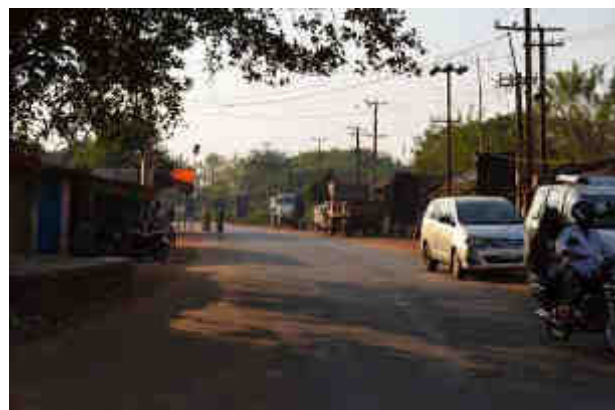
- Significant number of two wheelers, pedestrians and cyclists use the junction;
- Non-standard central traffic islands/ splitter were provided. Garbage is dumped near central traffic island; and
- Street light is absent.

- The junction layout is non-standard and has no control over the traffic movement. It is confusing who has priority in such a situation. This encourages lawless traffic movement and is hazardous. The existing central island is non-standard and hampers visibility at the junction.

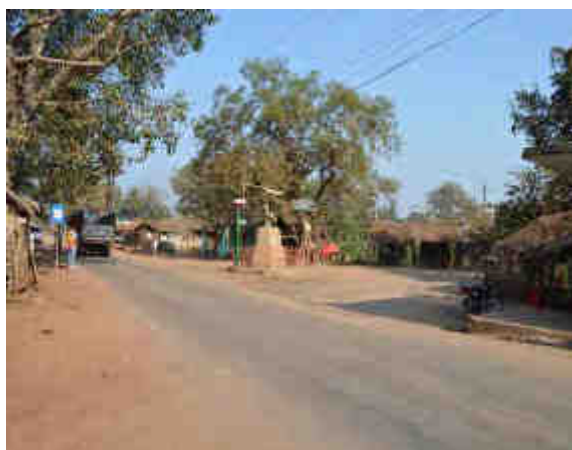
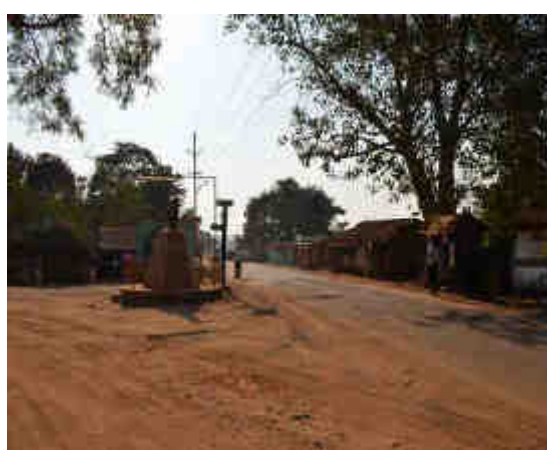
- Significant number of two wheelers, pedestrians and cyclists use the junction;
- Non-standard central traffic islands/ splitter were provided. Garbage is dumped near central traffic island; and
- Street light is absent.

- The junction layout is non-standard and has no control over the traffic movement. It is confusing who has priority in such a situation. This encourages lawless traffic movement and is hazardous. The existing central island is non-standard and hampers visibility at the junction.

- Recommendations:**
- Provide edge line markings, centerline markings and other junction road markings pertaining to junction control.

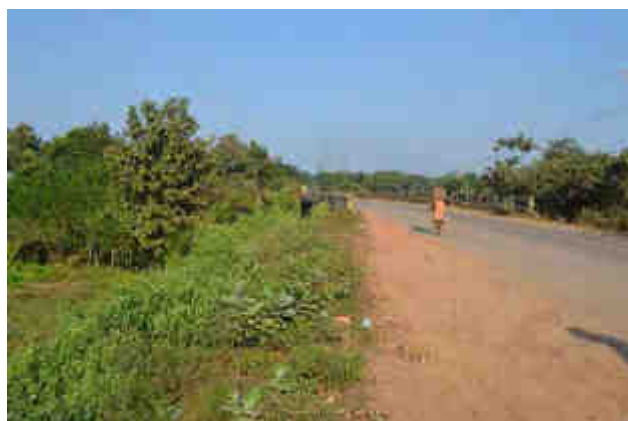
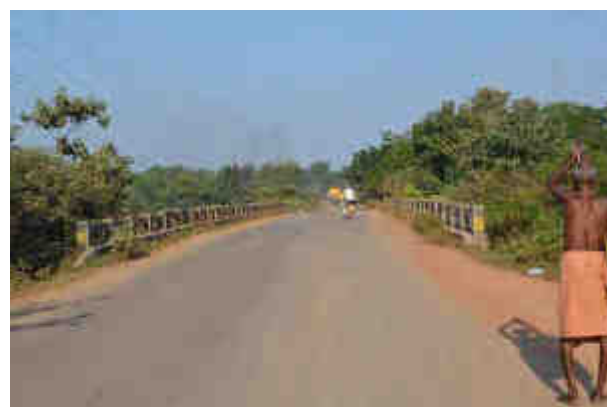
Approach to Major Bridge at high embankment at Km 51+640

At chainage 7+900, approach to bridge at high embankment is found, but no safety measures have been provided.

In the absence of adequate warning signs and reflective markings, the road layout and the hazard will not be clear for the road user, particularly during night conditions

and in worst conditions, this will lead to serious injury/ fatal accidents.

- Recommendation:**
- Provide curve warning sign in addition to crash barrier with delineators
 - Provide edge lane markings
 - Provide hazard markers on either edge of the parapets

- Recommendation:**
- Provide bar marking on either approaches to make vehicles slow down, in addition to curve warning signs and advisory speed limits
 - In case the location has a history of accidents, provide speed tables/ humps on either approach, along with warning signs for 'road hump'.

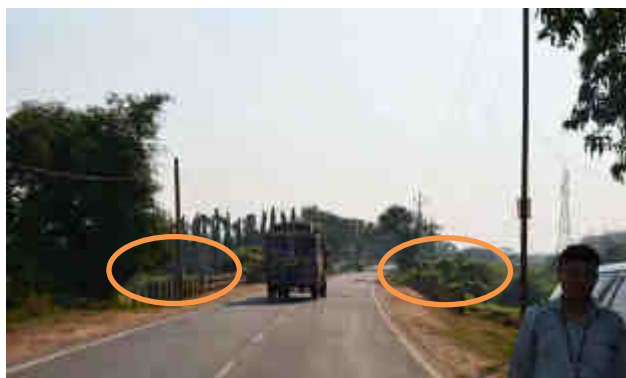
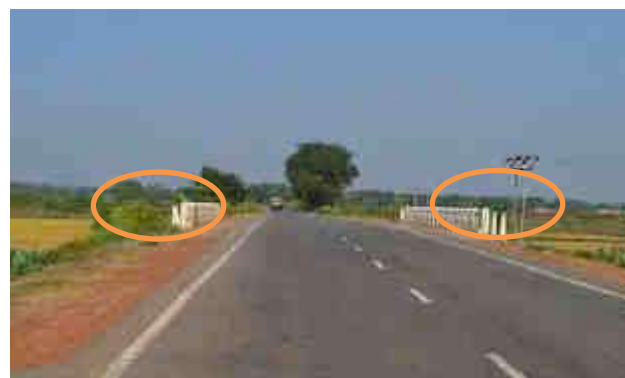
There is no hazard marker present on structures and major/minor bridges. Such locations are

Absence of OHM at Km 12+500 and Km 19+500

Reasons for concern: The bridge/ culvert parapets on the edge of the road adjacent to high speed traffic movement will be hazardous, particularly at dark conditions, and needs to be illuminated for a driver to judge the position of such road side hazard.

Recommendations: Install Object Hazard Marker (OHM) on both sides and for both approaches (i.e. Four numbers of each OHM for each structure.

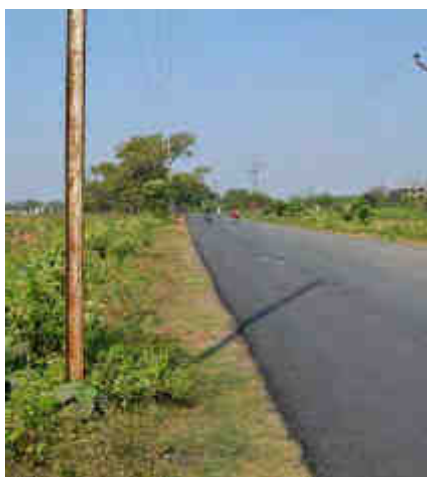
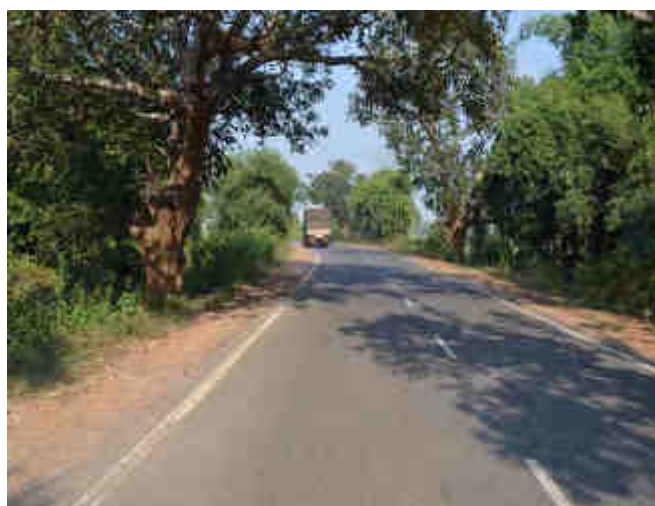
Tree and street light pole near pavement edge

The road side objects like trees, street lighting poles or other posts, buildings, and unprotected deep drains poses significant road safety hazard. At night time it becomes very difficult for drivers to judge the position of such road side hazard.

- Remove Trees from the road shoulders and relocate street lighting poles
- Provide crash barriers on locations where trees acts as a significant hazard and where the space is available to install crash barrier

- Delineate the hazards by installing OHMs or painting of the trees in black and white strips

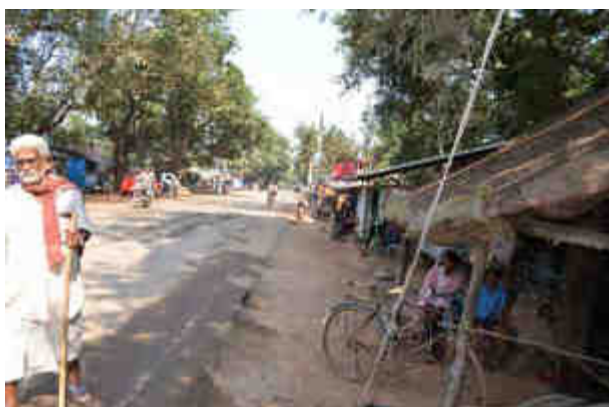
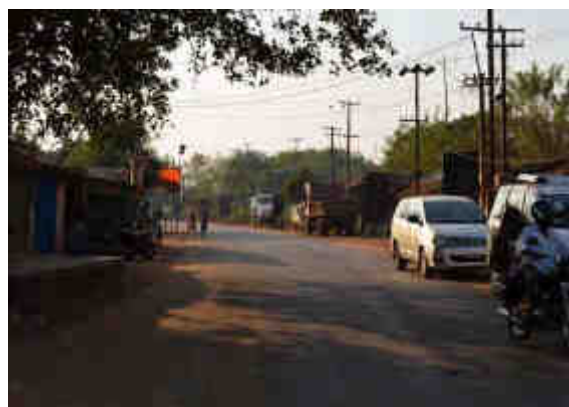
Built up Sections at Km 24+000 and Km 0+000

- No traffic calming measures are provided to slow down vehicles approaching at high speeds to the built up area
- Significant pedestrians including school children are noted, but no separate pedestrian facilities are provided along the road inside the BUA or to cross the road
- No road markings or warning signs to warn/ inform the road user of the built up nature of the area ahead
- No speed limit signs provided
